DESTRUCTIVE FLOODS IN THE UNITED
STATES IN 1904

EDWARD CHARLES MURPHY
AND OTHERS

WASHINGTON
GOVERNMENT PRINTING OFFICE
1905

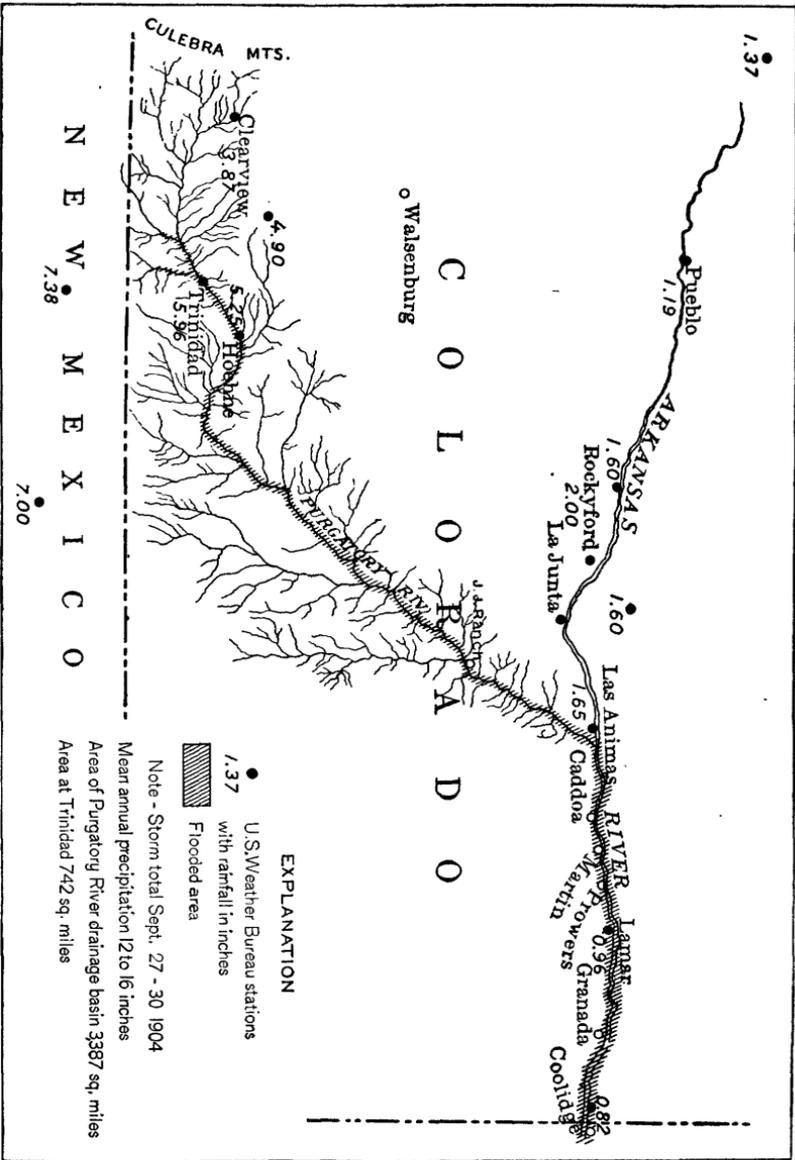
FIG. 15.—Drainage basin of Purgatory River.

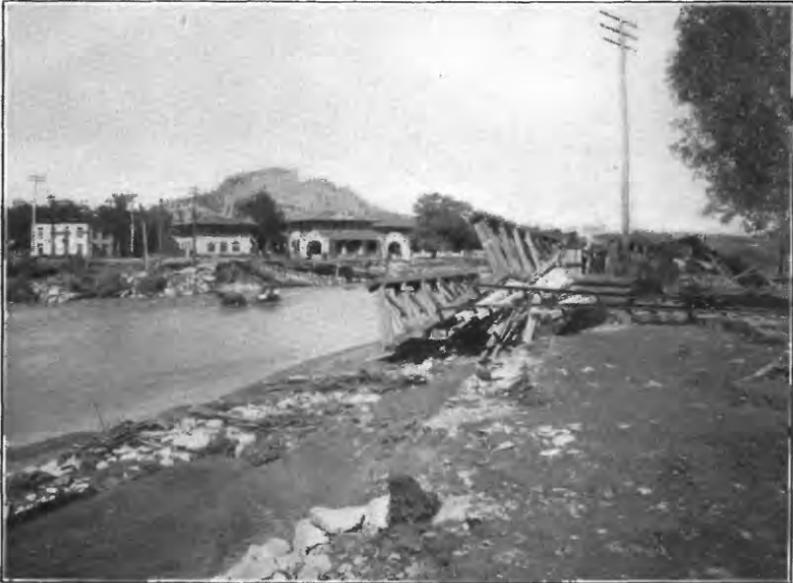
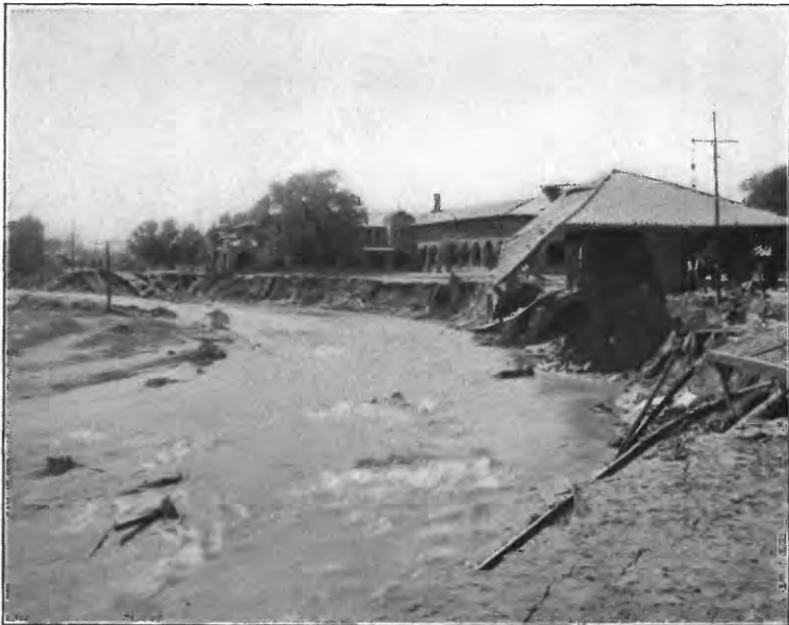
DESTRUCTION CAUSED BY FLOOD ON PURGATORY RIVER AT TRINIDAD, COLO.

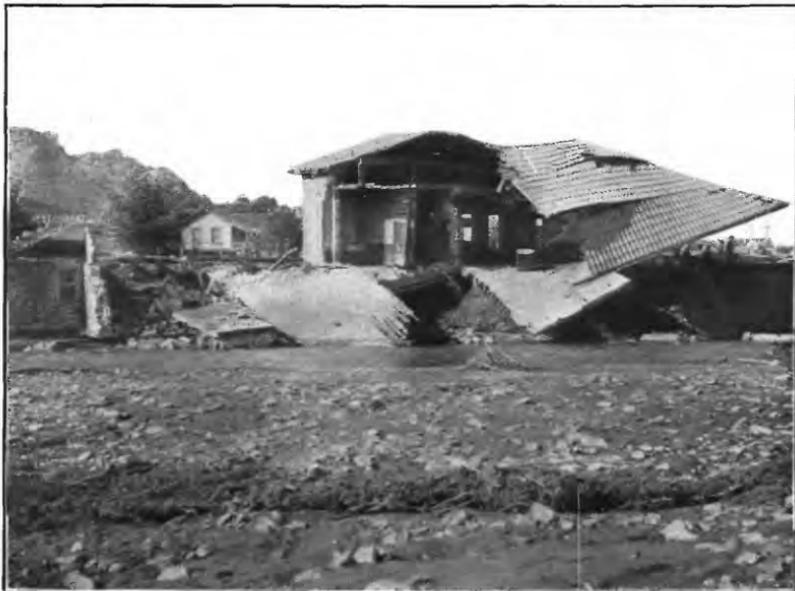
A. ATCHISON, TOPEKA AND SANTA FE RAILWAY STATION AT TRINIDAD, COLO.,
AFTER FLOOD OF SEPTEMBER, 1904.

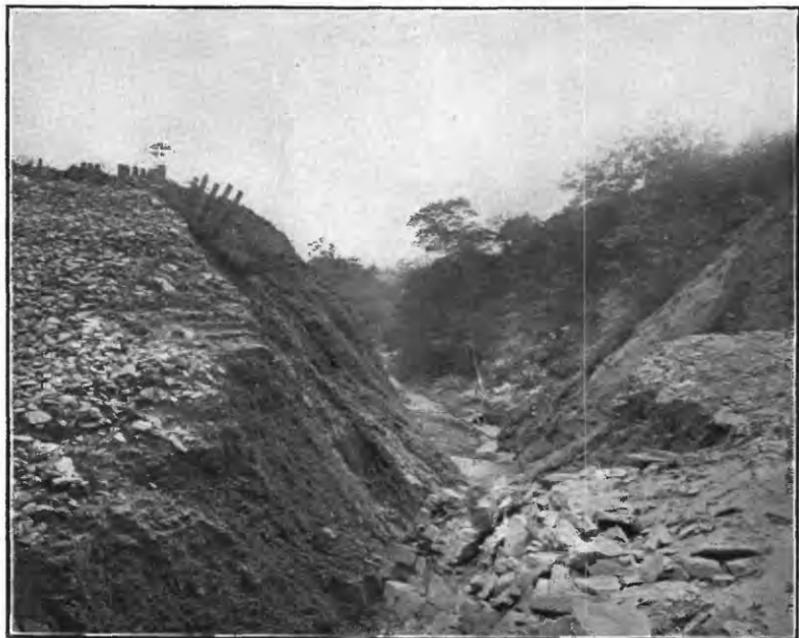
B VIEW SHOWING FAILURE OF DAM NEAR SCOTTTDALE, PA.

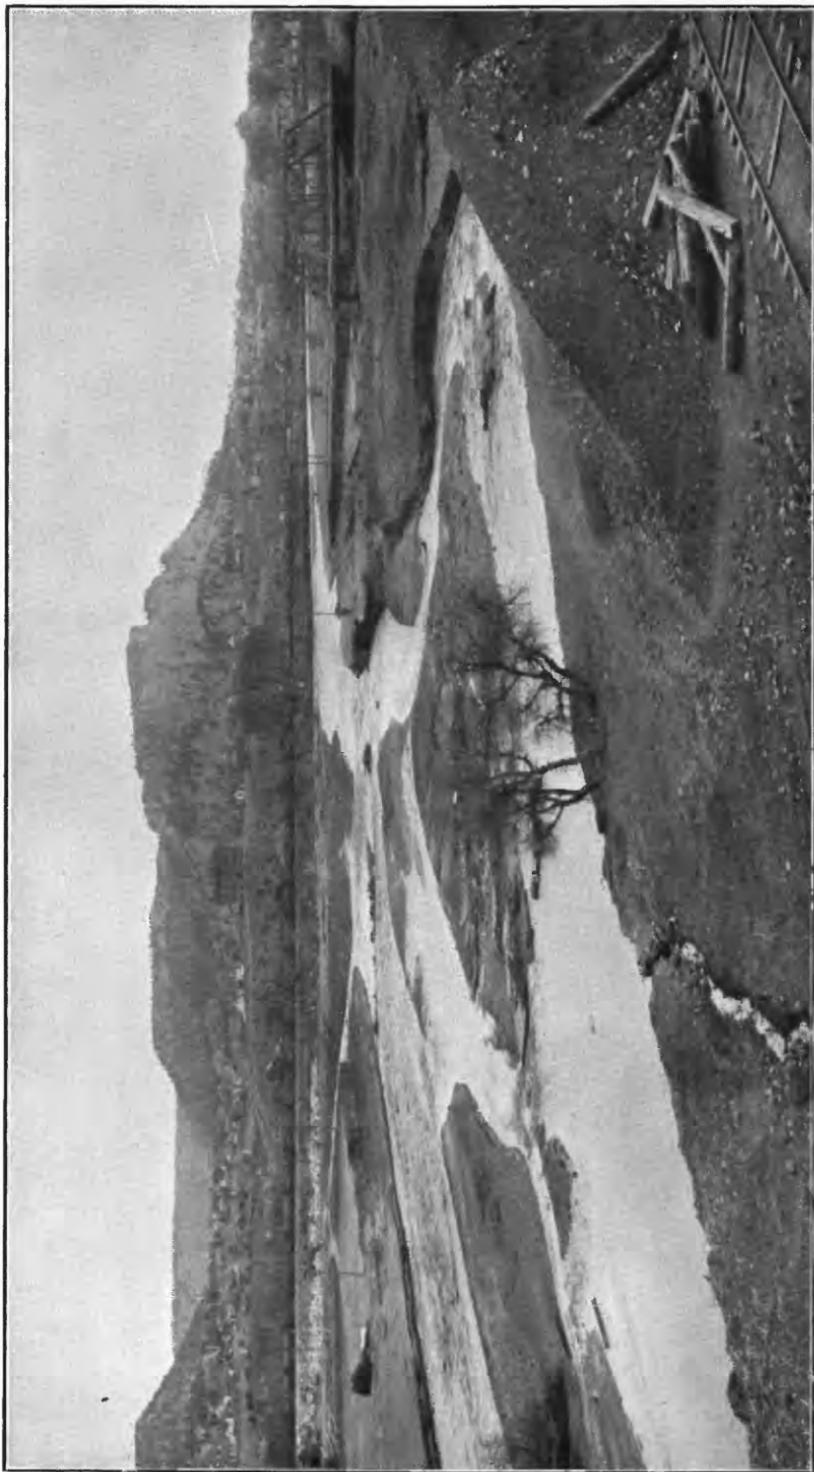
EROSION OF BANKS OF PURGATORY RIVER, TRINIDAD, COLO.

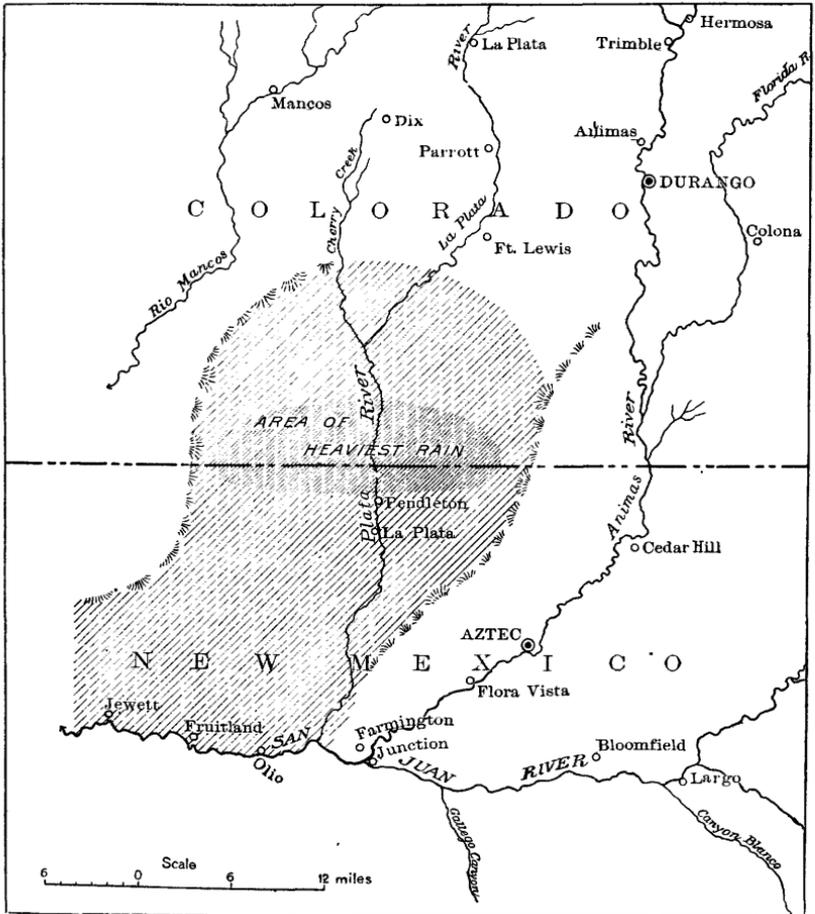
FIG. 17.—Drainage basin of La Plata River and area of heaviest rainfall on October 8, 1904.

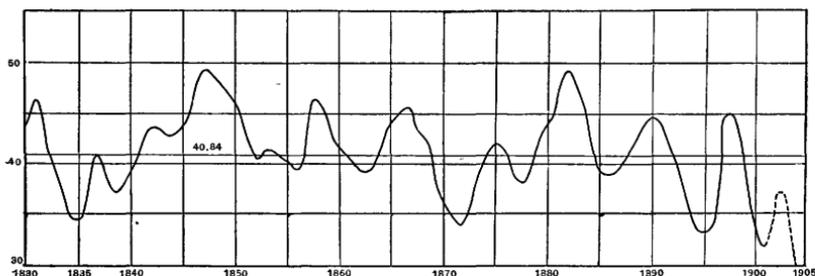
FIG. 18.—Curve showing mean annual precipitation at three places in the Ohio River drainage basin from 1830 to 1904.

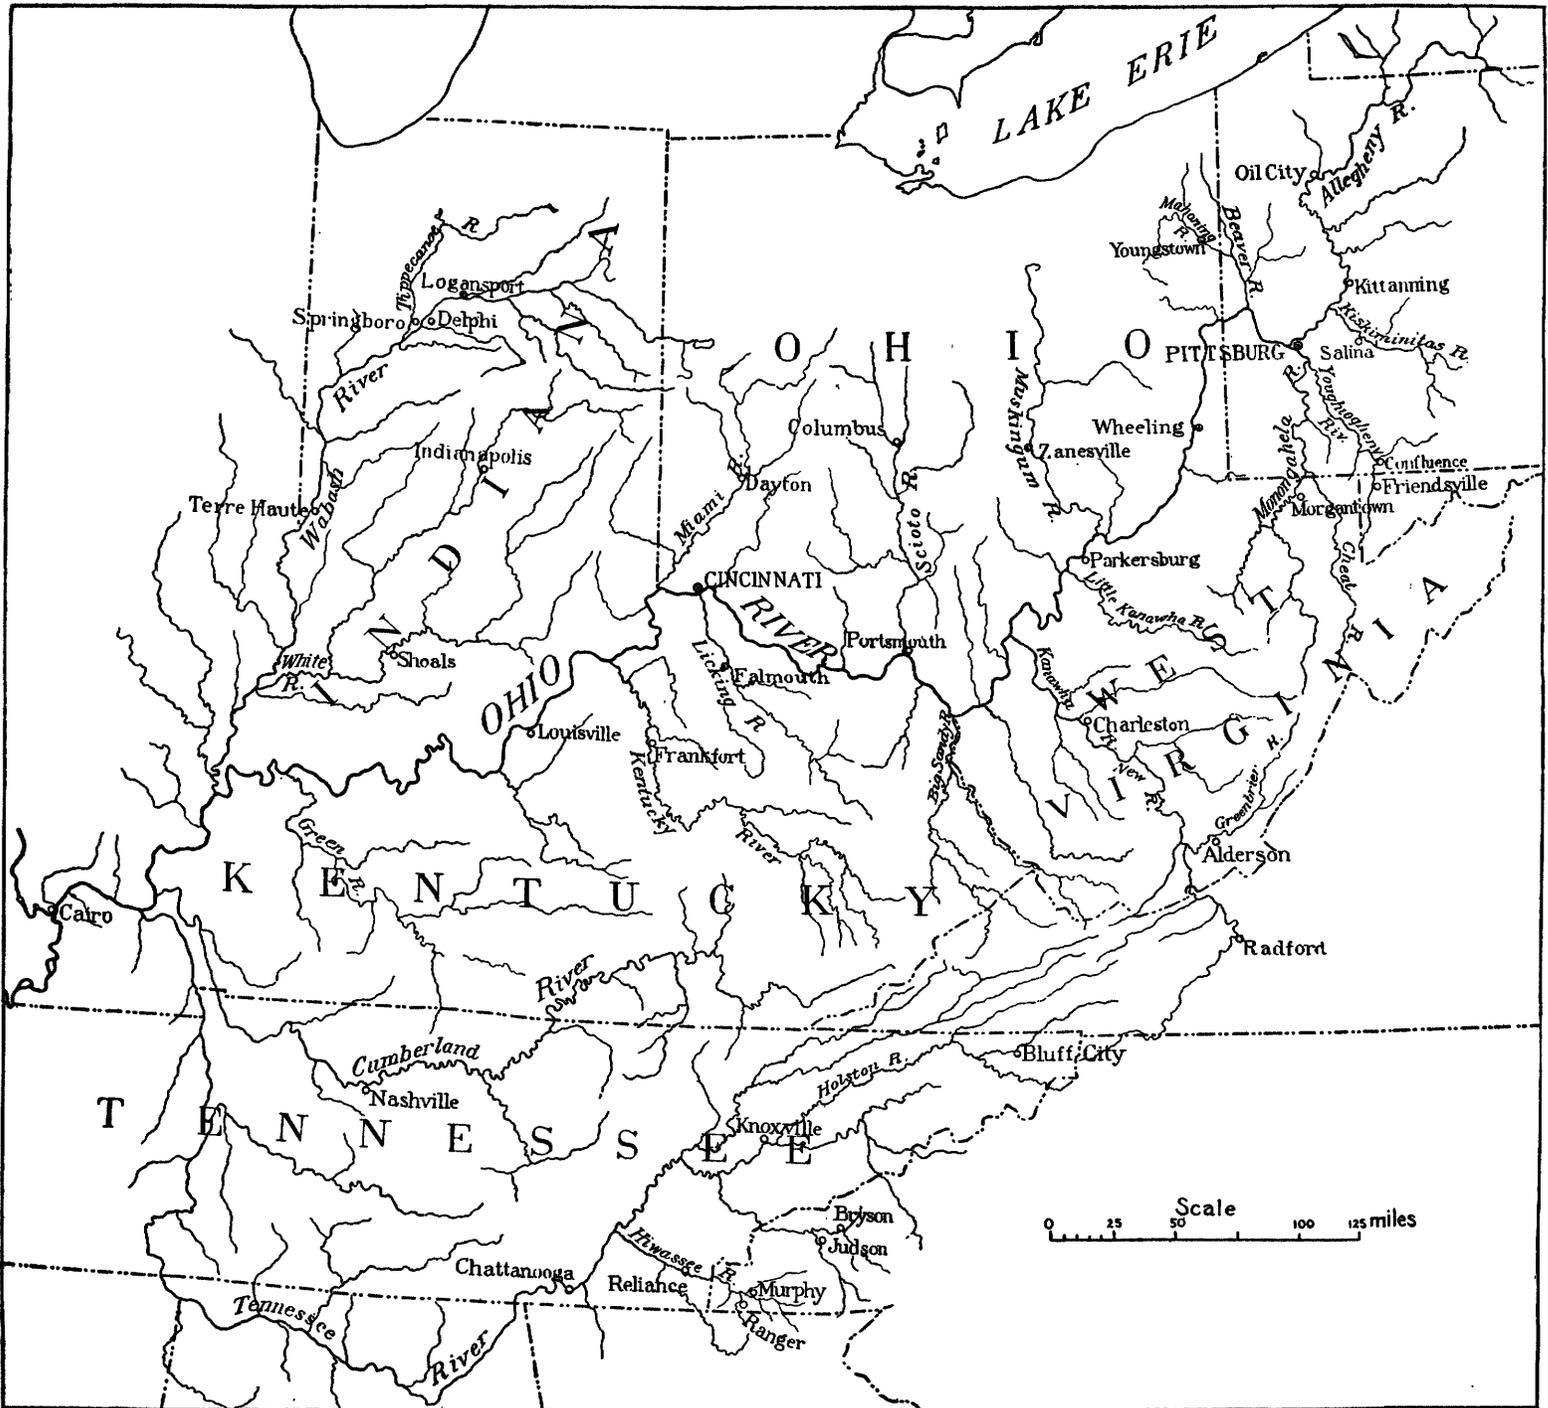
DRAINAGE BASIN OF OHIO RIVER.

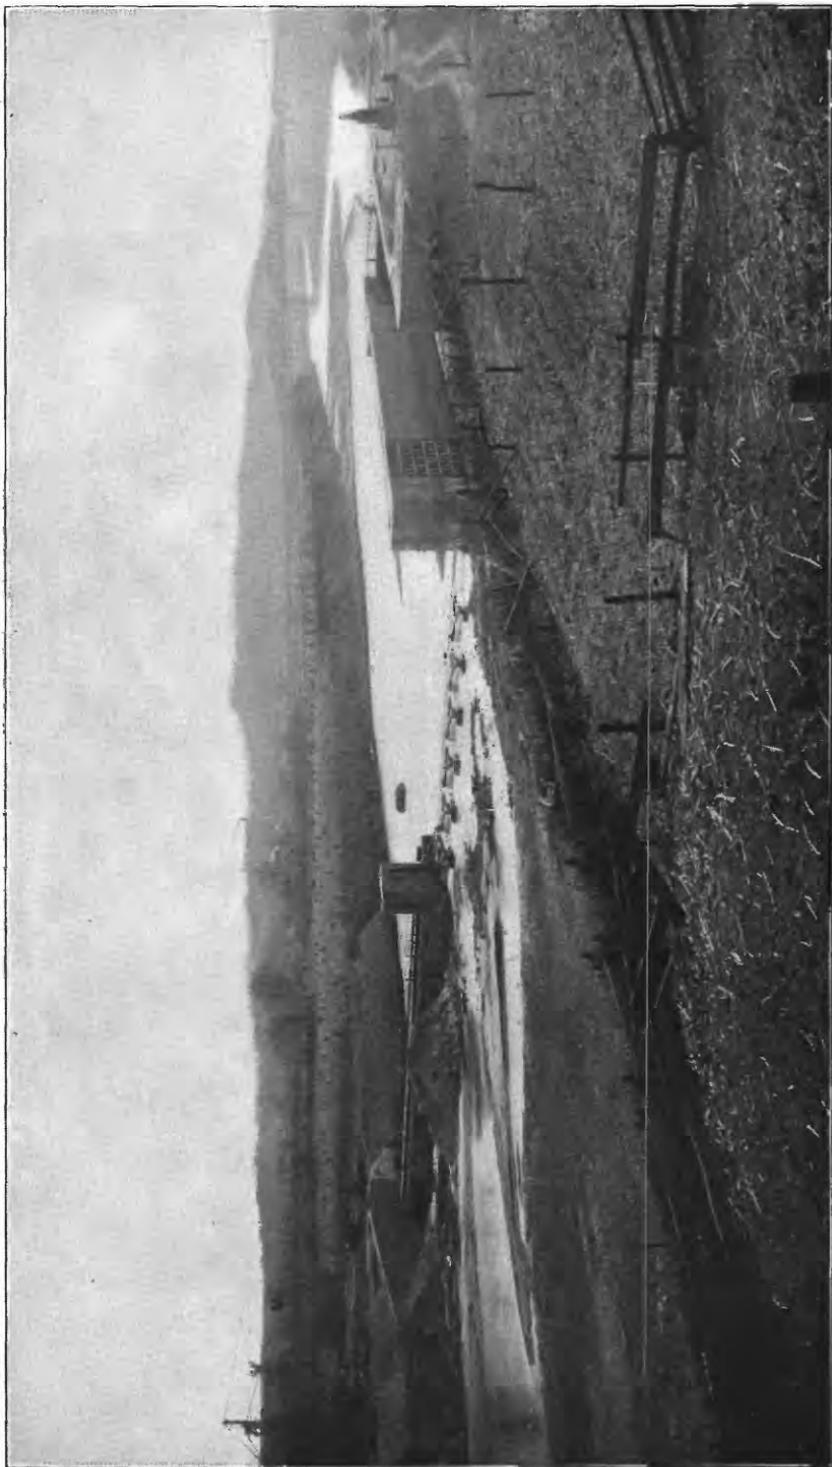
BIG SANDY RIVER, NEAR MOUTH, SHOWING EXTREME LOW-WATER CONDITIONS IN NOVEMBER, 1904.

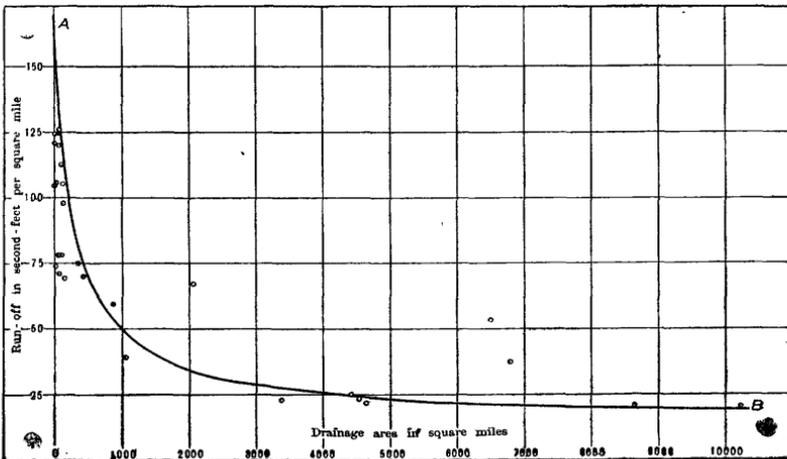
has been drawn to represent the relation between rate of flow and size of drainage basin for this section of the country. In this equation, M is the drainage area in square miles and q the maximum discharge in cubic feet per second per square mile of drainage.

FIG. 19.—Curve showing relation between size of drainage basin and run-off per square mile.
