WATER-SUPPLY PAPER 308

SURFACE WATER SUPPLY OF THE  
UNITED STATES

1911

PART VIII. WESTERN GULF OF MEXICO

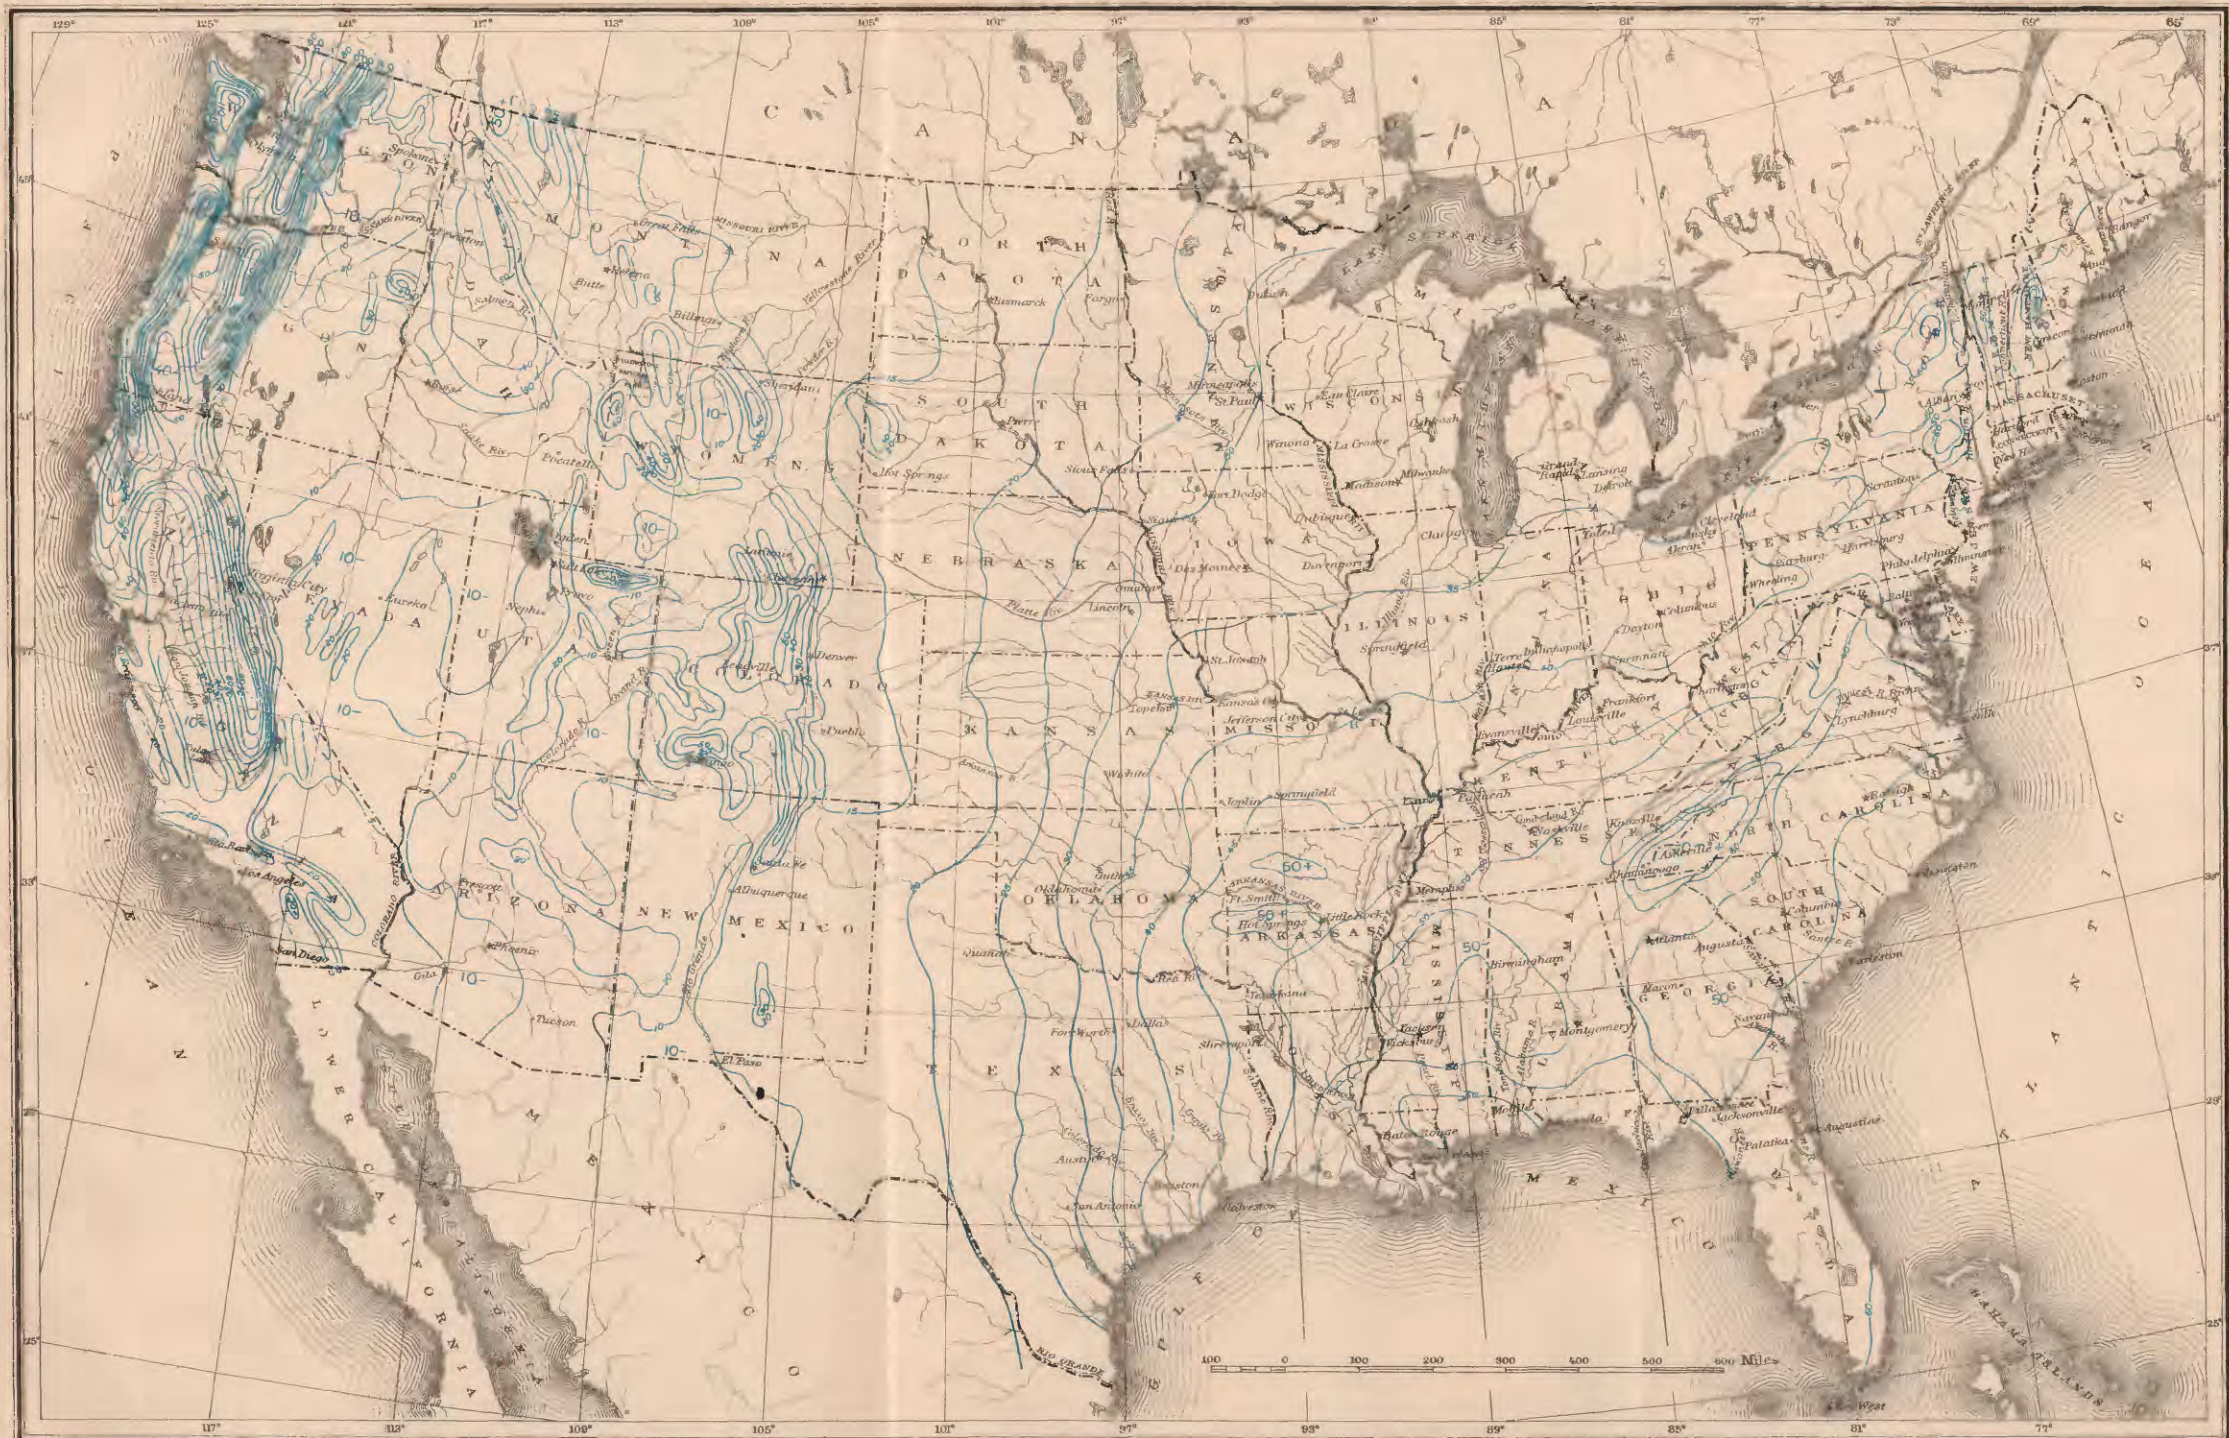
MAP OF UNITED STATES, SHOWING MEAN ANNUAL PRECIPITATION  
Blue lines and figures indicate average annual precipitation in depth in inches

| I. | Map of United States showing mean annual precipitation..... | 12 |

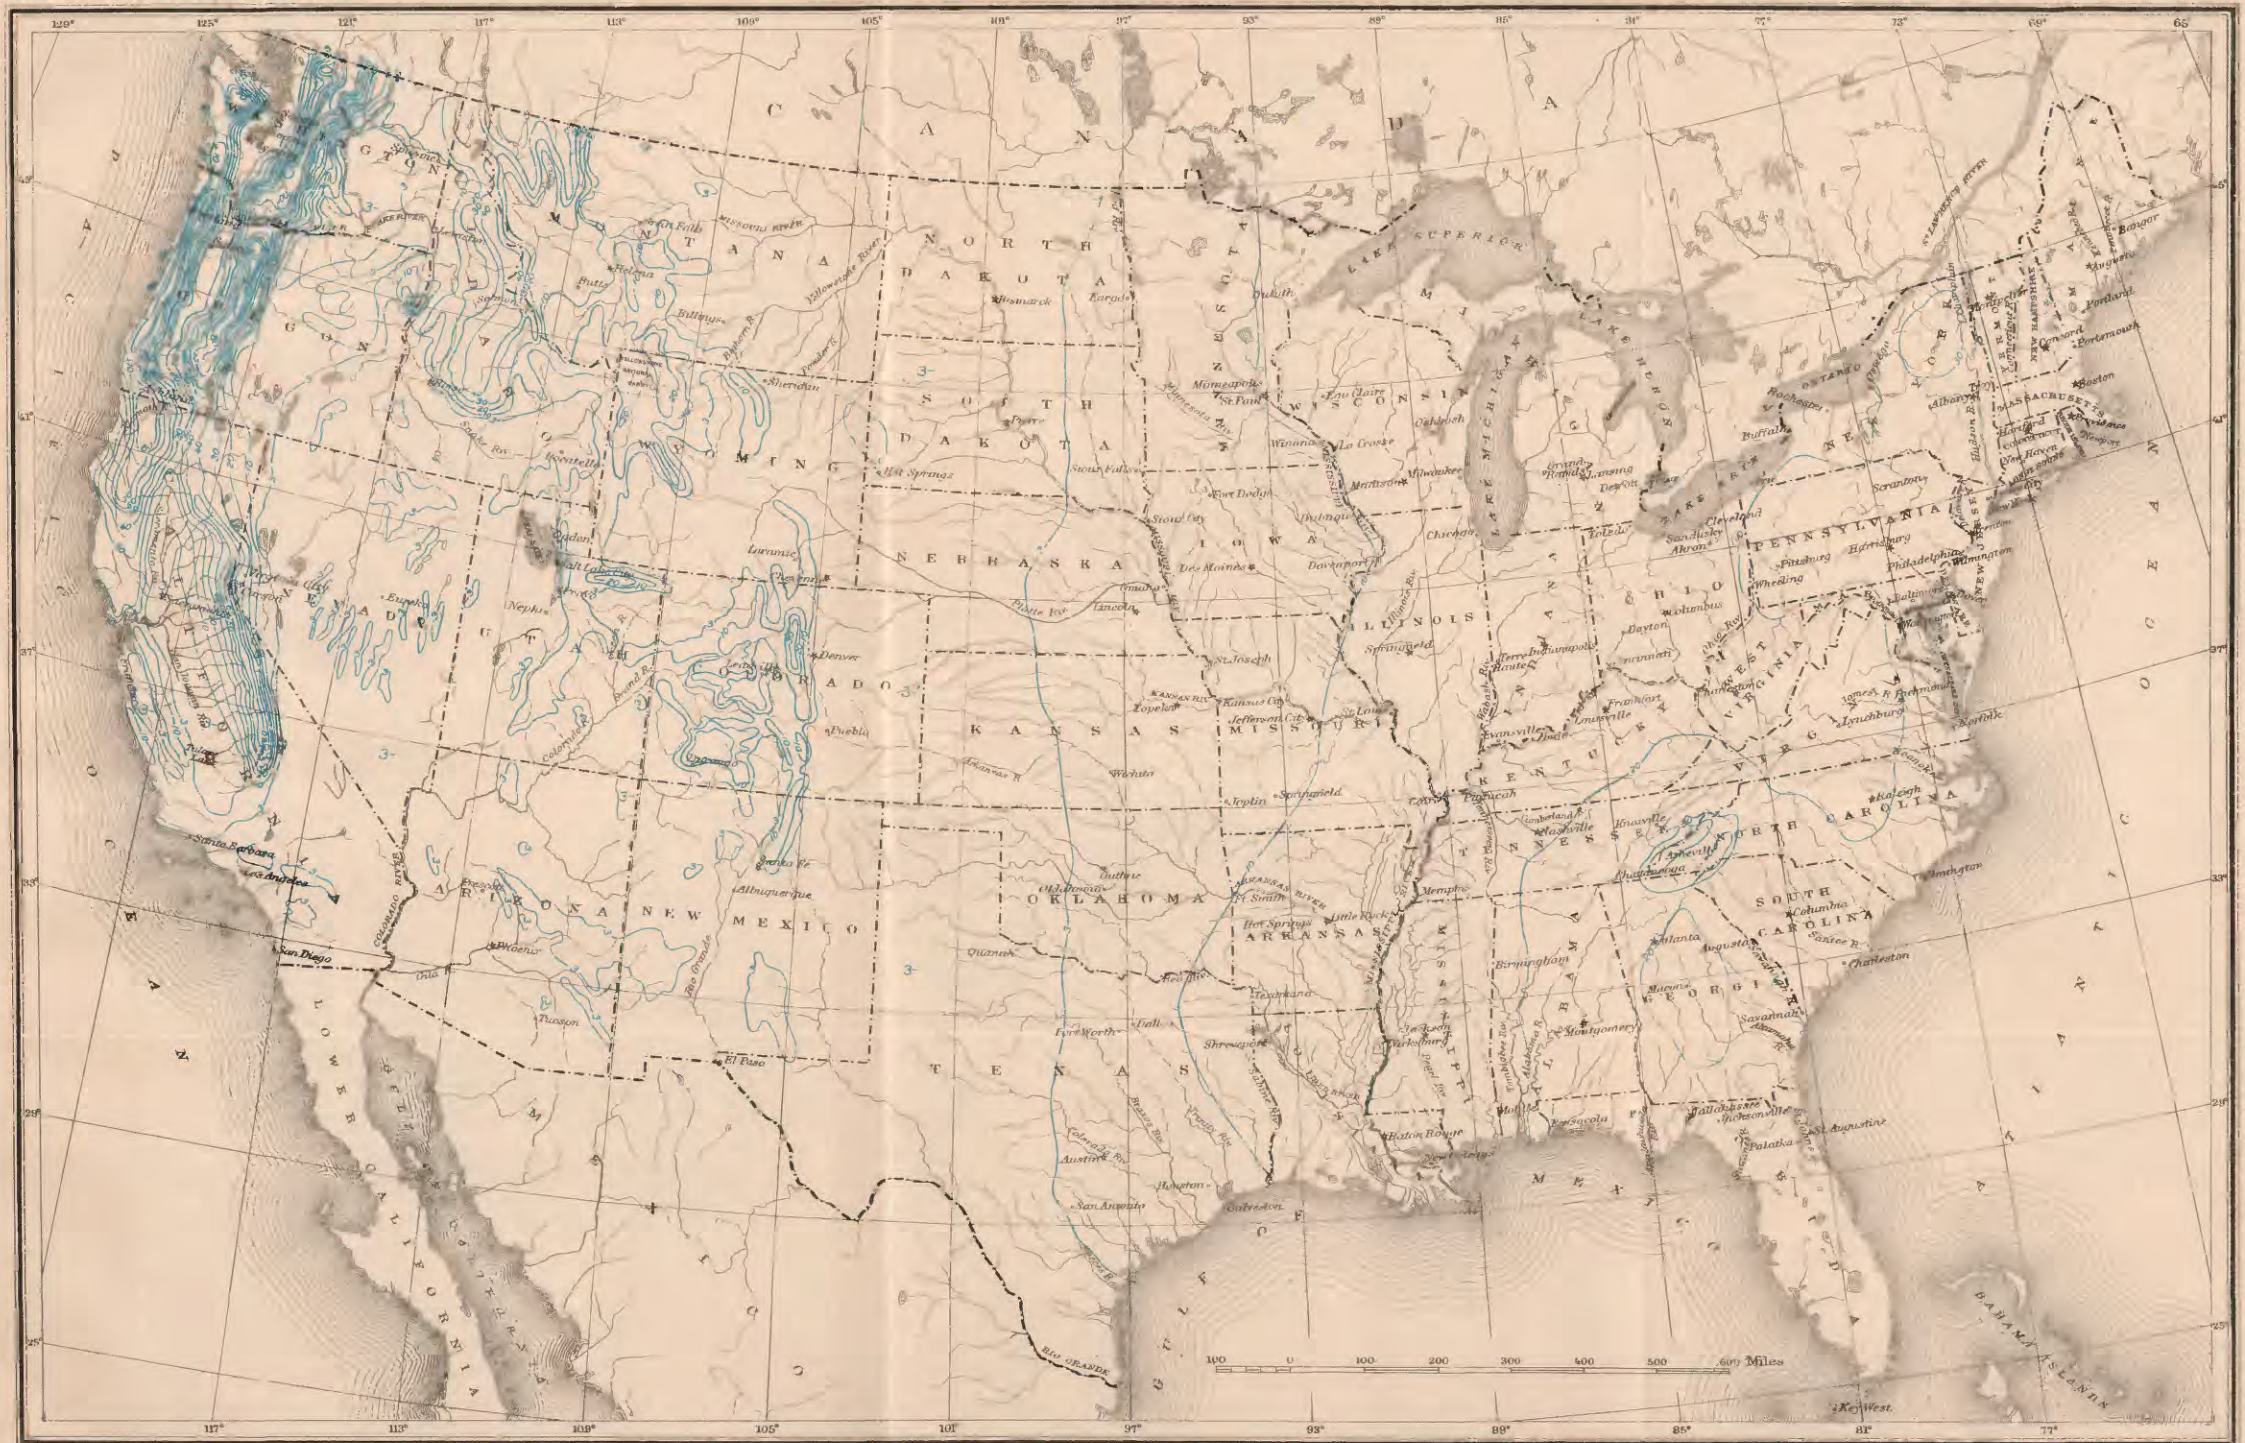
MAP OF UNITED STATES, SHOWING MEAN ANNUAL RUN-OFF  
Blue lines and figures indicate average annual run-off in depth in inches

| II. | Map of United States showing mean annual run-off..... | 12 |

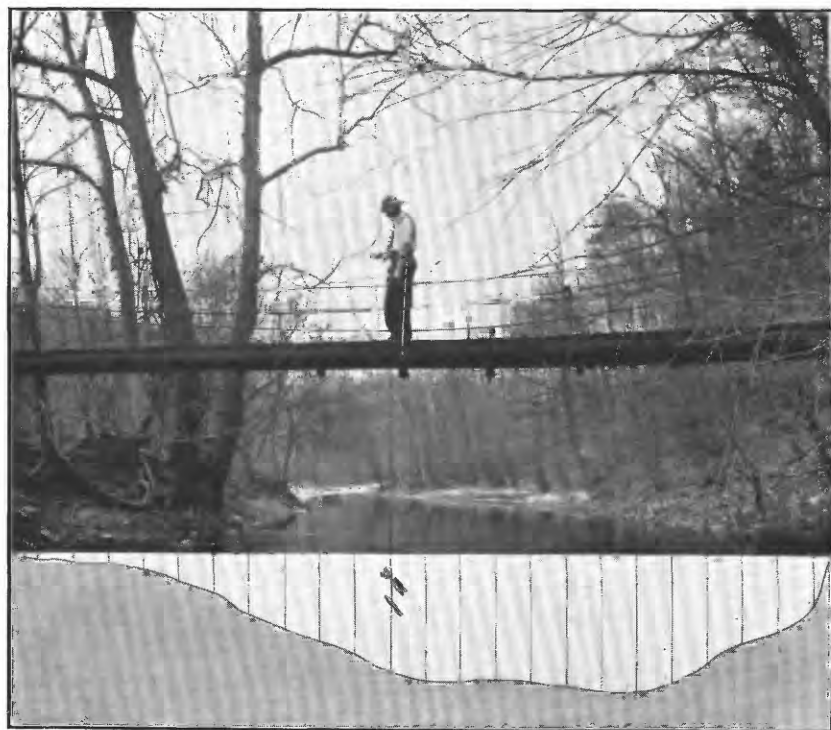
B. FOR BRIDGE MEASUREMENT.

TYPICAL GAGING STATIONS

| III. | Typical gaging stations: A, Cable station with automatic gage;<br>B, For bridge measurement..... | 12 |
