Water-Supply Paper 487

THE ARKANSAS RIVER FLOOD
OF JUNE 3-5, 1921

ROBERT FOLLANSBEE

EDWARD E. JONES

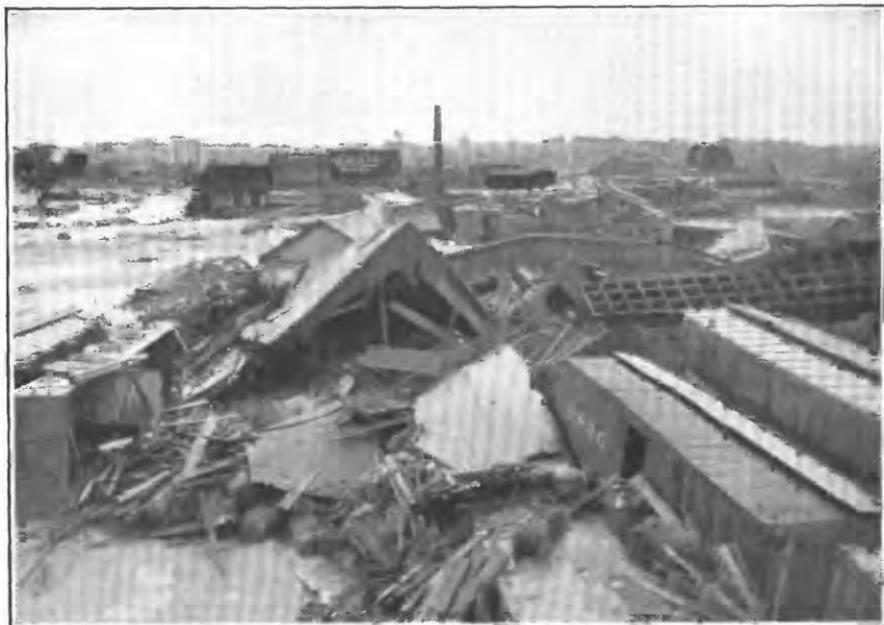
A. EFFECT OF FLOOD IN RAILROAD YARDS.

The heaviest loss was incurred by the railroad companies, as the flooded area included nearly all the extensive terminals of the roads that enter Pueblo (Pl. II, A). So great was the damage to railroad property not only in Pueblo but in the surrounding territory that not a relief train could enter Pueblo for two days. Of the six railroad bridges over Arkansas River and three over Fountain Creek, only one, the Santa Fe bridge to the Union Depot, escaped. All the others lost one or more spans or large portions of approaches. The Missouri Pacific yard and engine terminal was cut off by a new channel and was left on an island without rail connection. A Denver & Rio Grande train and a Missouri Pacific train were caught in the

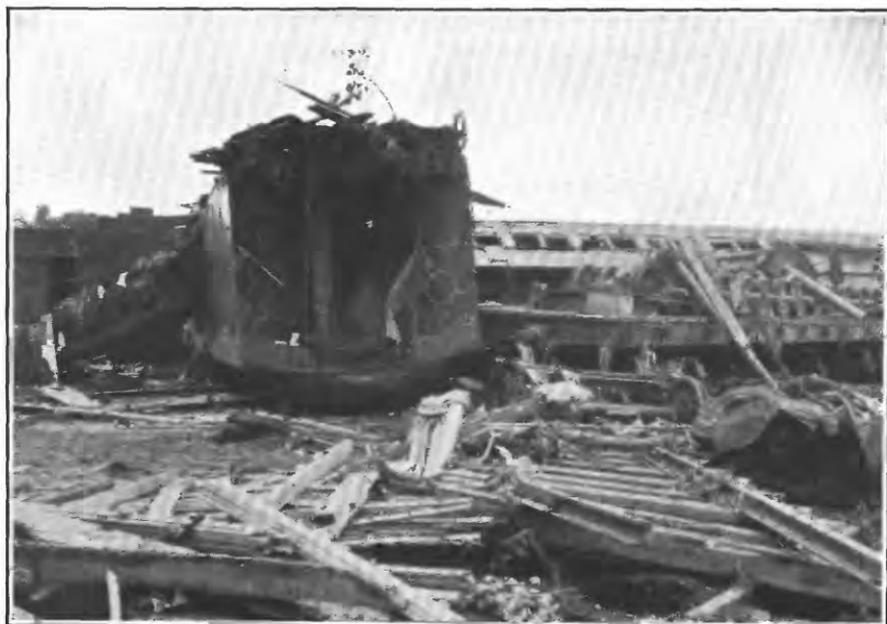
B. OVERTURNED BAGGAGE CAR FROM DENVER & RIO GRANDE TRAIN.

flood while trying to reach higher ground, cars were overturned, and several lives were lost (Pl. II, B). The 2,000 cars in the yards during the flood suffered enormous damage; many were floated away and overturned or crushed by the impact or pressure of debris. Some cars were floated great distances and were never recovered.² The total property loss in the city was estimated at \$10,000,000.

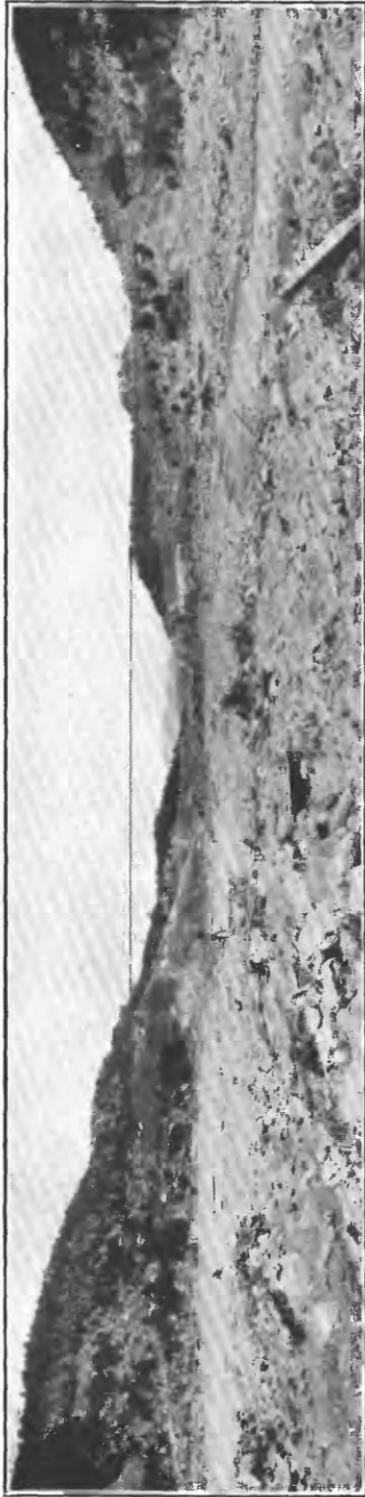
A. VIEW LOOKING UPSTREAM TOWARD SITE OF SCHAEFFER DAM.

Débris from dam in foreground. Line shows former crest of dam.

Mr. C. E. White, superintendent of the water division of the Beaver Park Irrigation Co., gave the following account of the failure of the reservoir (see Pl. III, A) :

By the failure of the Schaeffer dam about 3,600 acre-feet of water was released into Beaver Creek within 30 minutes. This resulted in a veritable wall of water rushing down Beaver Creek and causing a flood in Arkansas River. The sudden rush of water down the Arkansas swept all before it for several miles, or until the natural storage of the river channel reduced the peak. The greatest damage was caused near Swallows, where several buildings and all freight cars standing on side tracks were washed away. The following table shows the time the flood was observed at several points between the reservoir and Pueblo :

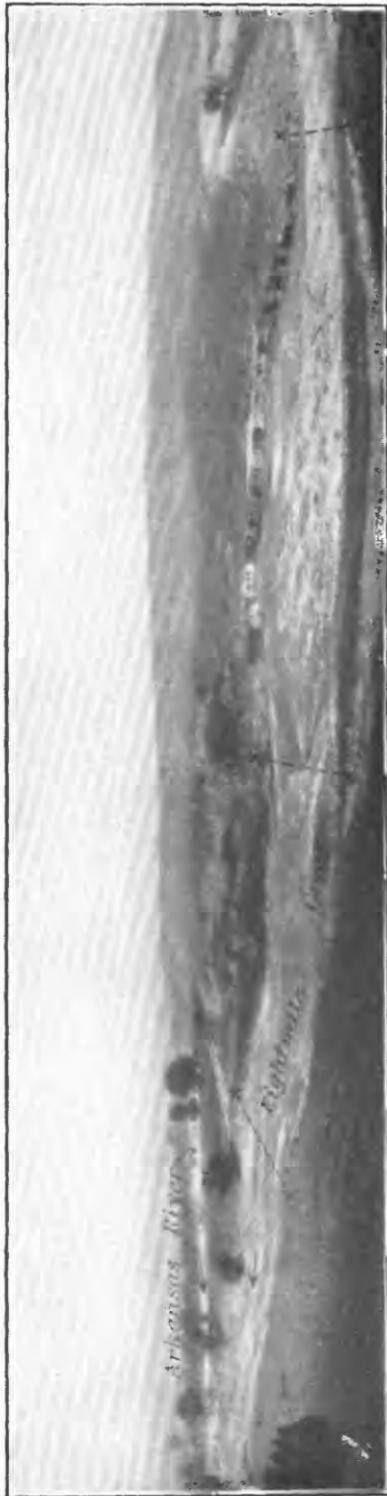
A. EIGHTMILE CREEK, SHOWING TYPICAL SECTION USED IN DETERMINING MAXIMUM DISCHARGE.

Dotted lines show location of upper, middle, and lower cross sections.

Each tributary stream was measured as near the mouth as the condition of the channel permitted. A careful inspection was made to locate a segment of channel which was reasonably straight and free from brush or other obstruction and in which the discharge had been confined to the regular channel with little or no overflow. In the portion of the stream measured cross sections were measured at the upper end, middle, and lower end. Plate IV, A, shows a typical segment. At each of the three sections stakes were set at the high-water line on each side of the channel. Beginning at the upstream end a level line was run around the six stakes, closing on the initial point with an allowable error of 0.05 foot. The distance on each side between stakes was measured along the high-water line. The cross section between each pair of stakes on opposite sides of the channel was carefully measured. The general location of each measuring point was determined by reference to section corners. Owing to the effect of bends in the channel that could not be entirely avoided, the difference in elevation between adjacent cross sections was not the same on both sides of the stream, nor was the distance as measured along the high-water line the same on both sides. Both distances and differences in elevation were averaged to determine the mean slope between adjacent sections.

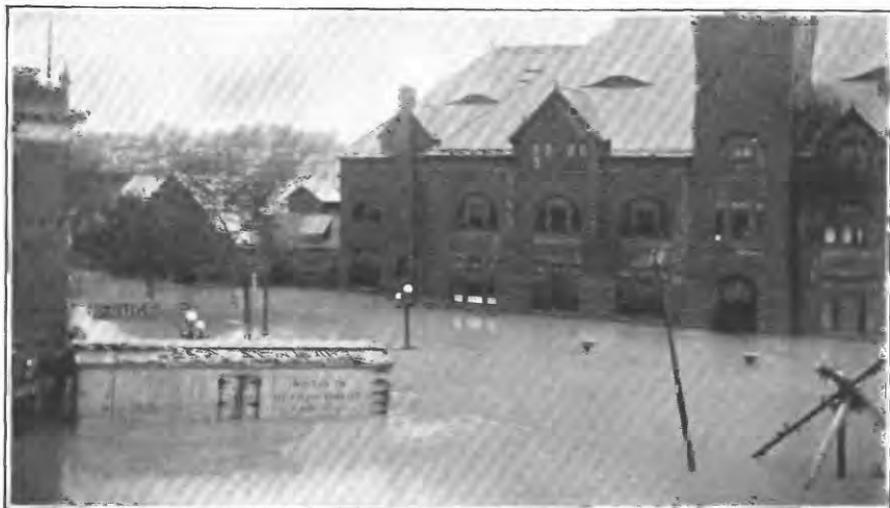
B. UNION DEPOT ON THE MORNING OF JUNE 4, 1921.

High-water mark near top of windows.

The recording gage at Pueblo was destroyed by the flood, and no continuous record of river height exists. From the testimony of local observers and from high-water marks it has been possible to construct a fairly complete and accurate hydrograph of the Arkansas at Pueblo from June 2 to 5 (fig. 1). The most complete record of the river during the time of the principal rise was that obtained by Mr. B. Milton Stearns, assistant chief train dispatcher of the Denver & Rio Grande Railroad. As the water rose in the Union Depot the distance to the water surface from a fixed point was measured with a level rod and the time noted. This was done at frequent intervals from 9 p. m. on the 3d to 7 a. m. on the 4th, the period during which the river was above the floor of the Union Depot. The reference points used were later connected to the city datum by level, and the maximum stage was found to be at 4,684.75 feet above the sea. The maximum stage at the river gage at the Main Street bridge was determined after the flood, from a well-defined water mark on the outside of the new city hall, 150 feet distant. This mark was found to be 24.66 feet above the zero of the gage, or 4,681.70 feet above the sea, 3.05 feet lower than the maximum observed at the Union Depot.

The difference is due chiefly to the fact that the Union Depot is 750 feet upstream from the river gage and 1,700 feet away from the river. A line of levels between high-water marks on the Victoria Avenue bridge, in line with the Union Depot, and the Main Street bridge showed a difference of 2.1 feet. The remaining difference is probably due to the fact that the water surface at the Union Depot was higher than at the river, 1,700 feet distant, as shown by level lines run after the flood.
