Water-Supply Paper 796-C

FLOOD IN LA CAÑADA VALLEY
CALIFORNIA

JANUARY 1, 1934

HAROLD C. TROXELL AND JOHN Q. PETERSON

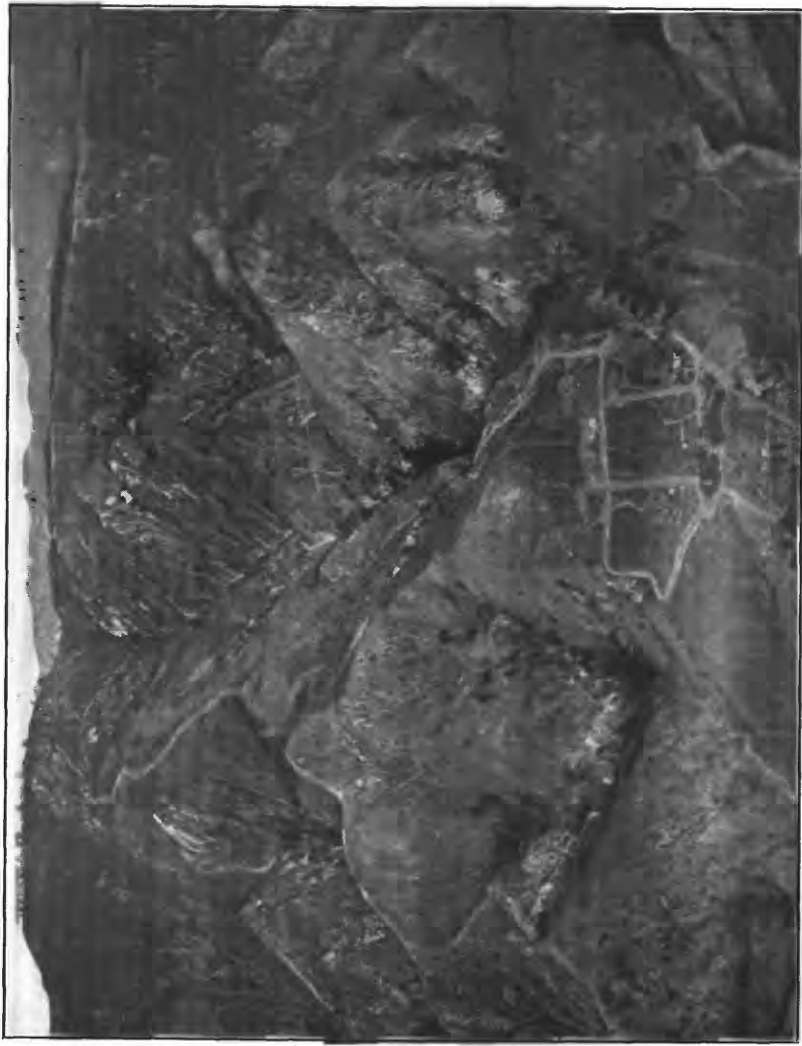
WESTERN PART OF PICKENS CREEK DRAINAGE AREA.

Page
Plate 16. La Cañada Valley, looking north.....	56
17. Western part of drainage area of Pickens Creek.....	56
18. Map of Los Angeles and vicinity.....	56

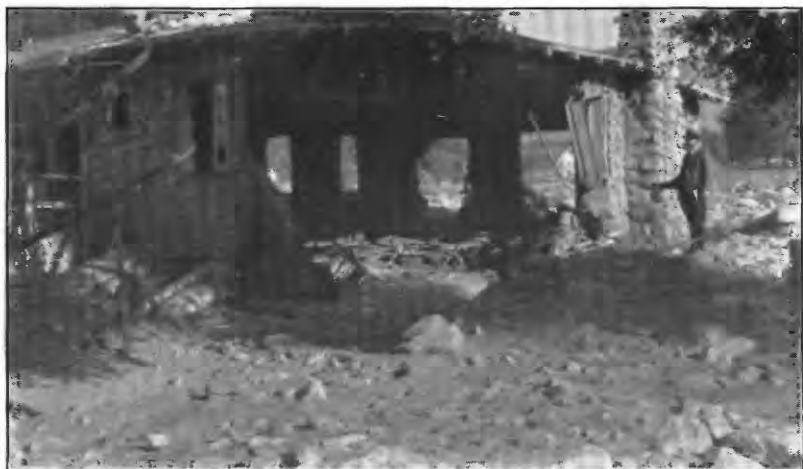
A. TYPICAL SCENE OF DESTRUCTION.

A section of Montrose most severely affected by Pickens Creek flood.

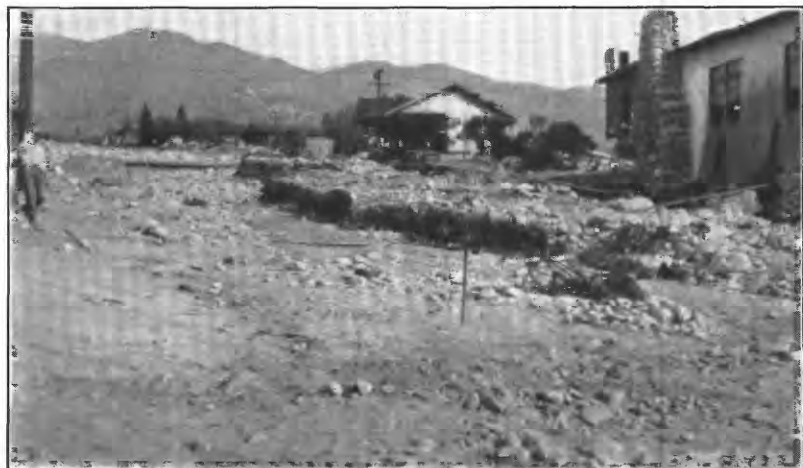
B. ENCROACHMENTS ON CHANNEL OF PICKENS CREEK.

View looking north.

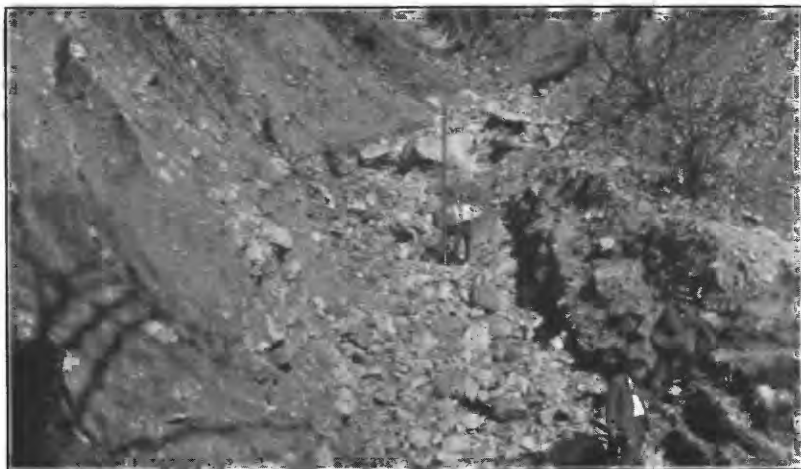
A. CONDITION OF CHANNEL OF PICKENS CREEK ABOVE ALTITUDE OF 3,200 FEET.

In the area shown in plate 20, A, the underlying bedrock is largely uncovered. The condition of the exposed rock might indicate that the uncovering had taken place fairly recently. In contrast plate 21, A, shows no exposure of the underlying rock formation.

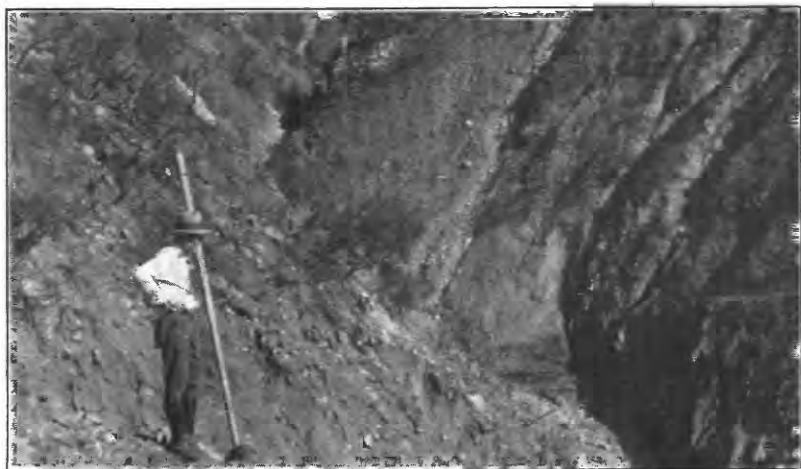
B. MATERIAL FROM ADJACENT SLOPES SLUMPED INTO THE BED OF PICKENS CREEK.

The character of the sides of the canyon is shown in plate 21, B. (See also pl. 17.) The presence of large quantities of easily erodible material is evident on these slopes - a condition which, however, is not uniform throughout Pickens Canyon, as parts of the canyon slopes are composed of almost bare rock walls, as shown in plate 20, B.

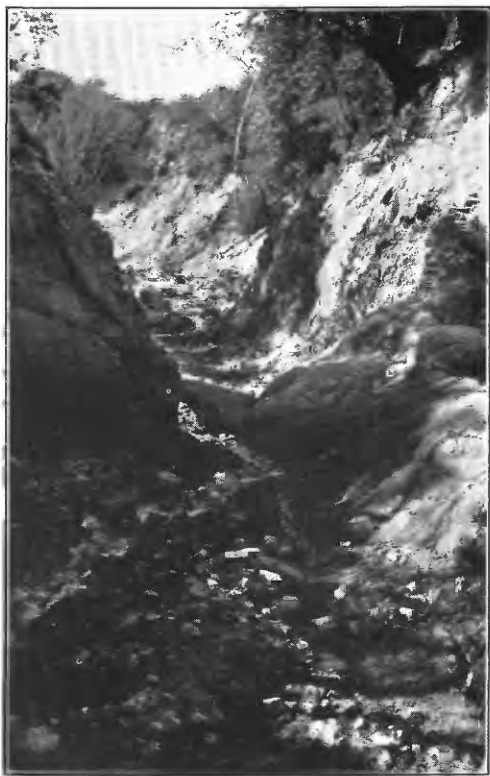
A. PICKENS CREEK AT ALTITUDE OF ABOUT 2,300 FEET.

Prior to the storm this part of the channel contained large deposits of debris in which a heavy growth of water-loving plant life had developed.

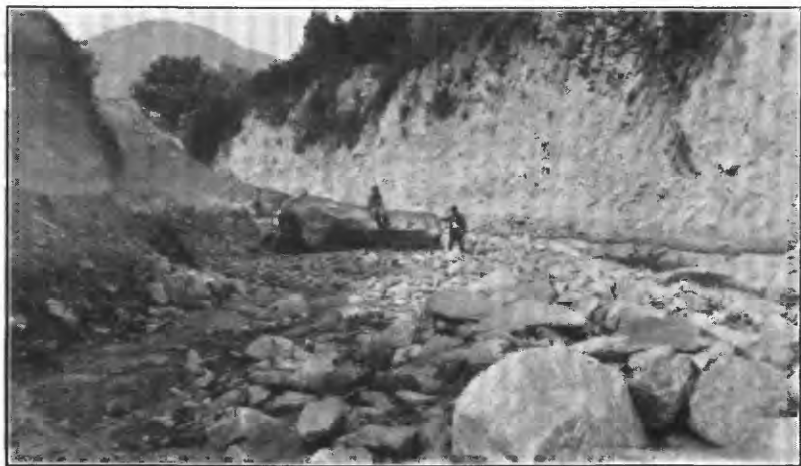
B. CHANNEL OF PICKENS CREEK ON DEBRIS CONE AT ALTITUDE OF ABOUT 2,000 FEET.

Below the bedrock section just described the channel of Pickens Creek passes onto the debris cone. As indicated by plate 22, B, the channel across the debris is wider and of lesser slope than that in the canyon section. (See fig. 11.) The side walls or banks of the channel across the cone range in height from about 150 feet at an altitude of 2,400 feet to practically zero just below the Foothill Boulevard. From the boulevard to Verdugo Creek the channel of Pickens Creek meanders over the top of the cone with no banks to confine it (pl. 19, B), and as this section is within the lower part of the debris cone, the slopes are less steep and the soil less rocky than in the higher part. This part of the cone was therefore considered desirable for residential uses and was the most highly developed part of La Cañada Valley.

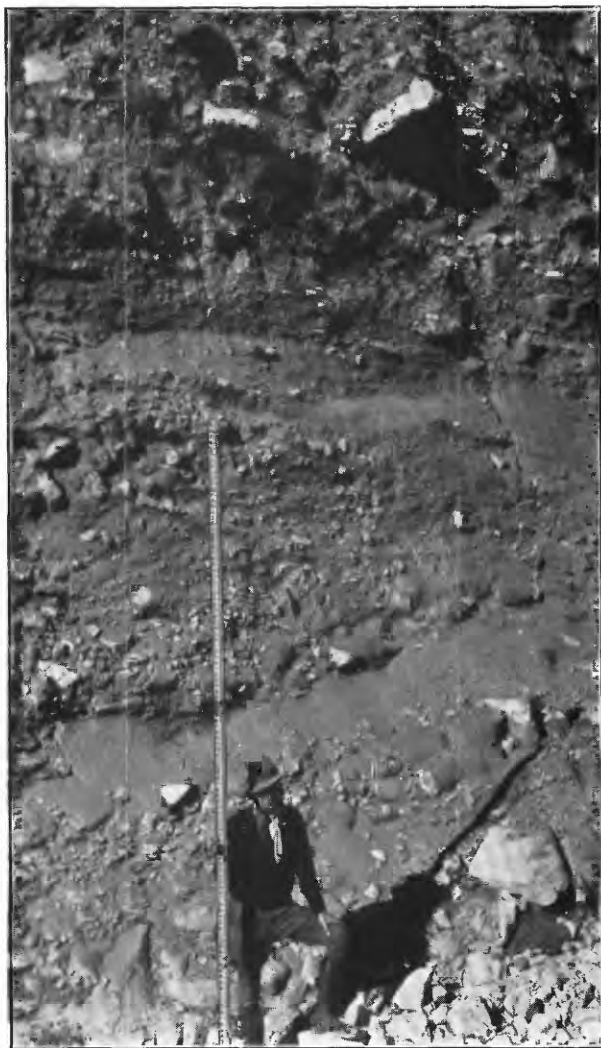
STREAM-BED EROSION ON DEBRIS CONE IN PICKENS CREEK ABOUT ONE-FOURTH MILE ABOVE ORANGE AVENUE.
A. Photograph taken in January 1934. B. Photograph taken at same locality in November 1934. Bed about 7 feet lower than as shown in A.

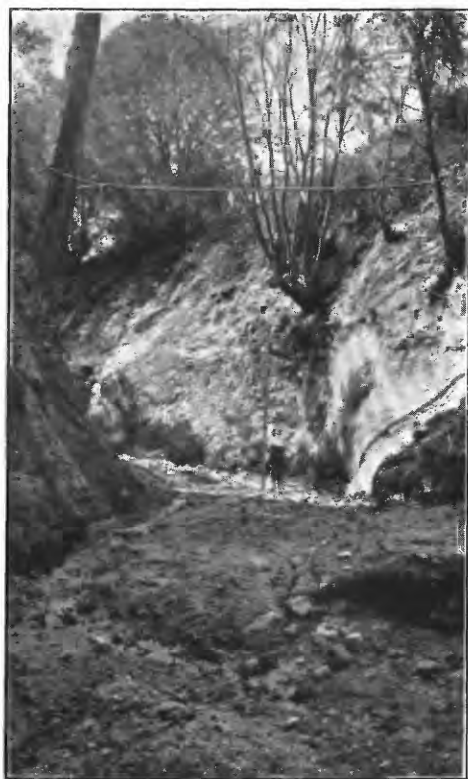
B. CANYON SECTION OF PICKENS CREEK IMMEDIATELY BELOW A SHARP BEND.
The position of the rope represents the peak stage of the flood of January 1, 1934, several hundred yards downstream from section shown in plate 26, A.

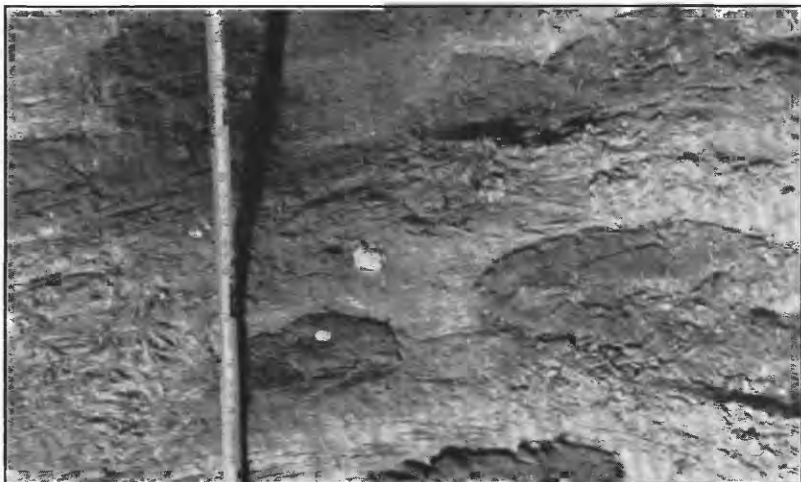
A. ABRASION MARKS ON TREE TRUNK IN PICKENS CANYON.

Tree is shown at left in plate 24, B.

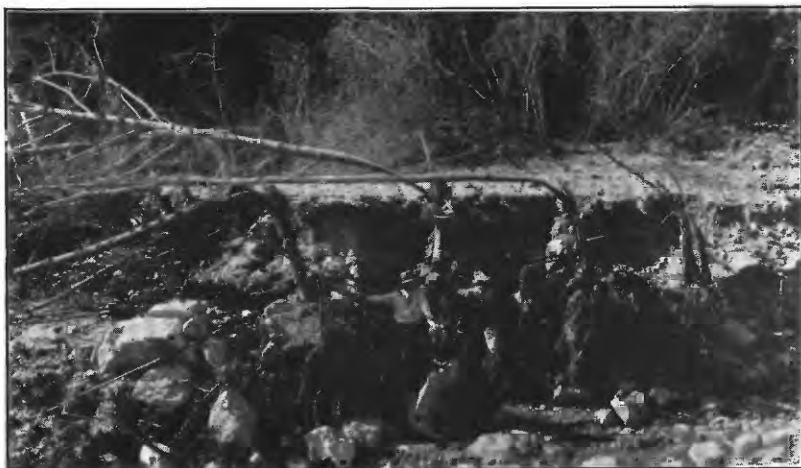
B. DAMAGED CONDITION OF TREES CAUSED BY SWIFTLY MOVING DEBRIS AND WATER IN CANYON SECTION OF PICKENS CREEK.

Altitude about 2,200 feet.

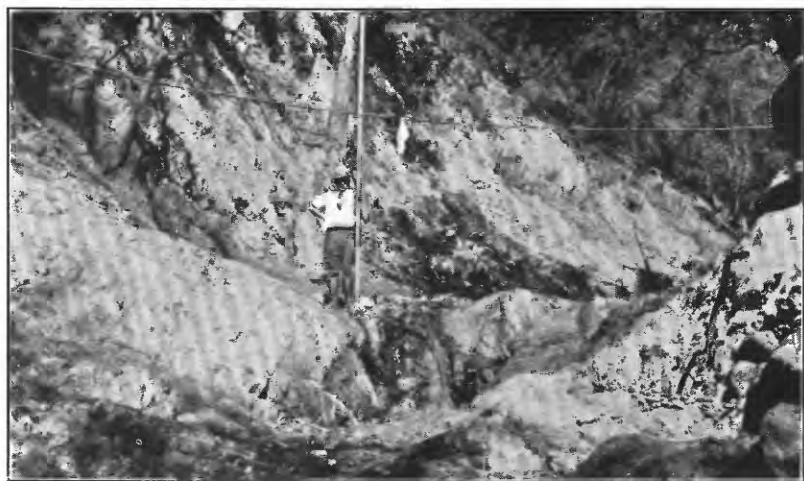
A. SMALL FALLS IN PICKENS CANYON.

The position of the rope represents the peak stage of the flood of January 1, 1934, several hundred yards upstream from the section shown in plate 24, B.

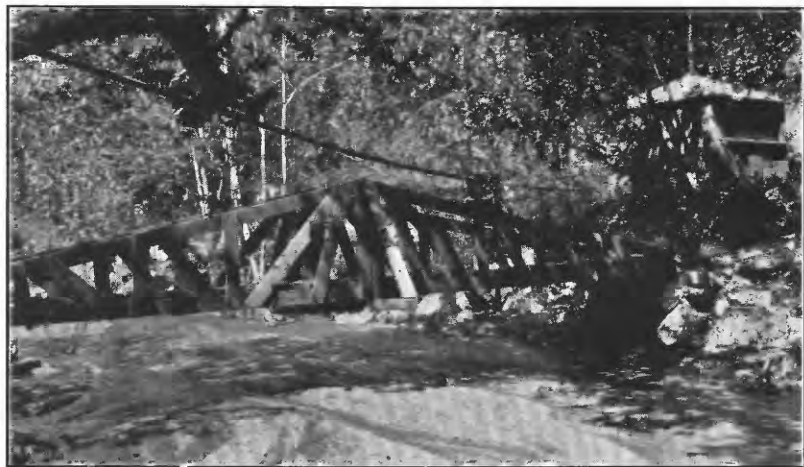
B. DEBRIS IN CHANNEL OF FISH CREEK, APRIL 2, 1925.

Compare with plate 27, A.

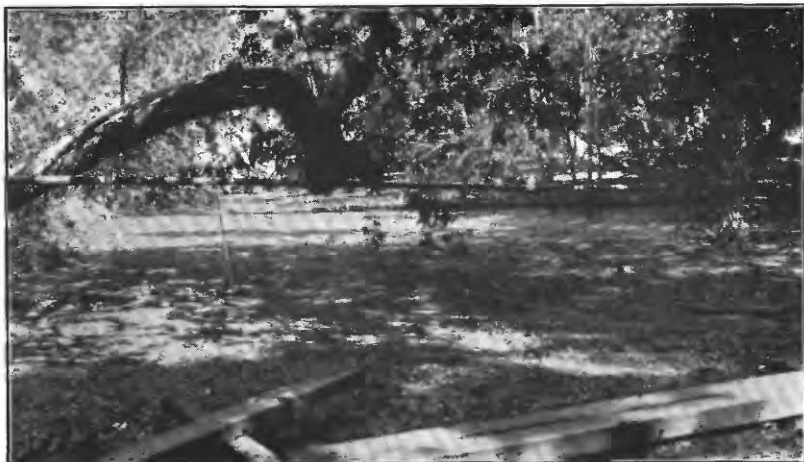
A. DEBRIS IN CHANNEL OF FISH CREEK, APRIL 18, 1925.

Compare with plate 26, B.

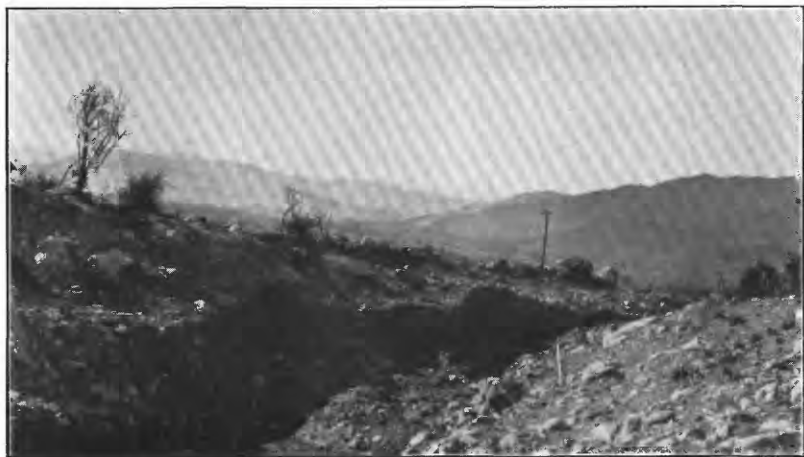
B. CHANNEL OF DUNSMORE CREEK AT END OF NEW YORK AVENUE.

The two large boulders on the left bank are those shown in plate 28, A. Note the erosion of the channel which occurred during falling stages of the flood.

The influences of these two parts of the debris wave on the stream channel are illustrated in plate 27, B. This picture of the debris cone

of Dunsmore Creek, which shows how both banks have been smoothed off - in fact, almost polished - by a loaded stream, indicates that the loaded condition continued until practically the entire debris deposit in the stream channel had been removed. Then followed a period in which the stream was underloaded and as a result scoured deeply into the bed of the channel, undercutting both banks.

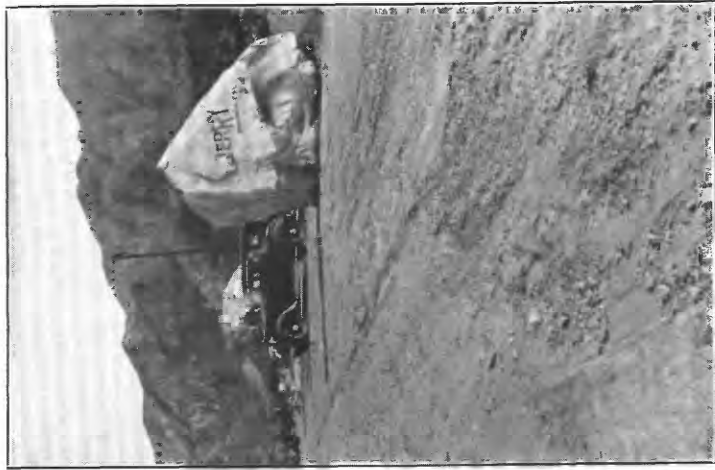
A. TWO BOULDERS ON PAVEMENT AT END OF
NEW YORK AVENUE.

These boulders were brought down Dunsmore Creek by the flood. Estimated weight over 60 tons each.

Because at sometime during the New Year's flood the channel of the stream in Dunsmore Canyon was bank full of debris, it was possible for the two large boulders shown in plate 28, A, at the upper end of the debris cone to travel downstream, either by rolling or sliding over a smooth bed, until they finally came to rest on top of one of the banks. These boulders can be seen in the background in plate 27, B. The movement of such boulders for any great distance down a very irregular stream bed containing other large stones and boulders and many rapids, such as existed prior to the New Year's storm, would be difficult to conceive were it not for the presence of a heavy debris load to smooth out the stream bed. It is doubtful whether in the absence of the debris load and the consequent effect of viscous flow boulders of this size could have moved more than a very short distance.

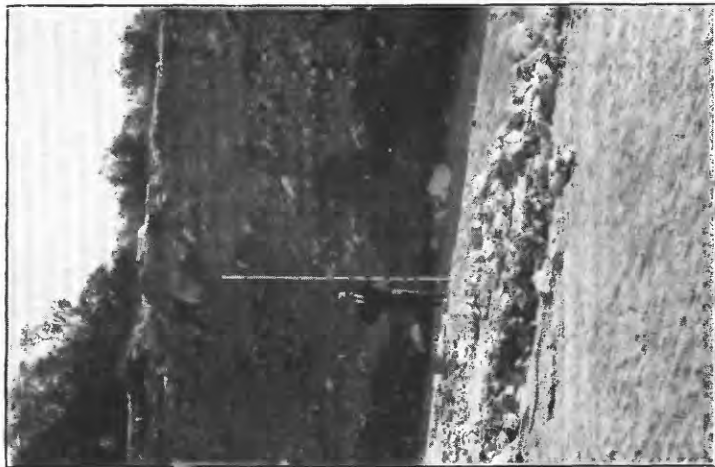
B. EAST BANK OF DICKENS CREEK AT ORANGE
AVENUE.

Material from the debris wave passed over the top of this 23-foot bank. Compare with view of opposite bank shown in plate 29, A.

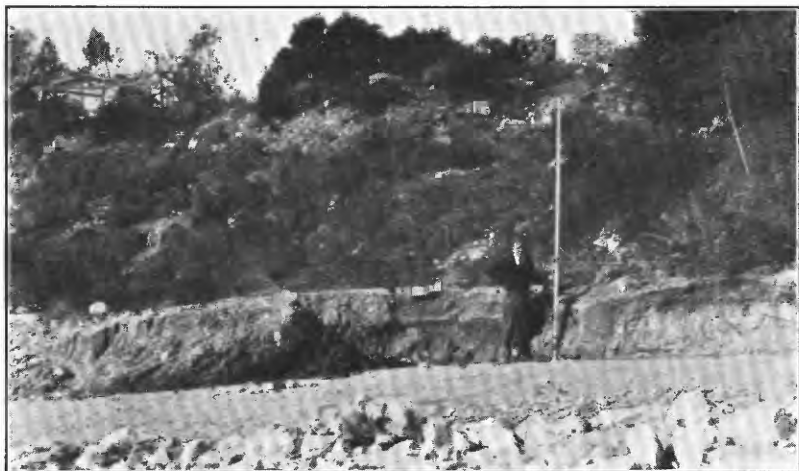
A. WEST BANK OF PICKENS CREEK AT ORANGE AVENUE.

The high-water mark of the flood was 18 feet lower on this bank than on the opposite bank shown in plate 28, B.

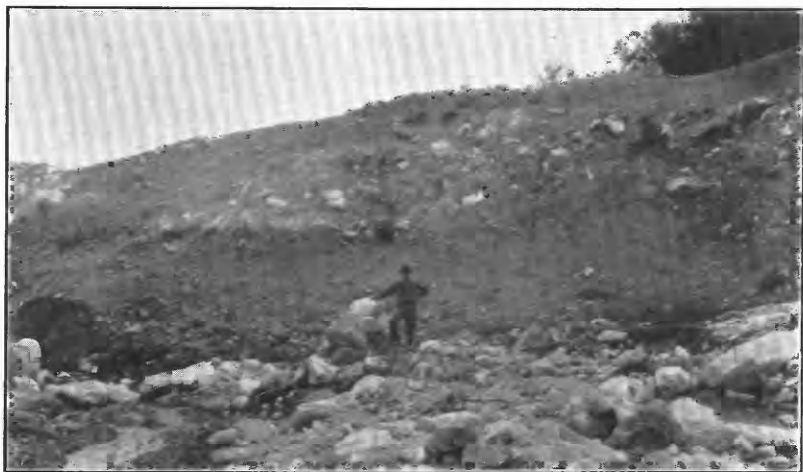
B. PICKENS CREEK ABOUT A QUARTER OF A MILE ABOVE ORANGE AVENUE.

At this bend in the channel, near the upper end of the debris cone, the crest of the debris wave passed over the top of the 22-foot bank.

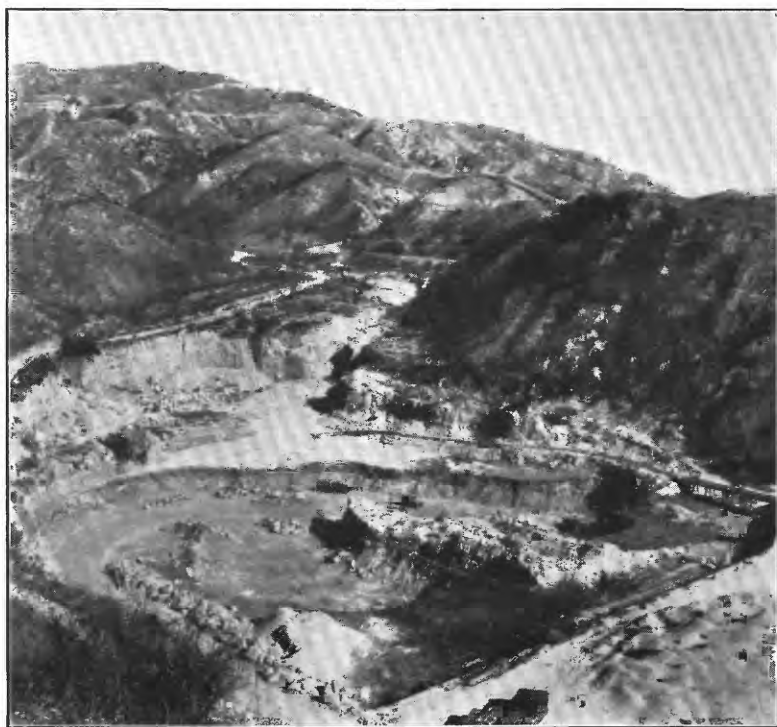
B. DEBRIS BASIN IN HAINES CANYON.

The extent of the debris deposited by the flood is indicated by this photograph. Steam shovels and trucks are at work removing the debris. The depth of the debris can be compared with the height of the trucks. The spillway section is in the right foreground.

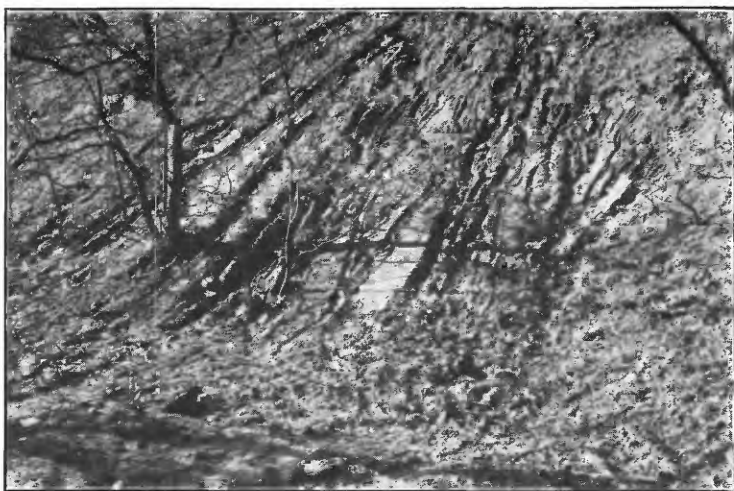
A. EXAMPLE OF SOIL EROSION.
Showing shoe-string gullies on a burned-over area.

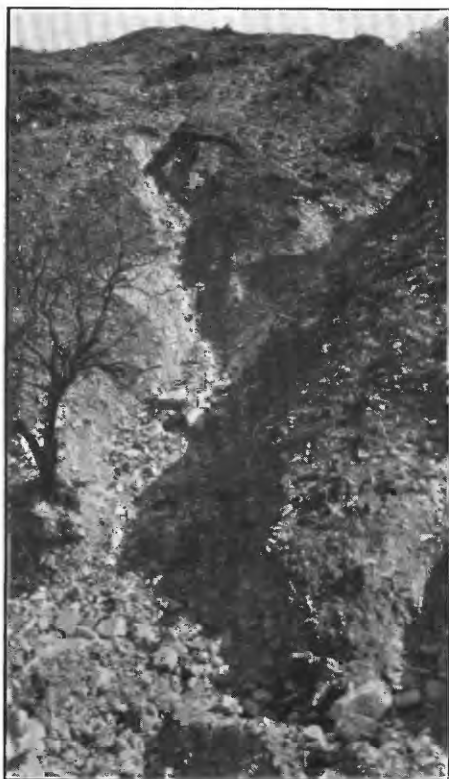
B. EXAMPLE OF GULLY EROSION.

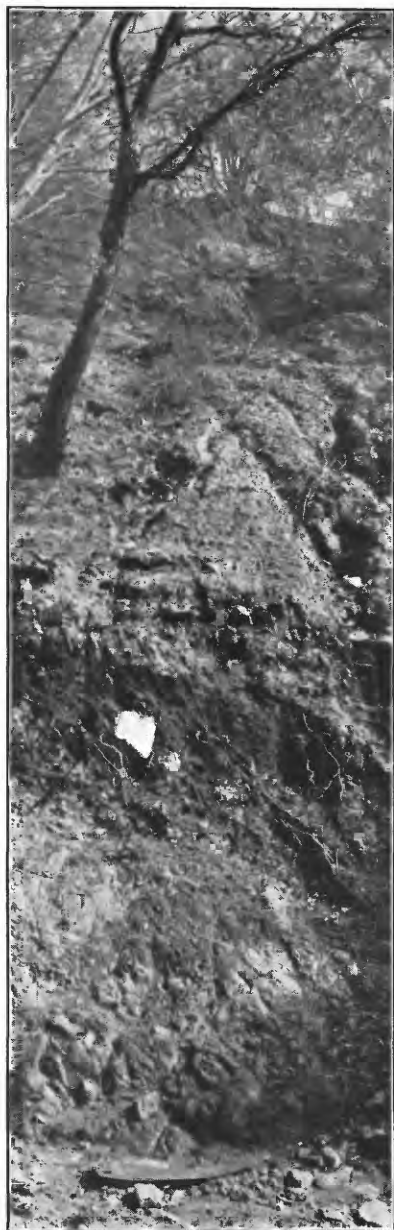
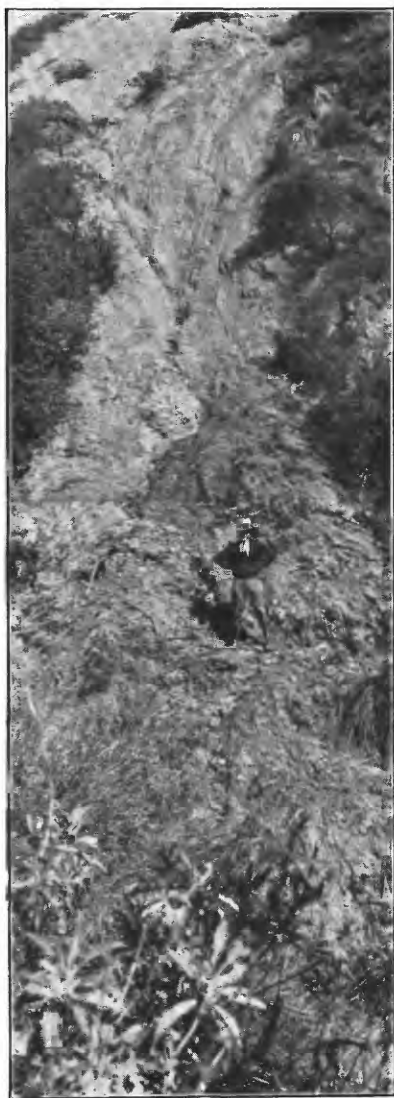
TYPICAL LANDSLIDES.

- A. Slide on upper end of the debris cone in Pickens Creek. Note that the lower portion of the slide has been removed by the flood.
- B. Landslide in Brand Park, Glendale Highlands. Slides like this one were found in the unburned area from Topanga to Pomona.

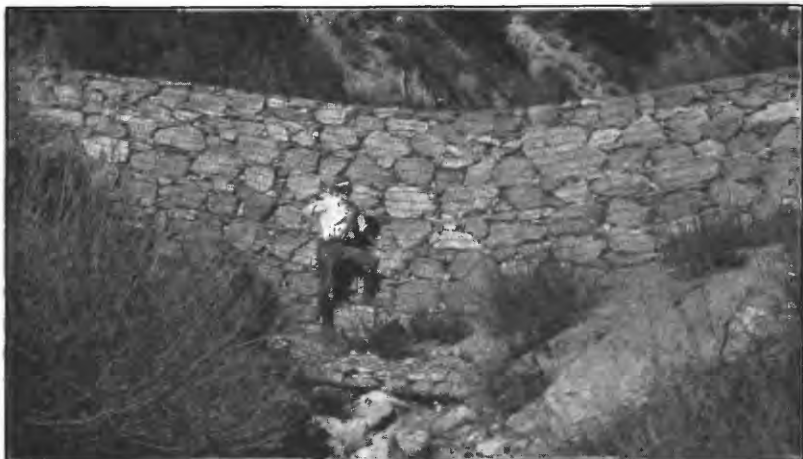
A. CHECK DAM IN HAINES CANYON
Typical wire-and-rock mattress check dam.

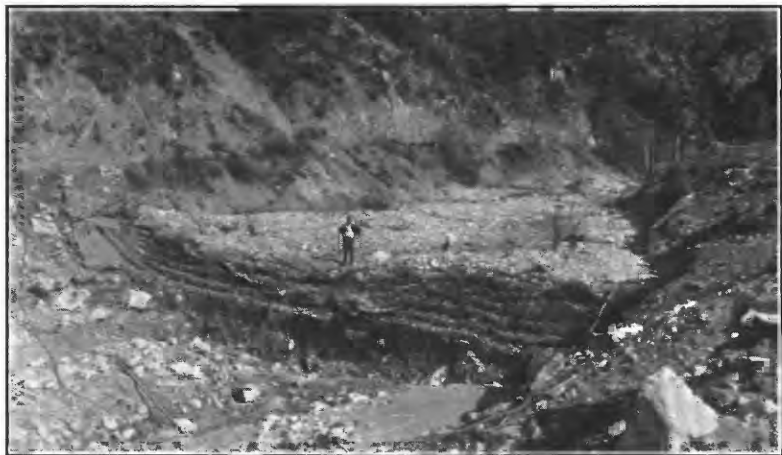
A. DEBRIS ABOVE A CHECK DAM IN HAINES CANYON.

Note the condition of the wire and the collection of debris above the dam, also the erosion downstream from the dam.

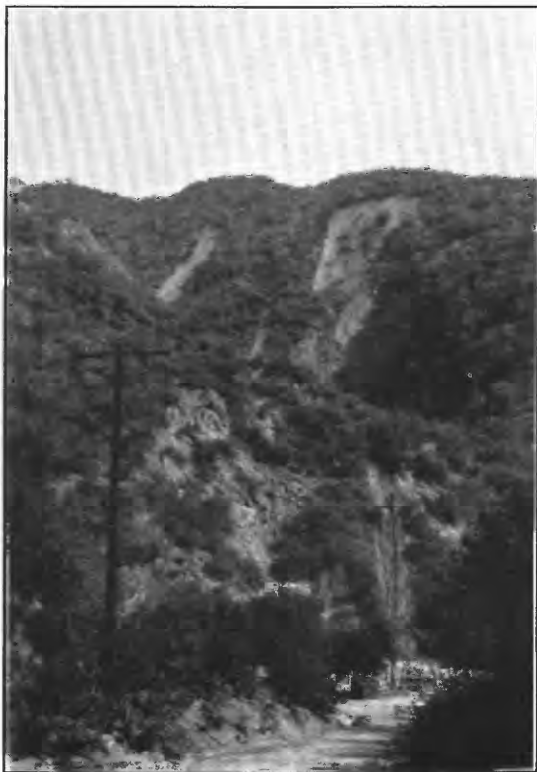
B. LANDSLIDES ON FOREST-COVERED SLOPES OF VERDUGO MOUNTAINS NEAR GLENDALE.
