NOTABLE LOCAL FLOODS OF 1939

Part 3. FLOOD OF AUGUST 21, 1939
IN TOWN OF BALDWIN, MAINE

GEOLOGICAL SURVEY WATER-SUPPLY PAPER 967-C

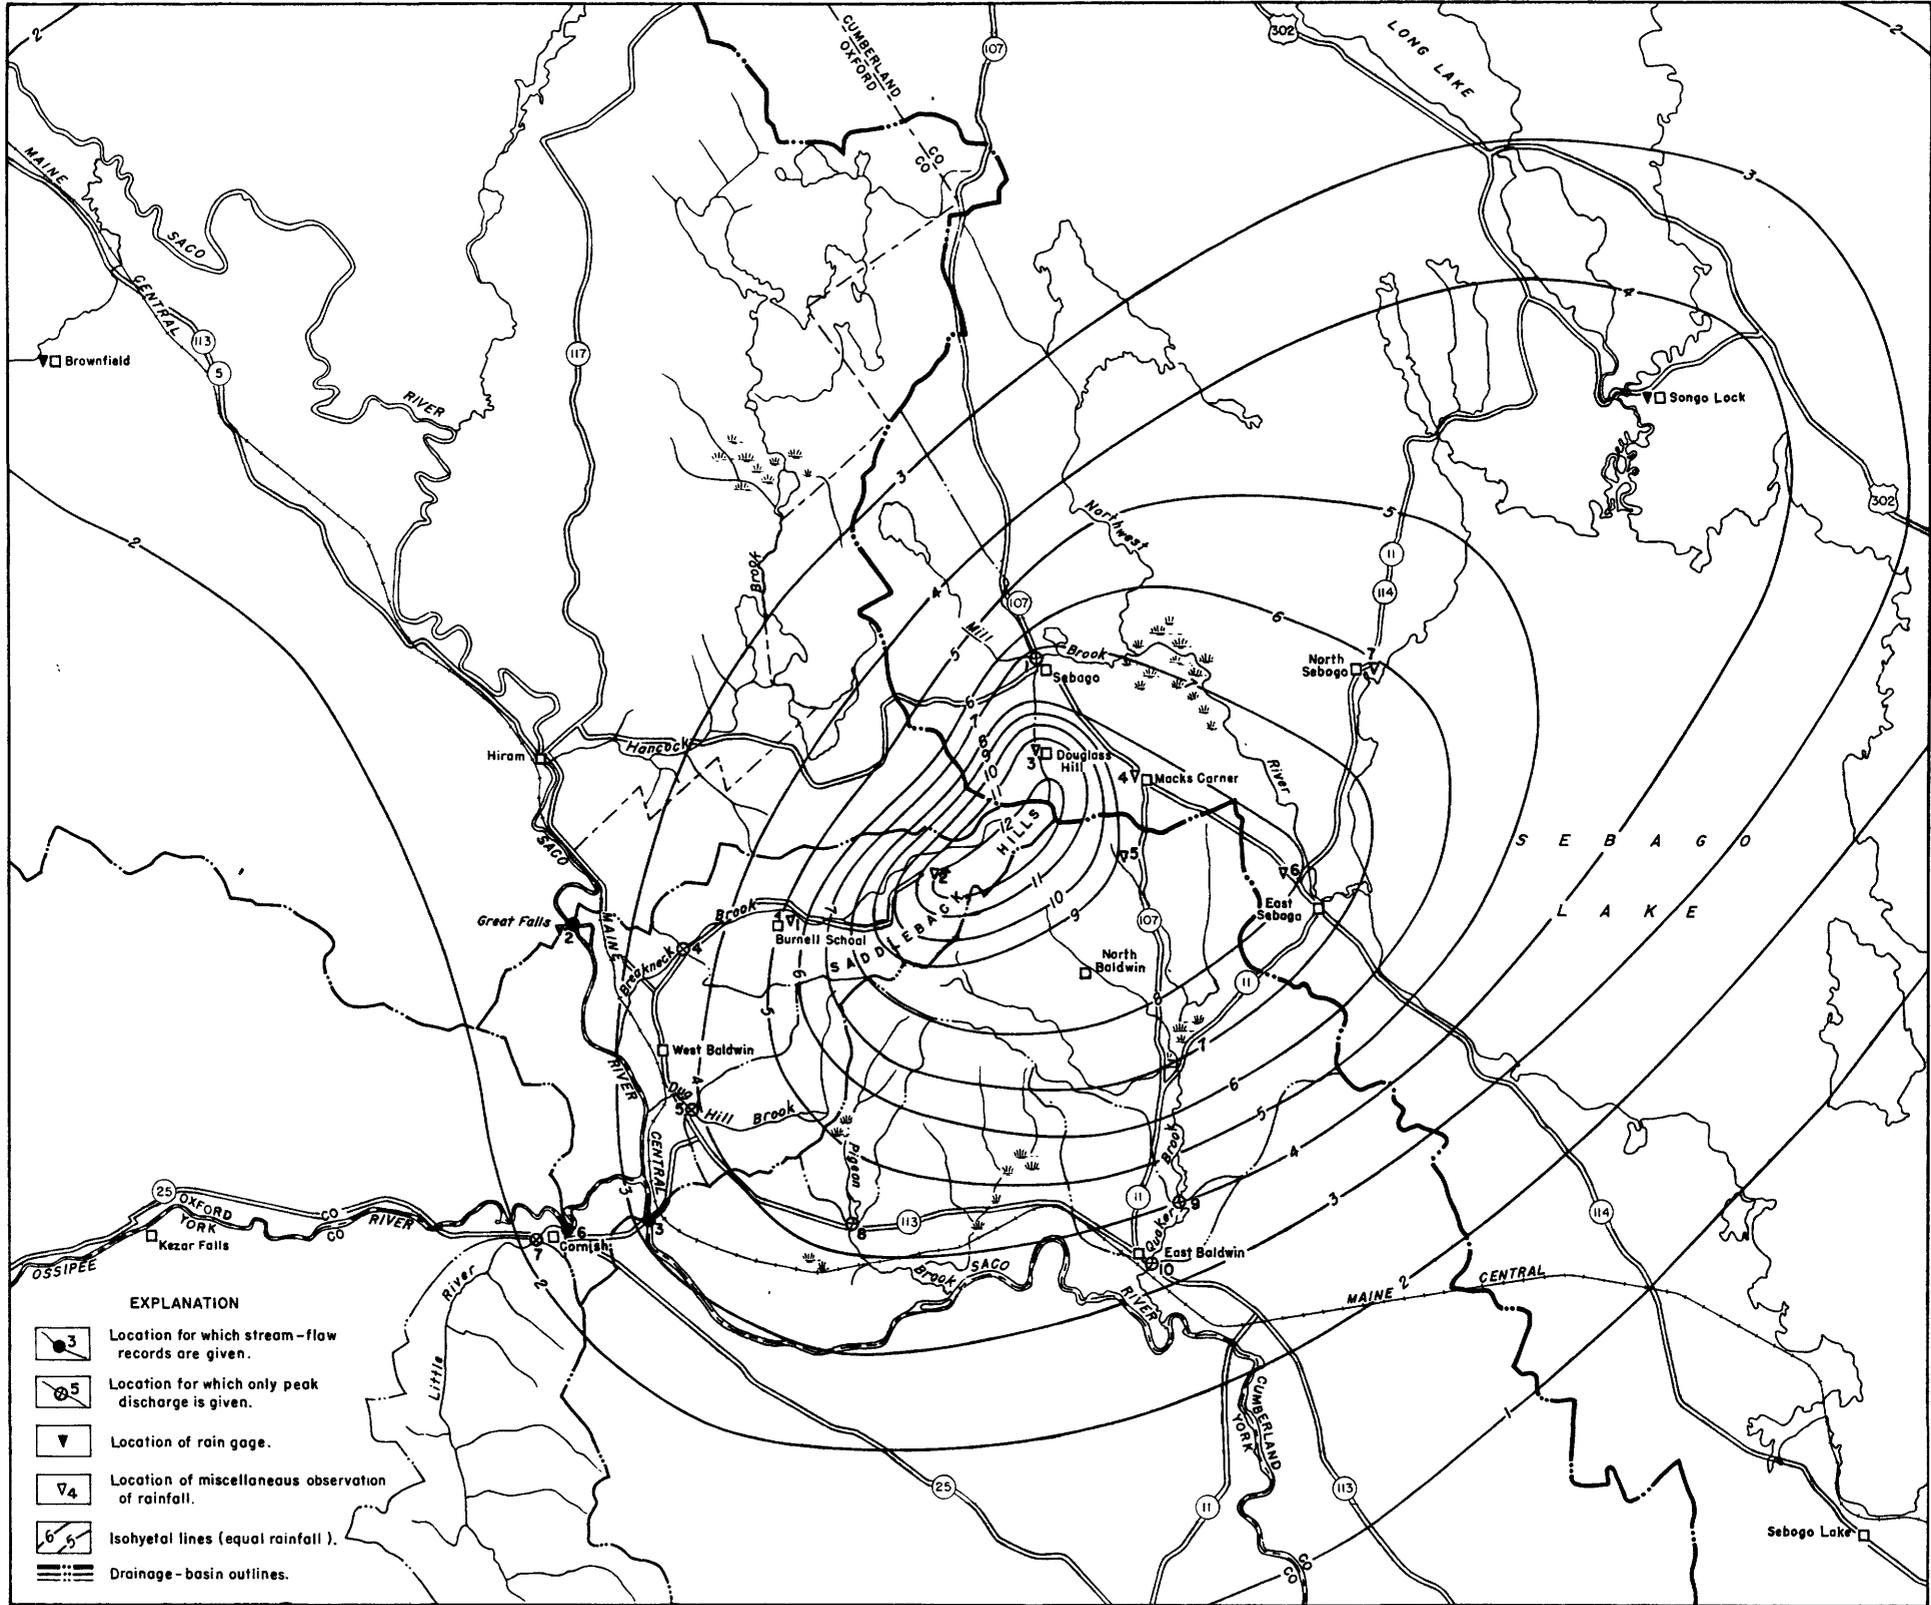
MAP OF FLOOD AREA SHOWING RAINFALL OBSERVATION POINTS, ISOHYETAL LINES, AND DISCHARGE OBSERVATION POINTS

EXPLANATION

3 Location for which stream-flow records are given.
-

5 Location for which only peak discharge is given.
-

Location of rain gage.
-

4 Location of miscellaneous observation of rainfall.
-

5 Isohyetal lines (equal rainfall).
-

Drainage-basin outlines.

It was reported that only light rain fell at Sebago Lake. In addition to the above records for the immediate storm area, rain gage records for adjacent areas are given in the following table. Within the limits of plate 12 the locations of the gages are shown. The place names for the other gages are given in figure 8.

On the basis of the records in the two preceding tables, isohyetal lines were drawn on the map (pl. 12). The areas enclosed by the various lines, as measured with a planimeter, are given below.

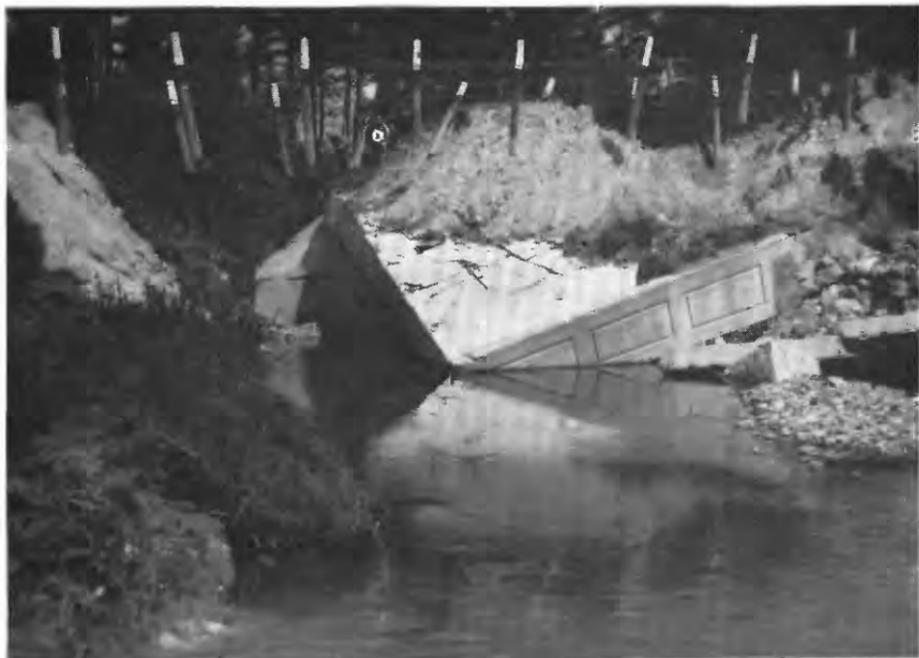
A. VIEW UPSTREAM OF BRIDGE ON BREAKNECK BROOK.
Bridge was undermined and collapsed, drowning three persons.

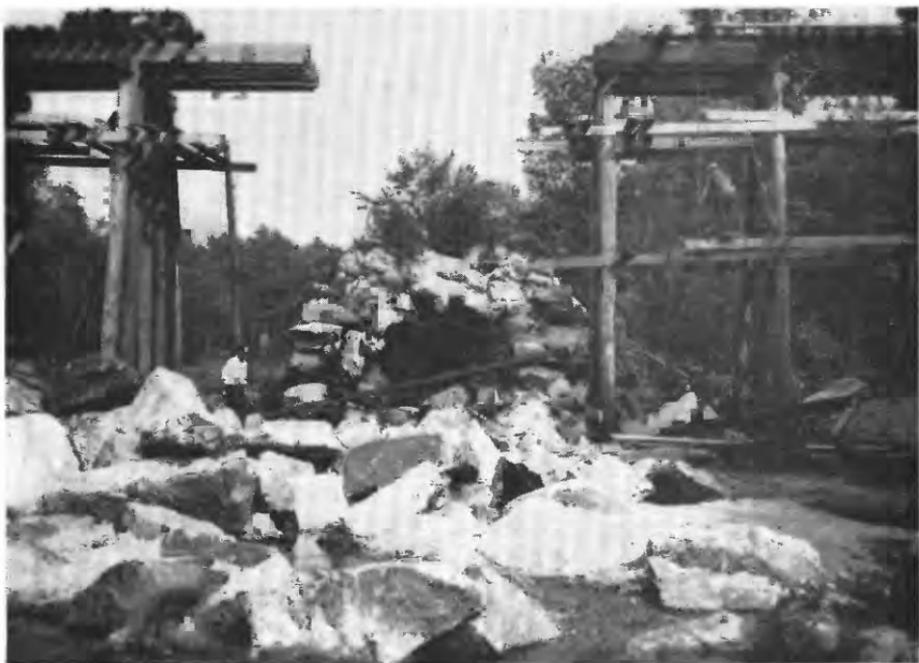
B. FILL OF MAINE CENTRAL RAILROAD WASHED OUT BY DUG HILL BROOK.
Top of trestle indicates height of original fill.

Transportation systems suffered the greatest property damage; (See pls. 13, B, 14.) Two railroad culverts and 17 highway bridges were destroyed, and roads were eroded to a depth of 4 or 5 feet in places. Damage to private property was not large. A few persons near the brooks suffered losses from flooded buildings, land erosion, and crop damage. The crop damage might have been more extensive had not agriculture in this area been largely confined to vegetable gardening. Three sawmill dams were washed out. Two, near Burnell School, will probably never be replaced as they were seldom used; the other, near East Sebago, has been rebuilt. Estimated dollar value of the damage is shown in the following table:

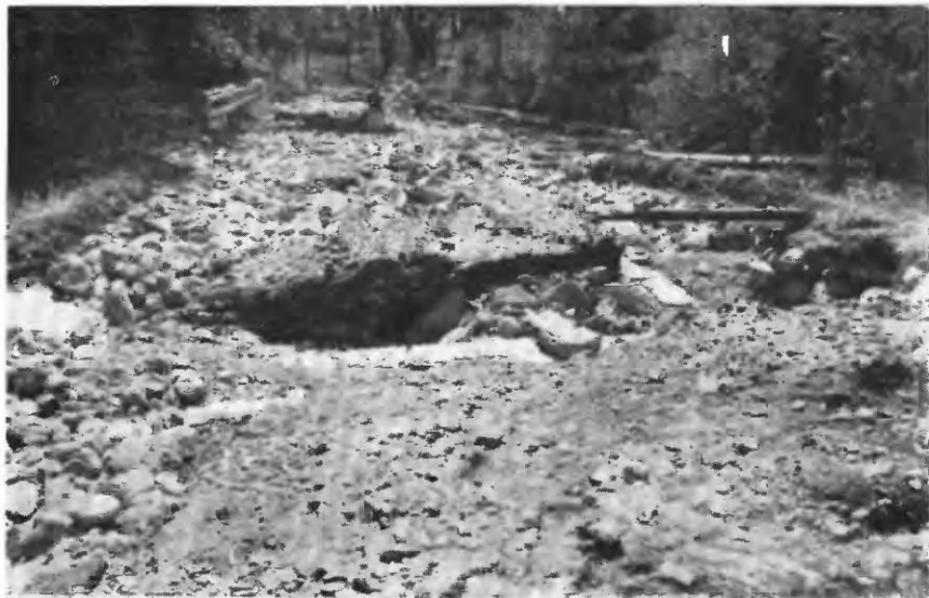
A. ON UPPER BREAKNECK BROOK.

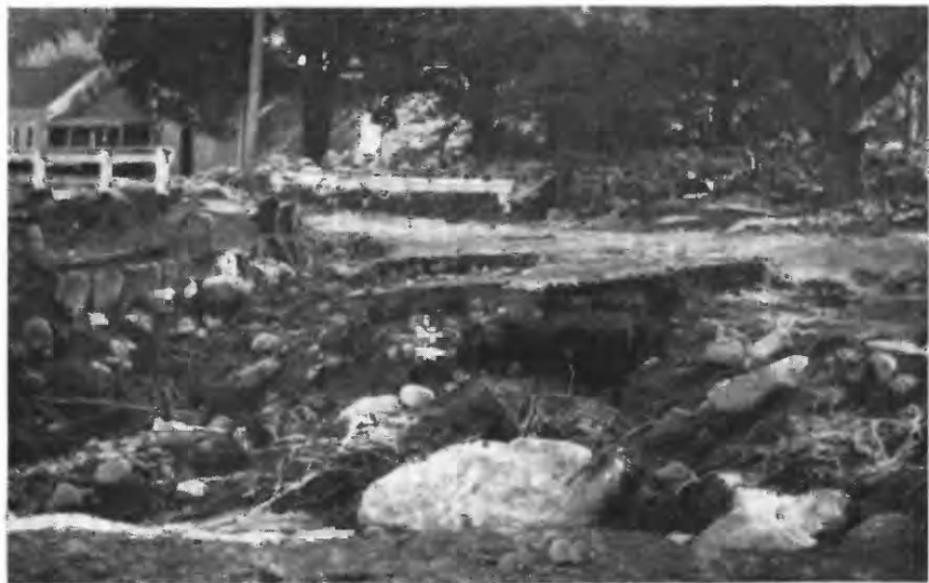
B. AT MACKS CORNER.
DAMAGE TO ROADS.

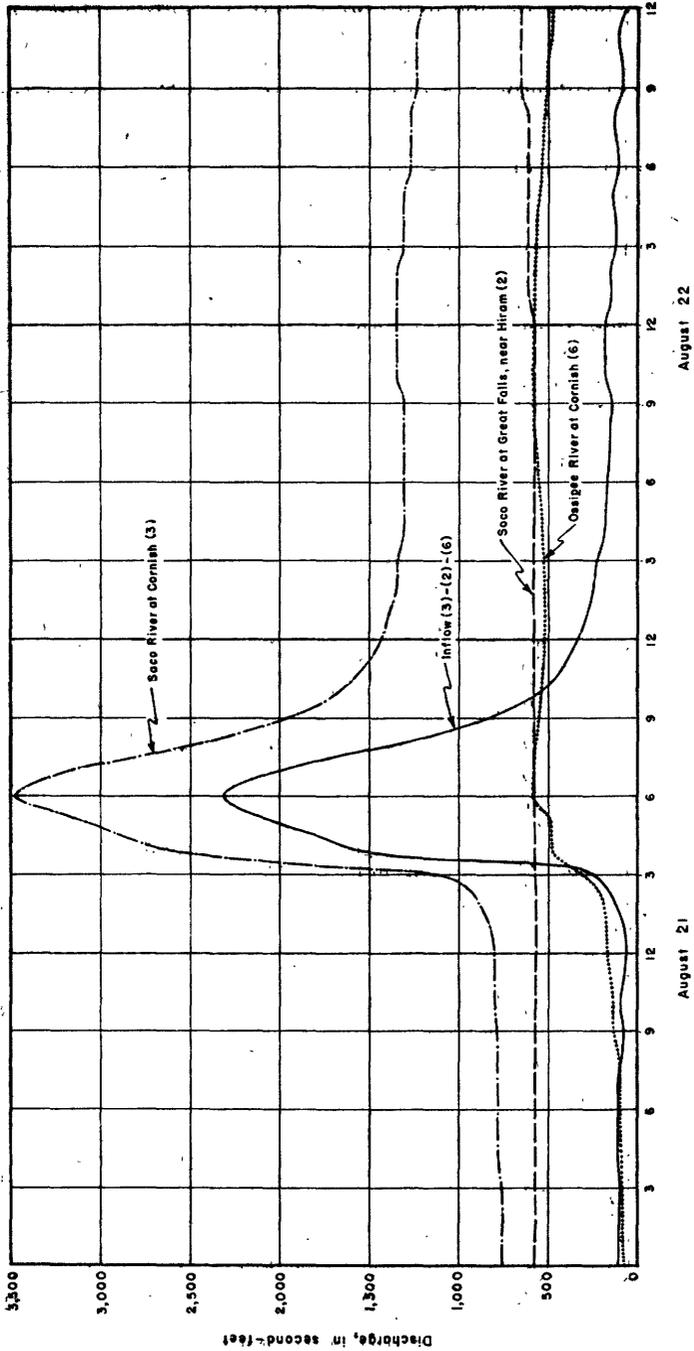
August 21 August 22
FIGURE 9.—Hydrograph of flood flows in Saco River Basin, August 21-22, 1939.

Power & Light Co., is also given. These records are plotted in figure 9. A study of this figure and plate 12 shows a most unusual situation. The hydrograph of Saco River at Cornish is a typical flood hydrograph. The Great Falls power plant is only $3\frac{1}{2}$ miles upstream, yet the flow was practically constant throughout the flood period. Likewise the hydrograph for Ossipee River at Cornish, 1 $\frac{1}{4}$ miles upstream, shows only a small increase in flow during the flood period. Such a situation is ideal for subtracting the measured flow upstream from Saco River at Cornish to get the flood flow from the intervening area of 13.0 square miles. The hydrograph of inflow computed in this manner is also shown in figure 9. The runoff represented by this hydrograph is about 1.4 inches. The peak rate of inflow indicated is probably somewhat less than actual, owing to channel storage between Great Falls and Cornish.
