GENERAL CHARACTERISTICS OF RECENT FLOOD DEPOSITS IN THE CONNECTICUT RIVER DRAINAGE BASIN, MASS.

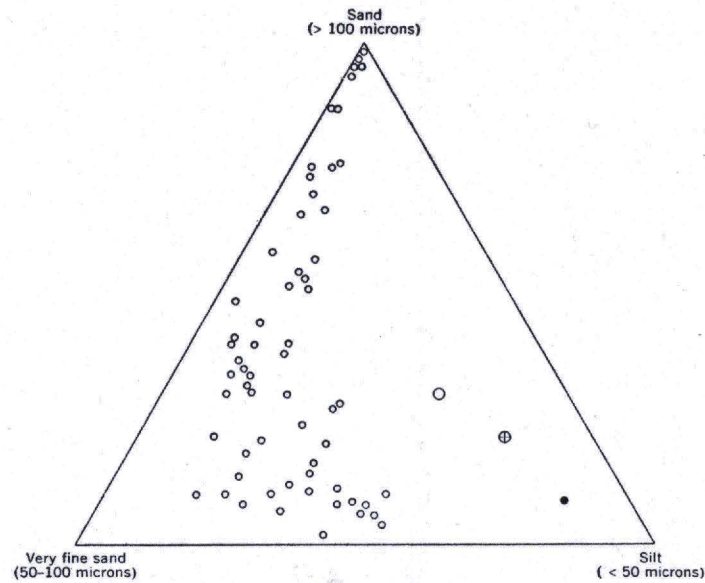
- Connecticut River flood deposit of March 1936
- Composite of 12 analyses; coarser deposits, flood of January-February 1937, Ohio Valley area (Water-Supply Paper 838, pl. 25, fig. 2, B)
- Composite of 159 analyses; finer-textured deposits, flood of January-February 1937, Ohio Valley area (Water-Supply Paper 838, pl. 25, fig. 2, A)
- ⊕ Composite of 4 analyses, Potomac River deposits, Seneca quad., Md.-Va. (Water-Supply Paper 838, pl. 25, fig. 2, C)

A Connecticut River flood sediments of March 1936
