Figure 19. --Map of area flooded by Missouri River at South Sioux City, Nebr., and Sioux City, Iowa, April 1952.

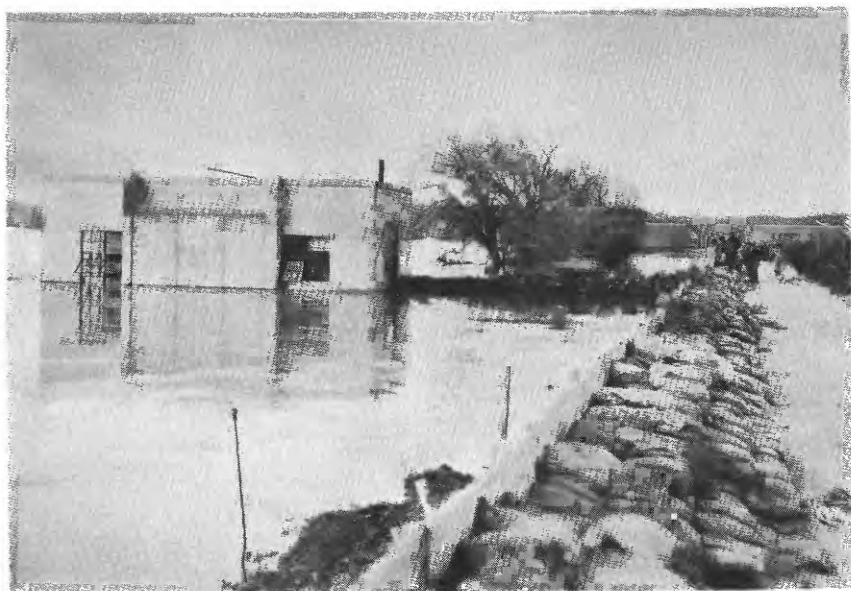
Figure 21.--Emergency levee built on existing levee at the intake structure of Council Bluffs. Photograph by Council Bluffs Nonpareil.

The Omaha-Council Bluffs levees were raised by adding earth fill upon which wood flashboards were erected and anchored by sandbag weights. (See fig. 21.) The concrete floodwall protecting industrial Omaha was raised by addition of wood flashboards bolted to the permanent structure. The amount of raise varied

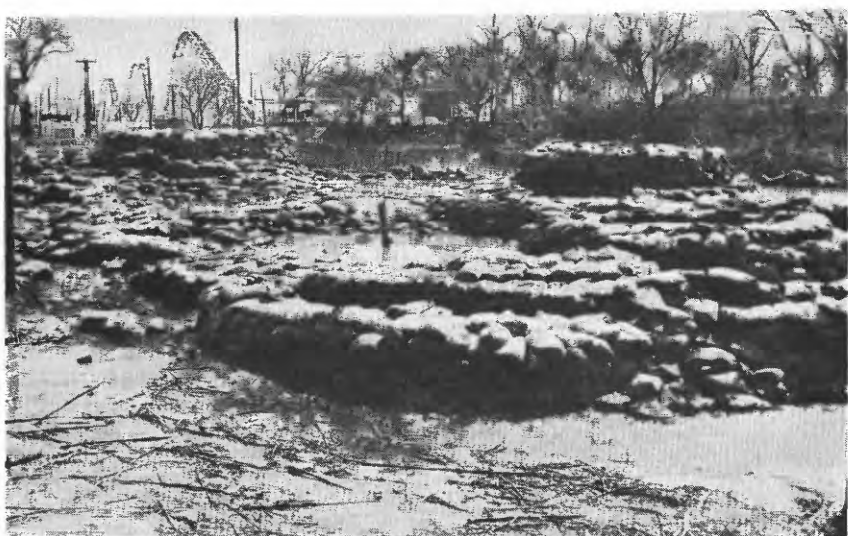
Figure 22. --Sand boils controlled by ring dikes of sandbags behind Council Bluffs levee. Photograph by Council Bluffs Nonpareil.

from 3 to 4 feet. Sandbag ring dikes were hastily constructed around each sand boil as it developed. (See fig. 22.) The greatest single threat to the dikes occurred on the night of April 18

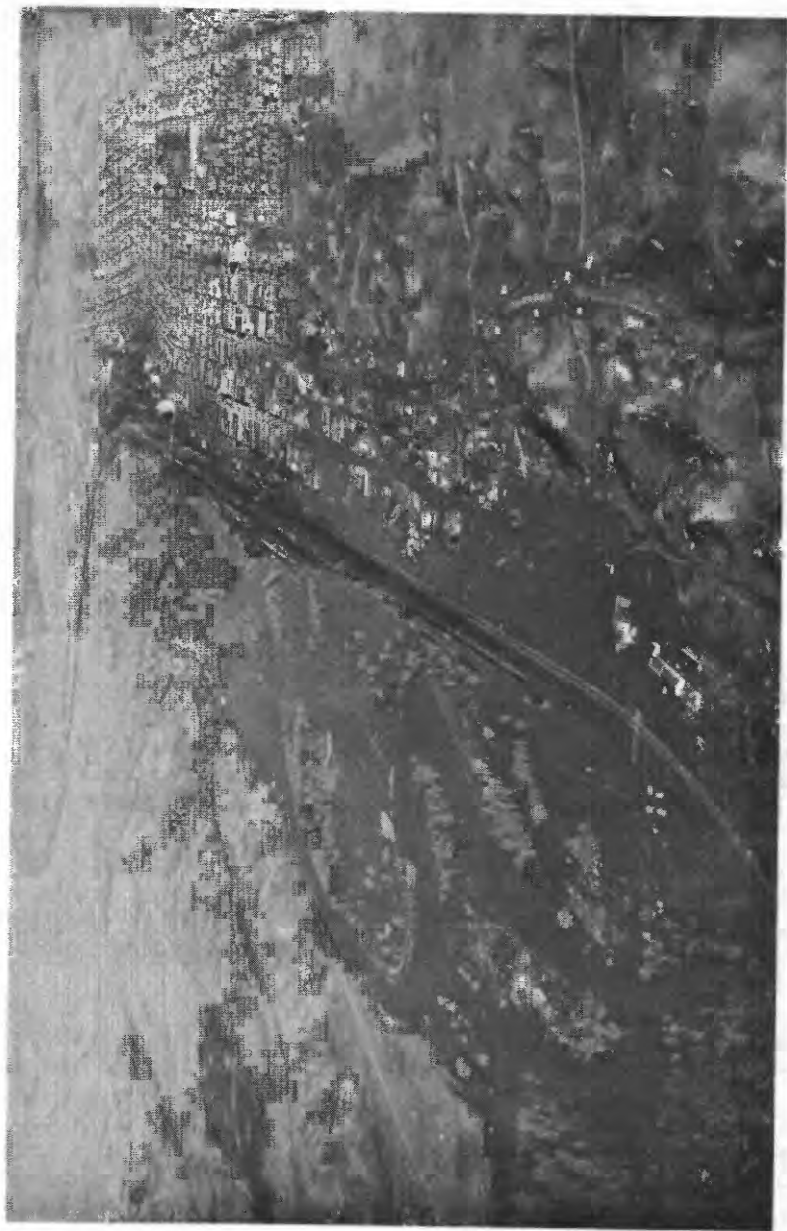
Figure 24. --Aerial view showing widespread flooding at north Havre, Mont., April 1952. Photograph by Corps of Engineers.

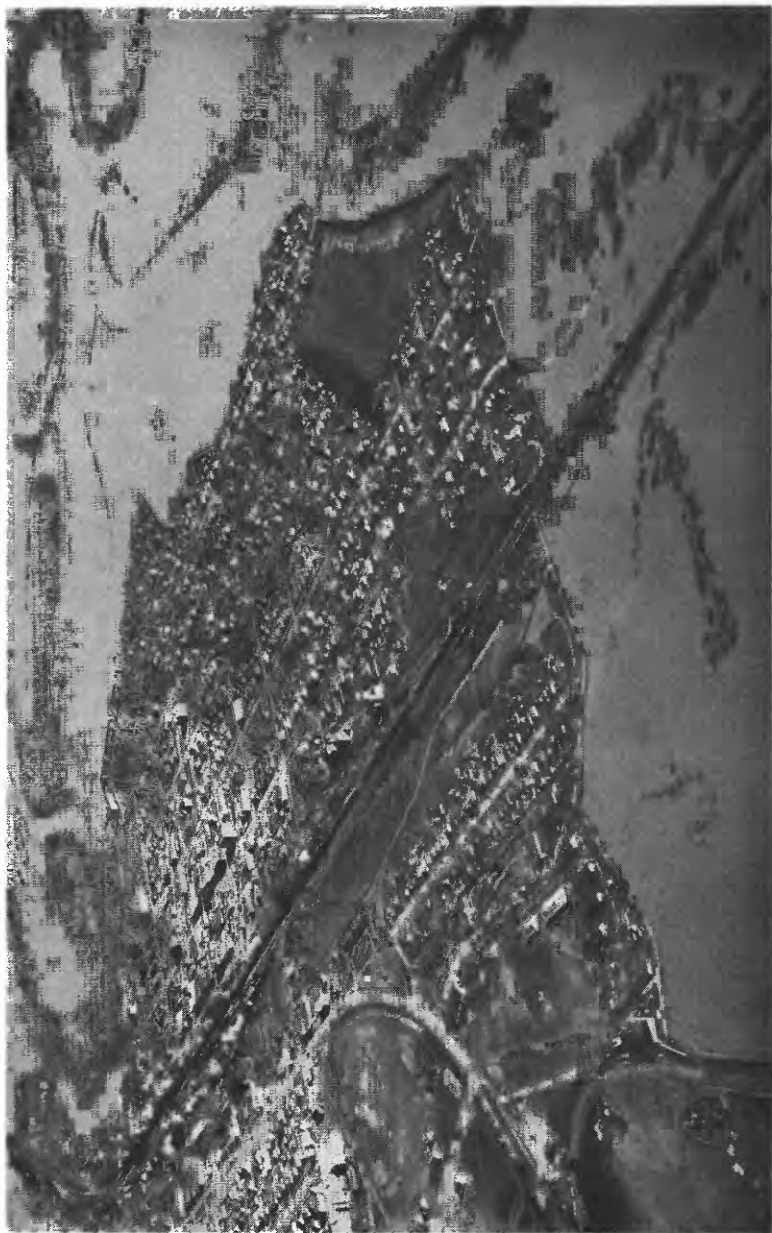
Figure 28. --Aerial view showing Glasgow, Mont., safe behind protective levee, April 17, 1952. Photograph by Corps of Engineers.
