MAP OF LOGAN DRAW BASIN ABOVE RONGIS RESERVOIR IN WYOMING, SHOWING AVERAGE LAND SLOPES AND STATUS OF CHANNEL EROSION

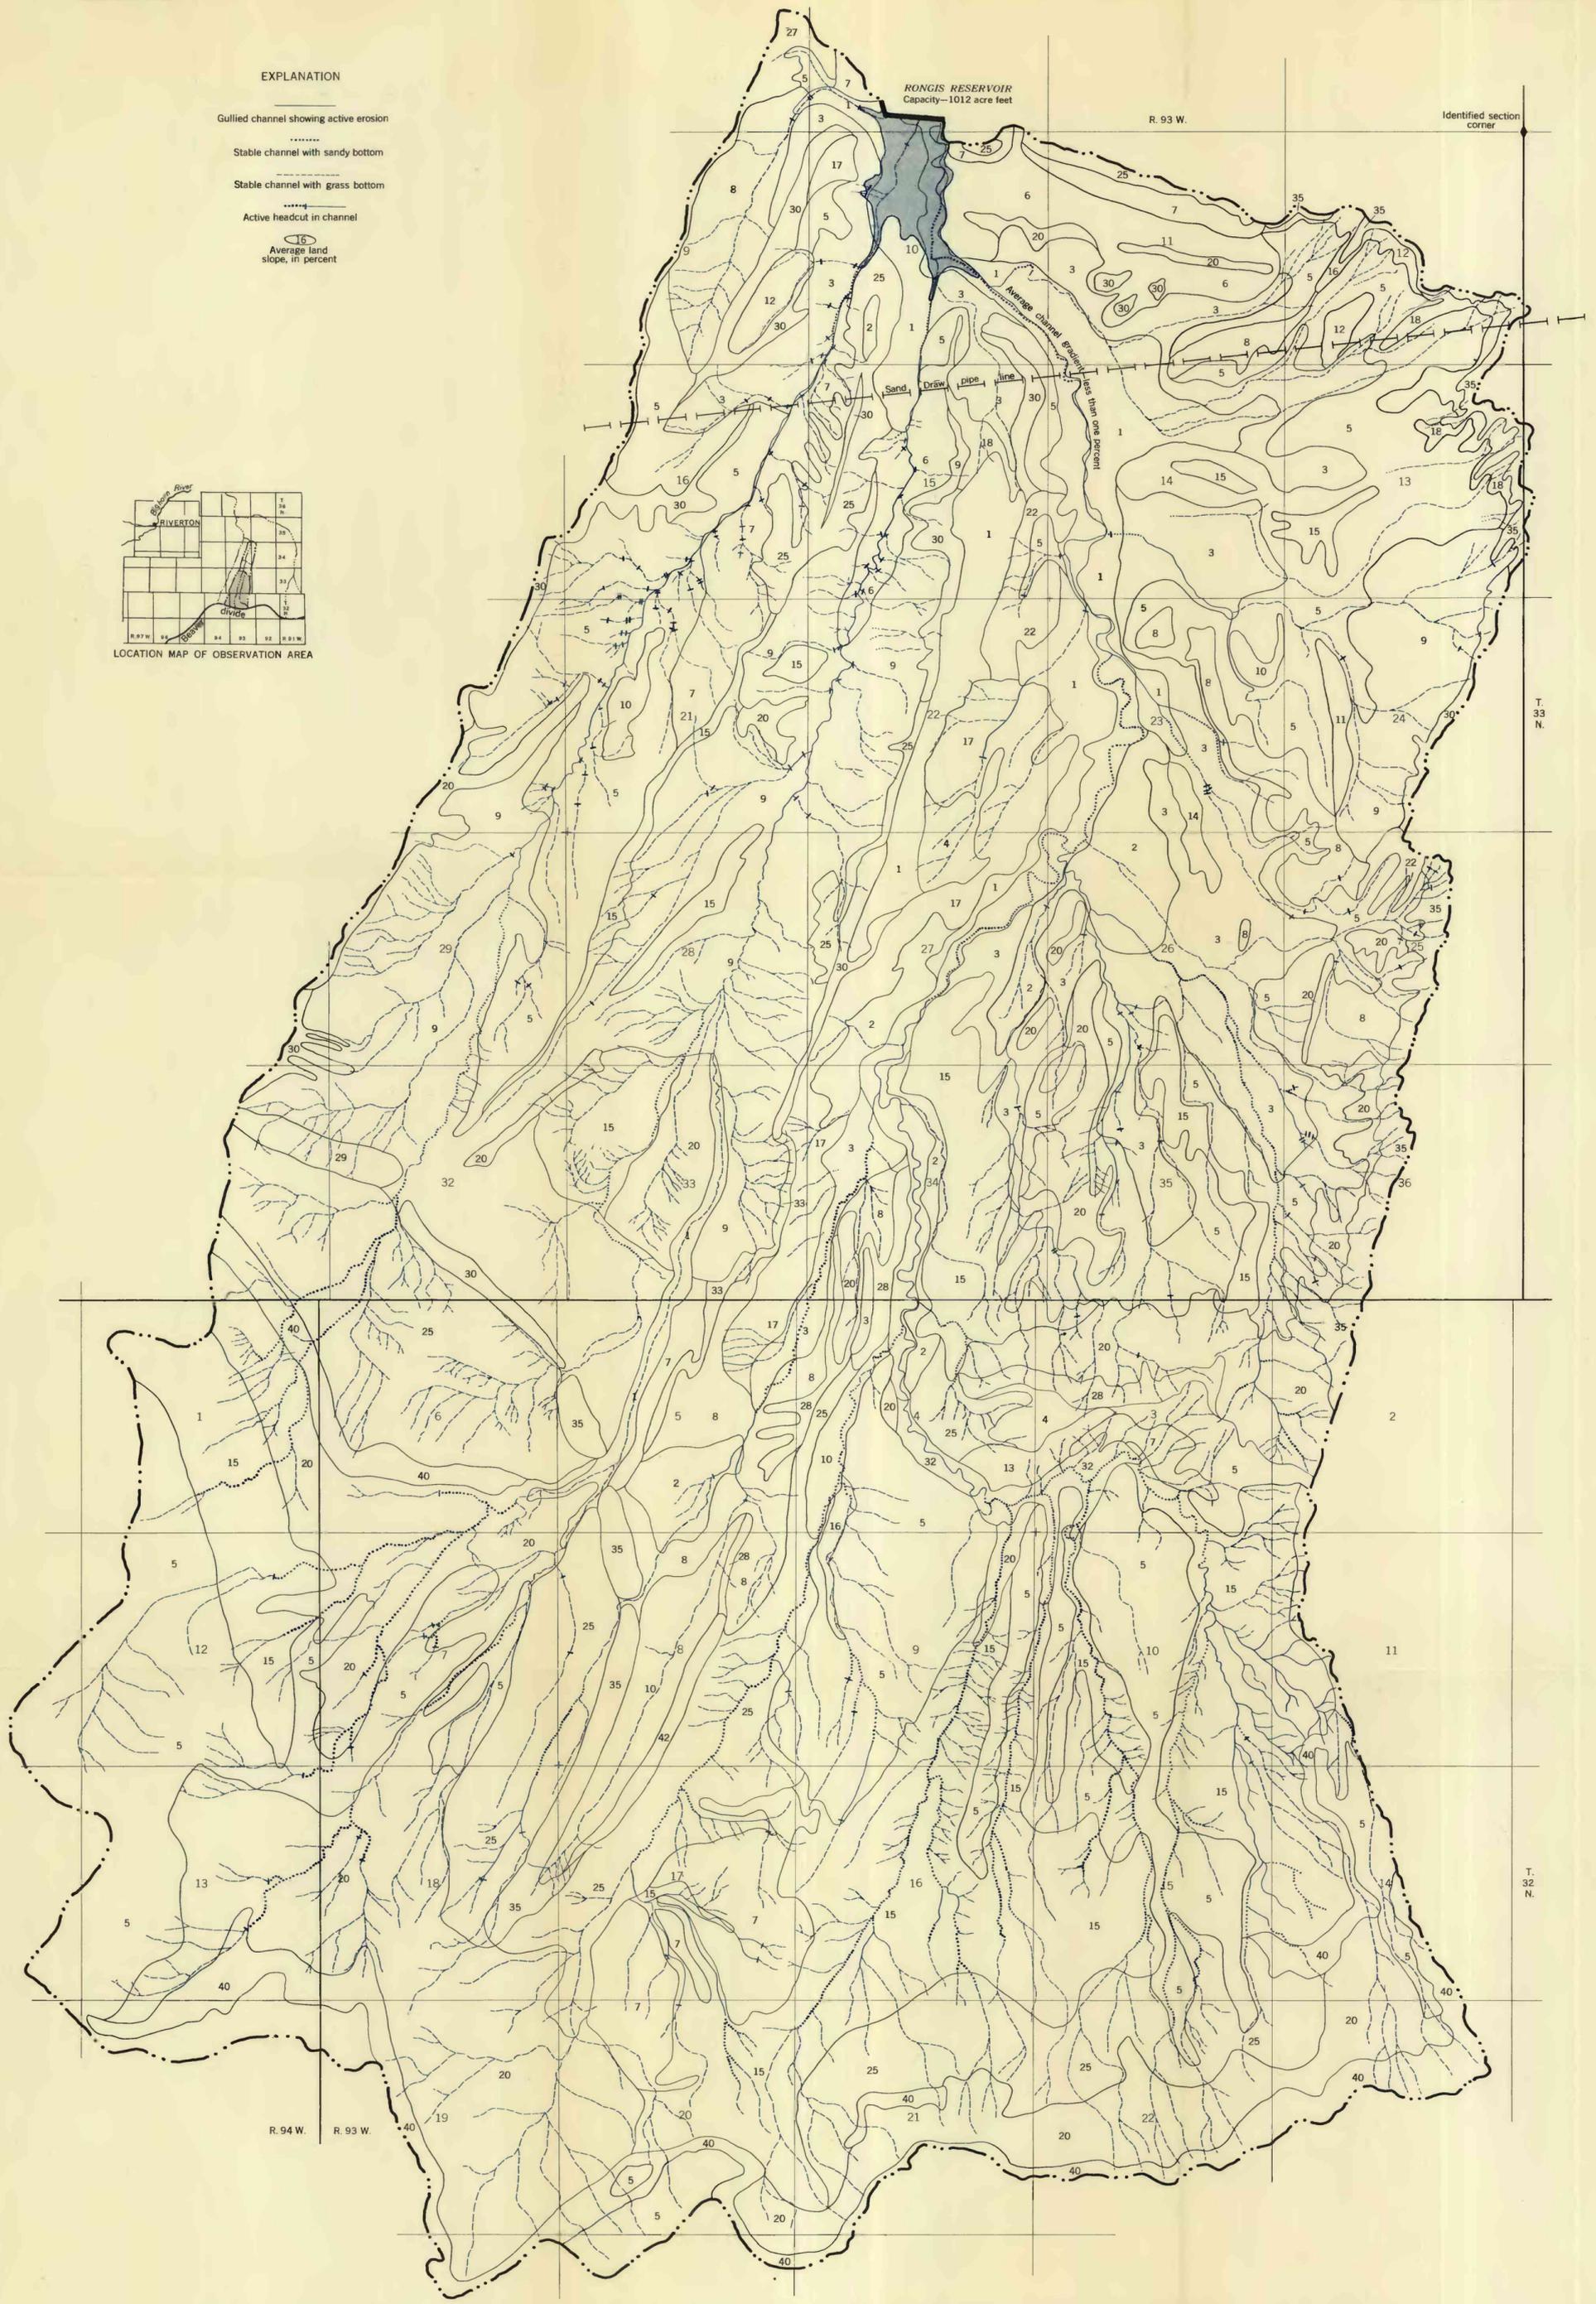
- Gullied channel showing active erosion
- ..... Stable channel with sandy bottom
- - - - - Stable channel with grass bottom
- Active headcut in channel
- Average land slope, in percent
