Evaluation and Control of Corrosion and Encrustation In Tube Wells of the Indus Plains, West Pakistan

GEOLOGICAL SURVEY WATER-SUPPLY PAPER 1608-L

By FRANK E. CLARKE and IVAN BARNES

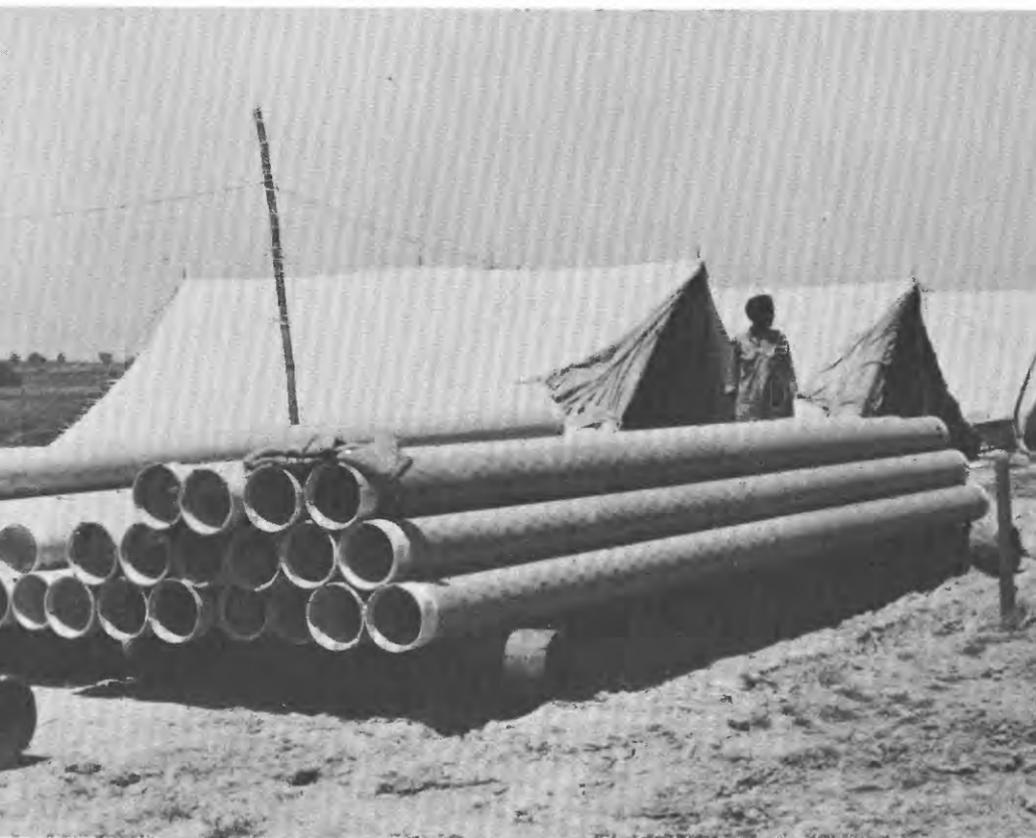
Slotted fiber-glass well casing, Indus Plains, West Pakistan. Courtesy Koppers Company, Organic Materials Division.

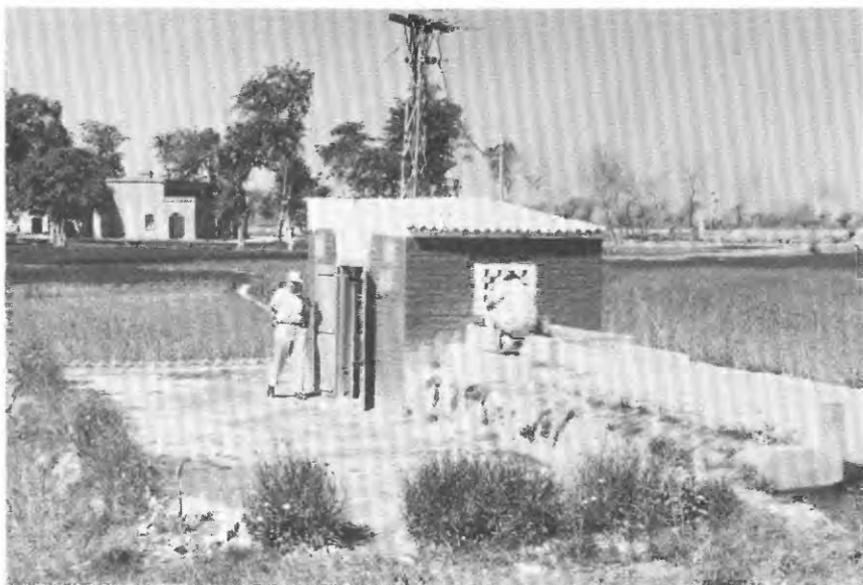
FIGURE 10.—Typical tube well.

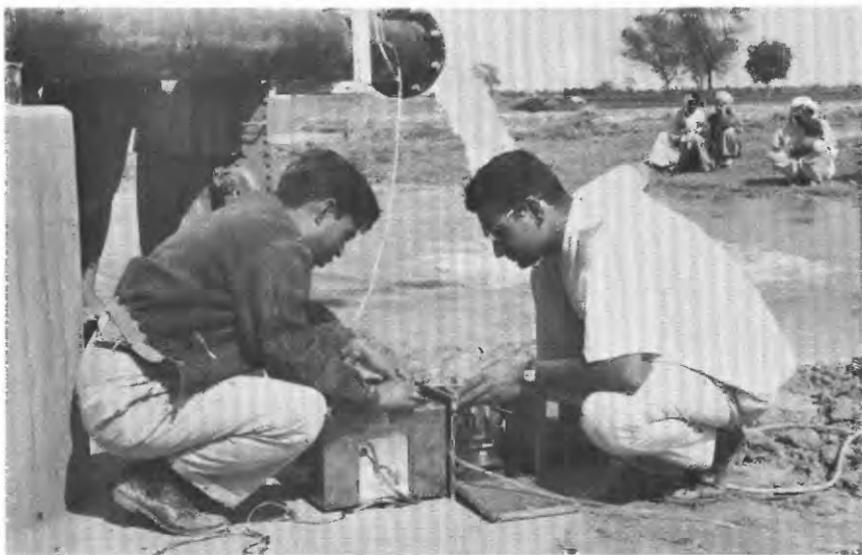
FIGURE 12.—Measuring electrode potential.

for bicarbonate ion. Electrode potential was measured by the method of Back and Barnes (1961) using a platinum-calomel electrode system in a special flow cell (figs. 12 and 13), together with the above-mentioned pH meter, which served as a potentiometer. Ferrous ion was determined colorimetrically with bipyridine reagent, and sulfide ion was determined by iodometric titration, as described by Clarke and Barnes (1964). Short-term corrosion rates were measured with an electrical-resistance type wire-loop probe inserted in the well water and monitored with a portable Kelvin Bridge circuit (corrosometer). This senses resistance changes in the test loops as evidence of change in diameter of the metal test specimens. The meter's dial reading represents an average value over the entire specimen, and therefore the reading is easily converted to metal penetration in inches per year (ipy) or any other convenient unit of metal loss. The type and size of wire corrosion specimens are selected to provide various rates of testing and sensitivity to corrosion. Such corrosion data in themselves are not quantitative indications of well life; however, they provide an excellent means for comparing performance of a particular metal in a variety of ground waters, or the effects of a particular ground water on various construction materials. Corrosometer tests provide useful data for correlating well performance records and water-quality data. A corrosion probe with its guard removed to show the wire loop specimen is illustrated in figure 14.

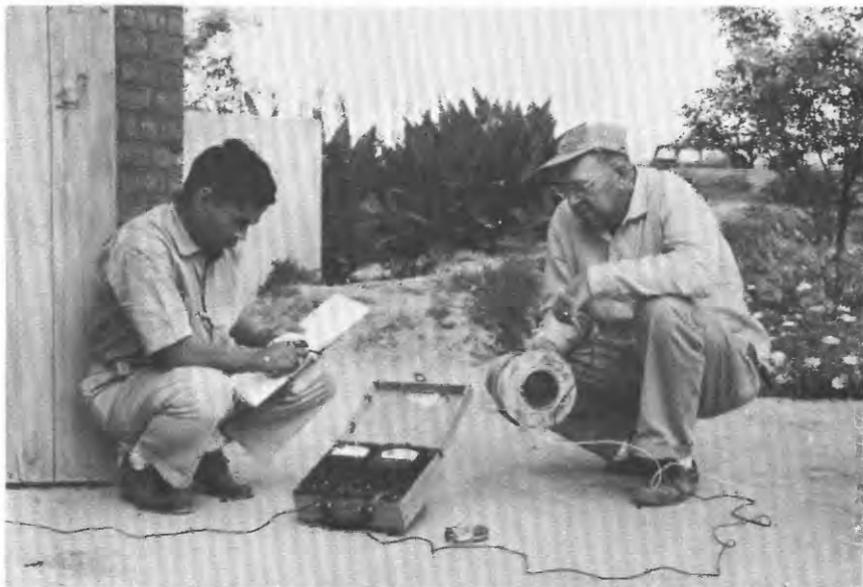
FIGURE 15.—Measuring long-line potential, SCARP-1 well.

Long-line corrosion current studies were made on selected SCARP-1 wells by the standard procedure of burying a copper sulfate reference electrode at various distances from the well, connecting it to the well head through a potentiometer, and measuring well-casing potential against the reference (fig. 15). This reveals differences in electrical potential between upper and lower portions of the casing filter pipe assembly. Results of the tests have been discussed by L. P. Sudrabin (written commun., 1964). Such surveys are useful in detecting massive corrosion cells caused by differences in concentrations of air or salt dissolved in the water at various levels in the underground system.

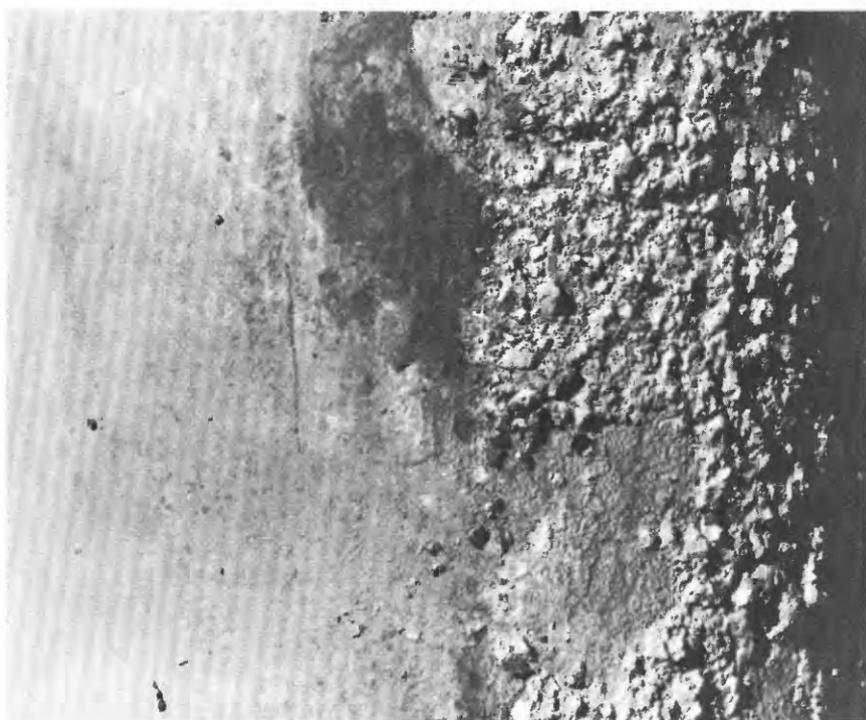
FIGURE 17.—Preferential encrustation of steel casing ($\times 1\frac{1}{2}$), Shādman well 34, SCARP-1.

The compositions of SCARP-1 encrustants are as variable as their depositional patterns, but calcium and iron are the major elements. External crusts are predominantly iron carbonate (siderite) with much smaller amounts of calcium carbonate (calcite) and heavy metal constituents. Deposits removed from the casing slots, like the one shown in figure 20, generally are complex, multilayer, sandwichlike plugs consisting of the original slot filling plus several layers of corrosion products on either side of it. This layering appears to be the result of continually changing depositional patterns, which are presumably the result of catalytic effects of successive deposits. The structure of the slot filling is shown in figure 21.

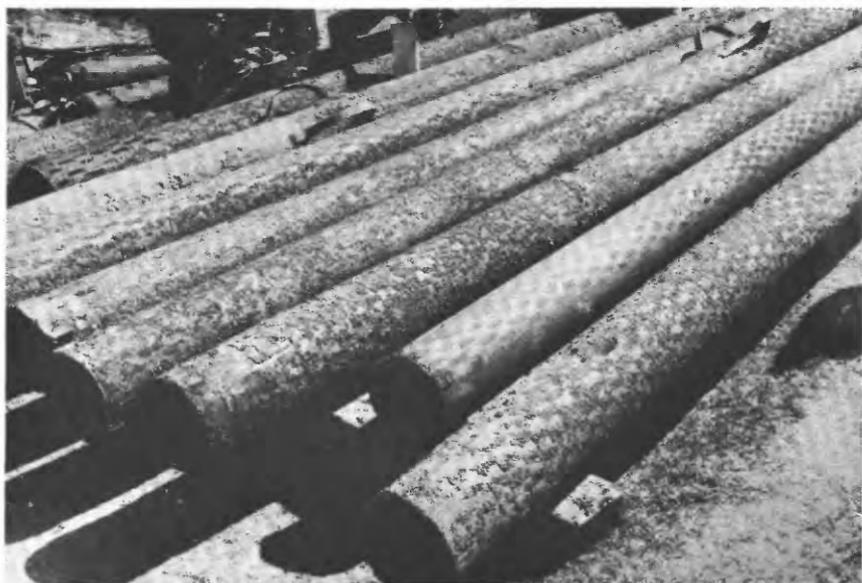
FIGURE 18.—Localized encrustation of casing slots, Shādman Well 34, SCARP-1.

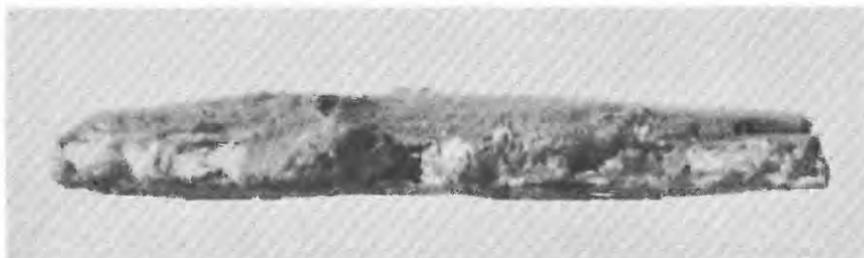
FIGURE 20.—Mineral deposit from casing slot ($\times 4$), Shādman well 34, SCARP-1.
