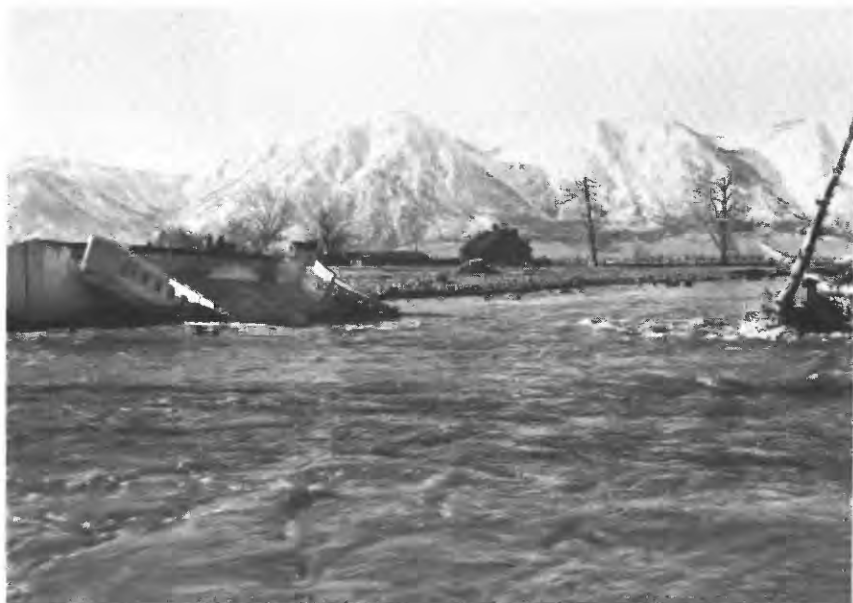
FIGURE 4.—Flood-damaged concrete bridge across the East Fork Carson River on Nevada State Highway 56, south of Gardnerville, Nev. Photograph by Nevada State Highway Department.

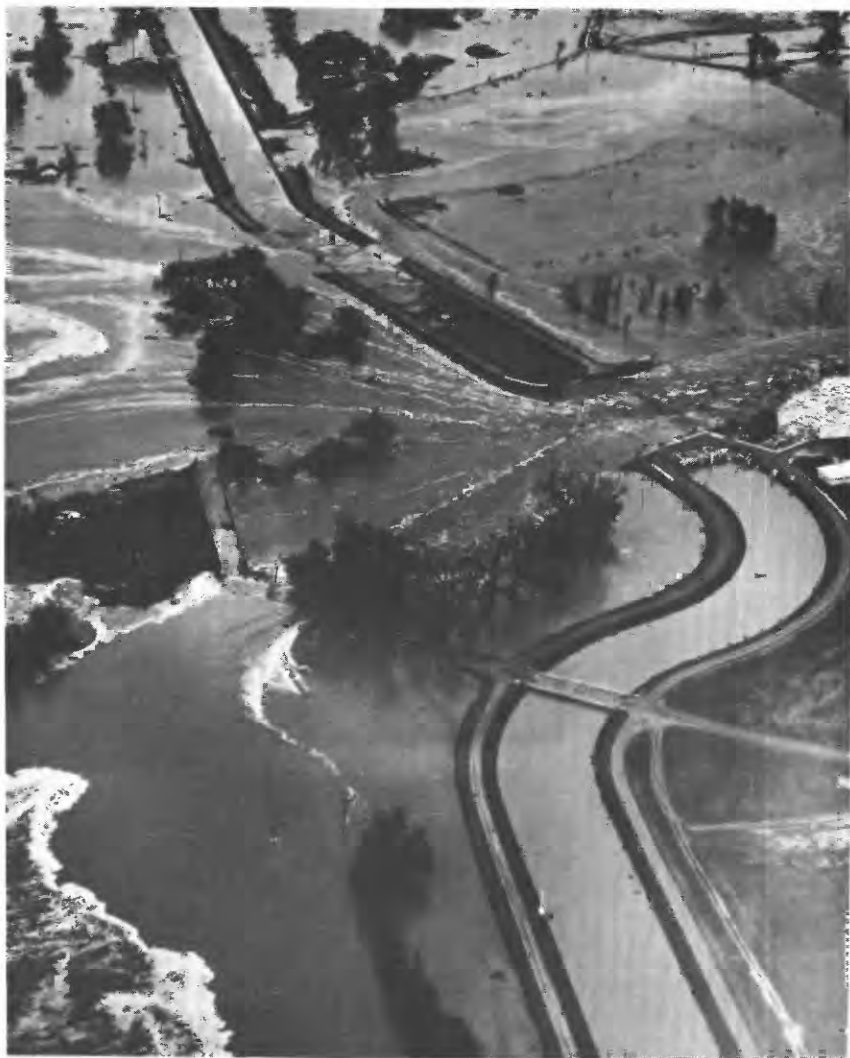
FIGURE 9.—Kaweah River flood at the Friant-Kern Canal crossing, California. The canal was breached by floodwaters in several places as shown in the upper part of the picture. Photograph by United Aerial Survey.

Friant-Kern Canal and overtopped and washed out large sections (fig. 9). Residences in the southern part of the town of Woodlake were flooded and damaged. More than half of the city of Visalia was flooded in December, and nearly a fourth of the city was reflooded in January. Several thousand people were forced to evacuate their homes. Damage was heavy in the business section and in a newer residential section in the southwestern part of the city where water in homes was as deep as 30 inches for about 6 days. The area flooded

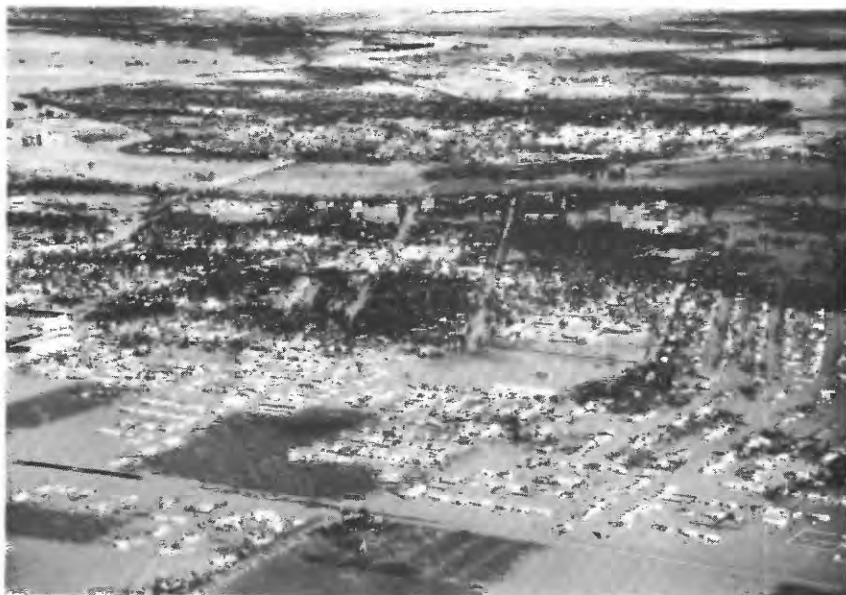
FIGURE 12.—Yuba City, Calif., under water as a result of Feather River levee failure. The city of Marysville is the "island" in the background surrounded by floodwaters of the Yuba and Feather Rivers. Photograph by Corps of Engineers.

The failure of the west levee of the Feather River at Shanghai Bend occurred about 12:10 a.m. on December 24. Water from this break entered Yuba City and flooded about 95 percent of the city (fig. 12). The depth of flooding varied from a few inches on the north side

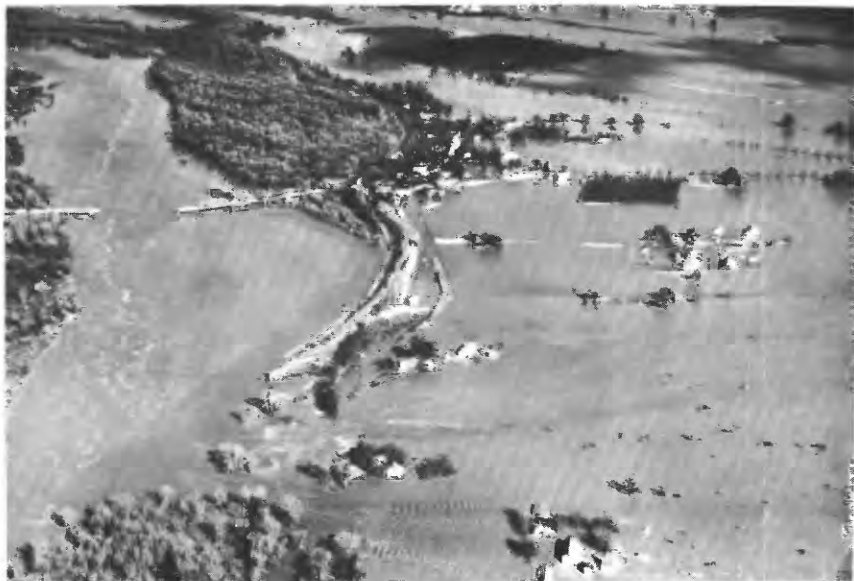
FIGURE 13.—Floodwaters of the Feather River at Nicolaus, Calif., on December 24. The break in the east levee is in the foreground. The Nicolaus gaging station is visible a short distance upstream from the break.

At Nicolaus part of the highway bridge across the Feather River was washed out, and the break in the east levee downstream from Nicolaus caused the flooding of about 24,600 acres of well-developed farmland (fig. 13). Two persons were reported to have lost their lives as a result of the flood in this area; approximately 98 farms and 12 nonfarm homes were flooded, and more than 400 persons were evacuated. The depth of floodwaters was 16 to 20 feet over most of the lower part of the area and 5 to 10 feet near Nicolaus. The levee was cut at the lower end to drain the floodwaters into the Sacramento River. Inflow through the Nicolaus break continued for 34 days until the gap was closed, and outflow through the lower cut continued for another 2 weeks. Then the cut was closed, and the remaining water was pumped out.

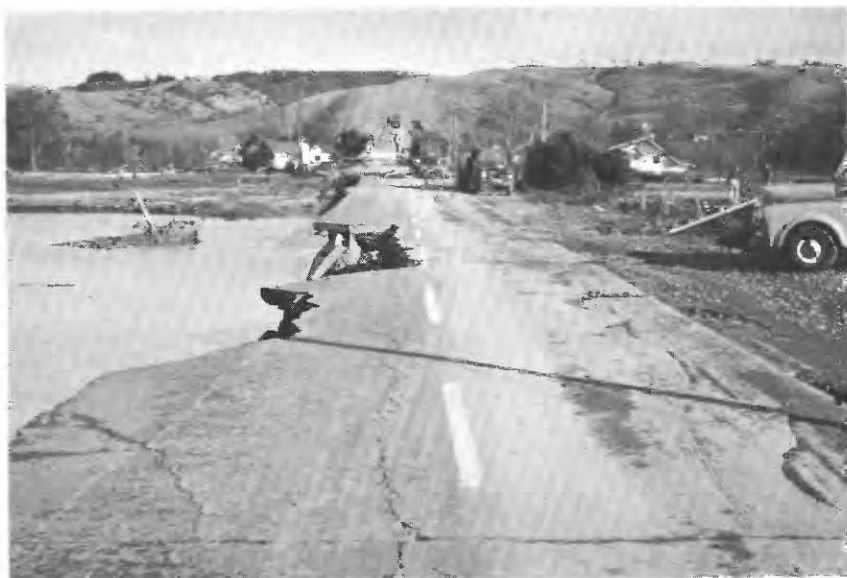
FIGURE 16.—Eel River flood damage near Fernbridge, Calif. Undercutting is on downstream side of Fernbridge-Ferndale highway. Flood-damaged homes are in middleground. Photograph by Proctor's, Eureka, Calif.

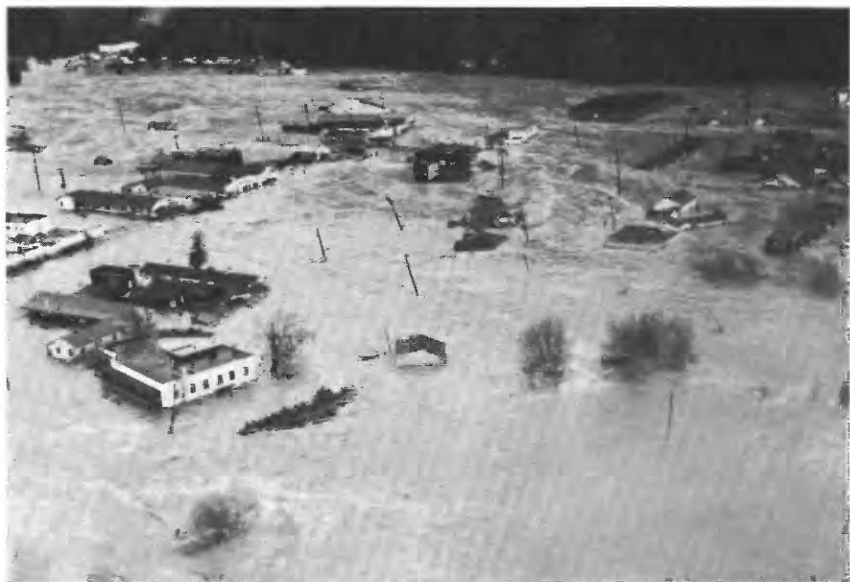
FIGURE 17.—Flooding in the town of Klamath, Calif., on the right bank of the Klamath River. Photograph by Proctor's, Eureka, Calif.

Major damage occurred in the lower reaches of the basin where six persons lost their lives as a direct result of the floods. The greatest damage was in and near the town of Klamath and in Hoopa Valley. The town of Klamath and the community of Klamath Glen, about 3 miles upstream, were almost completely destroyed (fig. 17). Much

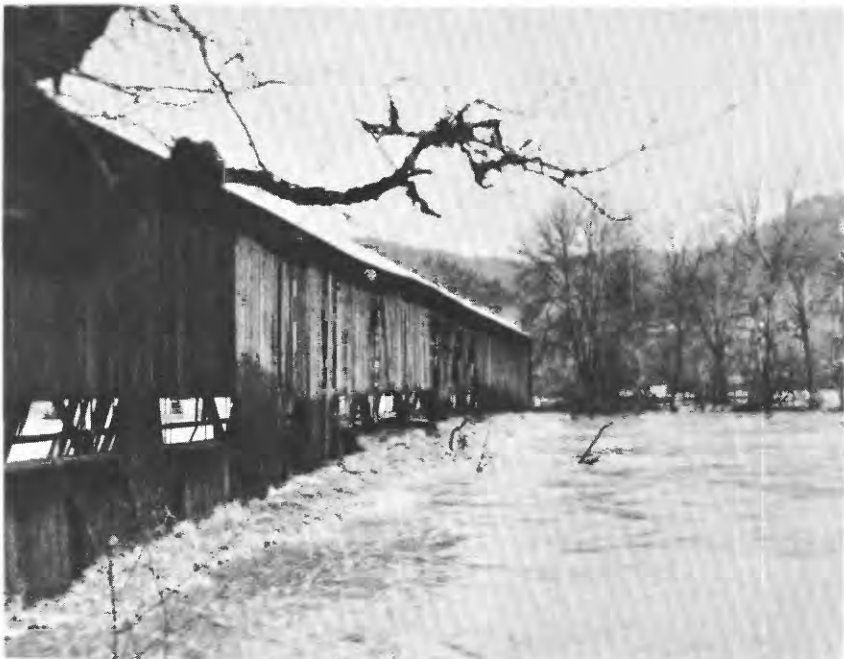
FIGURE 24.—Floodwaters over county road bridge across South Fork Umpqua River at Rice Creek, 2 miles upstream from Dillard, Oreg., at 11 a.m., December 22, 1955. Photograph by Dick Gilman, Roseburg, Oreg.
