The Corrosive Well Waters of Egypt's Western Desert

GEOLOGICAL SURVEY WATER-SUPPLY PAPER 1757-O

By FRANK E. CLARKE

CONTRIBUTIONS TO THE HYDROLOGY OF
AFRICA AND THE MEDITERRANEAN REGION

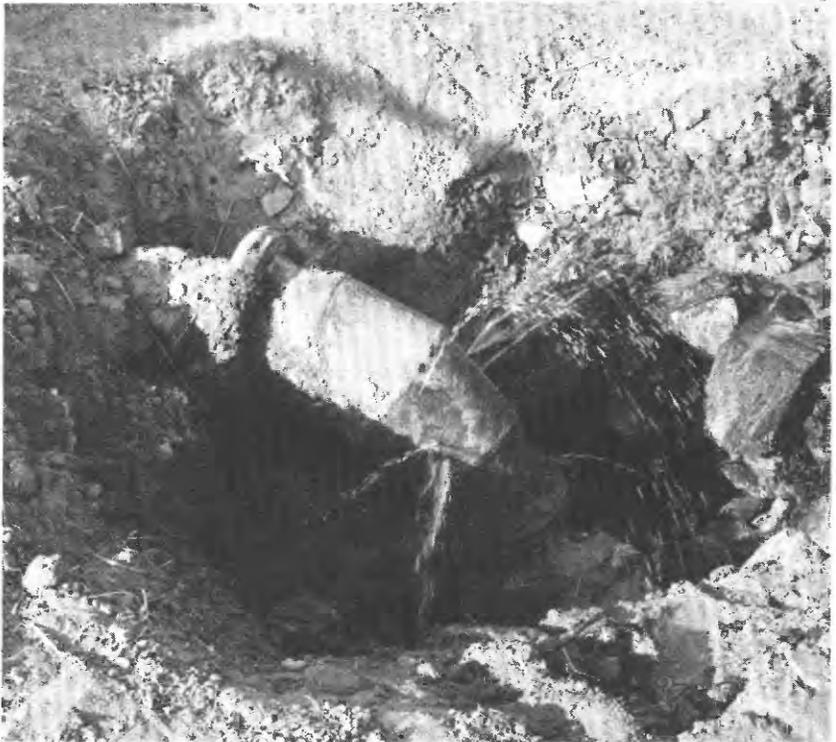
FIGURE 6.—Perforated elbow, Mut well 1, Dakhla Oasis.

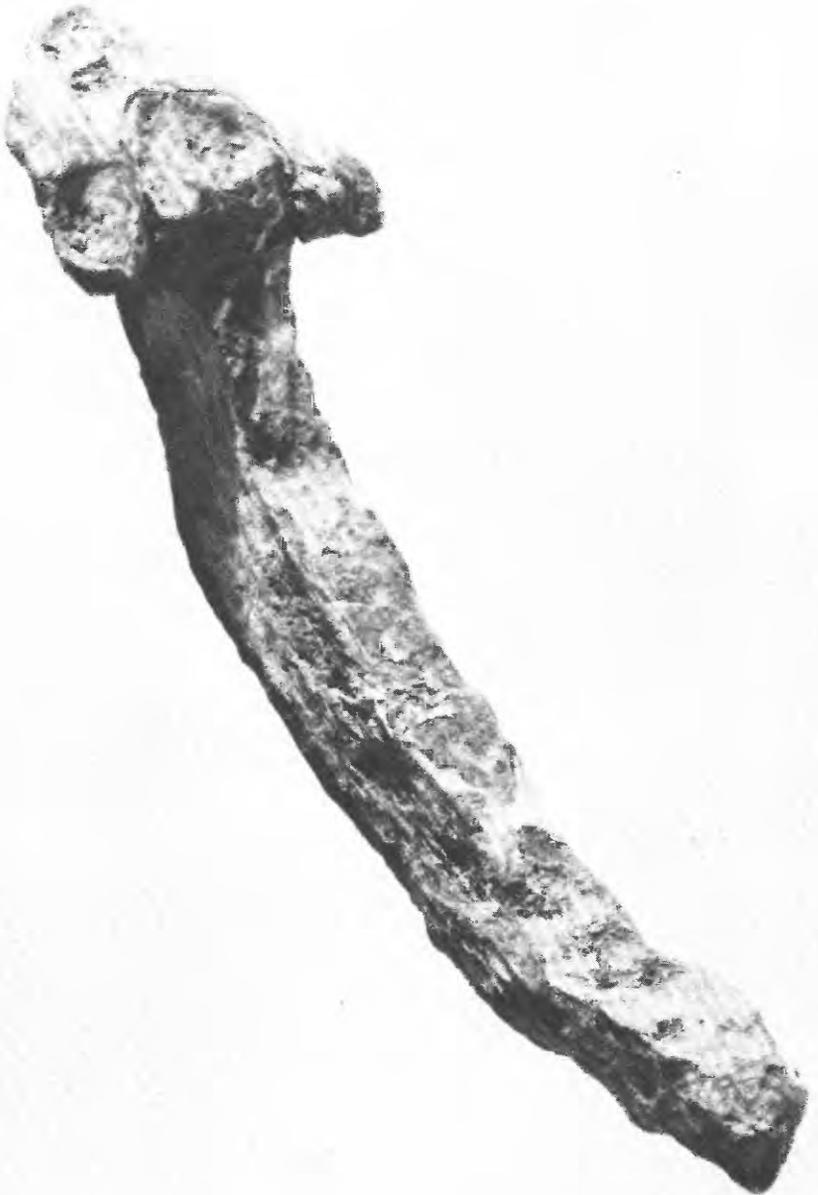
FIGURE 7.—Severed screen bridge, Kharga well 1A, Kharga Oasis, $\times 4.6$.

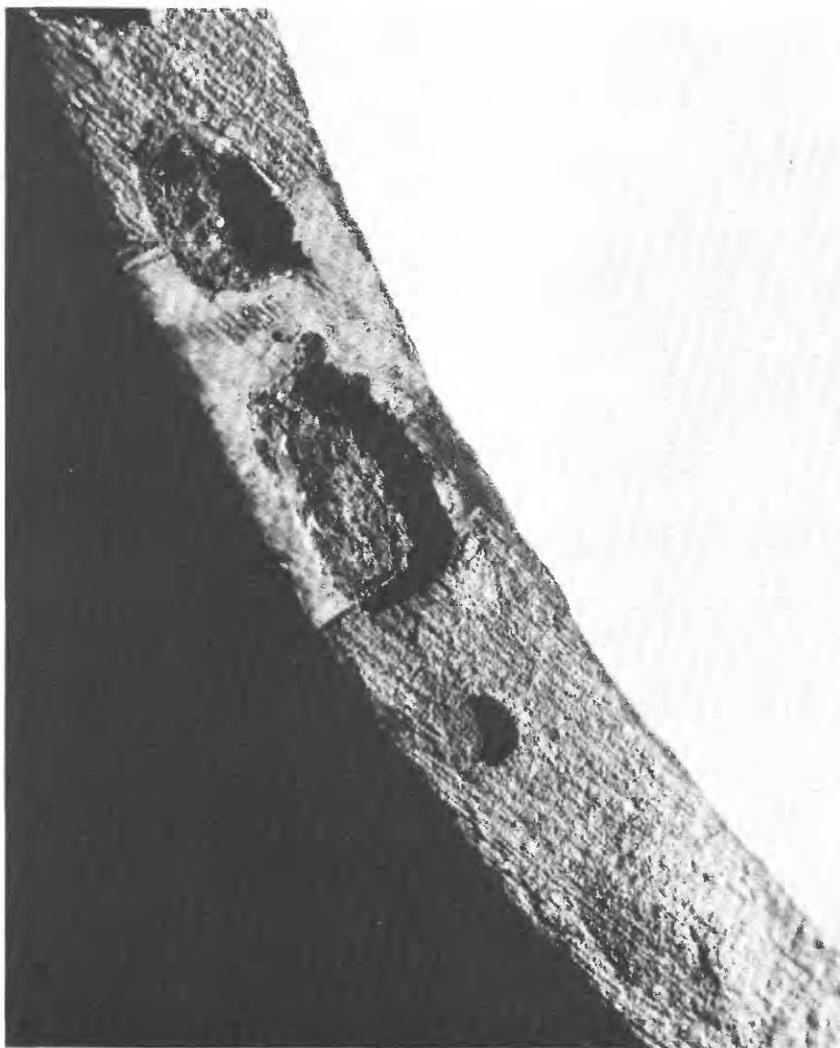
FIGURE 11.—Subsurface pitting, Kharga well 1A, $\times 5$.

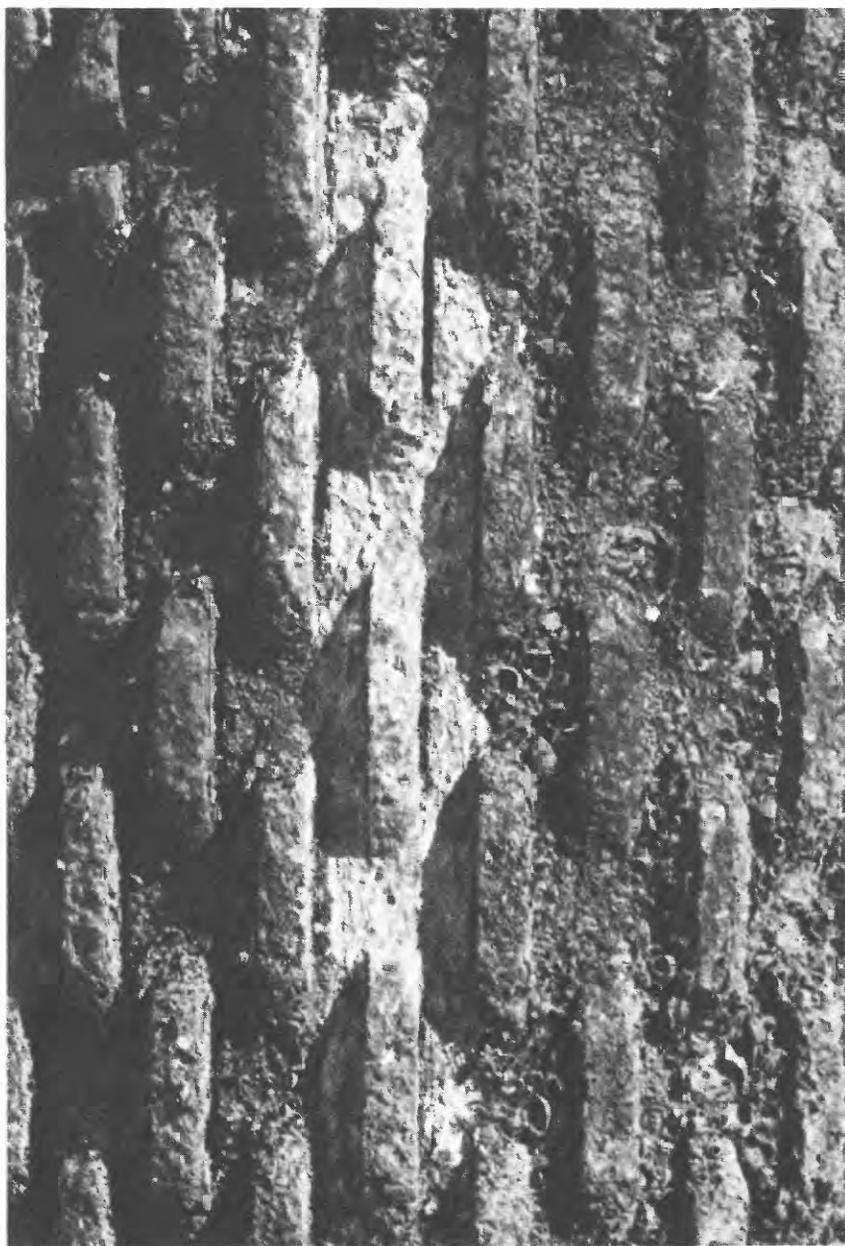
FIGURE 13.—Corroded bridge-slotted screen, after 2-year exposure, Kharga well 1A.

ized pits to 1.5 mm depth. On casual examination, however, the damage was difficult to detect. But surfaces which retained original mill marks and saw scratches flaked away to reveal deep sub-surface penetration of the type described by Paver and Pretorius and illustrated in figure 11. The corrosion deposit was heavy and relatively brittle. The aluminum specimen had developed white corrosion tubercles but had only insignificant etching on cut edges (fig. 12). The stainless steel screen specimen retained original mill marks and there was no evidence of corrosion.

The final inspection showed that two years of exposure had increased the overall metal loss in both mild steel specimens although the maximum depth of pitting was still about 1.5 mm. Damage of the type shown in figure 13 was concentrated on the convex surfaces of the slot bridge as evidence that stress from cold working was contributing to local attack. Analysis of the brittle black corrosion deposit showed it to contain iron sulfide (Fe_9S_8), in addition to the more common black hydrated iron oxide. The aluminum and stainless steel specimens endured the two-year exposure with no significant damage. Except for a superficial coating of iron corrosion products, small white tubercles

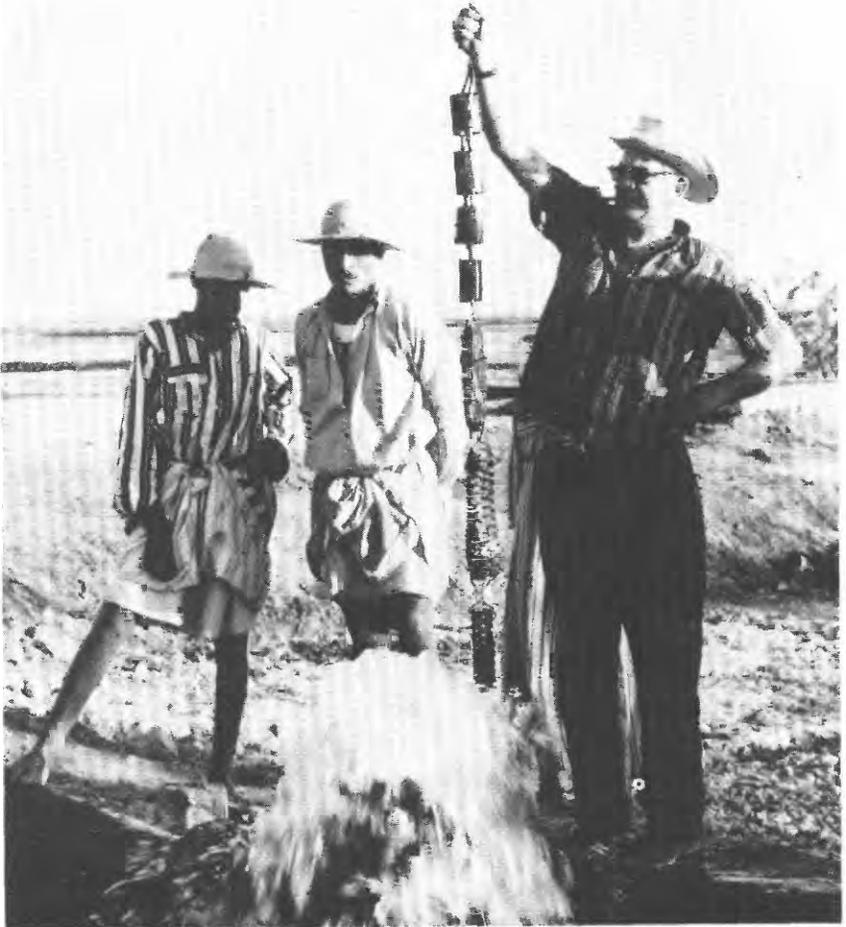
FIGURE 14.—Downhole corrosion specimen string, Mut well 2, Dakhla Oasis.

Similar surface line specimens of mild steel, aluminum, and stainless steel were installed in Mut well 1 of Dakhla Oasis in December 1962 and examined in May 1963, replaced with new specimens and examined again in March 1964. In April 1963 down-hole specimens consisting of weighted, rubber-insulated cylinders or flattened screen sections made variously from mild steel, aluminum, stainless steel, Monel Metal and Incoloy 800, also were suspended together on stainless steel cable in Mut well 2 just above screen height and 340 m below the surface. This specimen string was examined during the final inspection. The assembly is shown in figure 14.

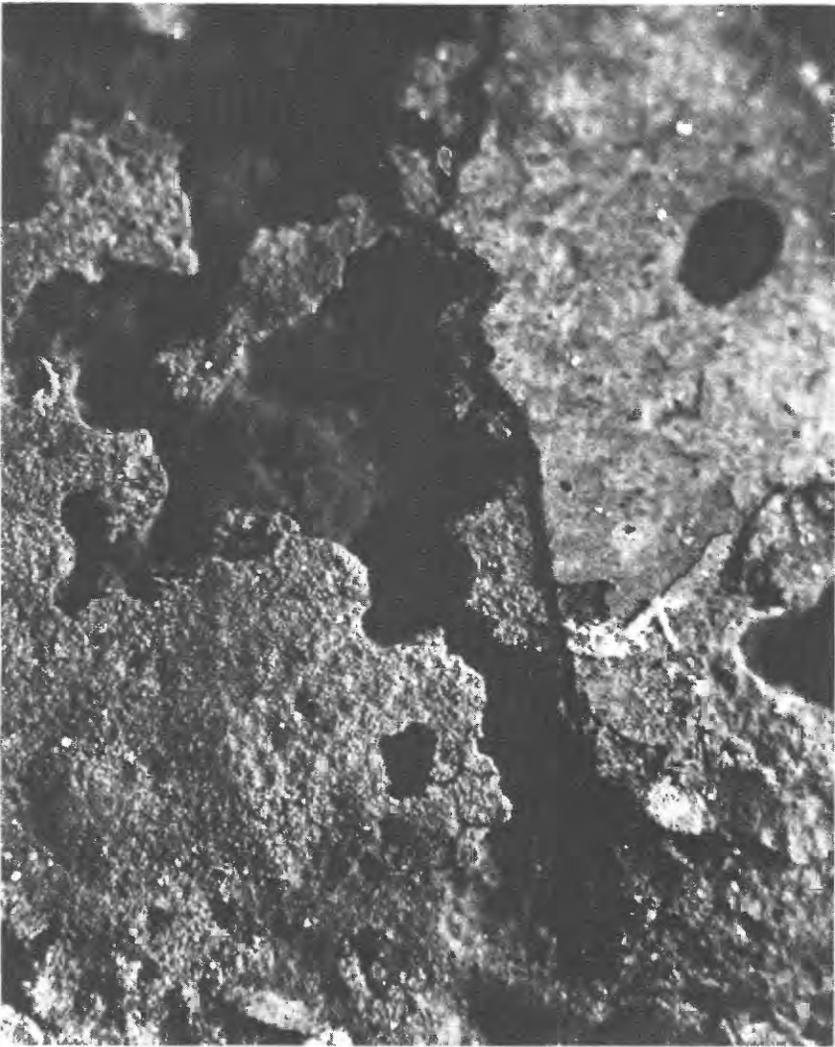
drilled in the specimens. Many bridge pieces had been completely penetrated by pitting. The drilled casing appeared to have lost about 25 percent of its average wall thickness and its 6 mm wall had been perforated in some places. All corroded areas were relatively clean with only superficial films of nonadherent deposits as shown in the macrograph (fig. 15). Final inspection in March 1964 showed similar severe damage on mild steel surface line specimens installed one year earlier and on the down-hole specimens mentioned above. In the latter exposure, the bridge-slotted specimen has been reduced to approximately 50 percent thickness

FIGURE 15.—Deep, deposit-free corrosion, steel specimen, Mut well 1, Dakhla Oasis $\times 7$.

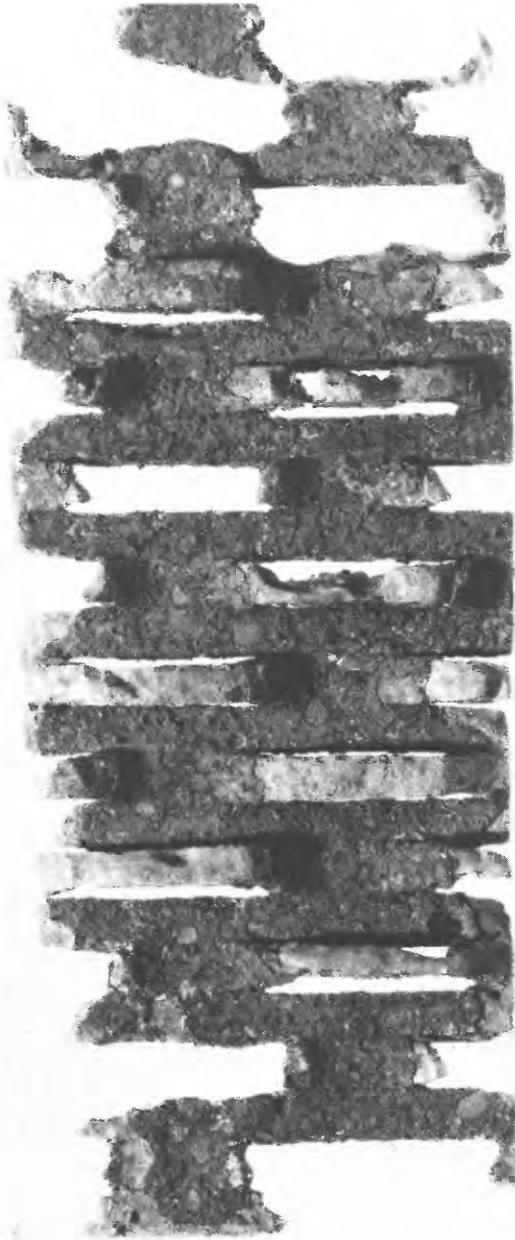
overall and had lost its bottom half entirely, dropping the drilled casing specimen and the tension weight (fig. 16).

FIGURE 16.—Severely corroded bridge-slotted steel specimen from down-hole string, Mut well 2.

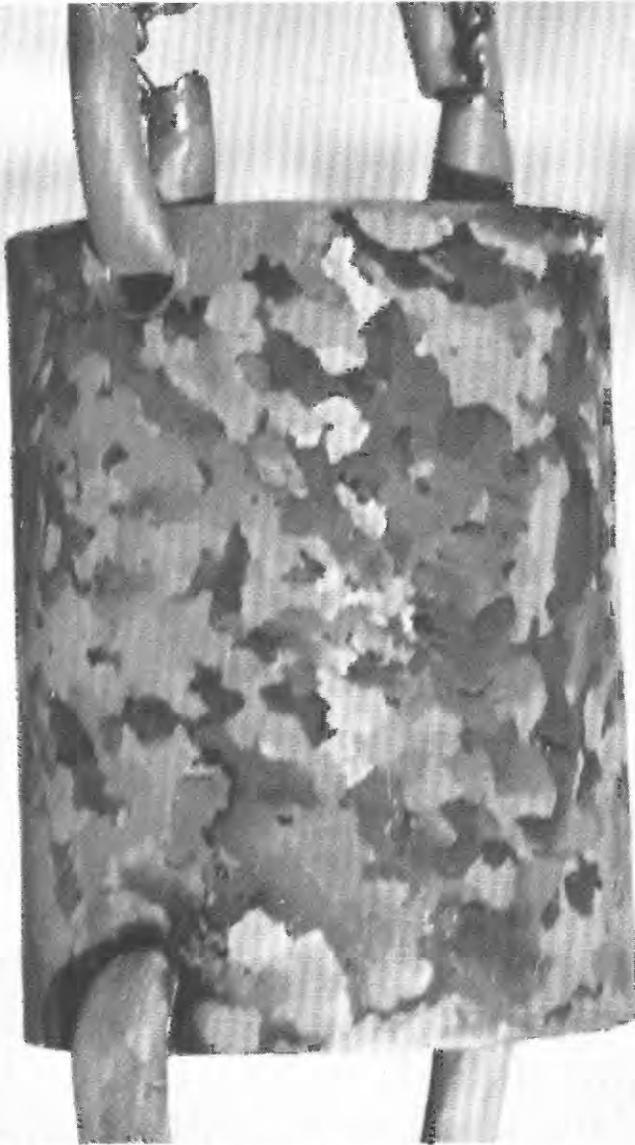
(Monel Metal) also was good. Although its surface was mottled blue, gold, and brown as evidence of selective nickel solution and there was overall etching and minor uniform metal loss (fig. 19), there was no localized pitting of the sort that occurred on mild steel.

FIGURE 19.—Slightly corroded Monel Metal specimen, down-hole string, Mut well 2.

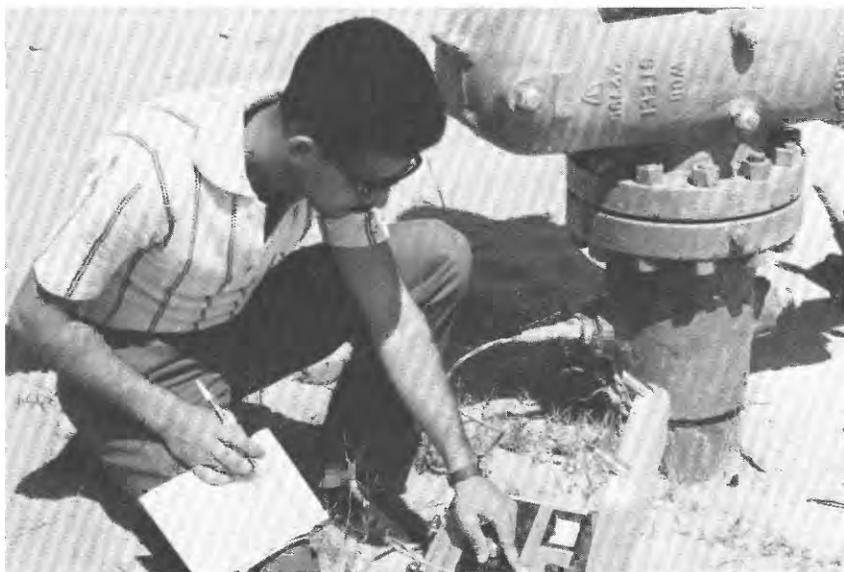
but is not affected by corrosion. A battery powered meter is used to compare electrical resistances in the exposed to that in the reference leg of the resistance bridge. Resistance change due to

FIGURE 20.—Mohammed Shaaban, Egyptian General Desert Development Organization, operating a corrosometer, Kharga well 1.

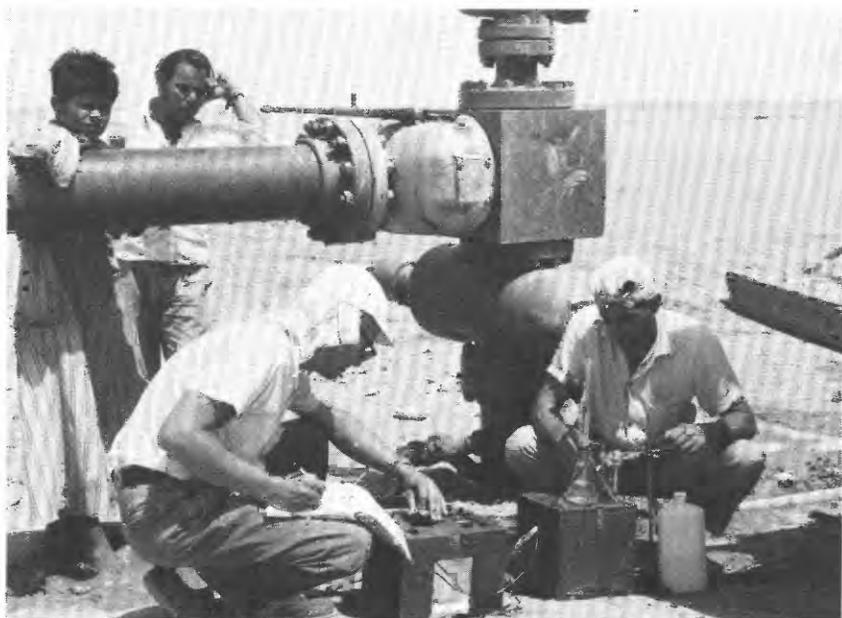
FIGURE 27.—Hassan Mostafa (right), Egyptian General Desert Development Organization, and the late Paul Bieber, U.S. Geological Survey, measuring bicarbonate ion in water from a Kharga Oasis well, 1962.

Later investigators, including those of the Nasr Oil Company, the Egyptian Desert Institute, and the EGDDO extended water-quality information with gas analysis and mineral analyses made of samples transported to laboratories in Cairo and other locations. Unfortunately, analyses at distant laboratories did not permit accurate measurement of unstable constituents and characteristics such as pH, oxidation potential (Eh) bicarbonate ion, and dissolved gases. To overcome this problem, both field tests for unstable parameters and laboratory analyses for the stable ones were included in the author's investigation reported here. Field tests were made for pH and bicarbonate ions by the methods of Barnes (1964), using an electronic pH meter with a glass-calomel electrode system both for measuring pH and for detecting the equivalence point in the bicarbonate titration (see fig. 27). Electrode potential was measured by the method of Back and Barnes (1961), using the pH meter as a potentiometer and a platinum-calomel electrode system in the flow cell shown in figure 28. Iron and sulfide ion were determined in the laboratory on samples

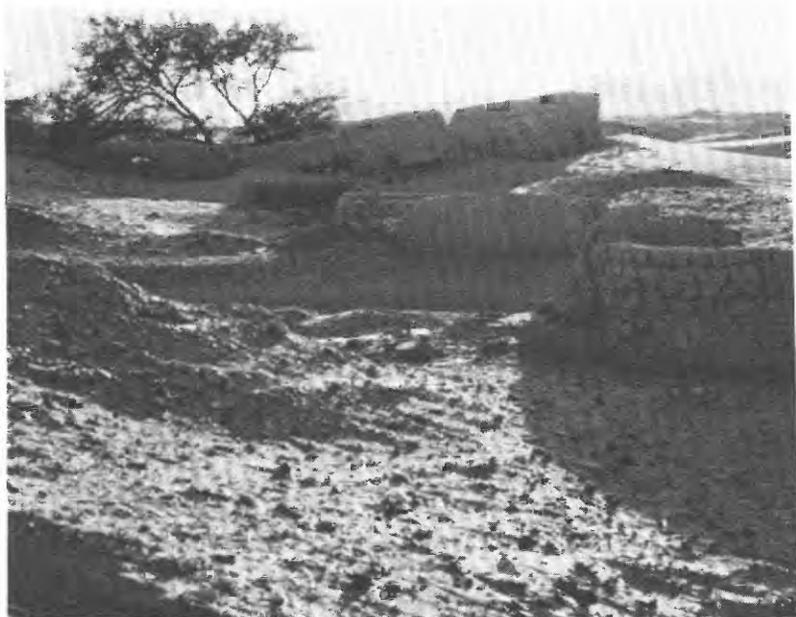
FIGURE 34.—Kanat at nonflowing well, Kharga Oasis.
