Fluvial Sediment in Kiowa Creek Basin Colorado

GEOLOGICAL SURVEY WATER-SUPPLY PAPER 1798-A

By JAMES C. MUNDORFF

SEDIMENTATION IN SMALL DRAINAGE BASINS

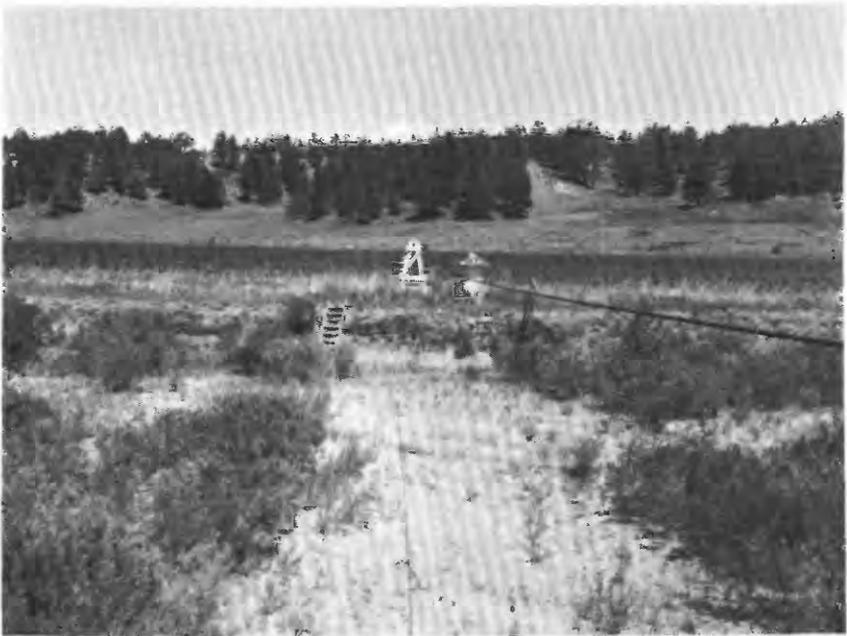
During periods of flow at the Elbert and Kiowa sites, suspended-sediment samples were collected with a U.S. DH-48 sampler by wading during minor stream rises and with a U.S. D-49 sampler suspended from a reel mounted on a cable car during major rises. In addition, samples were obtained with automatic samplers during major rises at both sites. Because of the lack of flow at Elbert during the past few years, the channel has become rather heavily vegetated. (See figs. 14, 15.) The investigational site at Kiowa and the stream reach downstream from the site are shown in figures 16 and 17. The gaging station and sediment station are at a cableway that spans a narrow artificial channel having nearly vertical banks. The artificial channel, about 800 feet long and on the average about 80 feet wide, was constructed to divert flow from an eroding stream meander. Figure 18 shows the general plan of the site.

FIGURE 14.—Cableway across Kiowa Creek at Elbert.

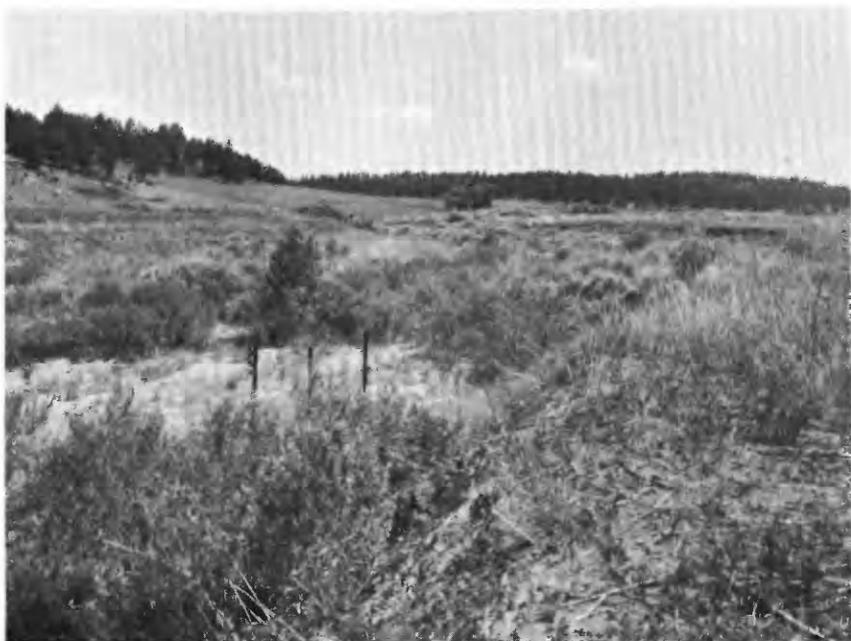
FIGURE 15.—Kiowa Creek channel upstream from cableway at Elbert.

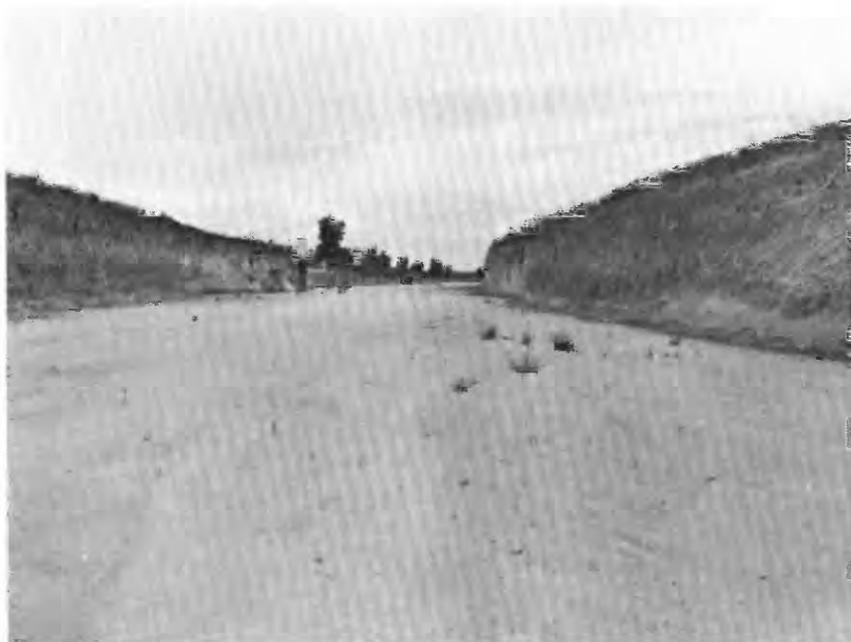
FIGURE 16.—Kiowa Creek channel at Kiowa. Channel is about 80 feet wide in this reach. Gage house and cableway are in background.

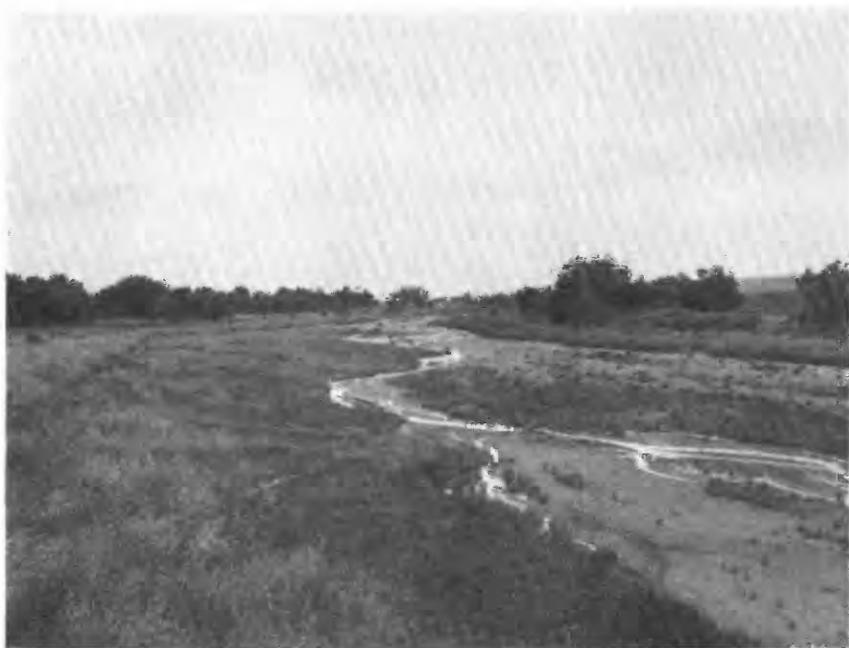
FIGURE 17.—Kiowa Creek channel about half a mile downstream from cableway at Kiowa and immediately upstream from bridge on State Route 86.
