Water-Supply Potential From an Asphalt-lined Catchment near Holualoa Kona, Hawaii

By SALWYN S. W. CHINN

GEOLOGICAL SURVEY WATER-SUPPLY PAPER 1809-P

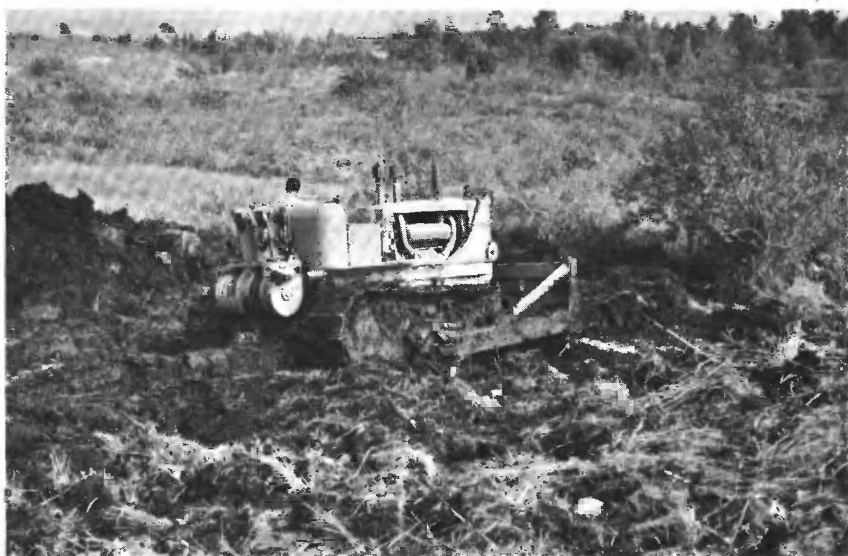
FIGURE 4.—Clearing Waiaha catchment site.

A bulldozer was used to clear the area (fig. 4) and to smooth and compact the soil. The weeds, brush, and other debris that remained after bulldozing were cleared by hand. After the area was cleared, a ridge of earth was placed around the perimeter to contain all rainwater and to prevent water from entering the catchment from the outside. The catchment area of 16,940 square feet was an oval 210 feet long and 120 feet wide whose natural topography provided a drop of 15 feet along its length.

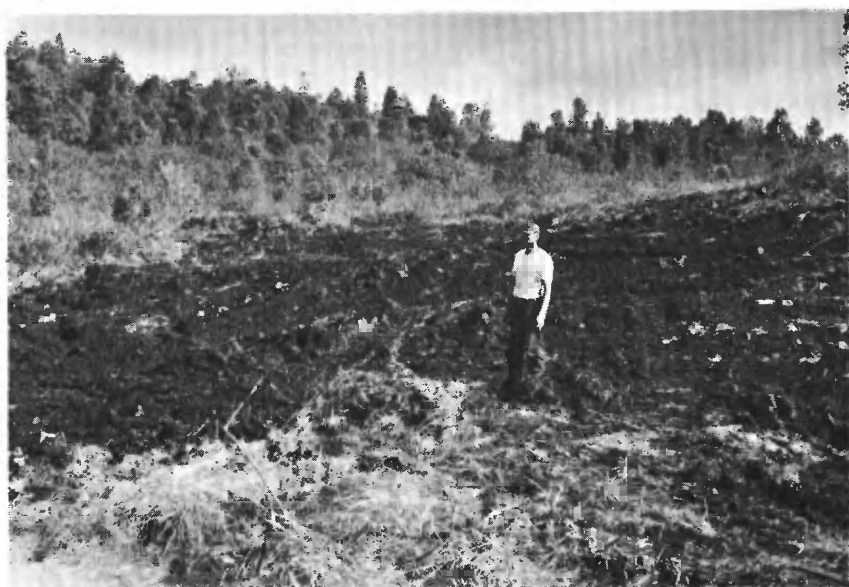
A

FIGURE 5.—Construction of catchment. A, After clearing and before compaction. B, spraying asphaltic membrane on catchment.

After the area was prepared and all weeds that came up after compaction were burned off (fig. 5A), the area was sprayed with a water-soluble soil sterilant. After the application of the soil sterilant, the area was primed with liquid asphalt and then sprayed with membrane asphalt (fig. 5B) at temperatures of 375°-425°F.

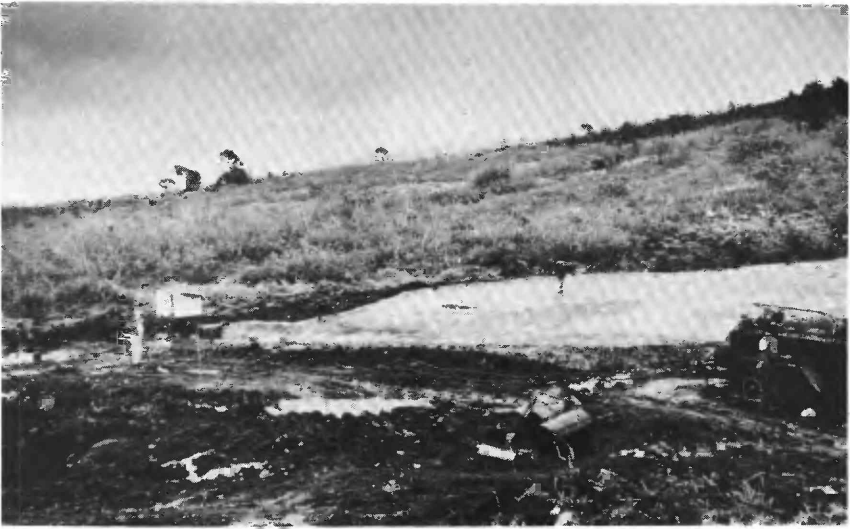
FIGURE 11.—Catchment after completion in June 1958.

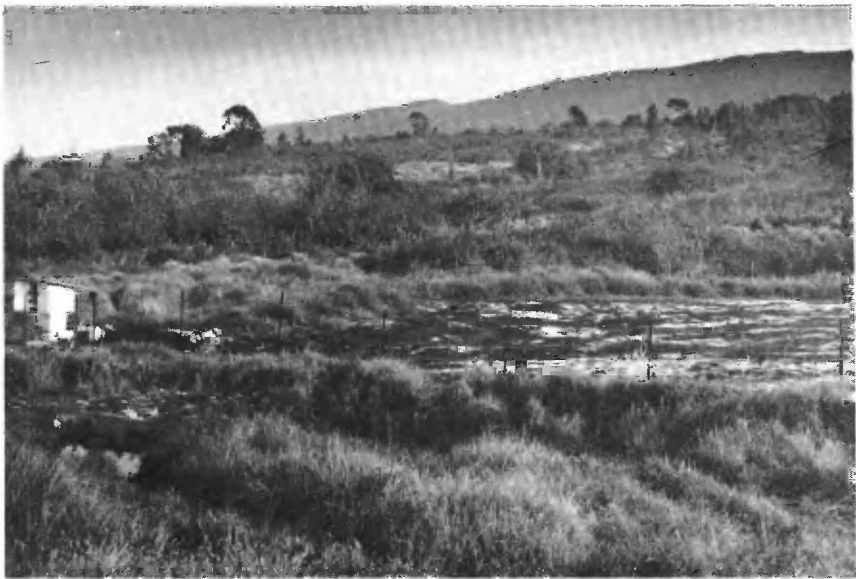
FIGURE 12.—Catchment in December 1961.

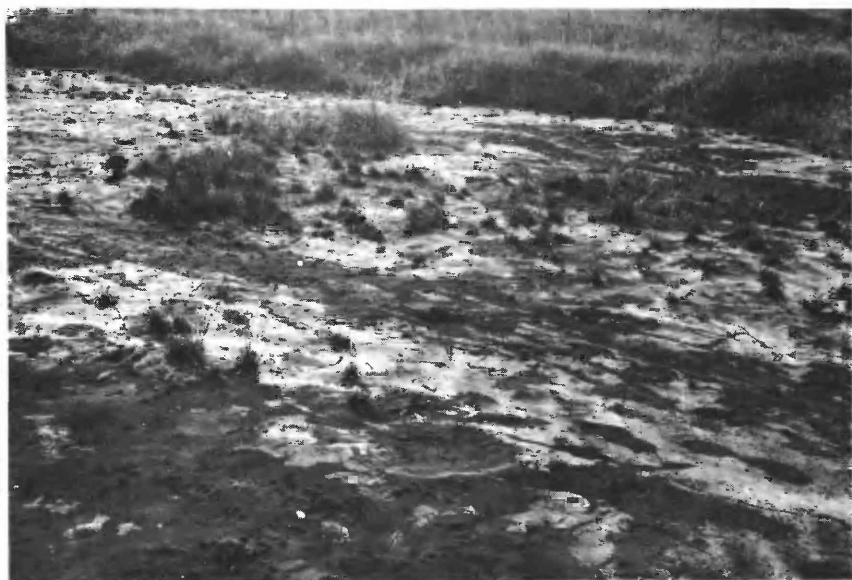
FIGURE 13.—Asphaltic membrane 3½ years after completion.
