Floods of August 1967 In East-Central Alaska

GEOLOGICAL SURVEY WATER-SUPPLY PAPER 1880-A

By J. M. CHILDERS, J. P. MECKEL, and G. S. ANDERSON

FLOODS OF 1967 IN THE UNITED STATES

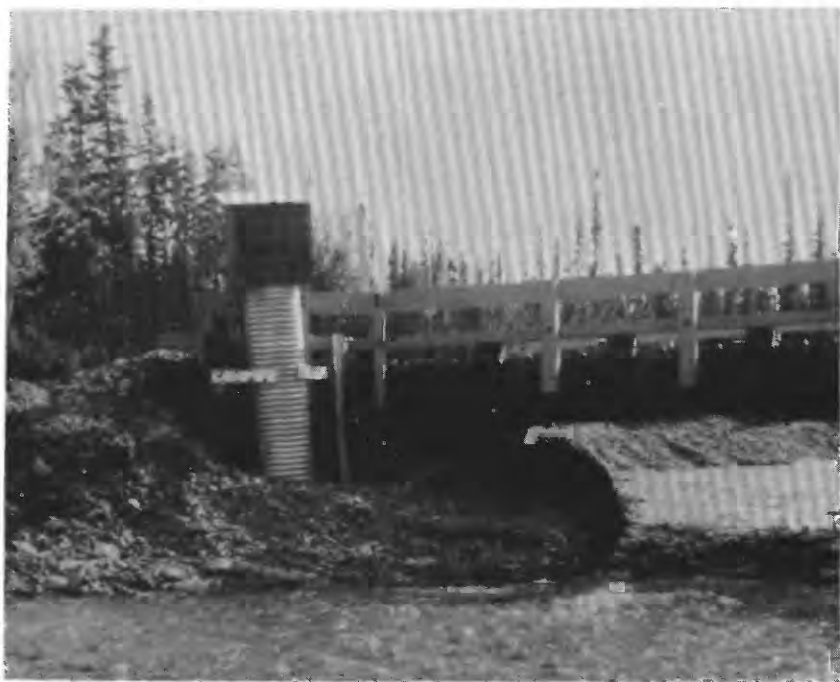
FIGURE 12.—U.S. Geological Survey gaging station on Boulder Creek near Central after flood of August 13. Photograph by U.S. Geological Survey.

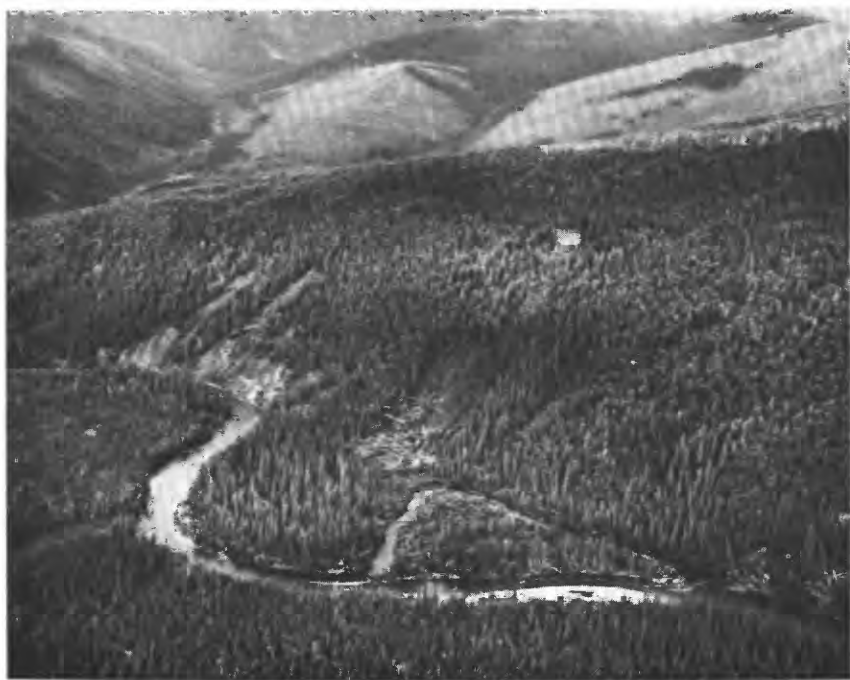
FIGURE 15.—Landslides in upper Chena River basin. Photograph by U.S. Army Corps of Engineers.

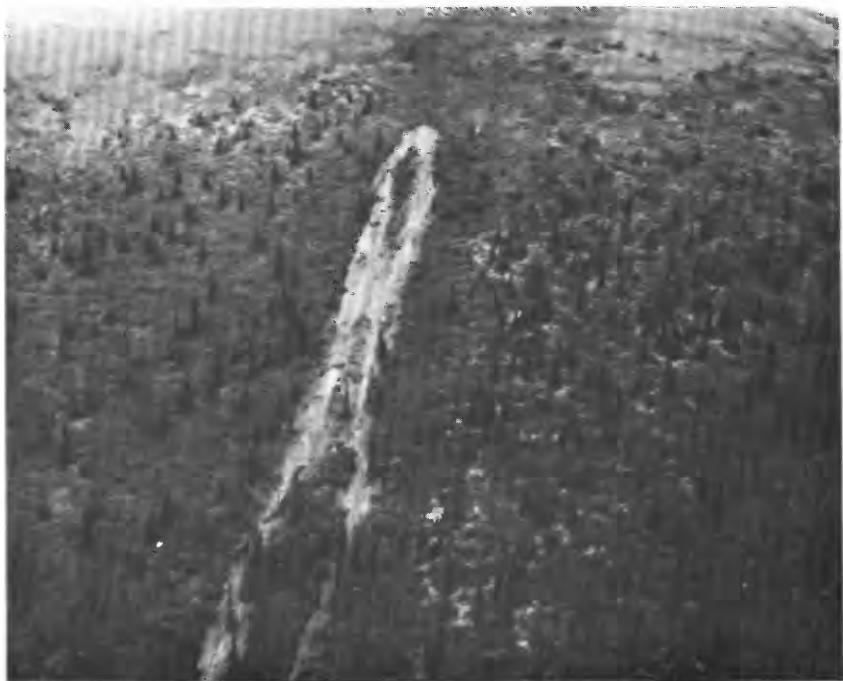
FIGURE 16.—Landslide in upper Chena River basin. Photograph by U.S. Army Corps of Engineers.

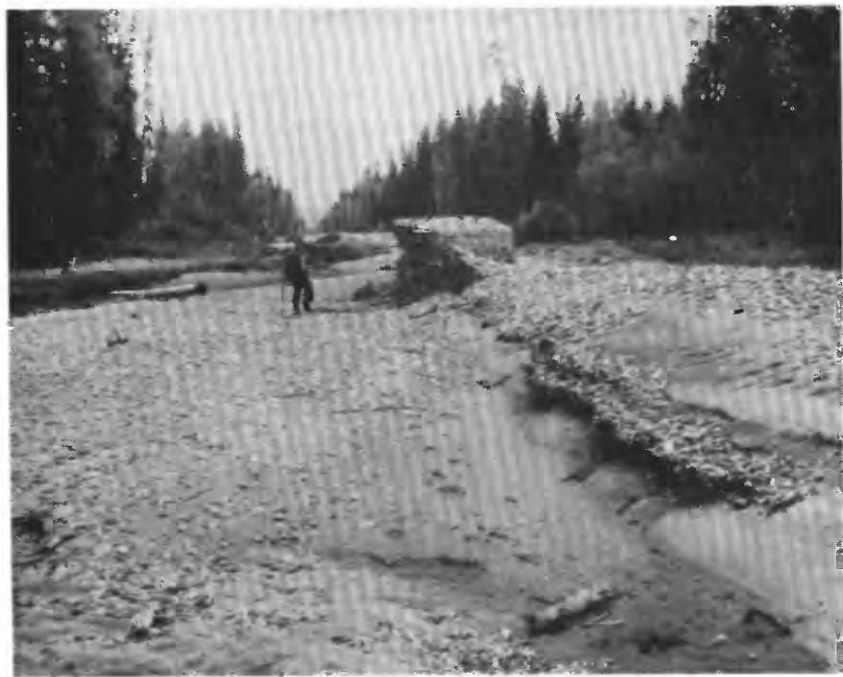
FIGURE 17.—Road washout along Chena Hot Springs Road. Photograph by U.S. Geological Survey.

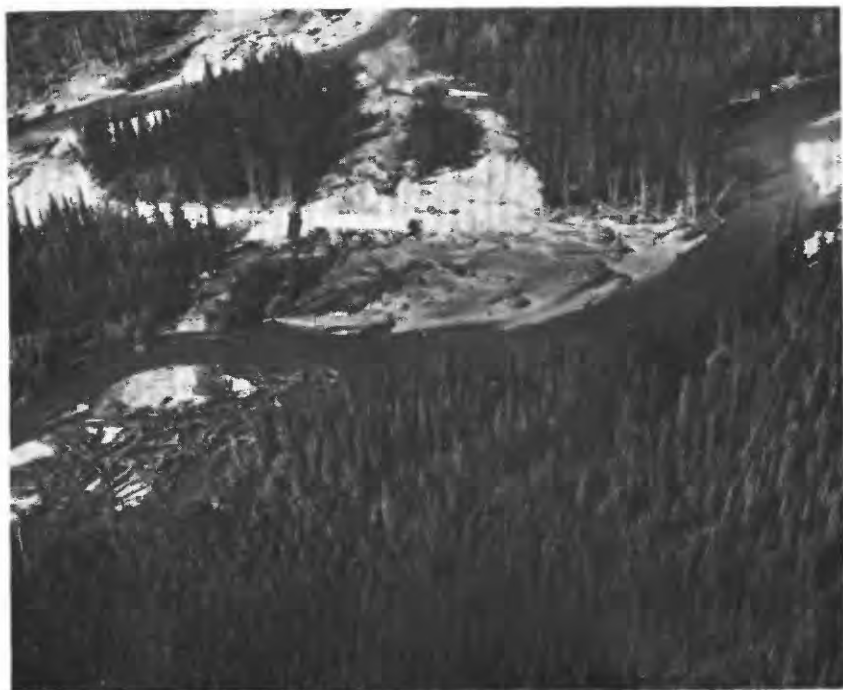
FIGURE 18.—Flood damage on Chena Hot Springs Road. Photograph by U.S. Army Corps of Engineers.

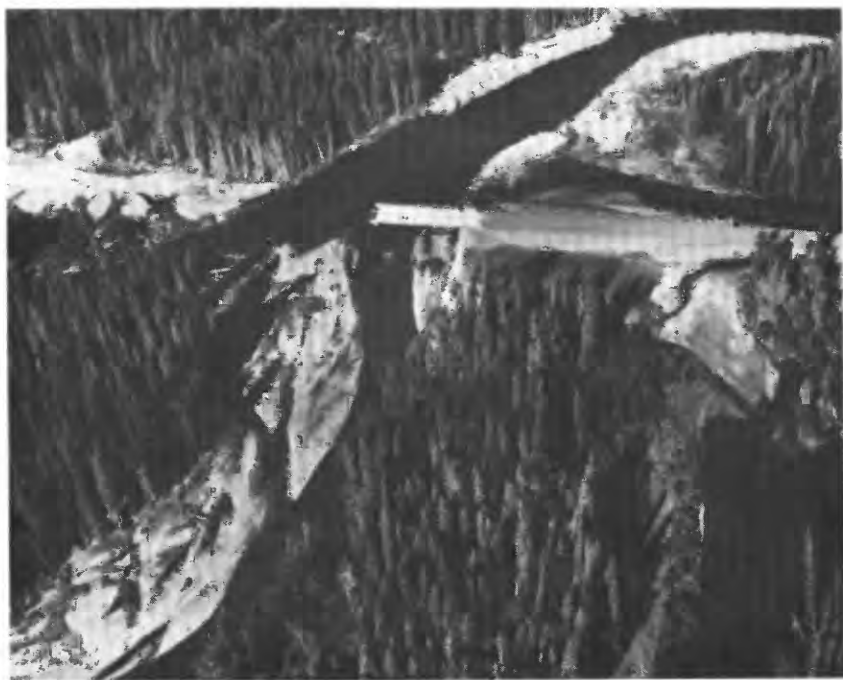
FIGURE 19.—Flood damage on Chena Hot Springs Road. Photograph by U.S. Army Corps of Engineers.

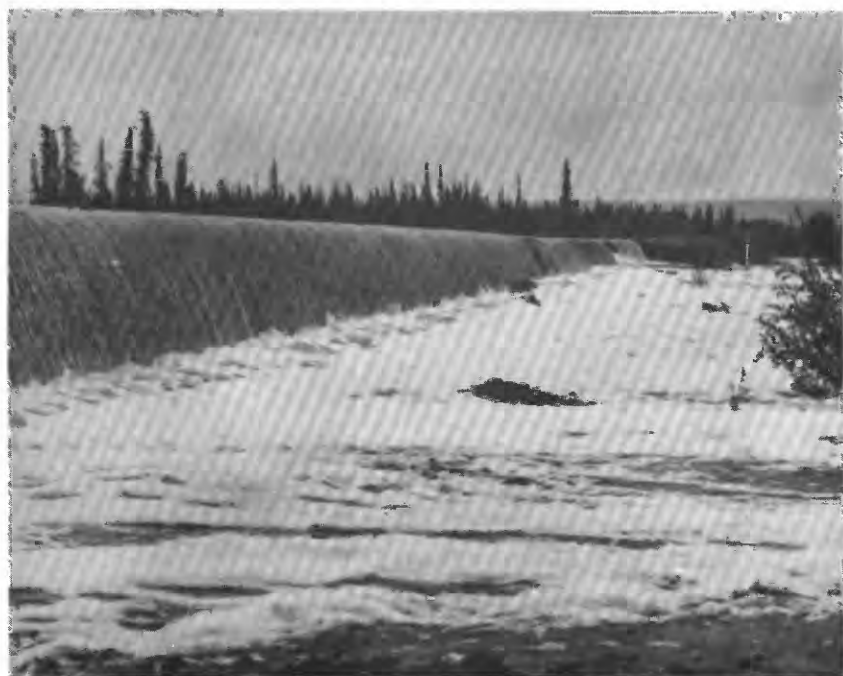
FIGURE 20.—Little Chena River flood at Chena Hot Springs Road. Photograph by Fairbanks News-Miner.

Springs Road crossing. Figure 20 shows flooding conditions near the site. After the picture was taken, the roadway was washed out, and the channel was scoured and widened so that it was completely changed below the bridge.

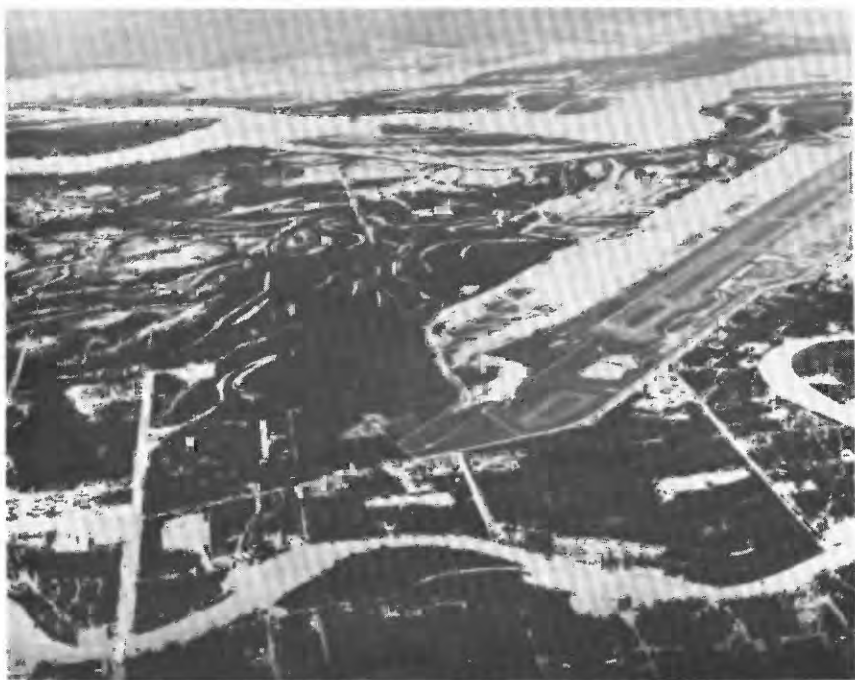
FIGURE 21.—Chena River flood around Fairbanks International Airport, August 15. Photograph by U.S. Army Corps of Engineers.

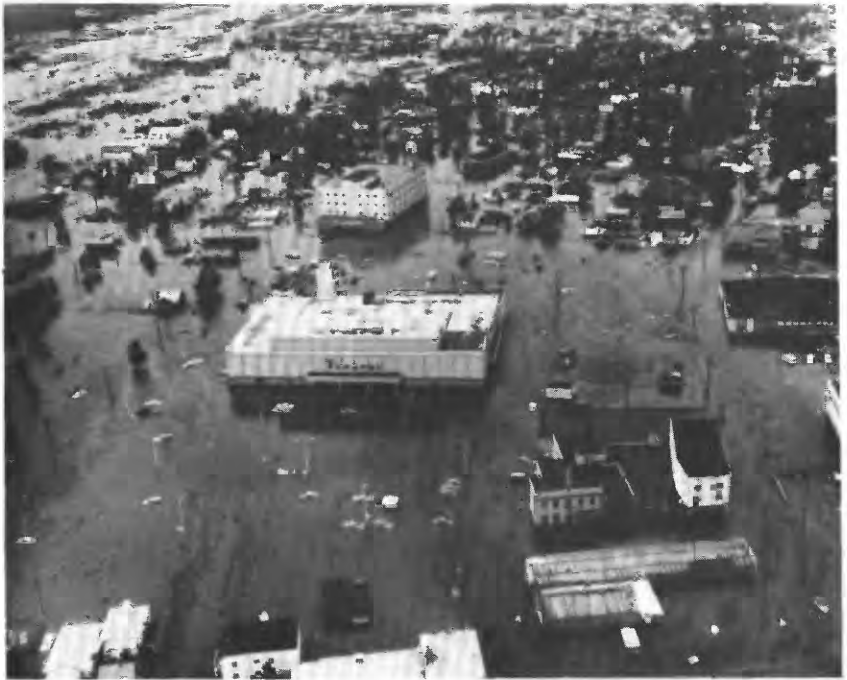
FIGURE 22.—Chena River flood in downtown Fairbanks, August 15. Photograph by U.S. Army Corps of Engineers.

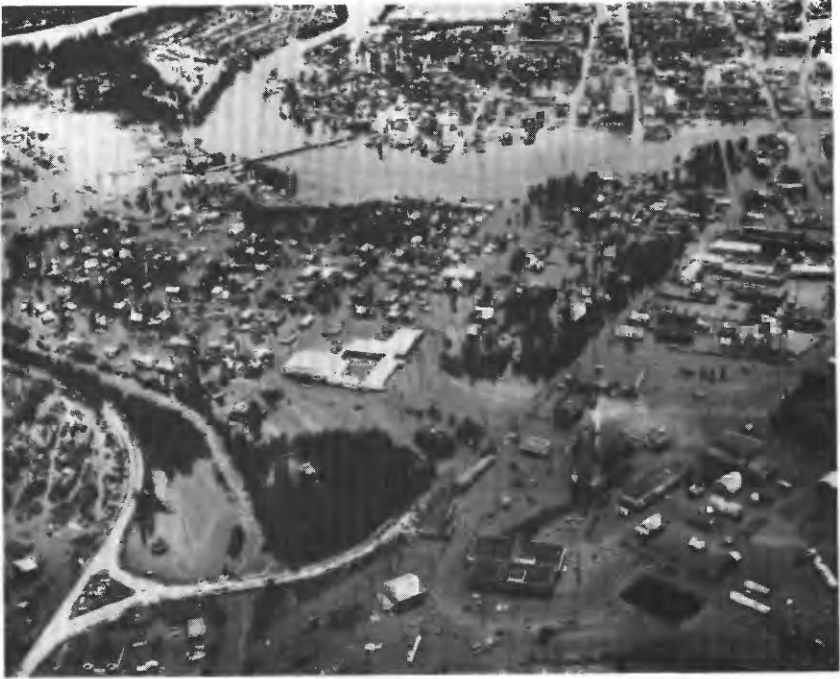
FIGURE 23.—Chena River flood at Fairbanks, August 15. Photograph by U.S. Army Corps of Engineers.

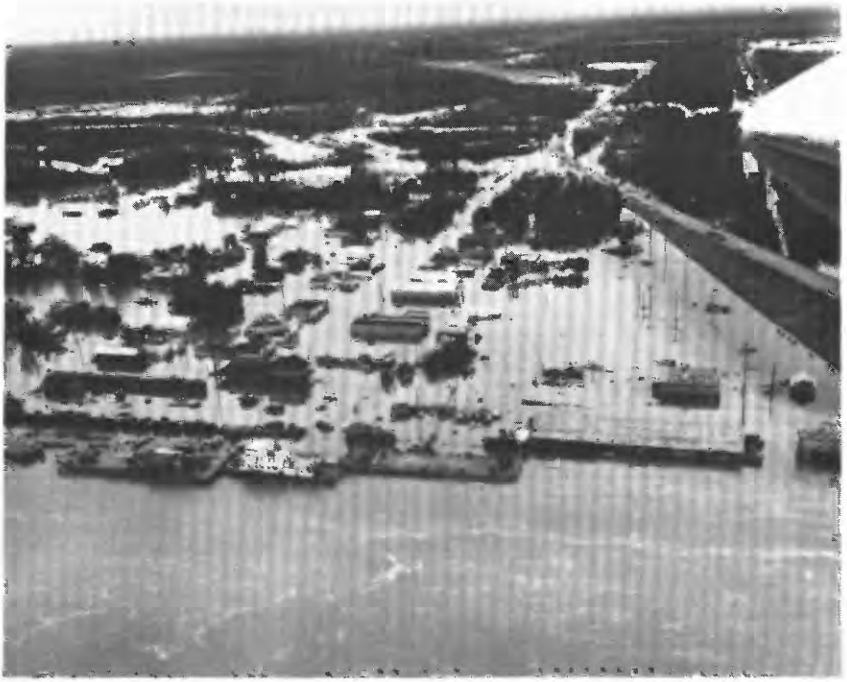
FIGURE 24.—Tanana River flood at Nenana, August 15. Photograph by Alaska Railroad.

river was over its banks in town for 10 days. Figure 24 shows flood conditions there on August 15. The discharge of 186,000 cfs at gage height 18.90 feet on August 18 is the maximum of record.
