Reconnaissance Assessment of Erosion and Sedimentation in the Cañada de los Alamos Basin, Los Angeles and Ventura Counties, California

GEOLOGICAL SURVEY WATER-SUPPLY PAPER 2061

By J. M. KNOTT

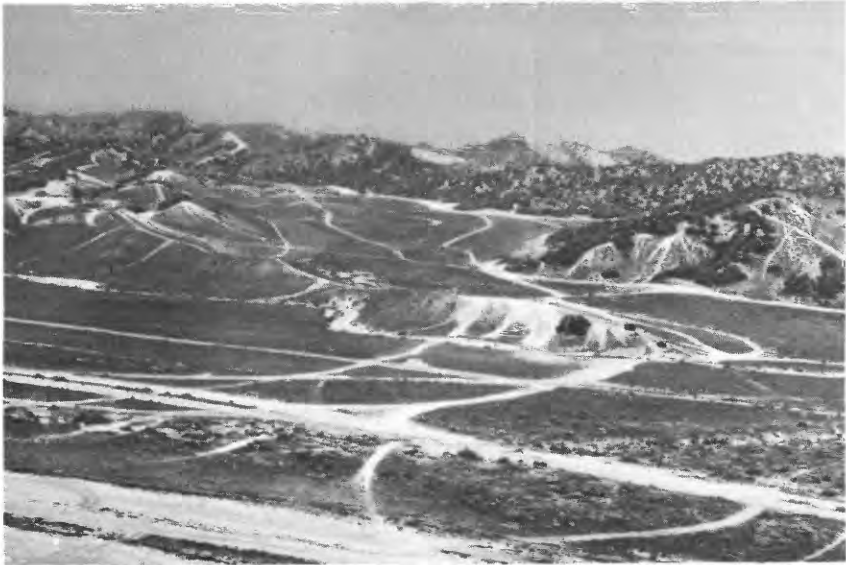
FIGURE 3.--View looking west from "Bench Mark Hill" at areas of ORV use in upper Hungry Valley. Crest of hill in center of photograph is about 70 ft above valley flat.

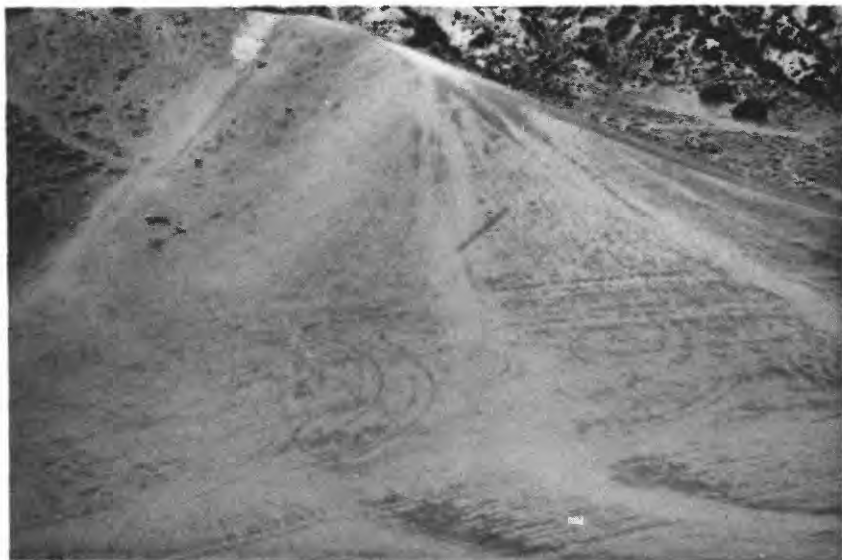
FIGURE 5.--ORV trails on moderate size hill (vertical distance from base to crest about 100 ft) as seen from crest of "Bench Mark Hill," January 1976. Erosion is largely due to surface abrasion by ORV's. Photograph by Howard Wilshire, Geologic Division, U.S. Geological Survey.

The major-storm sediment yield due to ORV's was approximated by determining the alluvium loss from a small basin (0.02 mi²), where ORV use was considered representative of the disturbed and partly disturbed area of upper Hungry Valley, and applying the value of sediment yield per unit area to the impacted area of upper Hungry Valley. Alluvium loss from the basin was determined by measuring the dimensions of a major gully network and visually estimating the average dimensions of upstream rills in and adjacent to ORV trails. Alluvium loss during the major storms of February and March 1978 was estimated on the basis of the enlargement of the gully network as shown in sequential photographs (figs. 5-7).

If ORV use in the small basin (0.02 mi²) shown in figures 5-7 is assumed to be representative of ORV use in the severely disturbed and moderately disturbed alluvium areas of Hungry Valley, and if the February and March 1978 storms are comparable to a 50-year storm, the major-storm sediment yield caused by ORV use can be approximated. Rainfall-intensity data for the February-March 1978 storms were not available during this study. Rainfall records at the Sandberg PTL climatological station (National Climatic Center, 1969, 1978), however, show close agreement

1. Examination of sequential photographs (figs. 5-7) suggested that about 80 percent of the alluvium loss in the gully occurred during the February and March 1978 storms.

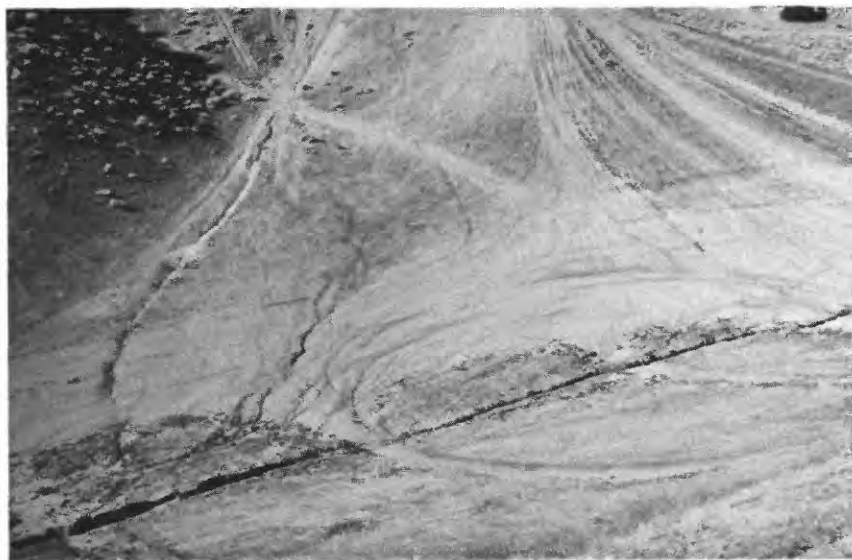
The gully network selected for measurement is at lat 34°45'39" N. and long 118°52'47" W. This gully was small to moderate in size prior to January 1978 (fig. 6); it attained the status of a large gully network during the major storms in February and March 1978 (fig. 7). The gully network is in an area where ORV use has been active, but many other sites were observed in the valley where ORV use was more intensive. Dimensions and volume of the gully network are summarized in table 2.

FIGURE 6.--Same hill in January 1978. Rills and small to moderate sized gullies are evident in and adjacent to ORV trails. Main gully in center of photograph is small enough to allow ORV crossing. Photograph by Howard Wilshire, Geologic Division, U.S. Geological Survey.

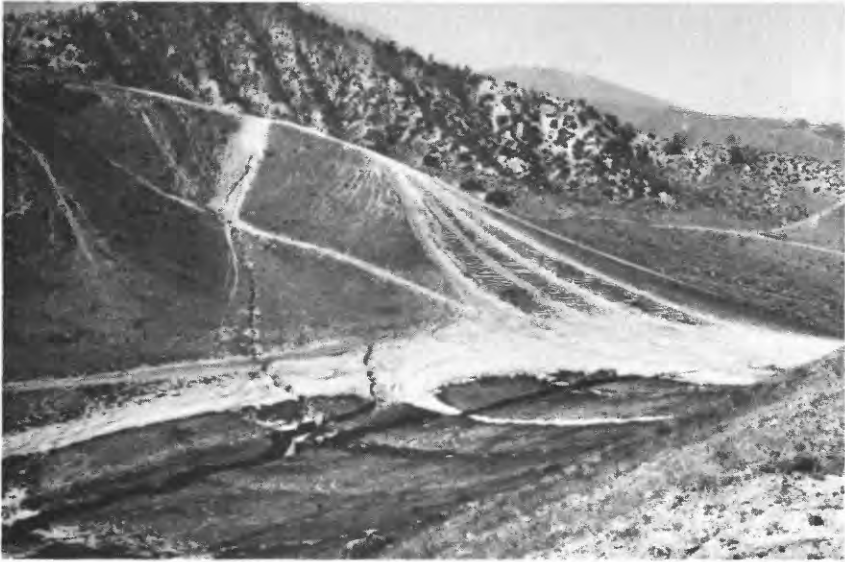
FIGURE 7.--Same hill in April 1978. A major gully network was formed during intense rainstorms in February and March. Main gully at ORV crossing in center of photograph is 5.6 ft wide and 6.5 ft deep.

Gully component	Station (ft)	Top width (ft)	Depth (ft)	Volume of alluvium loss (yds ³)	Remarks
Main-----	0	0	0		Head of gully on right side of figure 7.
	73	11.3	9.0		Maximum width of gully.
	150	5.6	6.5		Intersection of gully with ORV trail in center of figure 7.
	233	9.2	7.6		Intersection of main gully with large tributary gully.
	534	3.1	3.5		Near left border of figure 7.
	730	5.1	2.8		Intersection of main gully with large tributary gully.
	930	3.9	1.5	829	Last point of measurement for main gully.
Right channel of large tributary gully on right side of main gully.	8	8.4	7.1		8 ft upstream of station 233 of main gully.
	267	1.8	1.3		
	385	1.4	1.8	123	End of tributary gully.
Left channel of large tributary gully.	10	6.7	6.4		10 ft upstream of intersection with right channel.
	53	2.2	2.9		
	105	1.0	.8	37	End of gully.
Large tributary on right side of main gully.	4	3.7	2.9		4 ft upstream of station 730 of main gully.

154	5.9	3.9		Maximum width of gully.
	382	0	0	108	End of gully.
Small gullies and rills on right side of main gully.	--	--	--	26	
Small gullies and rills on left side of main gully.	--	--	--	2	Number and size of gullies on left side of main gully are insignificant, despite the existence of six ORV trails averaging about 8 ft in width.
Total-----	--	--	--	1,125

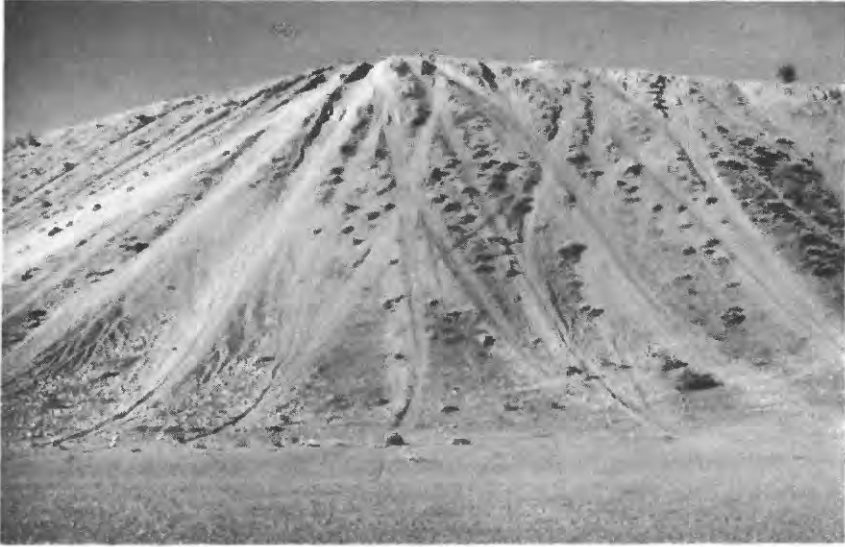
FIGURE 8.--"Bench Mark Hill" in January 1976 (vertical distance from base to crest about 130 ft). Erosion is largely due to surface abrasion by ORV's. Photograph by Howard Wilshire, Geologic Division, U.S. Geological Survey.

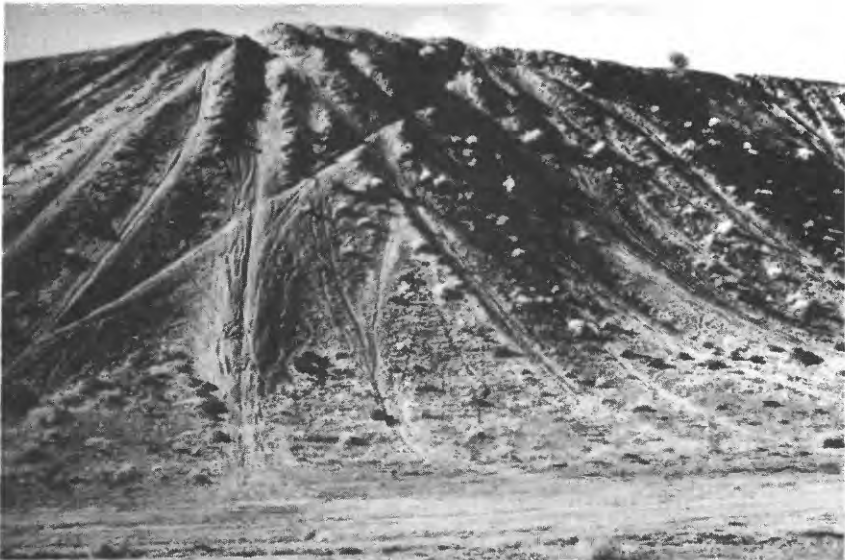
FIGURE 9.--"Bench Mark Hill" in January 1978. Photograph by Howard Wilshire, Geologic Division, U.S. Geological Survey.

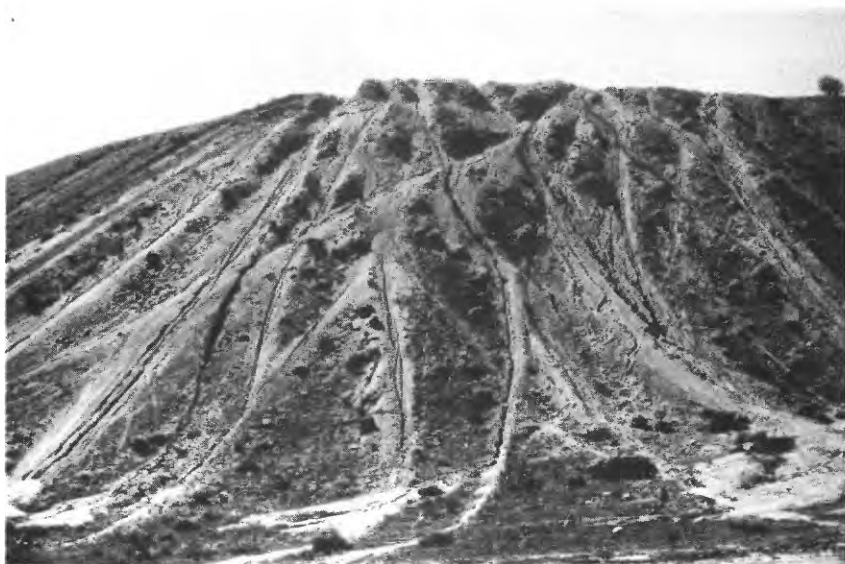
FIGURE 10.--"Bench Mark Hill" in March 1978. Many rills and small gullies formed during intense rainstorms in February and March. Small sediment deposits are evident at the mouths of gullies. Photograph by Howard Wilshire, Geologic Division, U.S. Geological Survey.

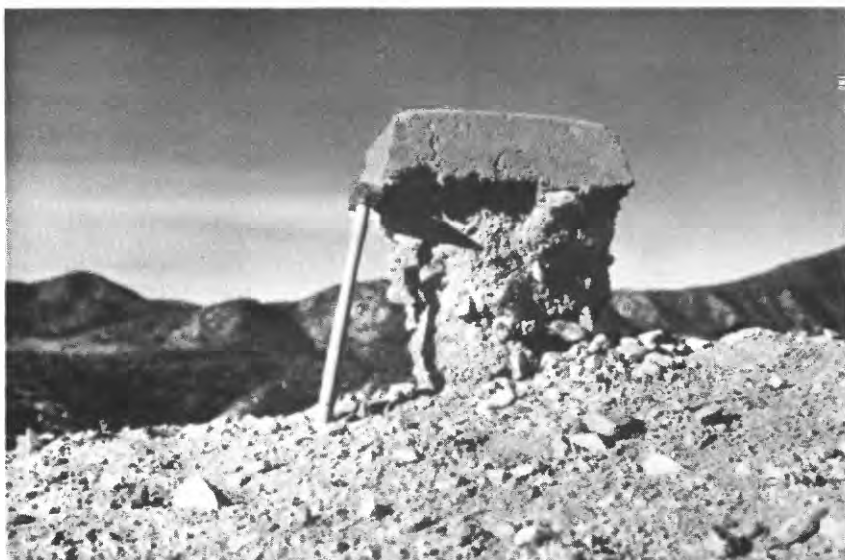
FIGURE 11.--Severely eroded benchmark on "Bench Mark Hill" in January 1976. This benchmark had been eroded out and, by April 1977, had rolled down the hill. Photograph by Howard Wilshire, Geologic Division, U.S. Geological Survey.

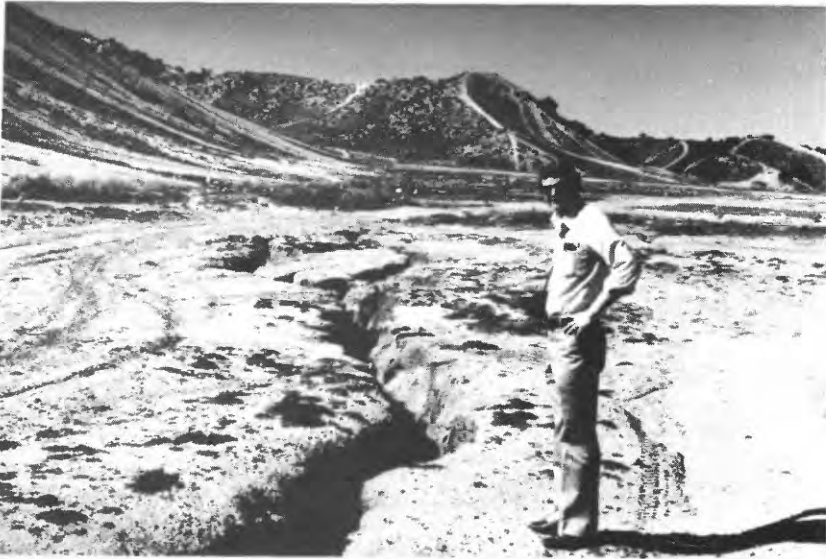
FIGURE 12.--One of numerous gullies formed at the base of "Bench Mark Hill" during the February and March 1978 rainstorms.

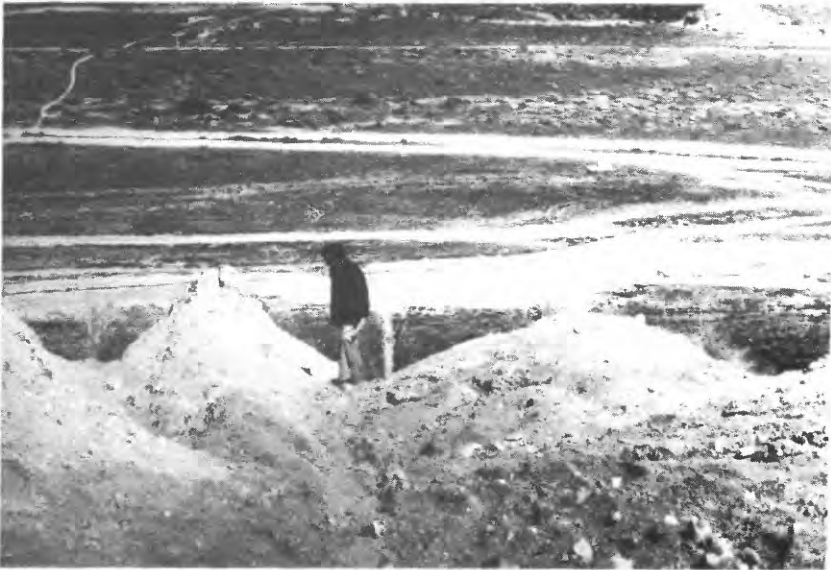
FIGURE 13.--Trenches eroded by surface abrasion of ORV's on top of "Bench Mark Hill."

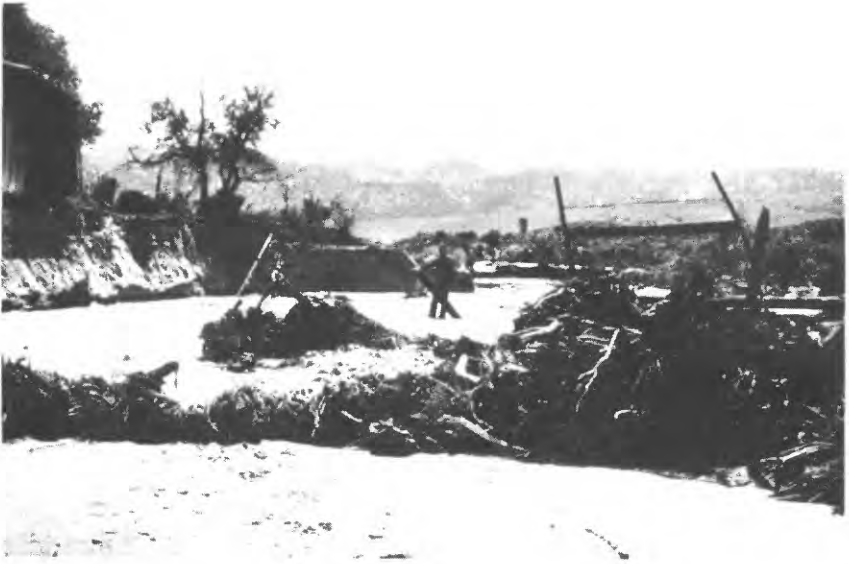
FIGURE 14.--Lateral migration of Cañada de los Alamos near Kinsey Ranch during February and March 1978. Channel receded 25 ft on left bank exposing pipeline to pumphouse. Original soil deposited on pipe indicates a maximum stream depth of about 3 ft near pipeline.

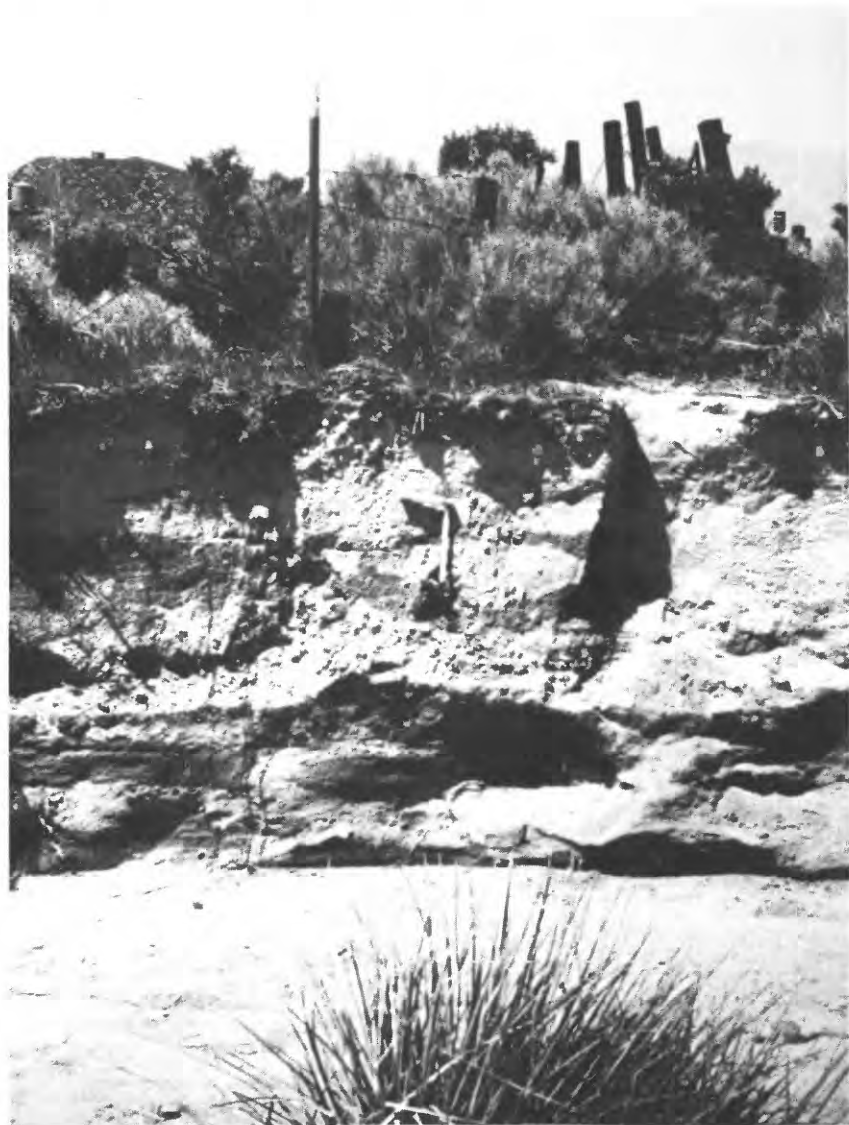
FIGURE 15.--Downcutting of a tributary to Cañada de los Alamos near Kinsey Ranch. Channel was a shallow swale prior to March 1978. The channel was about 5 ft deep and 30 ft wide in April 1978.
