Appearance and Water Quality of Turbidity Plumes Produced by Dredging in Tampa Bay, Florida

United States
Geological
Survey
Water-Supply
Paper 2192

Prepared in
cooperation
with the
U.S. Army Corps
of Engineers,
Jacksonville
District

By CARL R. GOODWIN and D. M. MICHAELIS

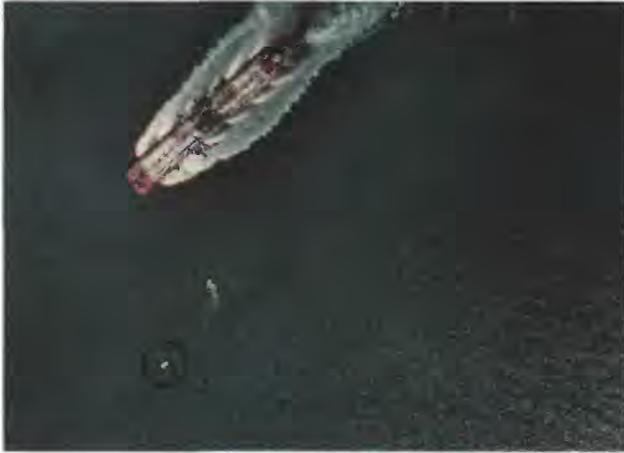
A, Site 1: Vertical view of sample site 200 m southwest of dredge. Time: 1213. Depth: 8.2 m. Scale (approx): 1:9,100.

<i>Turbidity (NTU)</i>	<i>Suspended solids (mg/L)</i>	<i>Transparency (cm)</i>
Top	7	29	46
Middle	7	29	—
Bottom	9	32	—

floodtide during and for several hours prior to data collection (fig. 10), the turbidity plume was elongated. Plume length exceeded 2 km, and its average width was about 100 m. Seventy-five percent of the material dredged was sand or larger size particles (table 4) and was described as slightly silty and very shelly fine to medium sand.

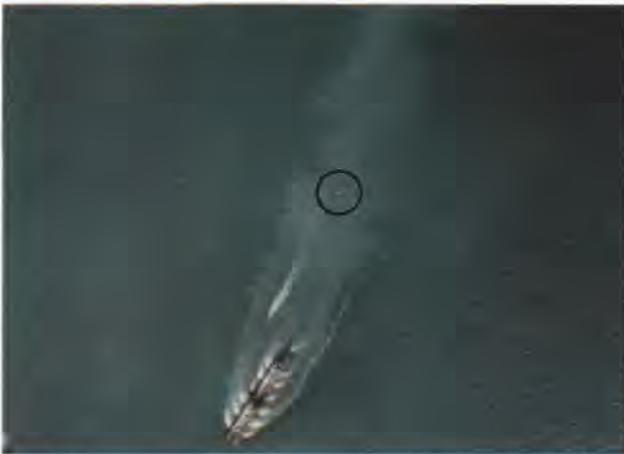
B, Site 2: Vertical view of sample site 400 m east of dredge. Time: 1322. Depth: 11.3 m. Scale (approx): 1:18,200.

<i>Turbidity (NTU)</i>	<i>Suspended solids (mg/L)</i>	<i>Transparency (cm)</i>
Top	6	29	61
Middle	6	29	—
Bottom	8	46	—

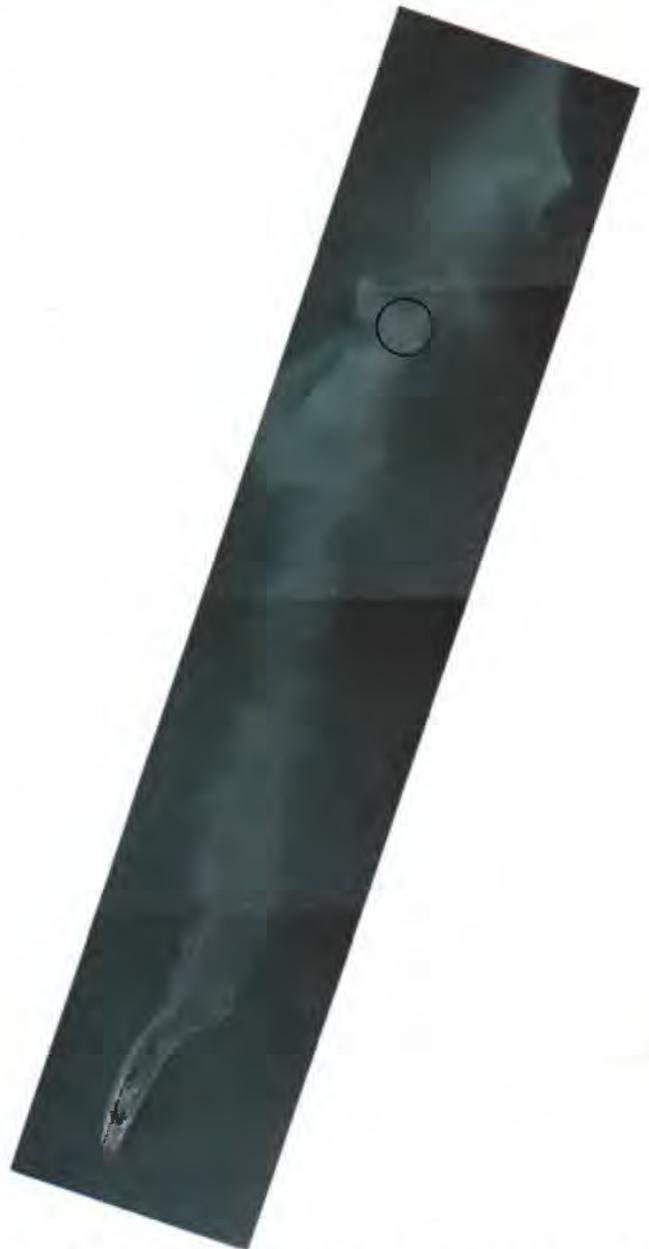
C, Site 3: Mosaic of hopper-dredge plume, sample site 900 m east of dredge. Time: 1340. Depth: 8.2 m. Scale (approx): 1:36,400.

Figure 11. Hopper-dredge loading during floodtide: photographs of and water-clarity data for sites 1–3. Circle indicates location of sampling boat.

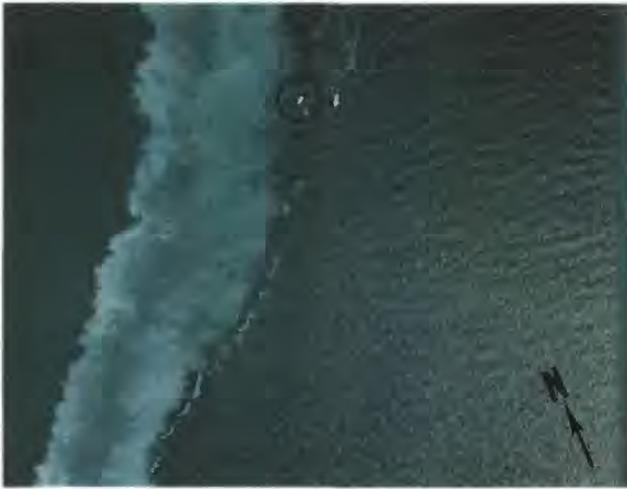
A, Site 4: Vertical view of sample site outside of plume, 1,300 m east of dredge. Time: 1219. Depth: 9.1 m. Scale (approx): 1:9,100.

Turbidity (NTU)	Suspended solids (mg/L)	Transparency (cm)
Top	3	15	91
Middle	2	14	—
Bottom	3	14	—

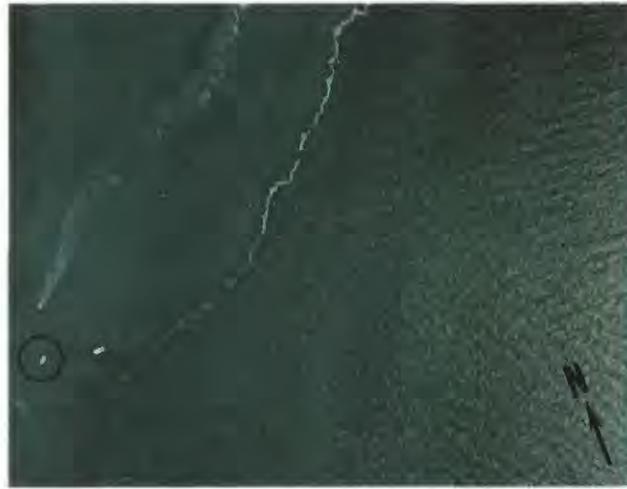
C, Site 6: Vertical view of sample site 1,000 m east of dredge. Time: 1203. Depth: 9.1 m. Scale (approx): 1:9,100.

Turbidity (NTU)	Suspended solids (mg/L)	Transparency (cm)
Top	9	26	91
Middle	15	23	—
Bottom	15	28	—

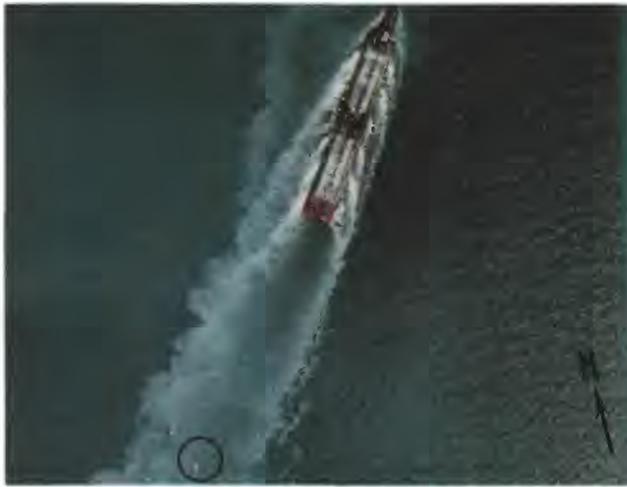
B, Site 5: Vertical view of dredge backing up. Sample site 300 m west of dredge. Time: 1245. Depth: 10.7 m. Scale (approx): 1:9,100.

Turbidity (NTU)	Suspended solids (mg/L)	Transparency (cm)
Top	8	35	46
Middle	8	45	—
Bottom	8	45	—

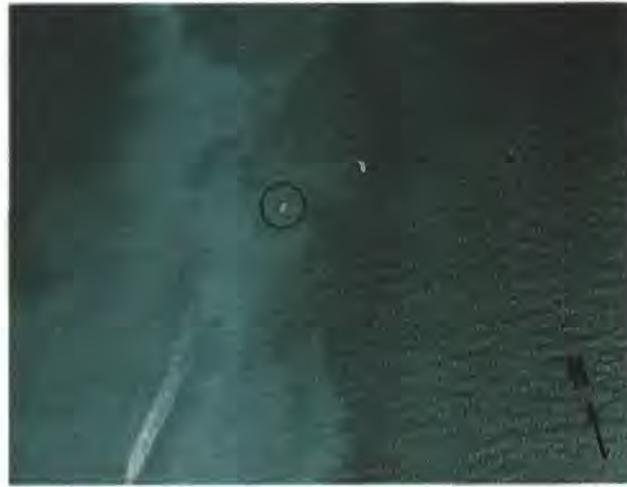
D, Site 7: Vertical view of sample site 1,000 m east of dredge. Time: 1302. Depth: 11.0 m. Scale (approx): 1:9,100.

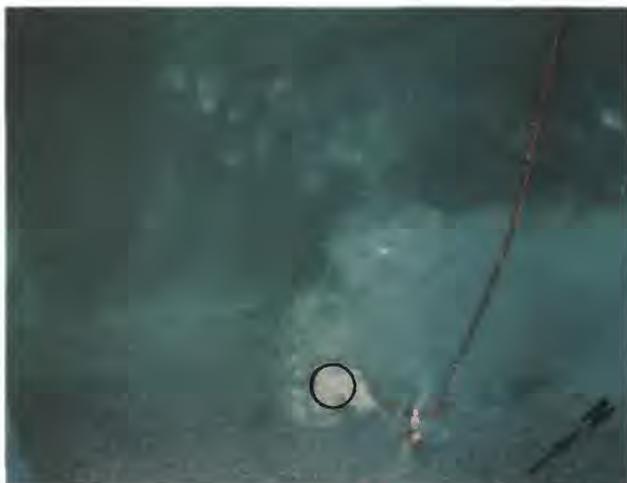
B, Site 9: Vertical view of discharge into open water at slack water. Time: 1240. Depth 7.0 m. Scale (approx): 1:9,100.

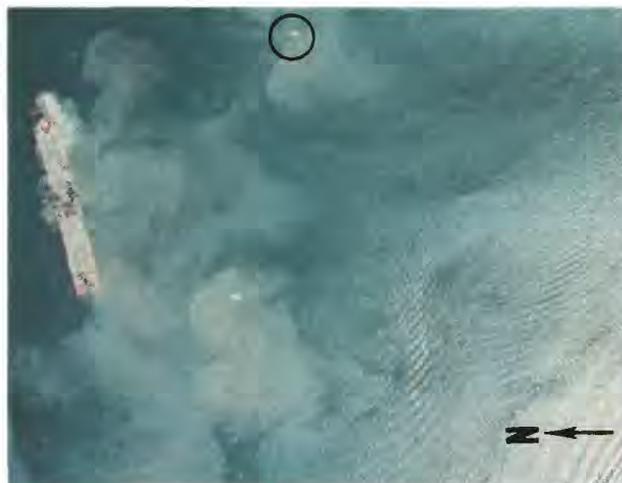
C, Site 10: Vertical view of hopper dredge maneuvering for docking. Time: 1300. Depth: 9.1 m. Scale (approx): 1:9,100.

Turbid patches of water formed as the hopper dredge maneuvered to reach the unloading facility at a pier on Mullet Key (site 10, fig. 15C). The turbidity was not a direct result of dredging, but rather an indirect or secondary effect caused by alternate forward and reverse propeller thrusts (prop wash) stirring the local bottom material. Maneuvering of the hopper dredge during slack tide produced turbid water patches with turbidity levels of 30 to 50 NTU.

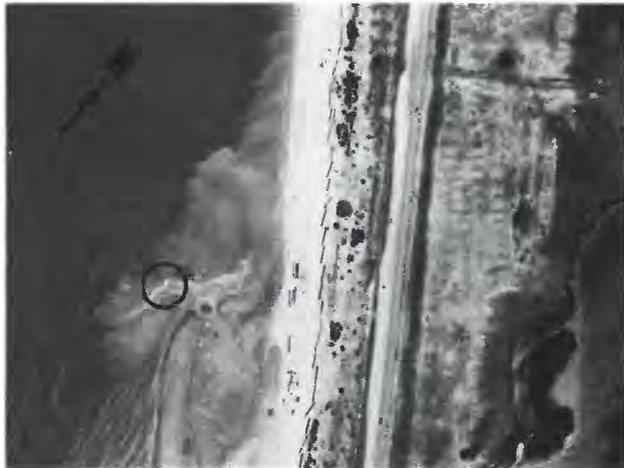
B, Site 12: Vertical view of beach nourishment on west shore of Mullet Key. Time: 1200. Depth: 2.7 m. Scale (approx): 1:9,100.

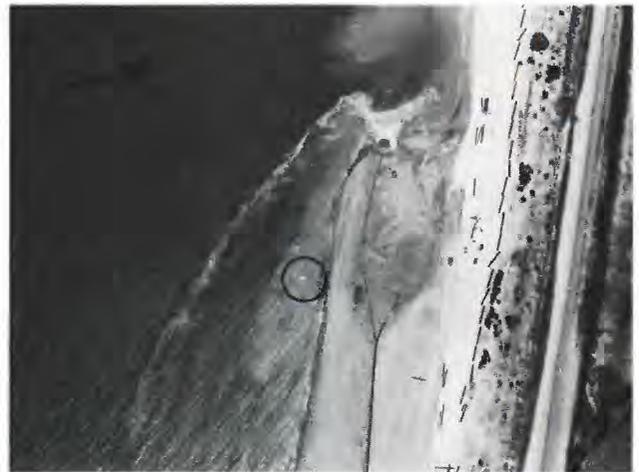
C, Site 13: Vertical view of beach nourishment on west shore of Mullet Key. Time: 1212. Depth: 2.4 m. Scale (approx): 1:9,100.

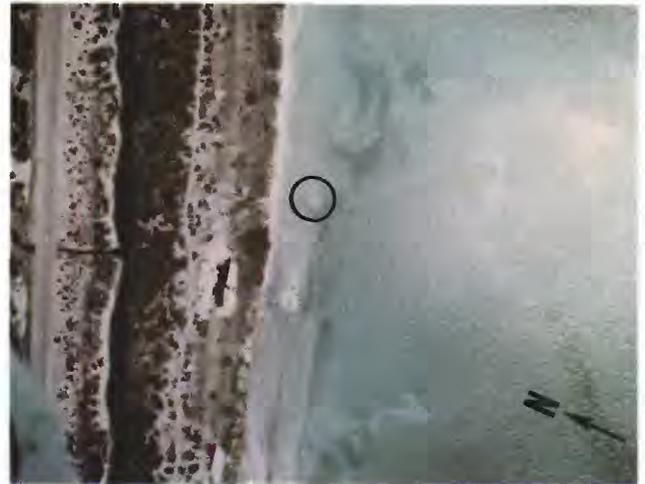
C, Site 16: Vertical view of south shore of Mullet Key during beach nourishment. Time: 1140. Depth: 0.5 m. Scale (approx): 1:9,100.

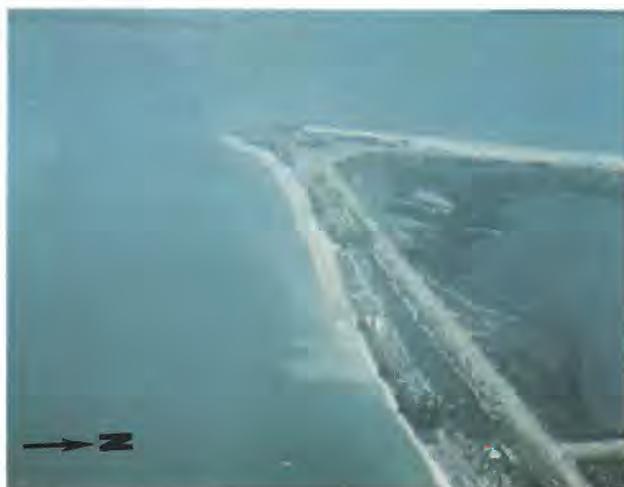
B, Site 15: Oblique view of south shore of Mullet Key during beach nourishment. Time: 1210.

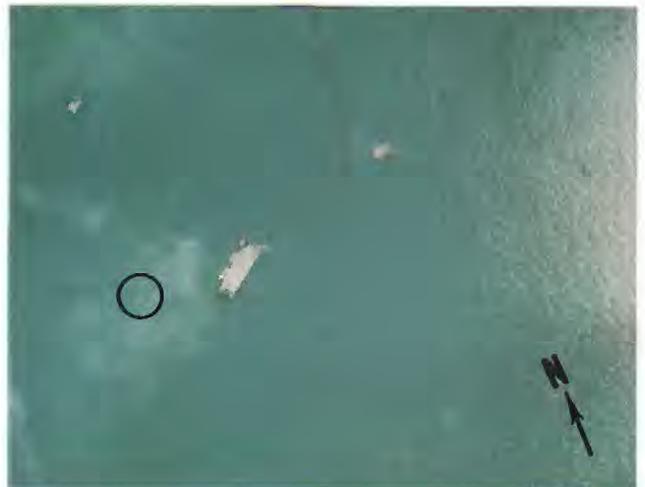
D, Site 17: Vertical view of pipeline dredge lowering the elevation of shoal areas. Time: 1105. Depth: 3.0 m. Scale (approx): 1:9,100.

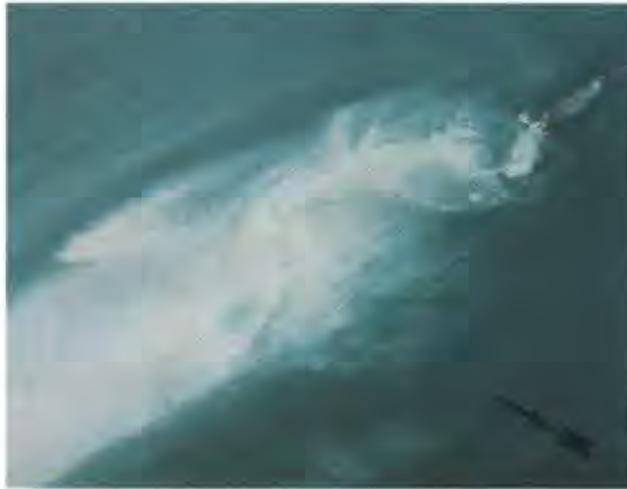
B, Site 19: Oblique view of uncontained open-water turbidity plume. Discharge outlet at top of picture is swinging from side to side causing the "S" patterns in the plume.

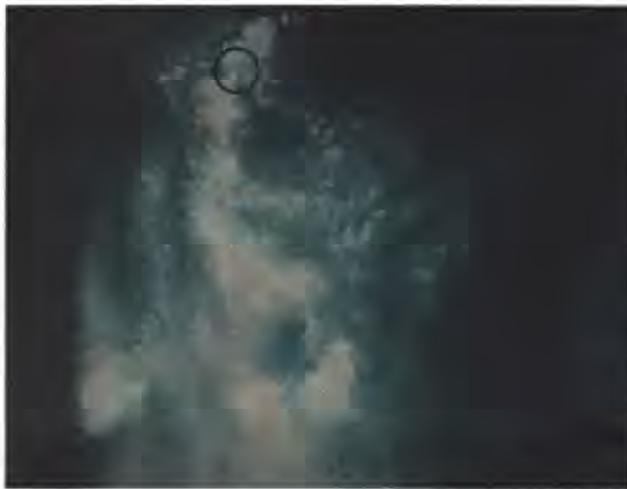
C, Site 20: Vertical view of *Western Condor* discharge pipe. Sample site about 50 m from discharge point. Time: 0950. Depth: 3.4 m. Scale (approx): 1:9,100.

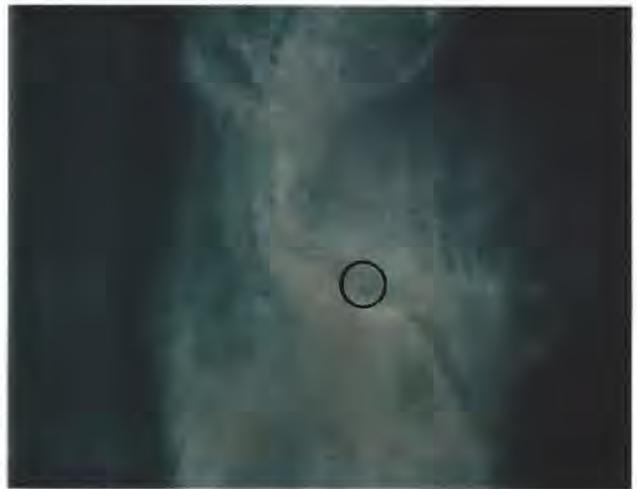
D, Site 21: Vertical view of sample site about 350 m from discharge point. Erosion of previously deposited material visible to right of plume. Time: 1000. Depth: 4.0 m. Scale (approx): 1:9,100.

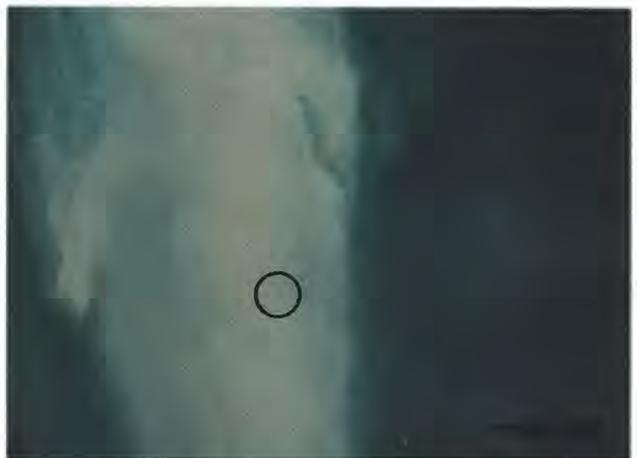
E, Site 22: Vertical view of sample site about 200 m from discharge point. Plume convergence noticeable. Time: 1012. Depth: 3.4 m. Scale (approx): 1:9,100.

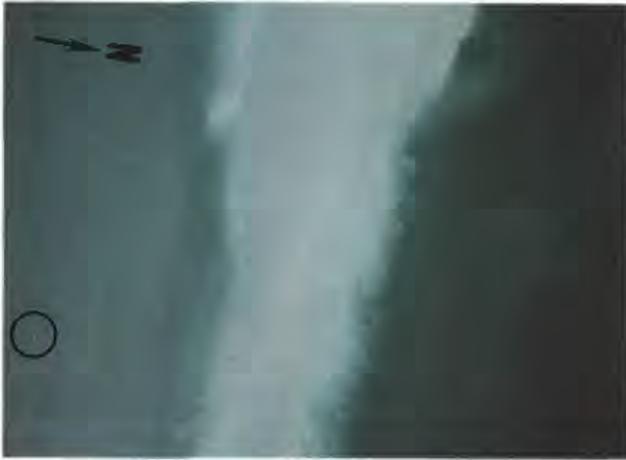
A, Site 23: Vertical view of sample site outside of main plume about 1,200 m from discharge point—convergence continuing. Time: 1020. Depth: 4.3 m. Scale (approx): 1:9,100.

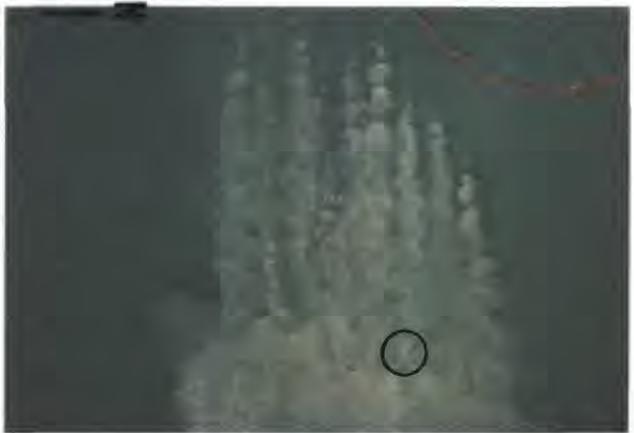
D, Site 26: Vertical view of secondary erosional plumes from previously deposited material. Time: 0915. Depth: 5.2 m. Scale (approx): 1:9,100.

<i>Turbidity (NTU)</i>	<i>Suspended solids (mg/L)</i>	<i>Transparency (cm)</i>
Top	85	207	107
Middle	15	66	—
Bottom	140	103	—

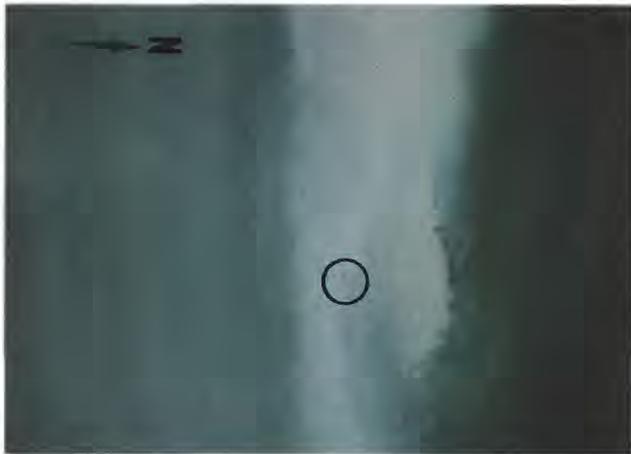
B, Site 24: Vertical view of sample site about 1,400 m from discharge point—convergence nearly complete. Time: 1015. Depth: 5.5 m. Scale (approx): 1:9,100.

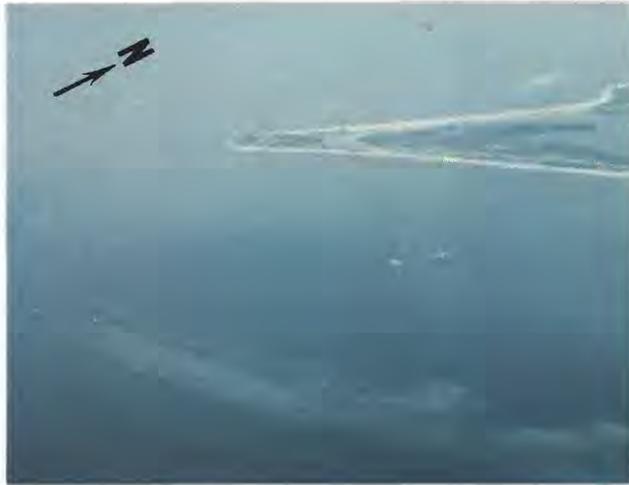
B, Site 28: Oblique view of open-water dredged-material placement area showing secondary erosional plume and intermittent primary plume with cutterhead dredge *Dave Blackburn* in background.

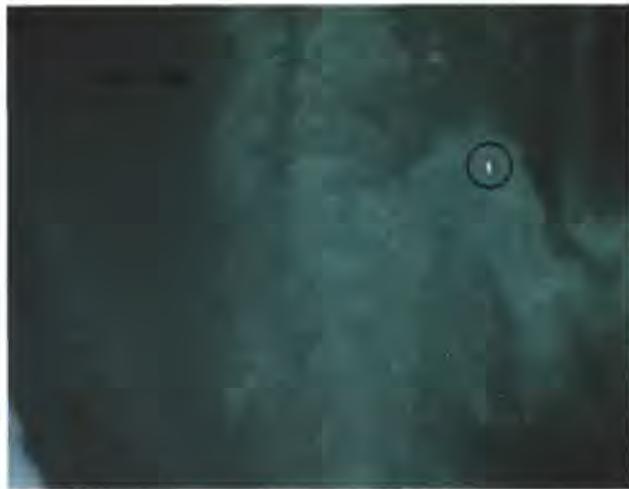
C, Site 29: Vertical view of sample site in intermittent primary plume about 500 m from discharge point. Time: 1135. Depth: 7.9 m. Scale (approx): 1:6,100.

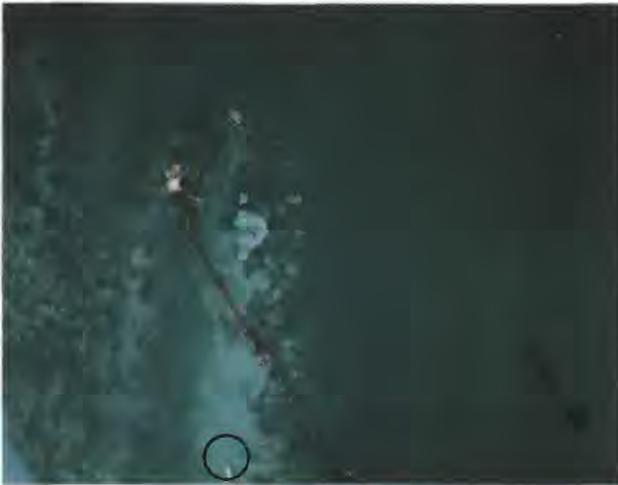
A, Site 30: Vertical view of sample site about 210 m from discharge point. Time: 1215. Depth: 7.9 m. Scale (approx): 1:6,100.

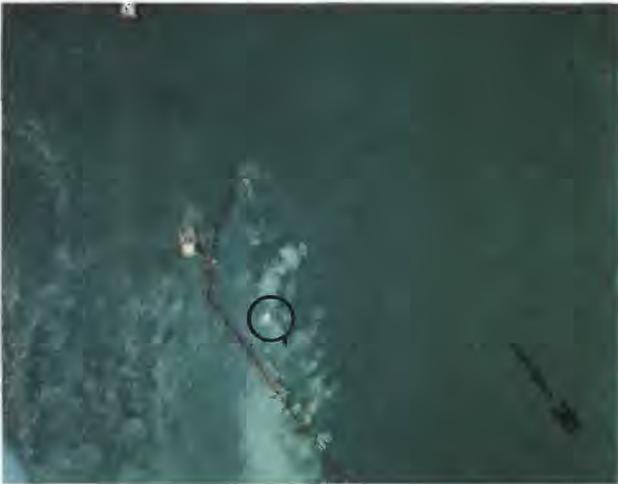
B, Site 31: Vertical view of sample site about 90 m from discharge point. Time: 1225. Depth: 7.9 m. Scale (approx): 1:6,100.

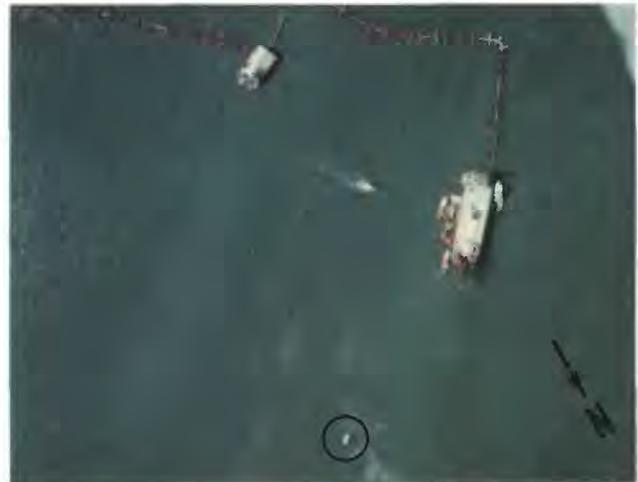
C, Site 32: Vertical view of cutterhead dredge *Dave Blackburn* in operation. Sample site is about 110 m from dredge. Time: 1200. Depth: 15.5 m. Scale (approx): 1:6,100.

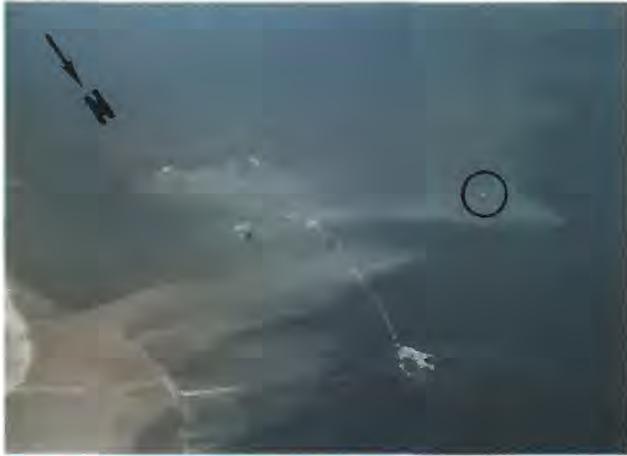
B, Site 34: Oblique view of sample site near edge of visible plume, 600 m from discharge point. Time: 1100. Depth: 4.9 m.

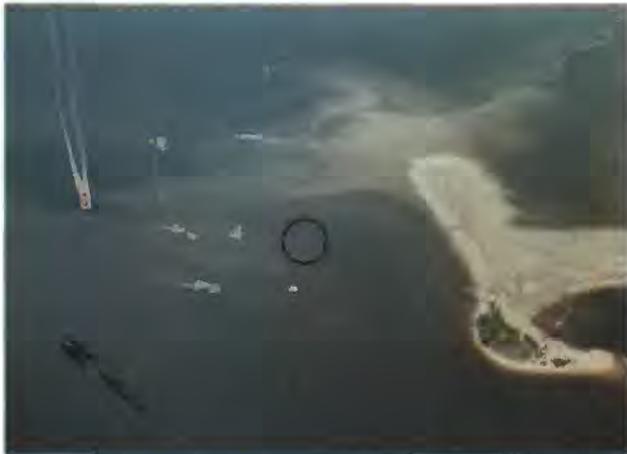
C, Site 35: Oblique view of sample site, 340 m from discharge point. Time 1105. Depth: 3.4 m.

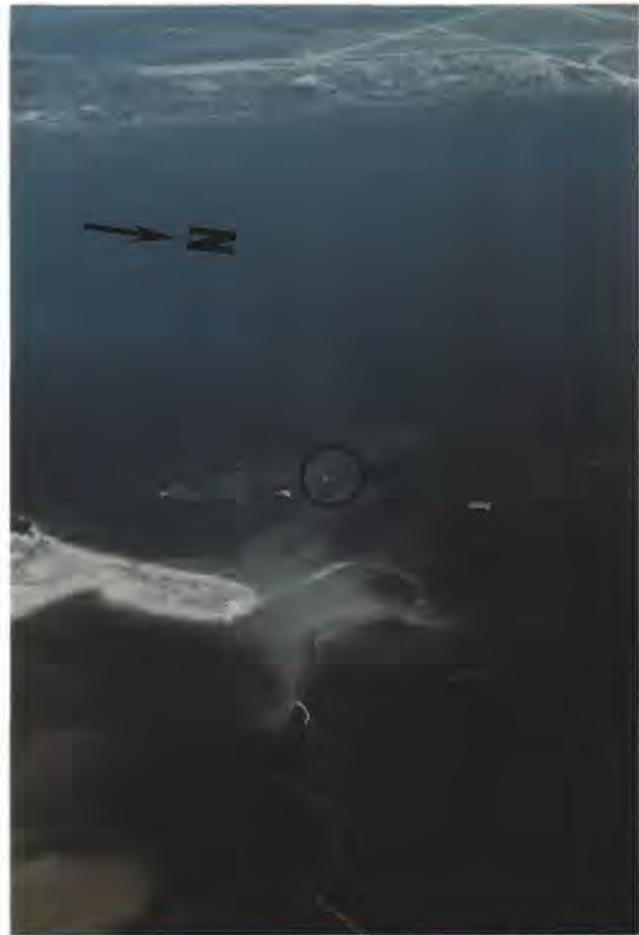
D, Site 36: Oblique view of construction area and environs. Sampling boat is in channel, about 500 m from discharge point. Time: 1055. Depth: 13.7 m.

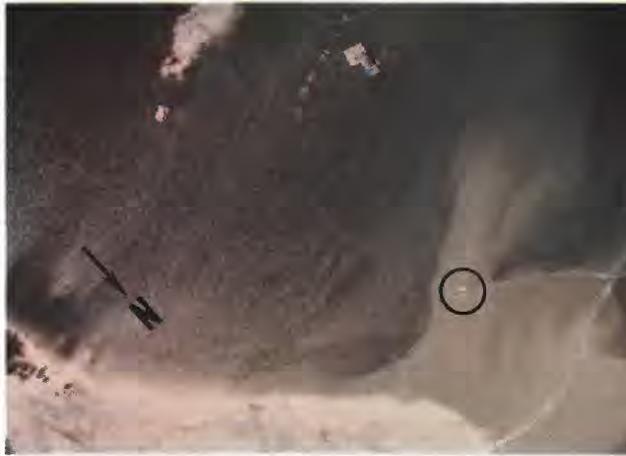
A, Site 37: Vertical view of sample site at opening between barrier and dike, 170 m from discharge point. Time: 1115. Depth: 2.1 m. Scale (approx): 1:9,100.

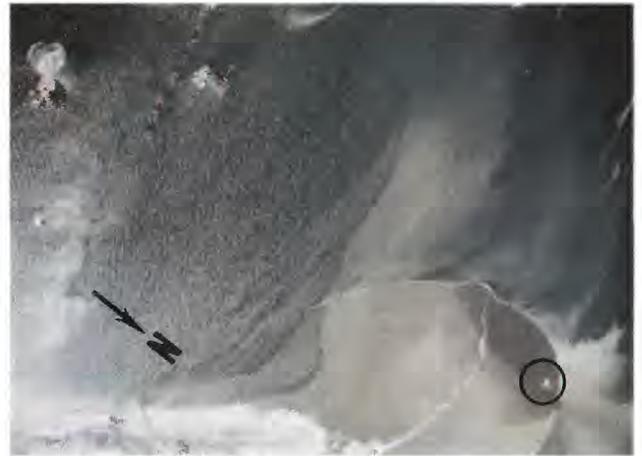
C, Site 39: Vertical view of sample site next to turbidity barrier, 270 m from discharge point. Time: 1130. Depth: 1.2 m. Scale (approx): 1:9,100.

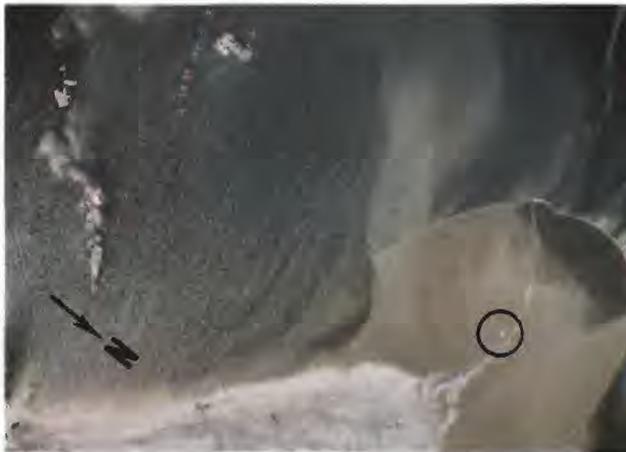
B, Site 38: Vertical view of sample site, 130 m from discharge point. Vessels are creating a secondary plume. Time: 1125. Depth: 1.2 m. Scale (approx): 1:9,100.

Turbidity (NTU)	Suspended solids (mg/L)	Transparency (cm)
Top	85	128	15
Middle	1,500	2,020	—
Bottom	800	1,580	—

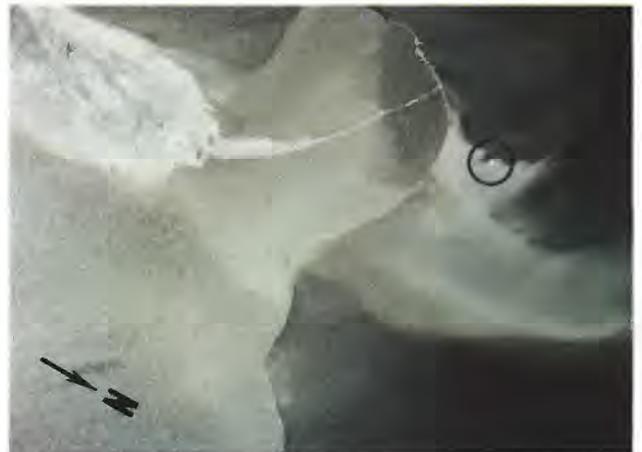
D, Site 40: Vertical view of sample site near gap, 320 m from discharge point. Time: 1135. Depth: 2.1 m. Scale (approx): 1:9,100.

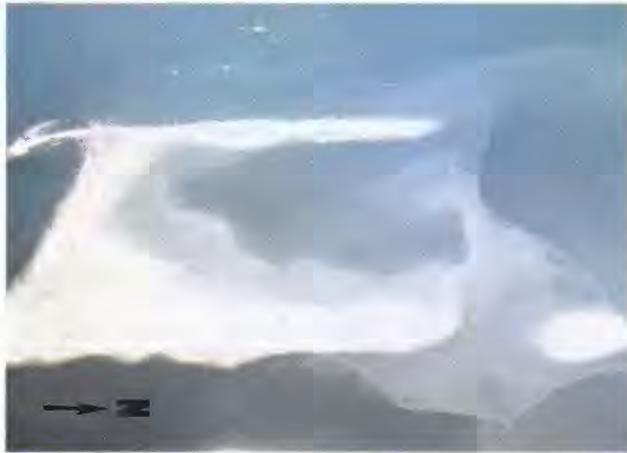
D, Site 44: Vertical view of sample site near edge of visible plume. Time: 1013. Depth: 2.4 m. Scale (approx): 1:9,100.

Turbidity (NTU)	Suspended solids (mg/L)	Transparency (cm)
Top	20	39	51
Middle	15	68	—
Bottom	14	25	—

A turbidity barrier was deployed across the northern end of a horseshoe-shaped, partly completed, diked impoundment (fig. 35). Sample collection was during floodtide (fig. 36) and the flow was northward. Ambient water-clarity data were collected at site 41 (fig. 37A). An overall view of the construction site is shown in figure 37B (site 42). A visible plume about 500 m long was sampled at two sites outside the barrier (sites 43 and 44, figs. 37C, D). Turbidity data at site 43 indicate that the

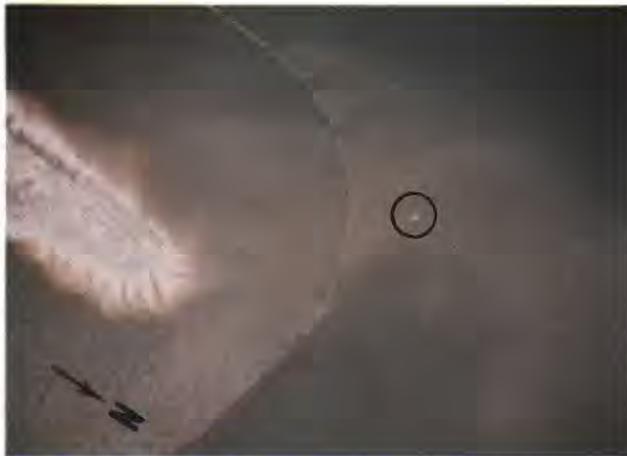
C, Site 43: Vertical view of sample site outside turbidity barrier. Time: 1000. Depth: 3.0 m. Scale (approx): 1:9,100.

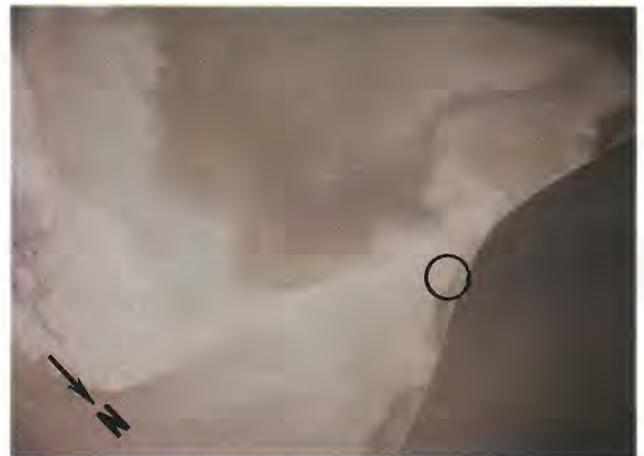
E, Site 45: Vertical view of sample site just inside turbidity barrier. Time: 1023. Depth: 2.1 m. Scale (approx): 1:9,100.

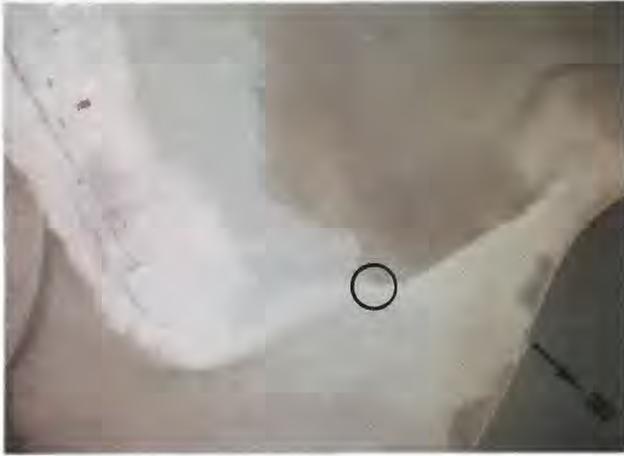
A, Site 46: Vertical view of sample site inside barrier near discharge point. Time: 1033. Depth: 1.2 m. Scale (approx): 1:9,100.

Turbidity (NTU)	Suspended solids (mg/L)	Transparency (cm)
Top	12,000	6,260	15
Middle	3,700	7,200	—
Bottom	200,000	130,000	—

A plume near the discharge point and within the turbidity barrier is shown in figures 37E and 38A-C (sites 45-48). Turbidity inside the barrier was dramatically higher than outside. At sites 45-48, relatively low turbidity levels and suspended-solids concentrations at the surface indicated rapid settling of fine material before it escaped confinement by the turbidity barrier. In freshwater or in the absence of montmorillonite clay minerals, the fine material in the dredged sediment would not settle as rapidly as documented here. Rapid buildup of fine materials on the bay bottom, however, is conducive to the formation of mud flows that carry material along the bottom for long distances from the original point of deposition.

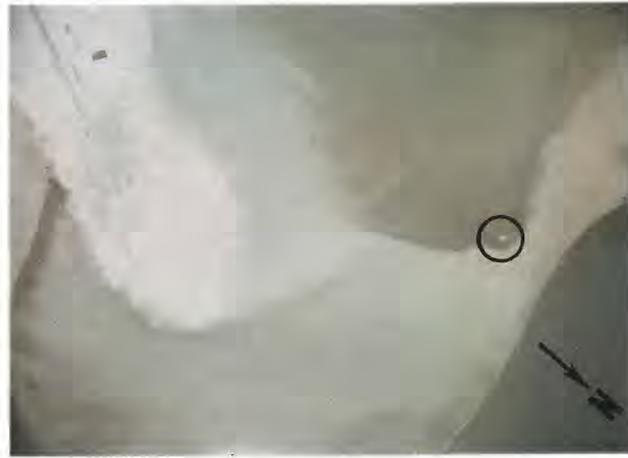
C, Site 48: Vertical view of sample site in dark area inside barrier. Time: 1055. Depth: 2.8 m. Scale (approx): 1:9,100.

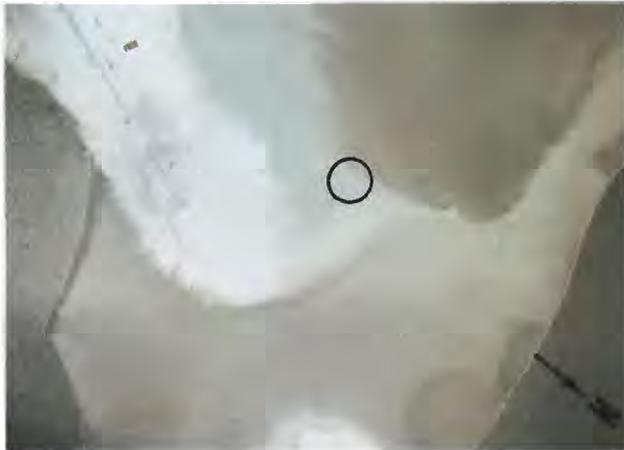
B, Site 47: Vertical view of sample site in light-gray area inside barrier. Time: 1045. Depth: 0.9 m. Scale (approx): 1:9,100.

Turbidity (NTU)	Suspended solids (mg/L)	Transparency (cm)
Top	230	200	15
Middle	3,600	3,290	—
Bottom	22,000	17,500	—

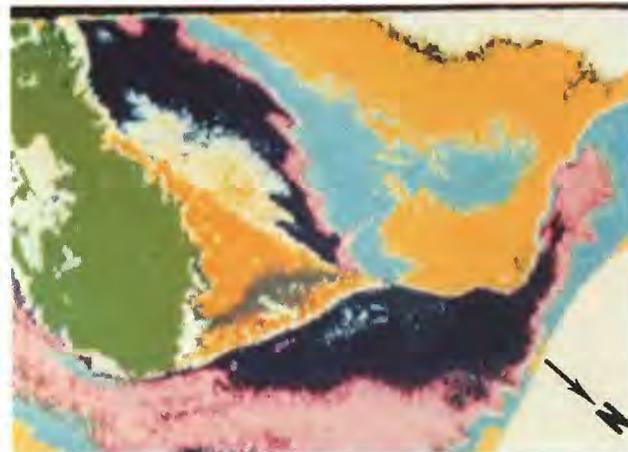
D, Site 49: Computer-generated color enhancement of C.

Green = emergent dredged material
 Gray } range of surface
 Orange } turbidity levels,
 Purple } from greatest
 Pink } (gray) to least
 Blue } (white)
 Yellow }
 White }

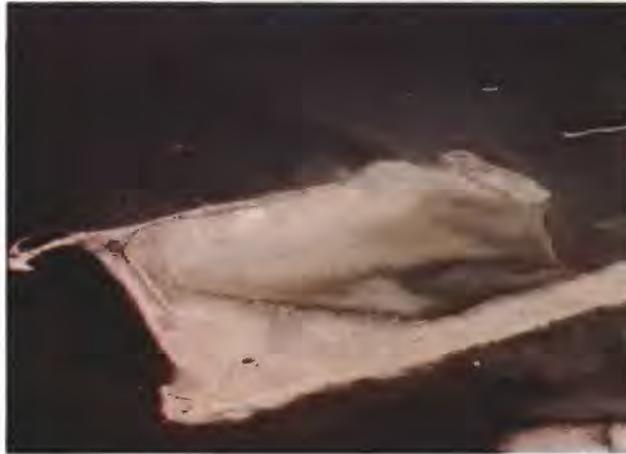
B, Site 51: Oblique view of study area. *Western Condor* dredge is in upper right with partly completed diked impoundment in center.

Ambient-water data were collected at site 50 (fig. 41A), northwest of the dredging area (fig. 39). Neither a well-defined plume nor a turbid area was visible near the dredge or dredged-material placement area outside the turbidity barrier (site 51, fig. 41B). Two samples were taken near the dredge (sites 52, 53), and one was

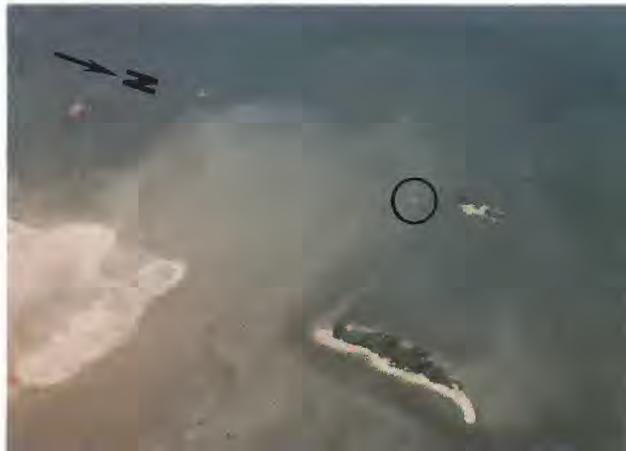
C, Site 52: Oblique view of sample site near *Western Condor* dredge. Time: 0915. Depth: 13.7 m.

Turbidity (NTU)	Suspended solids (mg/L)	Transparency (cm)
Top	25	63	30
Middle	9	24	—
Bottom	3,200	3,080	—

taken outside the barrier nearest the pipeline discharge point (site 54, fig. 42A). High bottom turbidity in the construction area (sites 52–54) indicated probable movement of fluid mud from the partly completed impoundment. Lower turbidity values at top and middle depths indicated rapid settling of fine material and effective operation of turbidity barriers. Sites 55 and 56 (figs. 42B, C) show an example of the generation of a secondary turbidity plume by turbulence from a pipe-towing vessel resuspending settled dredge material. Site 56 was photographed 45 minutes after site 55 at the same shutter speed but with a wider aperture. Some of the feathery texture in these two photographs may be bay-bottom features and edges of the secondary plume.

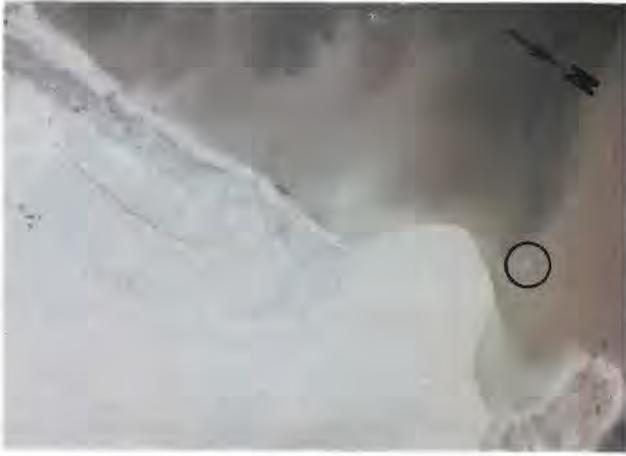
A, Site 54: Vertical view of sample site near turbidity barrier. Time: 1000. Depth: 1.5 m. Scale (approx): 1:9,100.

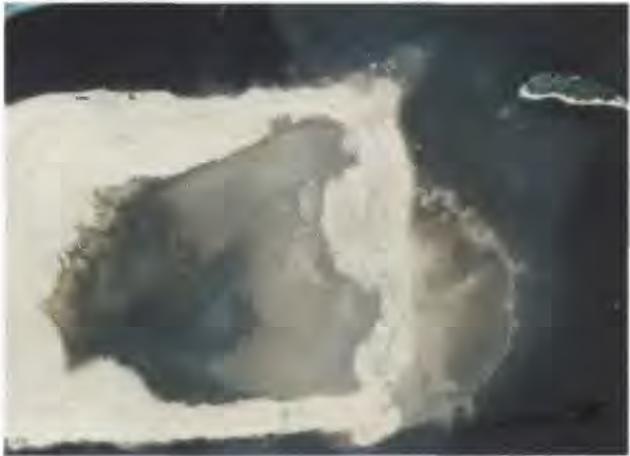
E, Site 58: Vertical view of completed impoundment taken on August 14, 1978, showing containment of fine material by turbidity barrier. Scale (approx): 1:36,400.

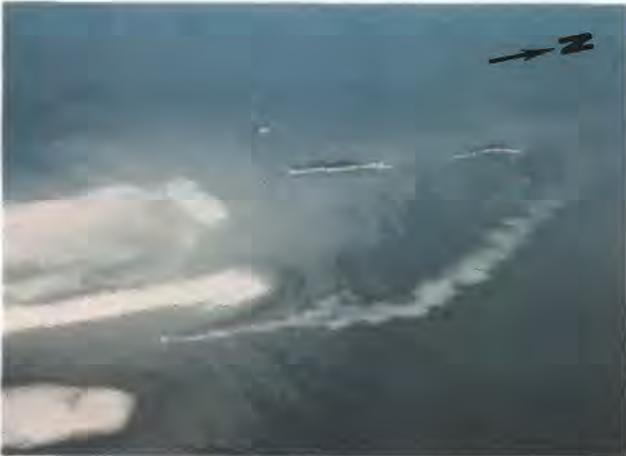
B, Site 55: Oblique view showing secondary turbidity plume in wake of vessel towing pipeline. Time 0920.
