# Channel Change on the Santa Cruz River, Pima County, Arizona, 1936–86

United States  
Geological  
Survey  
Water-Supply  
Paper 2429

Prepared in cooperation with  
the Pima County Department  
of Transportation and Flood  
Control District

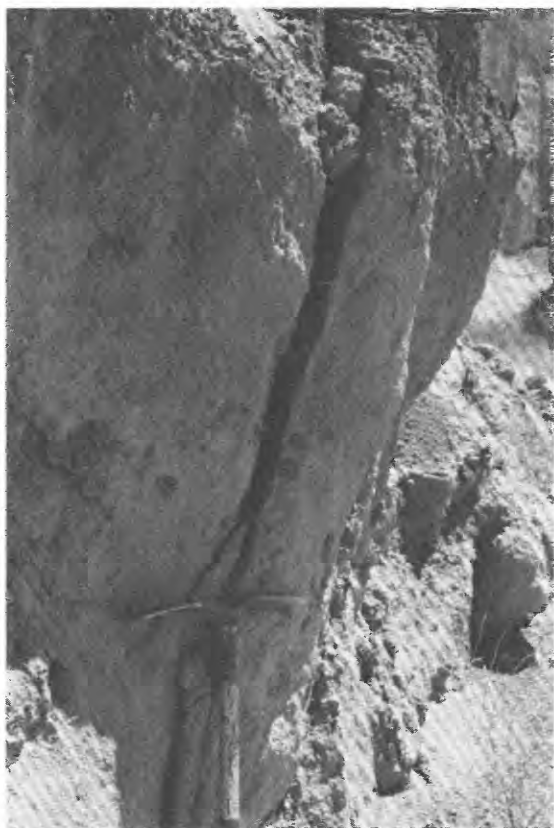
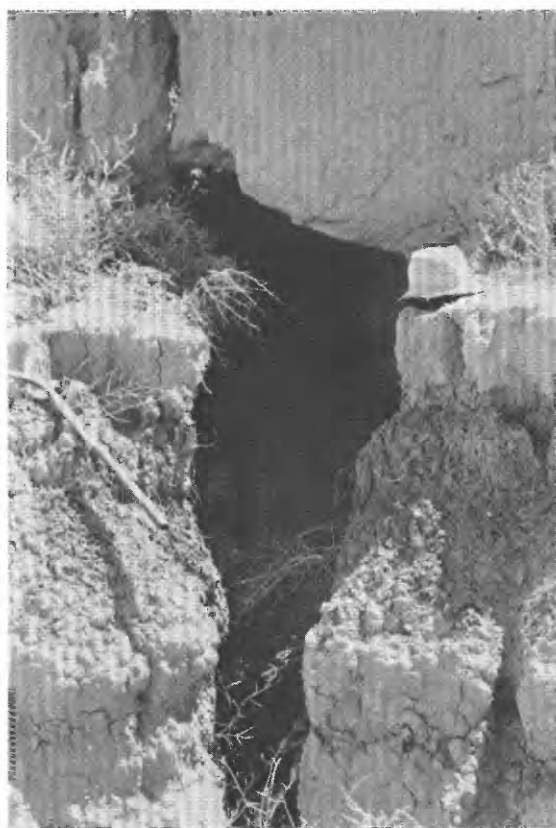
**Figure 12.** Structural weakening of arroyo walls, Santa Cruz River. A, Tension cracking leads to block failure of cohesive alluvium. B, Pipes enlarge and may produce cavernous discontinuities in alluvium.

Banks or arroyo walls on the Santa Cruz River that fail easily tend to be in alluvium of Holocene age that consists of fine-grained sand and silt cohesive enough to maintain an oversteepened face in the absence of disturbance but not so cohesive as to resist corrasion by streamflow. Even slight undercutting by corrasion can then produce large bank failures because of discontinuities in the alluvium produced by tension cracks, fissuring, and piping erosion (fig. 12). At the few locations in the study area where the

Santa Cruz River channel is incised into alluvium of Pleistocene age, bank retreat generally is slight despite abundant tension cracks and pipes in 15- to 20-ft-high vertical walls. Apparently, the more highly indurated older alluvium resists corrosion and undercutting by streamflow.

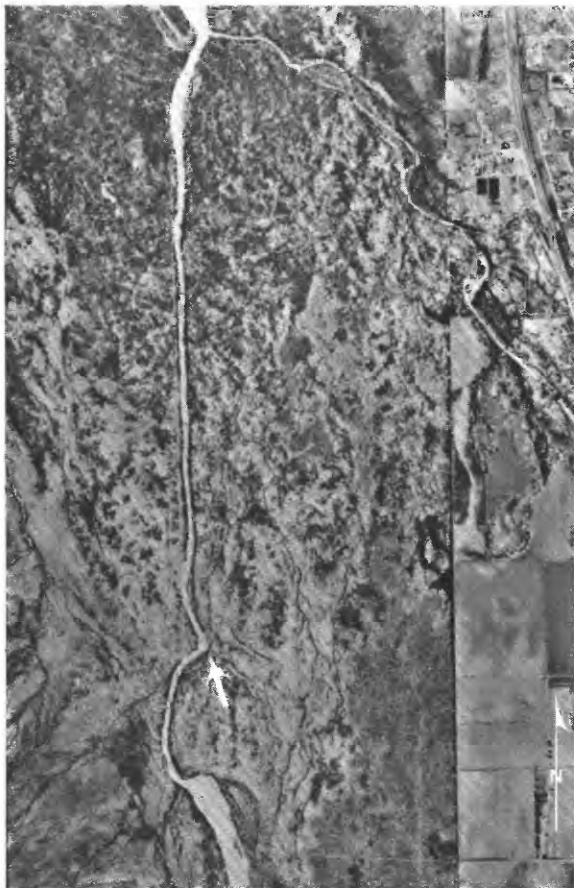
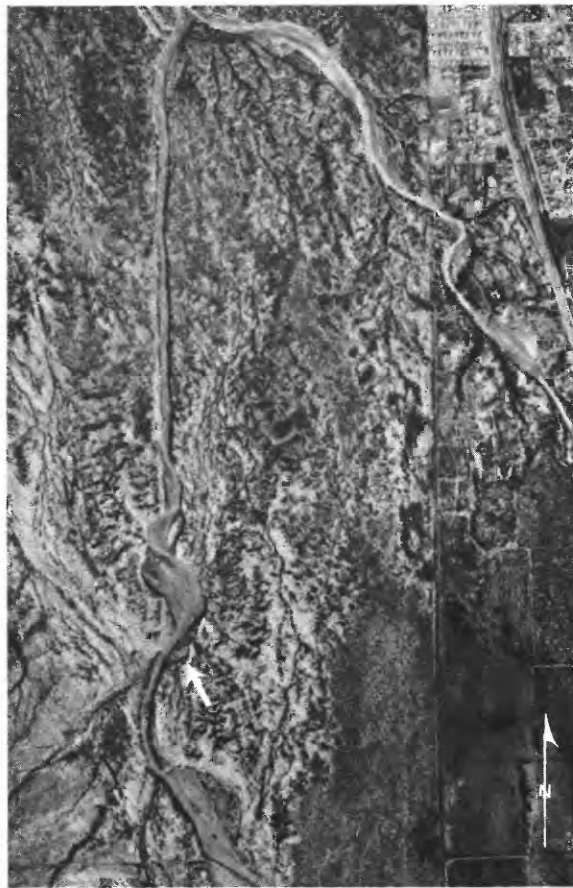
**Figure 18.** Changes on straight segment of the upper San Xavier reach, 1966–86. Arroyo width changed little except at the upstream end of the reach, where an entrenched meander was migrating into the straight

of the entrenched channel against the arroyo walls (fig. 17; Parker, 1989). Meanders generally shifted position by lateral extension with little downstream translation, causing arroyo widening to occur repeatedly at about the same locations throughout each time interval (fig. 15). Such a pattern suggests that arroyo-wall retreat generally is caused by flows that are unable to rework and transport the coarsest material in the point bars but are capable of eroding the weakly cemented, fine-grained arroyo walls (Meyer, 1989). Braided and straight arroyo segments generally widened much more slowly on the San Xavier reach, but the rate of arroyo widening may eventually increase in such reaches when penetrated by downstream migrating meanders (fig. 18).

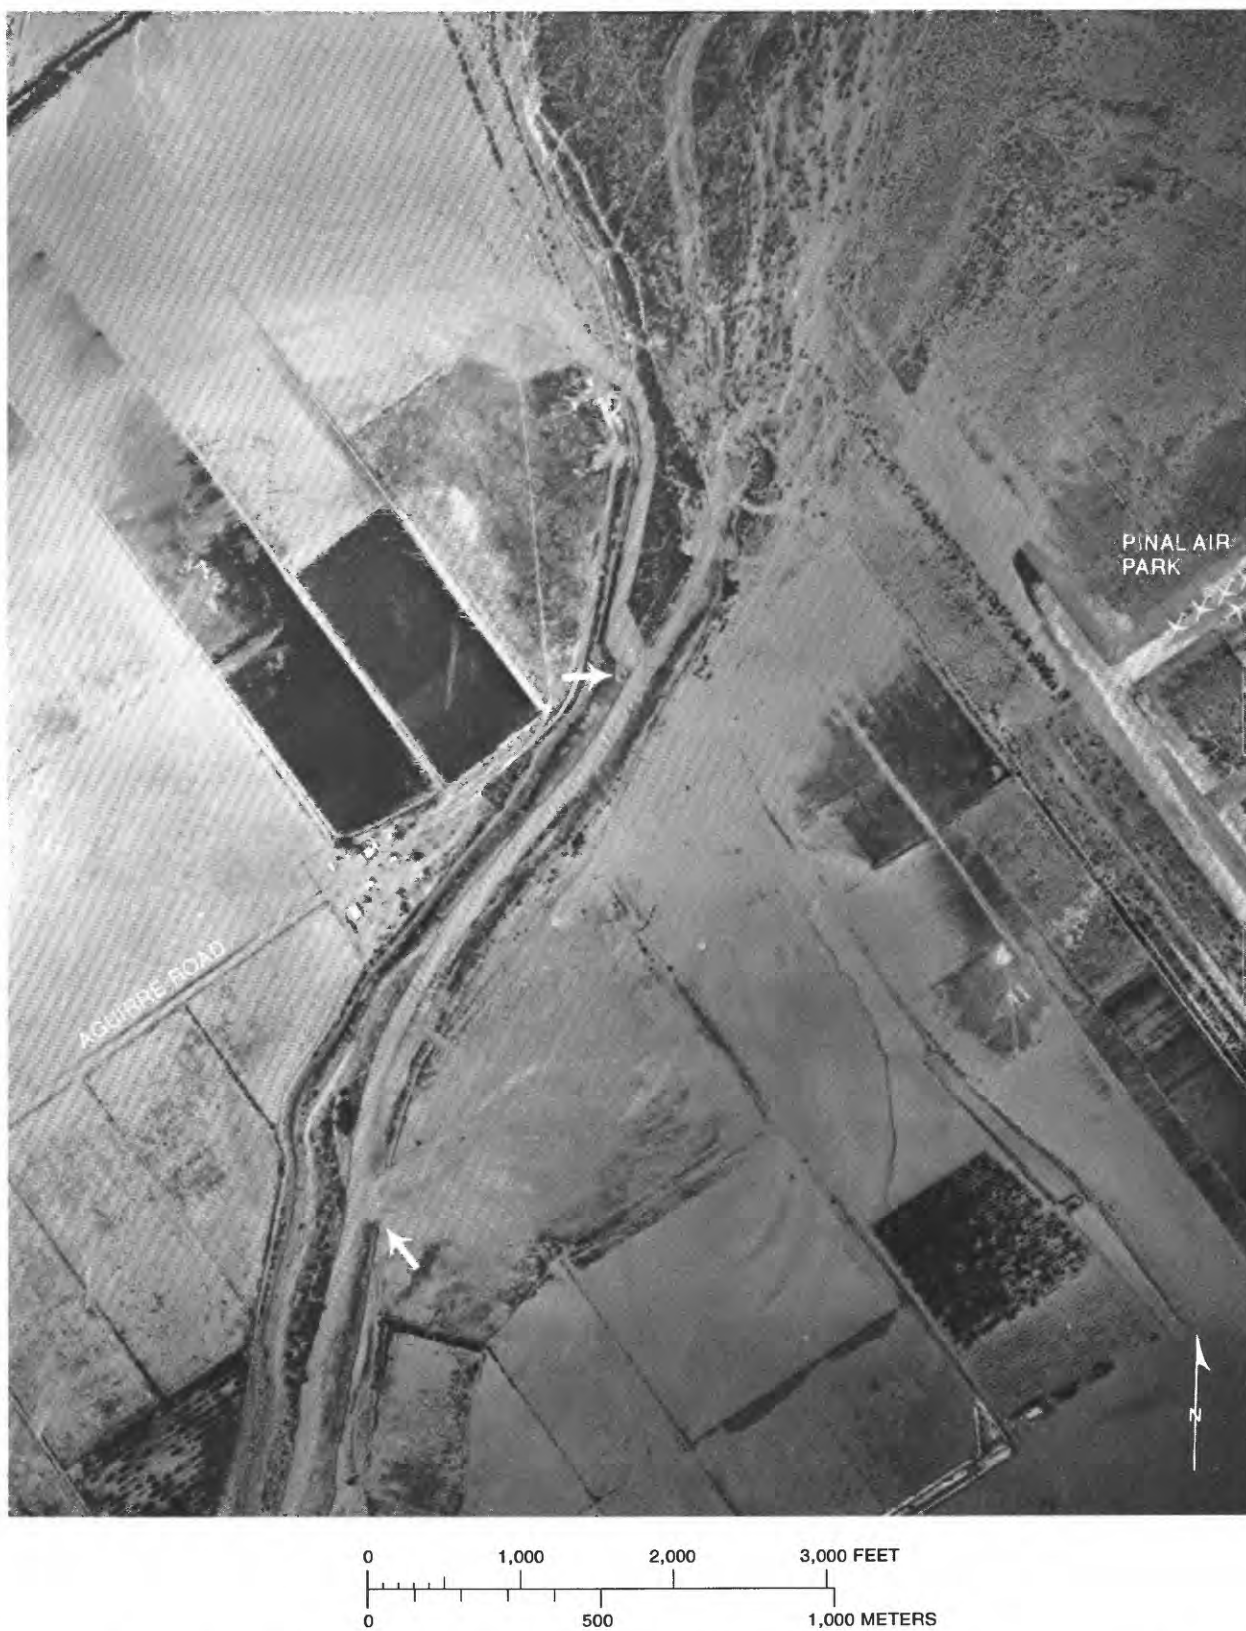
**Figure 24.** Floodwaters breaking through levees (indicated by arrows) on the lower Marana reach during the flood of October 1983. (Aerial photograph by Cooper Aerial Survey, 1983.)
