## SURFACE WATER

By D. B. Bogart and G. E. Ferguson

### CHARACTERISTICS OF DRAINAGE BASINS AND SUMMARIES OF GAGING- STATION RECORDS

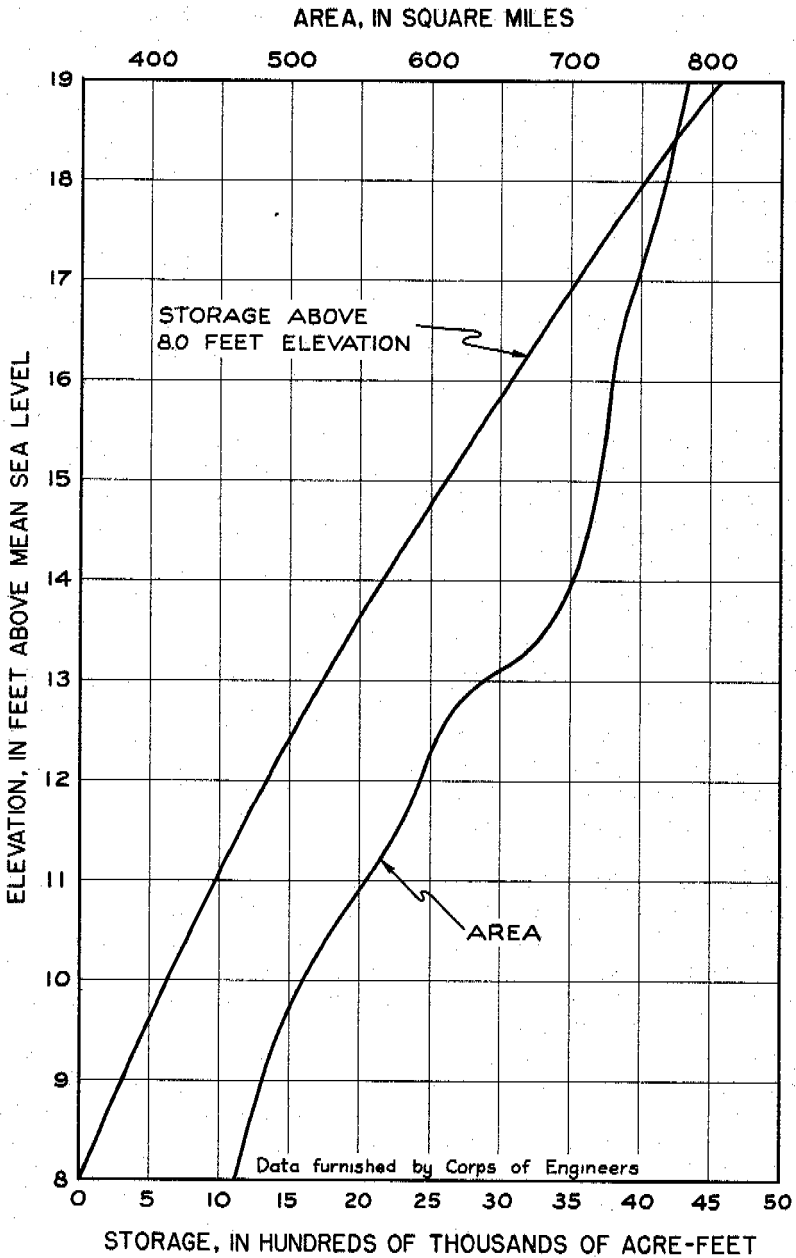
Figure 87. — Stage-area and storage-capacity curves for Lake Okeechobee.

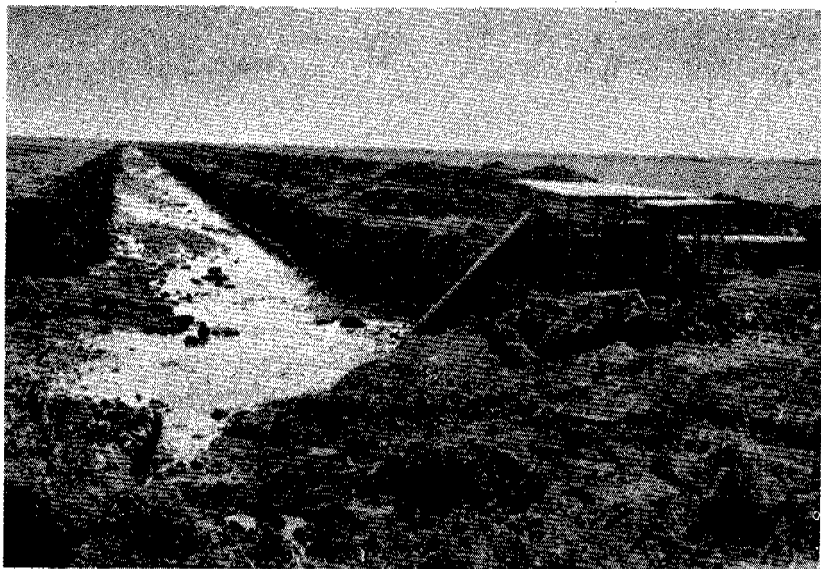
Figure 92. — Water control facilities in the upper Everglades. Main canal of East Shore Drainage District, under construction near Belle Glade; part of channel still to be excavated and spoil material to be graded to form a dike. Canal was excavated to the rock surface in 9 ft of muck soil; pump was a temporary installation for construction period; August 1944.

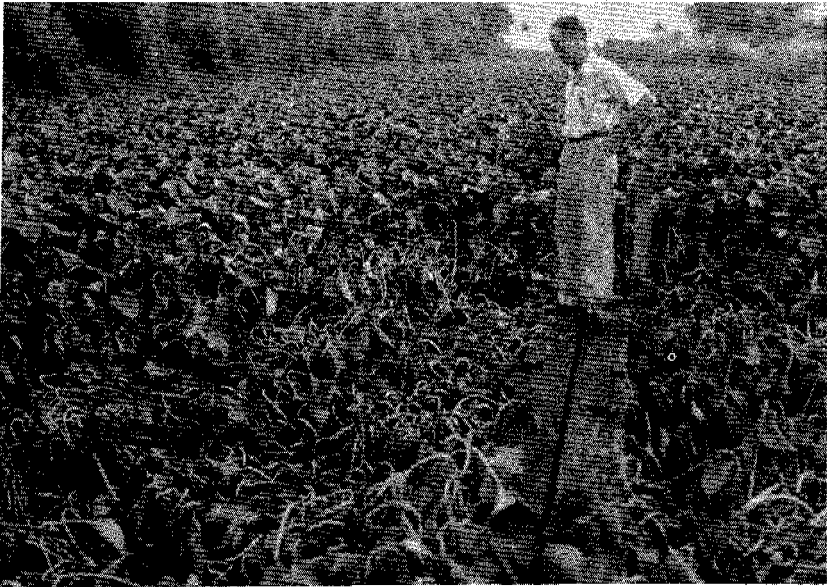
Figure 95. — Aquatic growth in Everglades canals. Dense cover of water hyacinth on North New River Canal at South Bay; view along centerline of canal in September 1946; the trampled-appearing area shows the affect of spray-application of 2-4, D, a herbicide that is effective in killing hyacinth.

Another important cause of canal inefficiency has been obstructions of aquatic weeds, an example of which is shown in figure 95. The bottom-rooted types are found principally in the secondary canals and field laterals (except in the lower Everglades—see data on Miami Canal) and may block flow almost completely. Fortunately, they seem to have a seasonal characteristic (they are affected by temperature or water velocity) and leave the channels comparatively clear at times. Without doubt, however, the water hyacinth, that beautiful but obnoxious floating plant, is the acknowledged champion among weed pests in canals.

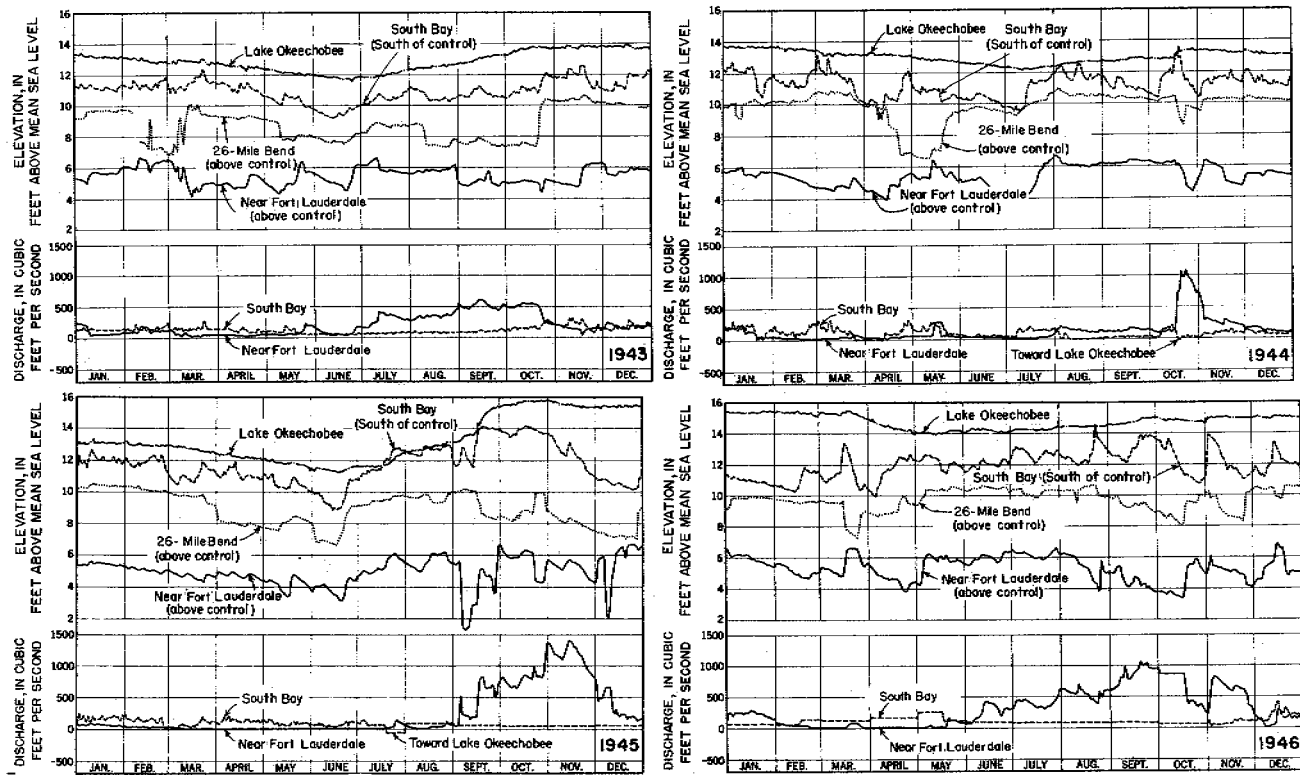
Figure 105. — Graphs showing stage and discharge of North New River Canal, 1943-46.
