Roughness Characteristics of Natural Channels

By HARRY H. BARNES, JR.

U.S. GEOLOGICAL SURVEY WATER-SUPPLY PAPER 1849

*Color photographs and descriptive
data for 50 stream channels for
which roughness coefficients have
been determined*

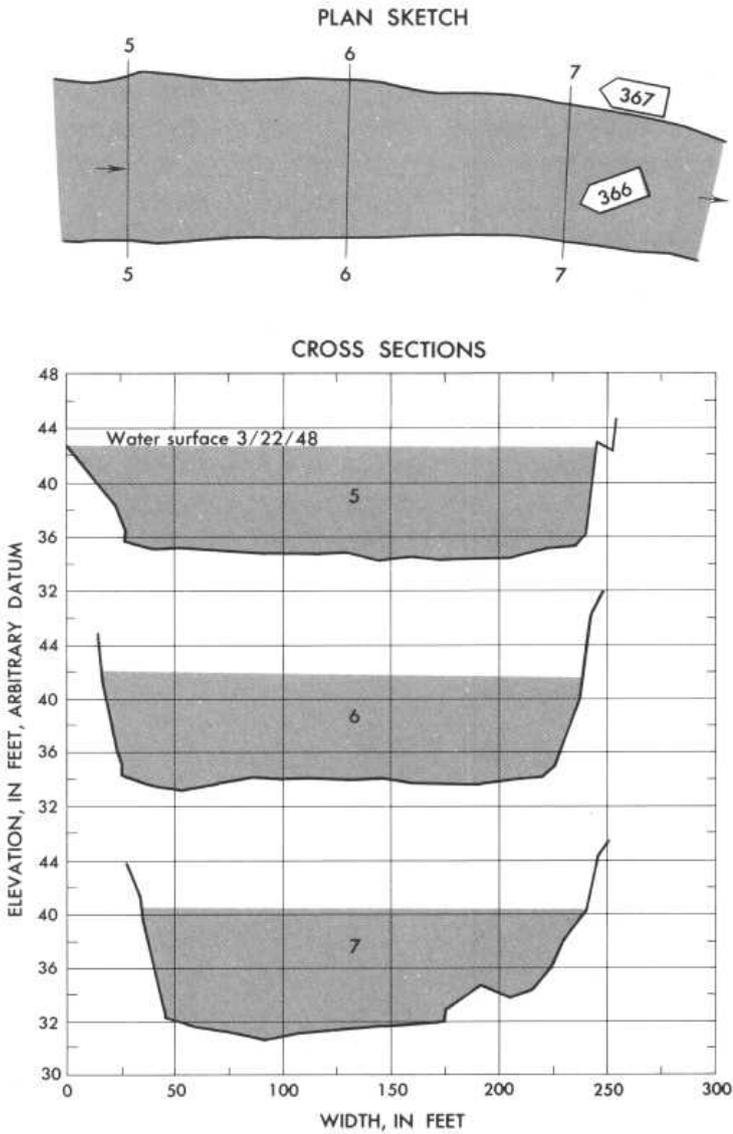
Plan sketch and cross sections, Beaver Kill at Cooks Falls, N.Y.

Description of channel.—Bed consists of coarse gravel and cobbles with scattered boulders. Light brush is on both banks and some trees are near water's edge on right bank.

Section	Area (sq ft)	Top width (ft)	Mean depth (ft)	Hydraulic radius (ft)	Mean velocity (ft per sec)	Length (ft) between sections	Fall (ft) between sections
5	1,700	244	7.0	6.85	9.11
6	1,660	221	7.5	7.36	9.33	279	0.65
7	1,590	206	7.7	7.59	9.72	283	1.25

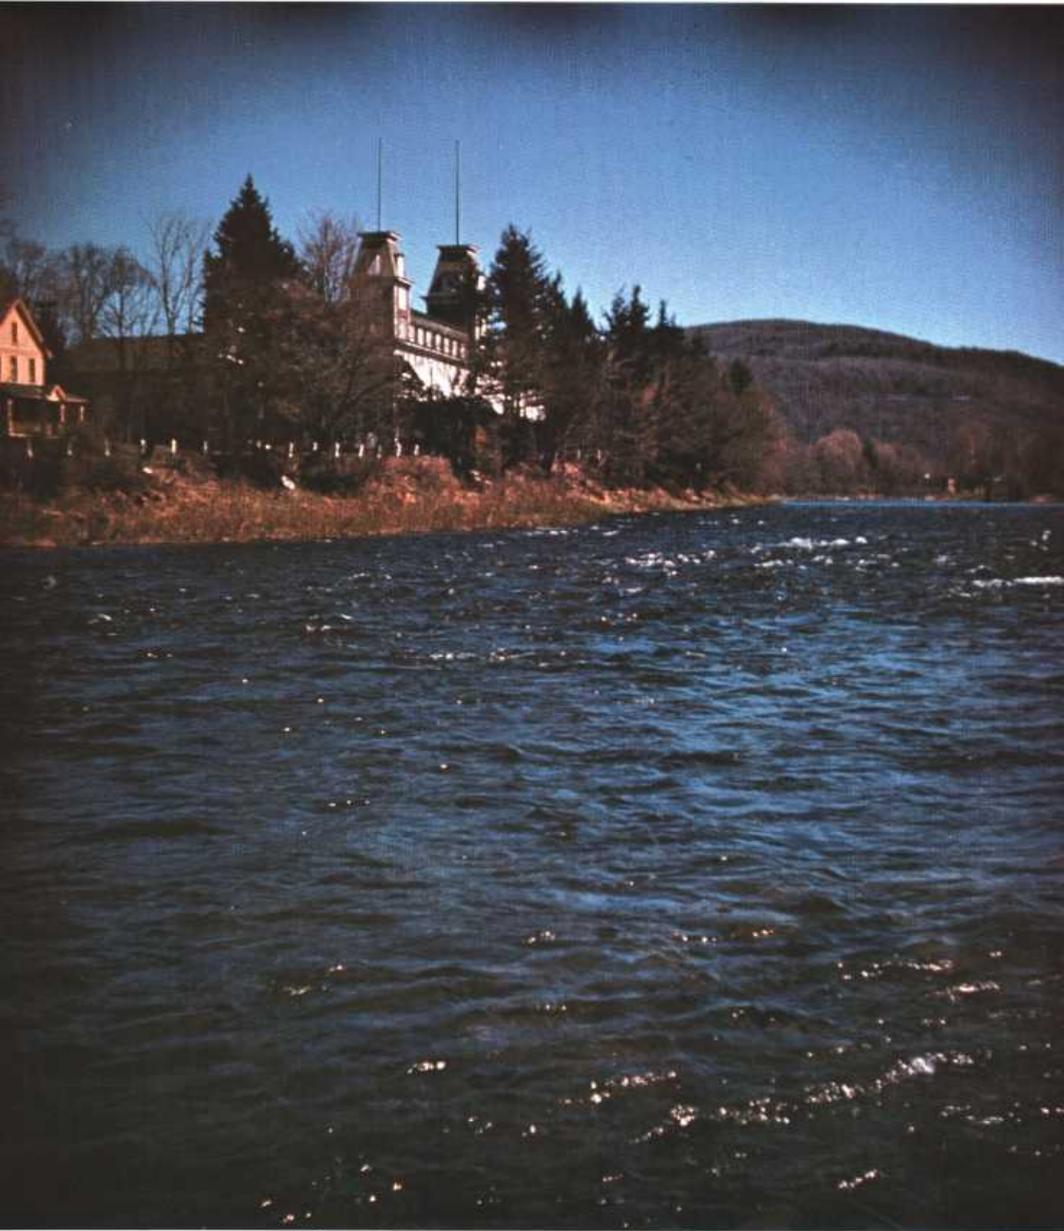
No. 366 upstream toward right bank from section 7, Beaver Kill at Cooks Falls, N.Y.

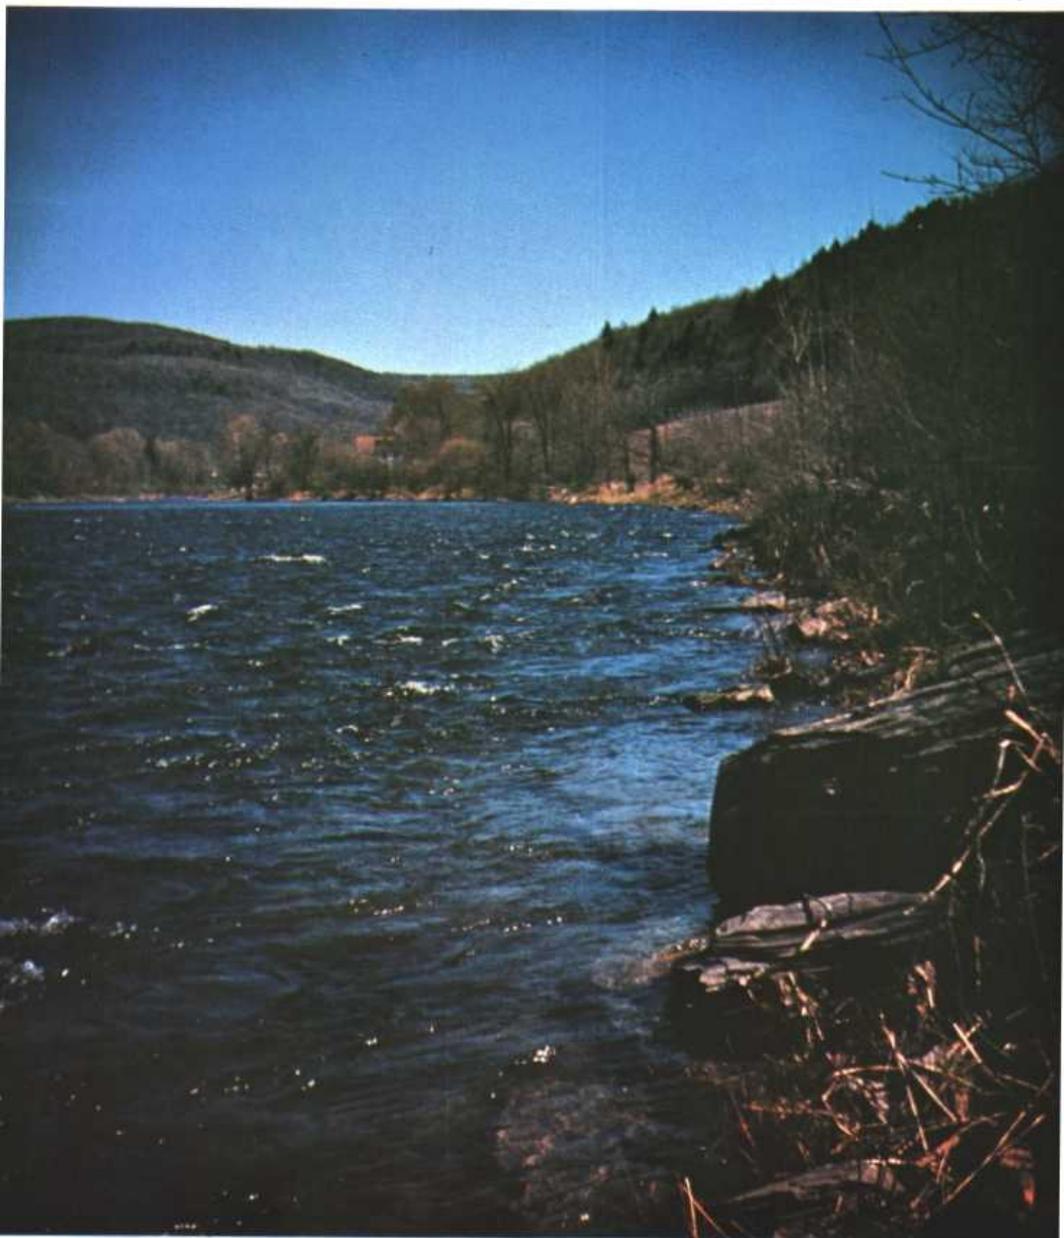
No. 367 upstream along left bank from section 7, Beaver Kill
at Cooks Falls, N.Y.

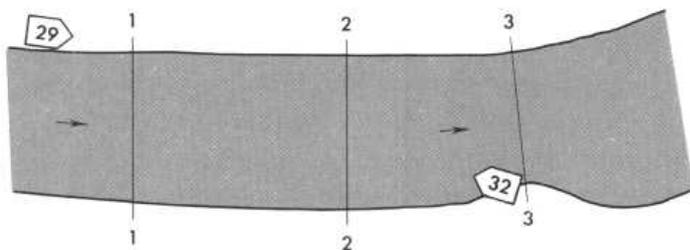
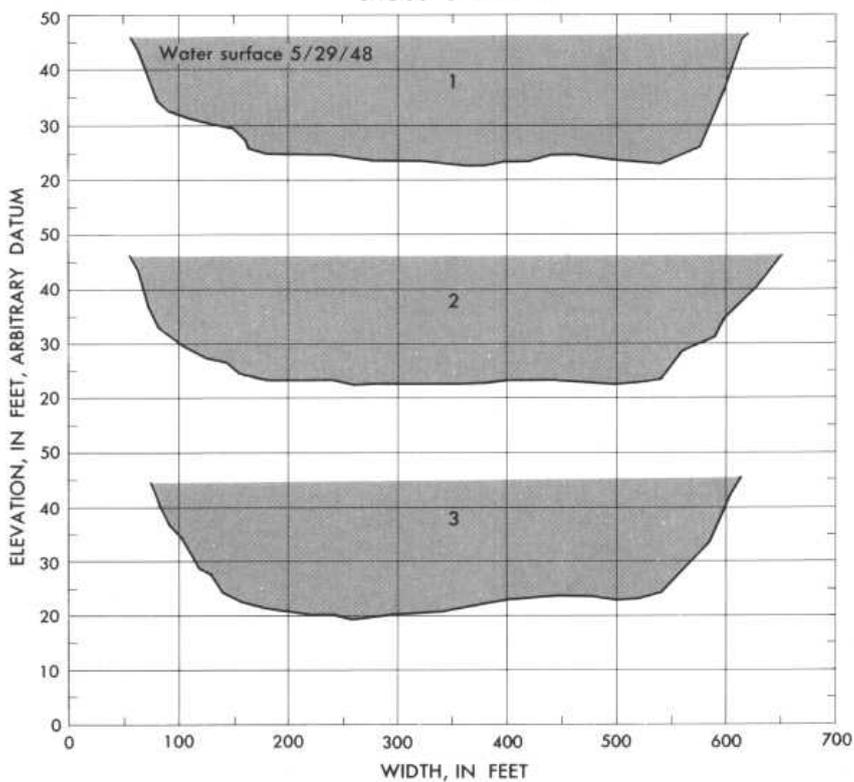
Plan sketch and cross sections, Clearwater River at Kamiah, Idaho.

Description of channel.—Bed is composed of gravel and boulders with some exposed bedrock. Channel is bordered by railroad on the right and highway on the left. Banks are gravel and rock and have light vegetation cover.

Section	Area (sq ft)	Top width (ft)	Mean depth (ft)	Hydraulic radius (ft)	Mean velocity (ft per sec)	Length (ft) between sections	Fall (ft) between sections
1.....	11,100	562	19.25	19.45	8.92
2.....	11,603	593	19.58	19.34	8.53	732	0.35
3.....	10,937	538	20.32	20.04	9.05	560	.67

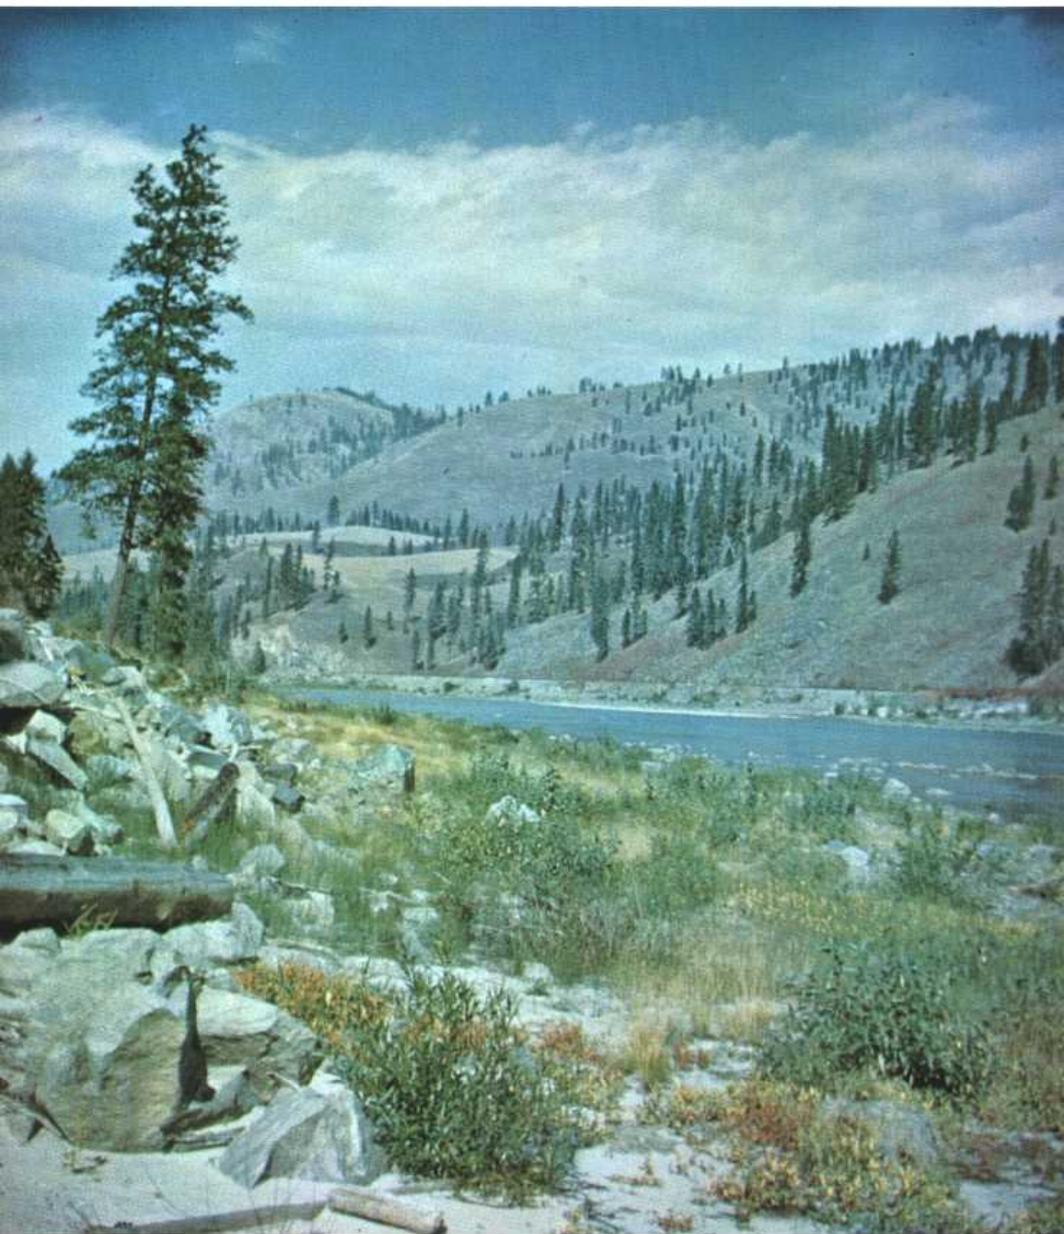
No. 29 downstream along left bank from above section 1,
Clearwater River at Kamiah, Idaho.

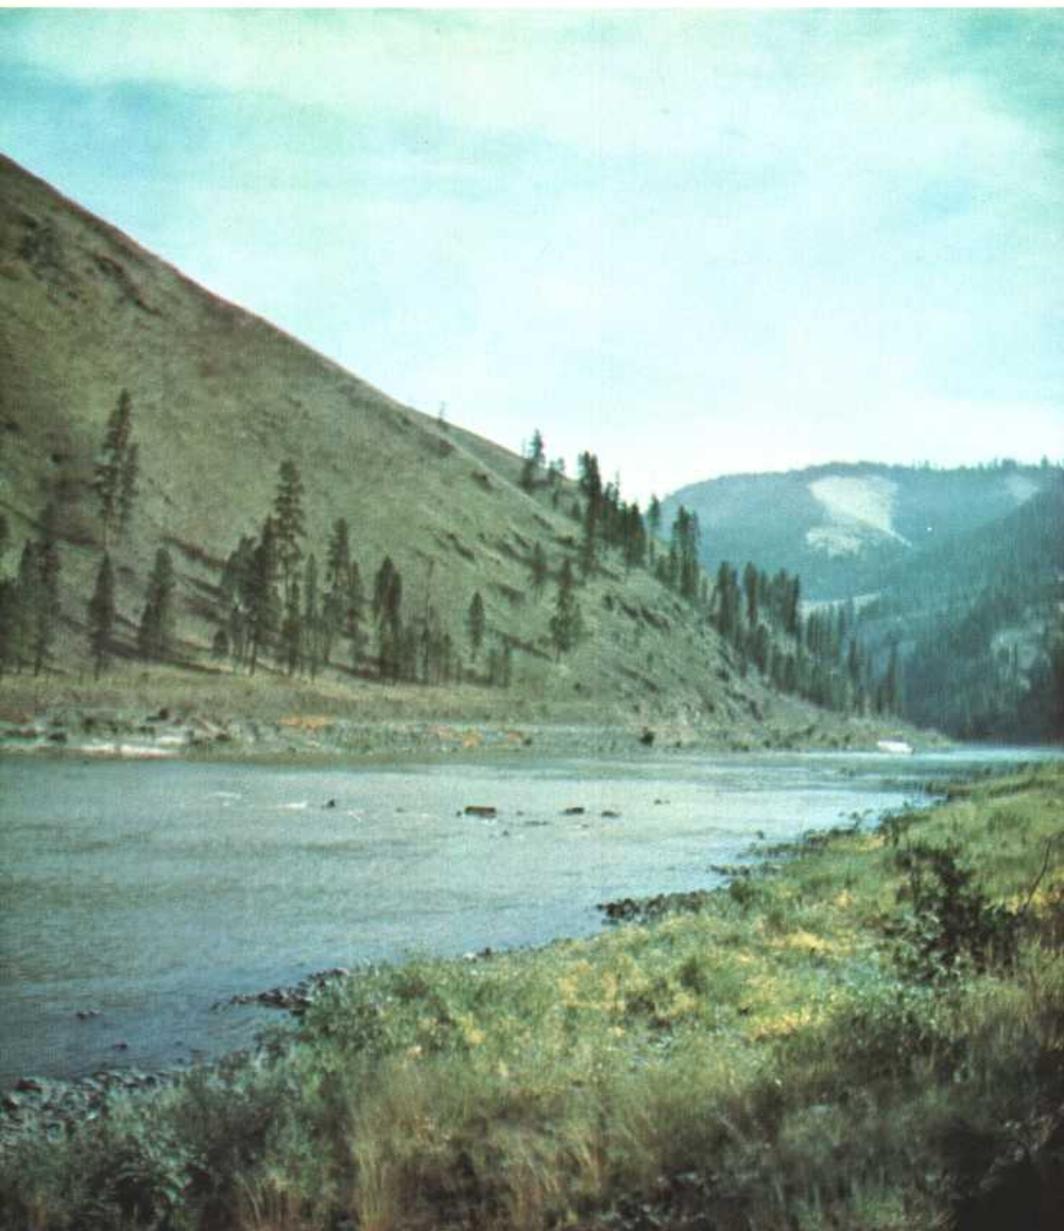
No. 32 upstream from left bank at section 3. Clearwater River
at Kamiah, Idaho.

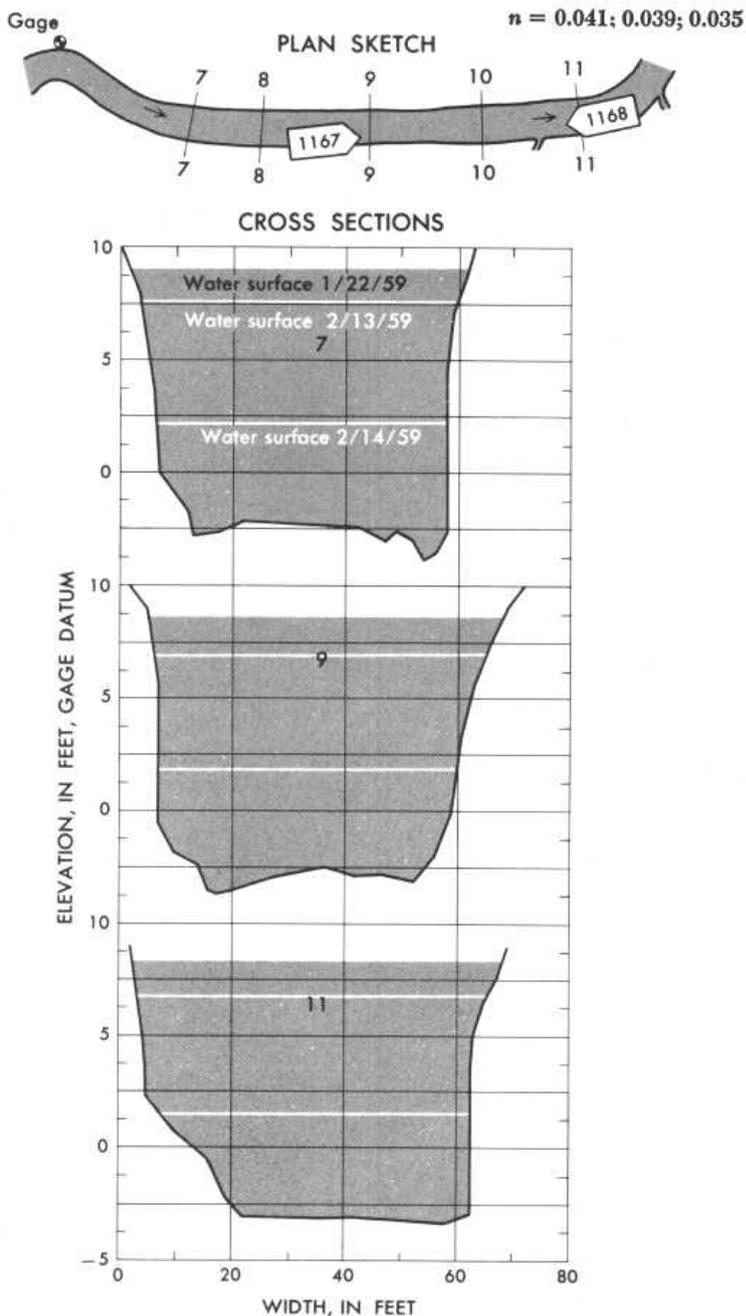
Plan sketch and cross sections, Etowah River
near Dawsonville, Ga.

Description of channel.—Bed is sand and gravel with several fallen trees in the reach. Banks are lined with overhanging trees and underbrush.

Section	Area (sq ft)	Top width (ft)	Mean depth (ft)	Hydraulic radius (ft)	Mean velocity (ft per sec)	Length (ft) between sections	Fall (ft) between sections
Jan. 22, 1959							
7.....	618	60	10.3	8.15	3.66
8.....	621	66	9.4	7.77	3.64	316	0.22
9.....	619	63	9.8	8.18	3.65	286	.18
10.....	610	63	9.7	7.77	3.70	293	.14
11.....	622	66	9.4	7.89	3.63	203	.17
Feb. 13, 1959							
7.....	528	57	9.3	7.37	3.50
8.....	531	64	8.3	6.95	3.48	316	0.19
9.....	532	59	9.0	7.56	3.48	286	.20
10.....	525	61	8.6	7.00	3.52	293	.14
11.....	530	62	8.6	7.10	3.49	203	.14
Feb. 14, 1959							
7.....	240	51	4.7	4.04	2.15
8.....	209	59	3.5	3.27	2.46	316	0.16
9.....	235	53	4.4	4.04	2.19	286	.17
10.....	203	59	3.4	3.19	2.54	293	.19
11.....	219	55	4.0	3.59	2.35	203	.15

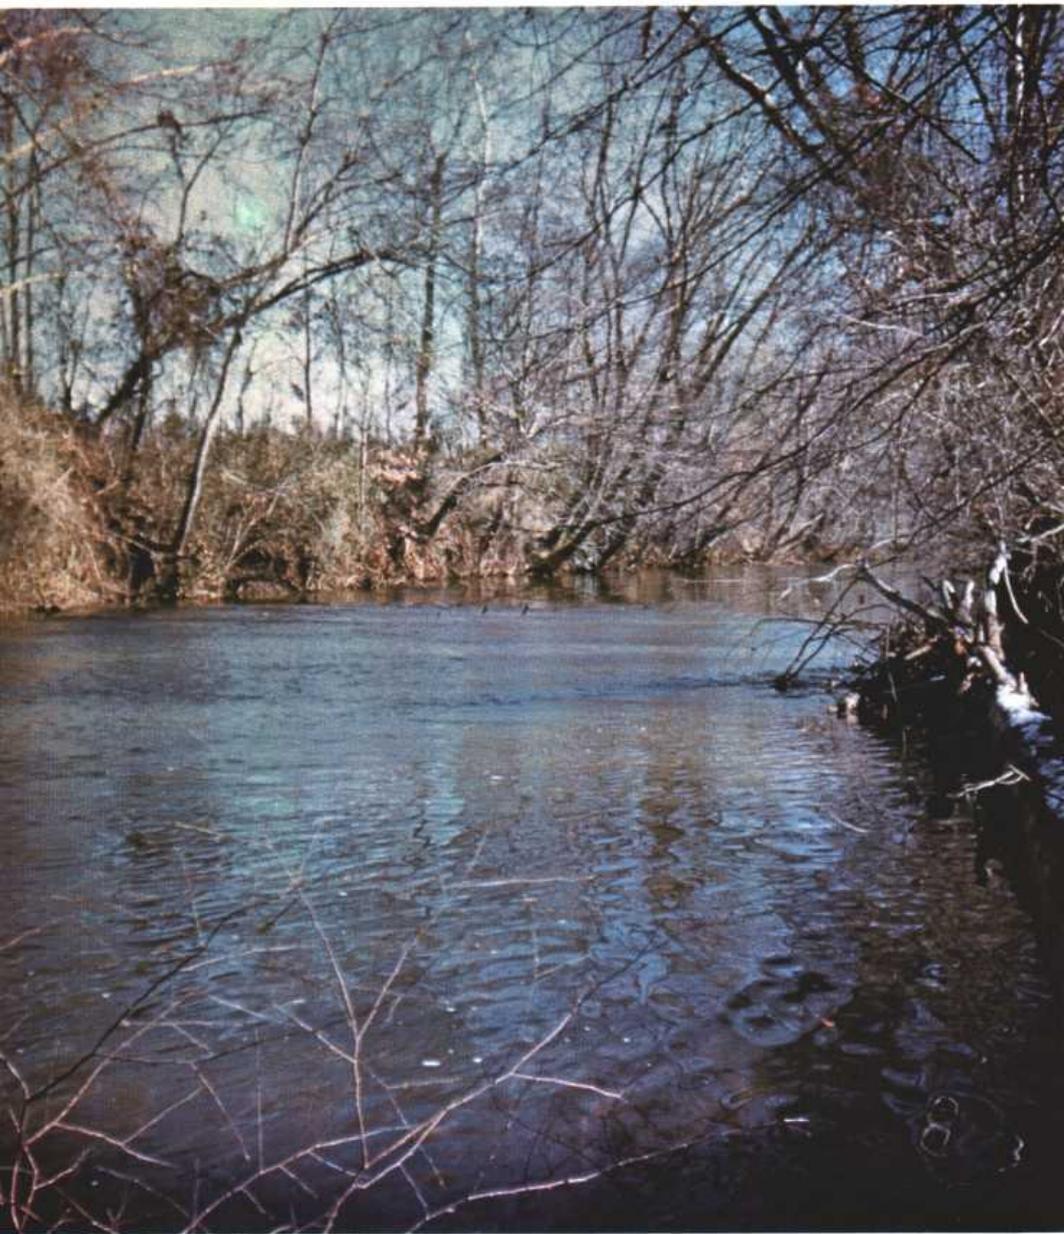
No. 1167 downstream from right bank above section 9, Etowah River near Dawsonville, Ga.

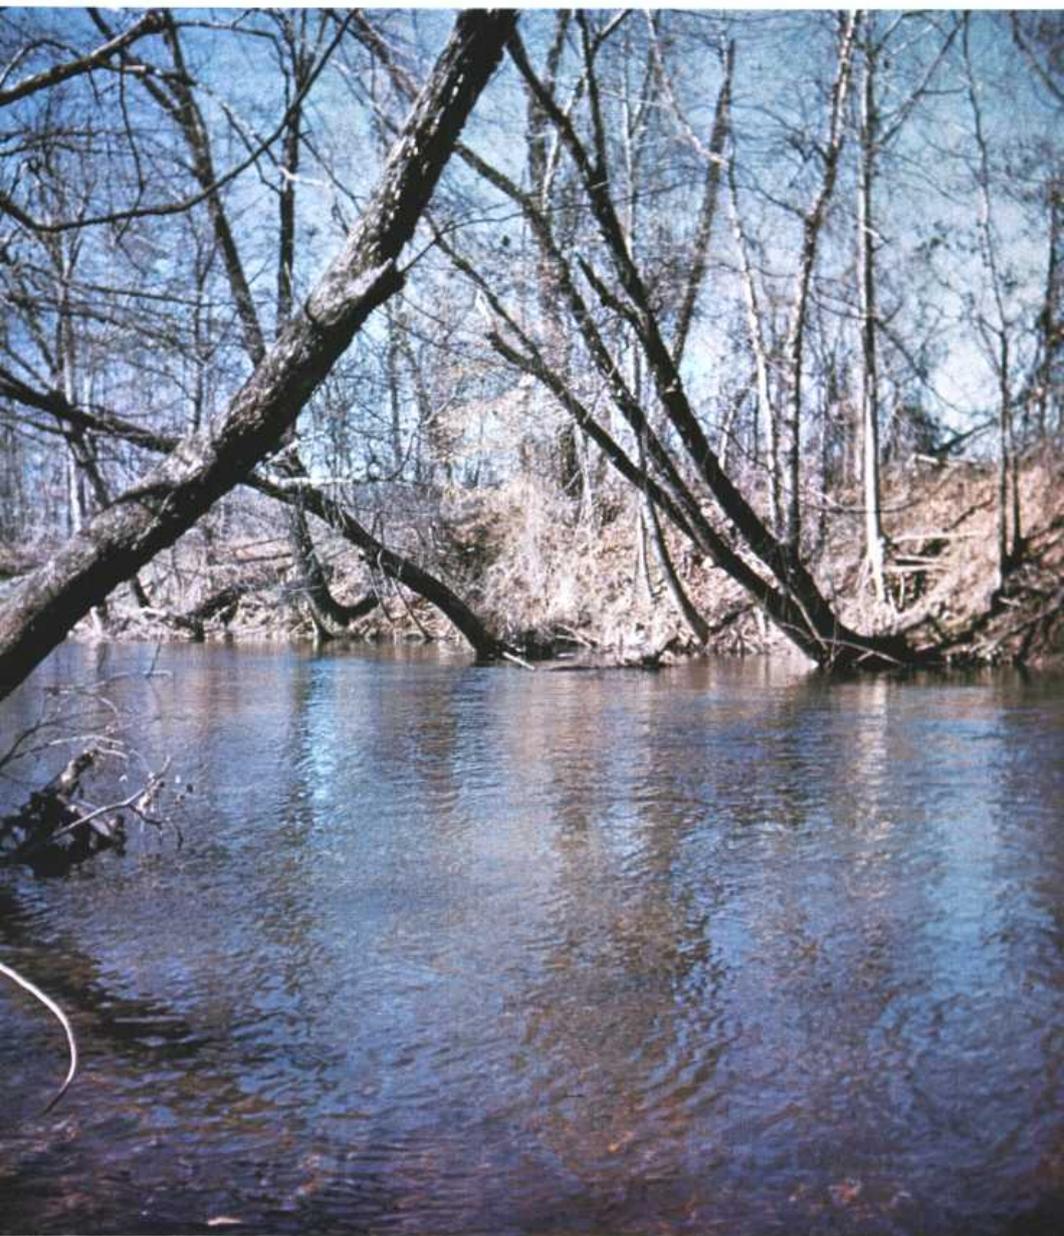
No. 1168 upstream from right bank at section 11, Etowah River near Dawsonville, Ga.

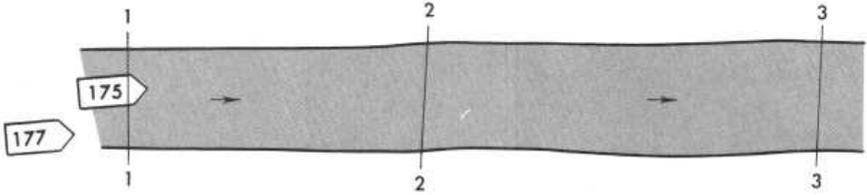
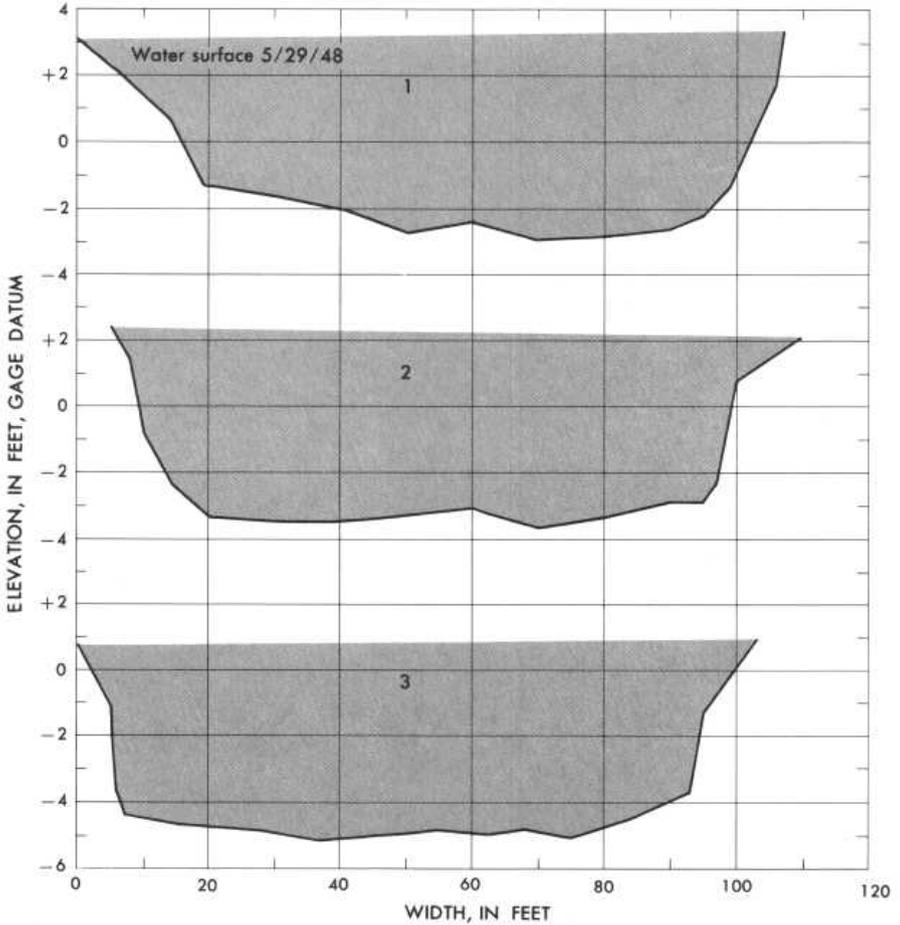
Plan sketch and cross sections, West Fork Bitterroot River near Conner, Mont.

Description of channel.—Bed is gravel and boulders; $d_{50} = 172$ mm, $d_{84} = 265$ mm. The left bank is lined with overhanging bushes. The right bank is lined with trees.

Section	Area (sq ft)	Top width (ft)	Mean depth (ft)	Hydraulic radius (ft)	Mean velocity (ft per sec)	Length (ft) between sections	Fall (ft) between sections
1.....	504	107	4.7	4.62	7.70
2.....	494	105	4.7	4.57	7.85	222	1.02
3.....	516	103	5.0	4.82	7.52	302	1.40

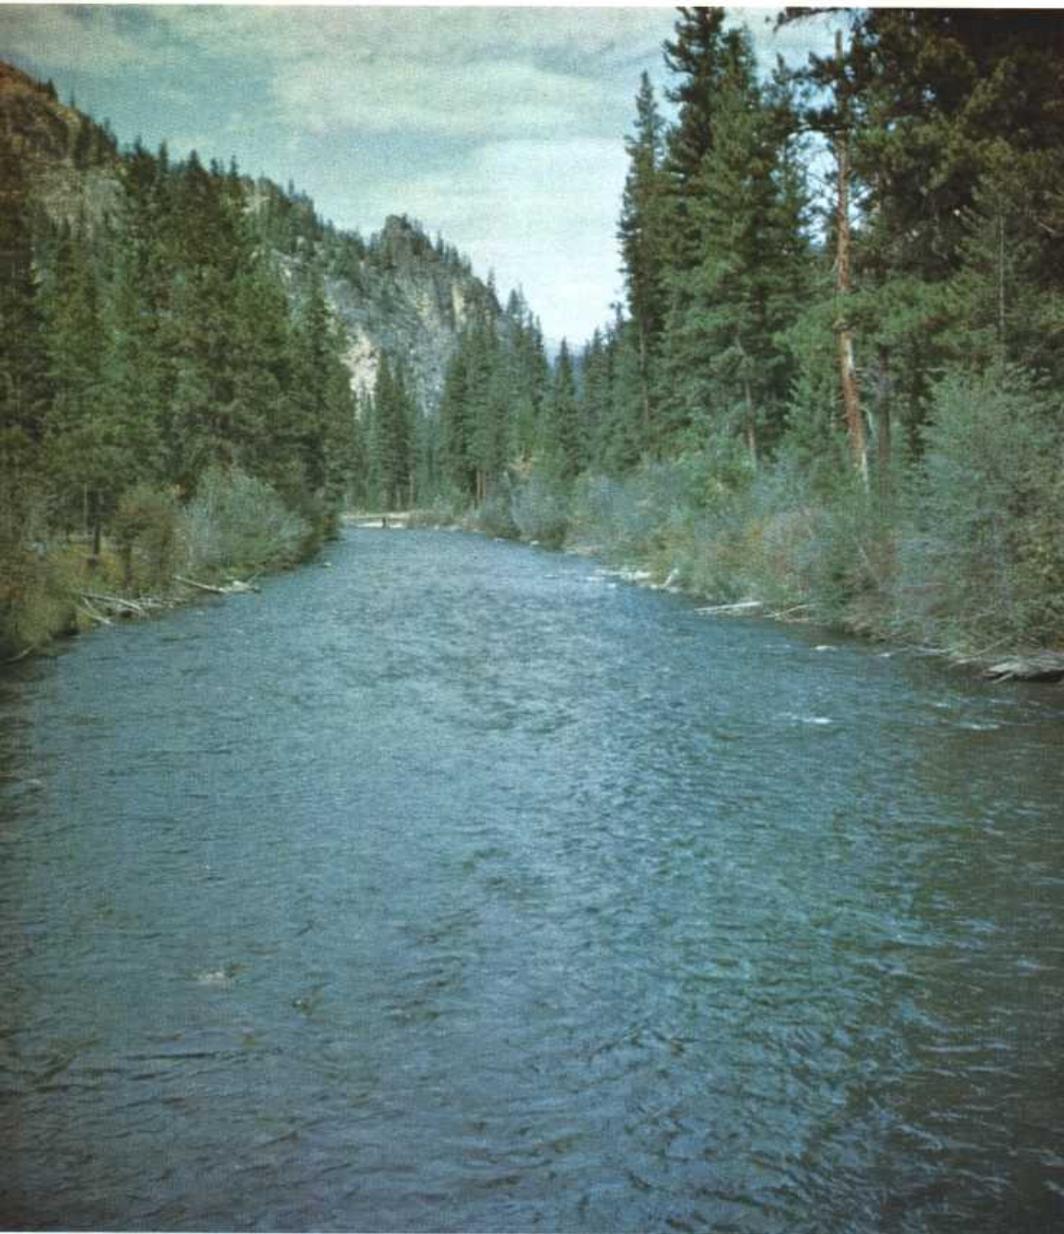
No. 175 downstream from section 1, West Fork Bitterroot
River near Conner, Mont.

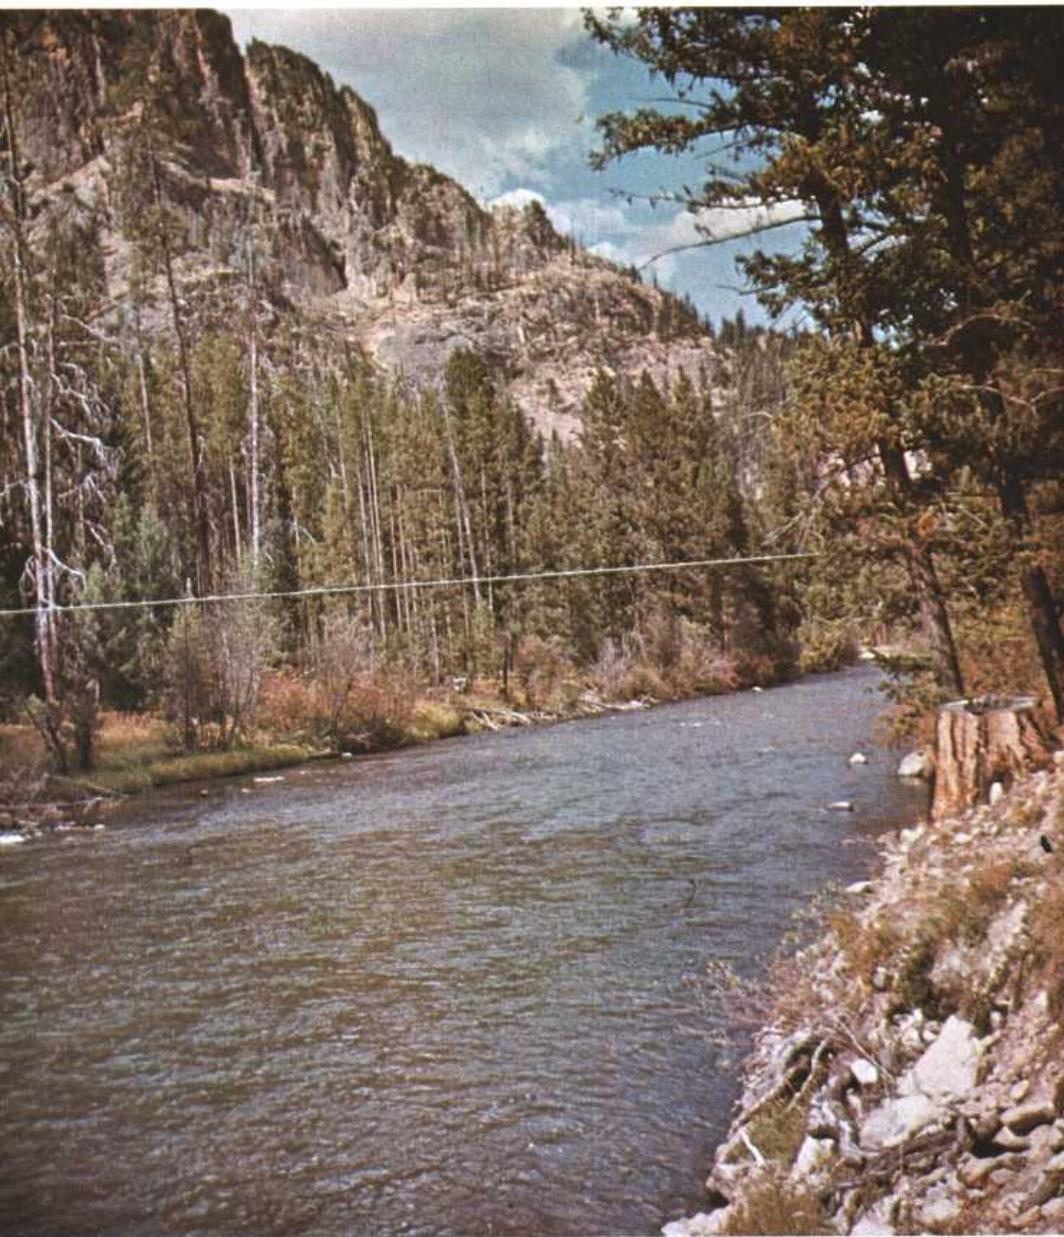
No. 177 downstream from right bank above section 1, West Fork Bitterroot River near Conner, Mont.

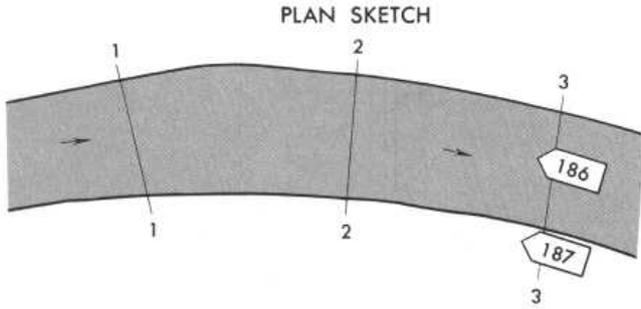
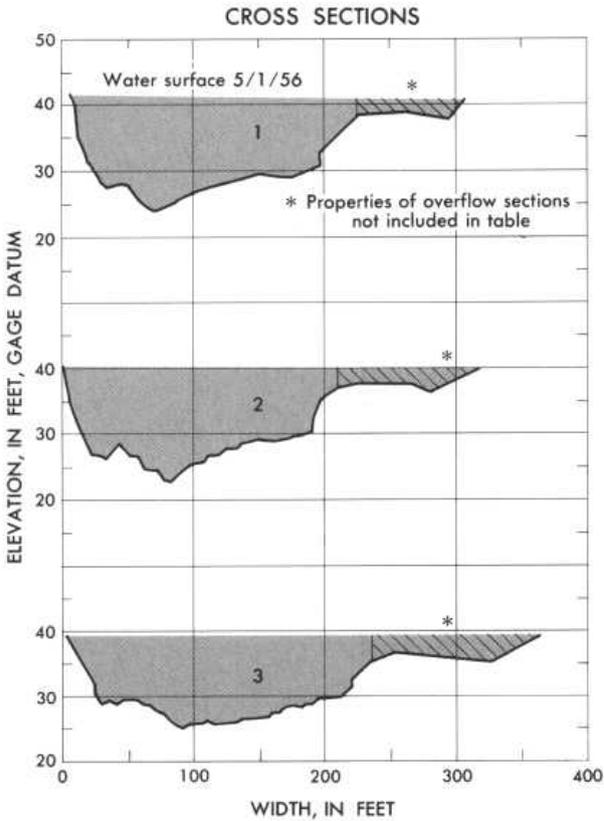
Plan sketch and cross sections, Yakima River at Umtanum, Wash.

Description of channel.—Bed consists of gravel and boulders.

Left bank is rock riprap with bushes. Right bank is mildly sloped and has some boulders, brush, and weed cover.

Section	Area (sq ft)	Top width (ft)	Mean depth (ft)	Hydraulic radius (ft)	Mean velocity (ft per sec)	Length (ft) between sections	Fall (ft) between sections
1	2,680	222	12.1	11.62	10.34
2	2,550	208	12.3	11.61	10.86	324	0.99
3	2,490	232	10.7	10.32	11.12	302	.86

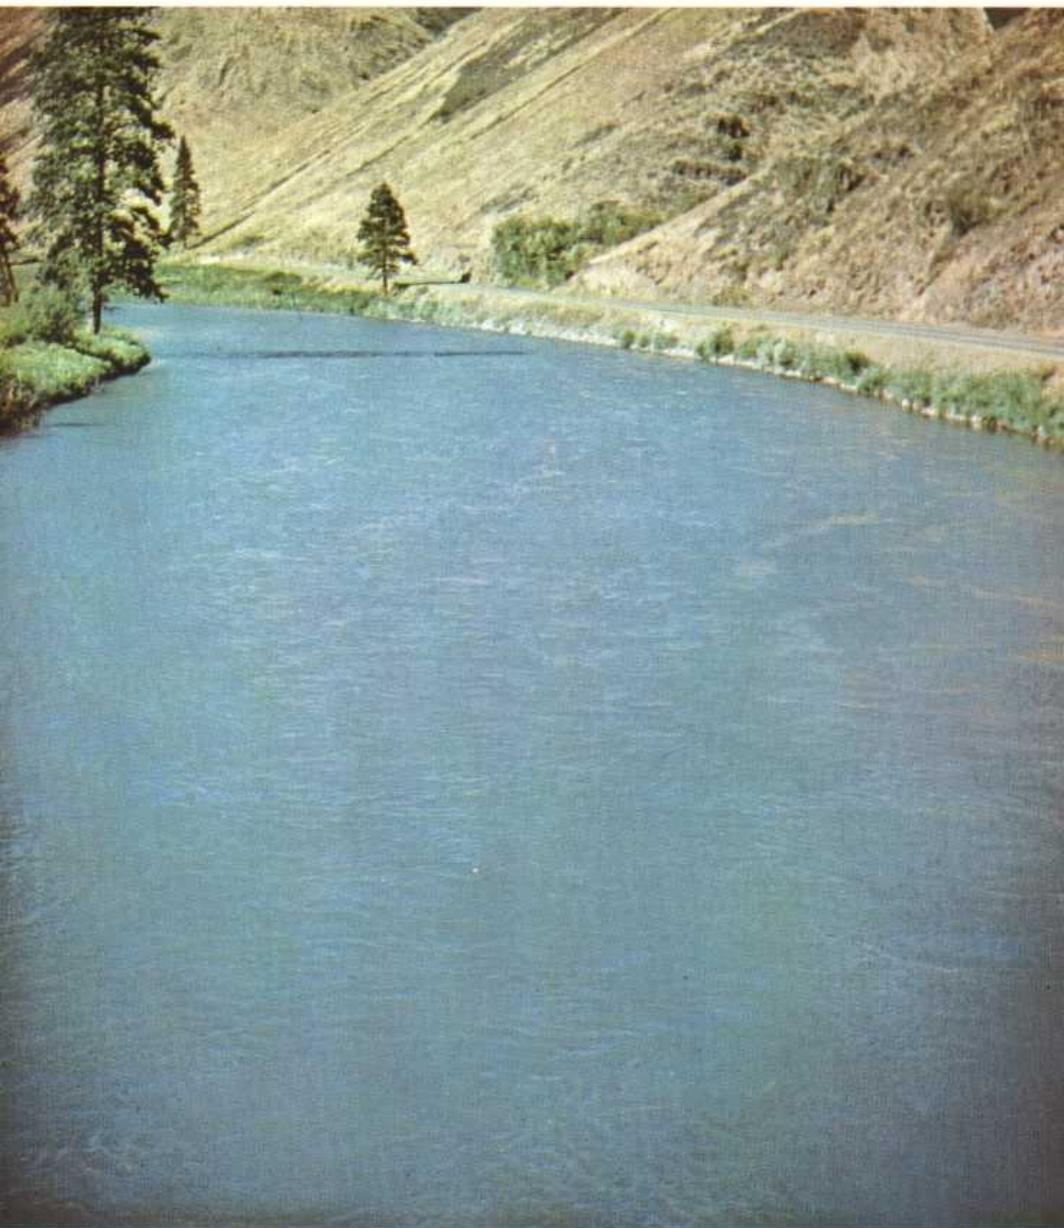
No. 186 upstream from section 3, Yakima River
at Umtanum, Wash.

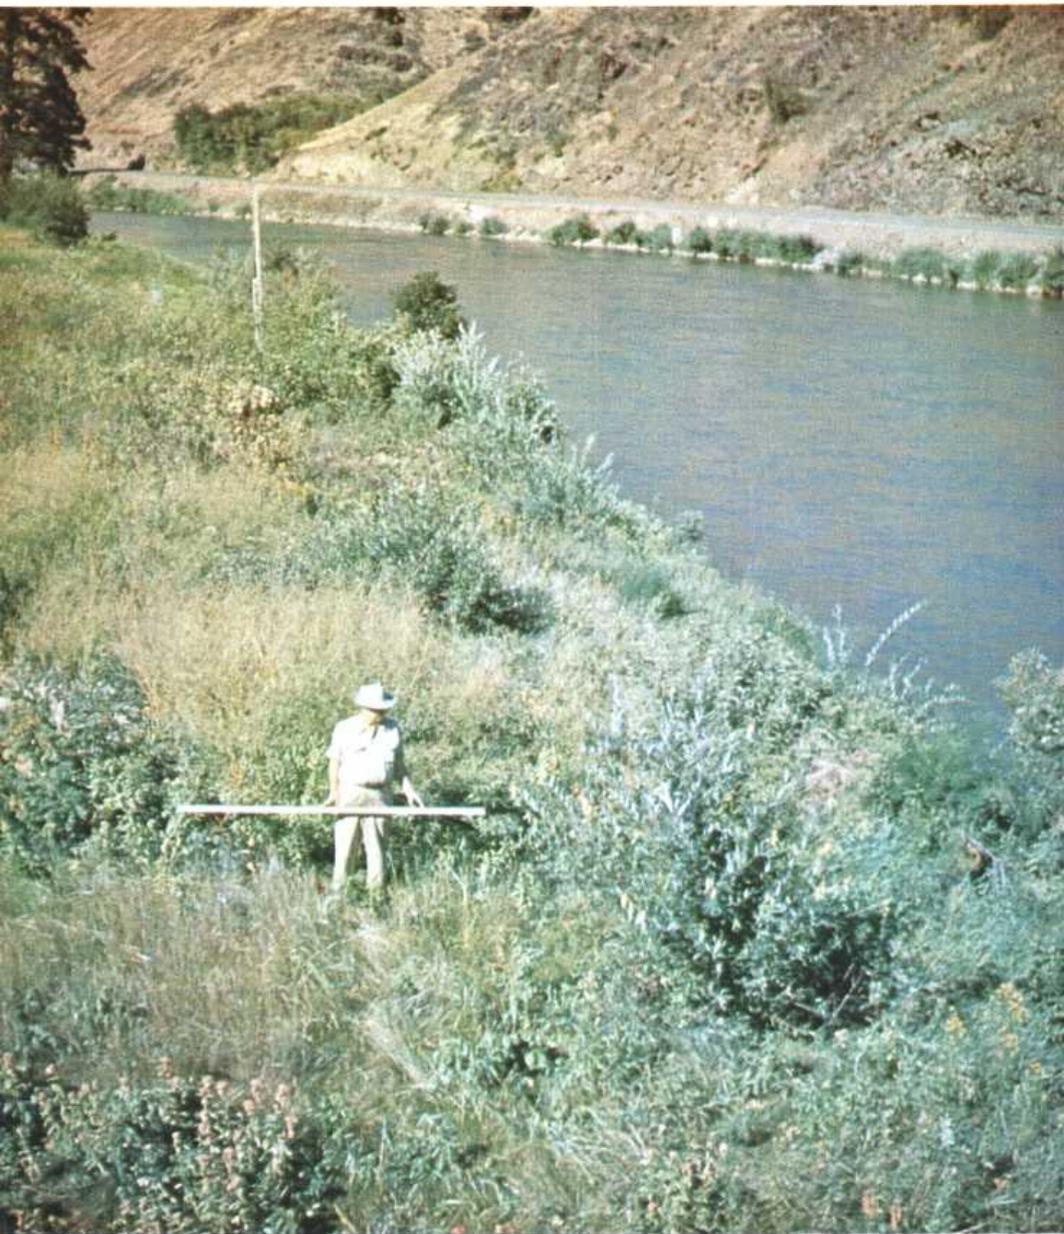
No. 187 upstream along right bank from below section 3,
Yakima River at Umtanum, Wash.

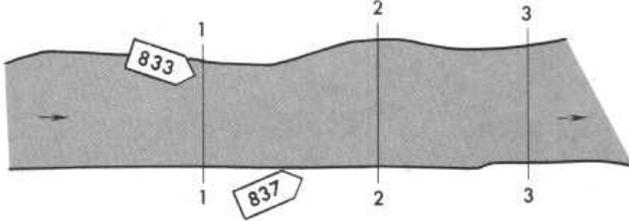
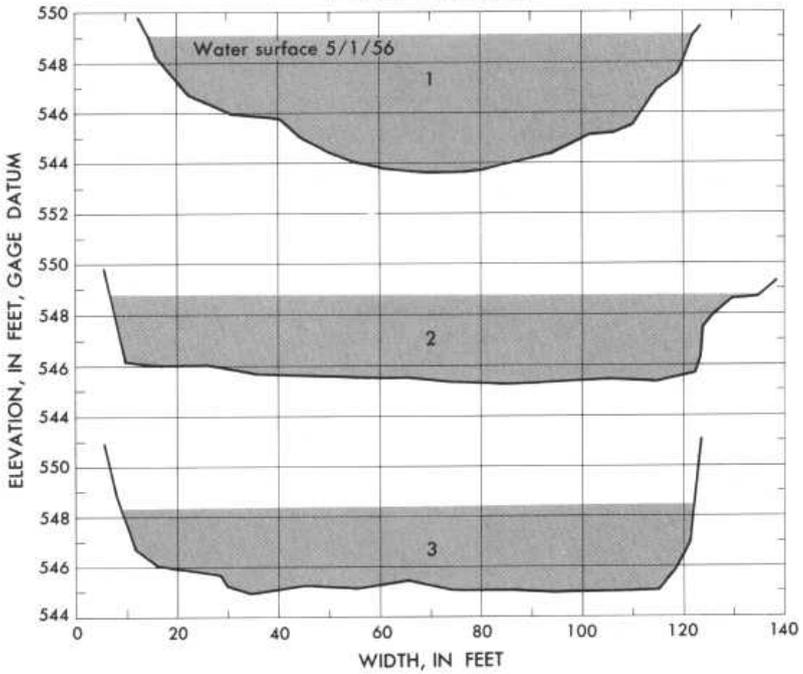
Plan sketch and cross sections, Middle Fork Vermilion River near Danville, Ill.

Description of channel.—Bed is gravel and small cobbles. Banks are lined with trees and small underbrush.

Section	Area (sq ft)	Top width (ft)	Mean depth (ft)	Hydraulic radius (ft)	Mean velocity (ft per sec)	Length (ft) between sections	Fall (ft) between sections
1.....	423	108	3.9	3.88	3.82
2.....	369	129	2.9	2.82	4.40	123	0.36
3.....	344	114	3.0	2.97	4.72	106	.35

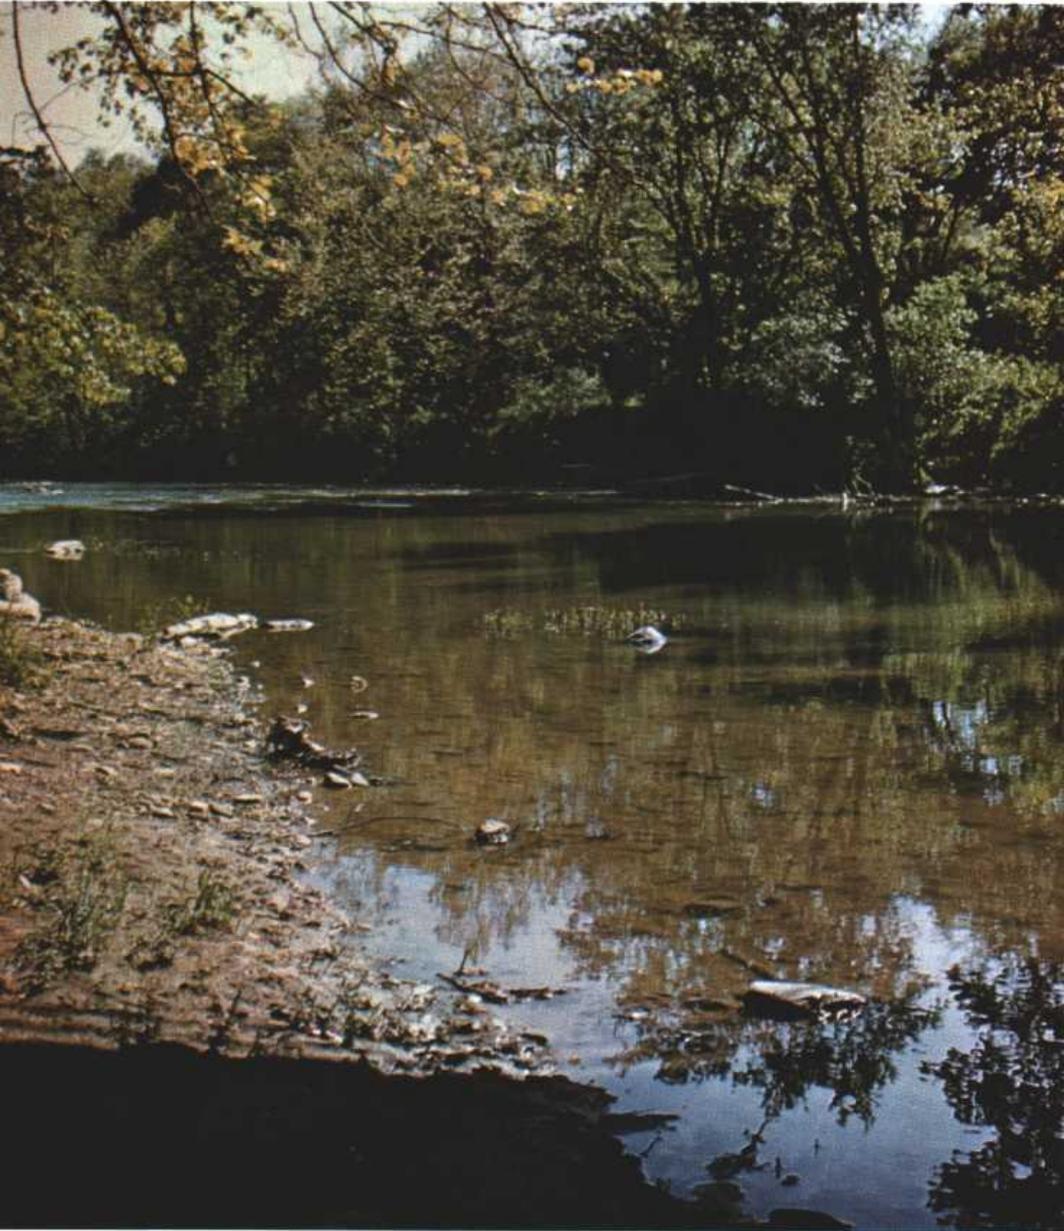
No. 833 downstream from left bank at section 1, Middle Fork
Vermilion River near Danville, Ill.

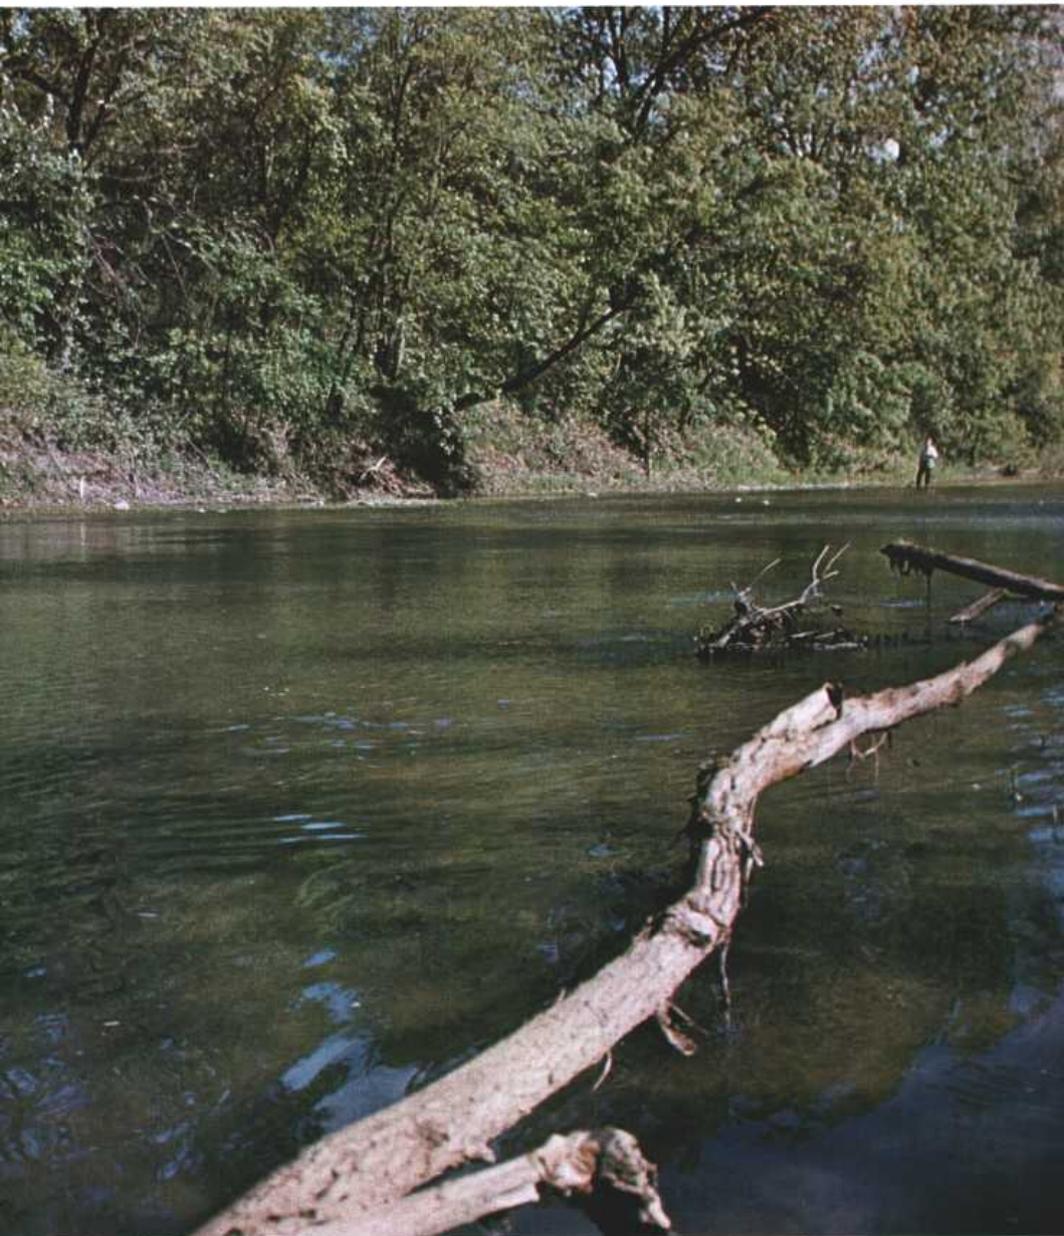
No. 837 downstream from right bank at section 1, Middle Fork Vermilion River near Danville, Ill.

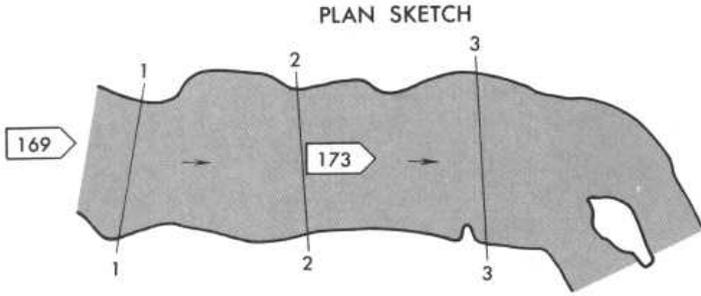
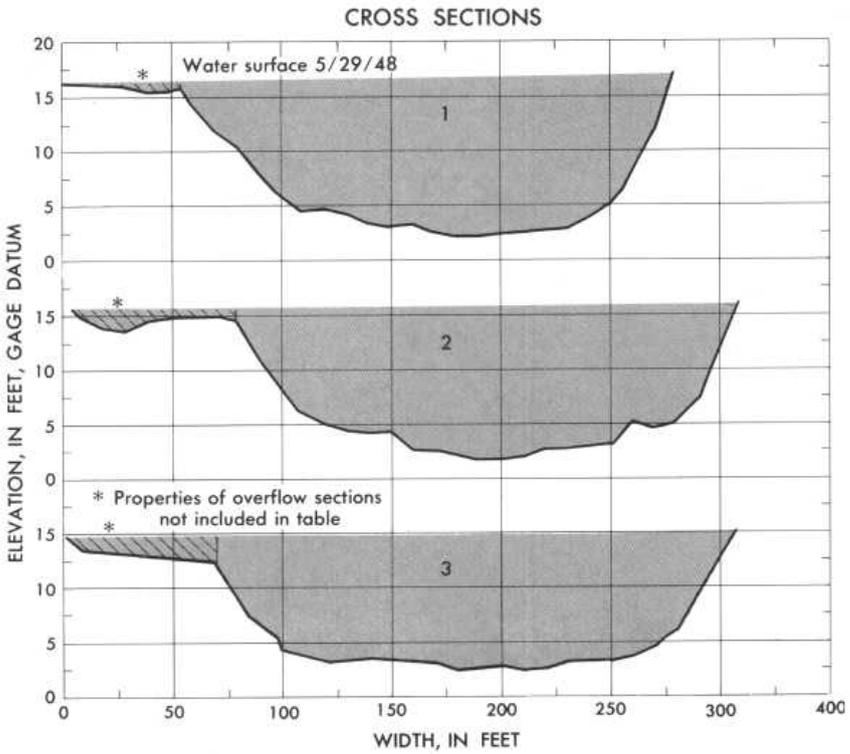
Plan sketch and cross sections, Wenatchee River at Plain, Wash.

Description of channel.—Bed is boulders; $d_{50} = 162$ mm, $d_{85} = 320$ mm. Banks are lined with trees and bushes.

Section	Area (sq ft)	Top width (ft)	Mean depth (ft)	Hydraulic radius (ft)	Mean velocity (ft per sec)	Length (ft) between sections	Fall (ft) between sections
1.....	2,480	224	11.1	10.86	9.15
2.....	2,470	228	10.8	10.58	9.19	311	0.75
3.....	2,440	237	10.3	10.05	9.30	325	.75
