Roughness Characteristics of Natural Channels

By HARRY H. BARNES, JR.

U.S. GEOLOGICAL SURVEY WATER-SUPPLY PAPER 1849

*Color photographs and descriptive
data for 50 stream channels for
which roughness coefficients have
been determined*

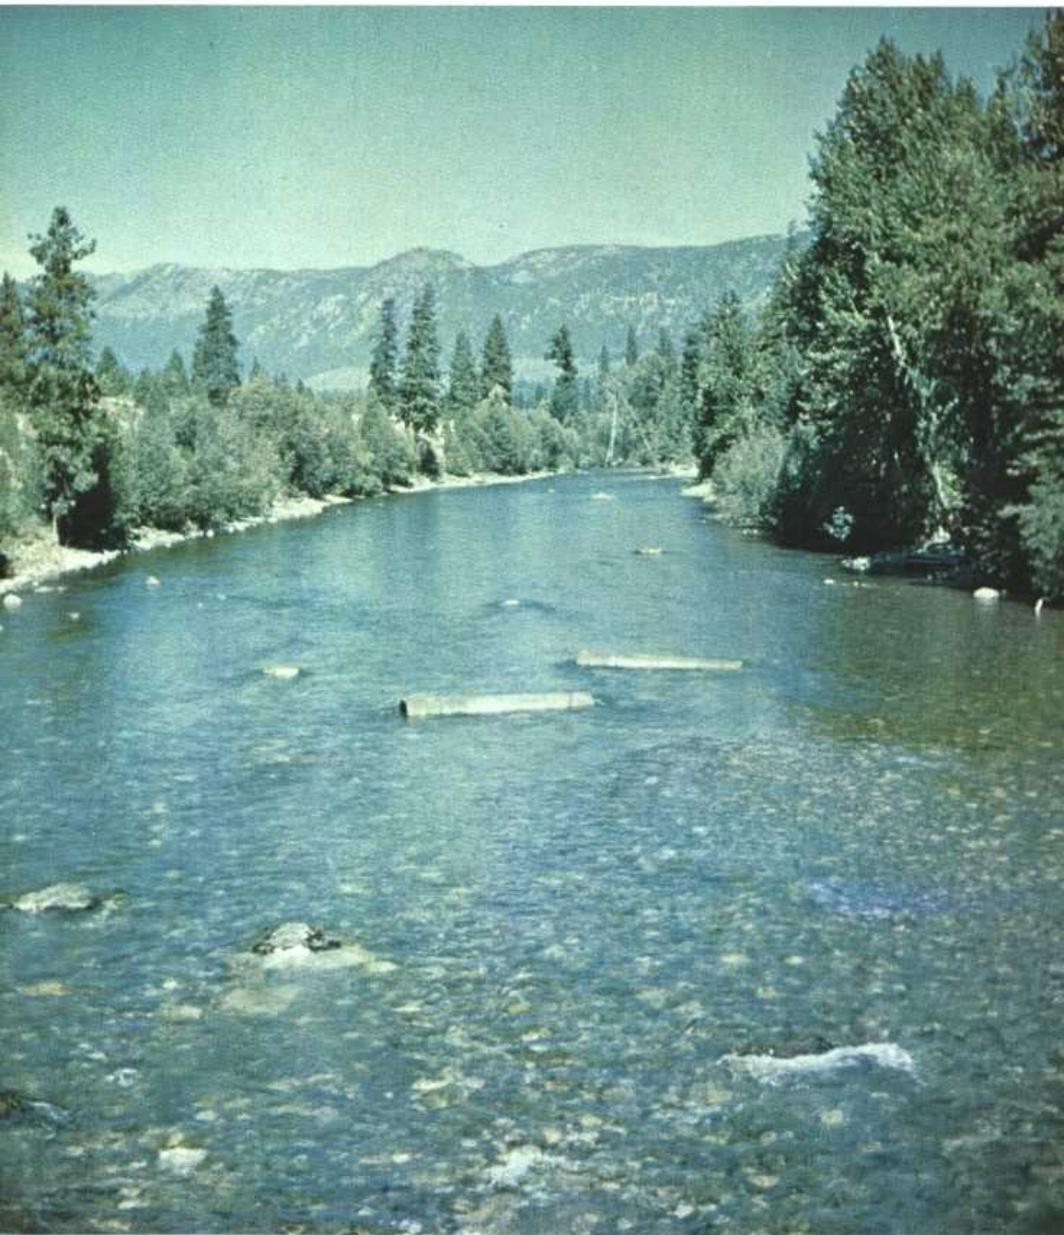
No. 169 downstream from above section 1, Wenatchee River
at Plain, Wash.

Description of channel.—Bed is boulders; $d_{50} = 162$ mm, $d_{85} = 320$ mm. Banks are lined with trees and bushes.

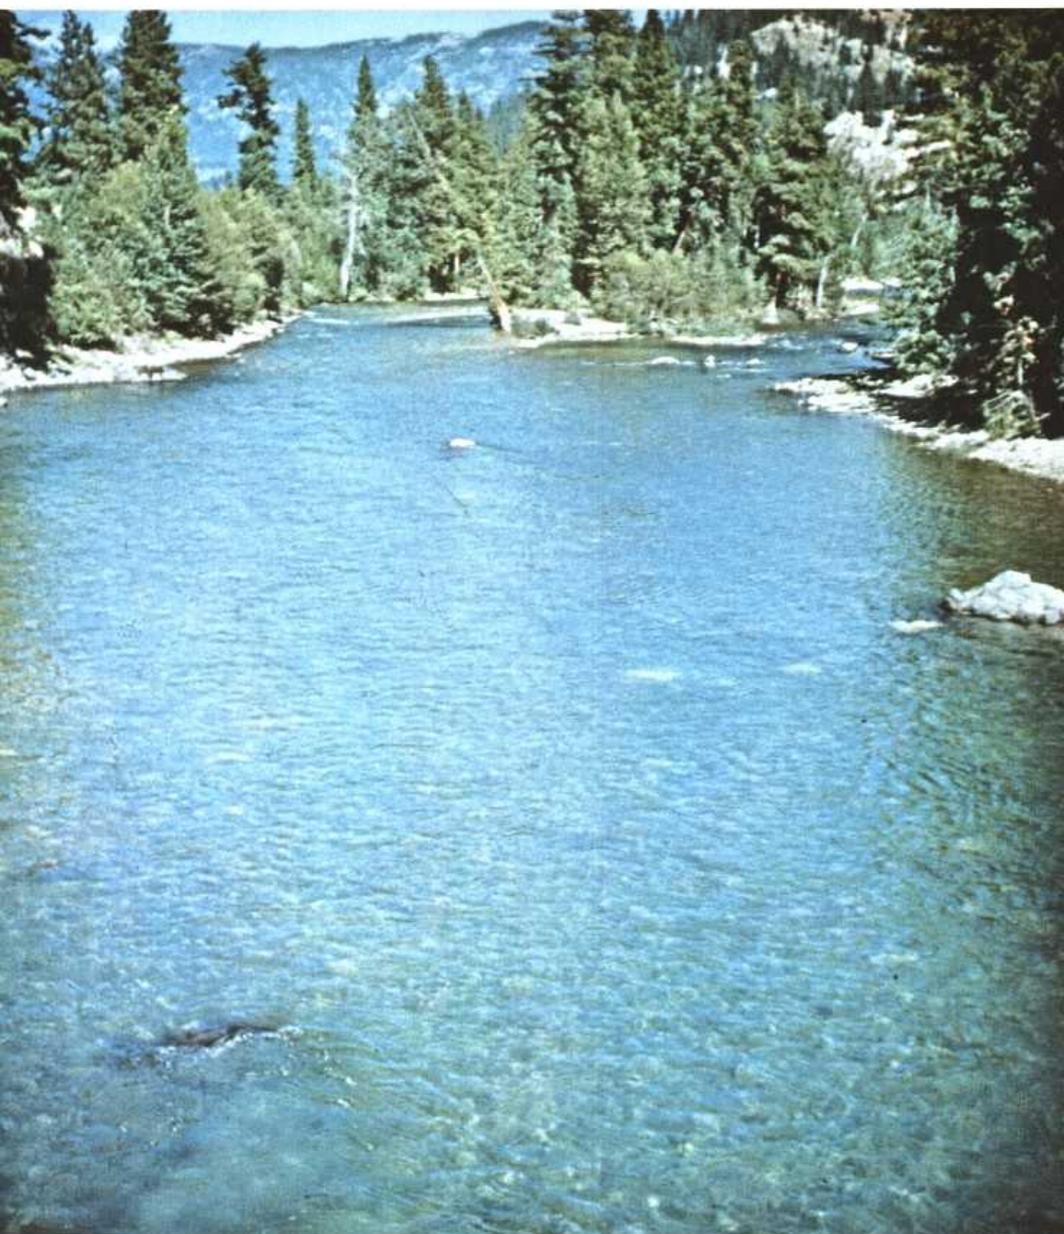
No. 173 downstream from section 2, Wenatchee River
at Plain, Wash.
