# Roughness Characteristics of Natural Channels

By HARRY H. BARNES, JR.

U.S. GEOLOGICAL SURVEY WATER-SUPPLY PAPER 1849

Color photographs and descriptive data for 50 stream channels for which roughness coefficients have been determined

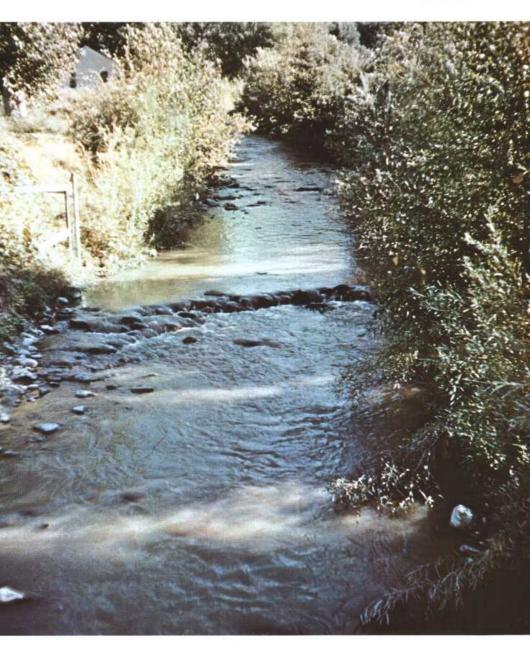
No. 1185 upstream from below section 3, Mission Creek near Cashmere, Wash.

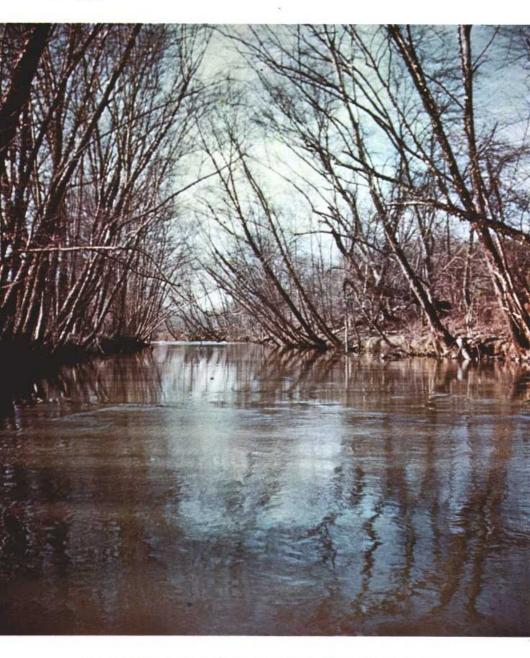
No. 1182 upstream from section 6, Haw River near Benaja, N.C.

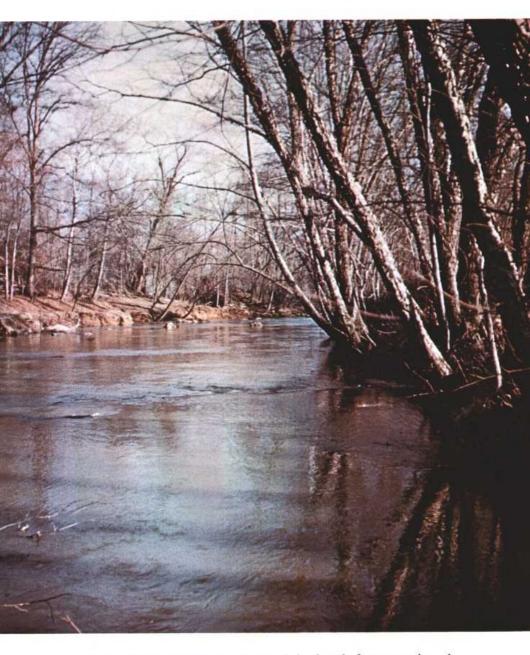
No. 1183 downstream along right bank from section 6, Haw River near Benaja, N.C.

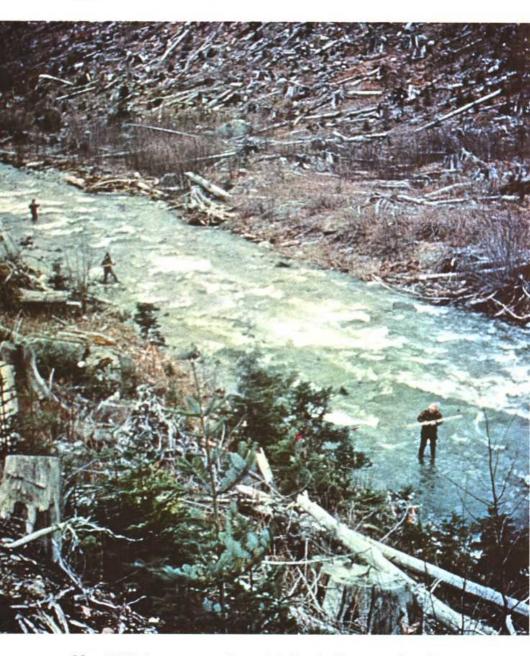
No. 1188 downstream from left bank above section 1, North Fork Cedar River near Lester, Wash.

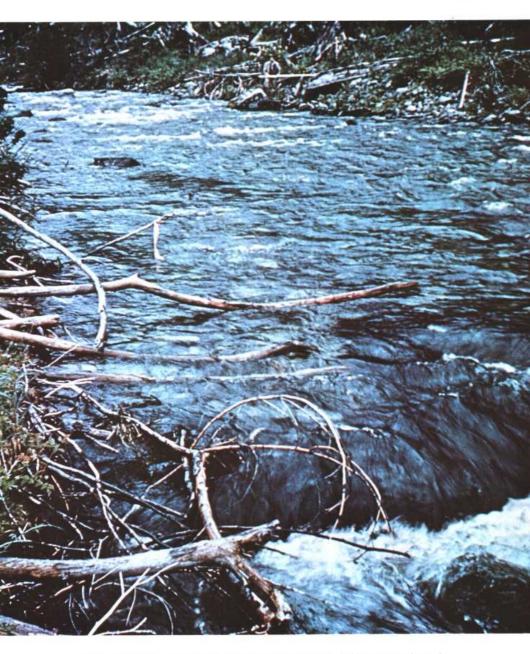
No. 1189 upstream from right bank below section 3, North Fork Cedar River near Lester, Wash.

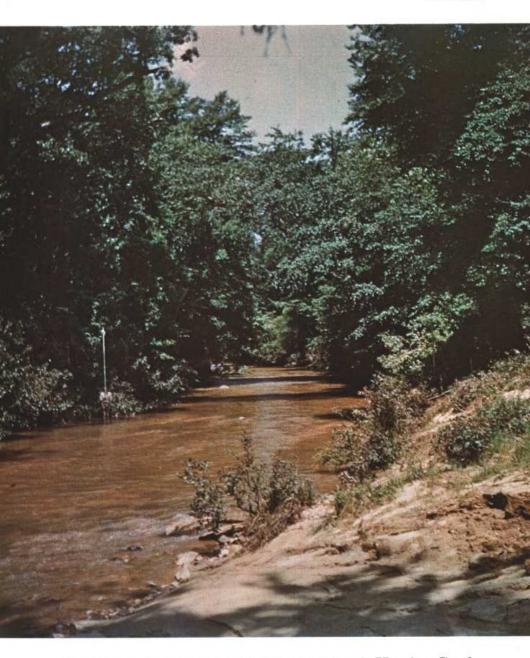
No. 432 upstream from left bank at section 3, Hominy Creek at Candler, N.C.
