Tohoku-Oki Earthquake Tsunami Runup and Inundation Data for Sites Around the Island of Hawai‘i

Open-File Report 2012–1229

By Frank A. Trusdell, Amy Chadderton, Graham Hinchliffe, Andrew Hara, Brent Patenge, and Tom Weber

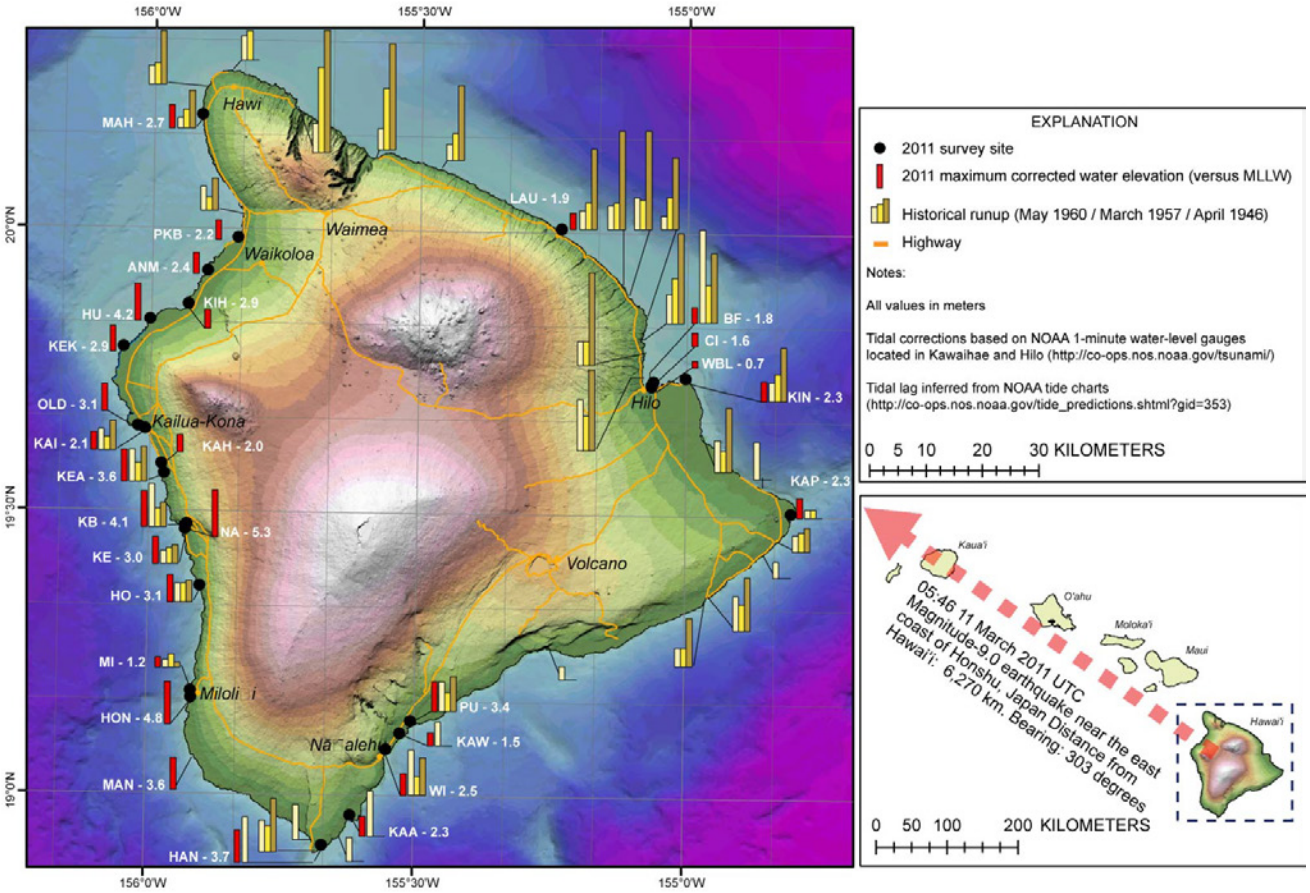
The 2011 Tohoku-Oki tsunami is unique in that it provided data for a tsunami generated from the western Pacific. Overall, the west coast of Hawai‘i Island had the highest runups (fig. 2). In places,

offshore bathymetry and (or) seaward projection(s) of the coastline appeared to funnel wave energy, creating higher runups.

Figure 2. Island of Hawai'i, showing runup data from 2011 Tohoku-Oki tsunami (red bars) in comparison with those from the 1960, 1957, and 1946 tsunamis. Earlier tsunamis arrived in Hawai'i generally from the east, resulting in higher runups on east side of island.

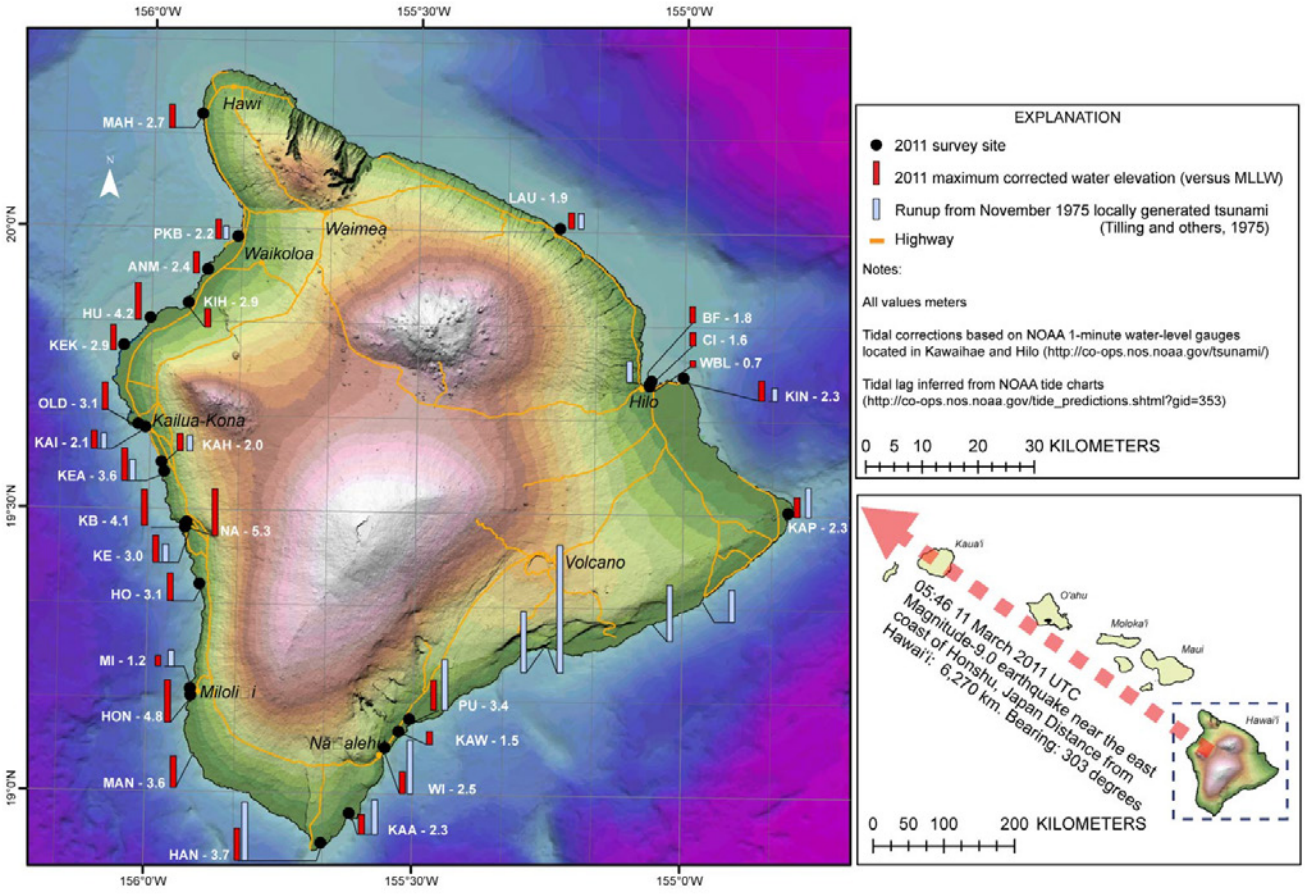
Runup data for the 2011 Japanese tsunami are compared with those from a locally derived tsunami generated by the November 1975 M 7.2 Kalapana earthquake in figure 3.

Figure 3. Island of Hawai'i, showing runup data from the 2011 Tohoku-Oki tsunami (red bars) in comparison with those from locally generated tsunami accompanying the 1975 M 7.2 Kalapana earthquake. As expected, runup from local tsunami was highest near the epicenter along the southeast coast.

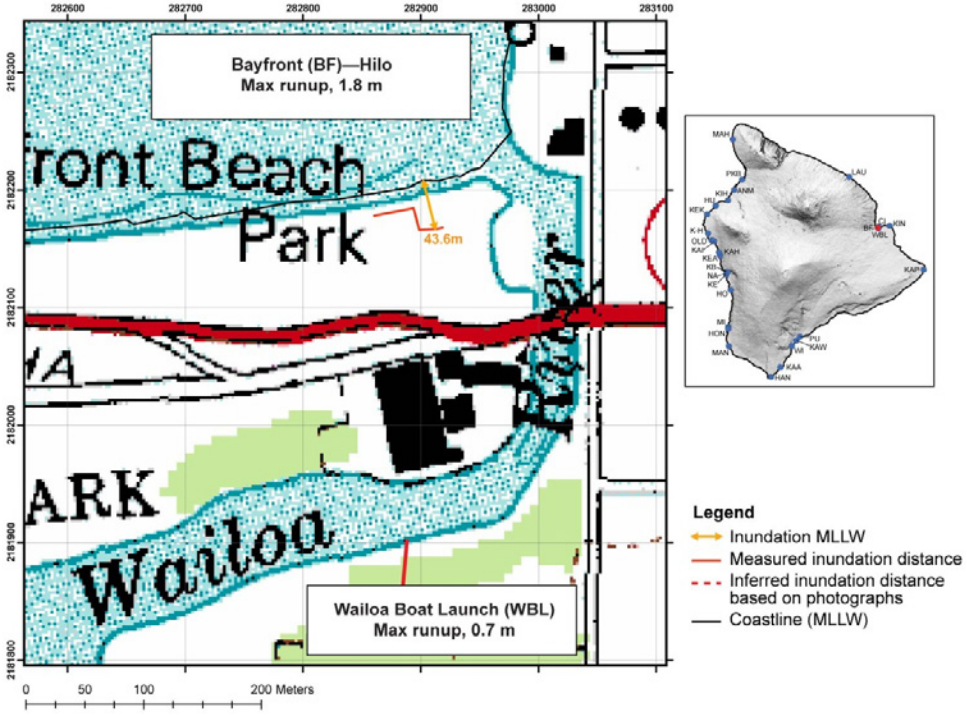
Figure B 1a. Wailoa River outlet. Area of study site near mouth of outlet; runup, 1.8 m.

Figure B1b. Debrisline near mouth of outlet near Suisan fish market in Hilo.

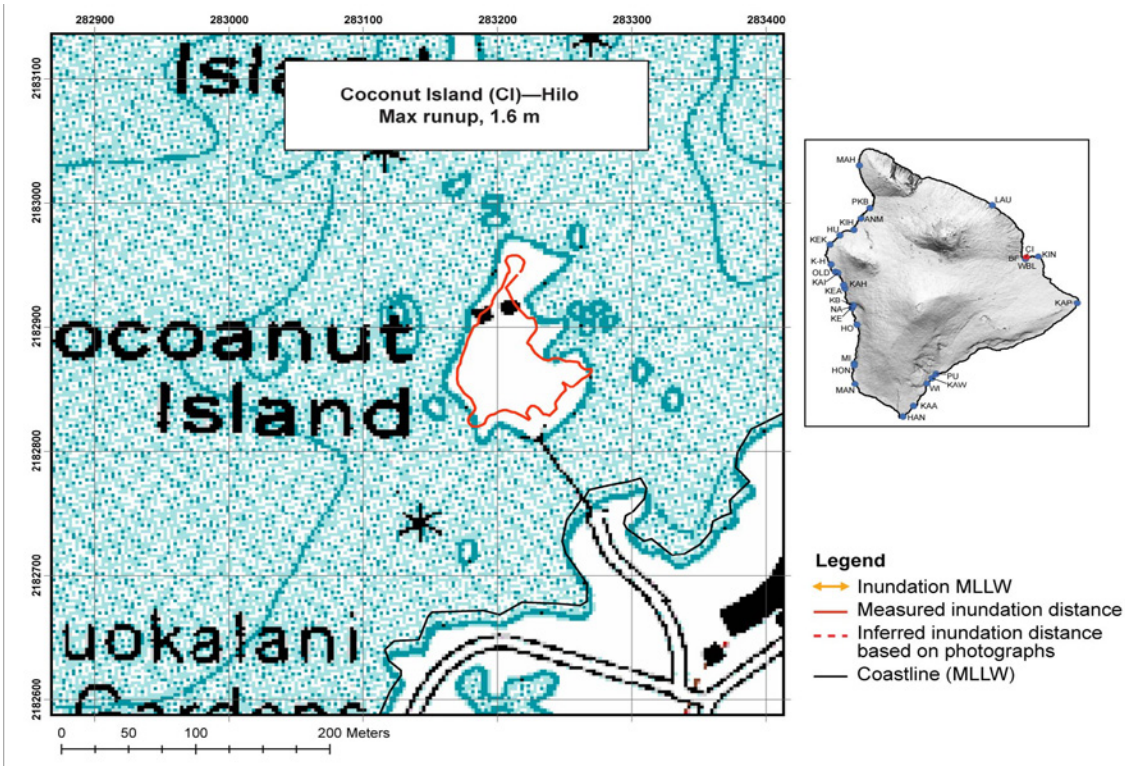
Figure B2a. Cocoanut Island (Mokuola). Area of study site near the Hilo Hawaiian Hotel in Hilo; runup, 1.6 m.

Figure B2b. Debrisline on Cocoanut (Coconut) Island (Mokuola) in Hilo.

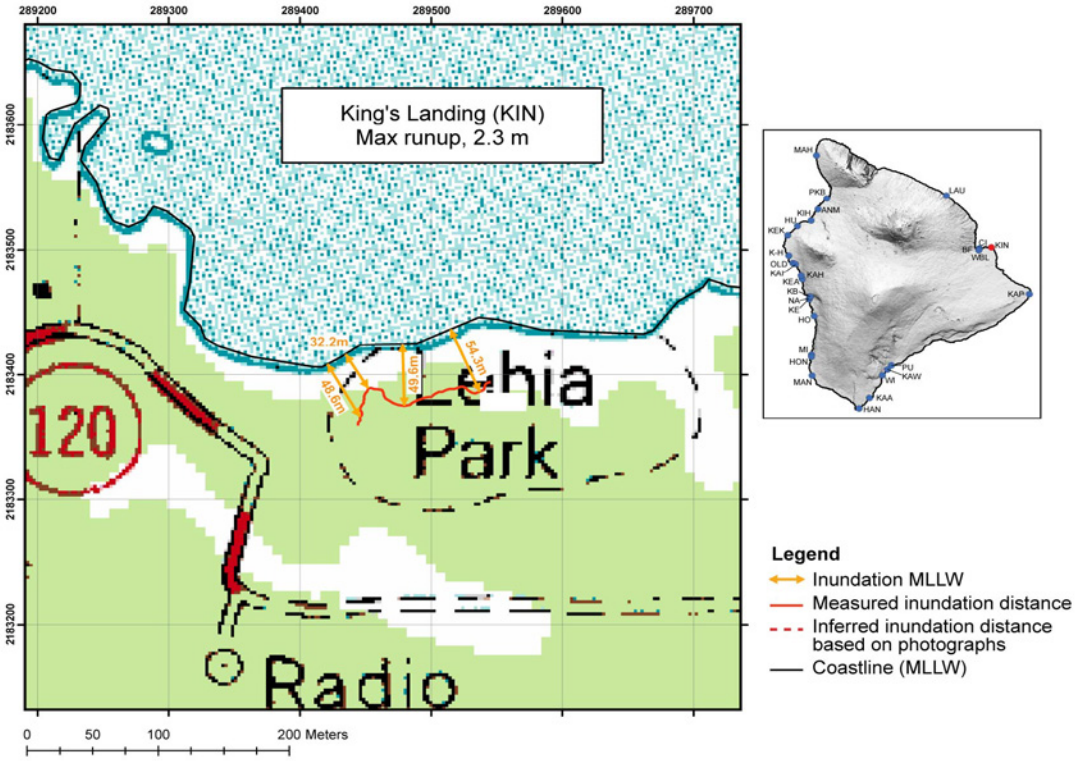
Figure B3. King's Landing, near Richardson Ocean Center, Hilo; runup, 2.3 m.

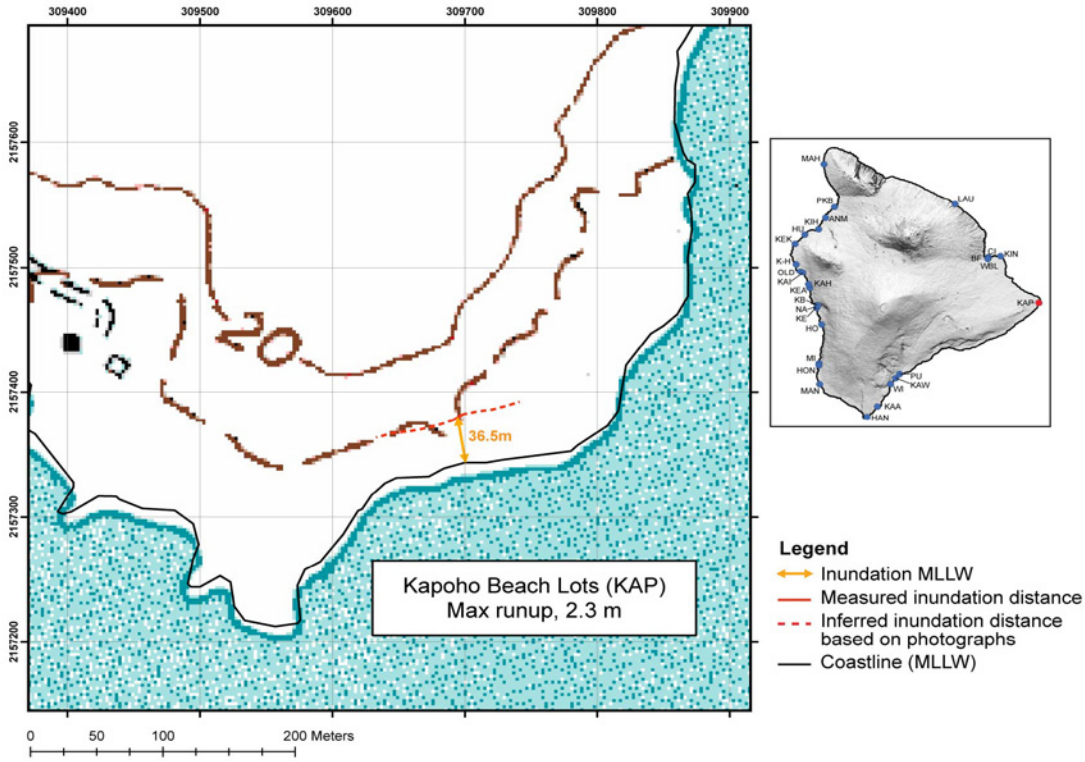
Figure B4. Kapoho Beach Lots near Cape Kumukahi, Puna; runup, 2.3 m.

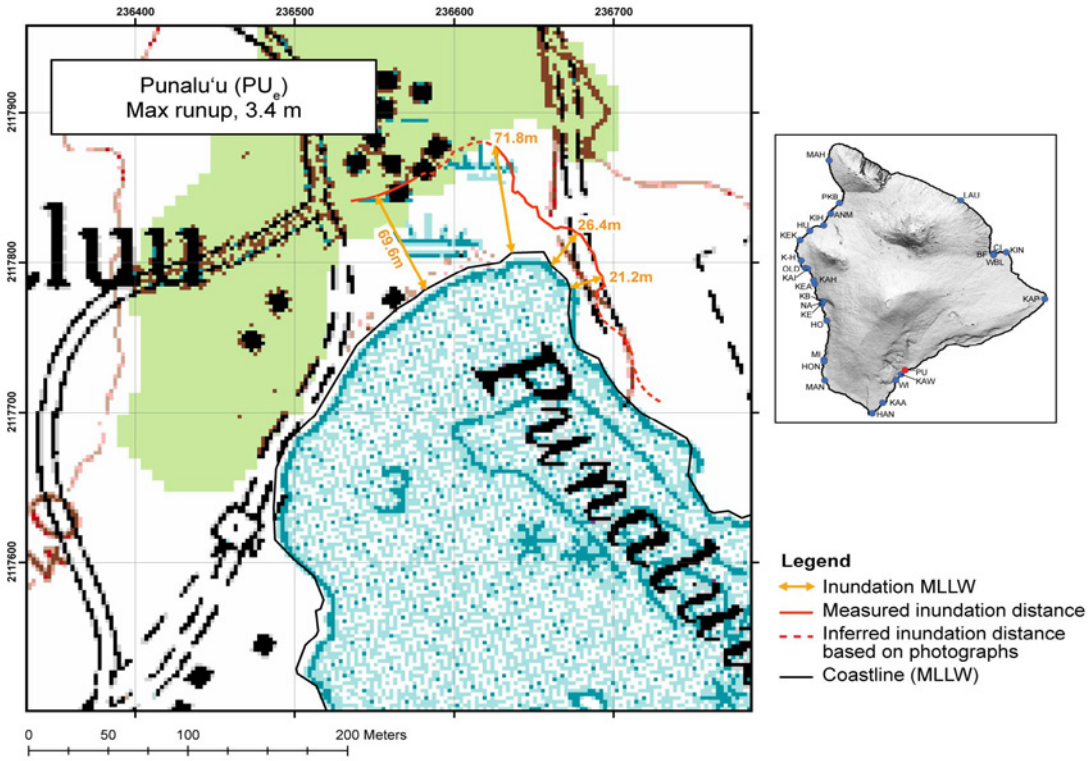
Figure B5a. Punalu'u Beach. Area of study site in Punalu'u, Ka'ū; runup, 3.4 m.

Figure B5b. Debrisline at base of coconut trees in backshore of Punalu'u Bay, Ka'ū.

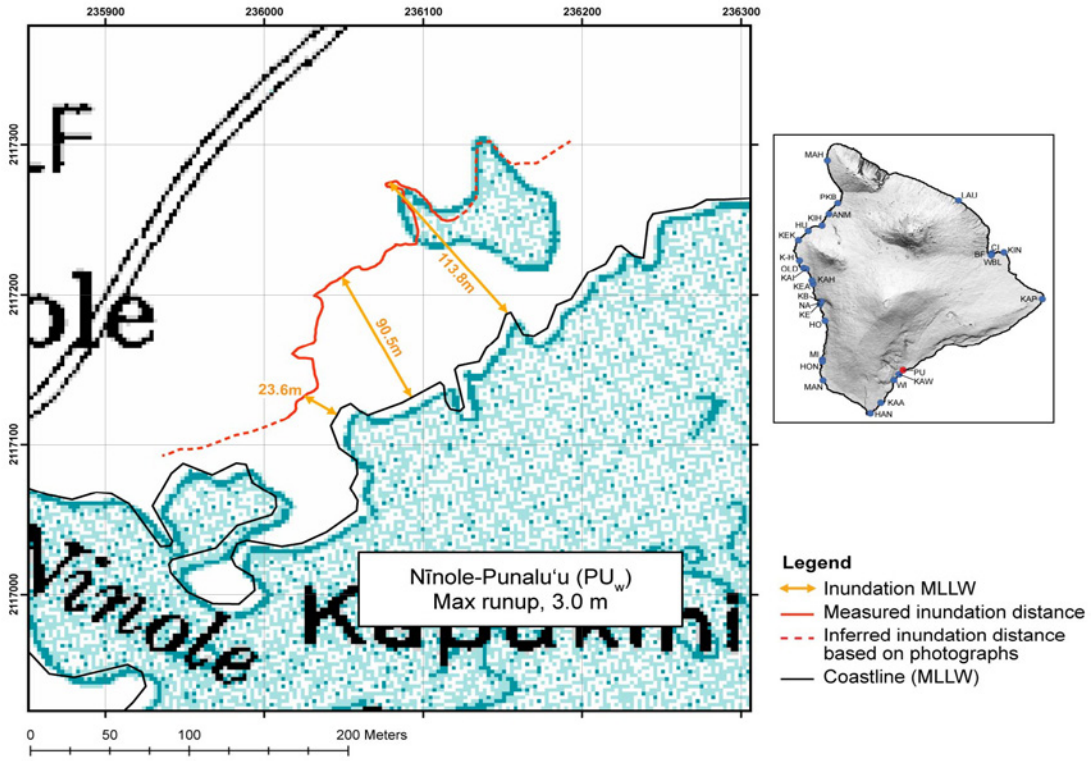
Figure B6a. Nīnole, west of Punalu'u Beach Park. Area of study site in Punalu'u, Ka'ū; runup, 3.0 m.

Figure B6b. Flowlines pressed onto grass the backshore of Nīnole, Ka'ū.

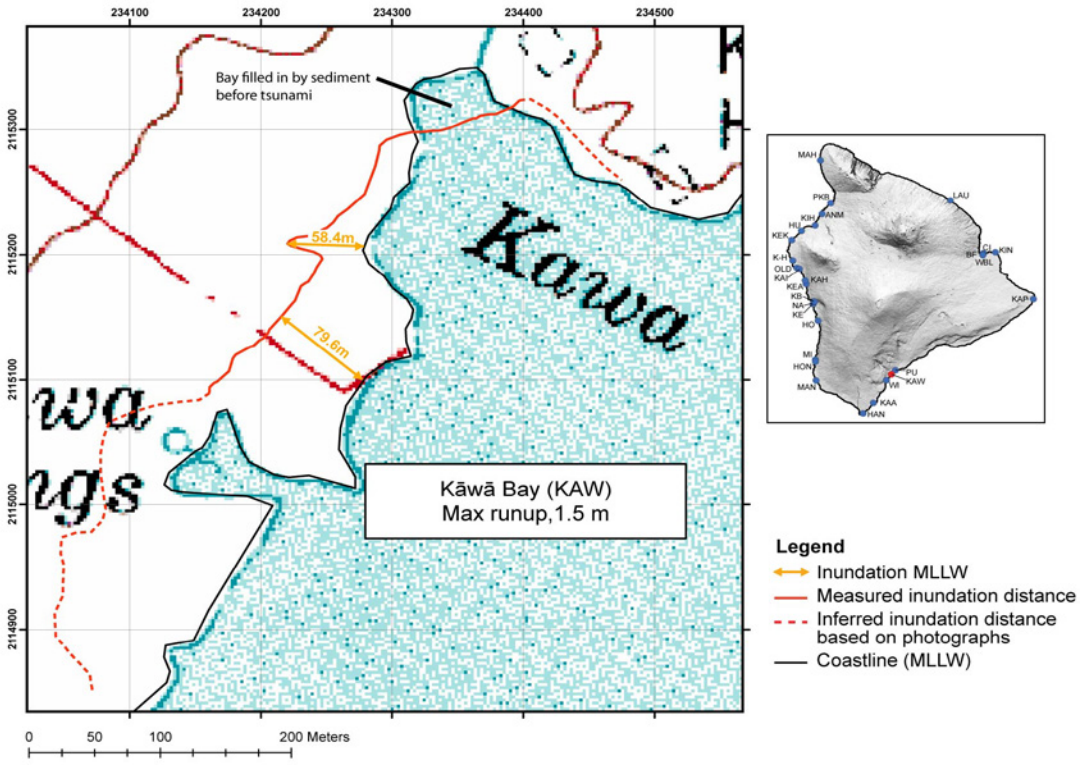
Figure B7. Kāwā, Kaʻū, showing area of study site; runup, 1.5 m.

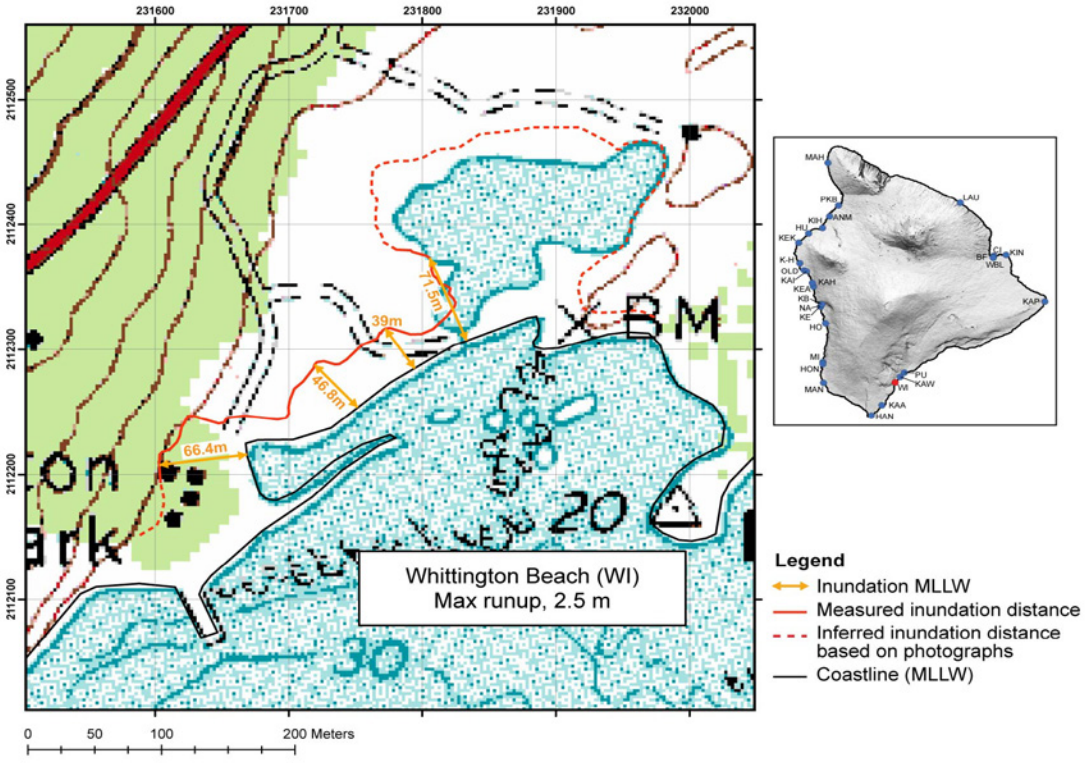
Figure B8. Whittington Beach Park, Kaʻū, showing area of study site; runup 2.5 m.

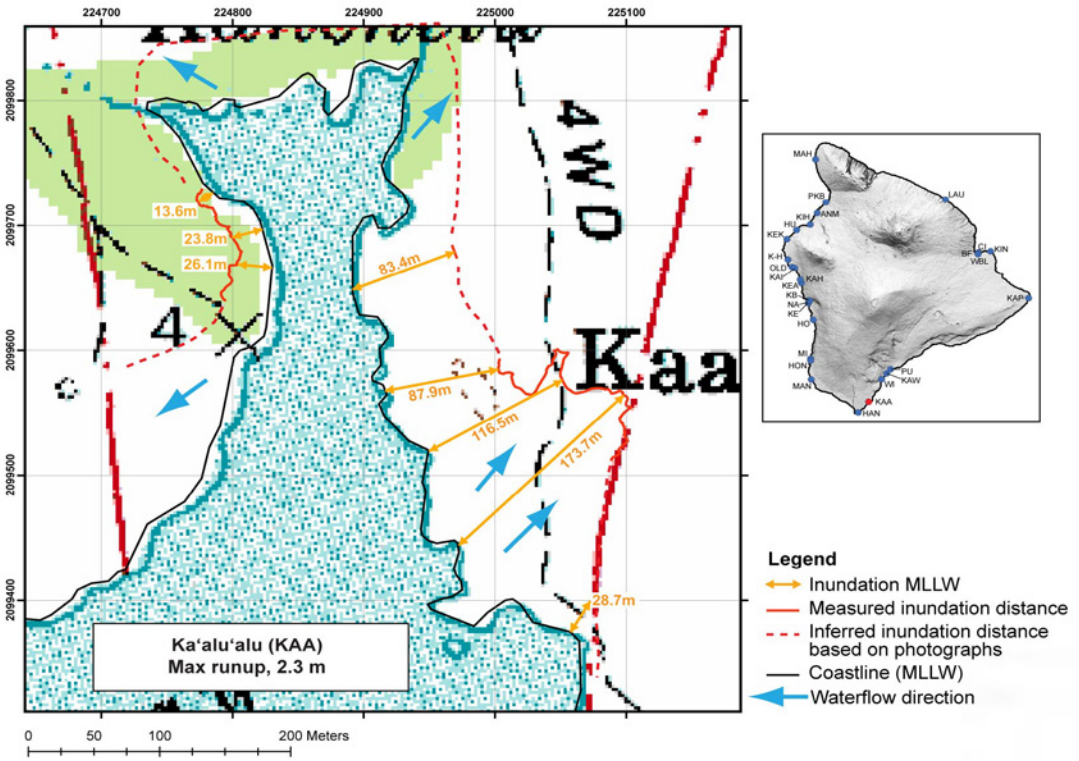
Figure B9a. Kaʻaluʻalu Bay, Kaʻū. Area of study site; runup, 2.3 m.

Figure B9b. Debrisline in backshore of Kaʻaluʻalu Bay, Kaʻū. Note shoreline nearly 200 m away, near coconut trees, in background.

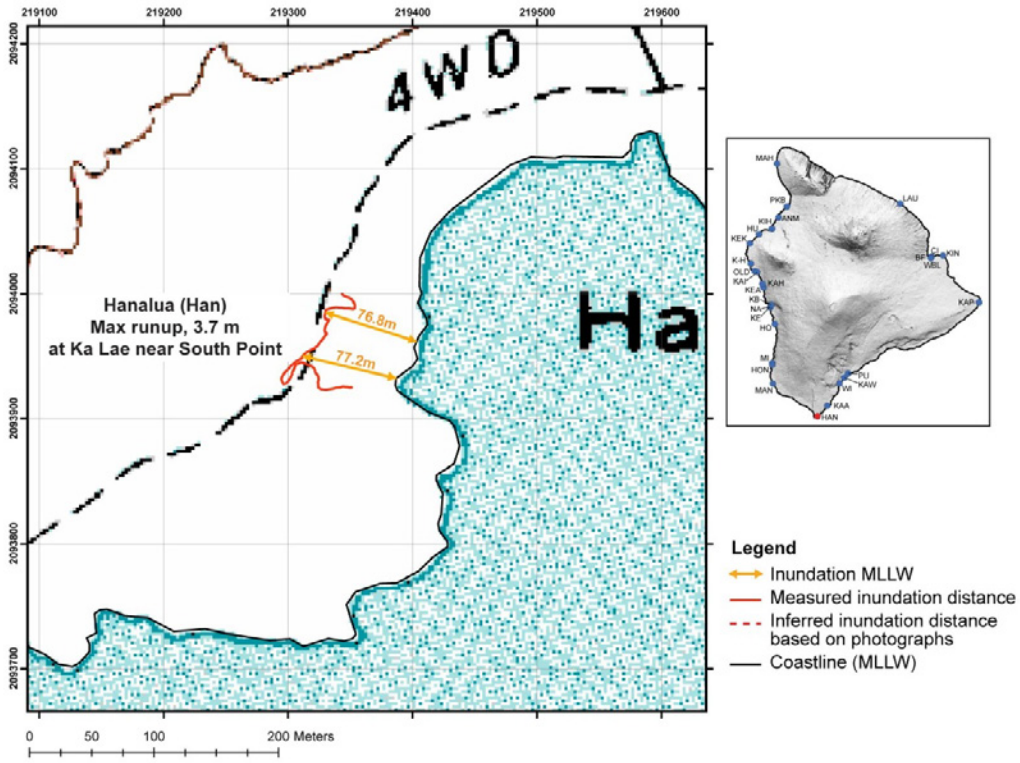
Figure B10. Hanalua Bay, showing area of study site east of South Point, Kaʻū; runup, 3.7 m.

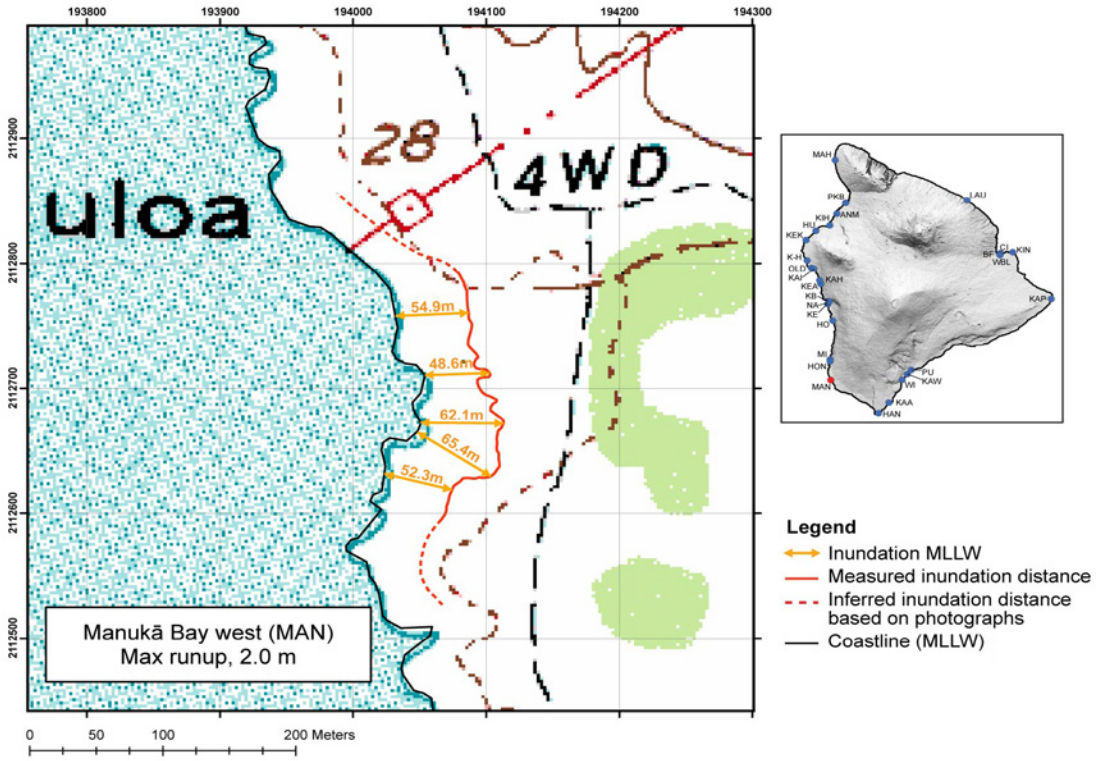
Figure B12a. Manukā Bay west, Kaʻū. Area of study site; runup, 2 m.

Figure B12b. Debrisline at Manukā Bay west, Kaʻū; runup, 2.0 m.

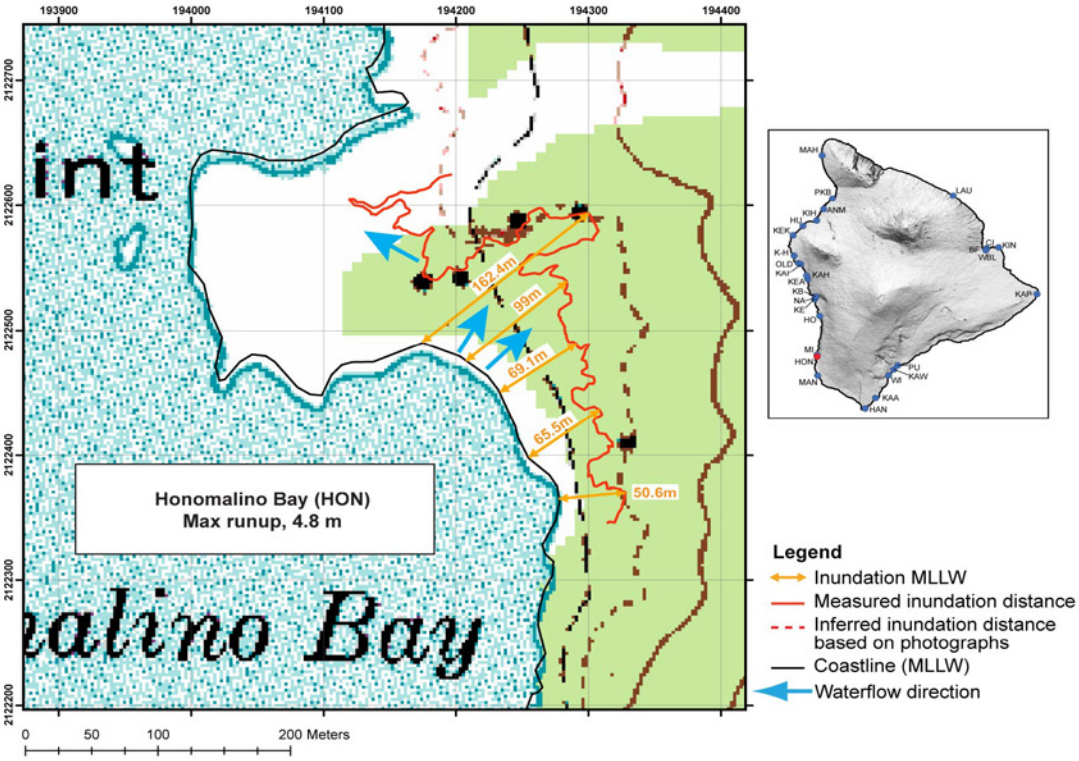
Figure B13a. Honomalino Bay, Kaʻū. Area of study site; runup, 4.8 m.

Figure B13b. Home located on northern point of Honomalino Bay, Kaʻū.

Figure B13c. Debris washed inland approximately 160 m at Honomalino Bay, Kaʻū.

Figure B13d. Signage bent by force of tsunami at Honomalino Bay, Kaʻū.

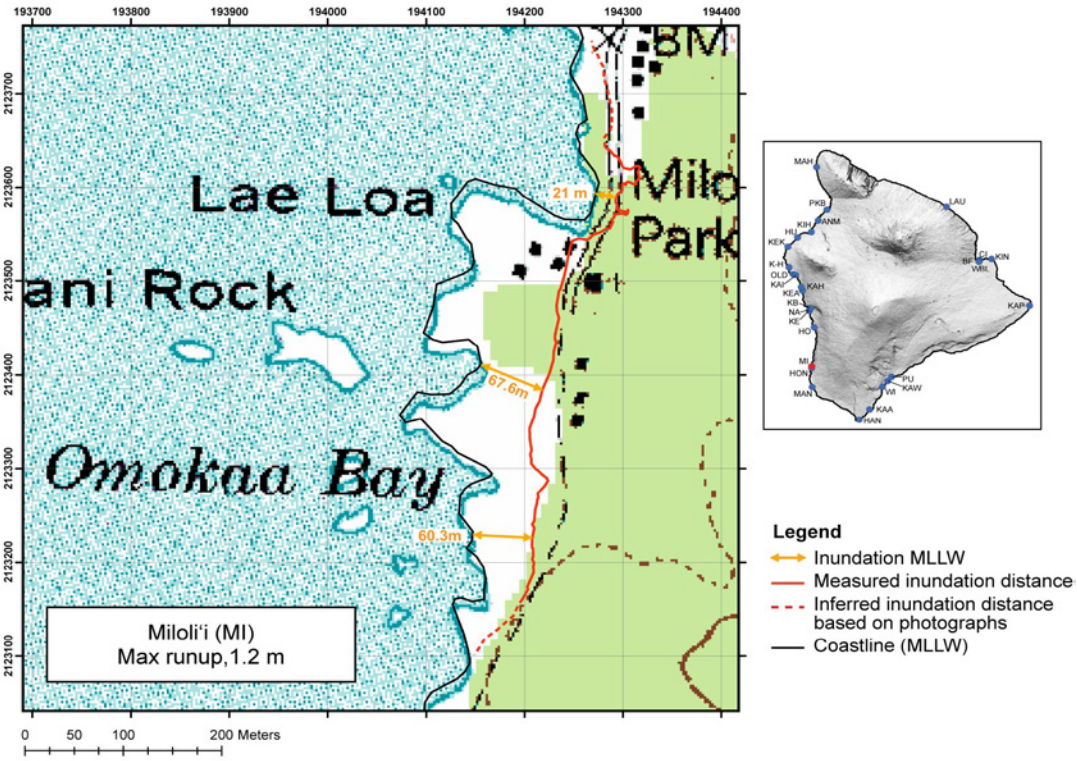
Figure B14a. Miloli‘i Beach Park, Ka‘ū. Area of study site; runup, 1.2 m.

Figure B14b. Debris from tsunami along road near Miloli‘i Beach Park, Ka‘ū.

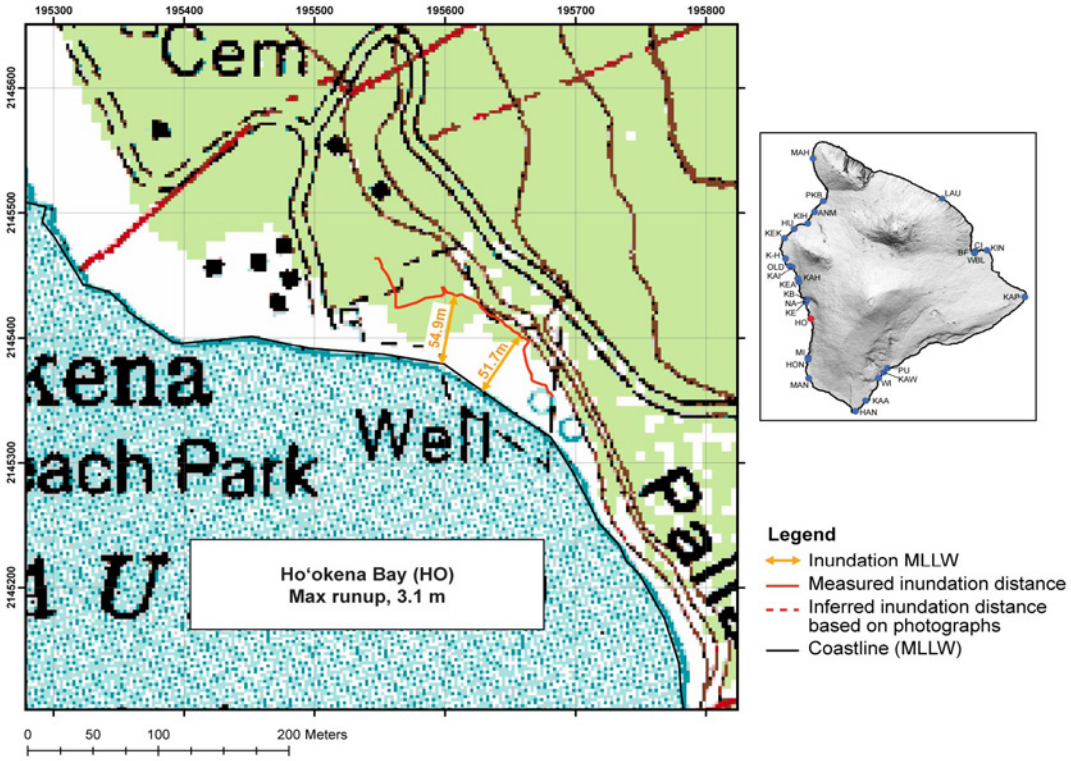
Figure B15. Ho‘okena Bay Park, Ka‘ū, showing area of study site; runup 3.1 m.

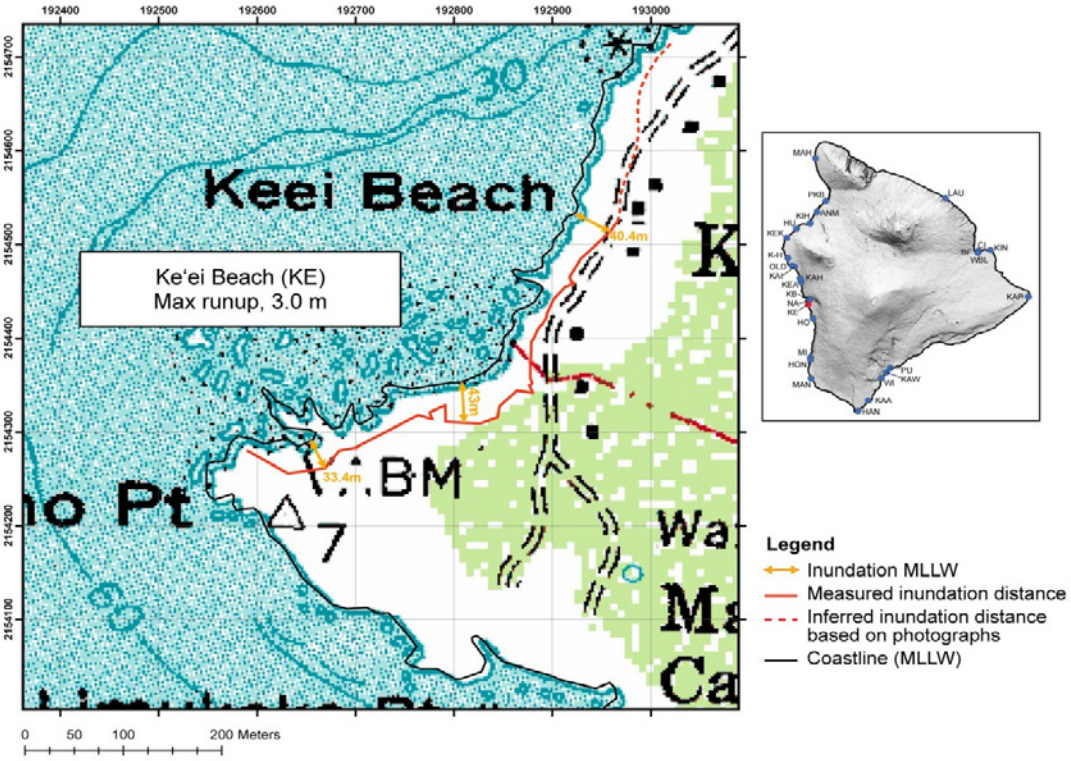
Figure B16. Ke‘ei Beach, Ka‘ū, showing area of study site; runup, 3 m.

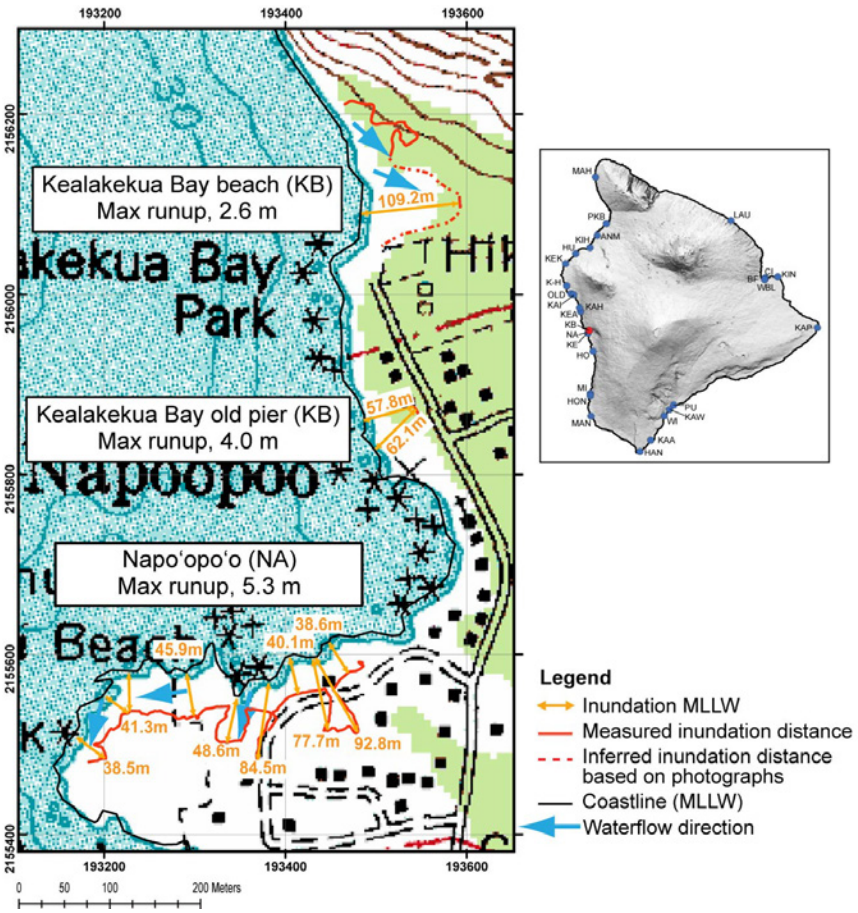
Figure B17a. Napoʻopoʻo Point and old pier and beach at Kealakekua Bay. Area of study site; runup, 5.3, 4, and 2.6 m.

Figure B17b. Vehicles swept inland at Napoʻopoʻo Point, Kealakekua Bay.

Figure B17c. Vehicles swept inland at Napoʻopoʻo Point, Kealakekua Bay.

Figure B17d. Debris swept inland at Napoʻopoʻo Point, Kealakekua Bay. Note debris pile at base of tree to left of center in photograph.

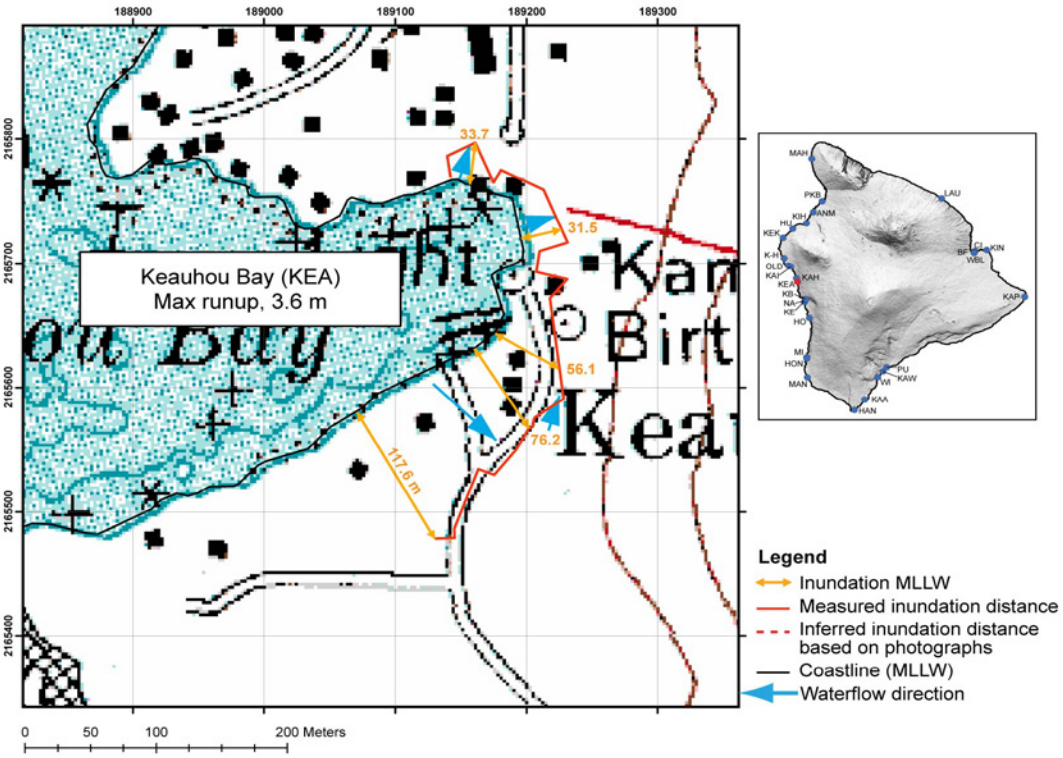
Figure B18a. Keauhou Bay, Kailua-Kona. Area of study site; runup, 3.6 m.

Figure B18b. View of Keauhou Bay outward from store. Wave reached top of vertical 2 by 4s (to right).

Figure B18c. Store-front walls breached by tsunami at Keauhou Bay. Wave reached top of vertical 2 by4s.

Figure B18d. North side of Keauhou Bay, where tsunami flooded park and washed onto roadway.

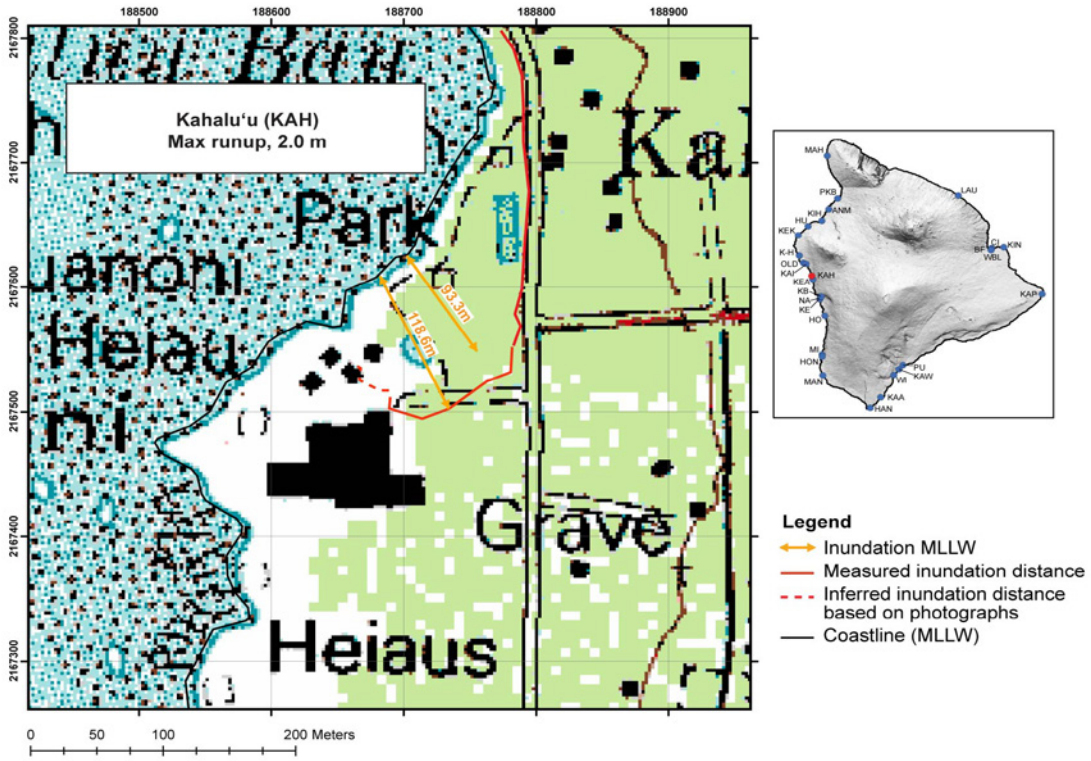
Figure B19. Kahalu'u Bay, Kailua-Kona, showing area of study site; runup, 2 m.

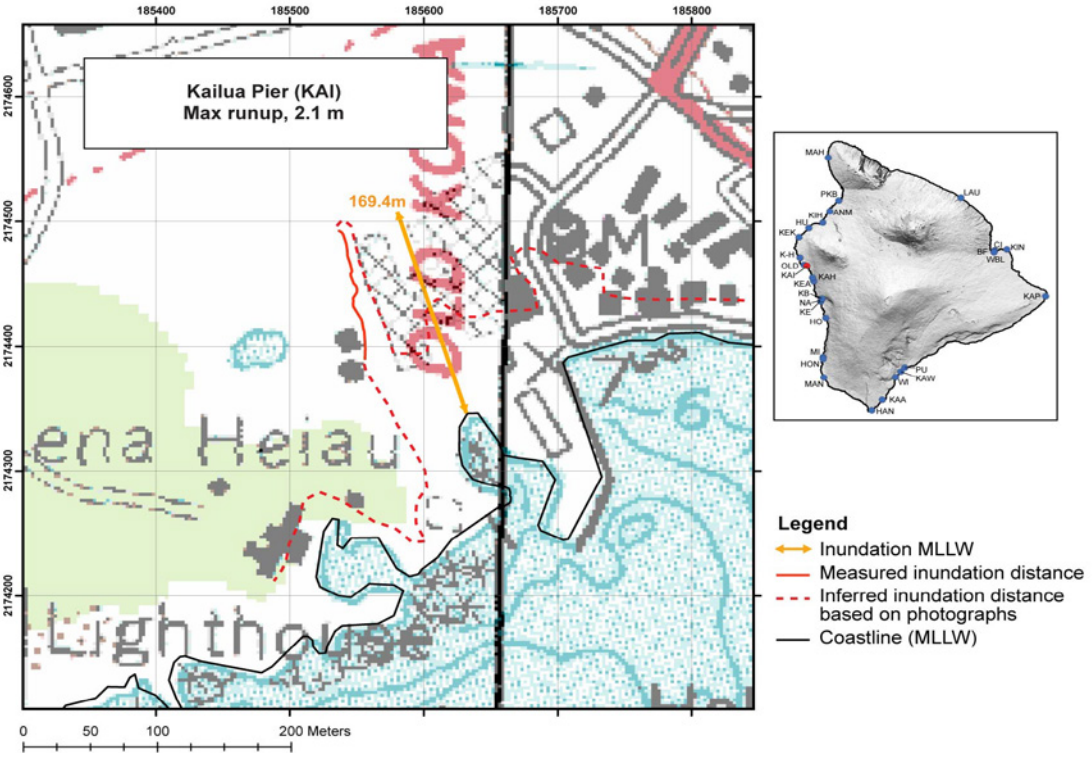
Figure B20a. Kailua Bay near the King Kamehameha Hotel, Kailua-Kona. Area of study site; runup, 2.1 m.

Figure B20b. Bar door with water-level line. Bar walls in background were breached by tsunami.

Figure B20c. Lū‘au grounds at the King Kamehemeha Hotel swept by tsunami. The Kailua pier in background was flooded by tsunami.

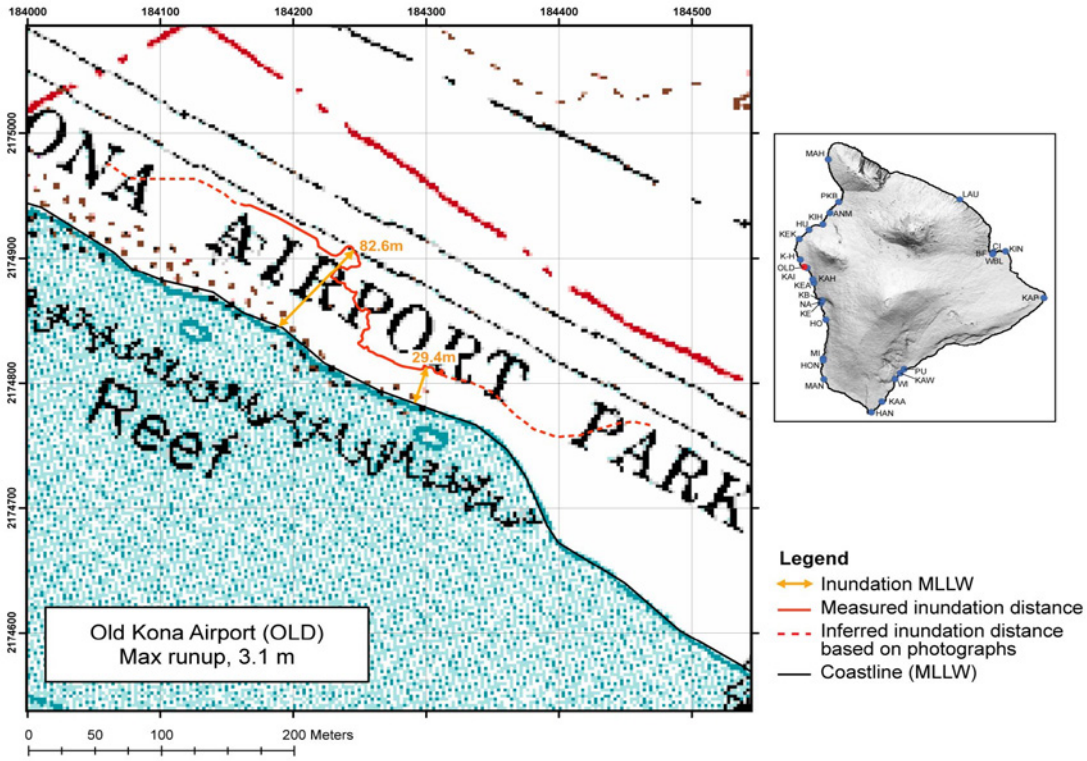
Figure B21a. Old Kona Airport Park, north of Kailua-Kona. Area of study site; runup, 3.1 m.

Figure B21b. Debrisline at the Old Kona Airport Park, north of Kailua-Kona.

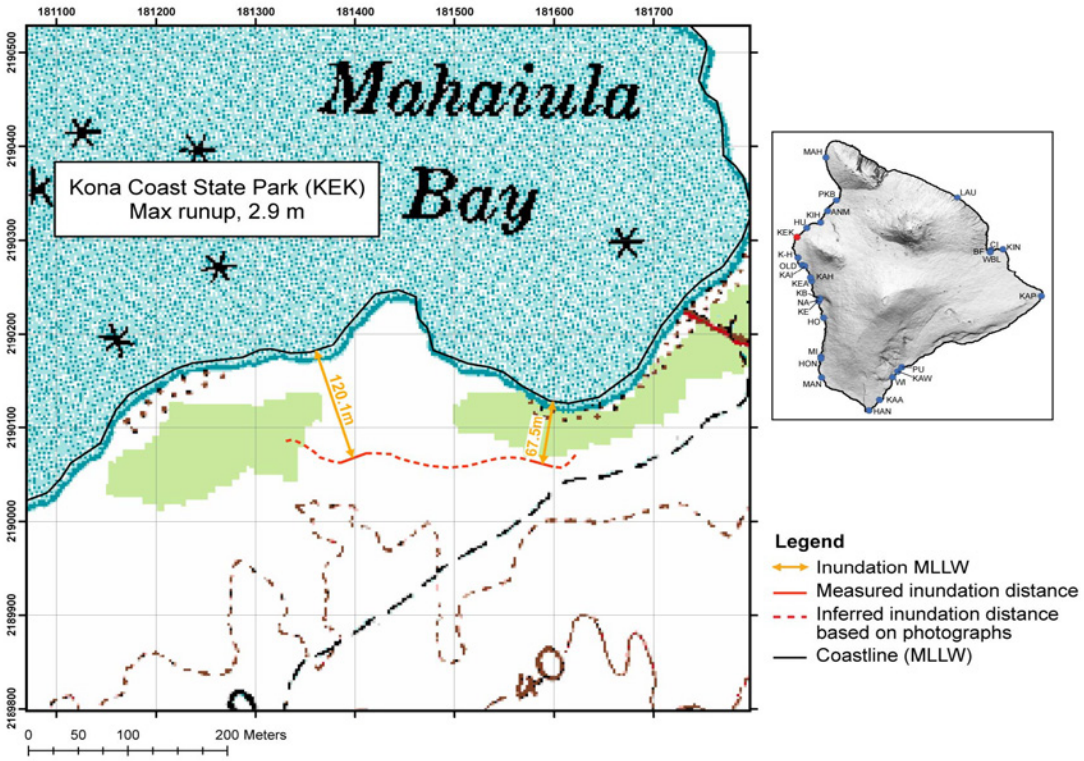
Figure B22a. Mahai‘ula Bay or Kona Coast State Park, north of the Kona Airport. Area of study site; runup, 2.9 m.

Figure B22b. Debris swept 120 m inland at Mahai‘ula Bay.

Figure B22c. Strandline at Mahai‘ula Bay.

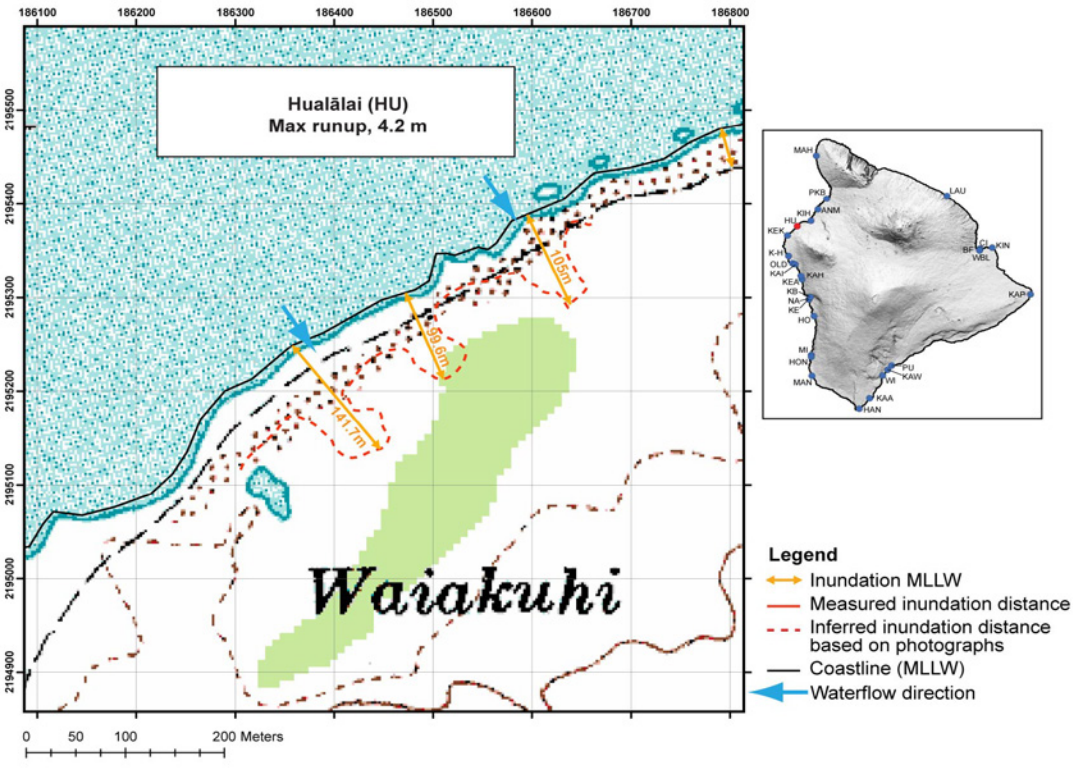
Figure B23. Hualālai resort beach at the Four Seasons Hotel, showing area of study site; runup, 4.2 m.

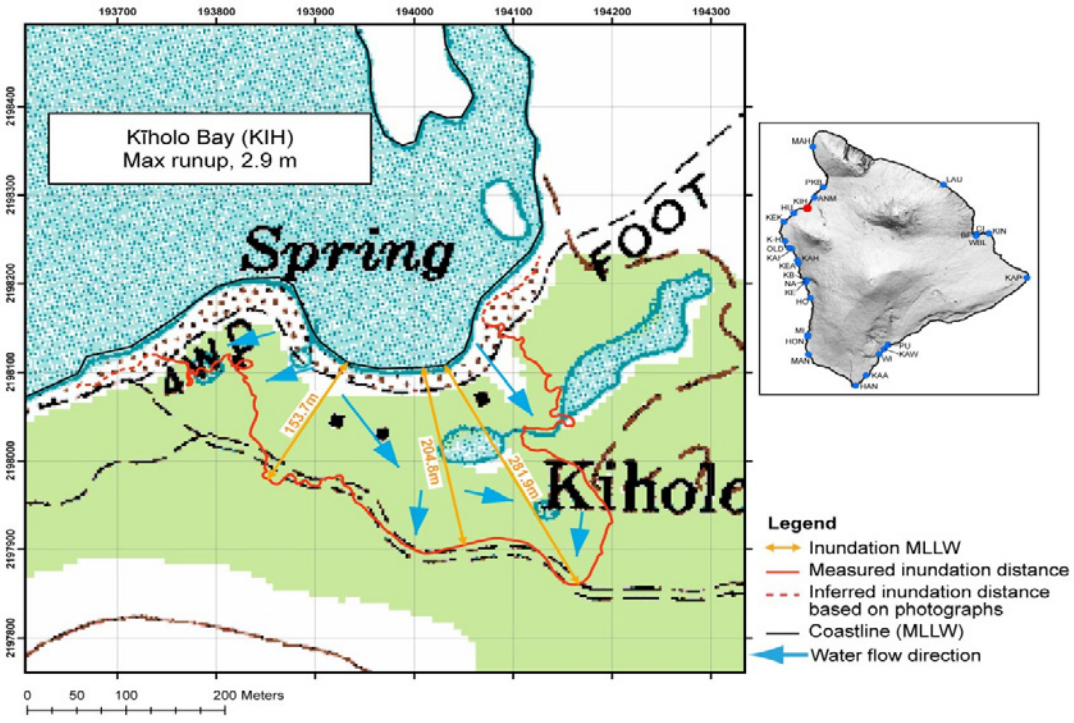
Figure B24a. Kīholo Bay, north side. Area of study site; runup, 2.9 m.

Figure B24b. Private home with breakaway walls. Structure sustained minimal damage.
