Tohoku-Oki Earthquake Tsunami Runup and Inundation Data for Sites Around the Island of Hawai‘i

Open-File Report 2012–1229

By Frank A. Trusdell, Amy Chadderton, Graham Hinchliffe, Andrew Hara, Brent Patenge, and Tom Weber

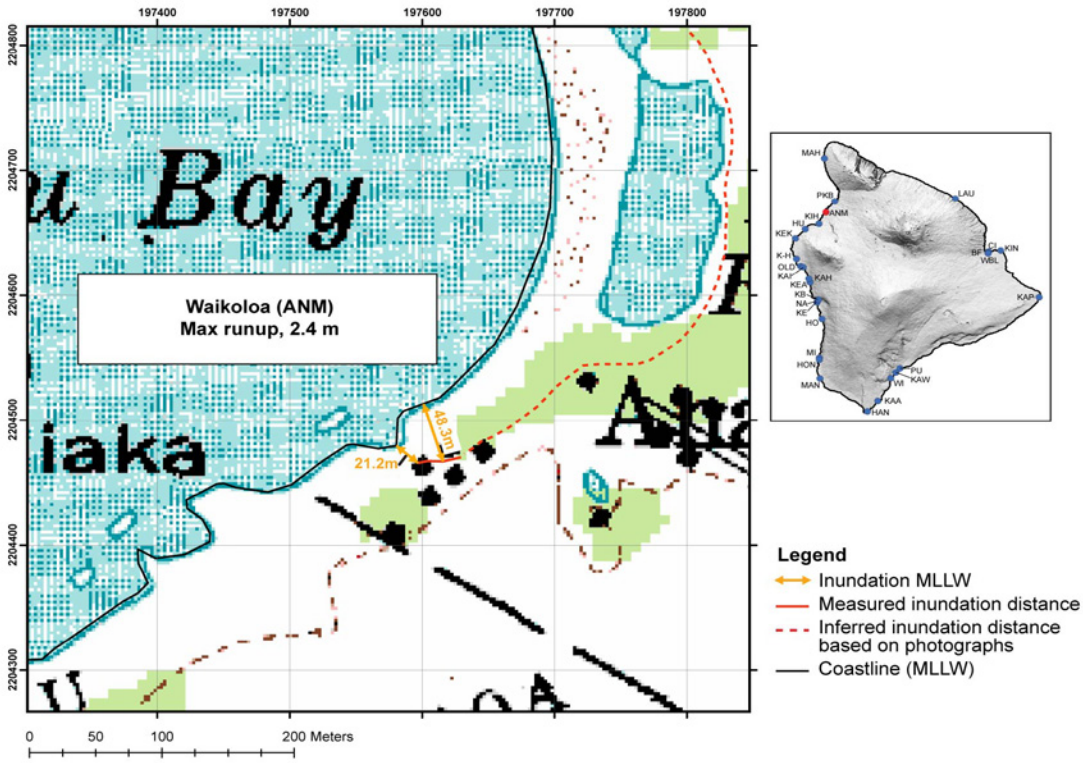
Figure B25a. Anaehoʻomalu Bay, Waikoloa. Area of study site; runup, 2.4 m.

Figure B25b. Fishpond breached by tsunami. View northward.

Figure B25c. Fishpond breached by tsunami. View northwestward.

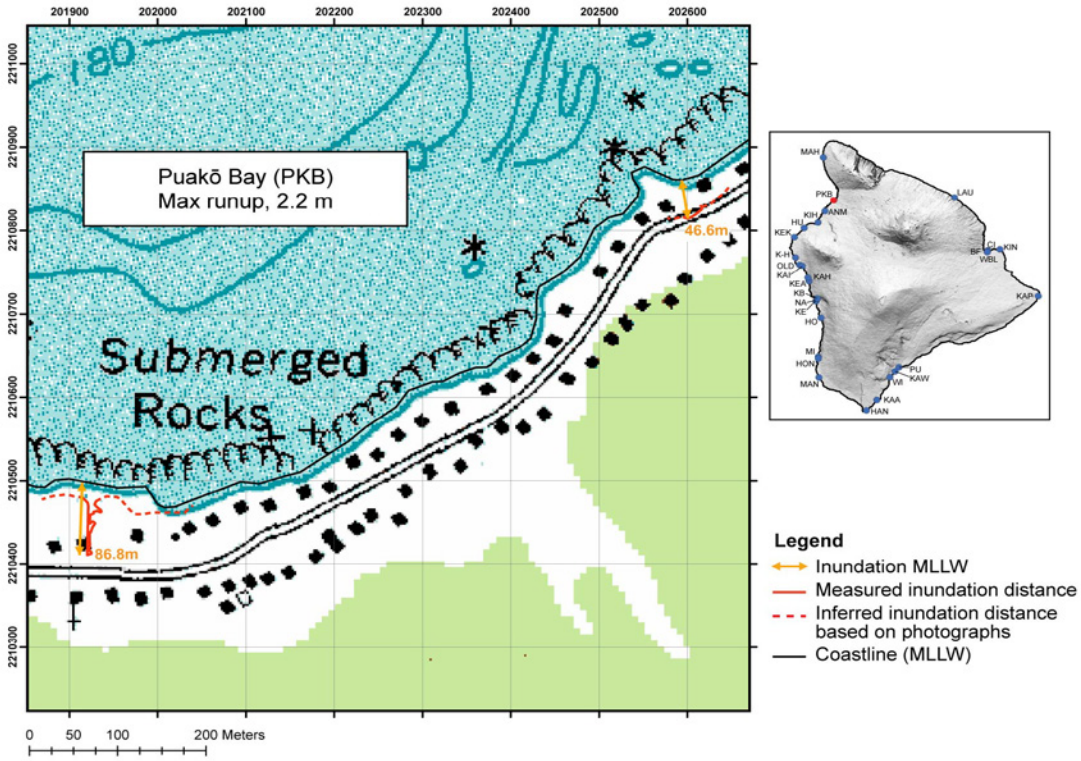
Figure B26a. Puakō Bay, North Kona. Area of study site; runup, 2.2 m.

Figure B26b. Debris swept inland on beach right-of-way at Puakō.

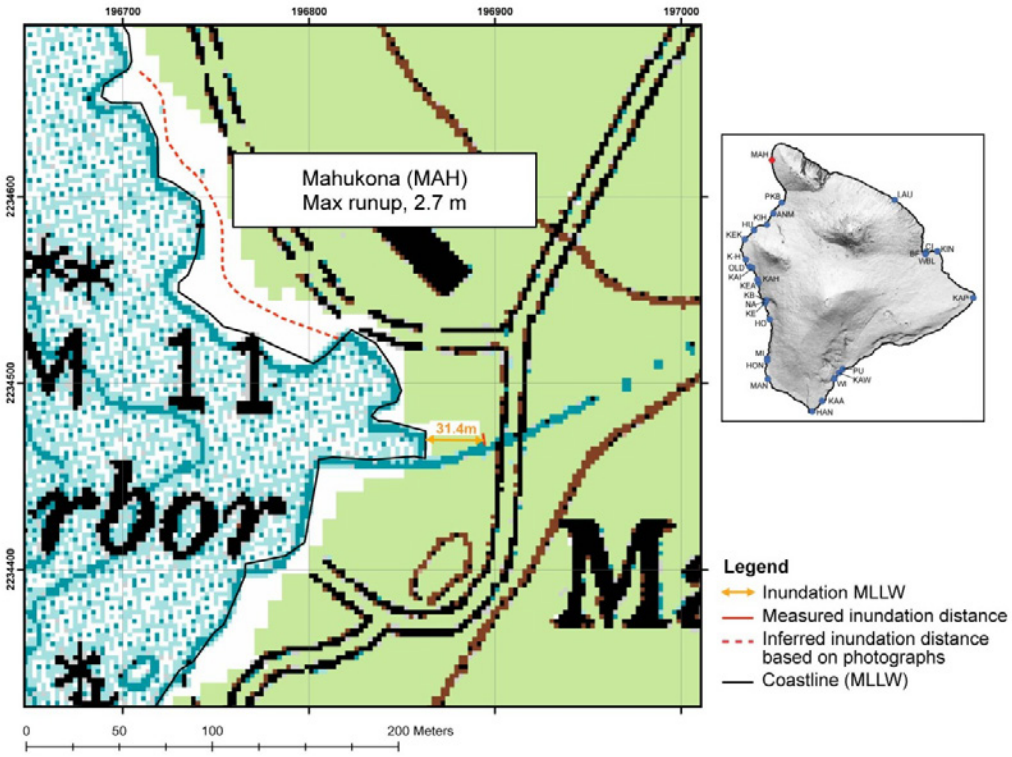
Figure B27a. Mahukona Harbor, Kohala. Area of study site; runup, 2.7 m.

Figure B27b. Debris swept inland up drainage ditch near old wharf at Mahukona Beach Park.

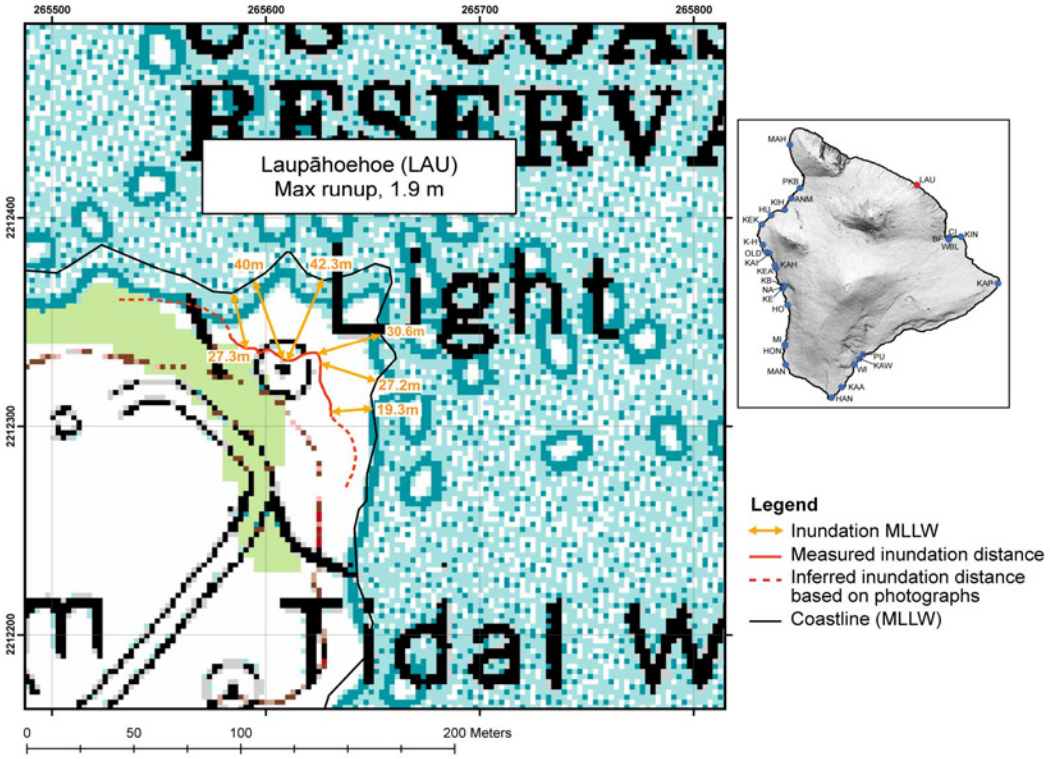
Figure B28a. Laupāhoehoe Point, at Laupāhoehoe Beach Park, north Hilo. Area of study site; runup, 1.9 m.

Figure B28b. Debris swept inland at Laupāhoehoe Point.
