Memorandum

Subject: Red Cub Mining Company
Curry County, Oregon
Docket DMA-1435

MAP SHOWING GEOLOGY, SURFACE AND UNDERGROUND WORKS

SOUTH END OF RED CUB PROPERTY
CURRY COUNTY, OREGON

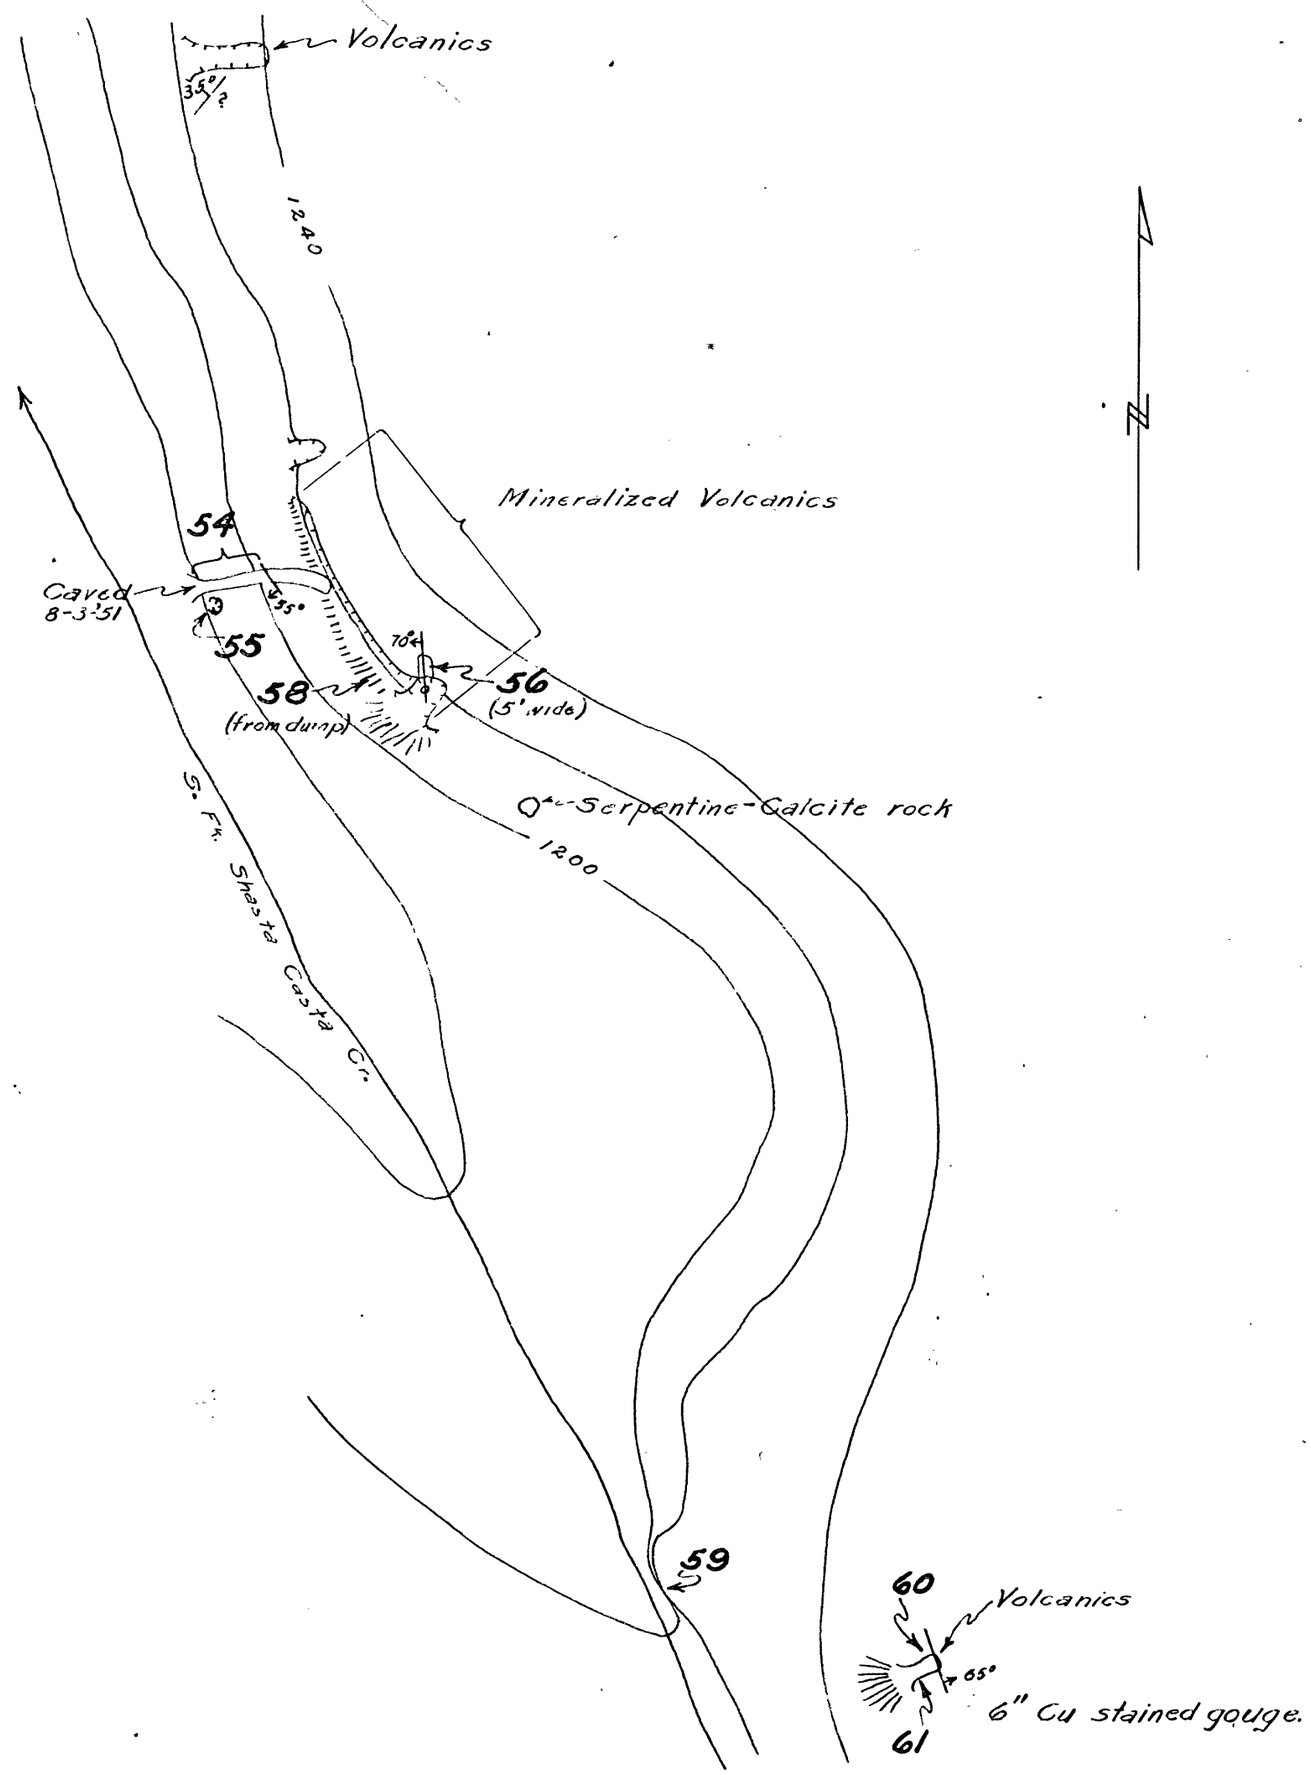
I would say that the samples as shown on the Bureau map, and on the map of this report, were not taken across the zones of most intense sulphide mineralization.

The ore is confined to shear zones in what are probably metamorphosed volcanics. The volcanics have been intruded by small stringers of quartz diorite. On the south end of the property (see map) a zone about 120 feet wide has been opened by a shallow hillside cut. This zone has been hydrothermally altered and bleached in places. The zone cannot be traced along the strike because of overburden. In claims just on the south side of Shasta Costa Creek two mineralized zones, one 50 feet wide, one over 200 feet wide, outcrop about 300 feet above the creek. The continuation to the north or south along the strike cannot be determined because of cover. There is sulphide min ralization on the slope north of Shasta Costa Creek also.

The workings which I saw were restricted to 3 small cuts and a 20-foot adit on the south end of the property. A somewhat longer adit, now caved, is also present in this area. (see map) Although adits of considerable length have been reported as present at the north end of the property, the company's engineer has not been able to locate them. He suggested that they may be covered by slides. There are several small pits in the center of the property, but, according to Mr. Smith, none of them reached bedrock.

52 · Bureau of Mines Sample Cu 0.05 %
(from end of caved adit)

53 · Bureau of Mines Sample Cu less than 0.02 %
(from stringer in caved adit)

54	Bureau	of Mines	Sample	Cu	0.28 %
55	"	"	"	Cu	0.11 %
56	"	"	"	Cu	0.72 %
58	"	"	"	Cu	8.52 %
59	"	"	"	Cu	less than 0.1 %
60	"	"	"	Cu	13.48 %
61	"	"	"	Cu	0.11 %
