EFFECTS OF COAL MINE SUBSIDENCE IN THE SHERIDAN, WYOMING, AREA

GEOLOGICAL SURVEY PROFESSIONAL PAPER 1164

By C. RICHARD DUNRUD *and* FRANK W. OSTERWALD

A summary of geology, subsidence, and other effects of past and present mining as related to the environment, coal resource management, and land use

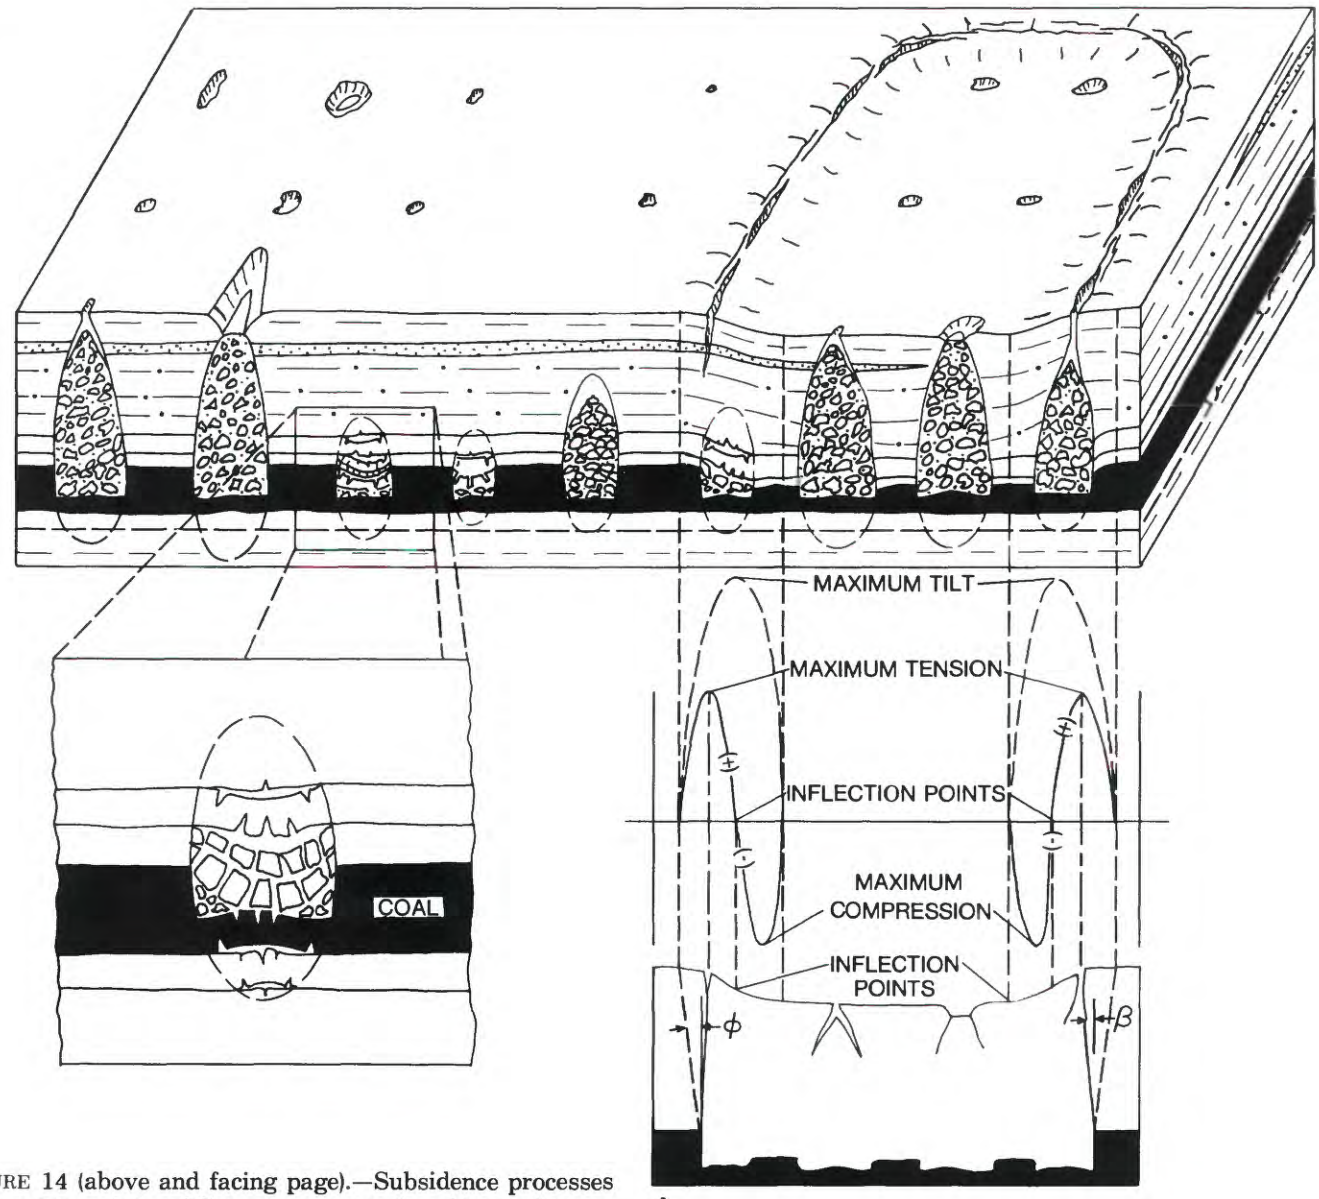
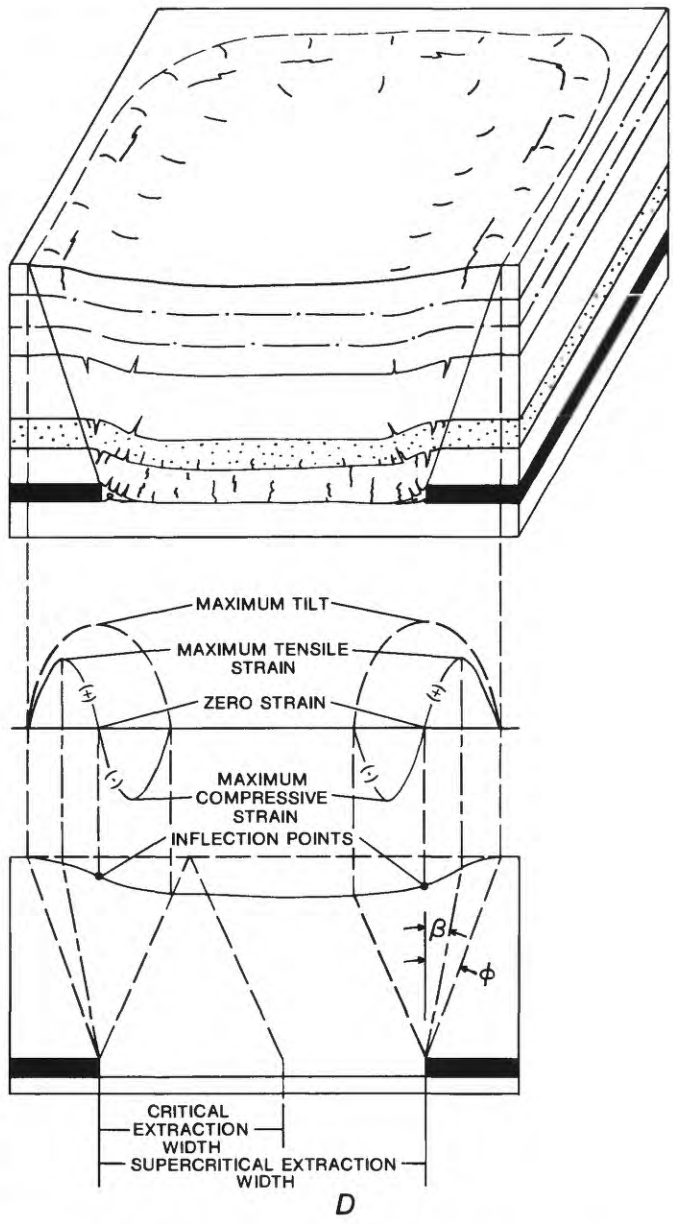
FIGURE 14 (above and facing page).—Subsidence processes caused by mining different amounts of coal beneath overburden of different strengths and thicknesses. *A*, Block diagram showing subsidence pits above caved mine openings where adjacent coal is sufficiently strong to support the weight of the overburden (left), and subsidence depressions and subsidence pits where the remaining coal yielded partially to the weight of the overburden (right). An enlarged view of the elliptical zone of compressive stress around a rectangular mine opening shows buckled and heaved floor and caved roof rocks that are common in zones of reduced stress within the zone of compression. Subsidence pits, which are the end result of successive collapse of the mine roofs, are deeper where no subsidence depression occurs than are pits within the depression. A plot of tilt, horizontal displacement, curvature, and strain caused by differential settlement is shown below the subsidence depression on right. ϕ, limit or draw angle; β, break angle; +, tensile strain; −, compressive strain. *B*, Caved opening above an entry in the Riverside mine (fig. 4) exposed on a surface mine cut (May 1978).Bedrock is soft, silty claystone with local thin carbonaceous zones. Entry is estimated to be about 3 m wide. The original height of the entries reportedly was about 2 m; the current limit of caving is about 9.5 m above the mine floor. *C*, Caved opening of an entry in the southern part of the

Acme mine (fig. 4) (January 1979). Mine entry is about 3 m wide and 3 m high. Bedrock is moderately well cemented sandy siltstone. Note that the caved fragments are much larger and occupy a larger volume at the Acme mine than do the caved fragments at the Riverside mine. *D*, Block diagram showing subsidence depression above mine opening where overburden is thicker than about 60 m or greater than about 10–15 times the thickness of coal mined. Subsidence profile shows tilt, tensile and compressive strain, inflection points, and critical and supercritical mining widths above an opening where the coal was completely removed.

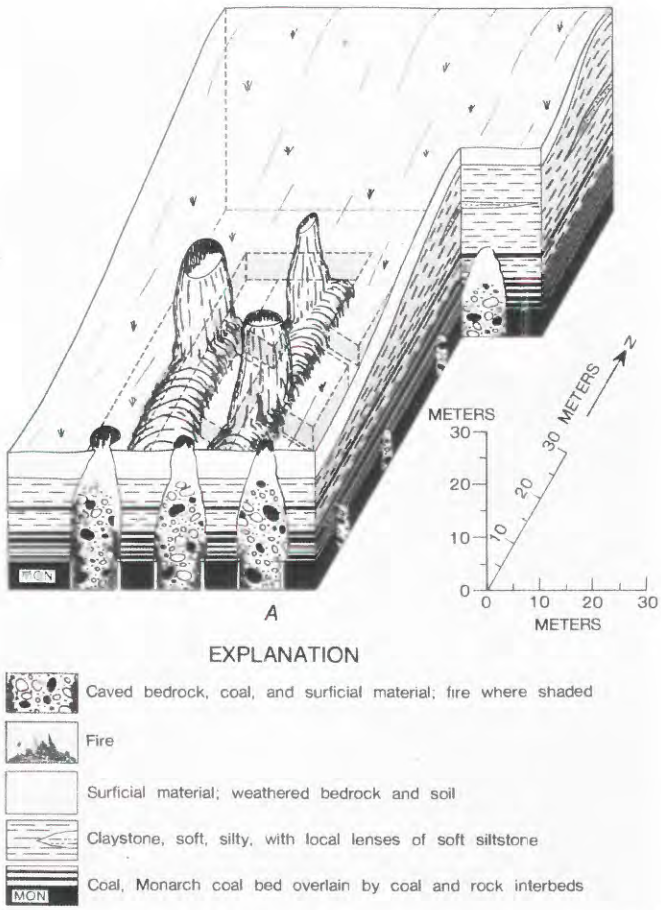
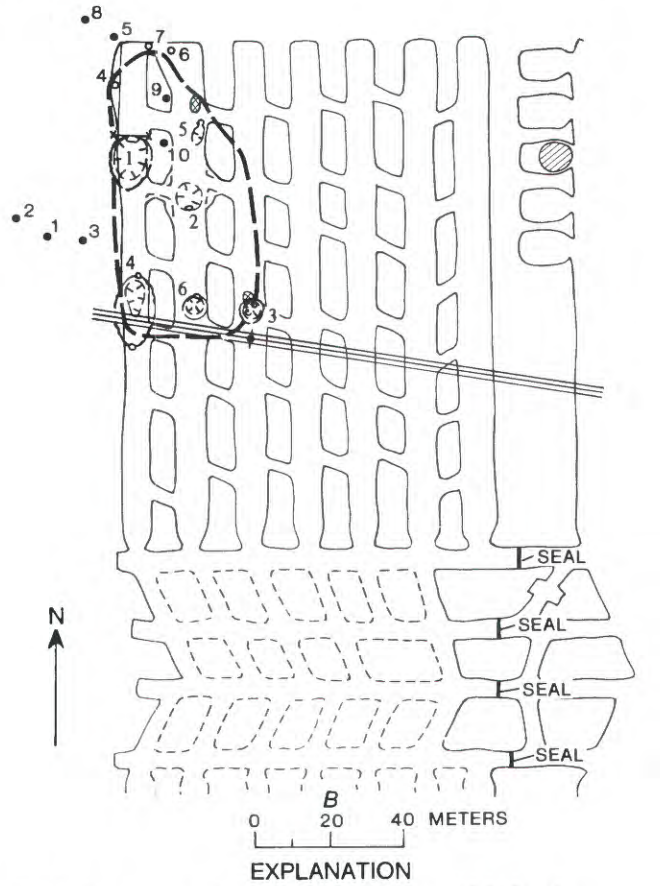
FIGURE 21.—Subsidence and fire above northwest part of New Monarch mine. *A*, Idealized block diagram showing subsidence pits, lithology of overburden, and underground mine workings in the fire area on January 9, 1979. *B*, Map showing relation of room-and-pillar mine workings to subsidence pits, filled pits, new pits, and estimated fire area (outlined by heavy dashed line), January 1979. Compiled by D. L. Donner, USBM, G. L. Mooney, DEQ, and C. R. Dunrud, based on taped traverses, drilling, geophysical logging, and inspection of pits. Voids 0.6 m high were encountered in drill holes 6 and 7; a void 6 m high and fire were encountered in drill hole 4.

◁ FIGURE 20.—Firepit above the east-central part of the Acme mine (May 1977). Broken, cracked, and locally blackened ground and scorched grass provide a stark contrast to the lush green grass surrounding this new firepit. *A*, Eastward view across firepit area. Meadowlands adjacent to the Tongue River are in the background. *B*, Southeastward view showing the jagged pit, which is bounded by crenulate, roughly concentric cracks. The depression (middle) is about 2.5 m deep. The pit, which is more than 3 m deep, contains fire and hot rocks, although they are not visible in picture because of the sunny day. Temperatures in the pit were measured at about 850°C with an optical pyrometer.

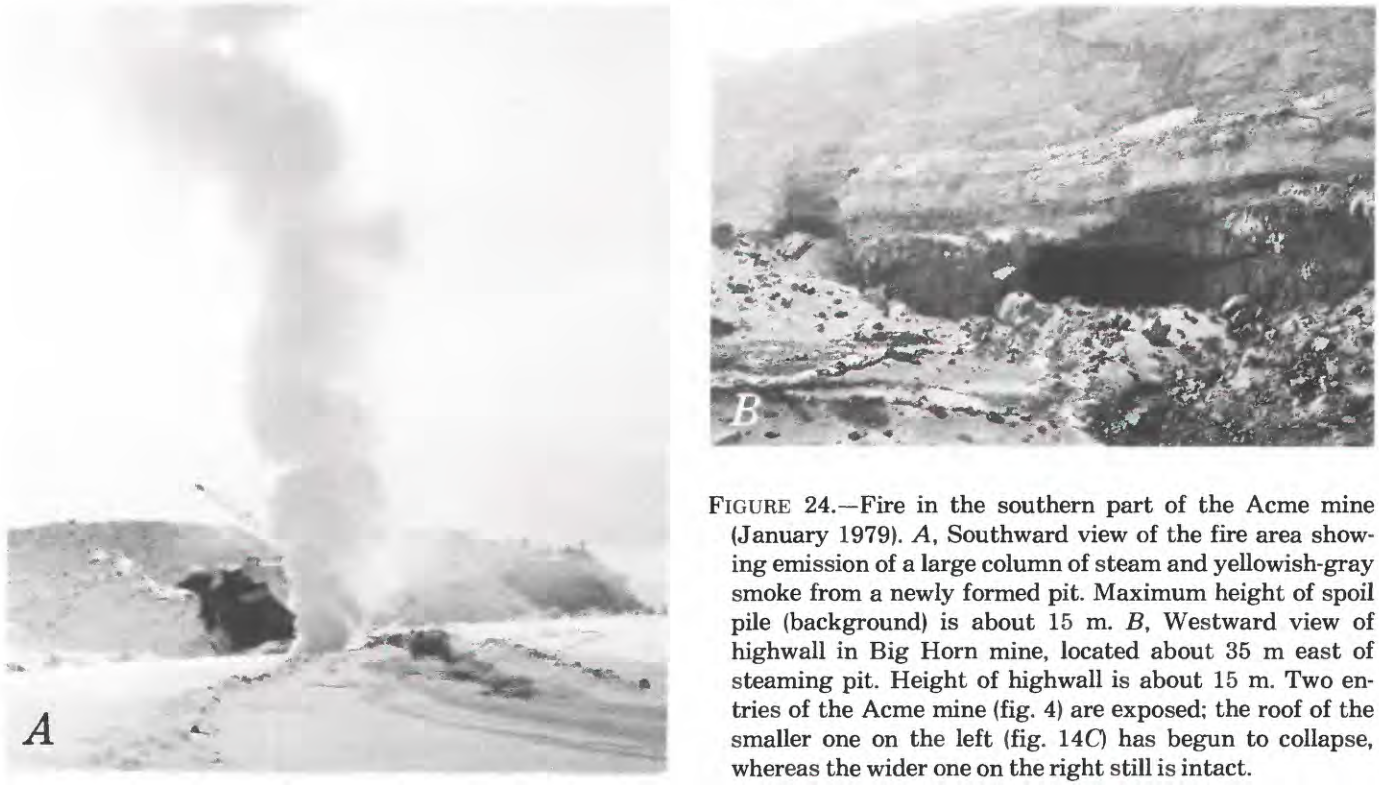
FIGURE 24.—Fire in the southern part of the Acme mine (January 1979). *A*, Southward view of the fire area showing emission of a large column of steam and yellowish-gray smoke from a newly formed pit. Maximum height of spoil pile (background) is about 15 m. *B*, Westward view of highwall in Big Horn mine, located about 35 m east of steaming pit. Height of highwall is about 15 m. Two entries of the Acme mine (fig. 4) are exposed; the roof of the smaller one on the left (fig. 14*C*) has begun to collapse, whereas the wider one on the right still is intact.

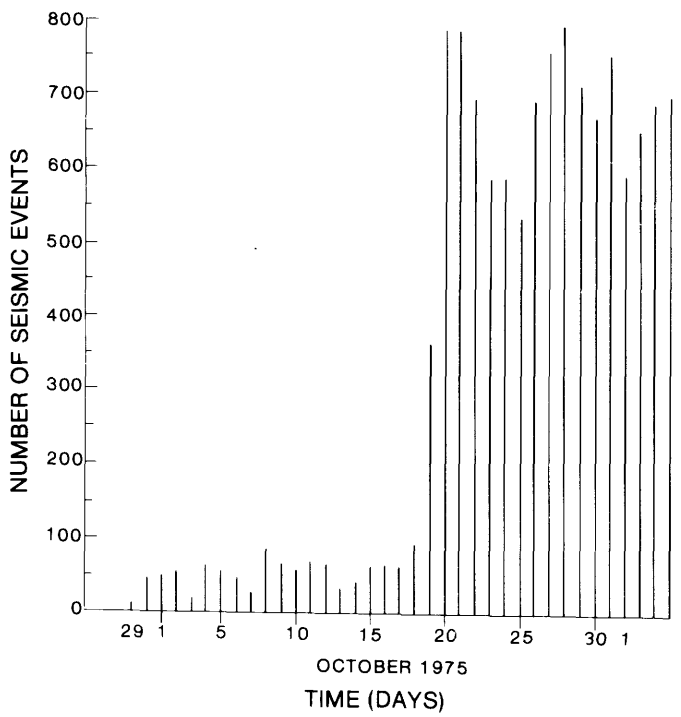
FIGURE 25.—Graph showing the daily number of small earth tremors at a seismometer station located near the firepit in the northern part of the Acme mine. The station was located about 185 m from the firepit from September 29 to October 19, 1975, then was moved to within about 30 m of the firepit. Note the approximate tenfold increase in number of events when the station was moved closer to the firepit. The earth tremors apparently are caused by the breaking and collapse of overburden material and perhaps by small underground explosions.
