Peak Discharge, Flood Profile, Flood Inundation, and Debris Movement Accompanying the Failure of the Upper Reservoir at the Taum Sauk Pump Storage Facility near Lesterville, Missouri

Scientific Investigations Report 2006–5284

By Paul H. Rydlund, Jr.

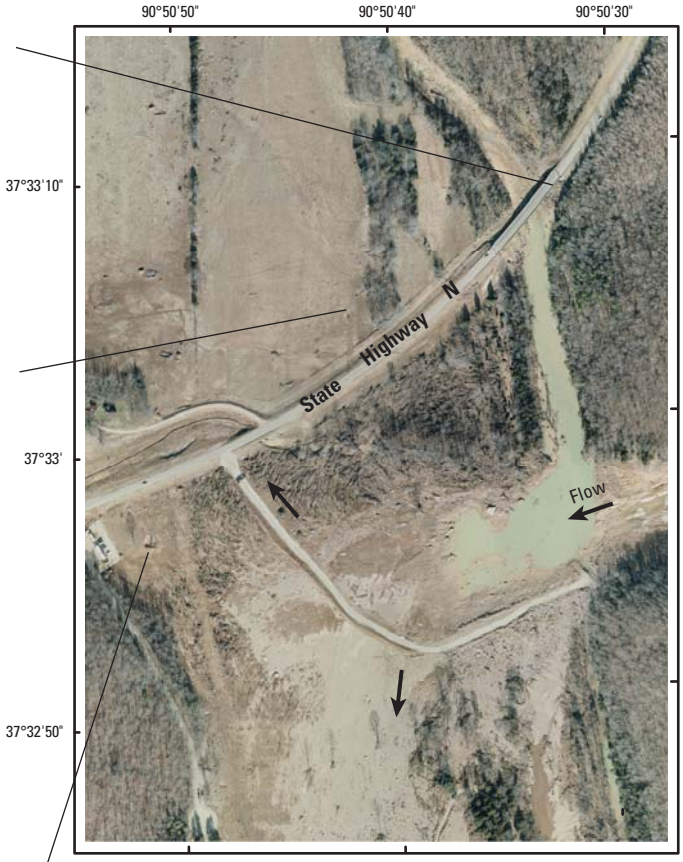
U.S. Geological Survey streamflow-gaging station and debris accumulation.

Tractor trailer washed off of State Highway N. Note the high water mark on the cab of the truck (photograph courtesy of Ken Beck, Reynolds County Courier, 2005).

Exposed foundation of park superintendent residence.

Figure 2. Flood wave damage at base of Proffit Mountain and State Highway N.
