# MEASUREMENTS OF LEAKAGE FROM LAKE MICHIGAN THROUGH THREE CONTROL STRUCTURES NEAR CHICAGO, ILLINOIS, APRIL–OCTOBER 1993

Water-Resources Investigations Report 94-4112

Prepared in cooperation with the
U.S. ARMY CORPS OF ENGINEERS, CHICAGO DISTRICT

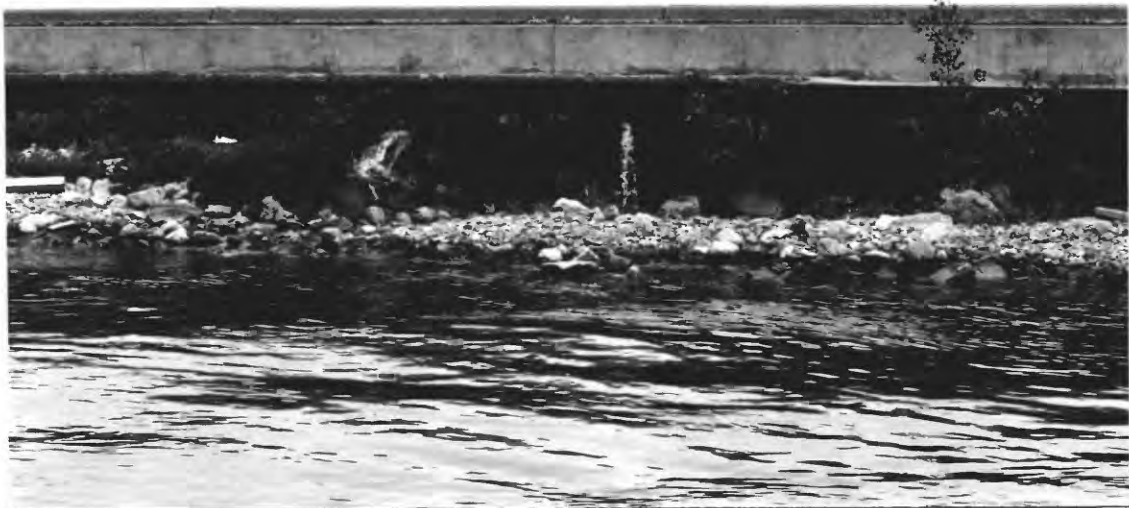
The CRCW was built in 1938 as a part of the construction of the Chicago Sanitary and Ship Canal and the diversion of the Chicago River. The harbor walls were constructed of rock-filled timber cribs and, in places, the walls have metal sheet piling on one or both sides of the wall. During 1987, the tops of most harbor walls were raised and capped with concrete to reduce overtopping by waves in Lake Michigan. As a result of the original construction technique, the walls are porous. Figure 3 shows leakage through the harbor wall on the northeast side of CRCW.

Figure 3. Leakage through southeast harbor wall at Chicago River Controlling Works, view looking east, July 10, 1993.

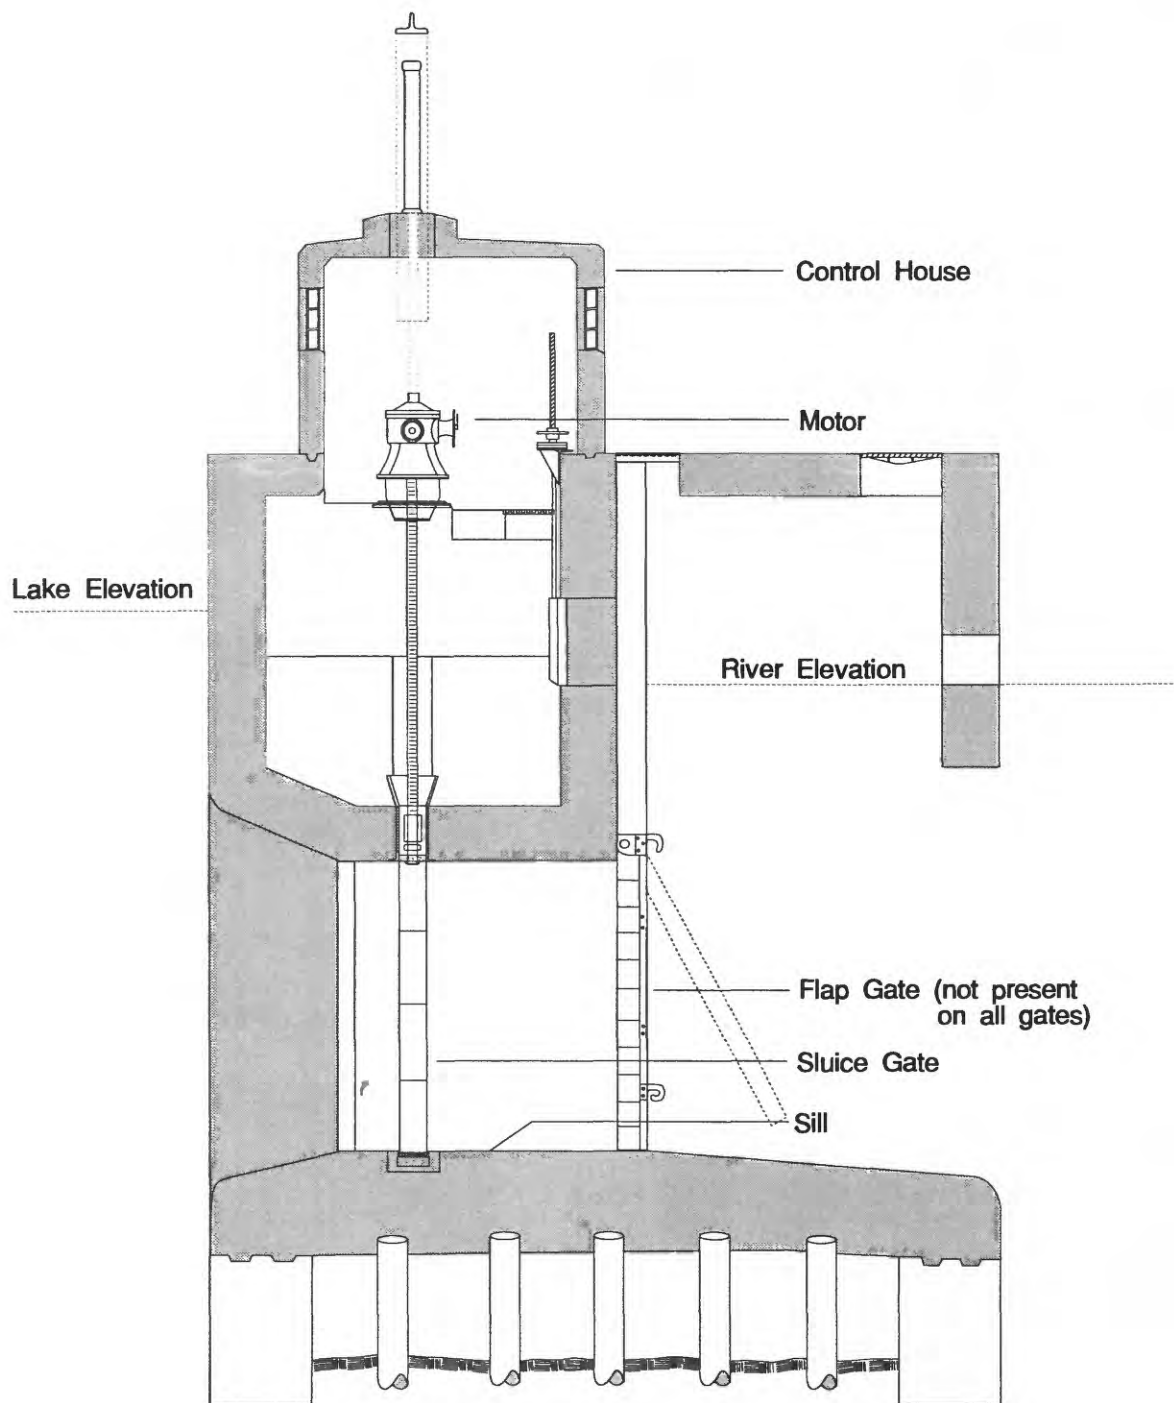
Two sets of sluice gates were constructed in the harbor wall: one located near the lock and another on the south harbor wall (fig. 2). A transverse section of a typical sluice gate at CRCW is shown in figure 5. The elevation of the concrete sill at the base of both sets of sluice gates is -16.0 ft Chicago City Datum (562.48 ft above sea level). Each sluice gate at CRCW is 10.5 ft wide and 10.5 ft high. During the summer, the sluice gates along the south harbor wall are opened to allow Lake Michigan water to flow into the Chicago River and down the CSSC to improve water quality in the CSSC. The sluice gates near the lock are used only for flushing ice down the Chicago River, for flow reversals, and when the south gates are inoperable. During storms, when the water-surface elevation of the Chicago River exceeds the elevation of Lake Michigan, both sluice gates may be opened to allow flow from the Chicago River to discharge into Lake Michigan. However, the sluice gates are used only infrequently for this purpose. The MWRD is responsible for the operation and maintenance of the sluice gates.

Figure 5. Typical sluice-gate configuration at Chicago River Controlling Works and Thomas J. O'Brien Lock and Dam.
