# A GEOLOGIC STUDY OF THE MADDEN DAM PROJECT, ALHAJUELA, CANAL ZONE

By FRANK REEVES and CLYDE P. ROSS

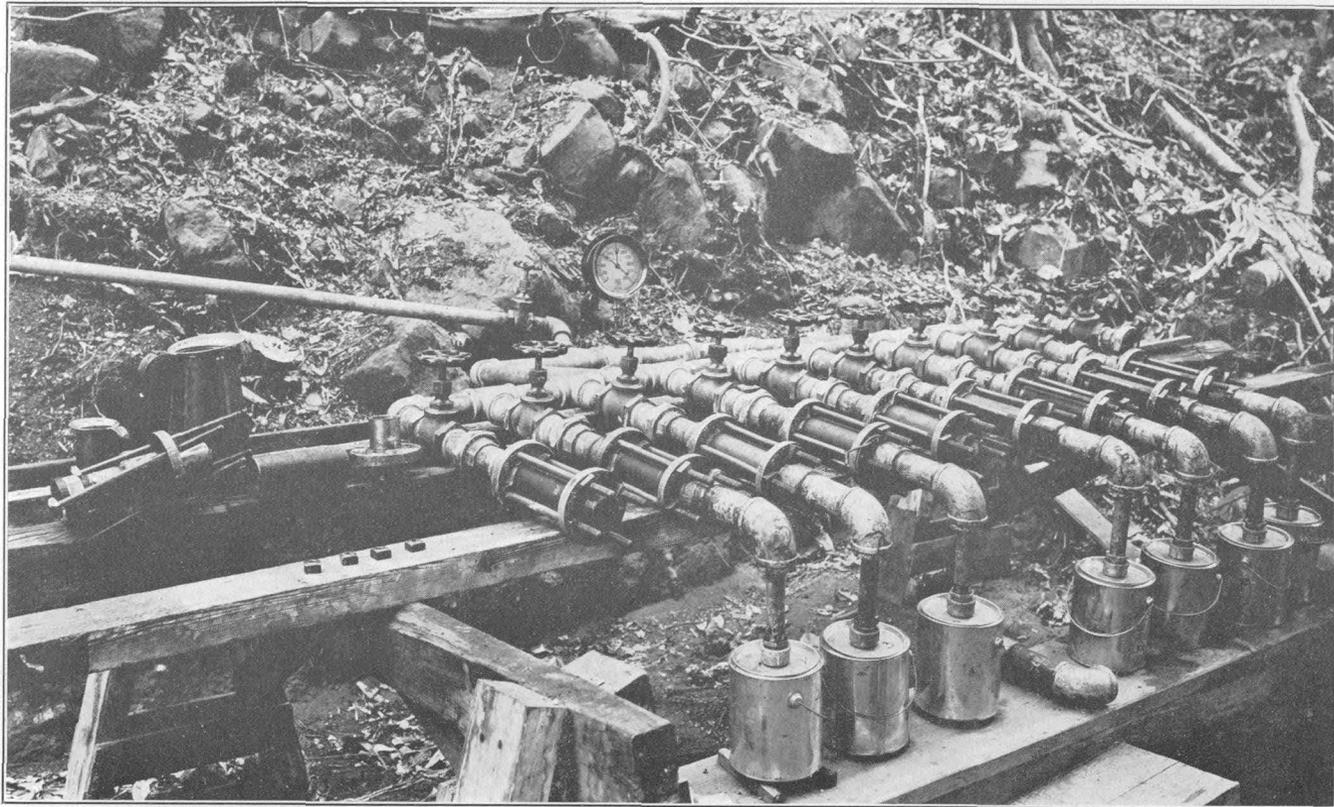
OUTFIT USED IN TESTS OF THE SOLUBILITY OF PIECES OF CORE FROM THE 2-INCH DIAMOND-DRILL HOLES NEAR DIAMOND-DRILL HOLE L-1

In an attempt to get some quantitative idea as to the permeability and solubility of the rocks of the reservoir area, pieces of core 5 inches long from the 2-inch diamond-drill hole L-2 were tamped into pieces of pipe with lead wool and steam packing and subjected at one end to the pressure of water led in a pipe down a cliff from a tank at such a height as to give a hydrostatic head of 184 feet, or a pressure of 80 pounds to the square inch. An idea of the layout for this test may be obtained from Plate 11.

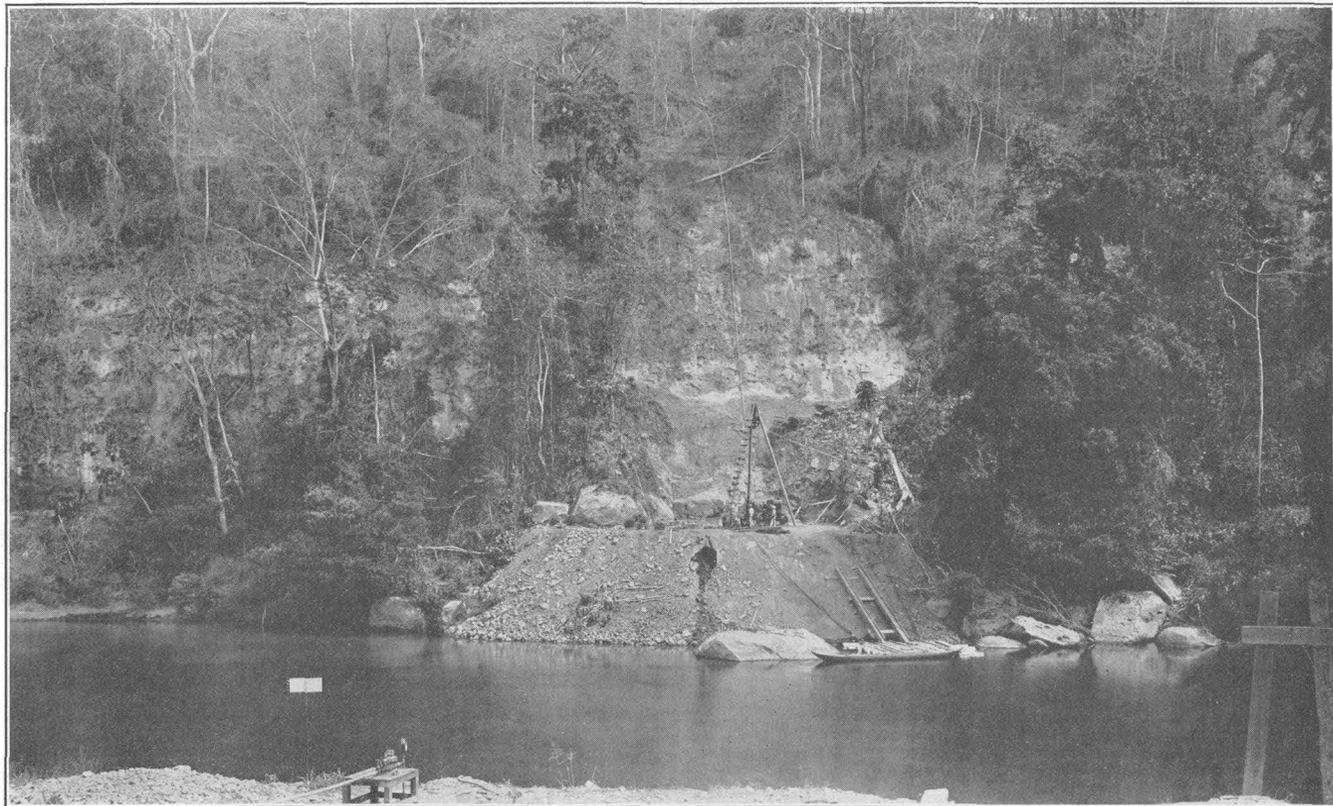
DIAMOND DRILL SINKING HOLE L-1 ON WEST SIDE OF DAM SITE 1

Pipe leads from tank above to solution-testing outfit hidden by bushes at right side of view. Pressure-testing outfit on hole L-2 in foreground.

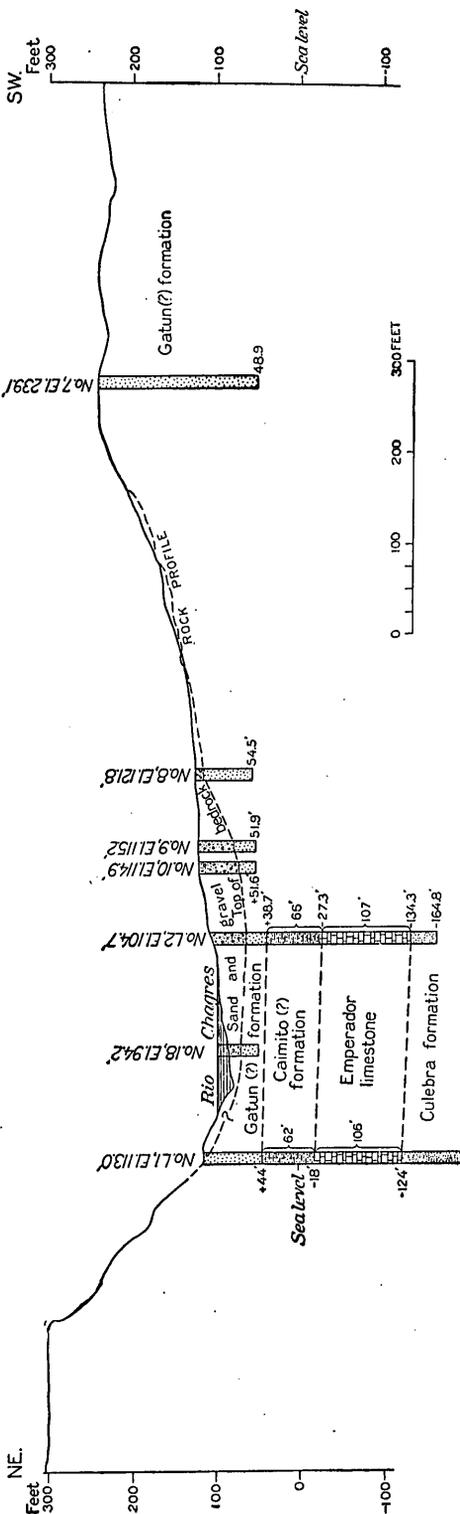
In accordance with the classification of the cores here adopted, hole L-3 of dam site 5 enters the Caimito (?) formation at a depth of 17.4 feet below that at which this rock is entered in holes L-1 and L-2 of dam site 1, as is shown in Figure 5. In other words, the Gatun (?) formation extends 17.4 feet deeper at site 5. As the Gatun (?) is a better rock for dam foundations than the Caimito (?), this difference would be in favor of site 5 except for the fact that bed-rock in the Gatun (?) at site 1 lies shallower than at site 5.

FIGURE 5.—Profile of dam site 1, Madden Dam project, showing bedrock profile and diamond-drill holes

At either site 1 or site 5 the abutments of the dam will rest on the Gatun (?) formation and the base will, if carried much below the bedrock surface, rest on the Caimito (?) formation. Both are firm, fairly massive rocks, of nearly equal mechanical strength, but in all respects the Gatun (?) is somewhat superior to the Caimito (?). The rock exposures at site 1 are shown in Figure 5.
