Tectonic Creep in the Hayward Fault Zone California

GEOLOGICAL SURVEY CIRCULAR 525

**TECTONIC CREEP IN THE
HAYWARD FAULT ZONE
CALIFORNIA**

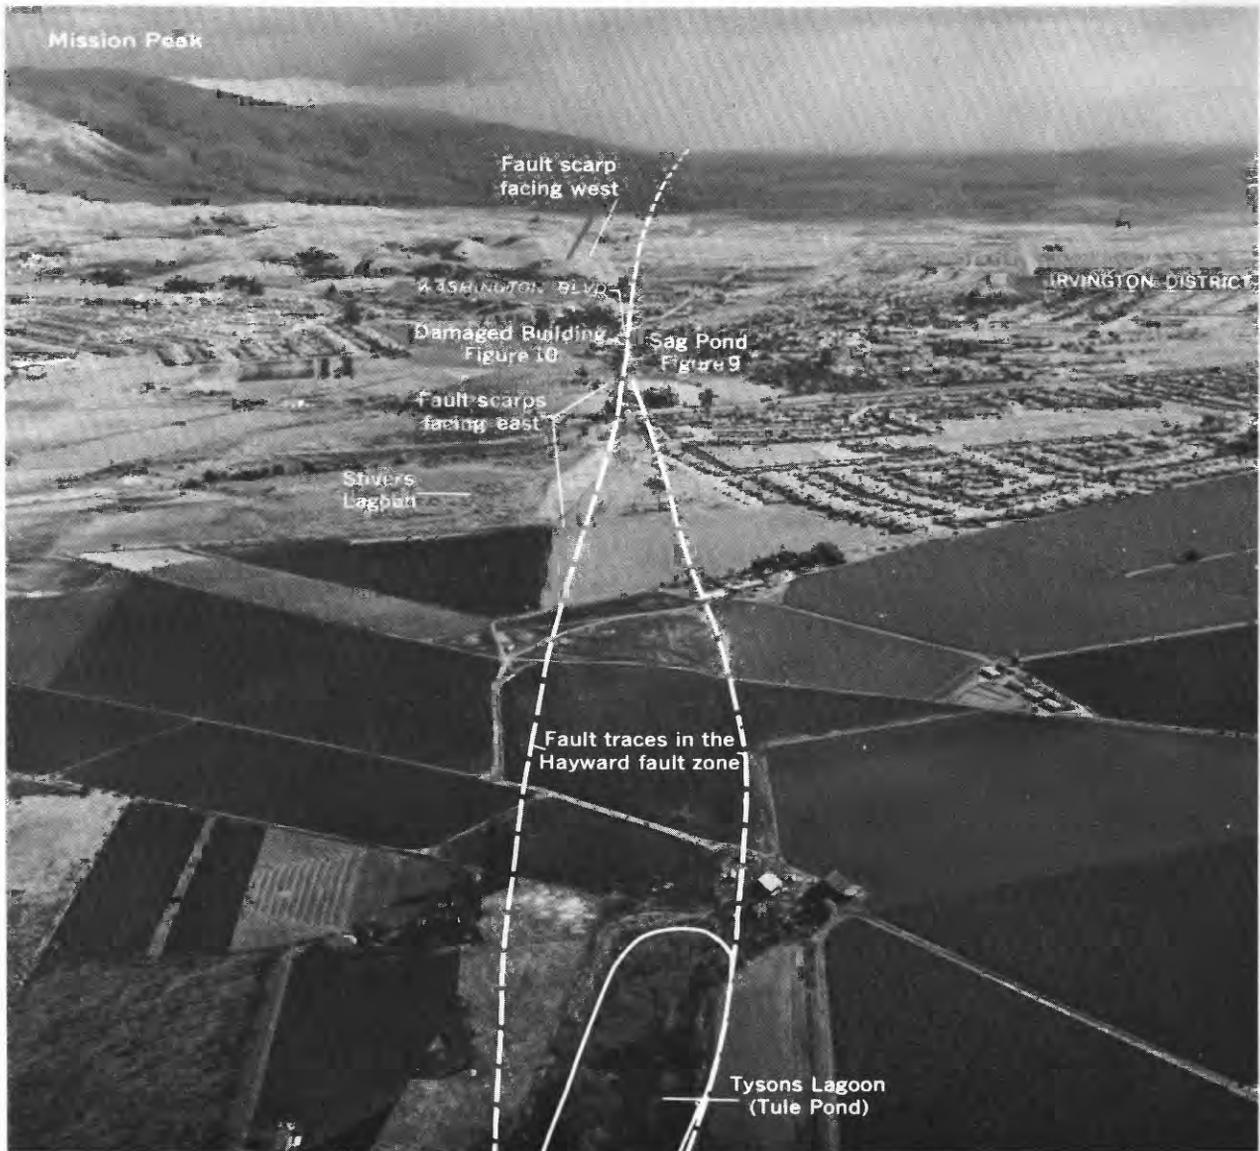
During the course of geologic field mapping along the Hayward fault in November 1960, the senior author discovered a damaged one-story storage building extending partly into the fault zone. A detailed inspection of the building showed that the damage was concentrated in the part of the building which lies along the northwest-trending fault zone and consisted of fractures, cracks, deflections, bends, and offsets, all of which indicated right-lateral movement. In checking the seismic history of the Fremont area, it was found that no earthquakes were recorded which appeared to have a magnitude strong enough to produce ground breakage along

Figure 8.—View looking southeast along strike of the Hayward fault zone near Irvington district, Fremont, Calif.
