GEOLOGIC INVESTIGATION AT THE SITE OF
the POST OFFICE BUILDING
WELCH, WEST VIRGINIA

GEOLOGIC INVESTIGATION AT THE SITE OF THE POST OFFICE BUILDING,
WELCH, WEST VIRGINIA

By Harold H. Hawkins

Geologic Report on Core Drilling at Welch, West Virginia, Post Office

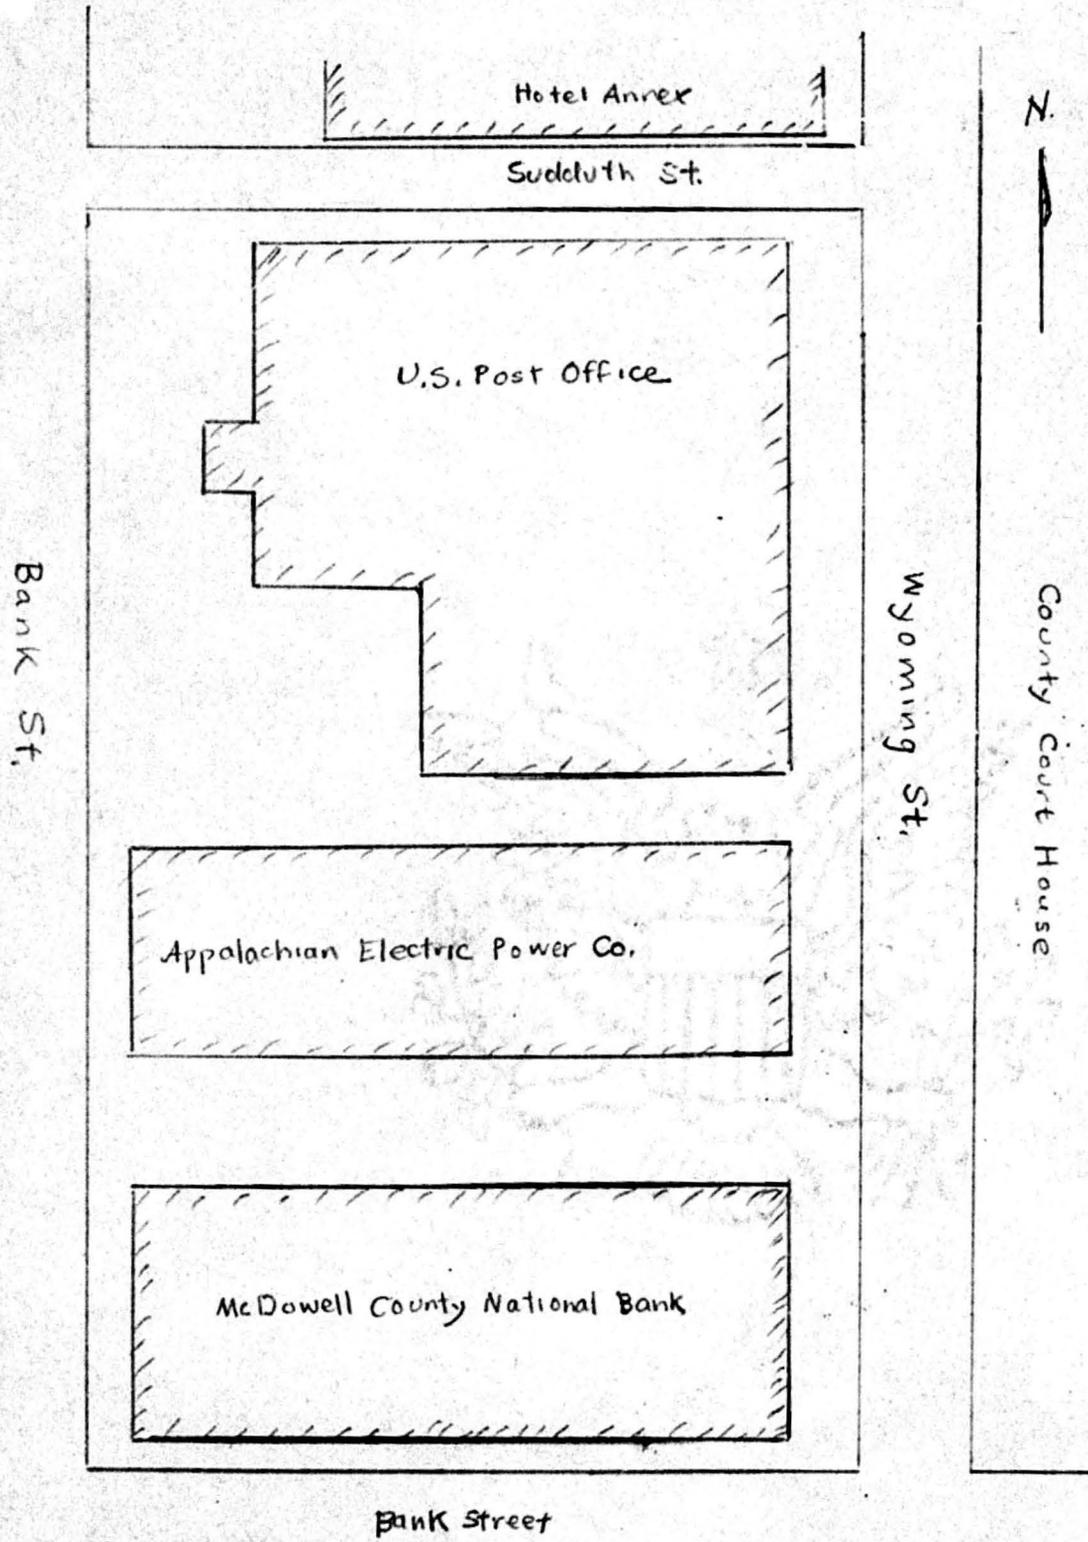
Fig 1, Hawkins report.
Location of Bldgs in Welch, W. Va.

Cracks were observed in several buildings, all downhill from and within a radius of 300 feet from the post office. The cracks observed in these buildings were said to have developed within the preceding 6 months except those in the Appalachian Electric Power Company building, which were said to have opened about 3 or 4 years ago and to have become larger during the past 6 months. There is a large crack in the west exterior wall of a commercial building at the southeast corner of Mercer and Railroad Streets, about 250 feet south of the post office. The exterior east wall and plate glass window of a building on the southwest corner of Wyoming and Bank Streets are cracked. Cracking, which may or may not be of the same origin, shows near the northeast corner of the McDowell County National Bank building on the northwest corner of Wyoming and Bank Streets. The east-west walls of the Appalachian Electric Power Company building next door to the post office, are badly cracked. Larger cracks are in the interior walls, located midway of the length of the building. One crack begins about 5 feet above the ground and widens progressively toward the roof. An index to the photographs of cracked walls included in this report is shown in figure 1. Figure 2 shows the lower end of the crack last described. A displacement in the sidewalk and curbing back of the Appalachian Electric Power Company building on Mercer Street is shown diagrammatically in figure 3.
