ICINGS ALONG THE TRANS-ALASKA PIPELINE ROUTE

By Charles E. Sloan, Chester Zenone,  
and Lawrence R. Mayo

Open-File Report 75-87

Anchorage, Alaska  
1975

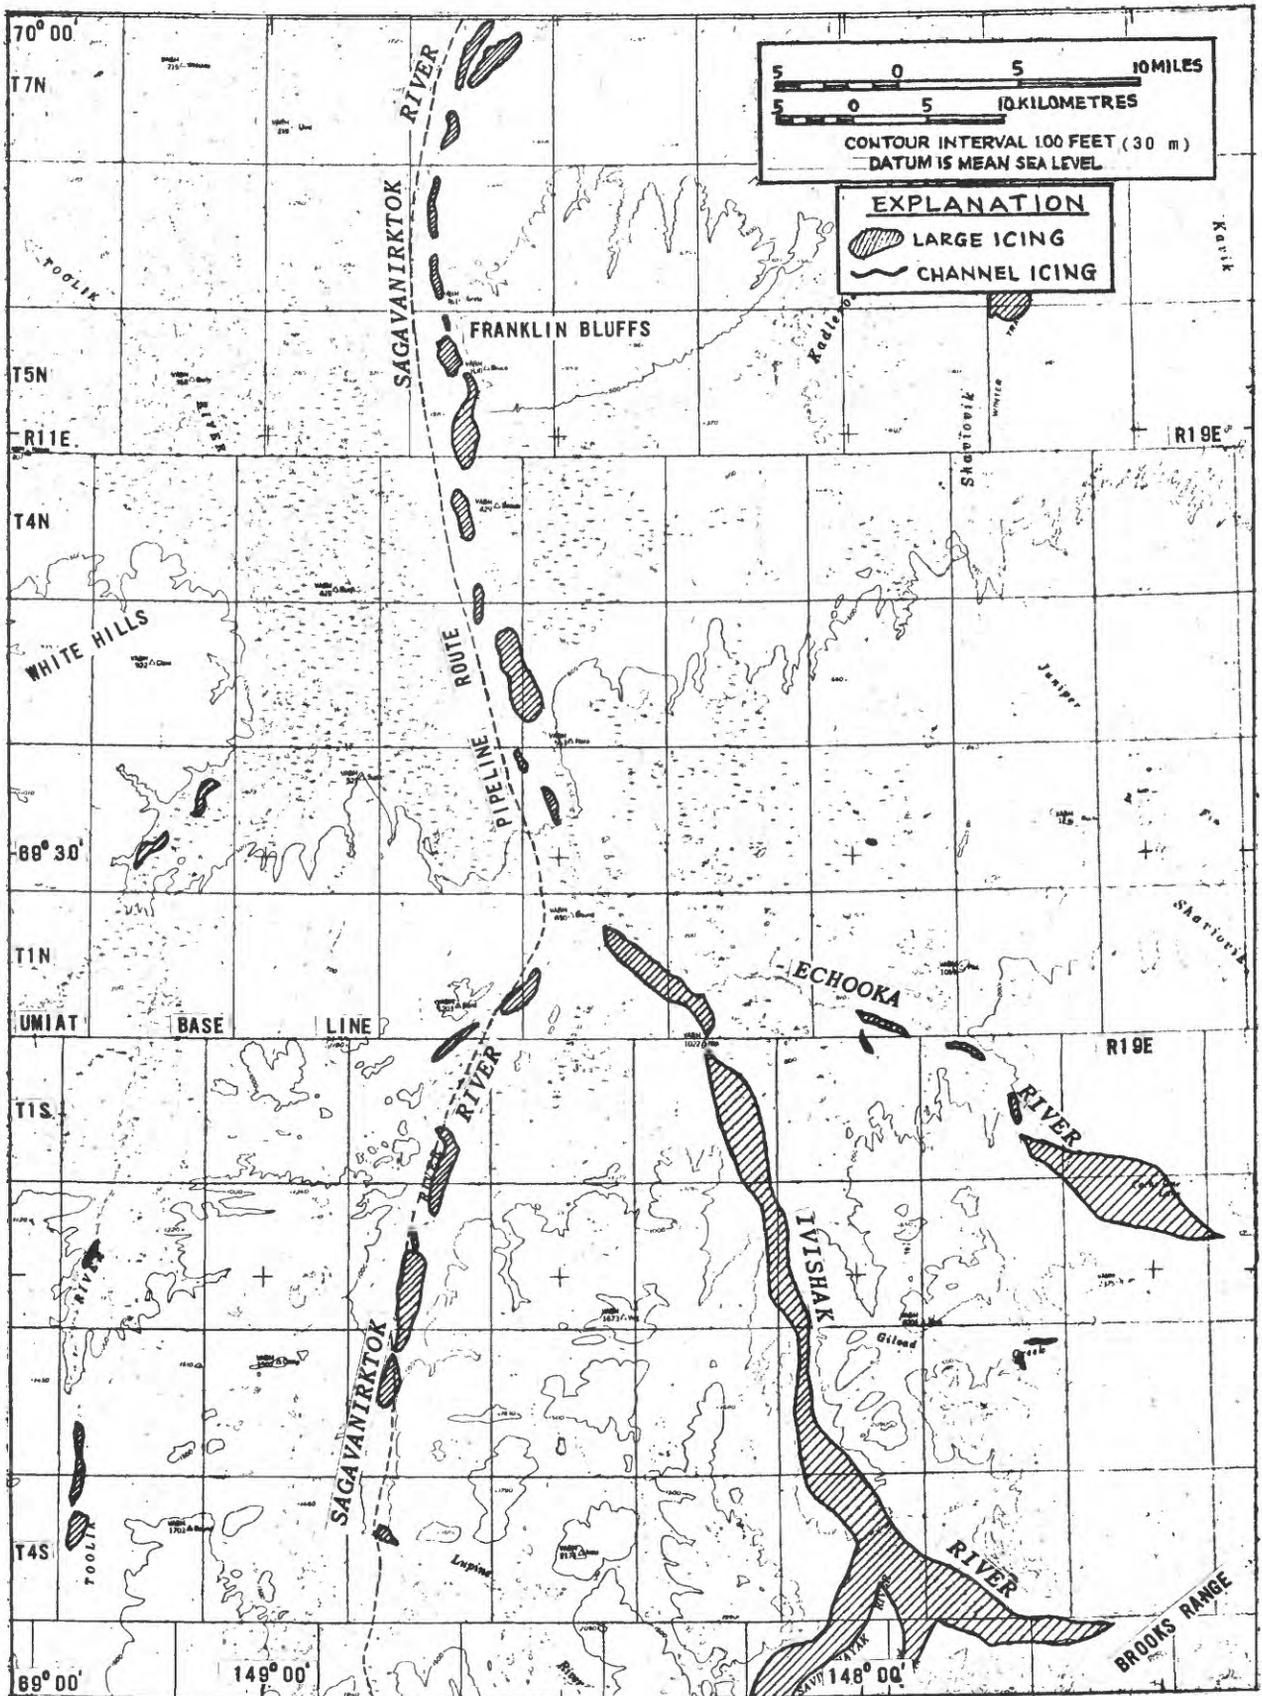
Broad flood-plain icings form on many of the braided reaches of the Sagavanirktok and Ivishak Rivers (figs. 7 and 8). An ERTS-1 (Earth Resources Technological Satellite) near-infrared image taken on March 31, 1973, shows the icing activity in the Sagavanirktok River basin. Water absorbs infrared radiation and is shown as black on the image (fig. 9a) in contrast to the white snow and ice. Broad overflow can be seen (fig. 9a) on the icings of the Echooka and Ivishak Rivers near the front of the Brooks Range and extending some distance downstream. An ERTS-1 scene of the same area on August 4, 1973, shows remnants of ice on the Echooka, Shaviovik, and Ivishak Rivers (fig. 9b). The large icing on the Echooka River may not melt entirely from year to year (fig. 10).

Figure 8.--Distribution of icings along the trans-Alaska pipeline route in the Sagavanirktok quadrangle.

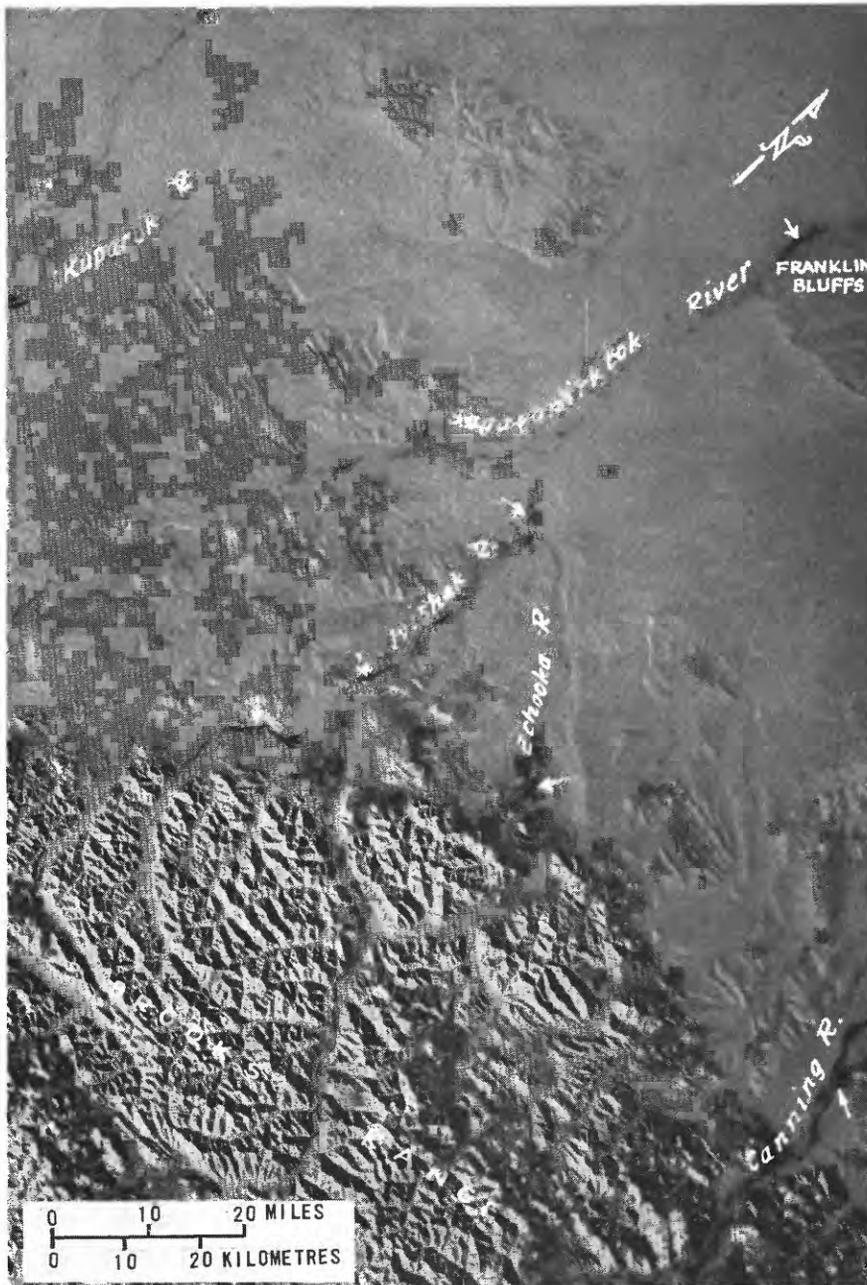
Figure 9a.--ERTS-1 image of Sagavanirktok River basin showing water surfaces (arrows) in icing areas, March 31, 1973 (scene no. 12511-21123, band 7).

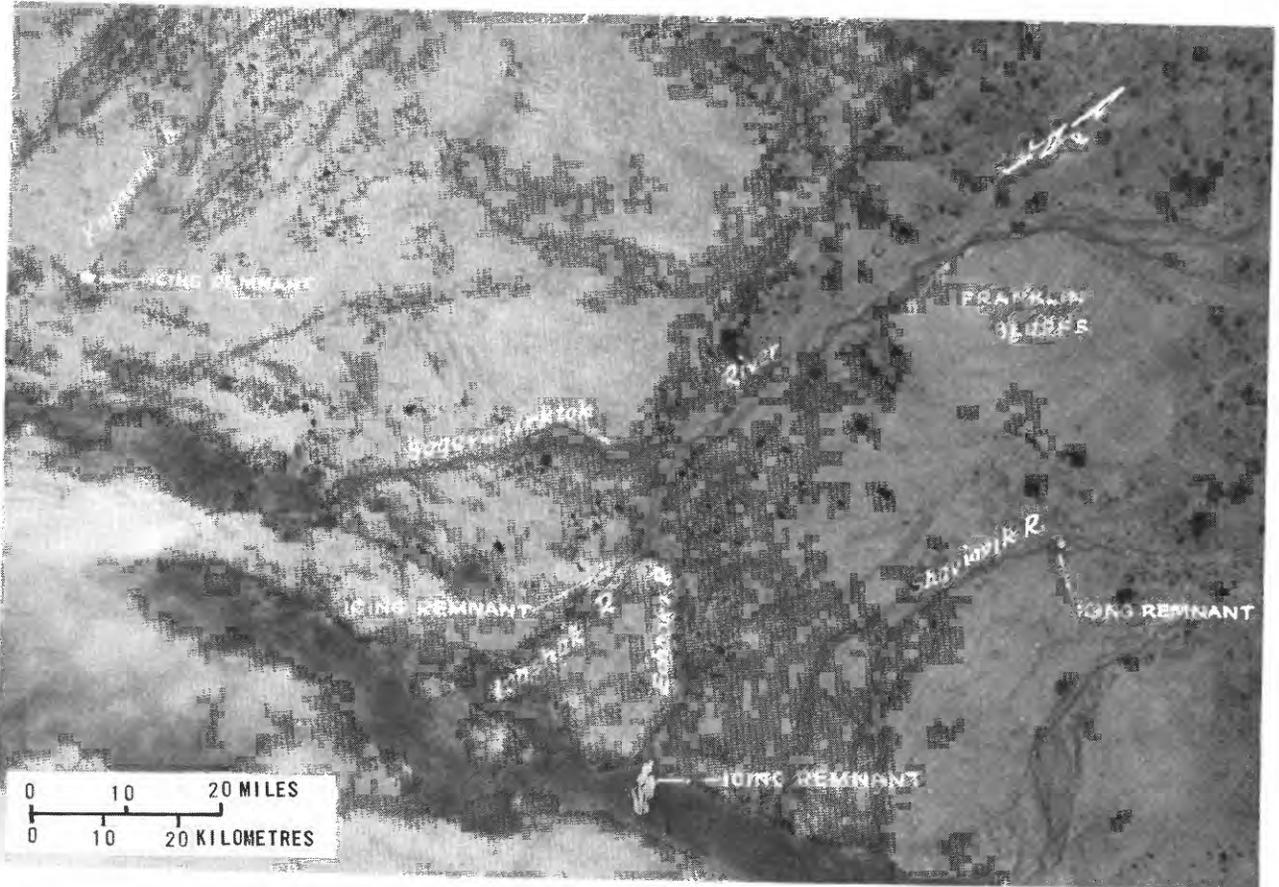
Figure 9b.--ERTS-1 image of same area as in figure 9a showing icing remnants on Echooka, Ivishak, and Shaviolik Rivers, August 4, 1973 (scene no. 1377-21112, band 6).

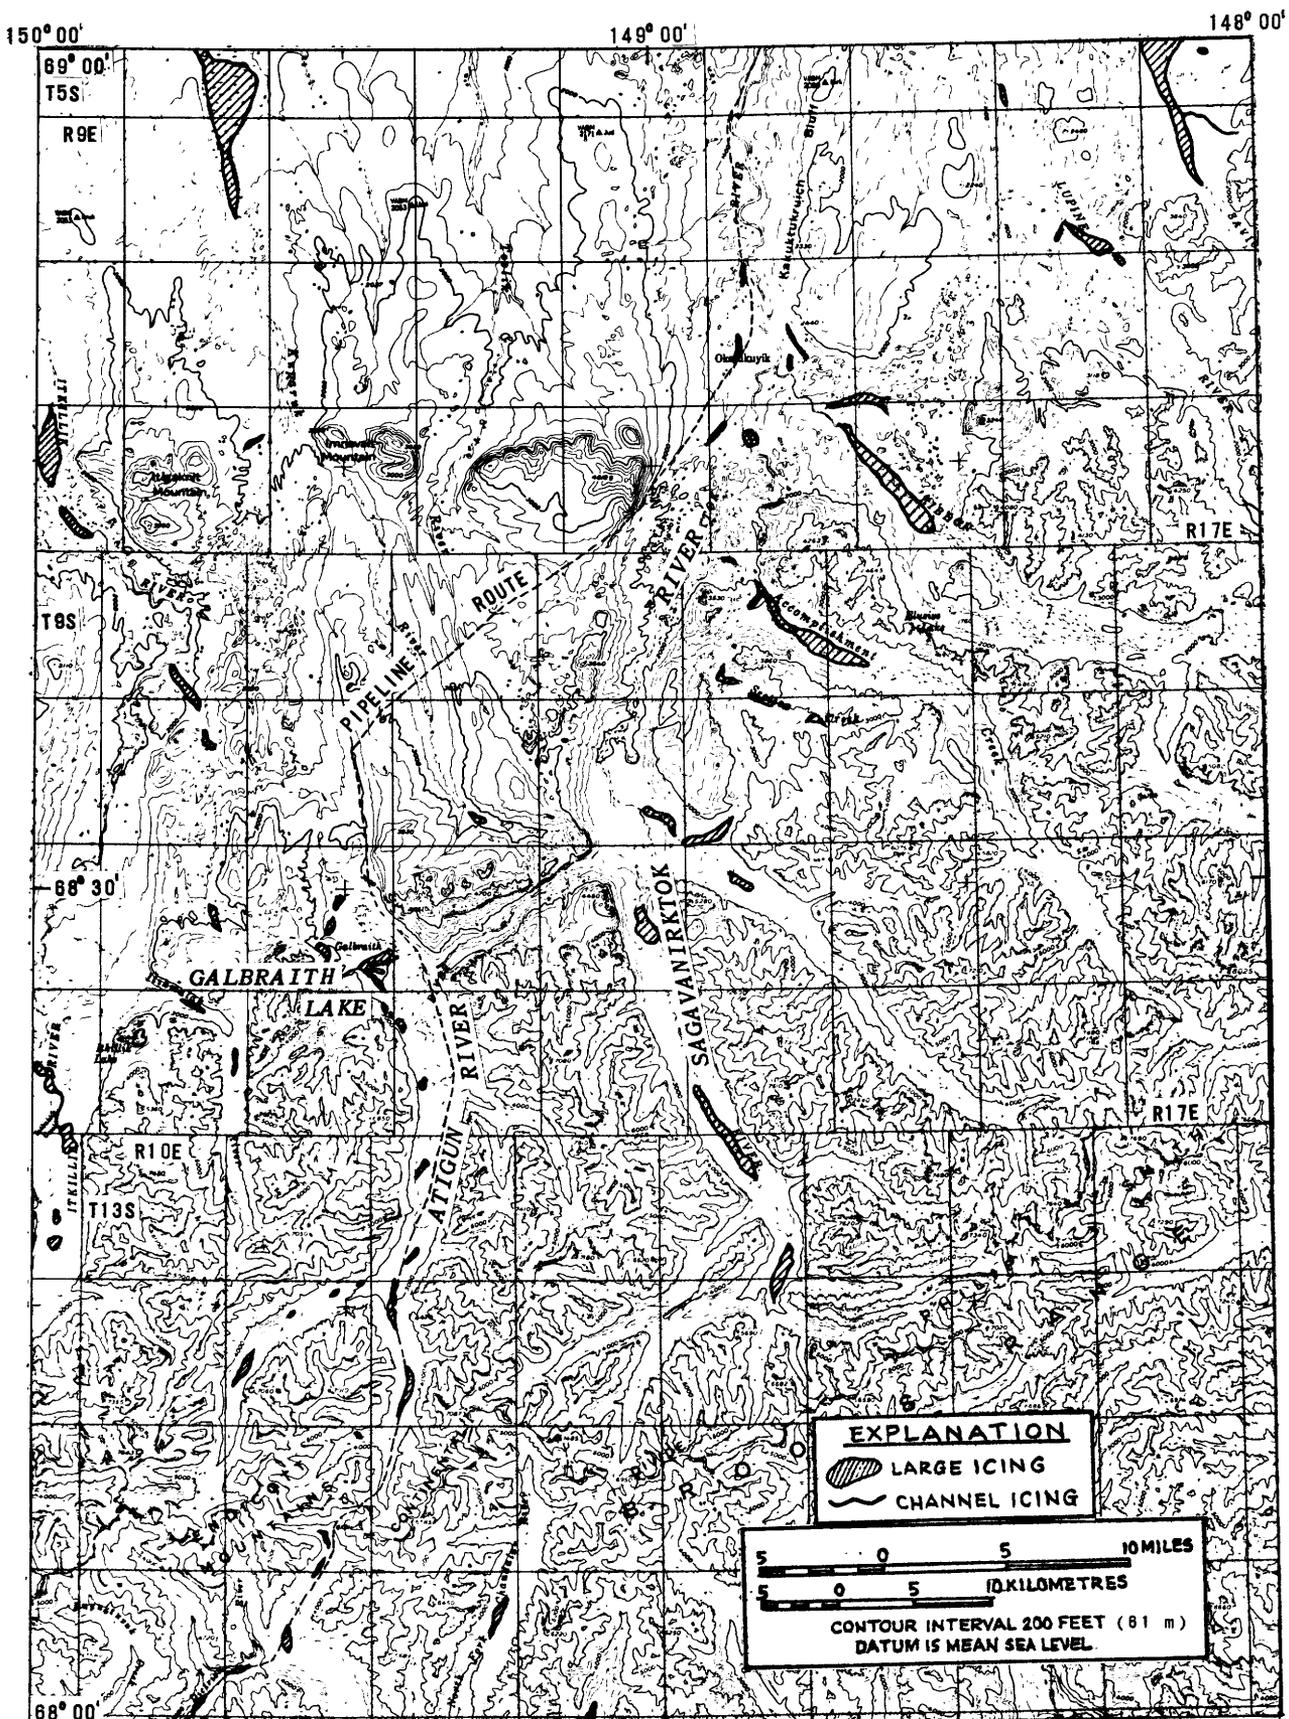
A large icing forms annually on the alluvial fan west of Galbraith Lake (figs. 11 and 12). Large icings also occur at wide, braided channel reaches of the upper Atigun River valley (figs. 11 and 13).

Figure 11.--Distribution of icings along the trans-Alaska pipeline route in the Philip Smith Mountains quadrangle.

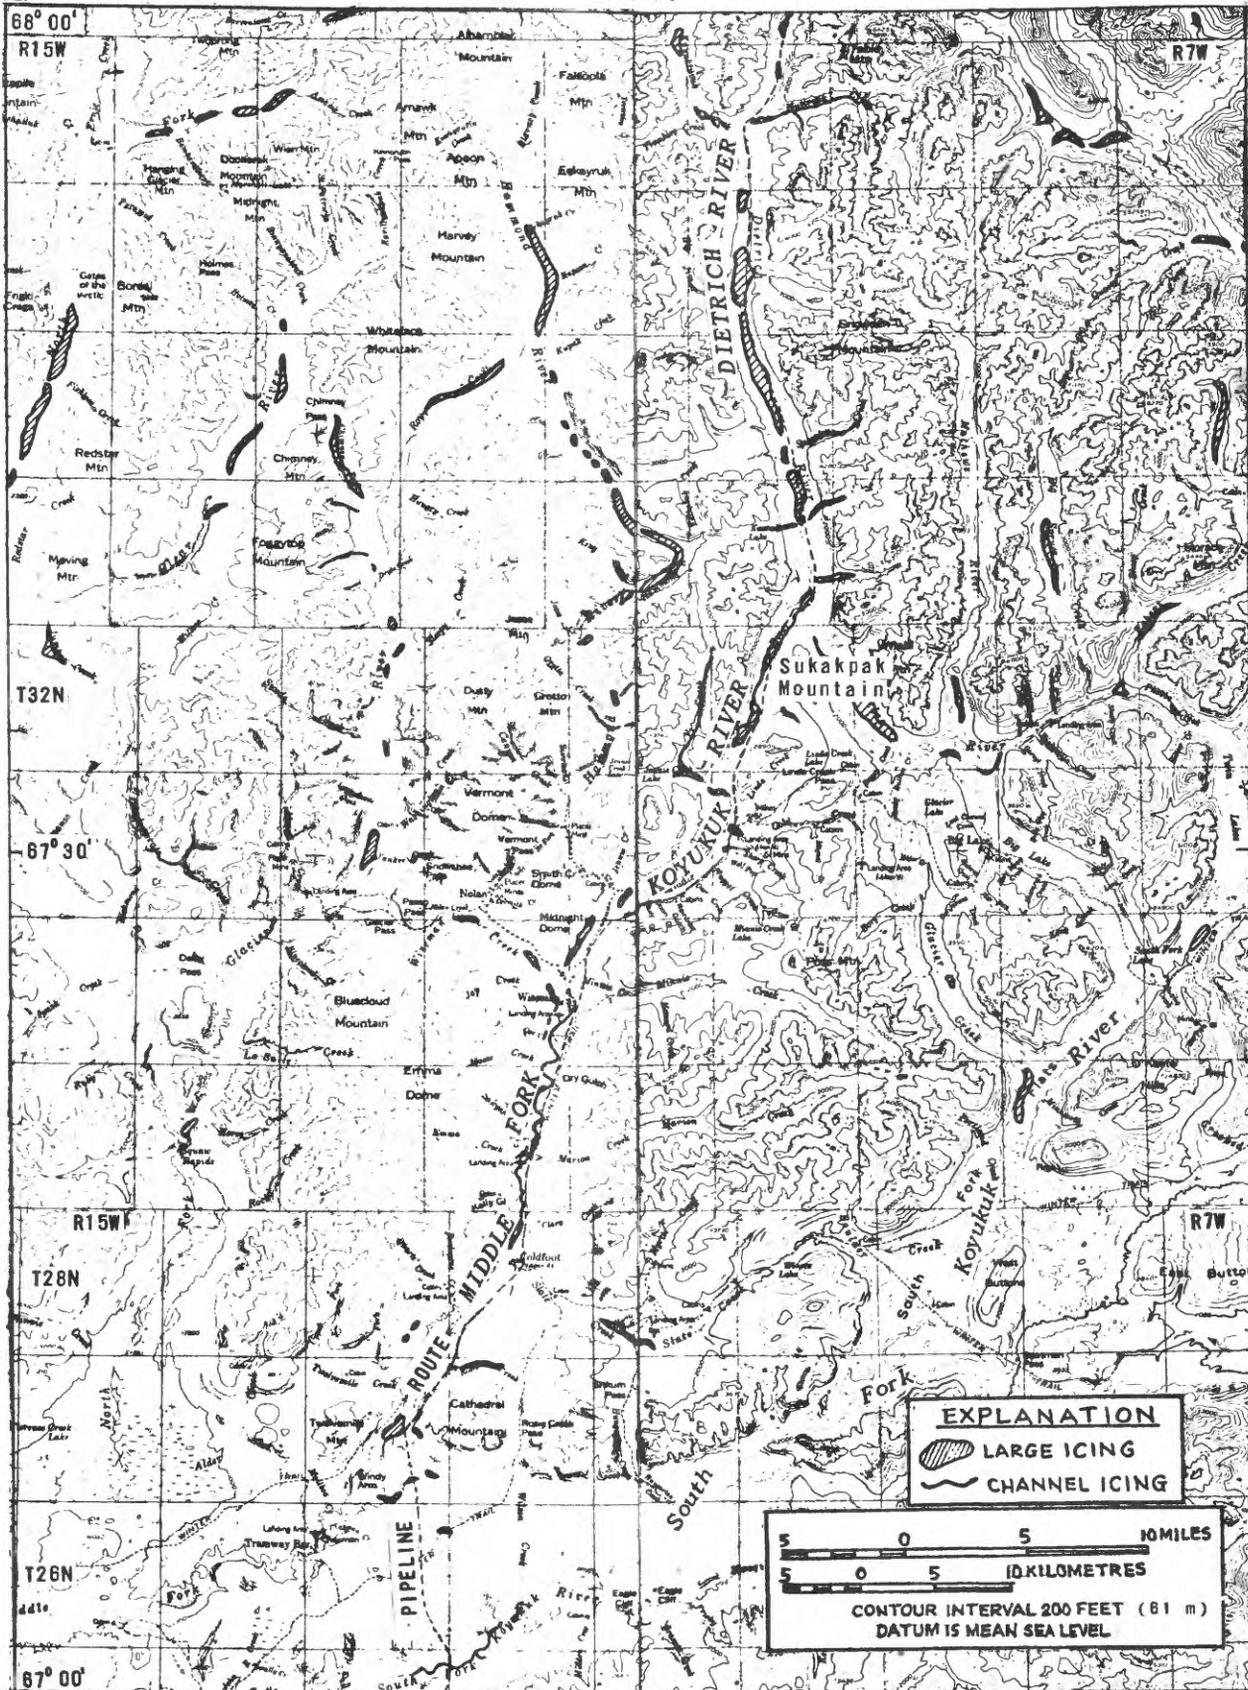
Icings inundate almost the entire active flood plain along braided channel reaches of the Dietrich River (fig. 14). Where the river channel is incised and the reach not braided, channel ice or only minor overflow icing occurs. The large icings on the Dietrich River seem to have their water source from the steep alluvial fans which have built out onto the Dietrich River flood plain (figs. 15a and 15b). Open leads in the Dietrich River icings can be seen at the base of the alluvial fans where ground water is emerging (fig. 16).

The ice on the Middle Fork Koyukuk River (fig. 14) generally is confined to the main channel, and small icings form at the mouths of some tributary streams. A few small hillside icings form on the west flank of Sukakpak Mountain.

Figure 14.--Distribution of icings along the trans-Alaska pipeline route in the Chandalar and Wiseman quadrangles.

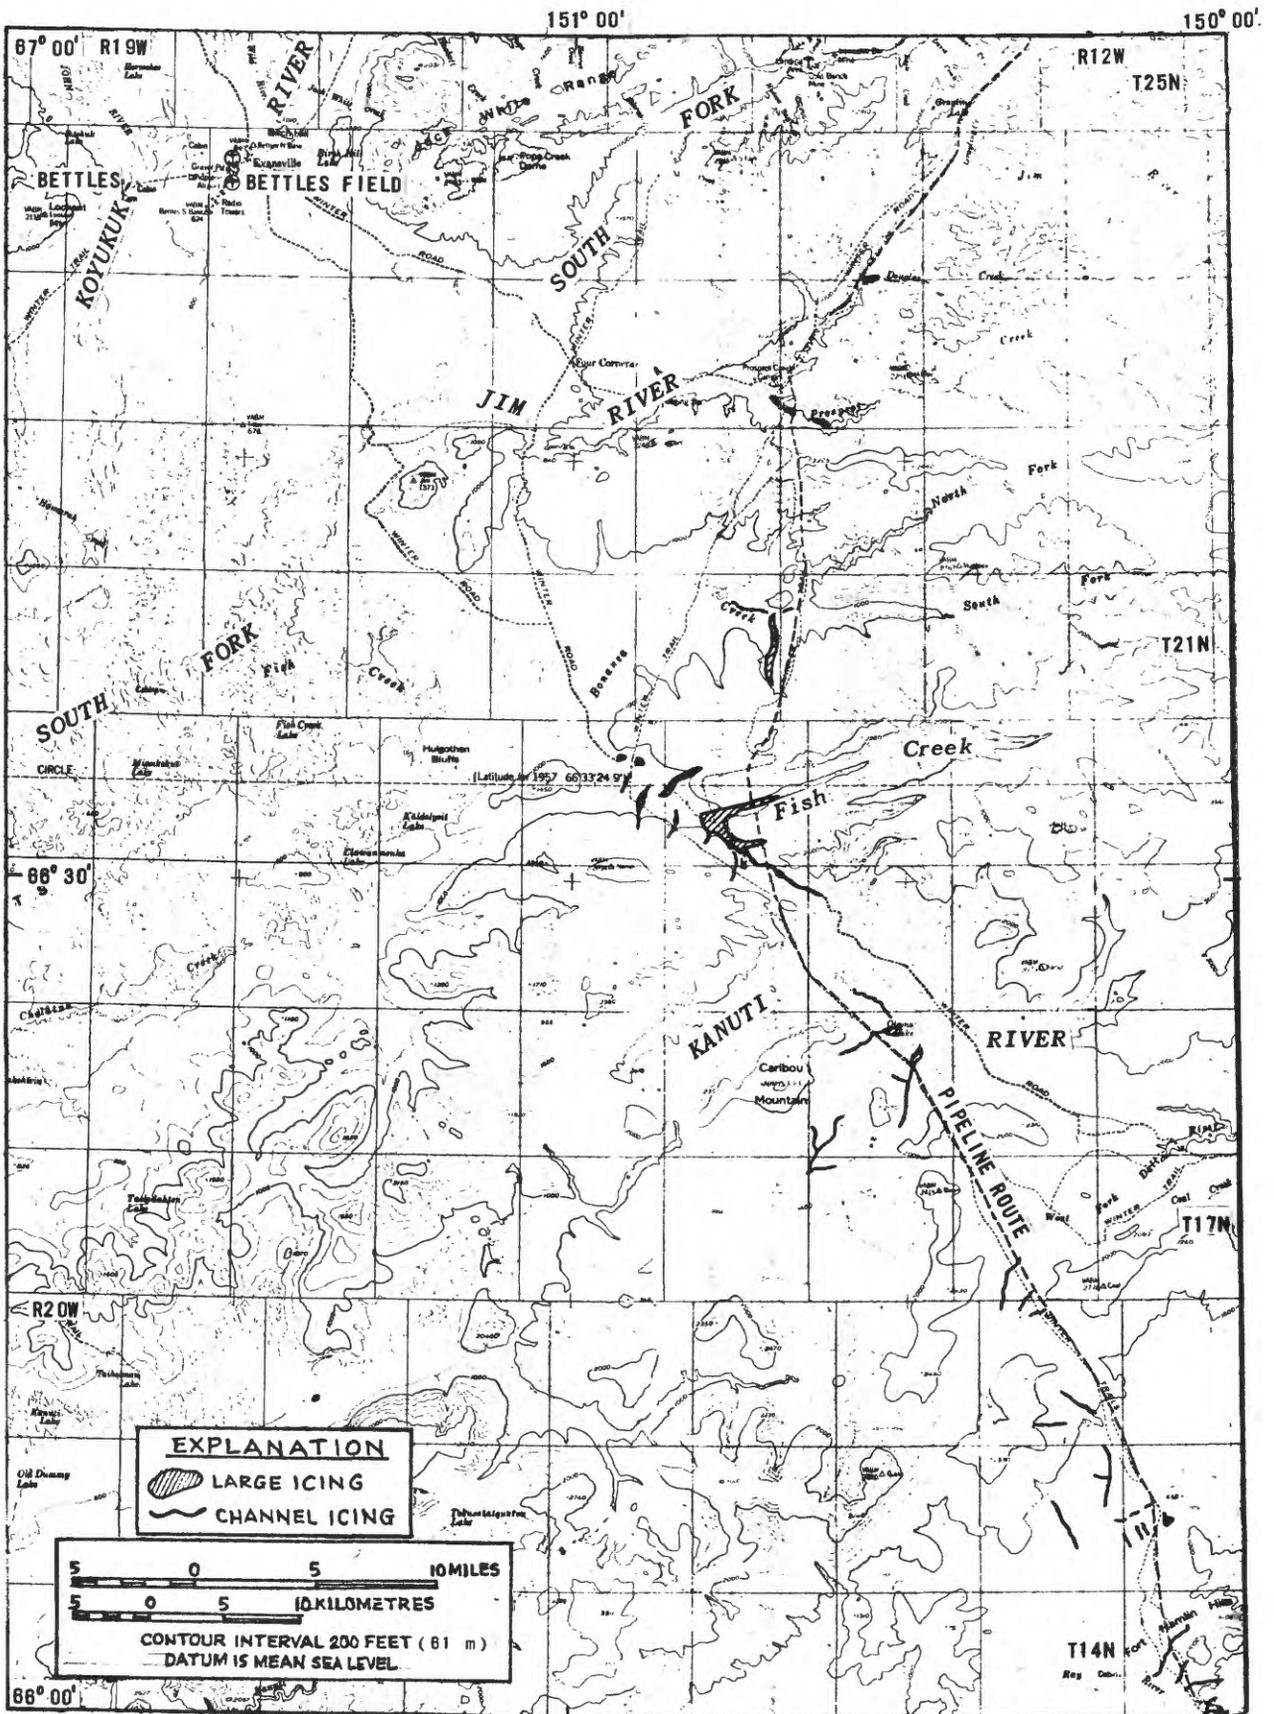
From the Middle Fork Koyukuk River to the Fairbanks area, the pipeline route transects rather than parallels the streams, valleys, and ridges. Channel icings occur in the South Fork Koyukuk River, Prospect Creek, and other large streams crossed by the pipeline route (fig. 17). Icings from springs in Fish Creek have caused several local reroutings of winter trails. Icings do not occur on the Yukon River at the pipeline bridge crossing.

Figure 17.--Distribution of icings along the trans-Alaska pipeline route in the Bettles quadrangle.

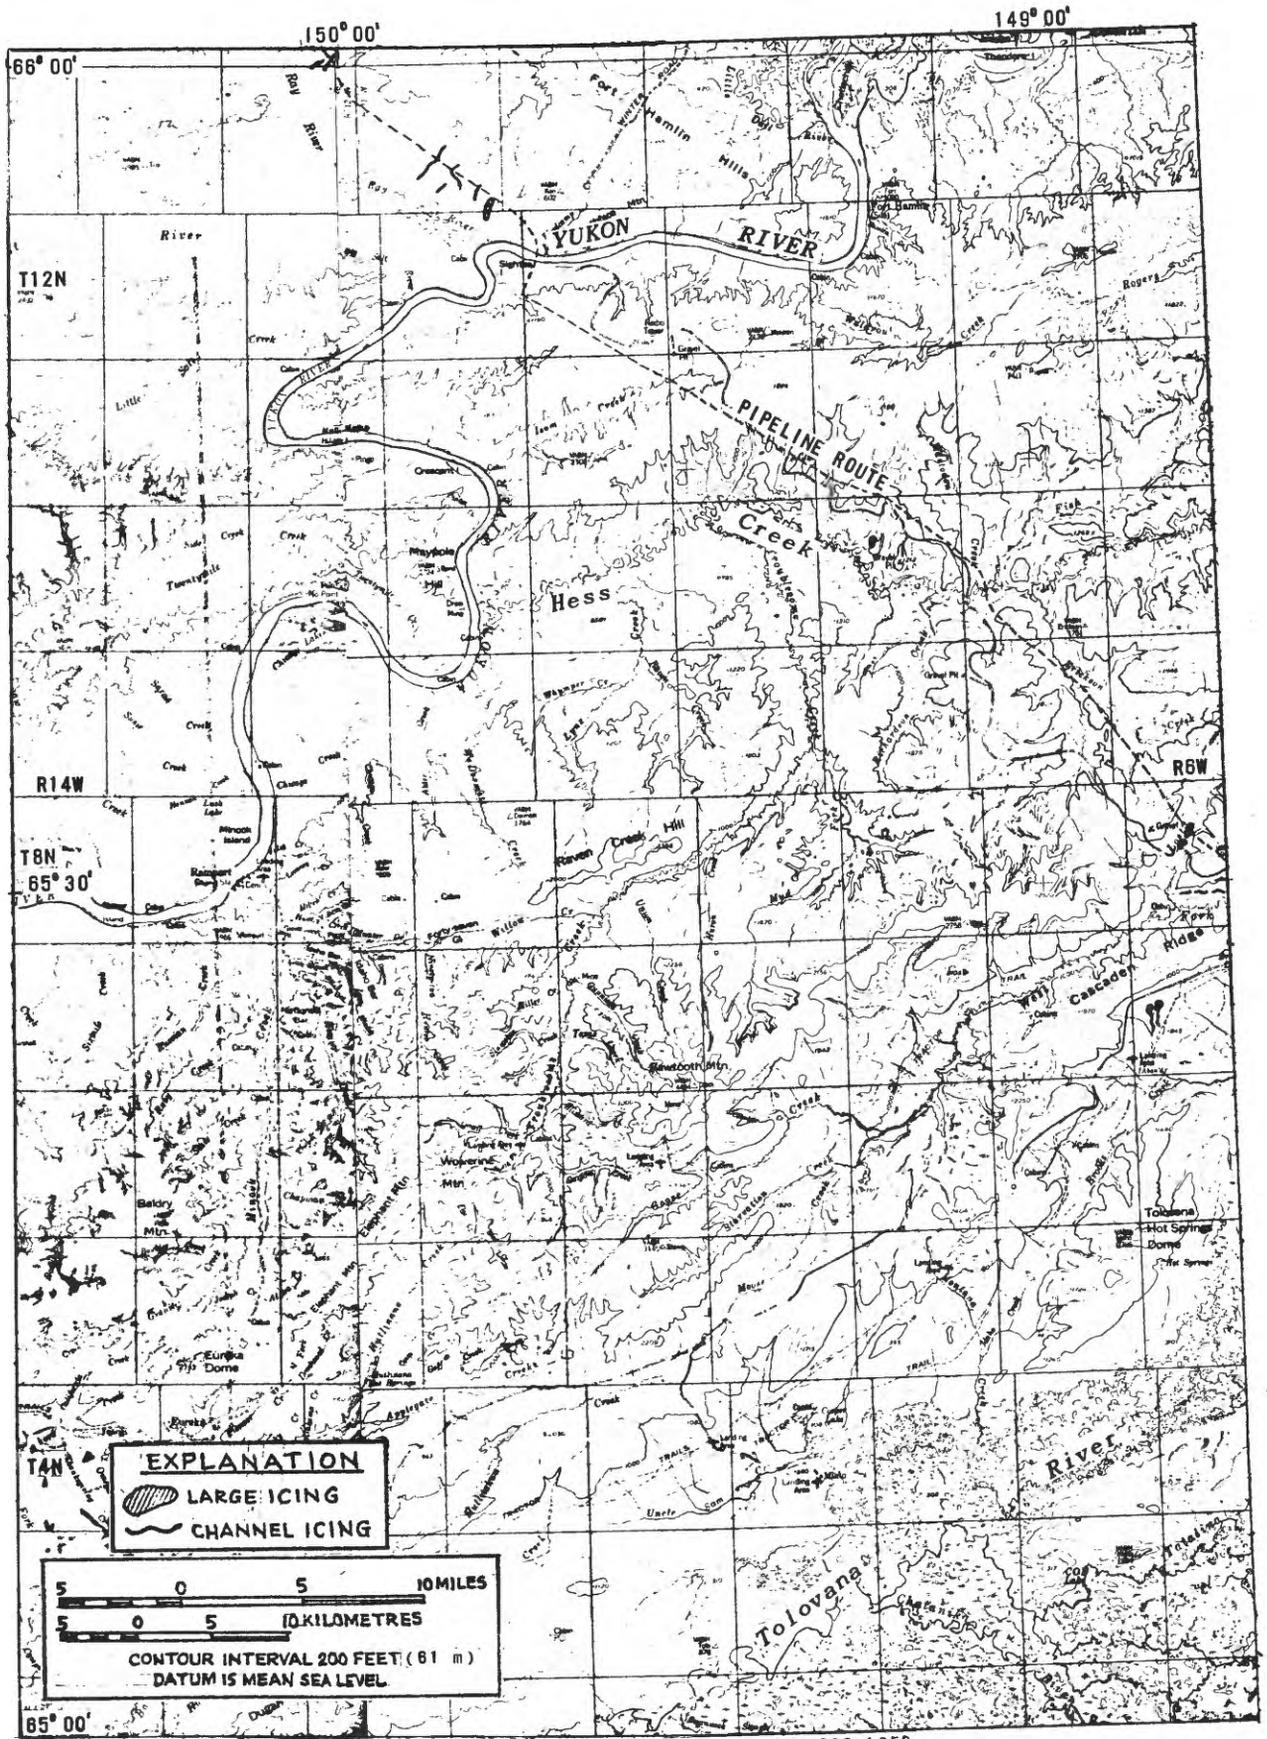
South of the Yukon River, narrow channel icings form on the small streams in the uplands (figs. 18 and 19). The source for these icings may be artesian water from bedrock drainage or from unfrozen ground above permafrost. The water emerges in small depressions or gullies that drain to the larger stream valleys.

Figure 18.--Distribution of icings along the trans-Alaska pipeline route in the Tanana and Livengood quadrangles.

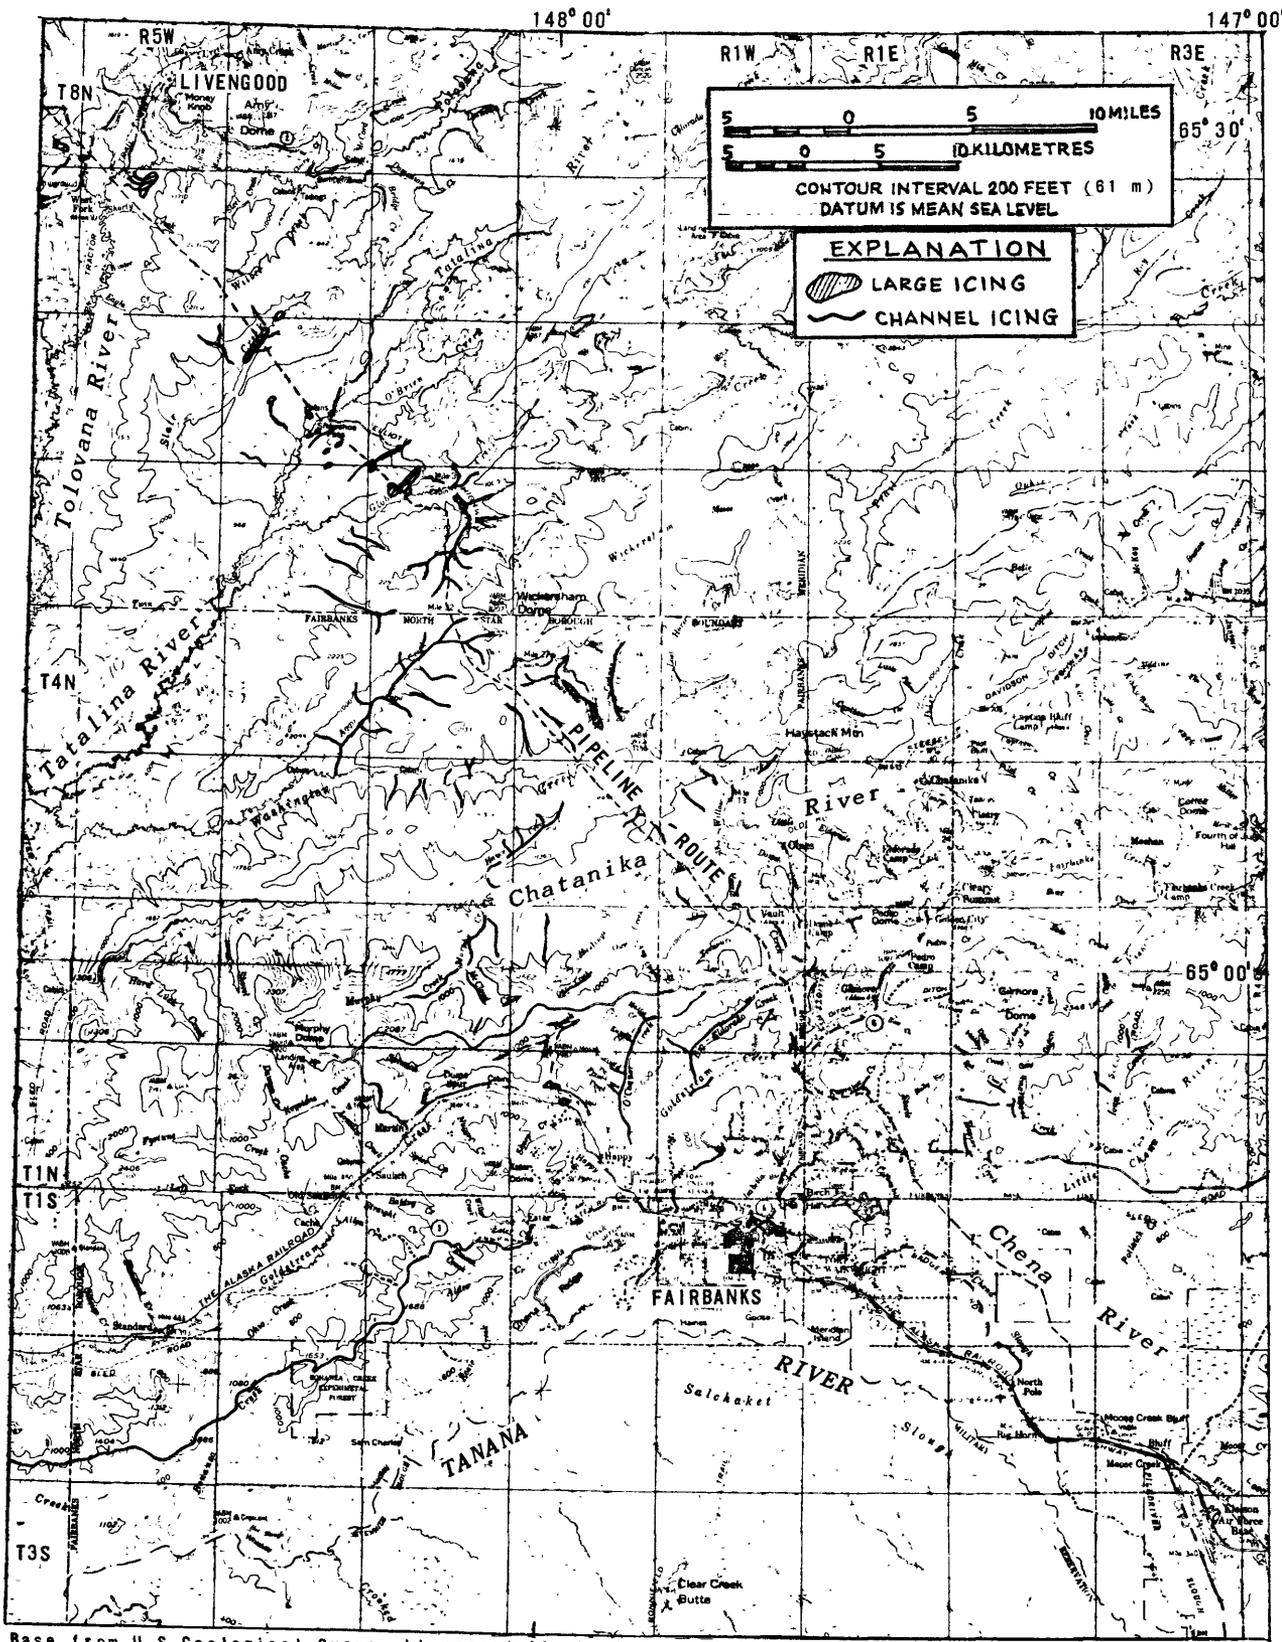
Channel ice and minor overflow icing occurs on the major streams crossed by the pipeline between Fairbanks (fig. 20) and Big Delta (fig. 21). Icings form on many smaller streams draining the Yukon-Tanana Uplands. Thermal infrared imagery obtained in February 1974 shows water overflowing the icings in the Minton Creek area (fig. 22). In this imagery, the presence of water is indicated by the white areas that signify relatively higher temperatures. A large icing occurs along the pipeline route in the flats north of Shaw Creek (fig. 23). An open channel is usually maintained along the Tanana River at the planned pipeline crossing because relatively warm ground water is discharged along the south bank.

Figure 20.--Distribution of icings along the trans-Alaska pipeline route in the Livengood and Fairbanks quadrangles.

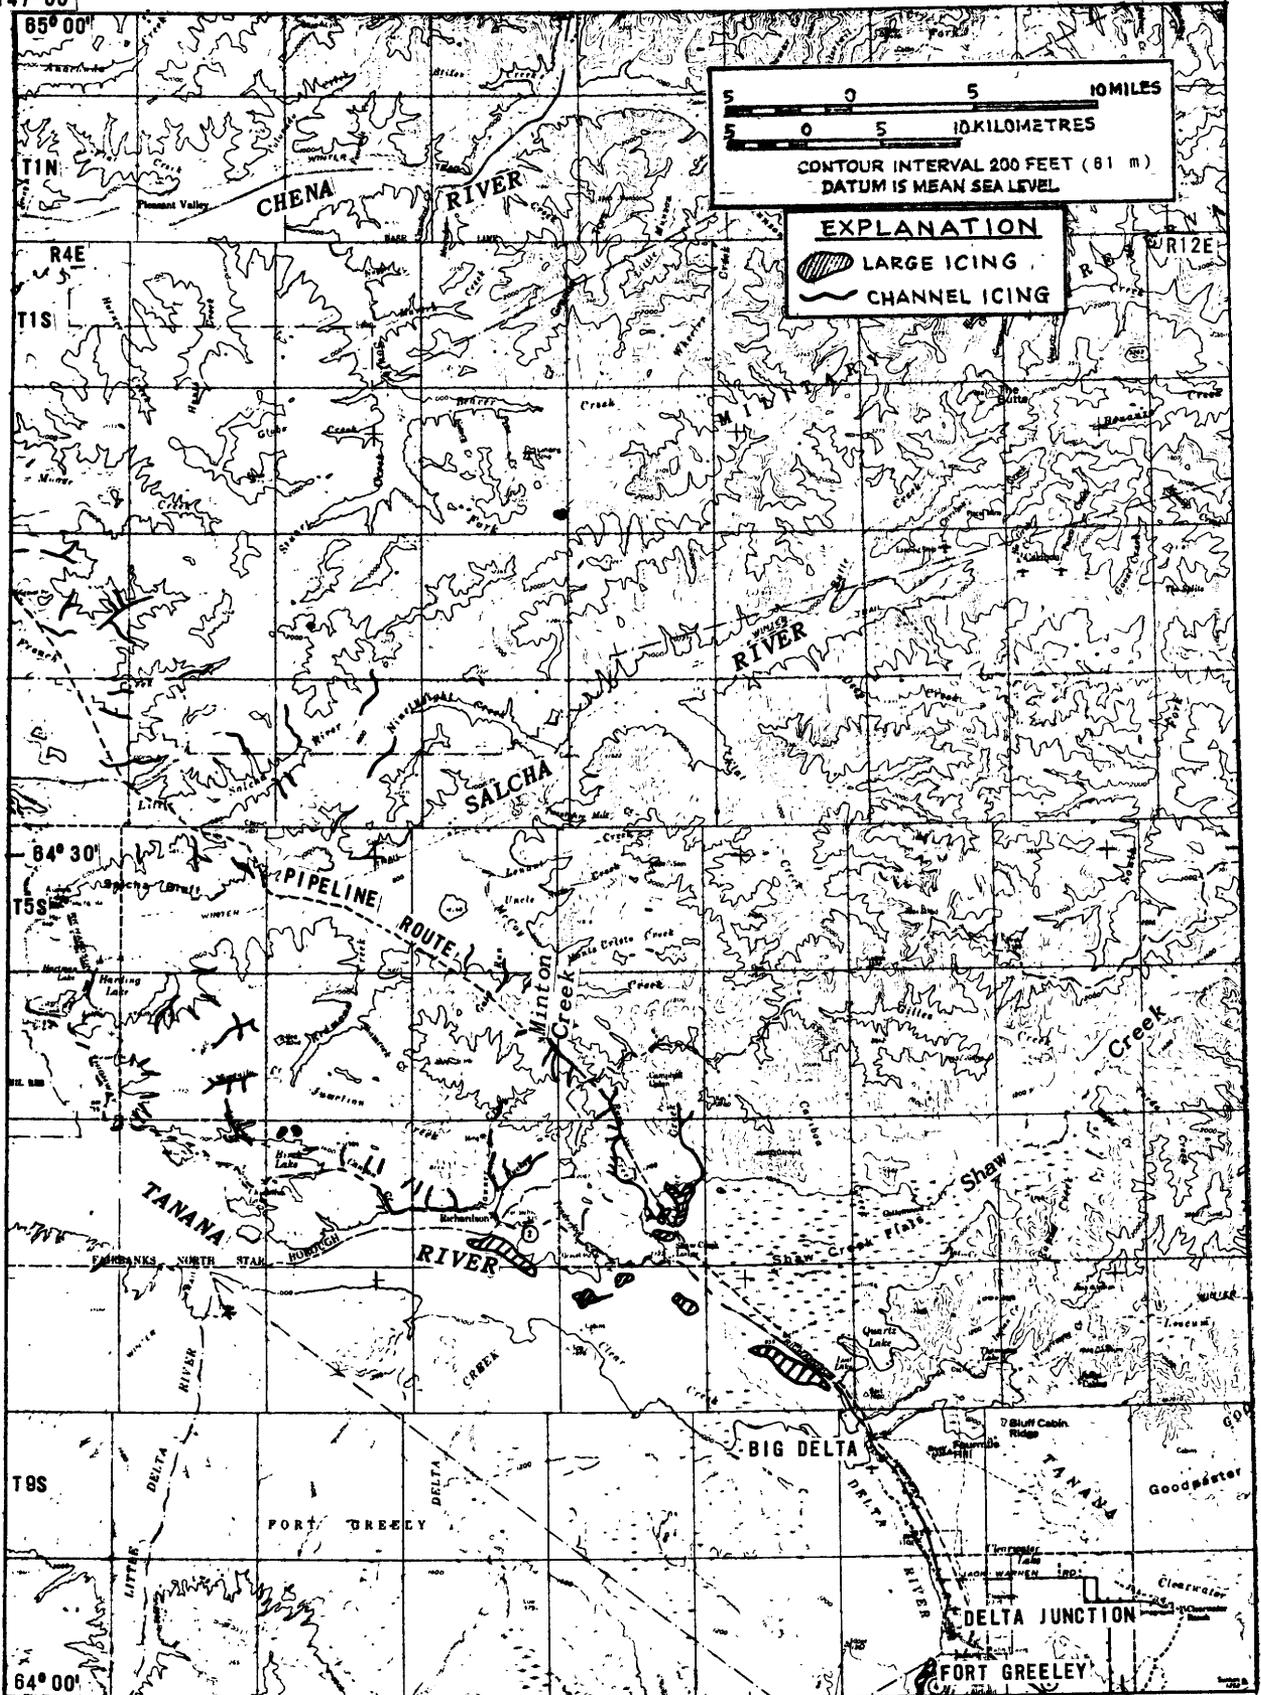
Figure 21.--Distribution of icings along the trans-Alaska pipeline route in the Big Delta quadrangle.

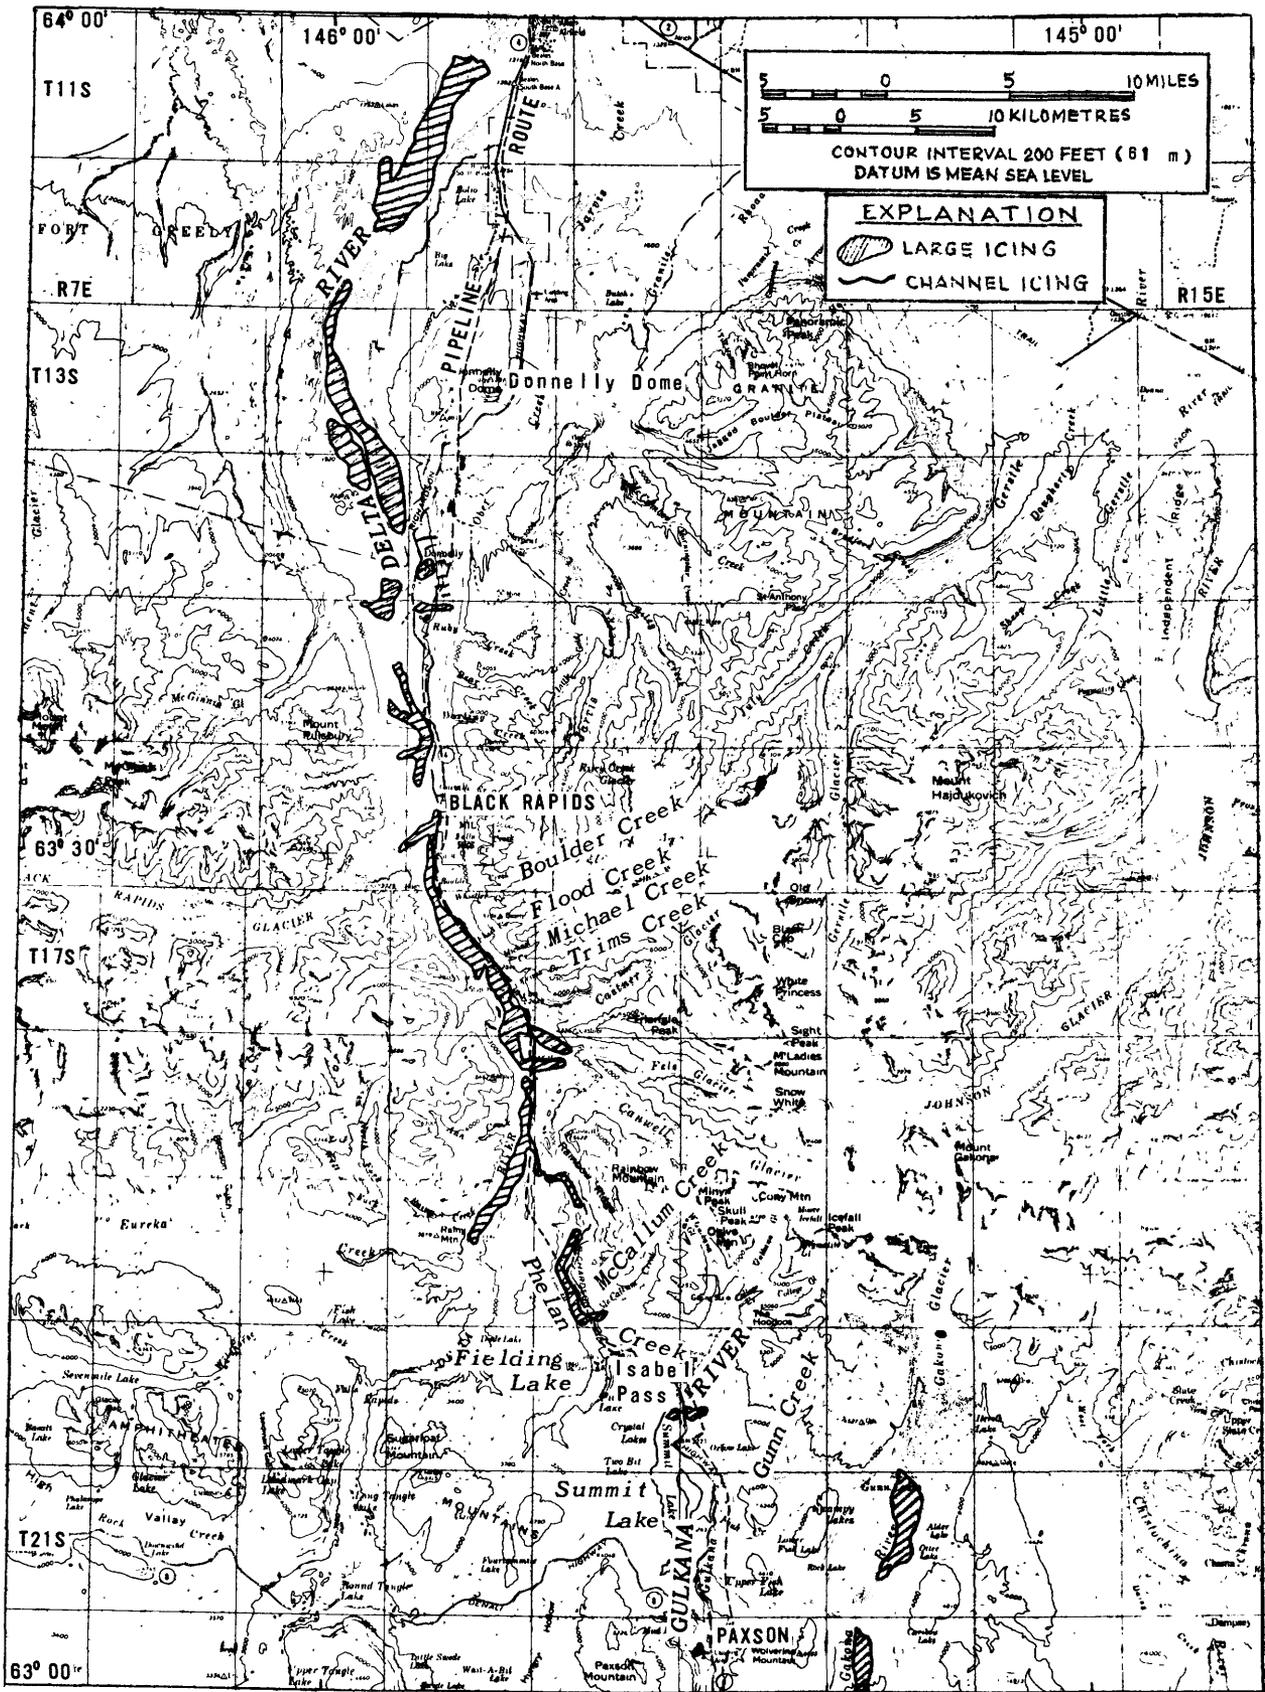
Small hillside and channel icings occur along the pipeline route between Donnelly Dome and Black Rapids (fig. 24). South of Black Rapids the pipeline route is in the active flood plain of the Delta River where extensive icings form annually (cover photograph; figs. 2, 25, and 26). The toes of several steep alluvial fans, including those of Boulder, Flood, and Trims Creeks, are crossed in this reach. The pipeline route also crosses the site of a large icing in Phelan Creek and site of another icing on the fan of McCallum Creek (fig. 27).

Figure 24.--Distribution of icings along the trans-Alaska pipeline route in the Mt. Hayes quadrangle.

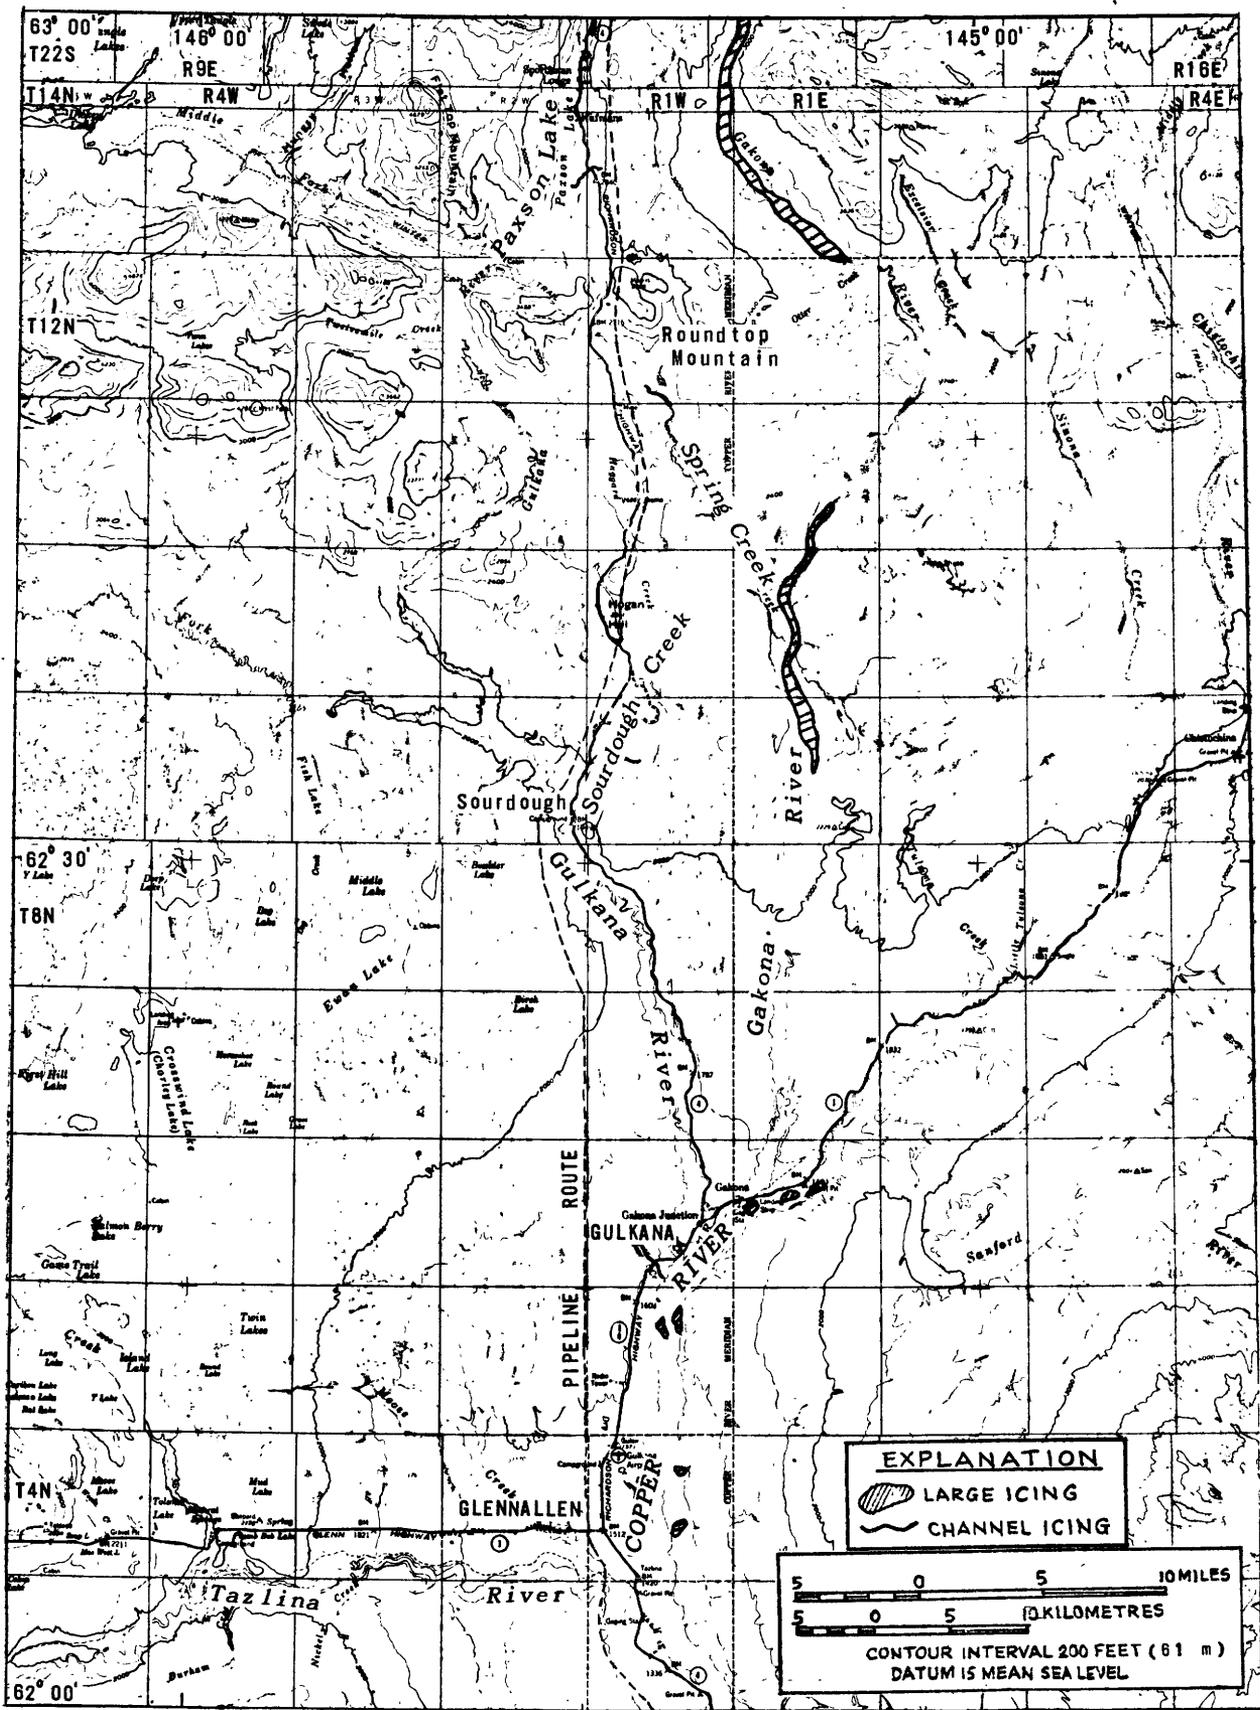
The main icings along the pipeline route through the Copper River basin are due to hillside springs and seeps, such as those along the Richardson Highway near Paxson Lake (fig. 30). Areas of stream icing occur along Spring Creek near Roundtop Mountain and along Sourdough Creek near the Gulkana River. Major icings have occurred at the Klutina River (fig. 31) and have inundated part of the town of Copper Center (U.S. Army Corps of Engineers, 1967). Large icings also form on the Tonsina River and Squirrel Creek below the pipeline crossing and have been reported on the Tazlina River (Williams, 1953). Normal channel ice with only minor overflow forms on the Gulkana River in the crossing reach (fig. 30).

Figure 30.--Distribution of icings along the trans-Alaska pipeline route in the Gulkana quadrangle.
