ICINGS ALONG THE TRANS-ALASKA PIPELINE ROUTE

By Charles E. Sloan, Chester Zenone,  
and Lawrence R. Mayo

Open-File Report 75-87

Anchorage, Alaska  
1975

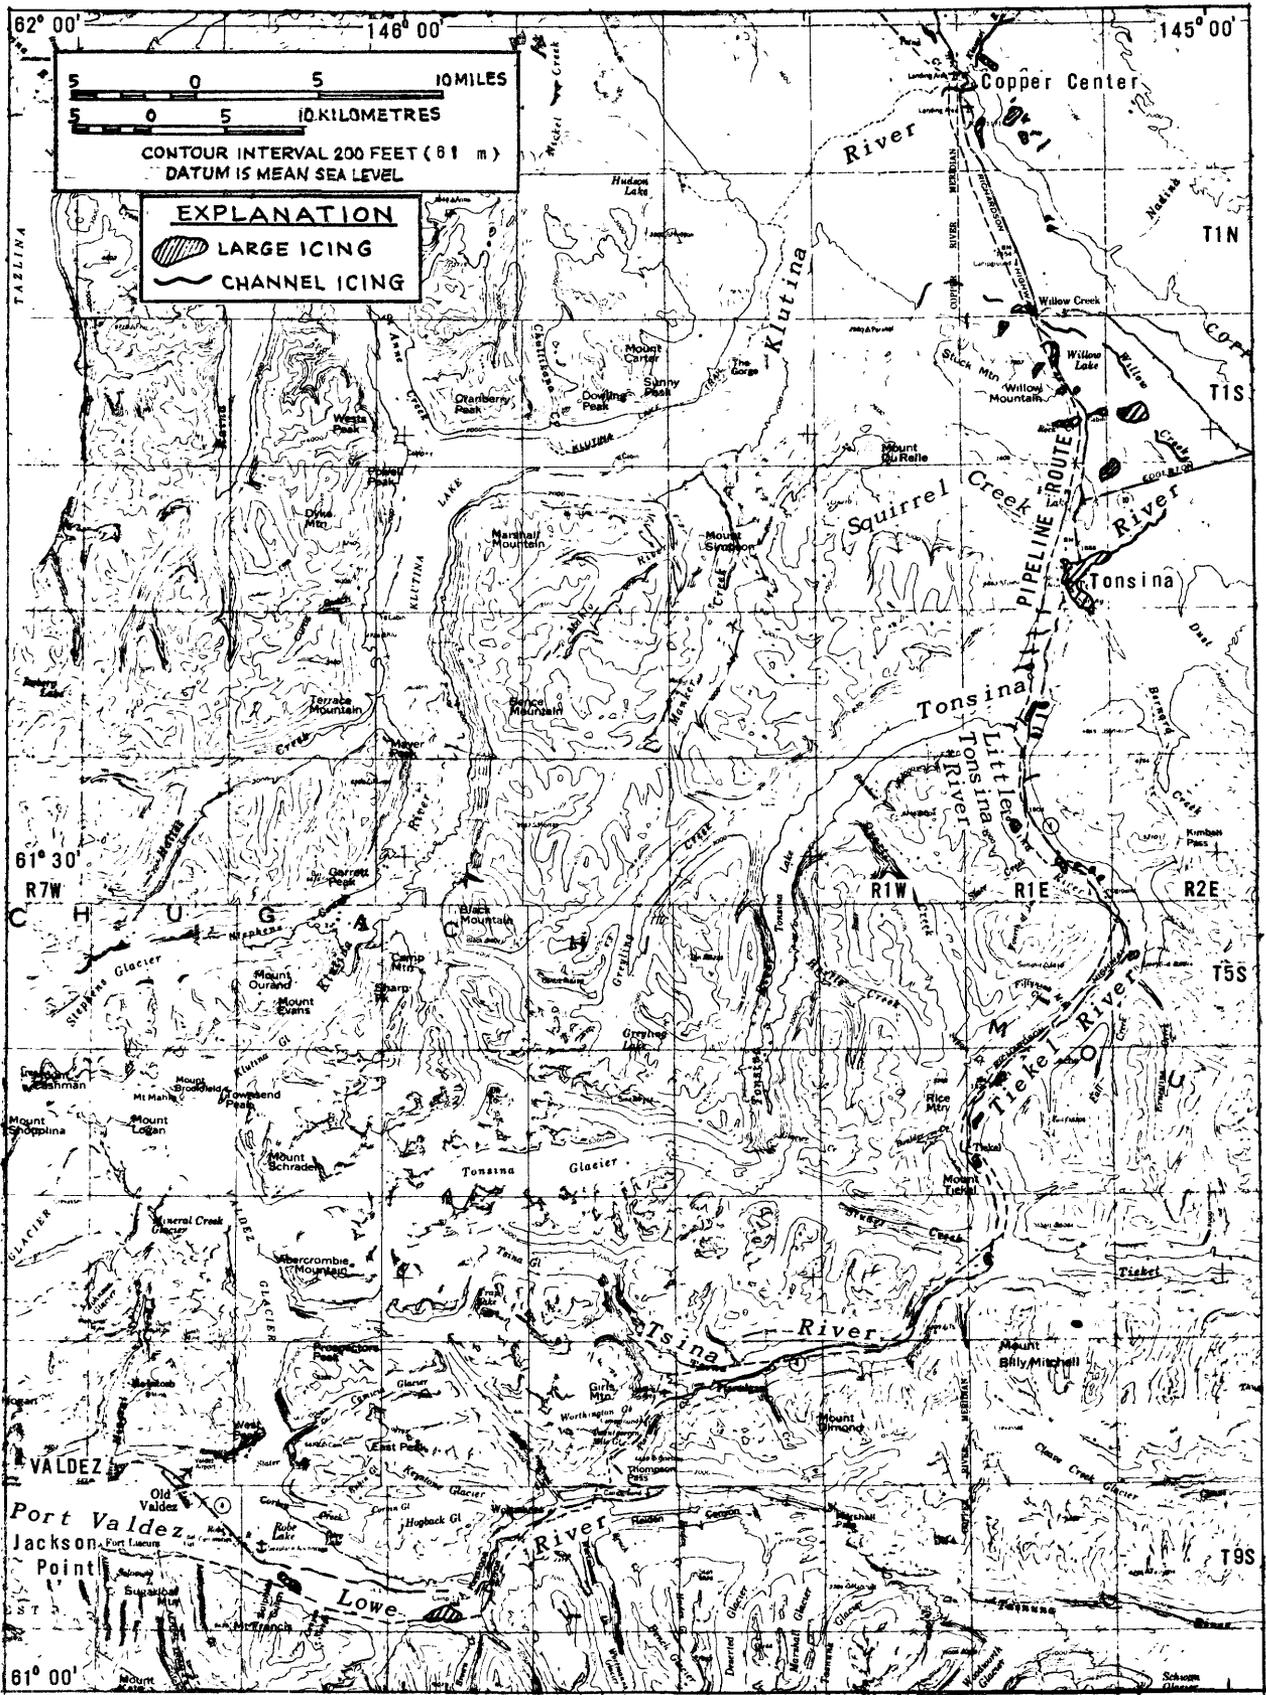
Streams in this section generally have high gradients, narrow valley bottoms, and few braided channel reaches except for the upper part of the Tsina and the lower part of the Lowe Rivers (fig. 31). Icings are generally small, discontinuous, and restricted to short braided channel reaches or hillside areas.

Figure 31.--Distribution of icings along the trans-Alaska pipeline route in the Valdez quadrangle.
