UNITED STATES
DEPARTMENT OF THE INTERIOR
GEOLOGICAL SURVEY

CHANNEL EROSION SURVEYS ALONG THE TAPS ROUTE,
ALASKA 1977

OPEN-FILE REPORT 78-611
(Basic Data)

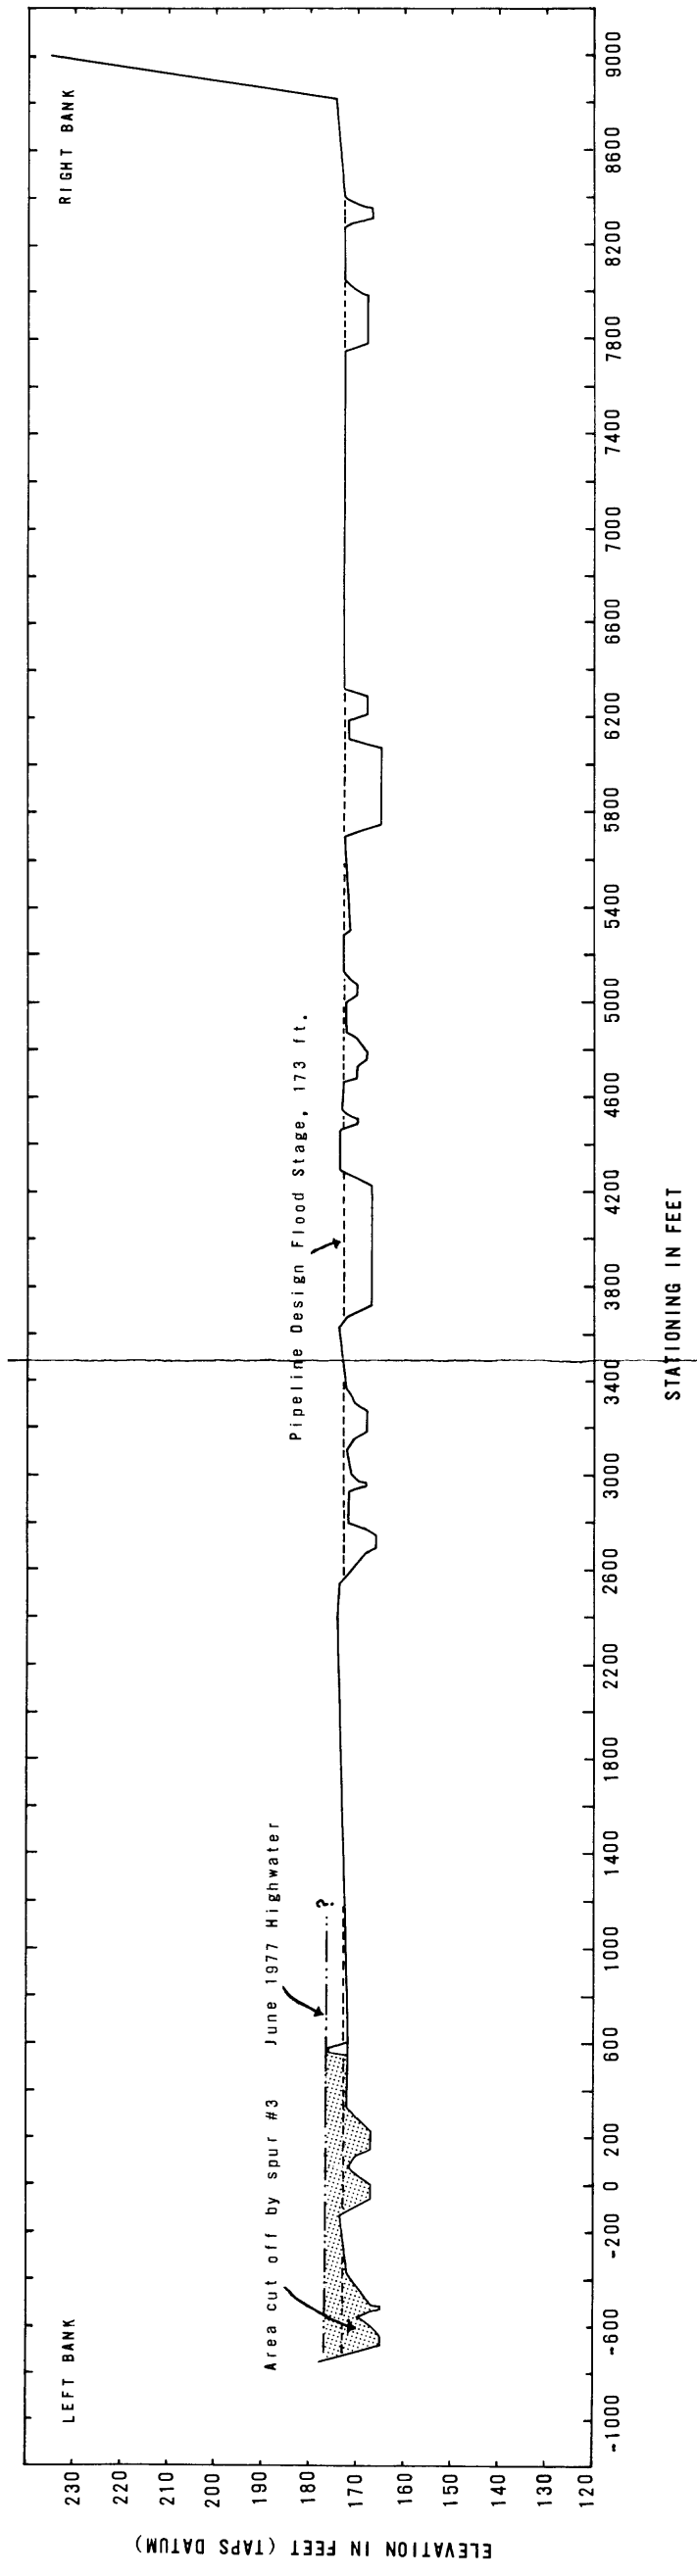
Figure 5. -- Cross section 5411+70 on alignment #134 of the Sagavanirktok River near Deadhorse, taken from Alyeska Pipeline Service Co. (1974), plate C-9a.

Figure 5 shows a cross section of the Sagavanirktok River just downstream from spur No. 3. The figure displays a typical wide, flat profile of braided river. The pipeline design flood stage of approximately 173 ft and the June 1977 flood stage of approximately 177 ft are shown. Spur No. 3, just downstream, is projected onto the cross section. The average fall for this section of the river is 0.00174 feet per foot.

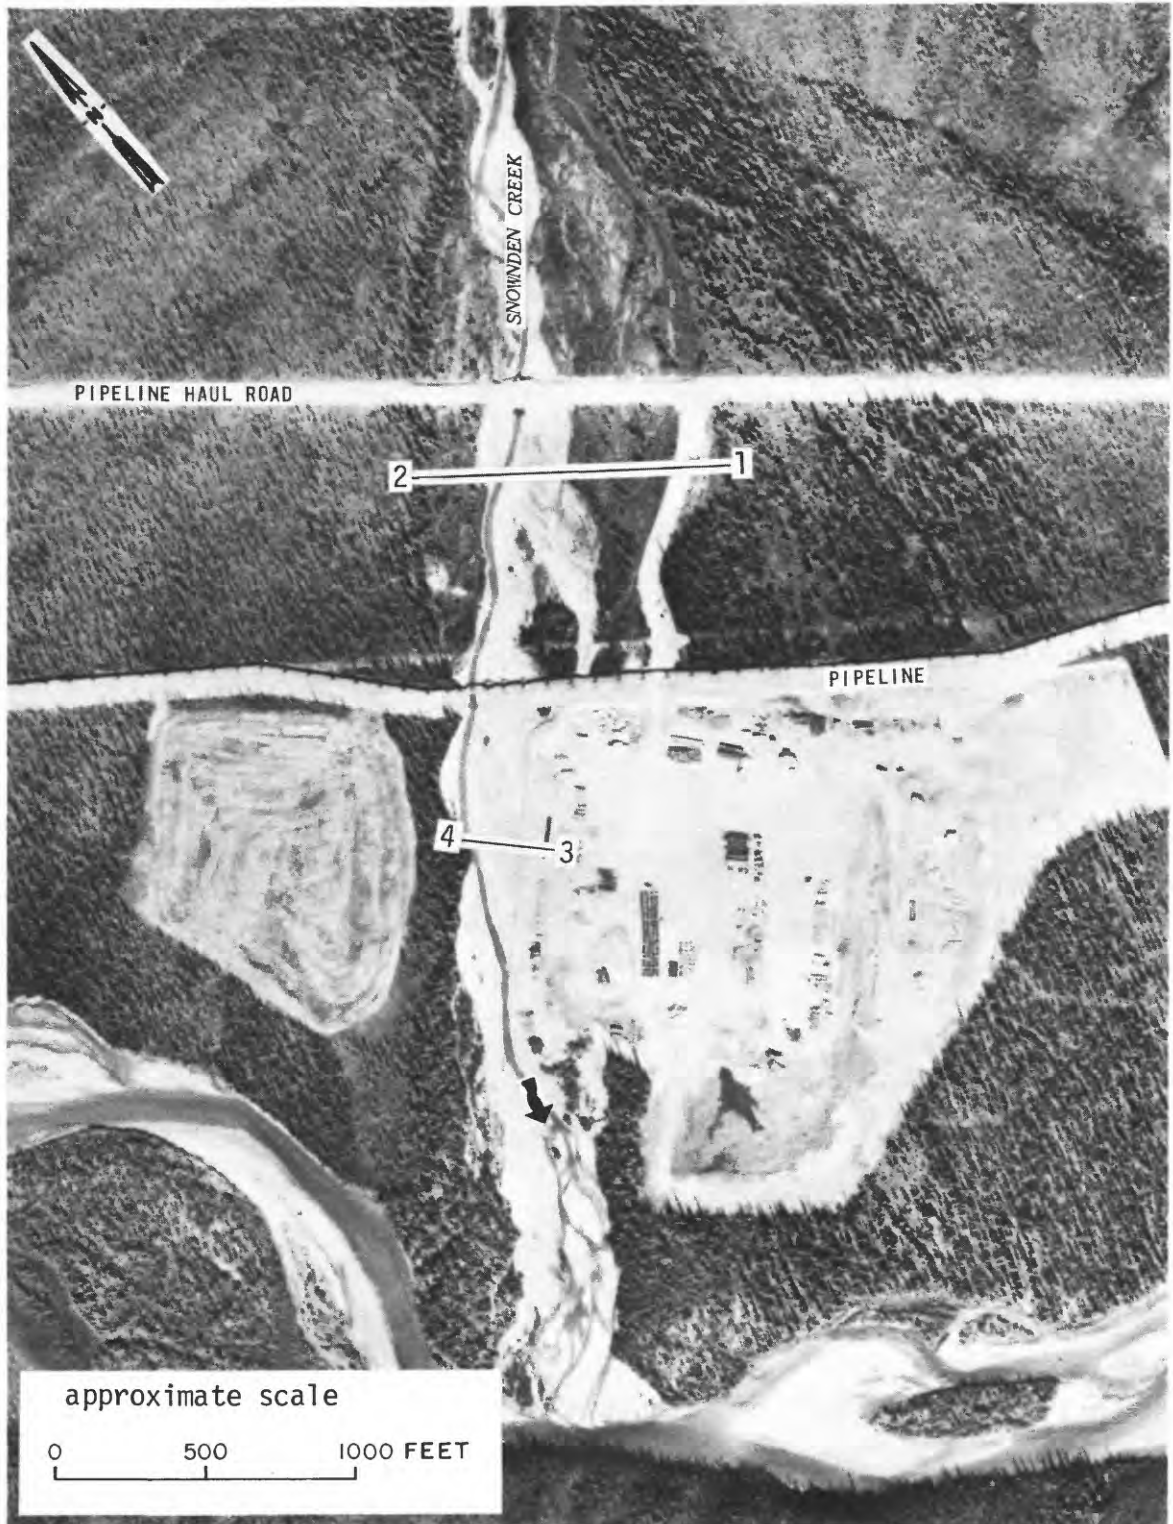
Figure 6. -- Snowden Creek near Dietrich camp, July 12, 1977

1977 Surveillance.--Figure 6 shows the Snowden Creek crossing site on July 12, 1977. During the past year, protective rip-rap has been installed around the centerline.

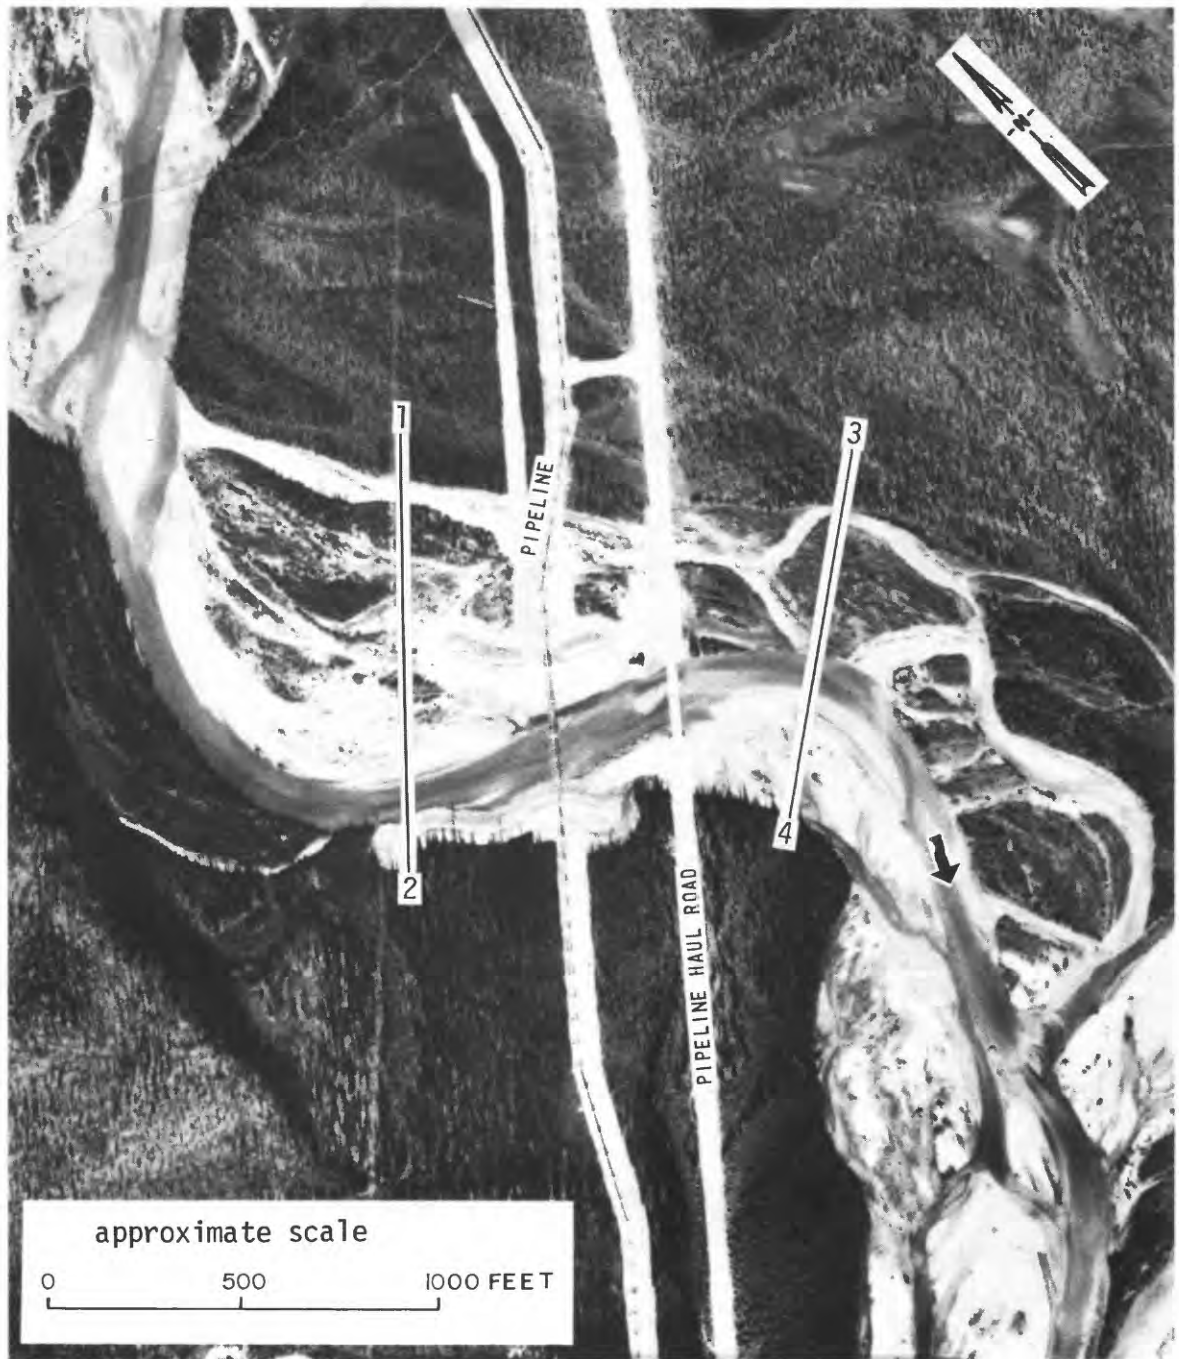
Figure 8. -- Dietrich River at Bettles River, July 12, 1977.

1977 Surveillance.--Figure 8 shows the Dietrich River site on July 12, 1977. During the last year, rip-rap has been installed along the right bank of the centerline.

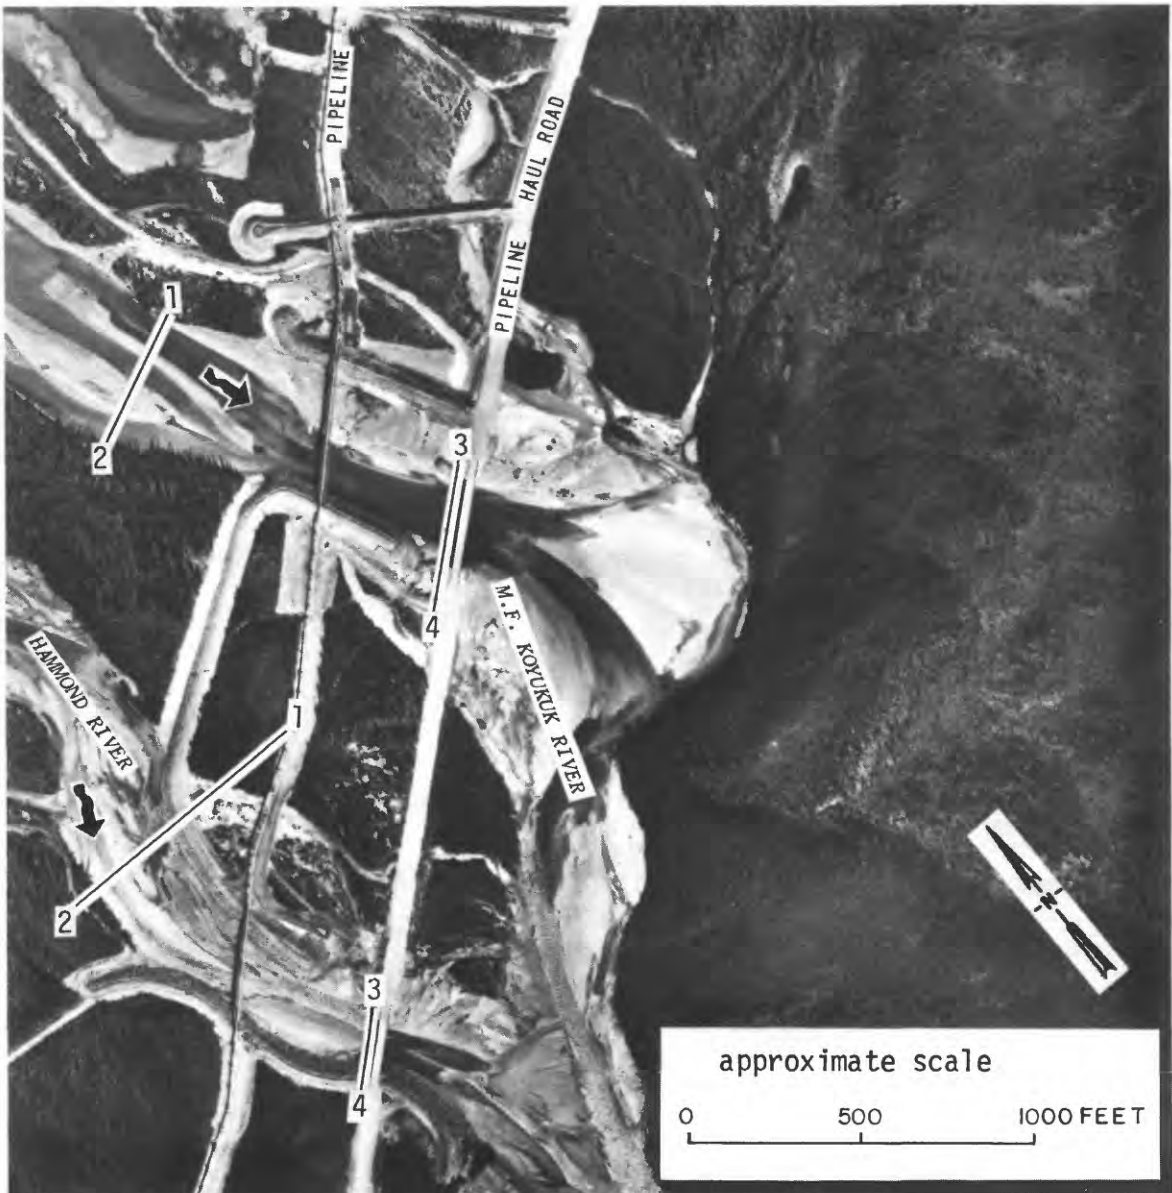
Figure 10. -- Middle Fork Koyukuk River at Hammond River and Hammond River near Wiseman, July 12, 1977. AIR PHOTO TECH

1977 Surveillance.--Figure 10 shows the Middle Fork Koyukuk River at the Hammond River crossing site on July 12, 1977. A protective dike extending from the right bank of the Middle Fork of the Koyukuk to the left bank of the Hammond River has been completed. A dike has been constructed on the left bank, extending from above the centerline to the haul road. In addition, fill which extended out from the left bank of the centerline has been removed by erosion.

1977 Surveillance.--Figure 10 shows the Hammond River crossing site on
July 12, 1977. A protective dike has been completed on the left
bank of the river. Fill extending off the right bank of the center-
line has eroded.

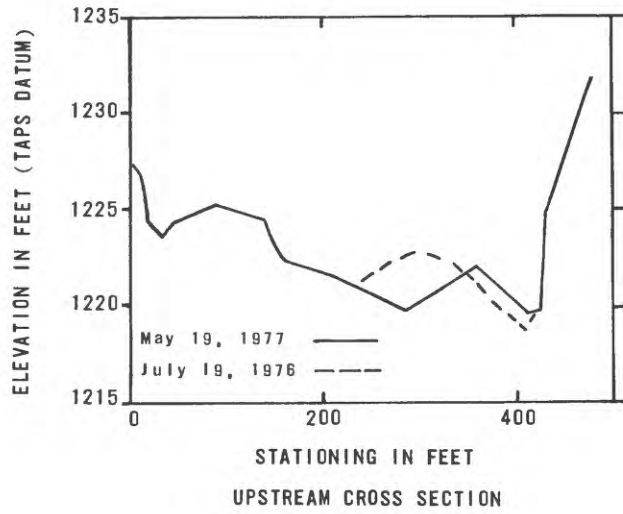
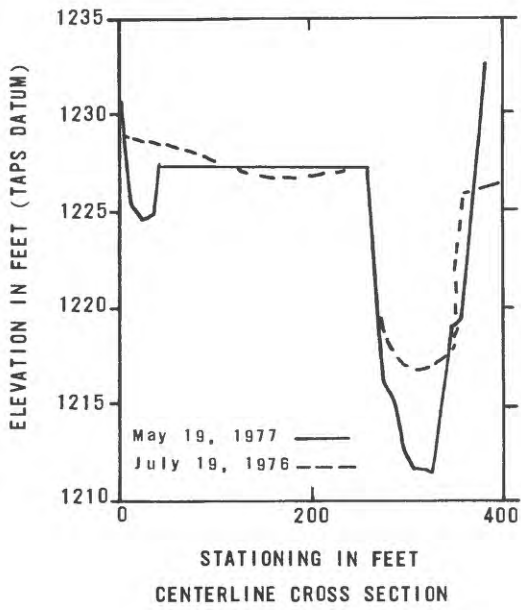
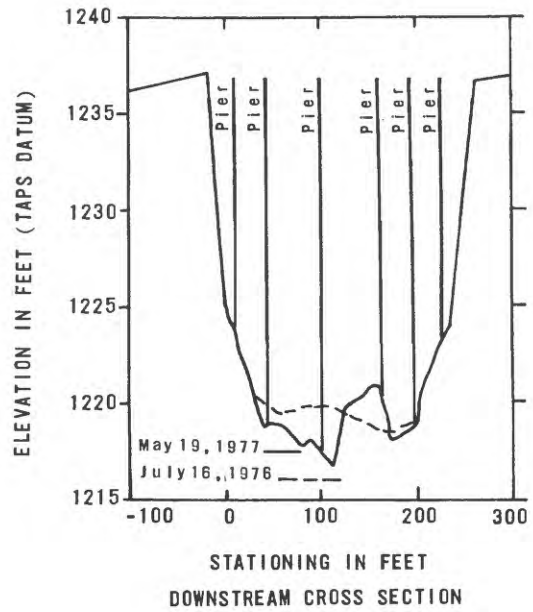
Figure 11. -- Cross sections of the Middle Fork Koyukuk River at Hammond River.

The site was resurveyed on May 19, 1977. All cross sections are significantly changed. Construction activities have radically constricted the centerline and helped deepen the thalweg to more than 5 ft. The thalweg of the downstream section has been slightly deepened (fig.11).

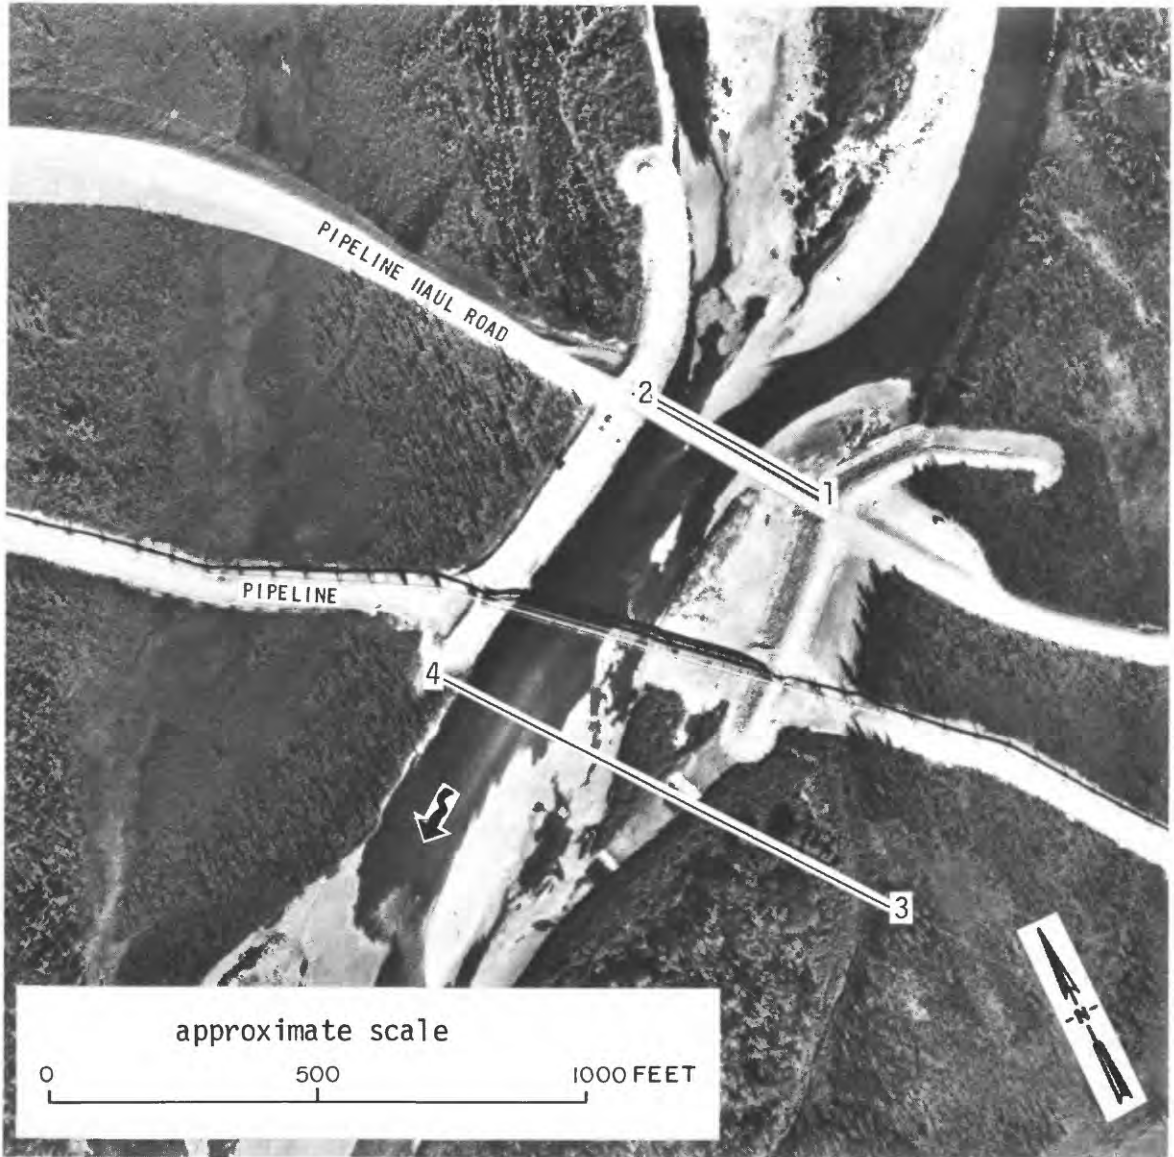
Figure 17. -- South Fork Koyukuk River near Wiseman, July 12, 1977.
AIR PHOTO TECH

1977 Surveillance.--Figure 17 shows the South Fork Koyukuk site on July 12, 1977. The site was resurveyed on September 17, 1977. There has been no significant change in the upstream cross section since 1975, but minor changes were found in both the centerline and downstream cross sections (fig. 18).

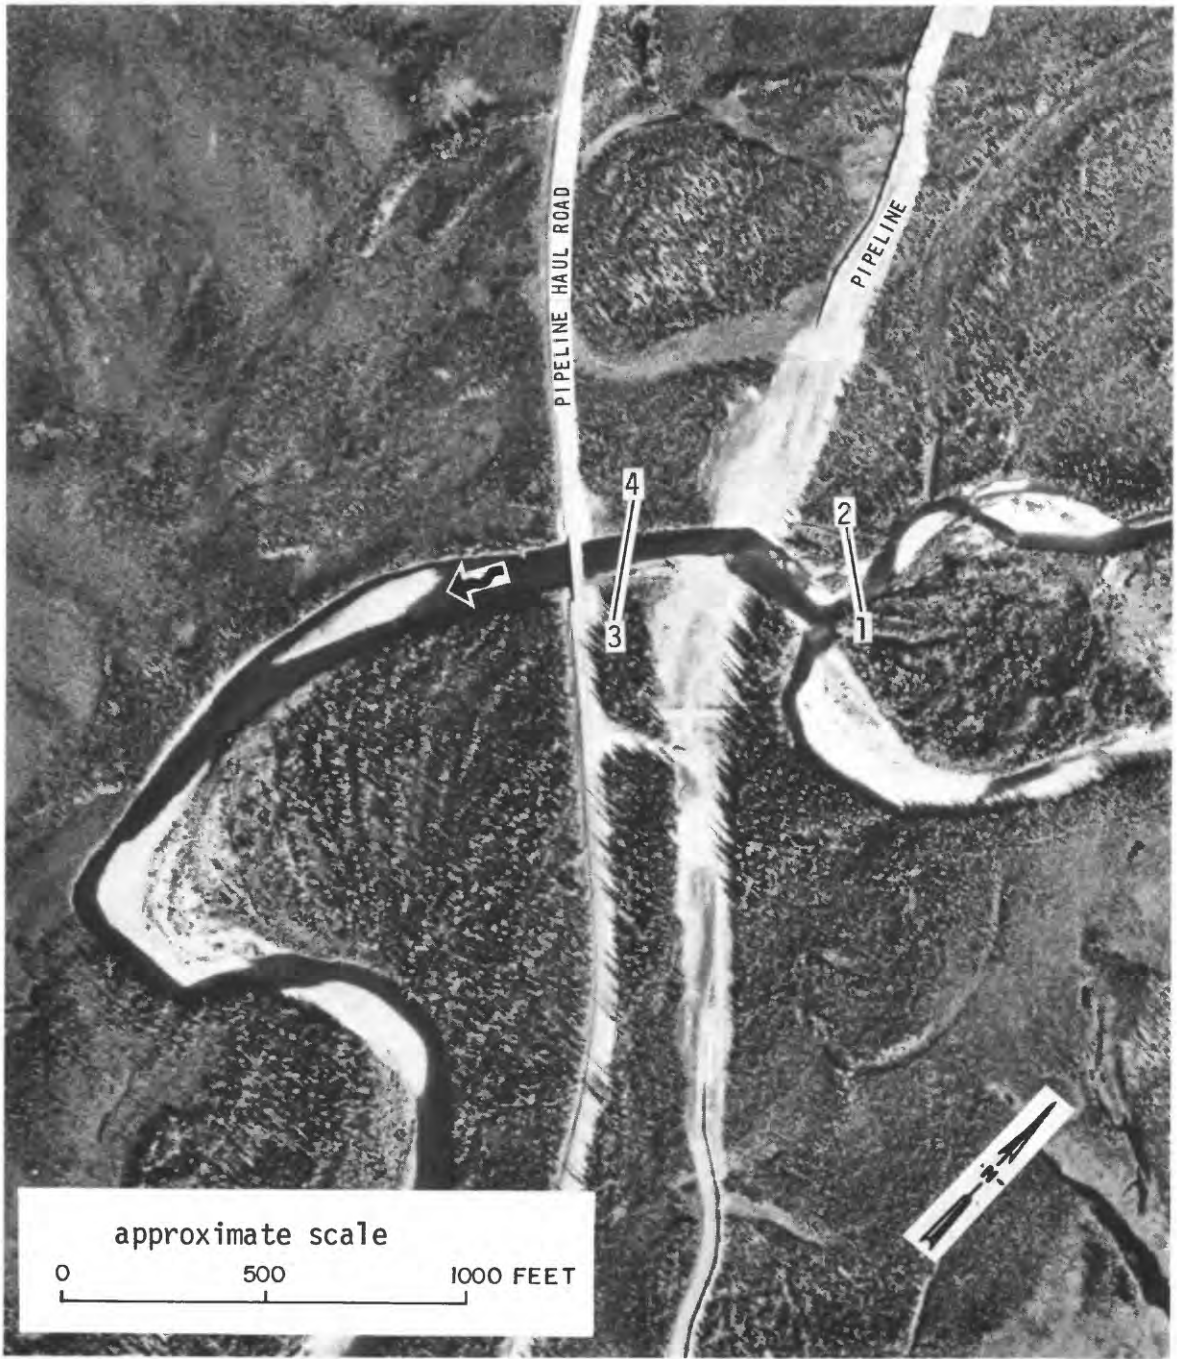
Figure 19. -- Jim River near Prospect Creek camp, September 1, 1977.

1977 Surveillance.--Figure 19 shows the Jim River crossing on September 1, 1977. The site was resurveyed on May 18, 1977. During the last year, backfilling and other construction activities have deepened the centerline cross section, the only significant change in the three measured sections (fig. 20). In addition, a berm has been constructed on the left bank at the centerline.

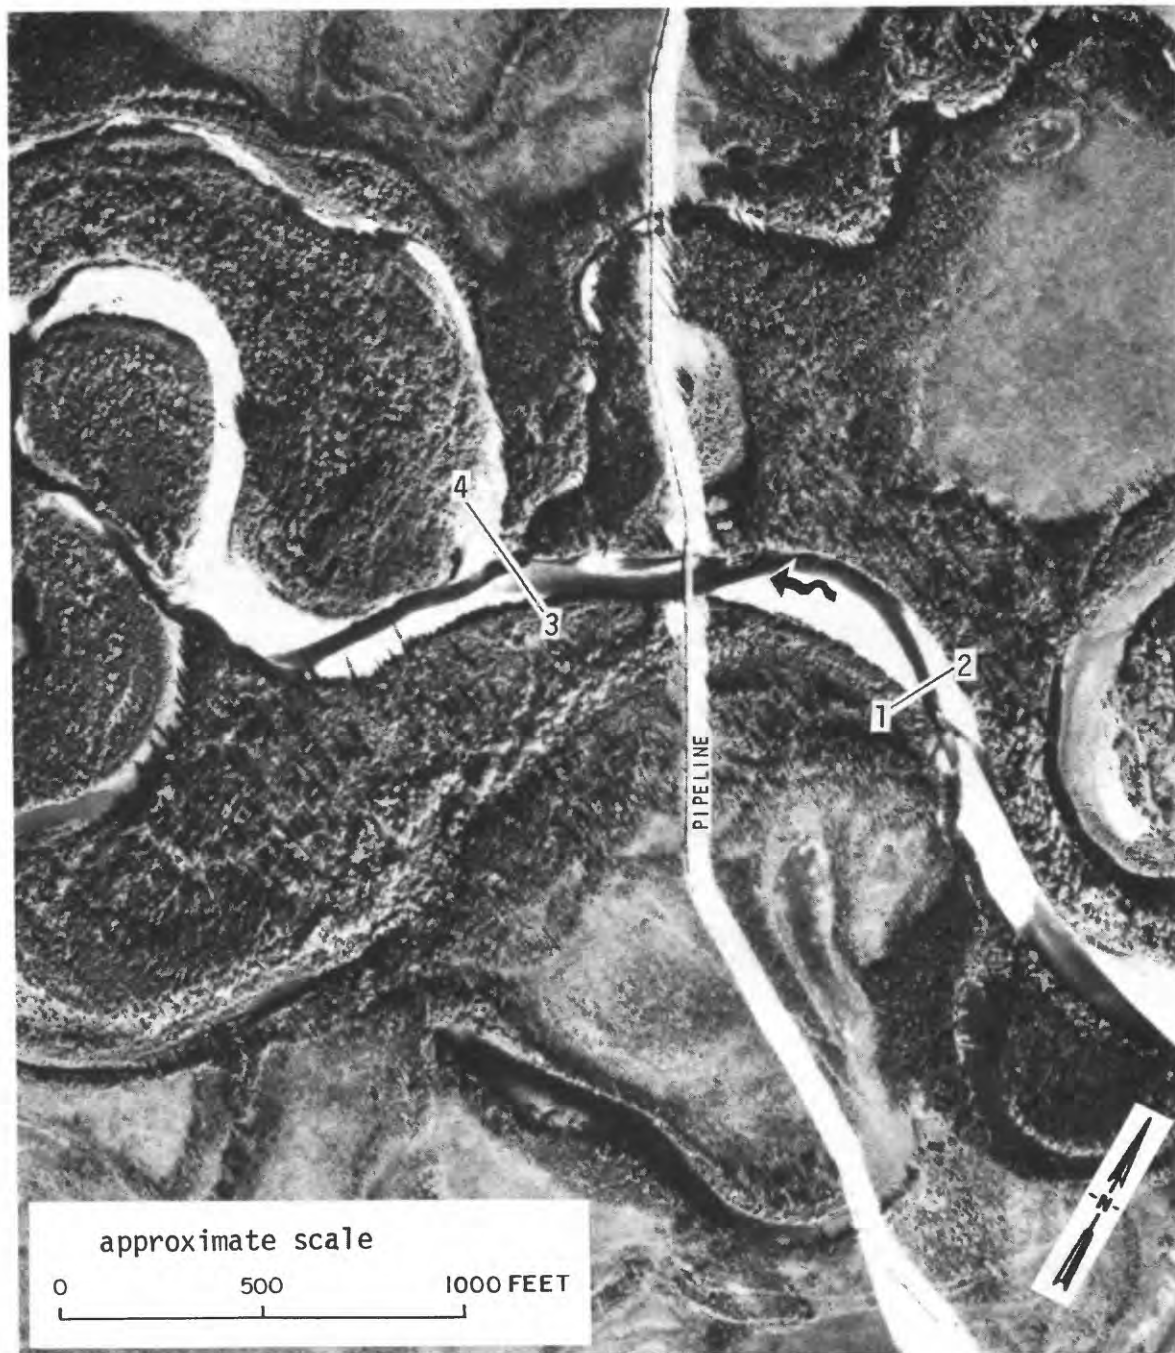
Figure 23. -- Hess Creek near Livengood, July 13, 1977.

1977 Surveillance.--Figure 23 shows the Hess Creek crossing site on July 13, 1977. The overhead pipeline crossing has been completed, and the temporary access bridge constructed last year has been removed. The Hess Creek and Castner Creek sites are the only channel erosion crossing sites to have the pipeline crossing completed between the 1976 and 1977 surveys. All others were finished before the 1976 survey. The crossing site was resurveyed on May 14, 1977. Figure 24 shows the construction-related changes in the centerline cross section.

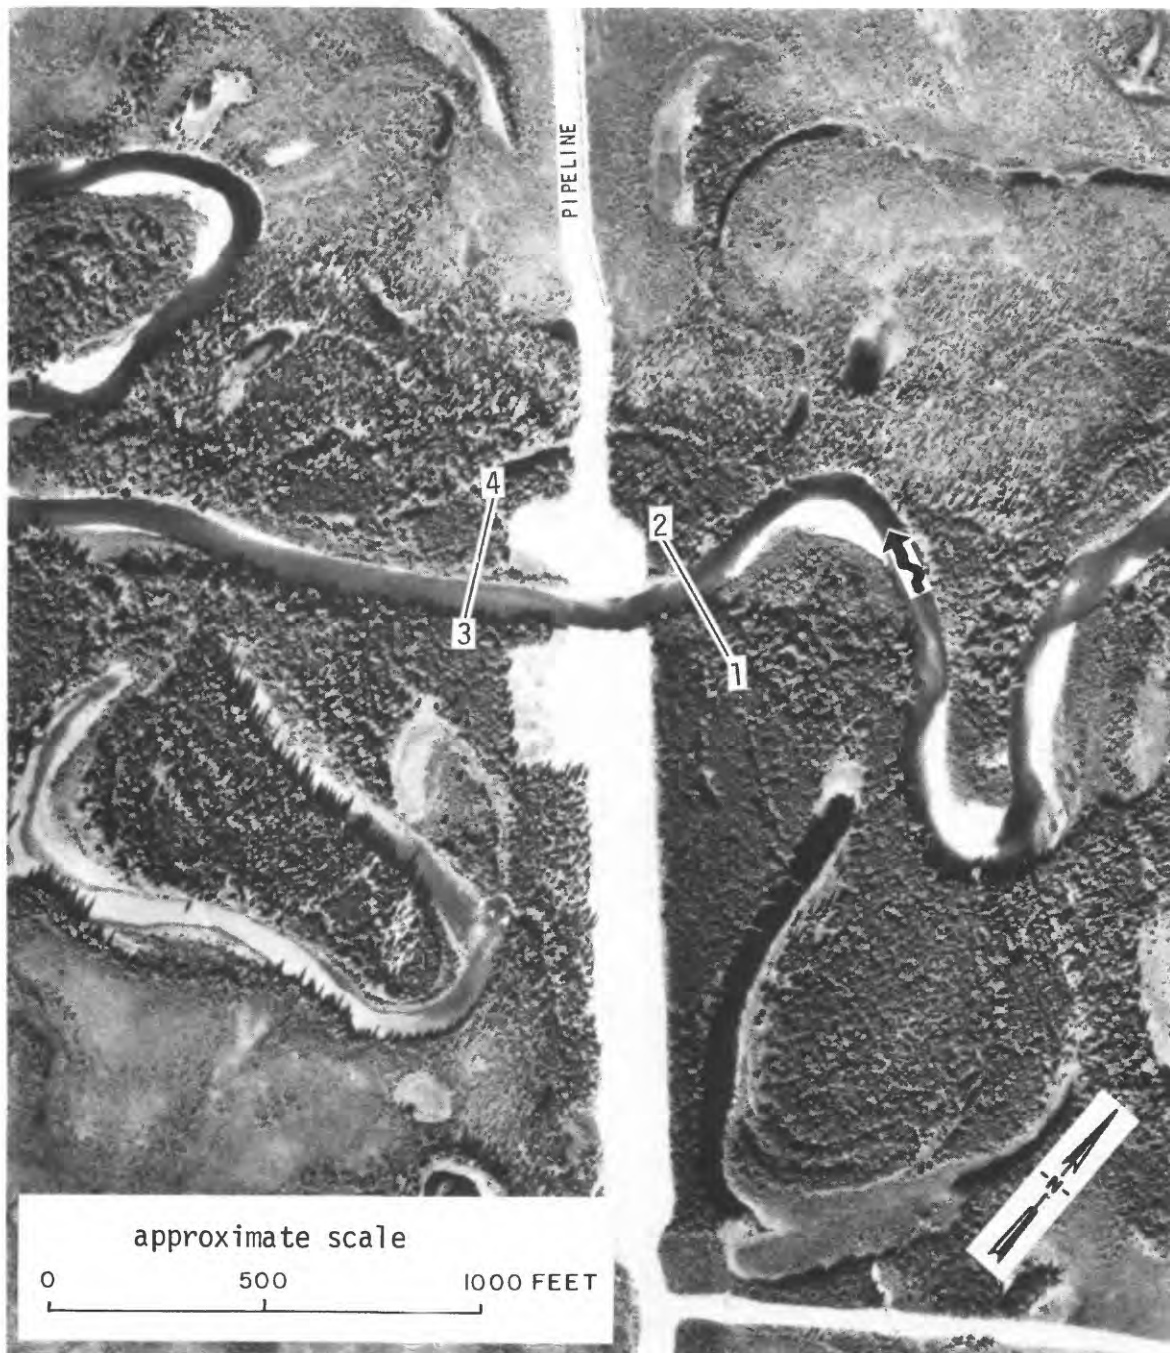
Figure 25. -- Chatanika River near Olnes, July 13, 1977.

1977 Surveillance.--Figure 25 shows the Chatanika River crossing site on July 13, 1977. The temporary access bridge installed before last year's survey had been removed.

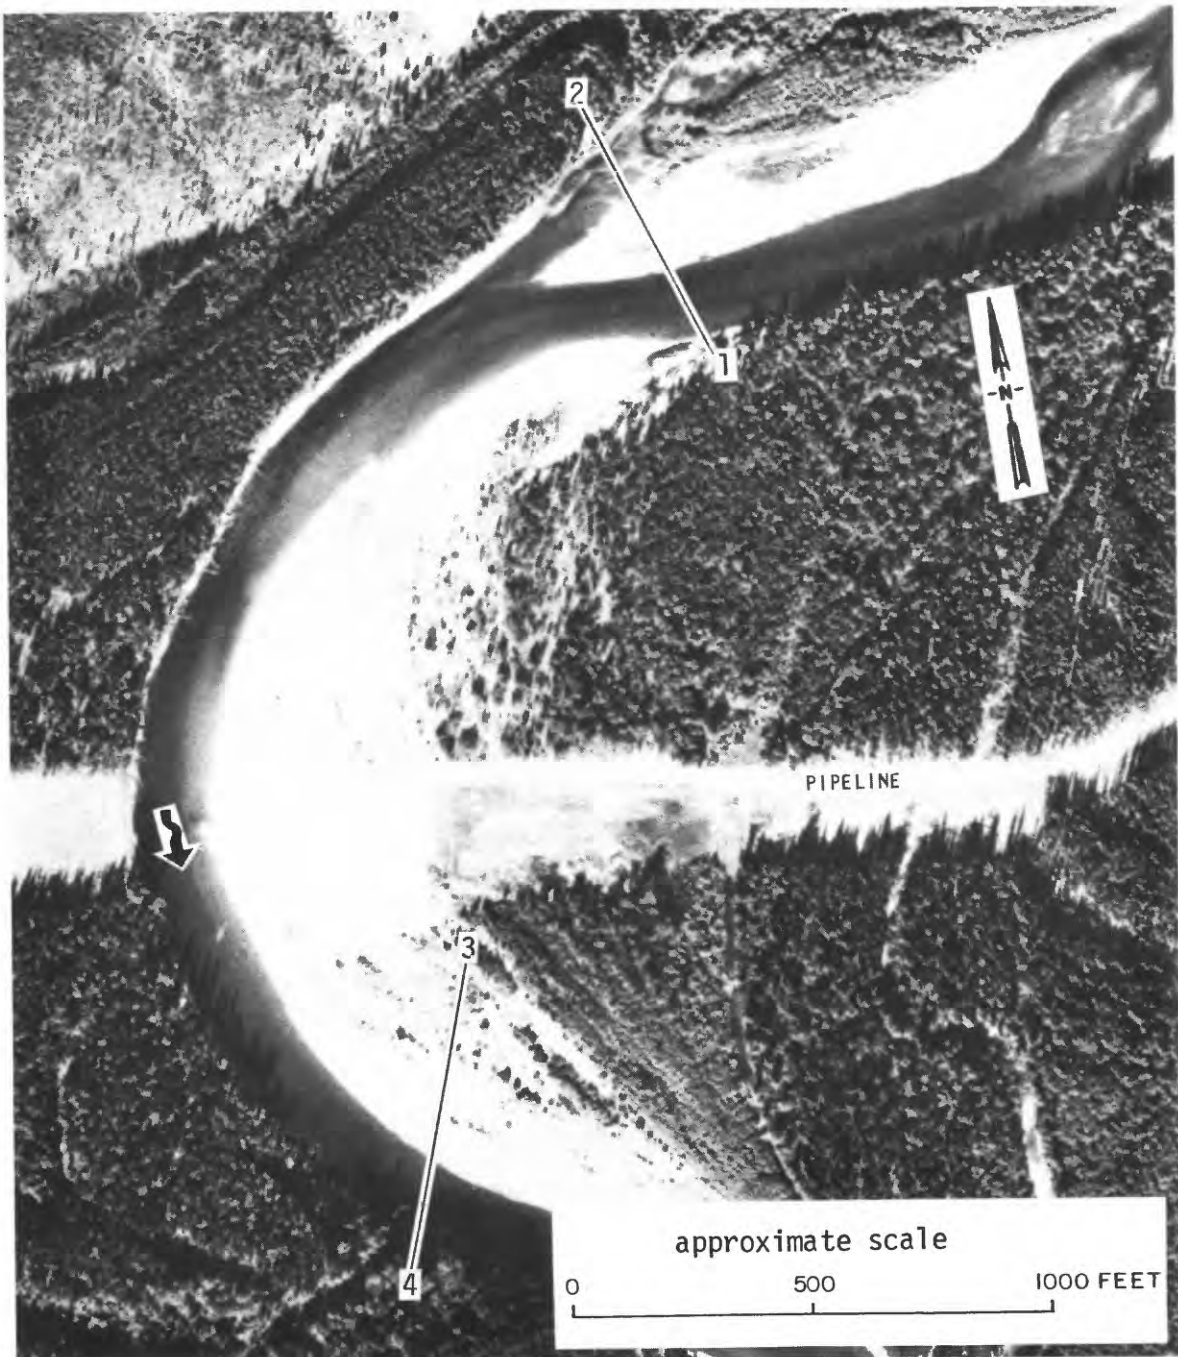
Figure 27. -- Salcha River near Salchaket, July 13, 1977.

1977 Surveillance.--Figure 27 shows the Salcha River crossing on July 13, 1977. The site was resurveyed on May 12, 1977. The river at this site continues to be active; changes were found in all three cross sections. In each case the right bank has been eroded. The most dramatic effects occurred at the centerline where over 10 ft of lateral erosion and over 6.2 ft of vertical scour (fig. 28) were measured during the breakup flood. The peak of the flood occurred on May 19. It was measured as 11,500 ft³/s at the Salcha River gage near Salchaket, and is considered a moderate flood.

Taken together, the three cross sections indicate that the meander has widened during the last year, continuing a trend noted in 1974.

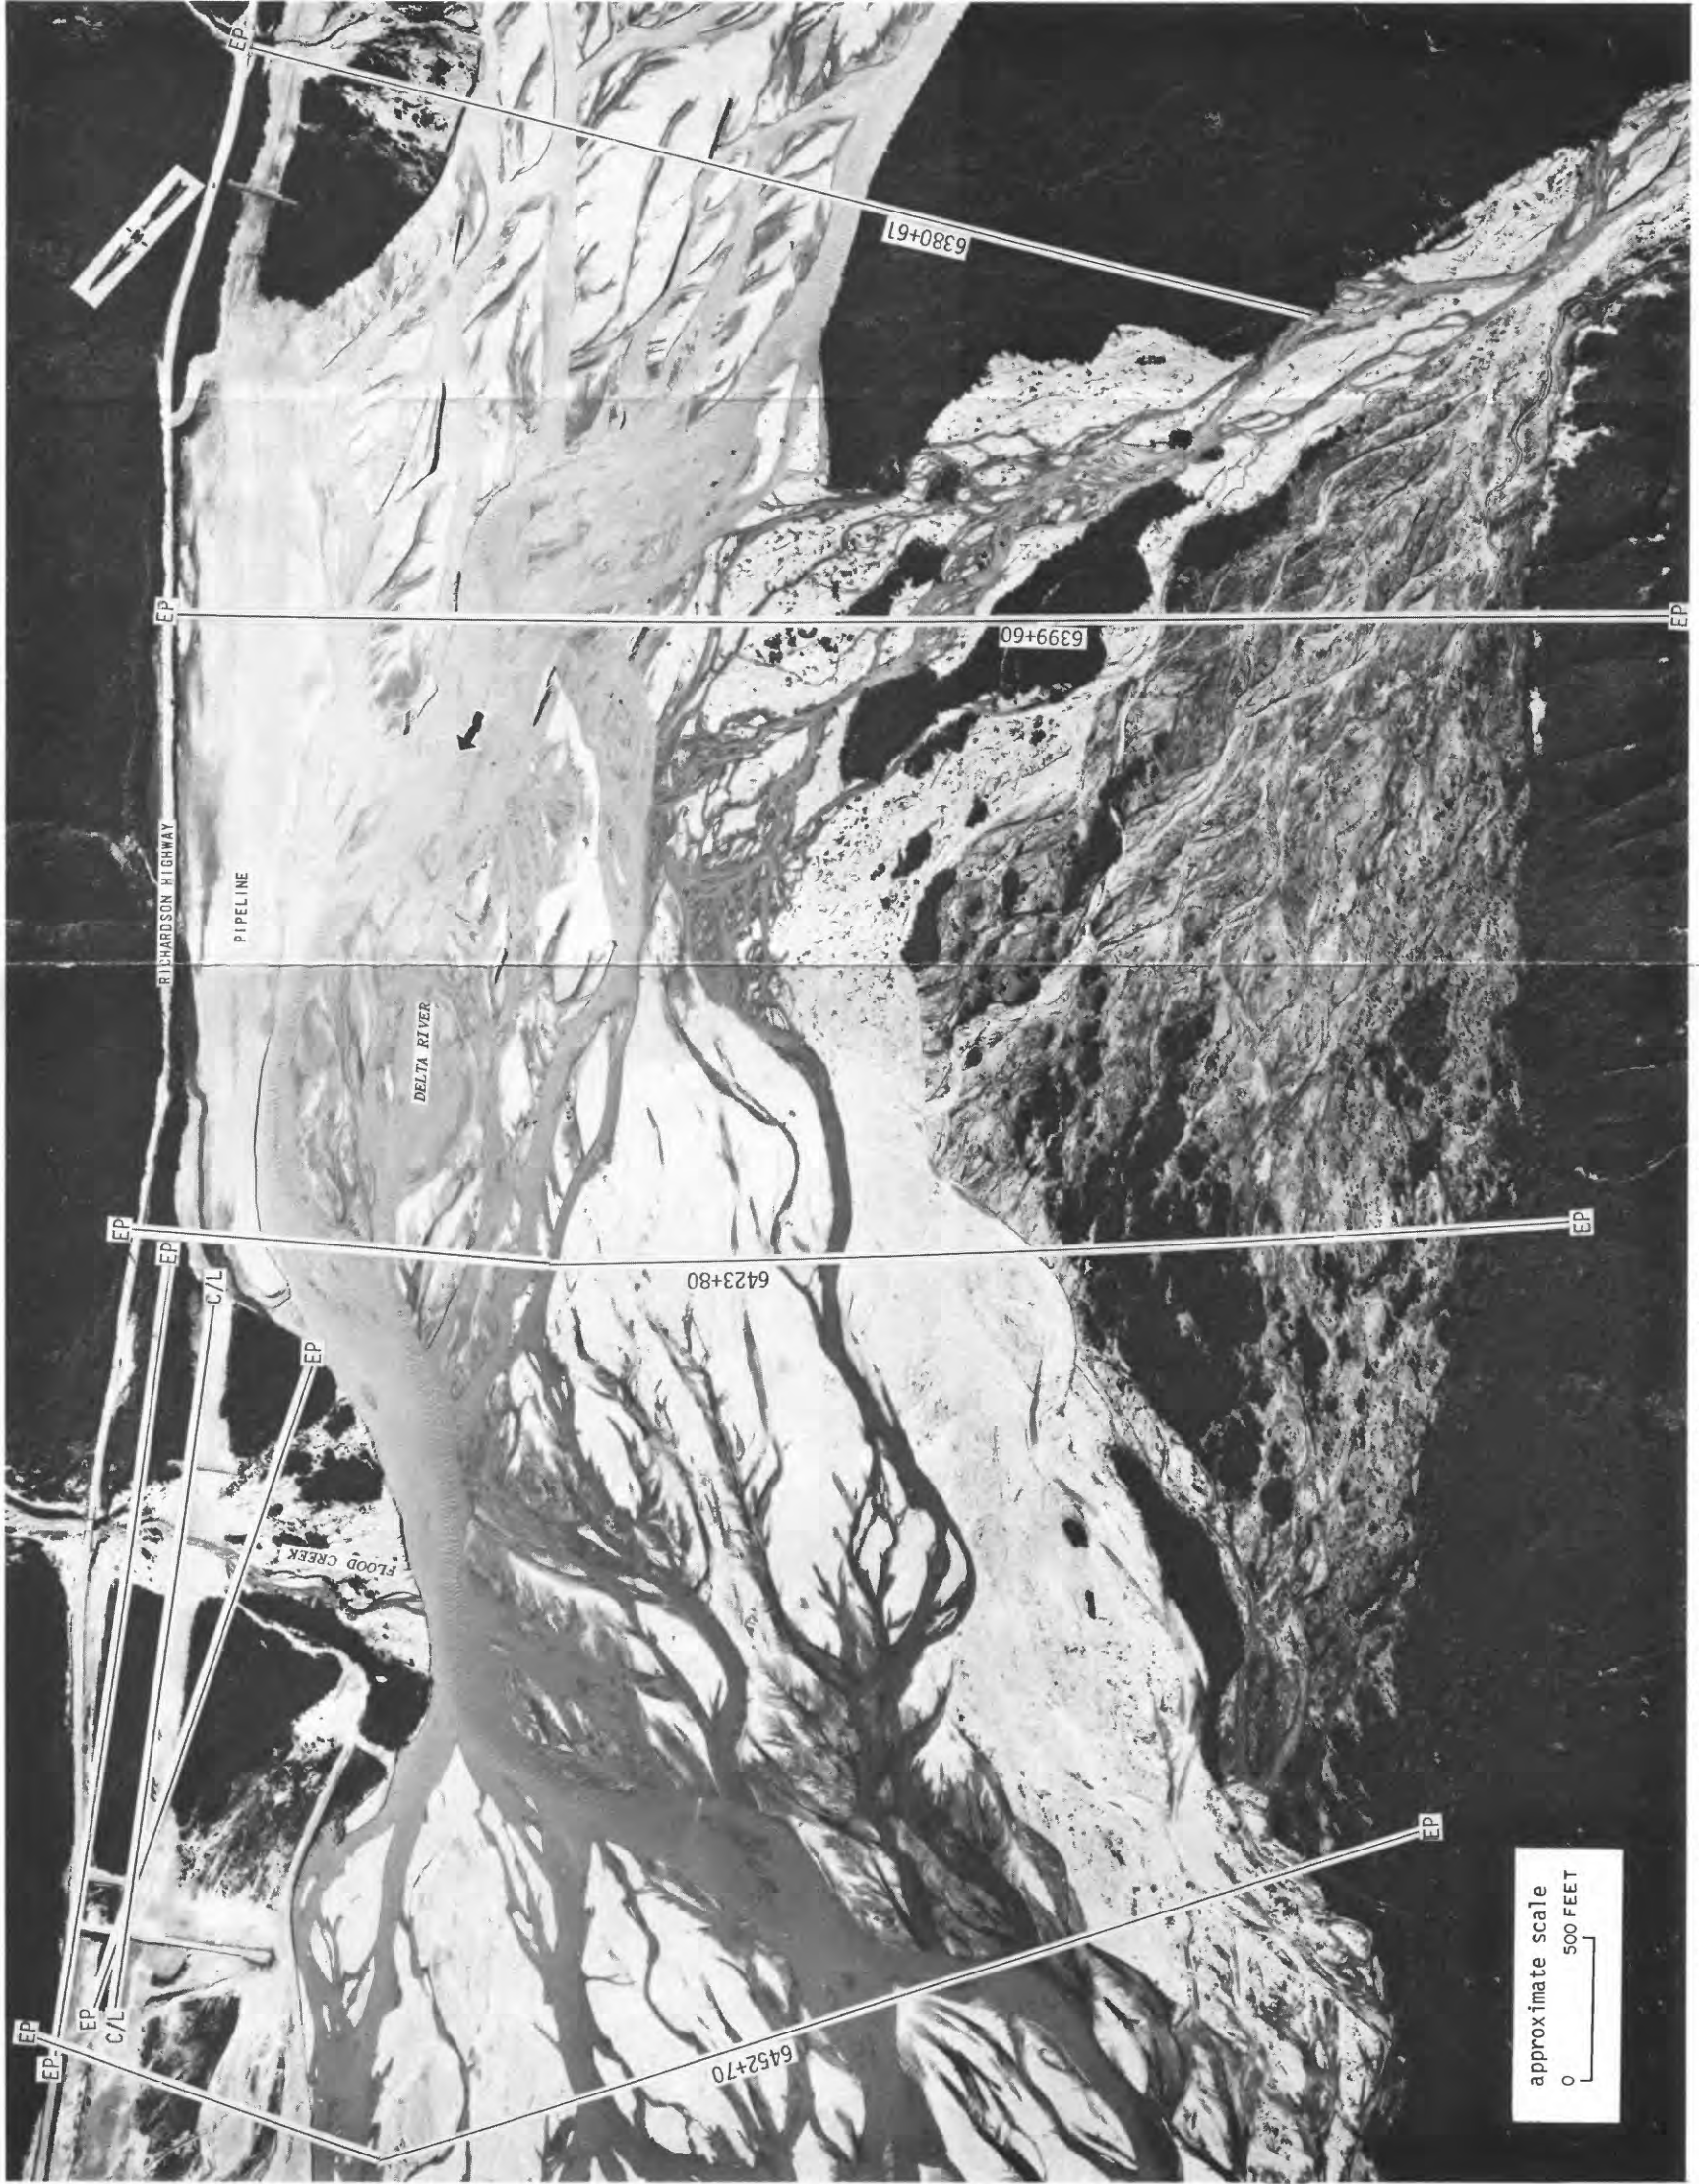
Figure 29. -- Flood Creek near Rapids, July 10, 1977.
NORTH PACIFIC AERIAL SURVEYS

1977 Surveillance.--Figure 29 shows the Flood Creek crossing on July 10, 1977. The crossing was resurveyed photogrammetrically on that date and a field inspection was made in September. It appears that the only significant change is below the downstream cross section where the channel is straightening.
