UNITED STATES
DEPARTMENT OF THE INTERIOR
GEOLOGICAL SURVEY

CHANNEL EROSION SURVEYS ALONG THE TAPS ROUTE,
ALASKA 1977

OPEN-FILE REPORT 78-611
(Basic Data)

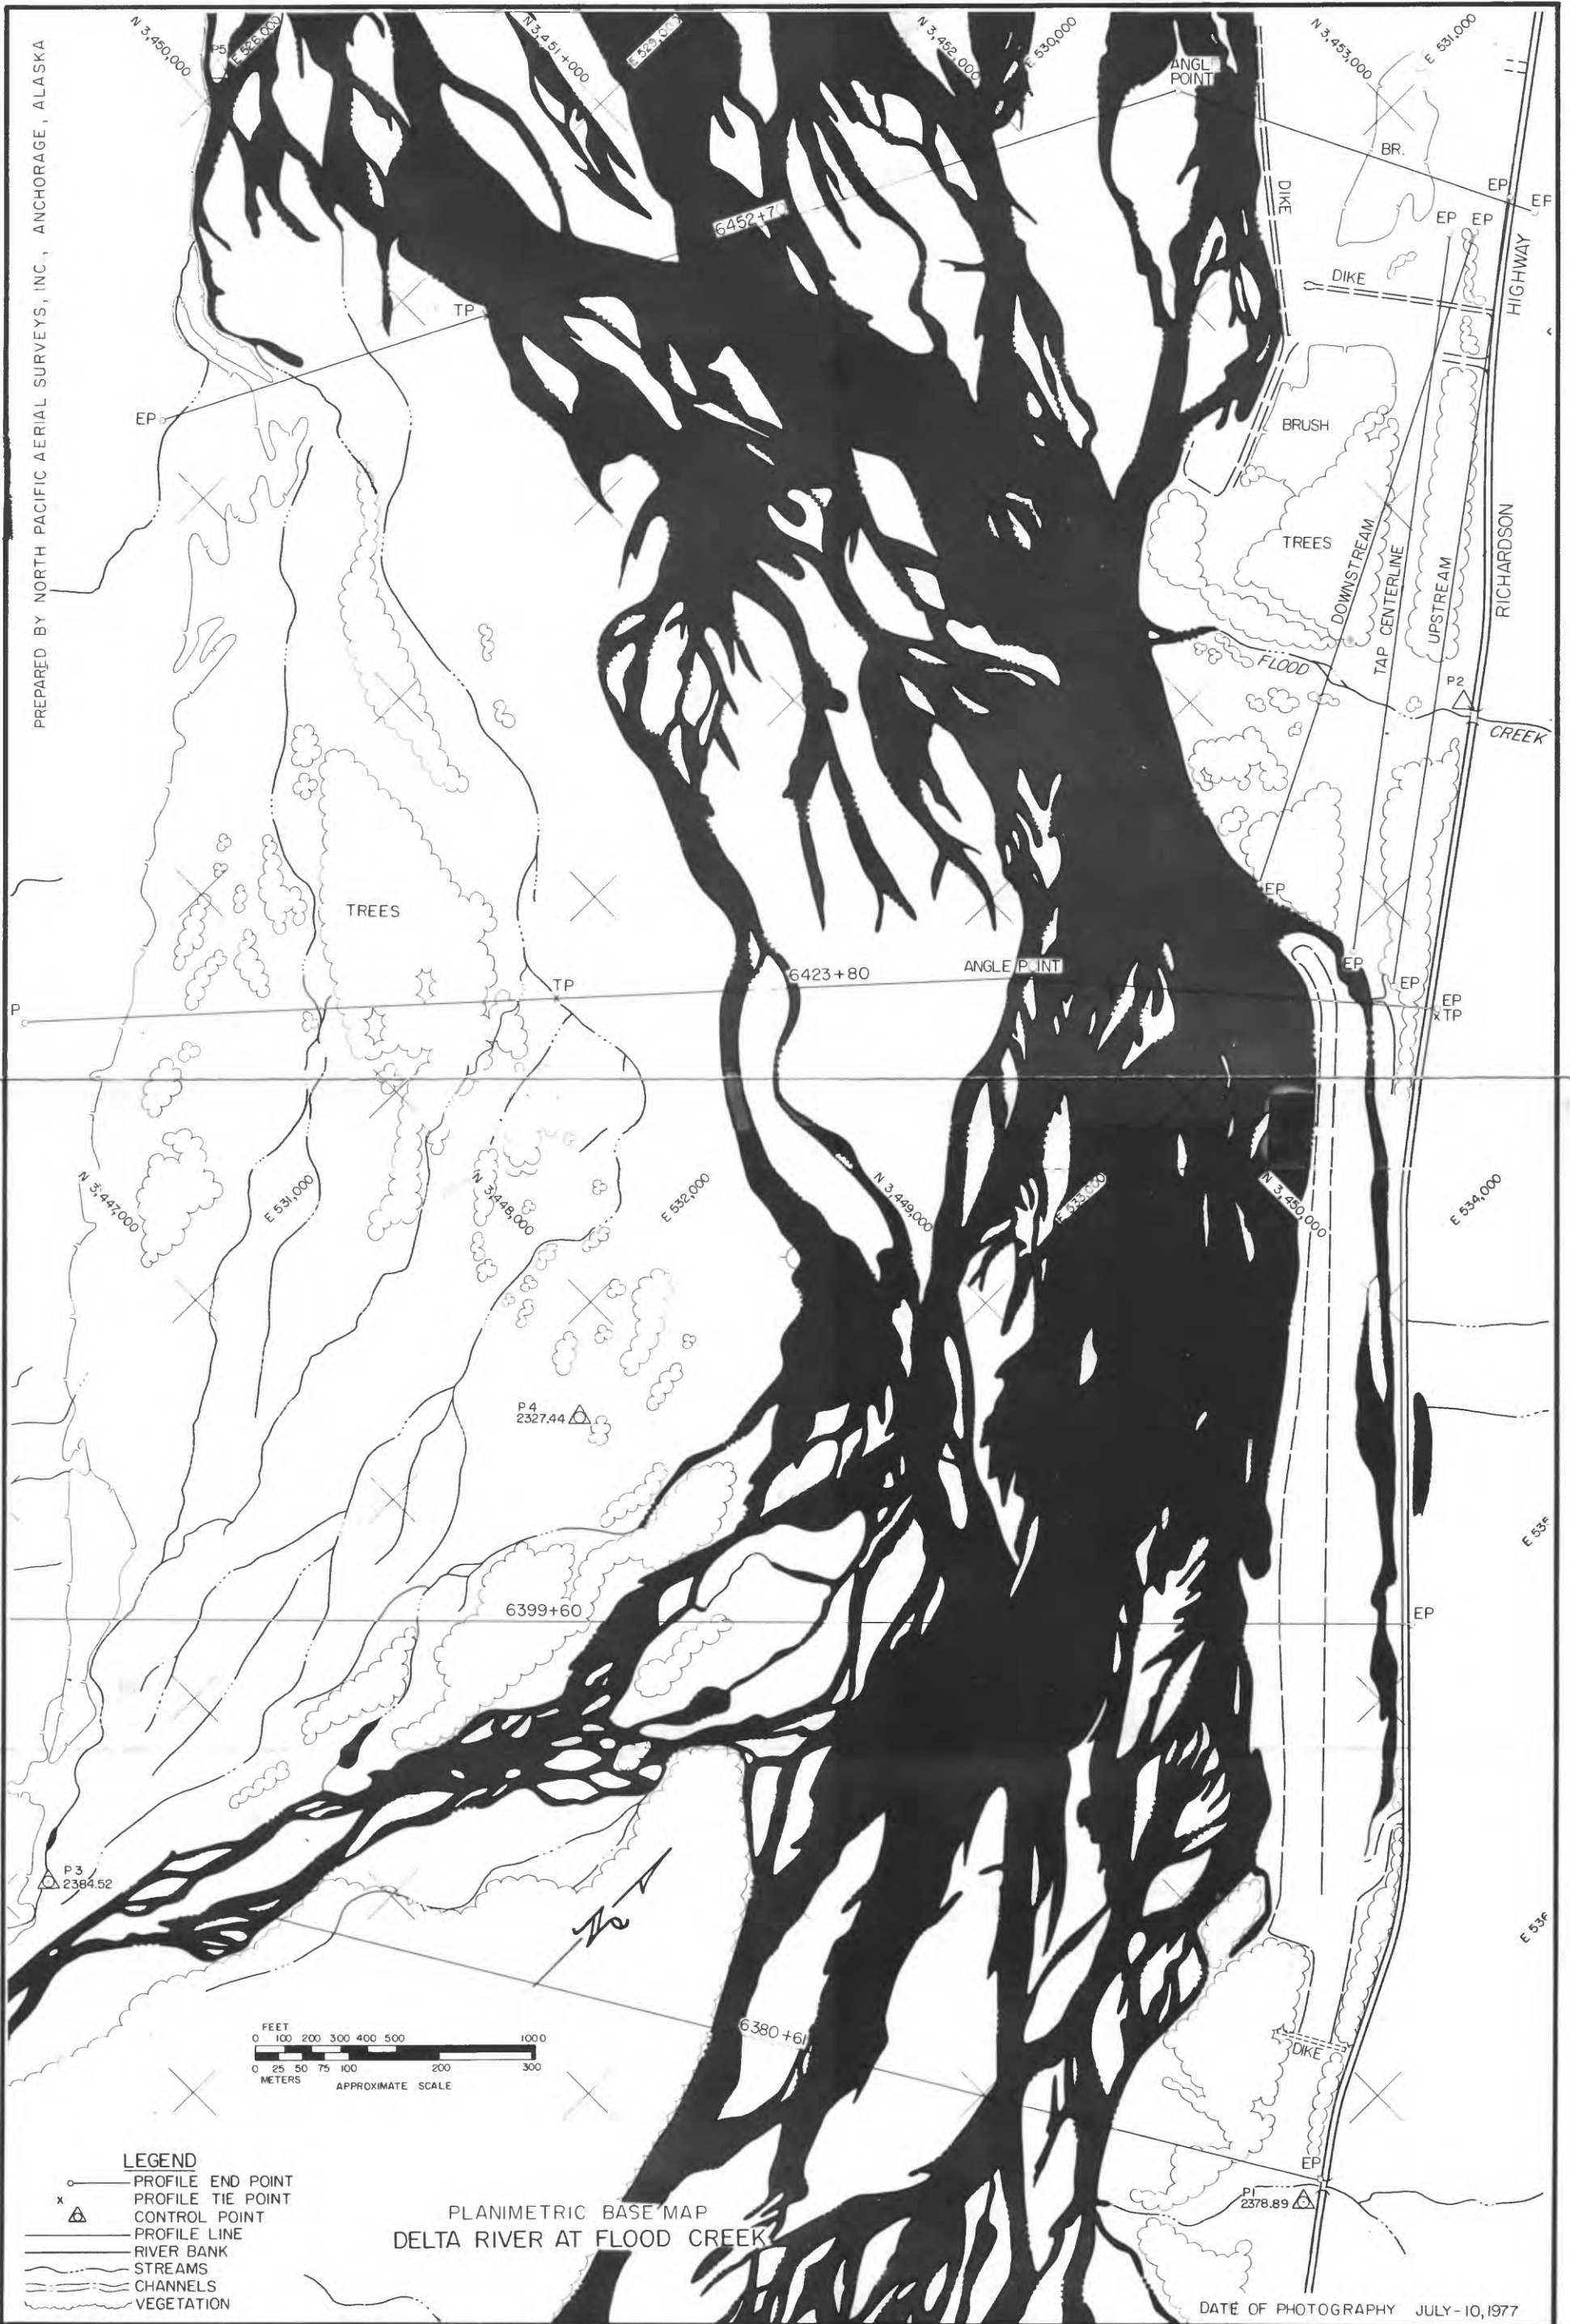
Figure 31a. -- Planimetric map of the Delta River at Flood Creek.

1977 Surveillance.--Figure 31a shows the Delta River at the Flood Creek site on July 10, 1977, the date of the photogrammetric survey. In 1976, (fig. 31b) two lateral construction dikes running past the two upstream cross sections artificially constricted the river near its left bank. These washed out during the past year. As a result, the major conveyance near cross sections 6399+60 and 6423+80 has shifted closer to the right bank and the braiding pattern is more intricate (fig. 31a).

The July photograph shows the main channel on cross section 6423+80 attacking the longshore dike which protects the pipeline. In September, it was noted that the main channel had shifted back toward the center of the channel and a bar had formed along the longshore dike.

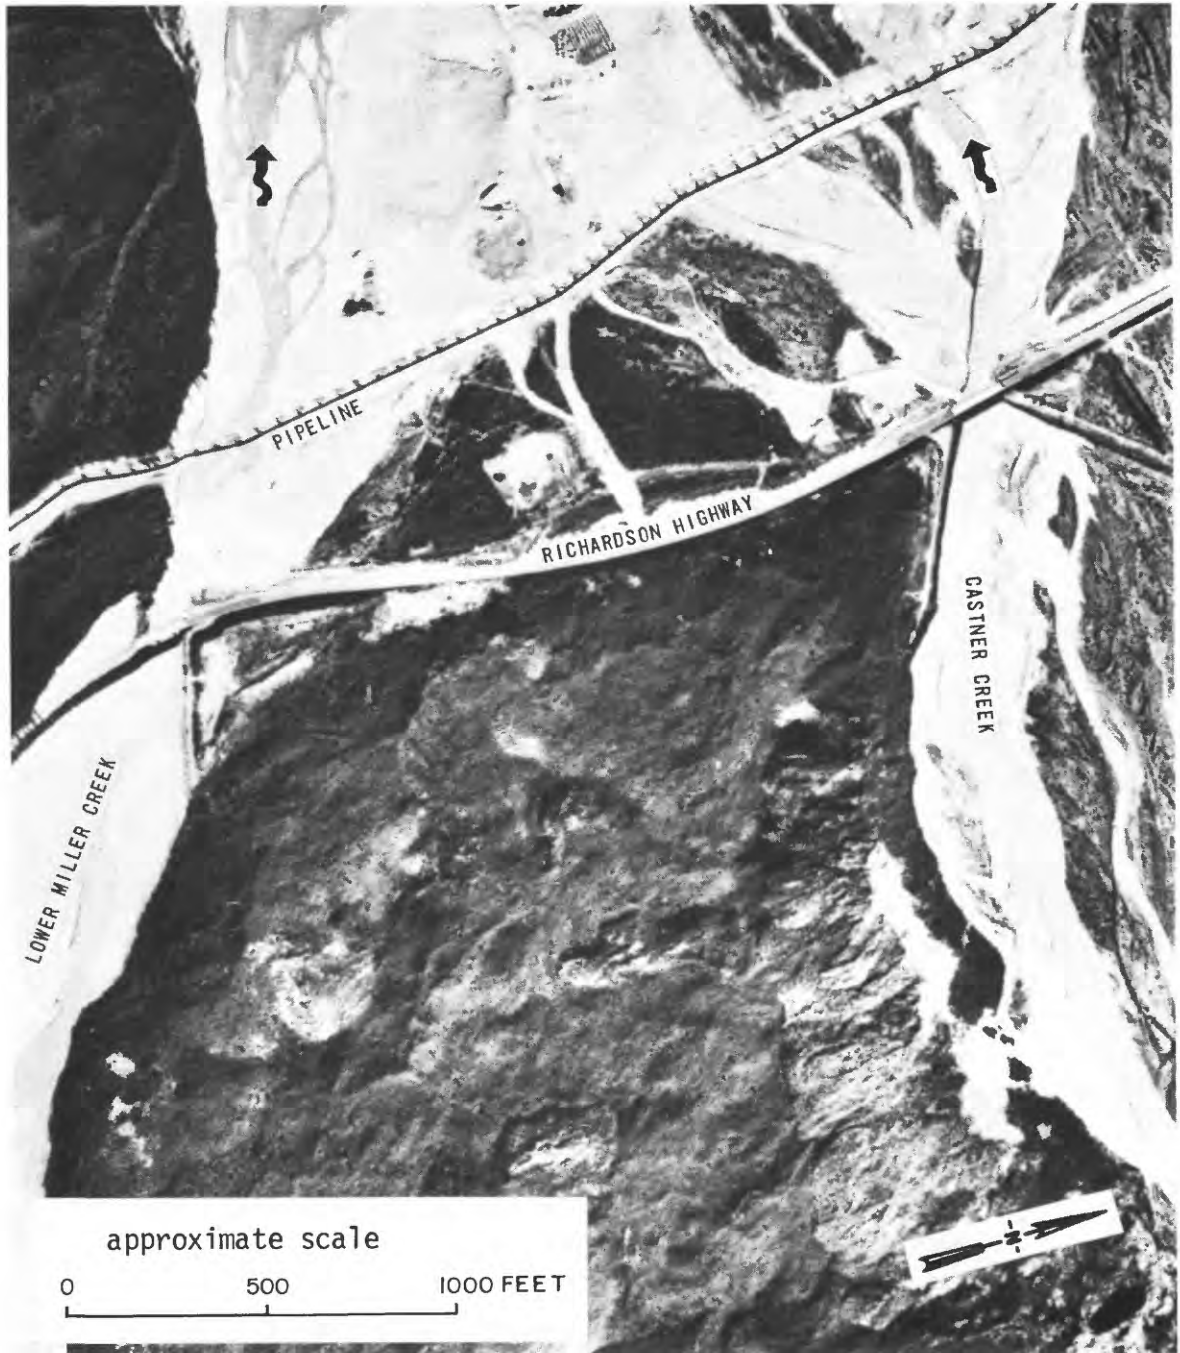
Figure 32. -- Castner and Lower Miller Creeks, July 29, 1977.
AIR PHOTO TECH

1977 Surveillance.--Figure 32 shows the Castner Creek and Lower Miller Creek near Rapids site on July 29, 1977. During the last year, overhead crossings have been completed across both streams.

Comparison of the 1976 and 1977 air photos, as well as a visual inspection of the site made on September 19, 1977, indicate that no significant change has occurred during the past year.

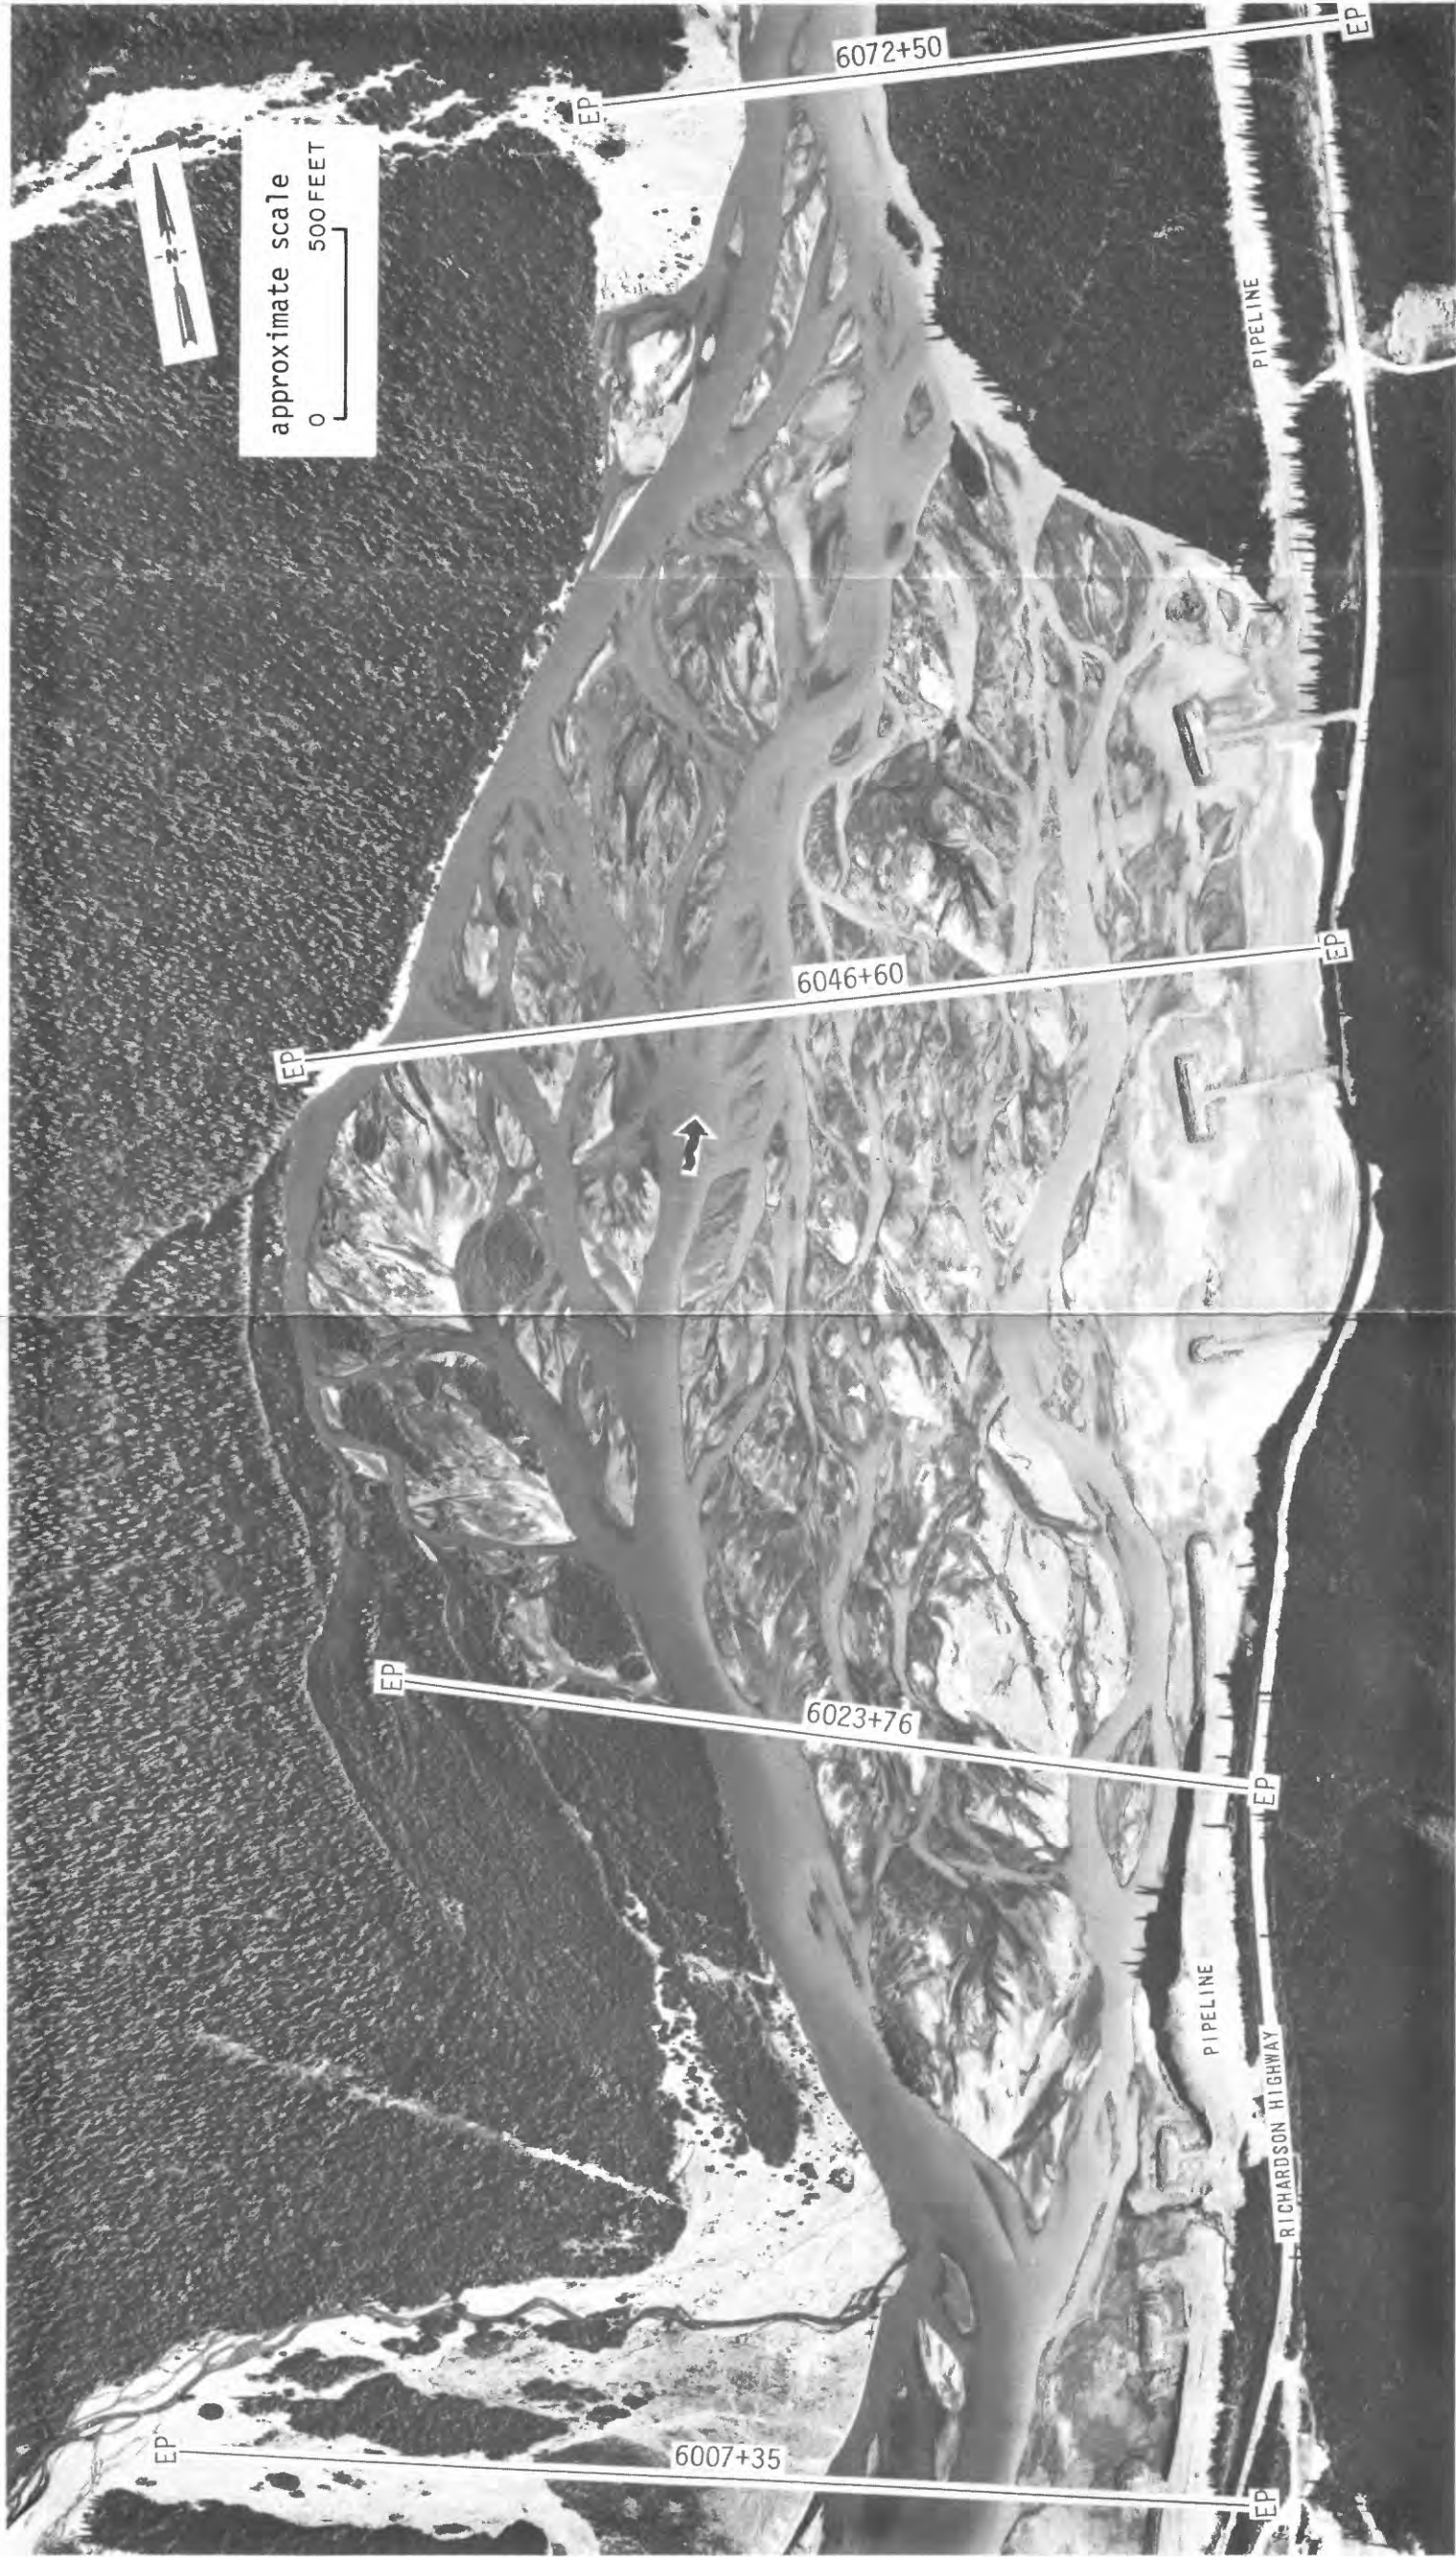
Figure 33. -- Delta River at Phelan Creek, July 10, 1977.
NORTH PACIFIC AERIAL SURVEYS

1977 Surveillance.--Figure 33 shows the Delta River at Phelan Creek site as of July 10, 1977. The three upstream spur dikes and the longshore dike near the center of the picture have been constructed during the last year. The picture shows part of the flow to be surrounding the downstream spur dike, but a field inspection of the site made in September indicated that this is no longer the case.

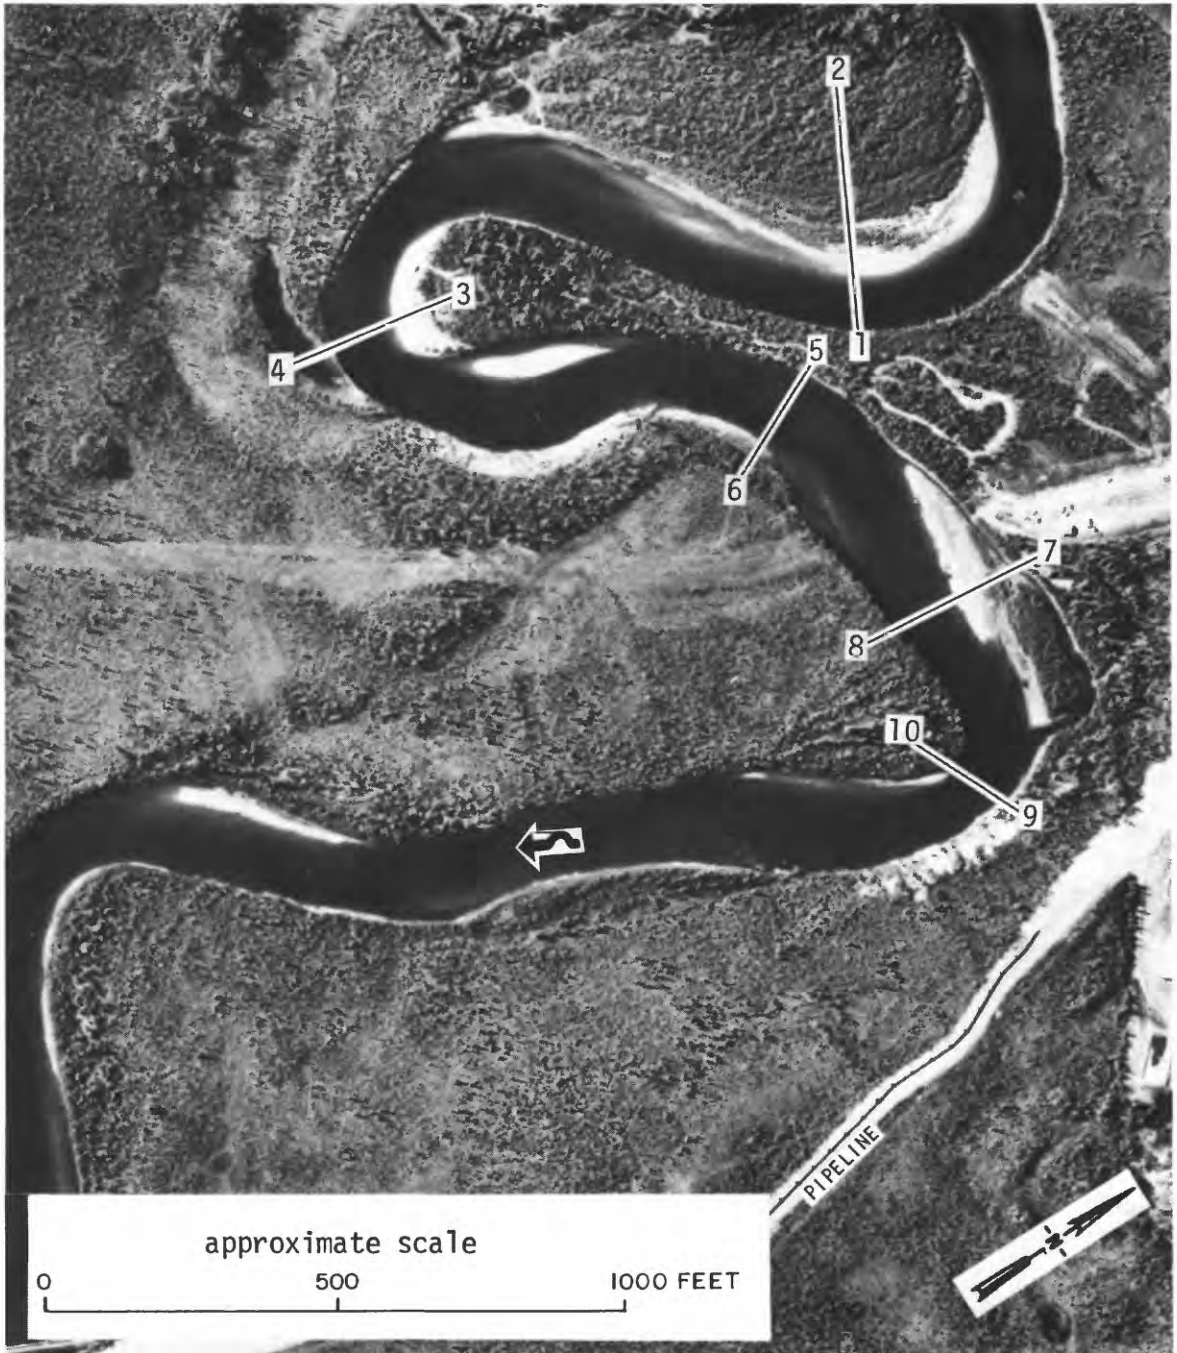
Figure 34. -- Gulkana River near Sourdough, July 29, 1977. AIR PHOTO TECH

1977 Surveillance.--Figure 34 shows the Gulkana River site on July 29, 1977. The pipeline crossing was moved after the 1975 survey and appears in the lower right-hand corner of the figure. As explained in Doyle and Childers (1976), it was decided to continue monitoring this site because of the excellent past records accumulated.

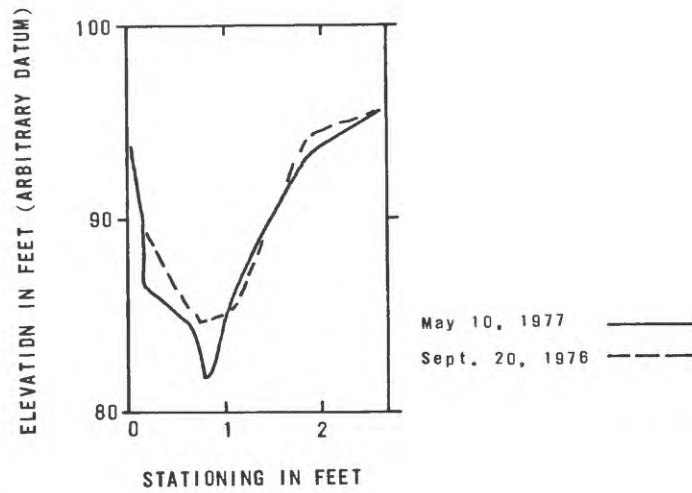
Figure 35.--Cross section No. 5 of the Galkana River near Sourdough.

The site was resurveyed on May 10, 1977. Only cross section No. 5 showed significant change (fig. 35). The left bank of cross section No. 5 has slumped every year since 1974. However, comparison of air photos of July 1977 and August 1976 shows the bank has not changed position laterally.

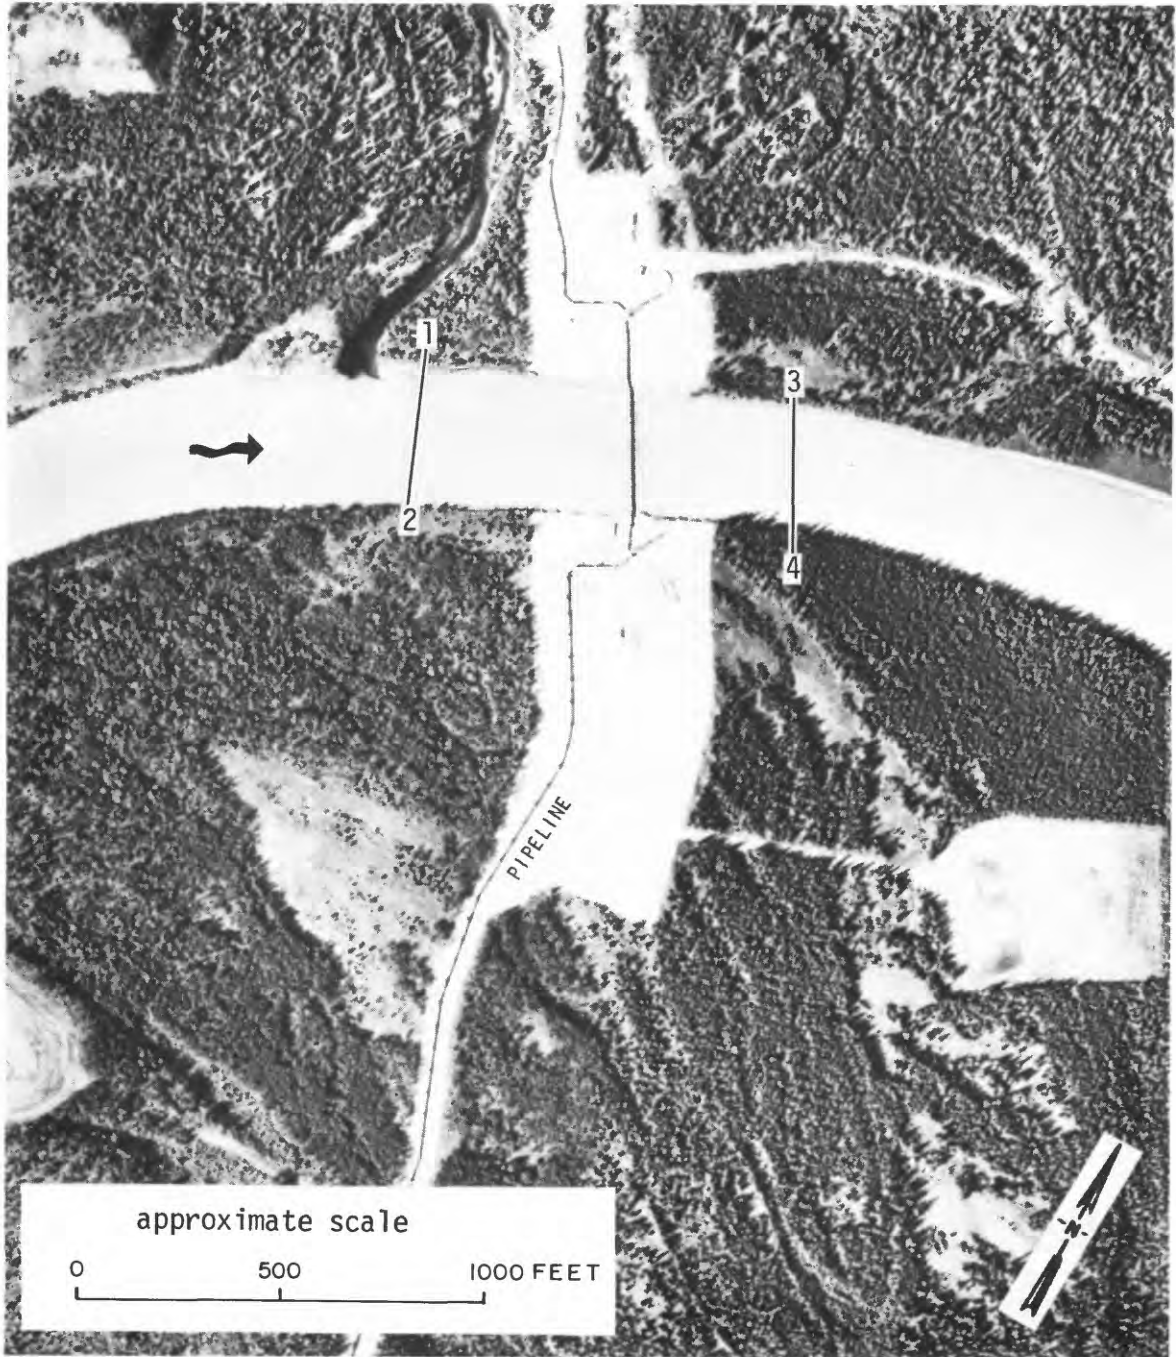
Figure 36. -- Tazlina River near Glennallen, July 29, 1977. AIR PHOTO TECH

1977 Surveillance.--Figure 36 shows the Tazlina River crossing on July 29, 1977. Cross sections were resurveyed September 21, 1977. Cross sections were not obtained after construction was completed in 1976 and the centerline section had not been resurveyed since 1974. The centerline as actually constructed, and the 1977 centerline cross section are both approximately 200 ft east of the 1974 section. The shape of this year's section and on-site observations indicate that little change has occurred. No significant change has been found in either the downstream or upstream sections since 1974.

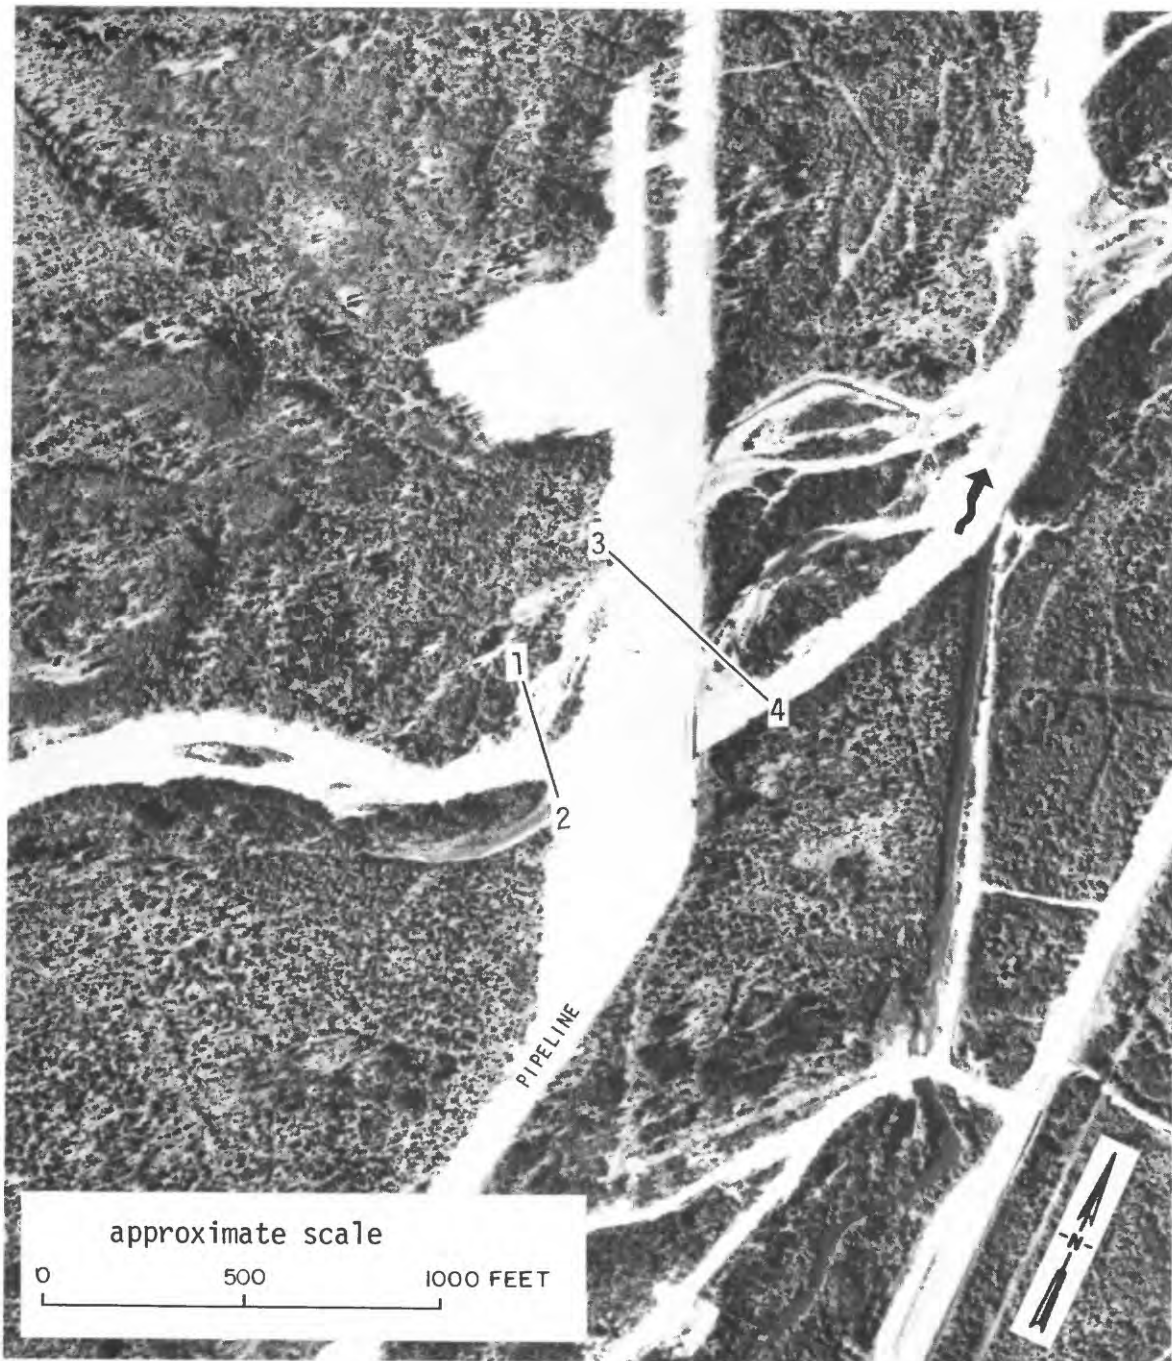
Figure 38. -- Tonsina River near Tonsina, July 29, 1977. AIR PHOTO TECH

1977 Surveillance.--Figure 38 shows the Tonsina River crossing site on July 29, 1977. During the last year considerable brush cutting has occurred on the upstream side of the access pad, and minor construction work along the centerline is still being completed.

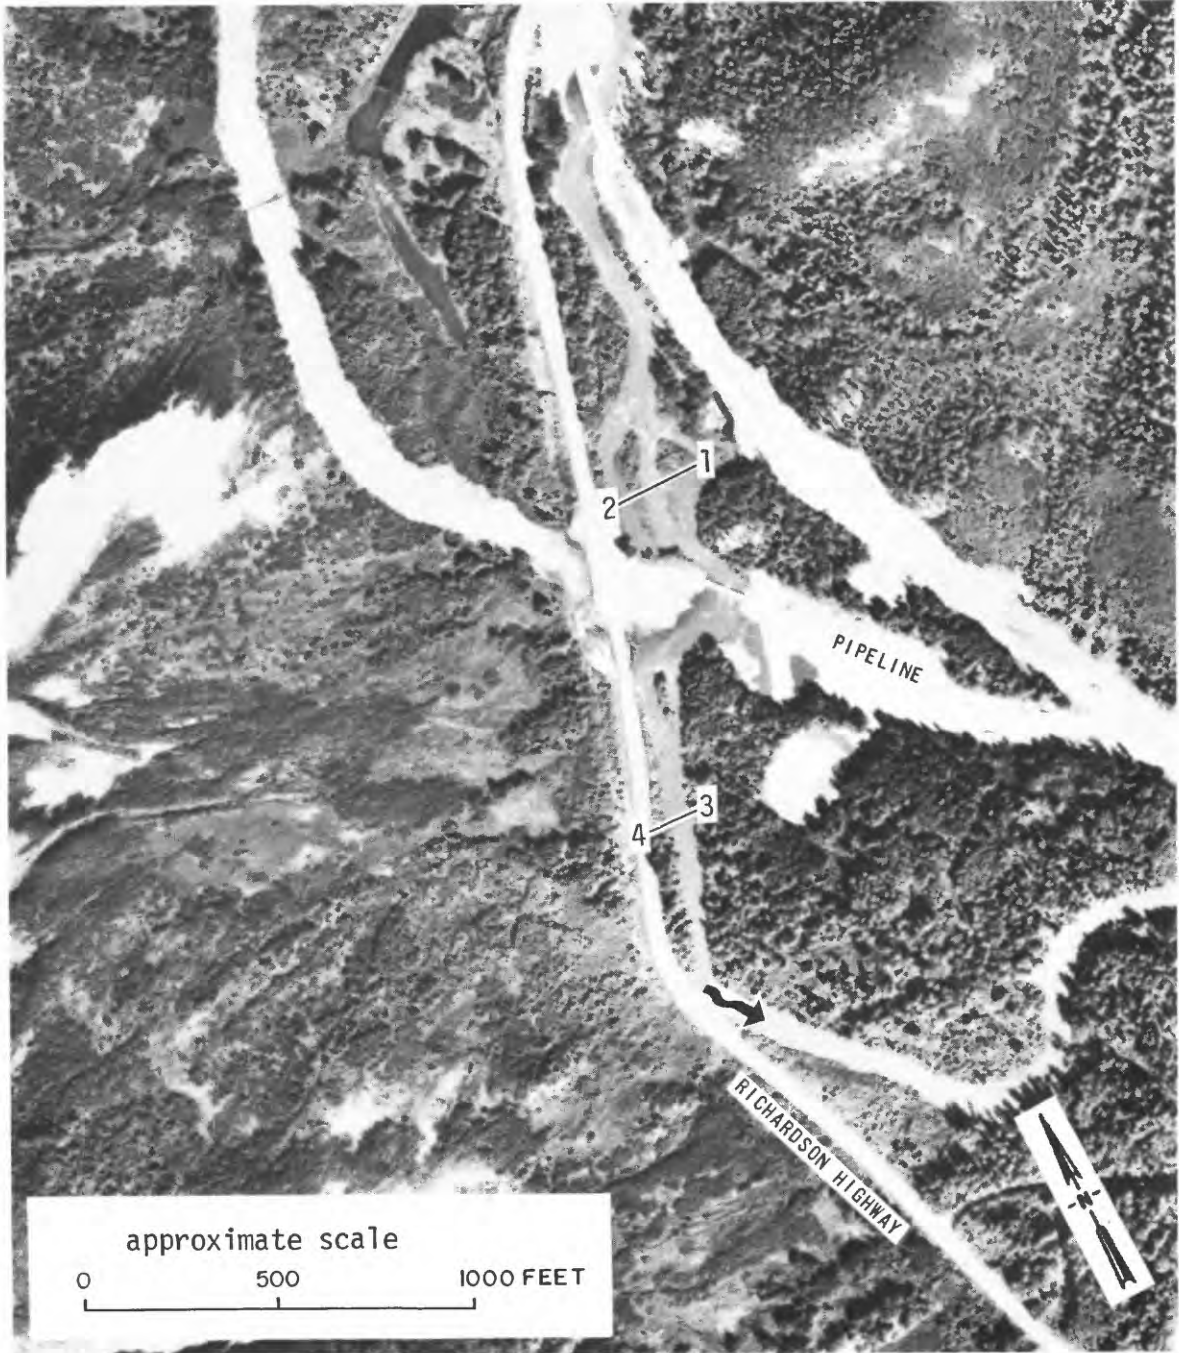
Figure 40. -- Tiekel River at Tiekel, July 11, 1977. AIR PHOTO TECH

1977 Surveillance.--Figure 40 displays the Tiekel River at Tiekel crossing site on July 11, 1977. The site was resurveyed on September 23, 1977; at that time the centerline appeared to be still under construction. Note that a new alignment for the Richardson Highway has been constructed near the crossing.

Apart from minor grading operations, no major change was found in the centerline cross section. Visual inspection indicated no significant change in either the upstream or downstream sections; in fact, none has been found since the site was established in 1973.

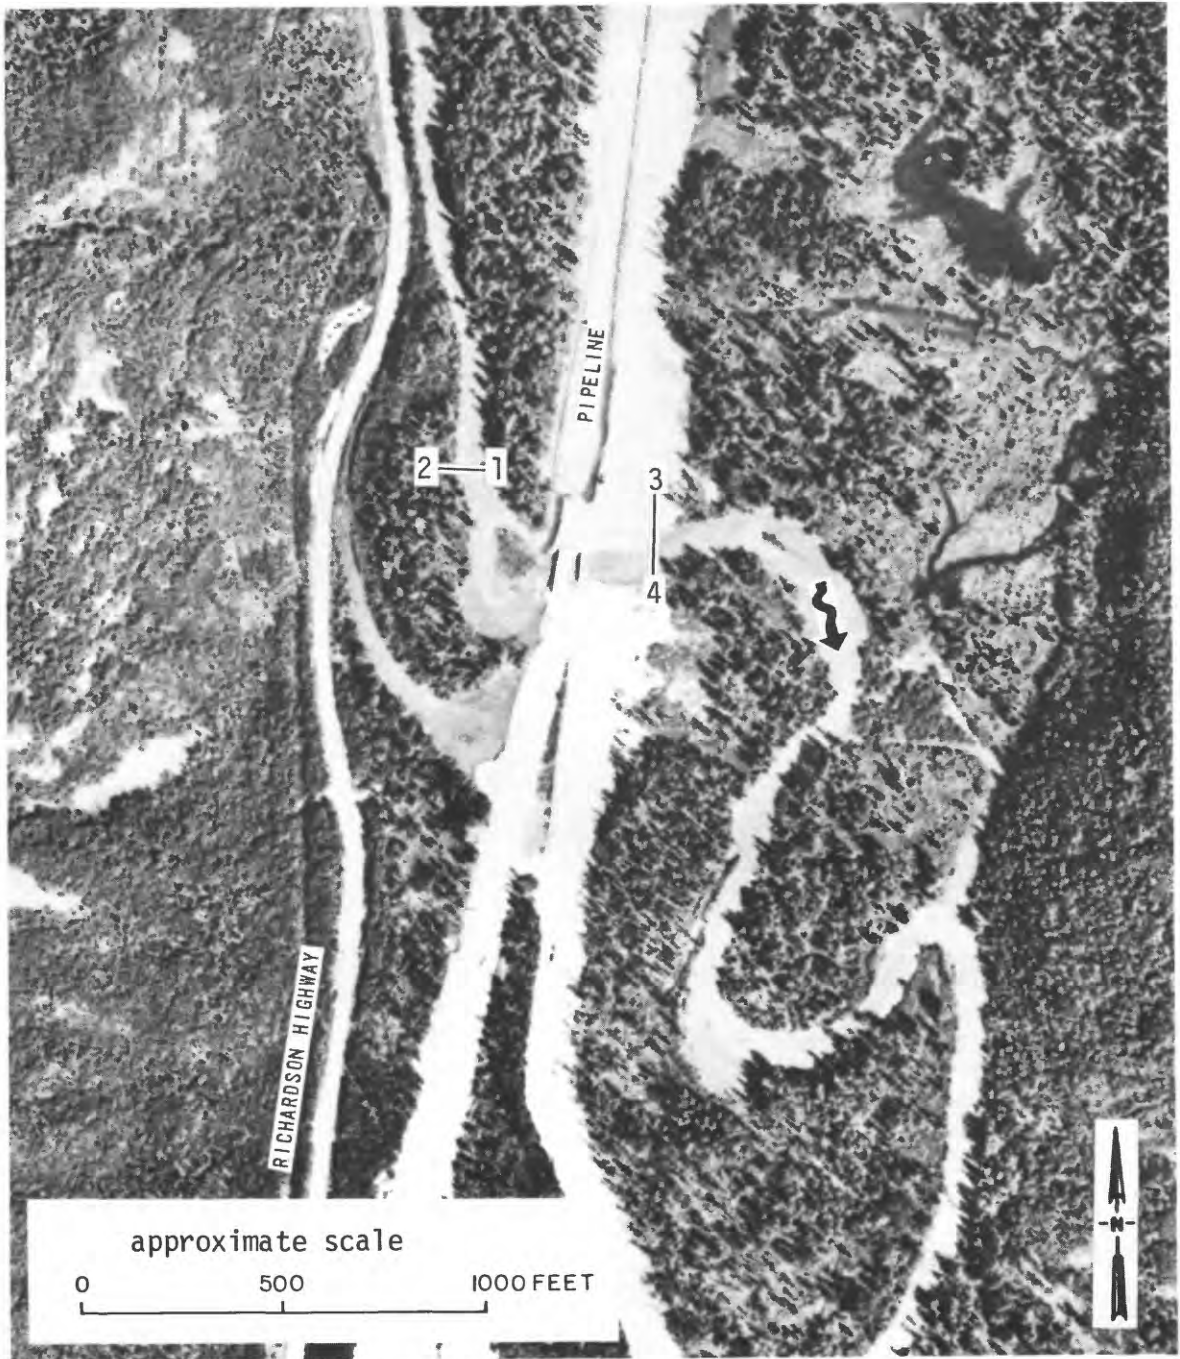
Figure 41. -- Tiekel River near Tiekel, July 11, 1977. AIR PHOTO TECH

1977 Surveillance.--Figure 41 shows the Tiekel River crossing site near Tiekel on July 11, 1977. A new alignment for the Richardson Highway was being constructed alongside the centerline. The highway bridge has been installed just upstream from the temporary access bridge for the pipeline.

The crossing site was resurveyed on September 22, 1977. No significant changes were found in any cross section. No changes have been found in the upstream or the downstream section since the site was established in 1973.

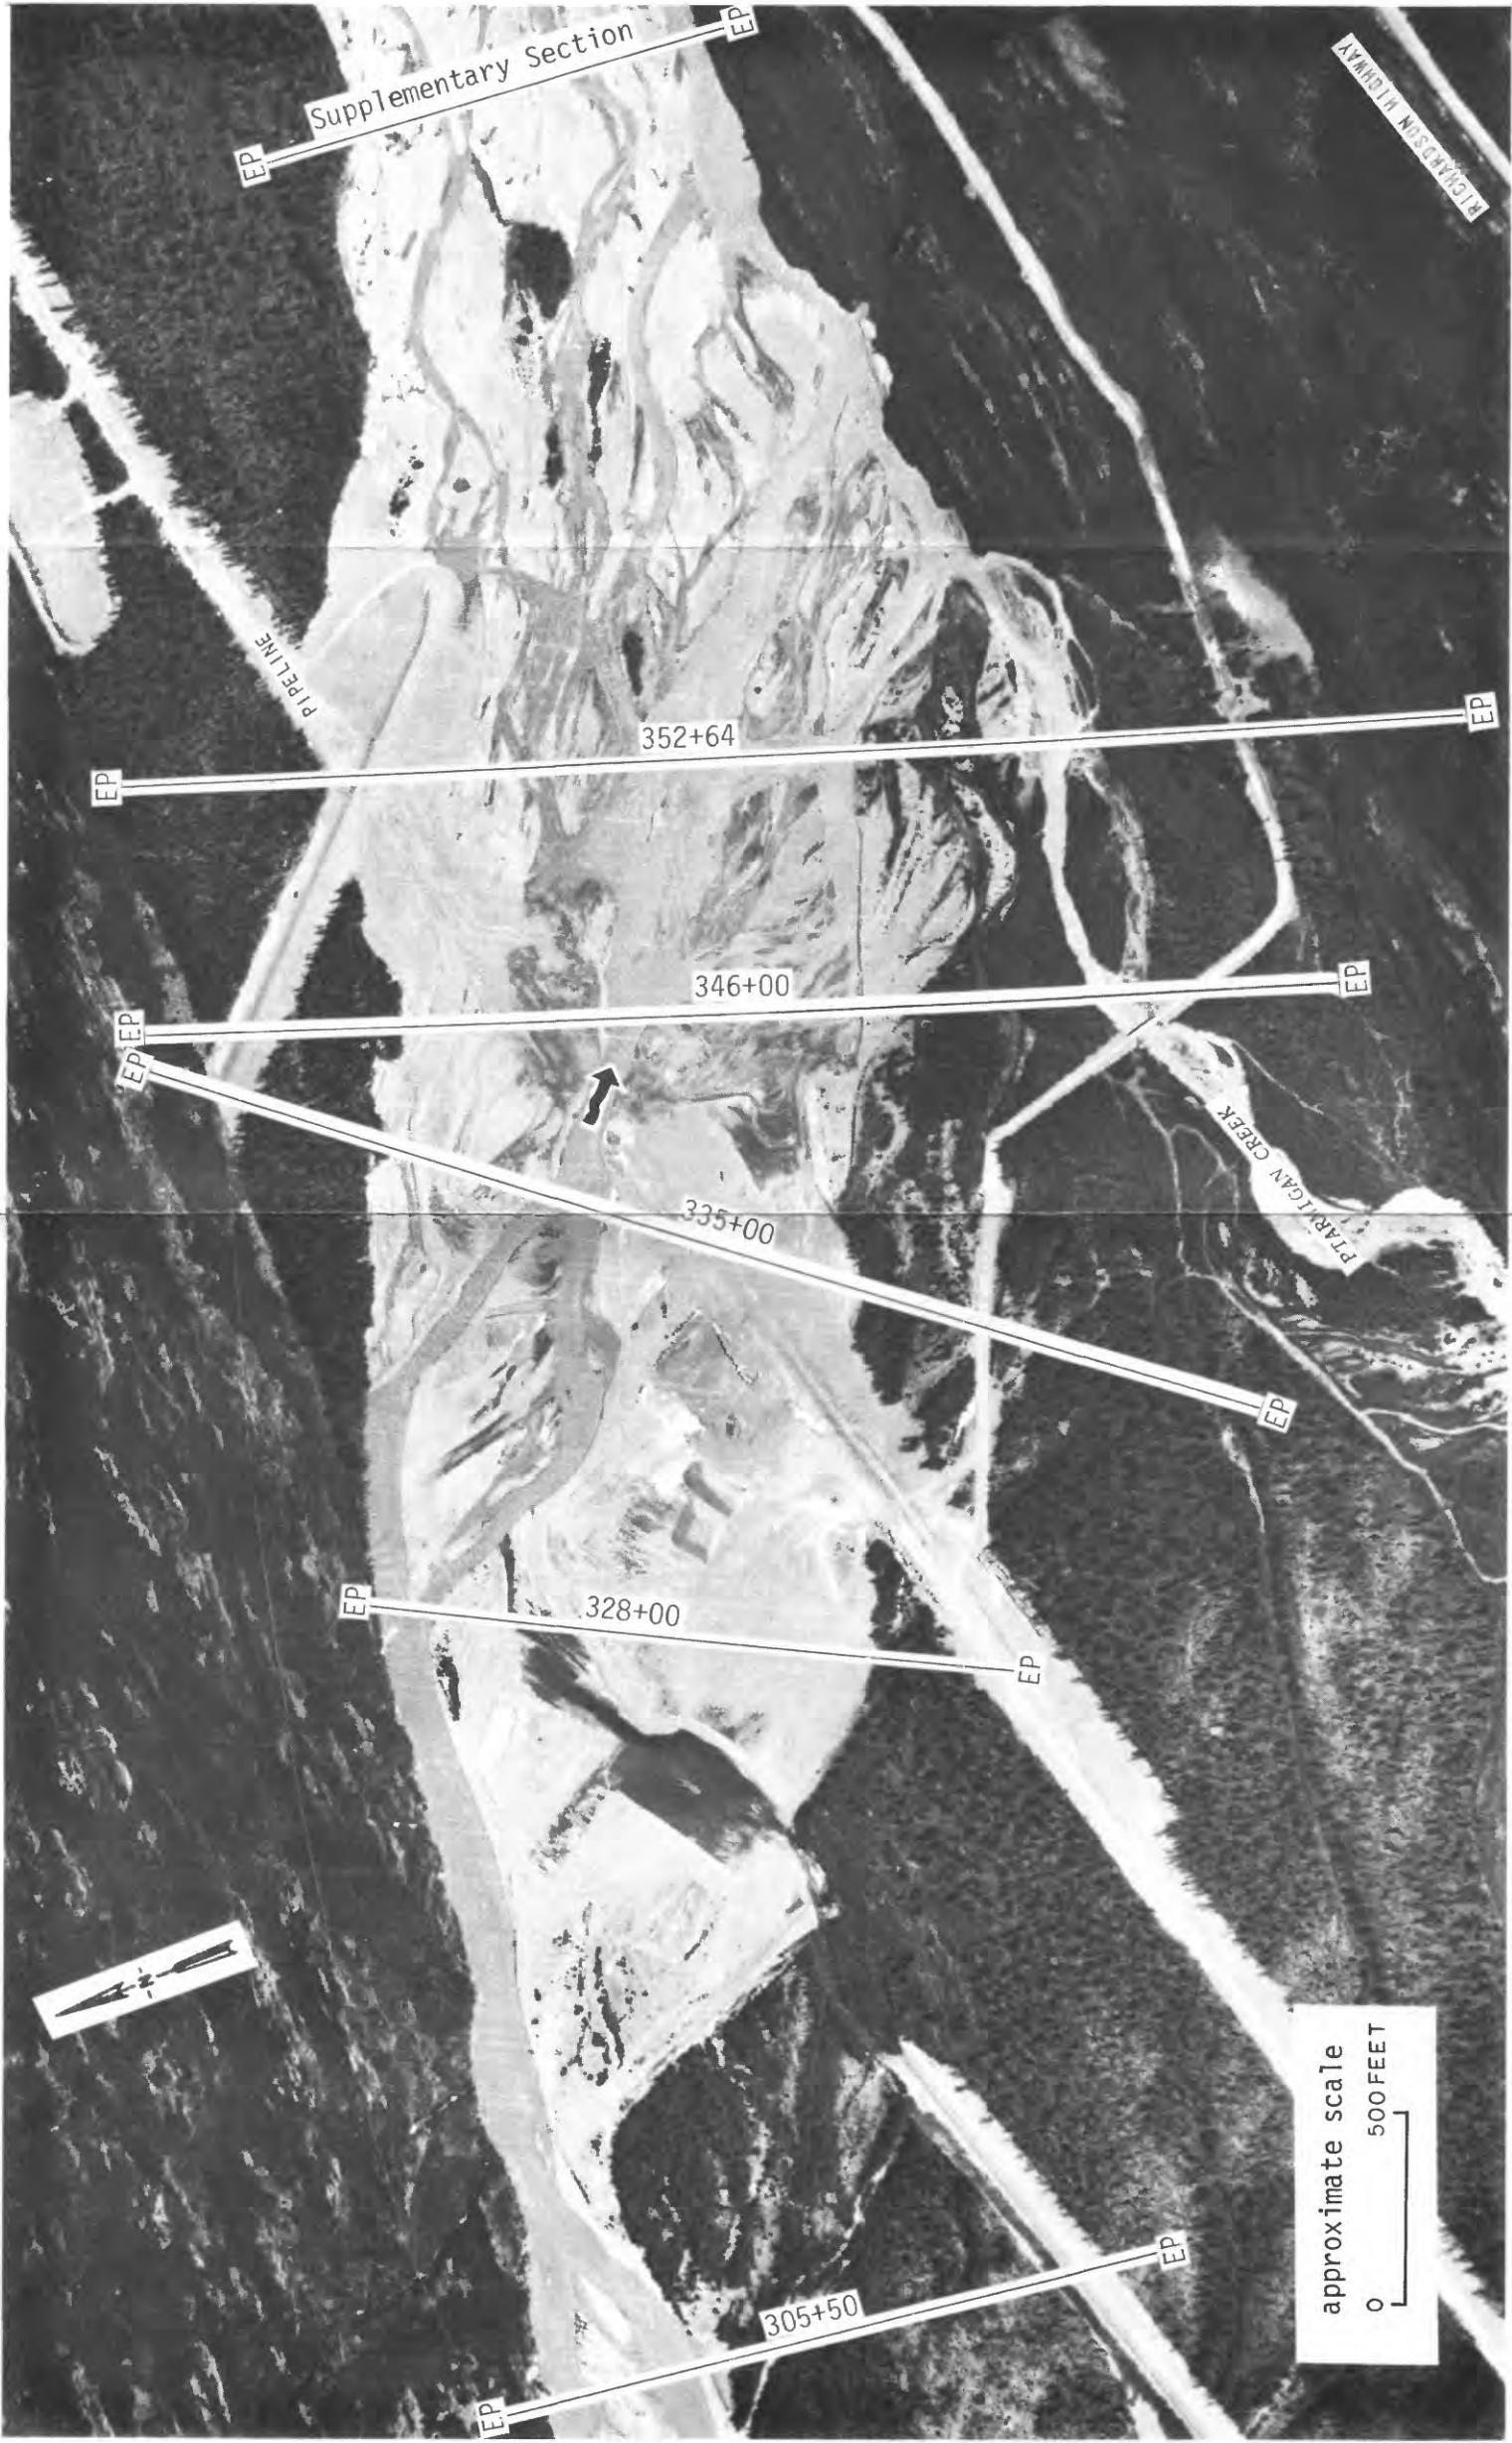
Figure 44. -- Tsina River at Ptarmigan, July 11, 1977.
 NORTH PACIFIC AERIAL SURVEYS

1977 Surveillance.--Figure 44 shows the Tsina River at Ptarmigan site on July 11, 1977. The site was resurveyed photogrammetrically on that date and visited in September. Dikes have been constructed along the channel upstream from the centerline. These have constricted the braiding pattern and moved it toward the right bank.
