UNITED STATES
DEPARTMENT OF THE INTERIOR
GEOLOGICAL SURVEY

CHANNEL EROSION SURVEYS ALONG THE TAPS ROUTE,
ALASKA 1977

OPEN-FILE REPORT 78-611
(Basic Data)

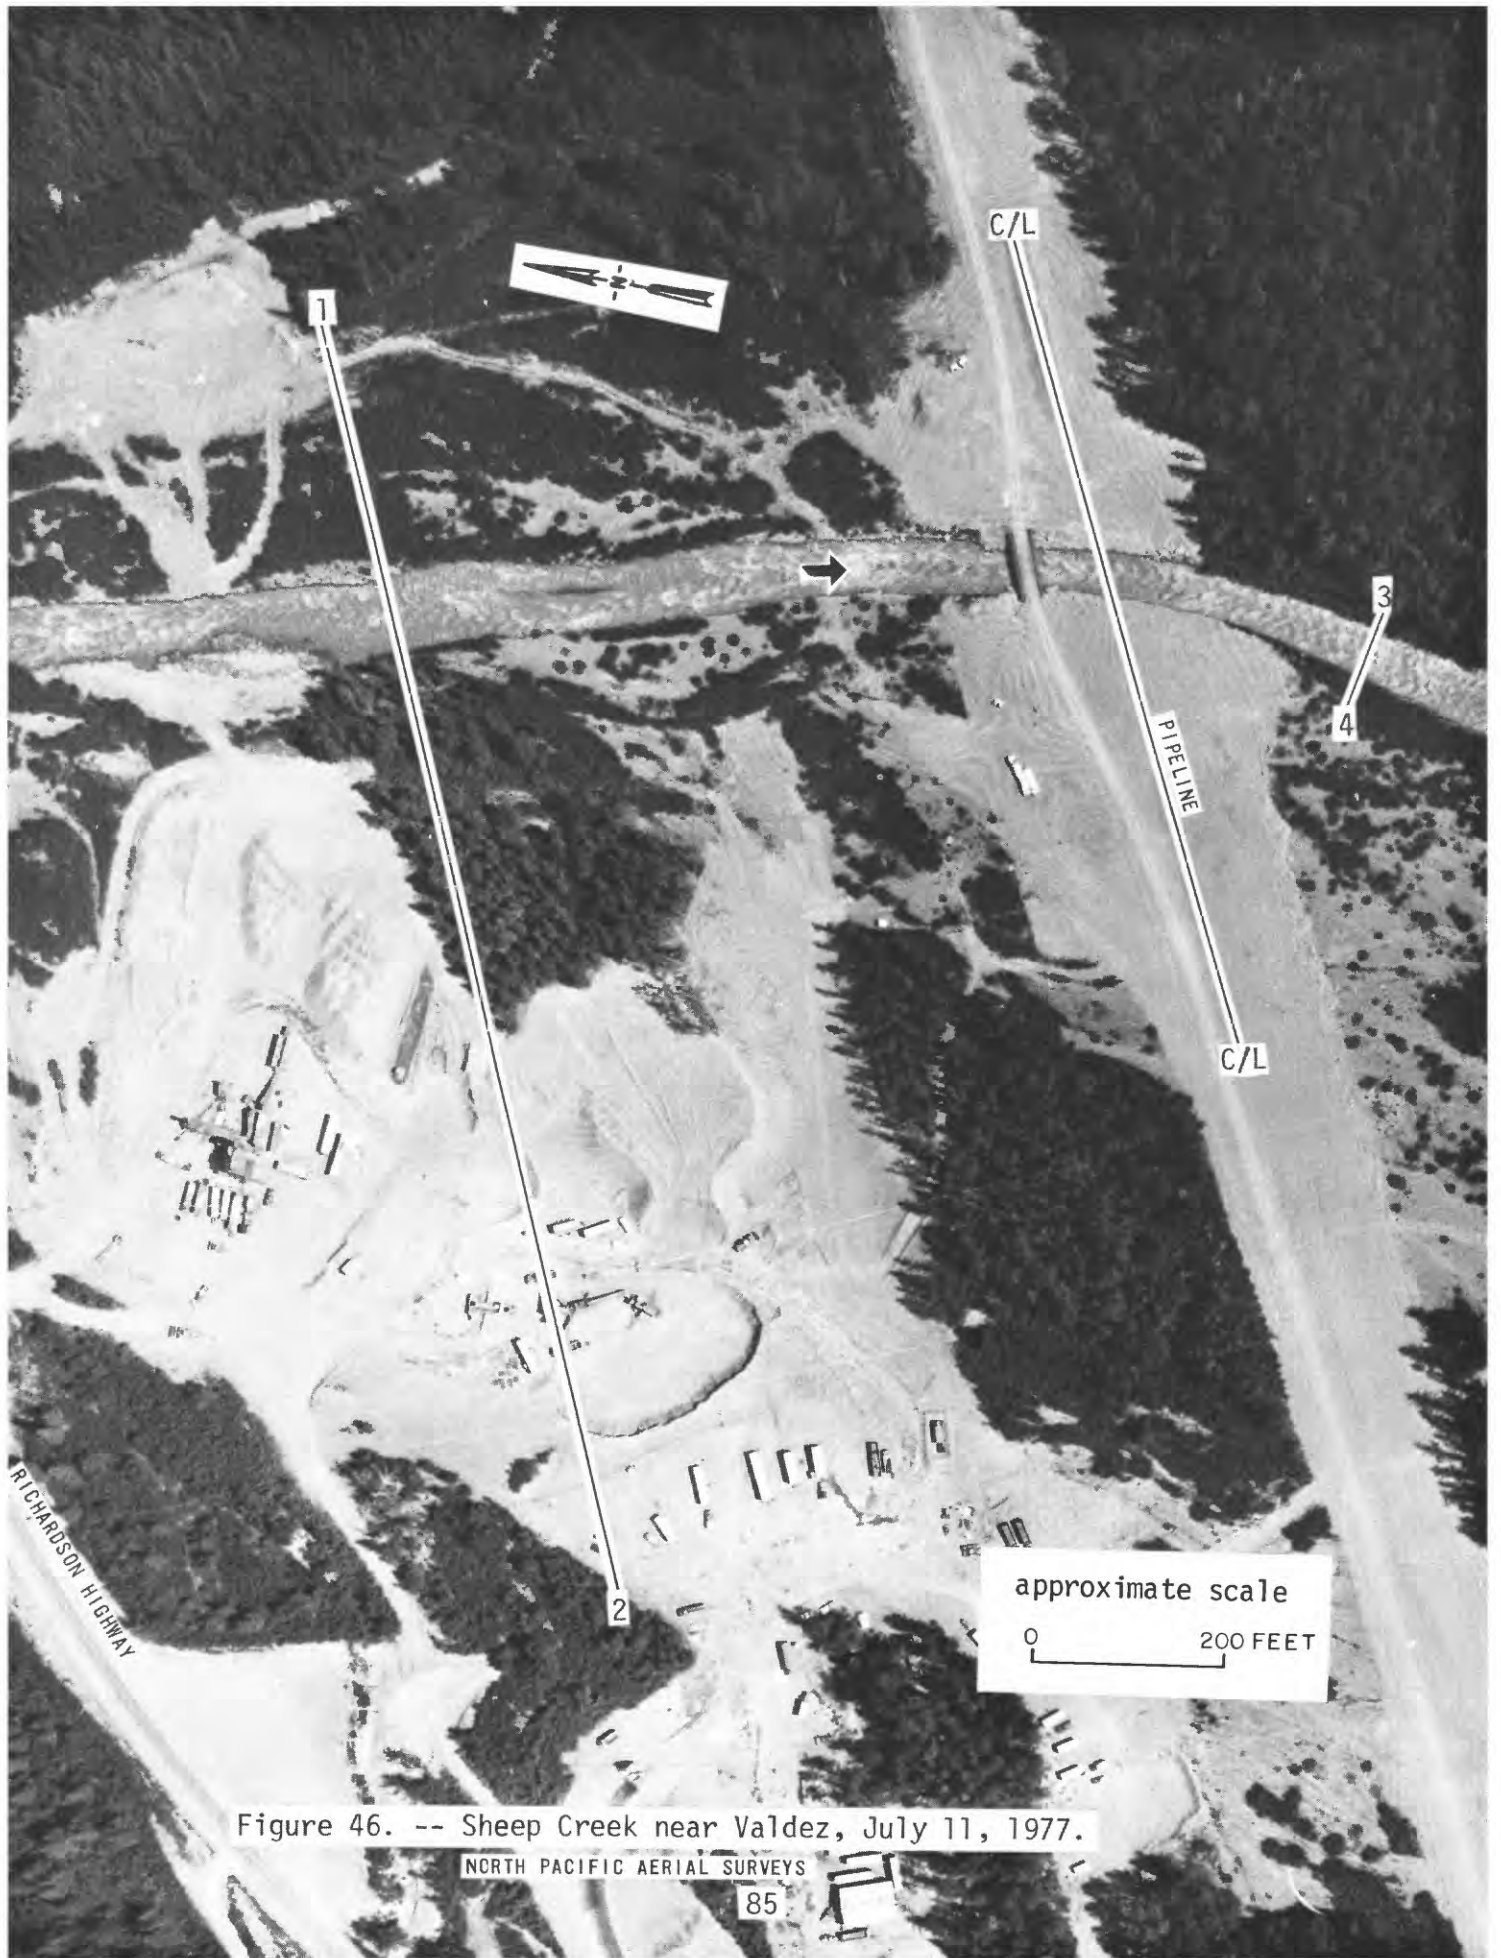
Figure 46. -- Sheep Creek near Valdez, July 11, 1977.

1977 Surveillance.--Figure 46 shows the Sheep Creek crossing site on July 11, 1977. The site was resurveyed photogrammetrically on that date and a field inspection was made in September.

No significant changes were found in either the upstream or downstream cross sections. Figure 47 displays changes made by construction equipment on the centerline in the last year.

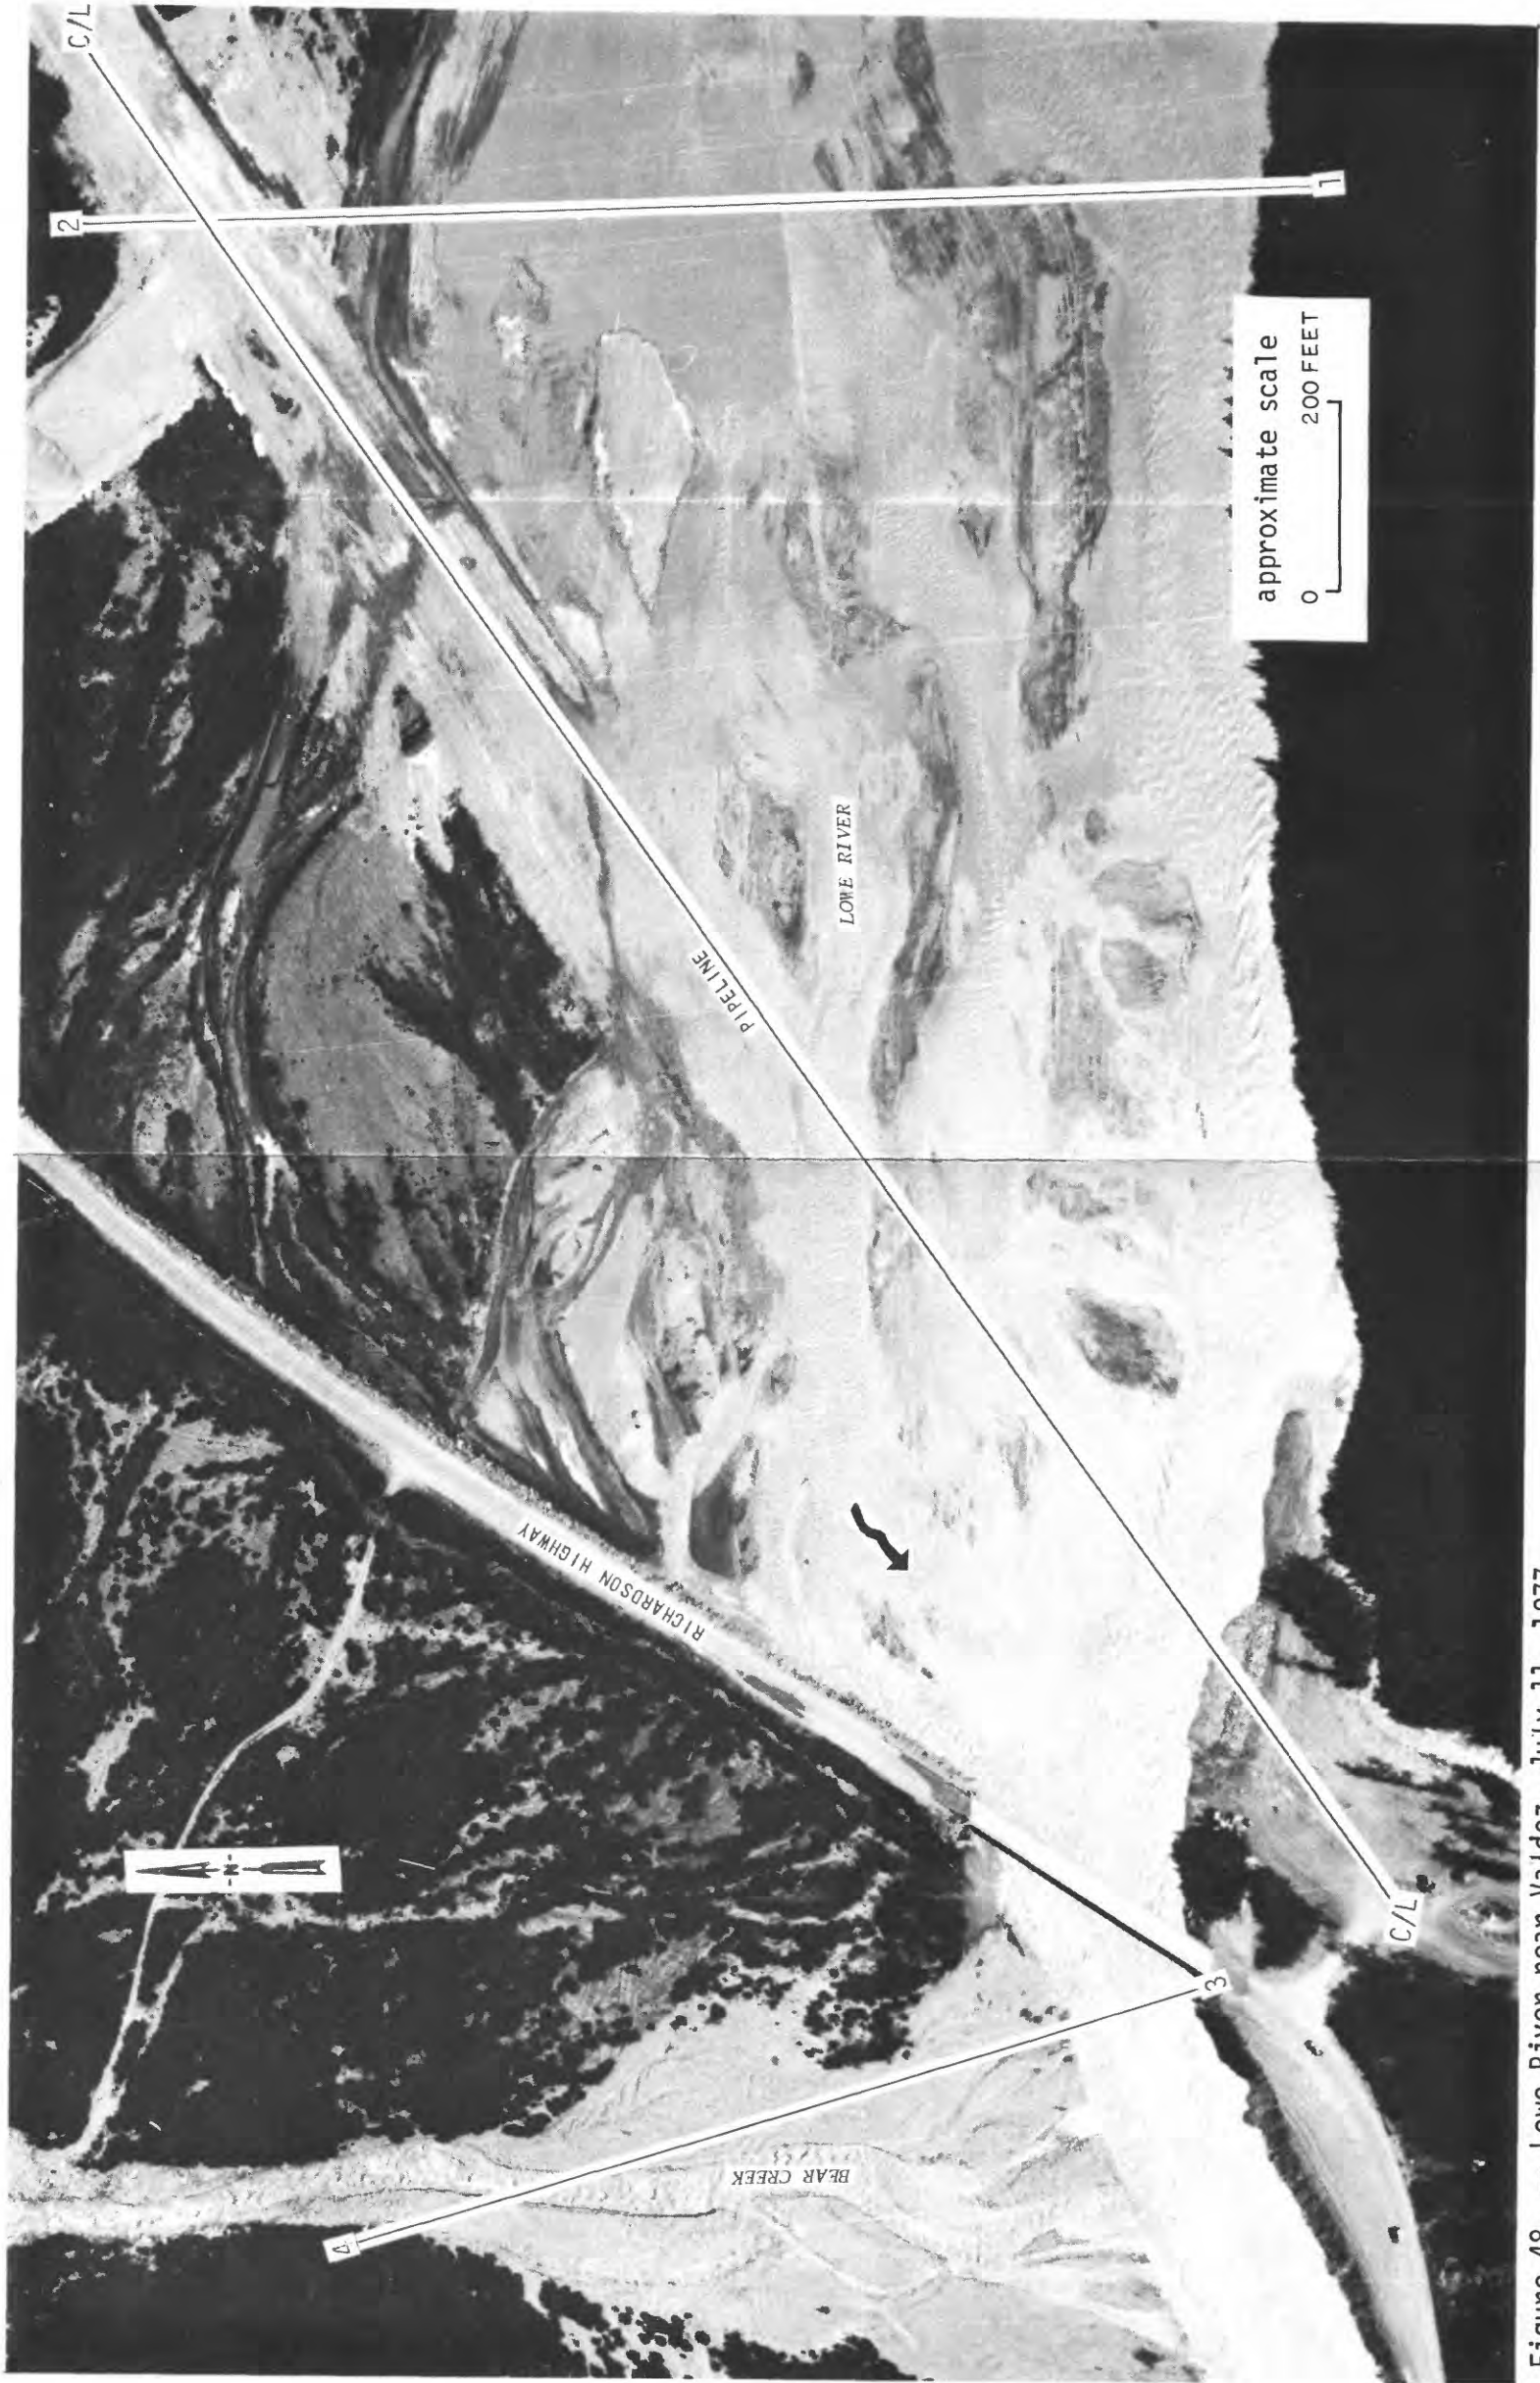
Figure 48. -- Lowe River near Valdez, July 11, 1977.
NORTH PACIFIC AERIAL SURVEYS

1977 Surveillance.--Figure 48 shows the Low River crossing site on July 11, 1977. The site was resurveyed photogrammetrically on that date, and a field inspection was made in September.

No significant change was found in the downstream cross section, but high water has covered the flood plain along the right bank at the upstream section. During the last year, the left bank of the centerline has been backfilled and a rip-rap dike has been constructed at the shore. This changed the profile of the left bank at the centerline, but the remainder of the cross section is identical to the last year's (fig. 49).
