DEPARTMENT OF THE INTERIOR
UNITED STATES GEOLOGICAL SURVEY

GEOLOGIC ROAD LOG
ALYESKA HAUL ROAD, ALASKA
JUNE-AUGUST, 1975

OPEN FILE REPORT
79-227

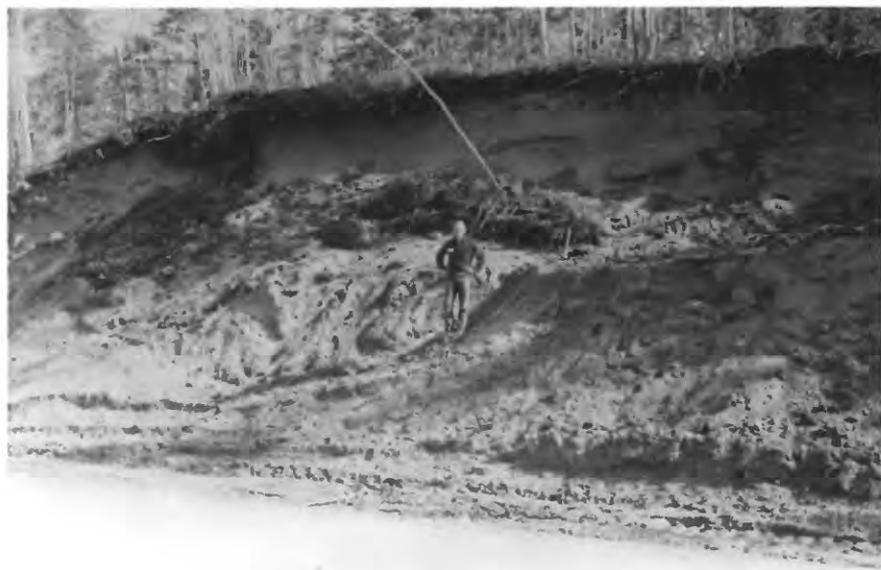
Figure 6. Bedded sand opposite entrance to Fivemile Camp (Site 23). August 1, 1975.

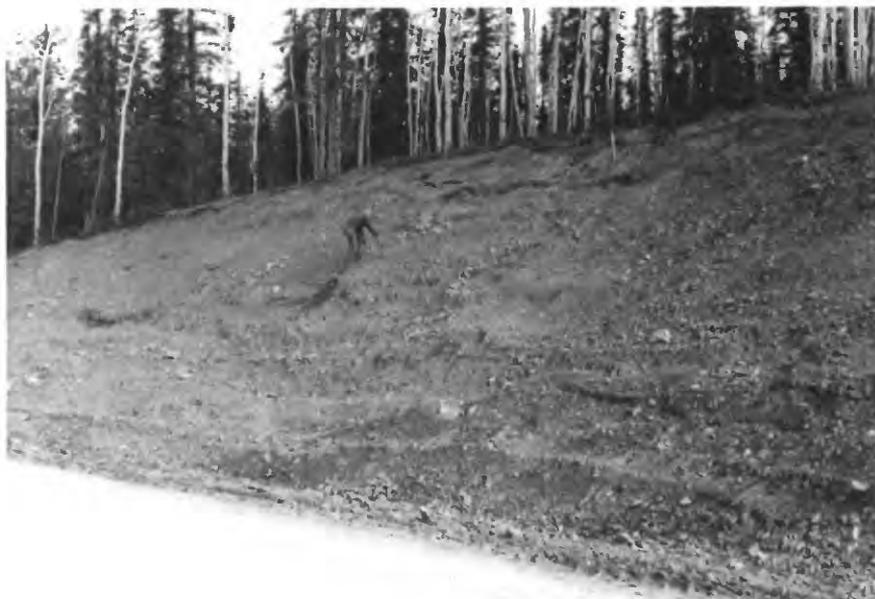
Figure 7. Loess above bedrock at Mile 6.7 (Site 24). Road crosses ridge crest here. June 24, 1975.

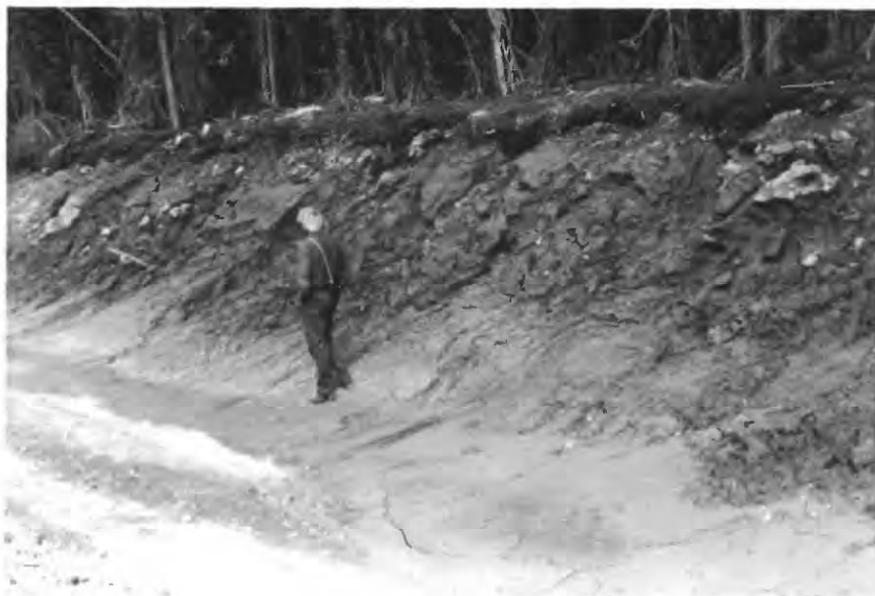
Site No.	Mileage ^{1/}	Description
21	0.0	North bank of Yukon River.
22	1.9	Cuts 4-6 m high along both sides of haul road expose horizontally bedded grey silt which contains occasional granules and snail shells and is interbedded with clayey silt and organic silt layers. Face of east cut is stable, but west cut exhibits minor slumping into roadside ditch (Fig. 5).
23	4.3	Cutbank 6-8 m high opposite entrance to Fivemile Camp (Fig. 6). Alluvial sand and granules, with thin gravel layer near top. Arkosic composition, with feldspar prominent in sand-to-granule range. Capped by loess blanket 0.3 m thick. Some minor slumping on June 24, but exposure appeared entirely stable on August 1.
*24	6.7	Stable cut as much as 9 m deep where road crosses ridge crest exposes loess above bedrock and rock rubble (Fig. 7). Loess bears mature Subarctic Brown Soil profile. At its north end (Mile 6.9), eastern cutbank is 3-6 m high and exposes mainly colluvial silt, fine sand, and rock rubble. Small gullies were active on June 24; minor slumping and gullying were continuing on August 1 (Fig. 8).

Figure 8. North end of above Site 24 (Mile 6.9). Road is descending north flank of ridge, and colluvial cover above bedrock has thickened. August 1, 1975.

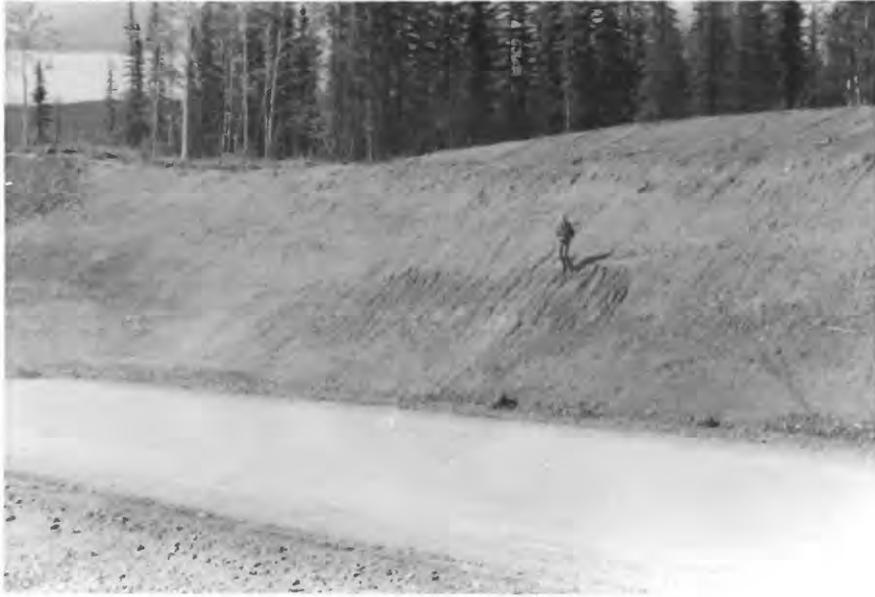
Figure 9. Road cut through ridge crest at Mile 11.3 (Site 27). Man is standing on contact between gravel and highly weathered bedrock. June 24, 1975.

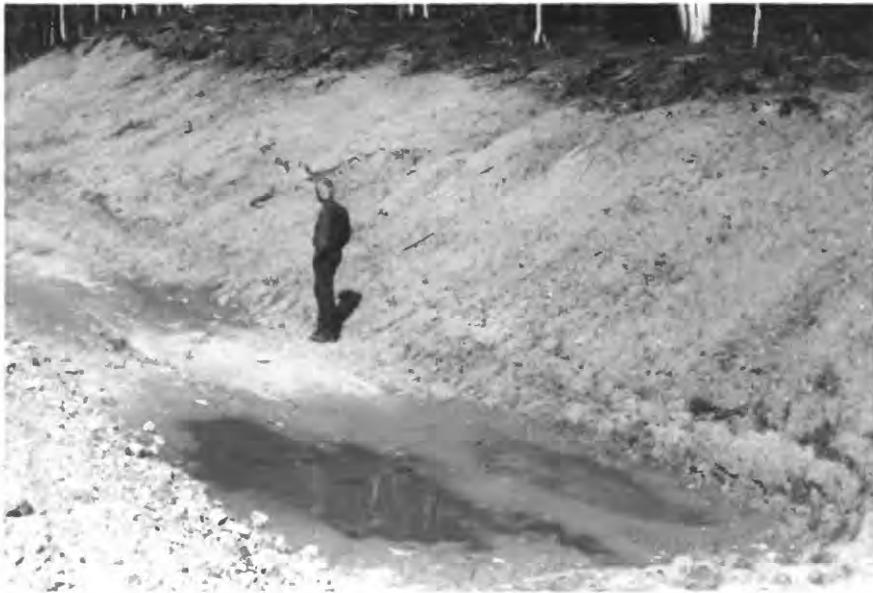
Figure 10. Road cut through colluvium-filled swale at Mile 13.8 (Site 29). August 1, 1975.

Site No.	Mileage	Description
*28	12.4	Cut through minor ridge crest which stands higher than Site 27. Bedrock to crest of ridge, with no overlying gravel. Roadway and cuts stable on June 24; locally gullied on August 1 where thick colluvium overlies bedrock.
*29	13.4-14.9	Cuts through ridge crests at Miles 13.4 and 14.9 expose highly shattered rock with thin loess cap. Faces stable on June 24; stable except for minor loess gullying on August 1. Colluvium-filled swale between these ridges is exposed in a 3-m cut at Mile 13.8. Roadside ditch wet in places on August 1, and bank showed minor flow and collapse features (Fig. 10).
30	15.4 & 15.8	Cuts about 15 m deep expose shattered granitic rock with thin soil cap (Fig. 11). Very little loess above bedrock in this area, and slopes appear relatively well drained and stable.
*31	17.4	South flank of tributary to Ray River. Colluvial silt in cut 5 m deep. Some slump and flowage on June 24; localized slumping and wet zones still evident on August 1.

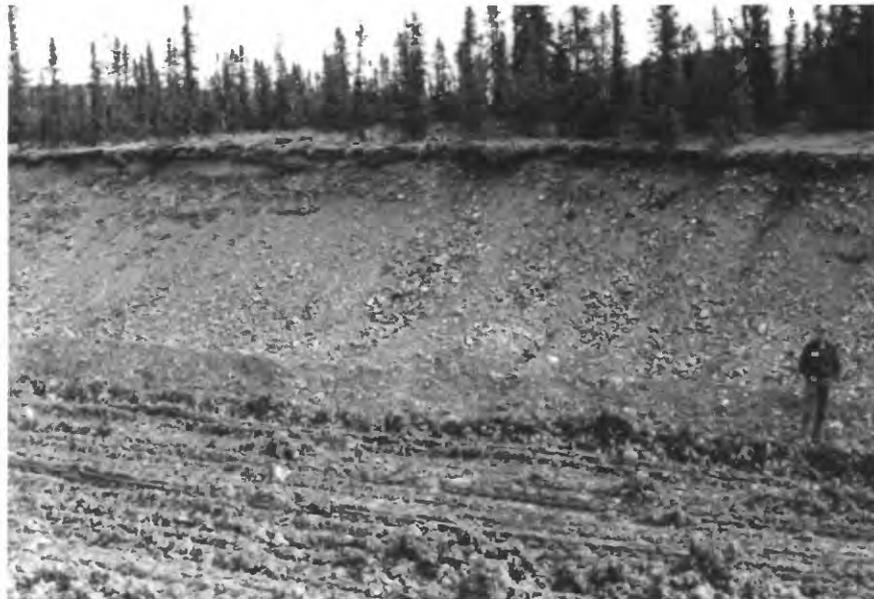
Site No.	Mileage	Description
57	83.4	Access road to Prospect Creek Camp.
*58	87.0	Cut 5 m deep into alluvial terrace exposes gravel with thin cap of sand and sod (Fig. 17). Floor of roadside ditch consists of moist sand, gravel, and grey clayey silt, churned together by heavy construction machinery. The terrace gravel probably was deposited over Pleistocene lake beds. Ditch was still wet, soft, and muddy on August 1, and had been widened to about 15 m by removal of borrow material. Road shoulder was actively sloughing into ditch (Fig. 18).
59	88.0	Road crosses Jim River near mouth of Douglas Creek.
*60	89.9	Surface drainage ponded along east side of road.
61	95.7	Road ascends and crosses probable moraine front. No cuts available to show character of the glacial drift.
62	99.6	Road crosses recessional moraine which separates Jim River drainage from tributaries to South Fork of Koyukuk River.
*63	104.6	Crossing South Fork Koyukuk River. Several shallow ponds have been dammed by roadway where it extends across floodplain.

Figure 17. Alluvial gravel in road cut near Jim River (Site 58). June 24, 1975.

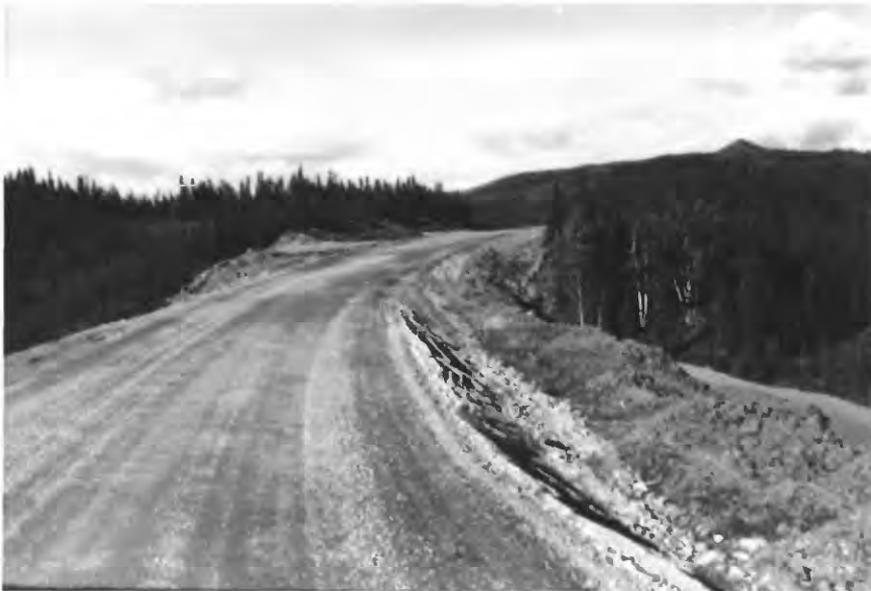
Figure 20. Haul road ascending moraine front in Middle Fork Valley (Site 71). June 24, 1975.

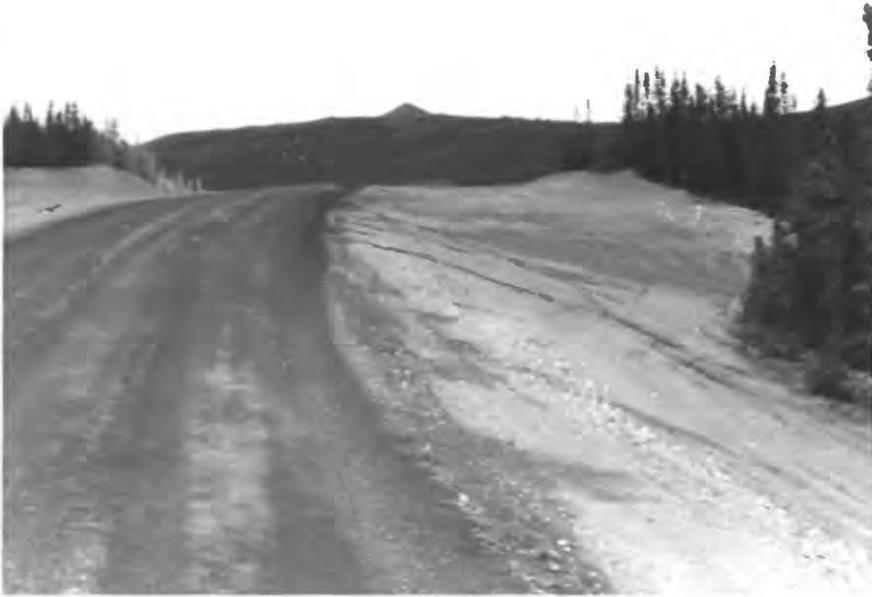
Figure 23. Site 71 on July 31, 1975.

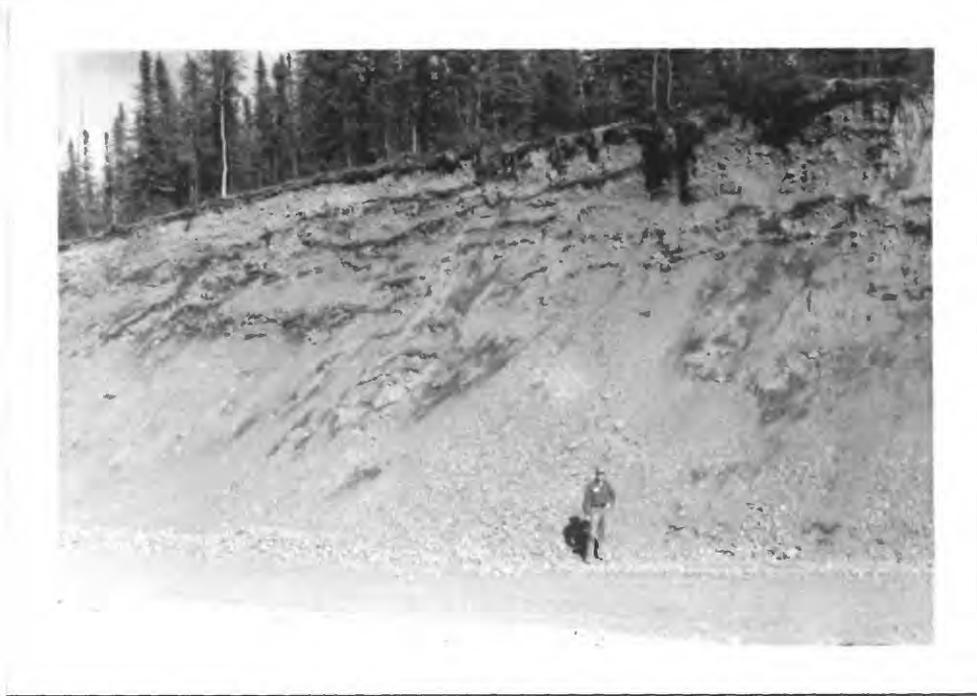
72	117.2	Road cut 12-15 m high exposes probable fan deposits (Fig. 25). Clasts poorly bedded and sorted, but most are angular, of local lithology, and range from pebbles to very small boulders. No striated or faceted clasts evident. Cut dry and stable, with only slight raveling.
73	117.4	Shallow (2-3 m) cuts into till. Dry and stable.
*74	117.5-118.5	Road crosses poorly drained upland which appears to be ground moraine. Solifluction appears to be widespread, but roadway dry and stable.
*75	119.7	Cut along east side of road stands 6-7 m high. Muck and gravel alternately exposed, with ice-rich muck probably forming channel fills in gravel. Upon thawing, muck yields lobes of flowing mud which have nearly filled roadside ditch in places (Fig. 26). Two flow lobes still

Figure 25. Fan gravel exposed at Site 72. June 24, 1974.

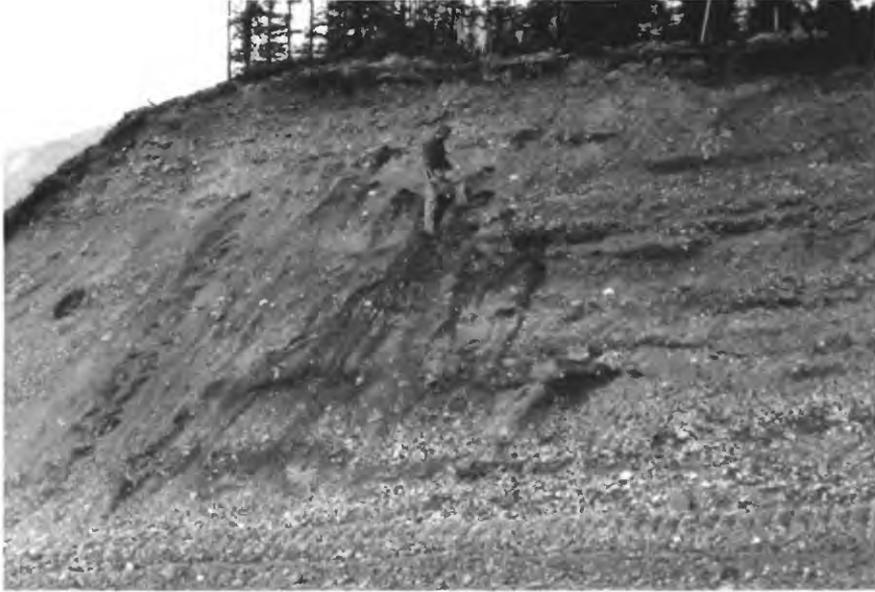
Figure 27. Terrace gravel at Site 79. June 25, 1975.

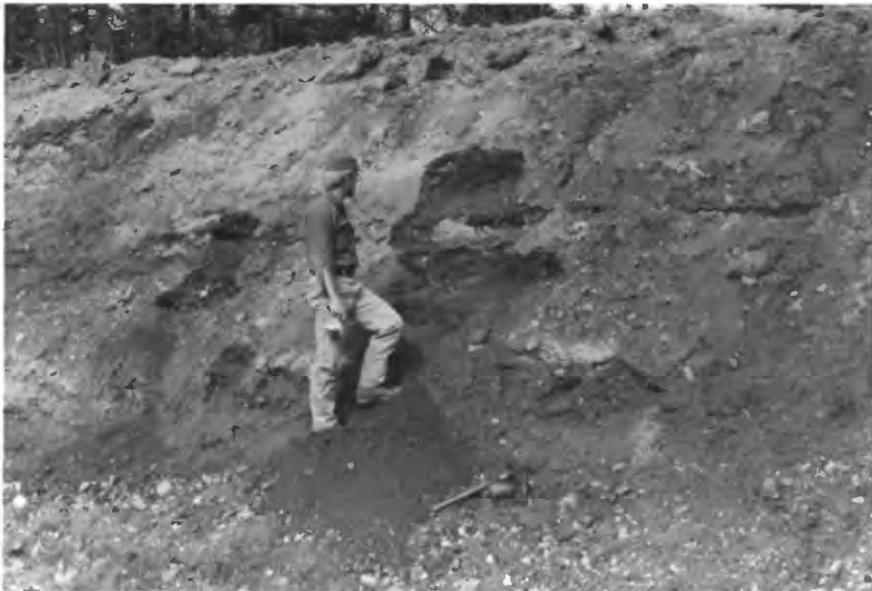
Site No.	Mileage	Description
*78	124.7	Entrance to Coldfoot Camp. Between Miles 124.7 and 131.6, road follows alluvial terrace flanked by possible solifluction slope to east. Foot of slope occasionally extends to road edge, where small amounts of water are ponded against road bed in places.
79	131.6	Road ascends to surface of higher alluvial terrace. Cut 7 m deep at terrace edge exhibits fluvial gravel with minor sand beds beneath thin (0.5 m) loess cap (Fig. 27). Bank appears entirely stable. Road follows terrace surface from Mile 131.6 to 134.1. Roadway stable, and ditches generally dry. No cuts present.
80	135.4- 135.6	Cuts 3-5 m deep into hummocky surfaces along both sides of road. Fluvial sand and gravel throughout, and faces are stable.
81	136.3	Cut similar to Site 80, east side road.
82	136.7	Cut 4-5 m deep along west side road exposes bedded sand and gravel above 2 diamicton (till-like) units separated by a buried Histosol (organic soil) (Fig. 28). Measured section near midpoint of exposure shows:

Figure 28. Buried Histosol in diamicton at Site 82. June 25, 1975.

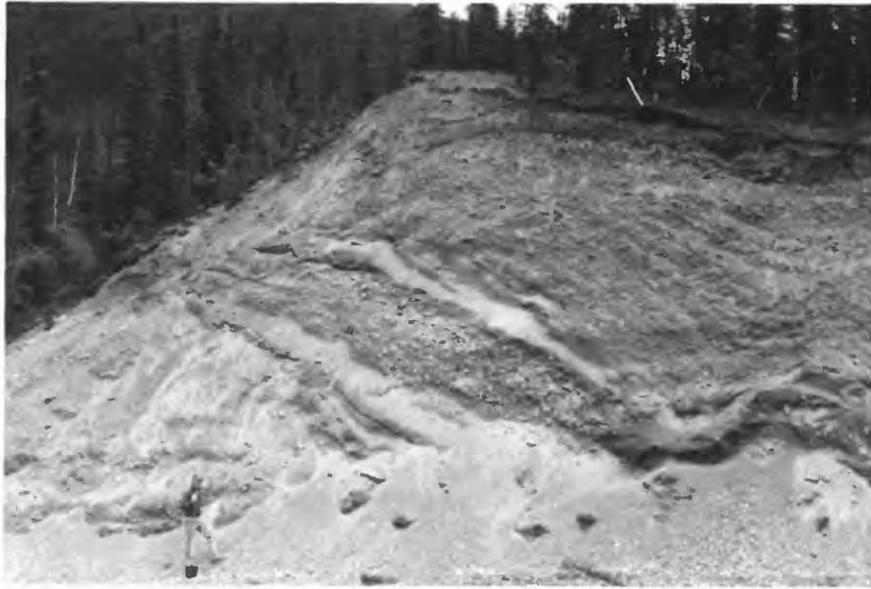
Figure 31. Ice-contact gravel at Site 84. Note steeply dipping foreset beds. June 25, 1975.

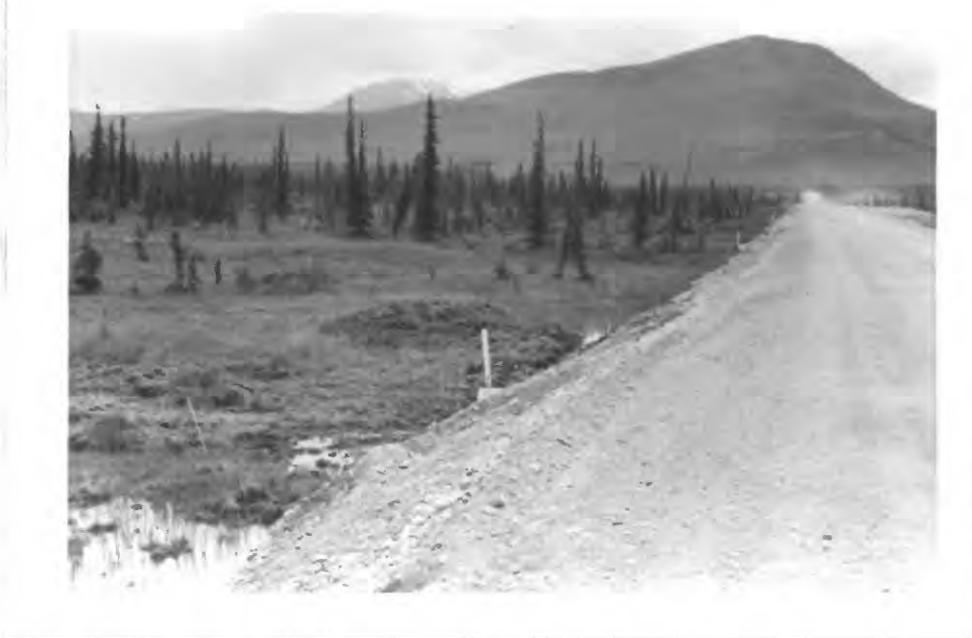
Site No.	Mileage	Description
93	154.2	Borrow pit east of road provides fresh exposures of the coarse limestone rubble at base of Sukakpak Mtn. Probably landslide deposit rather than rock glacier because (1) it is not connected to any modern or ancient talus slope, (2) a relatively fresh detachment scar overlooks the deposit, and (3) deposit contains many huge blocks much larger than those in modern talus of the mountain.
*94	154.6- 154.9	Road crosses muskeg terrain which has poor surface drainage and many frost mounds (palsas) (Fig. 33). Mounds range in height up to 1.5 m, occur along both sides of road and are currently active, with open tension cracks 20-50 cm deep. They appear to be ice-cored because thaw leads to formation of nearly circular small ponds (Fig. 34). This stretch of road (ca. Mile 154.4 to 154.9) was being rebuilt and regraded on July 31. Substantial quantities of gravel were being added, suggesting that thaw of permafrost and/or compression or soft bog sediments had caused appreciable subsidence.

Figure 33 (above). Muskeg terrain and palsas at Site 94. June 25, 1975.

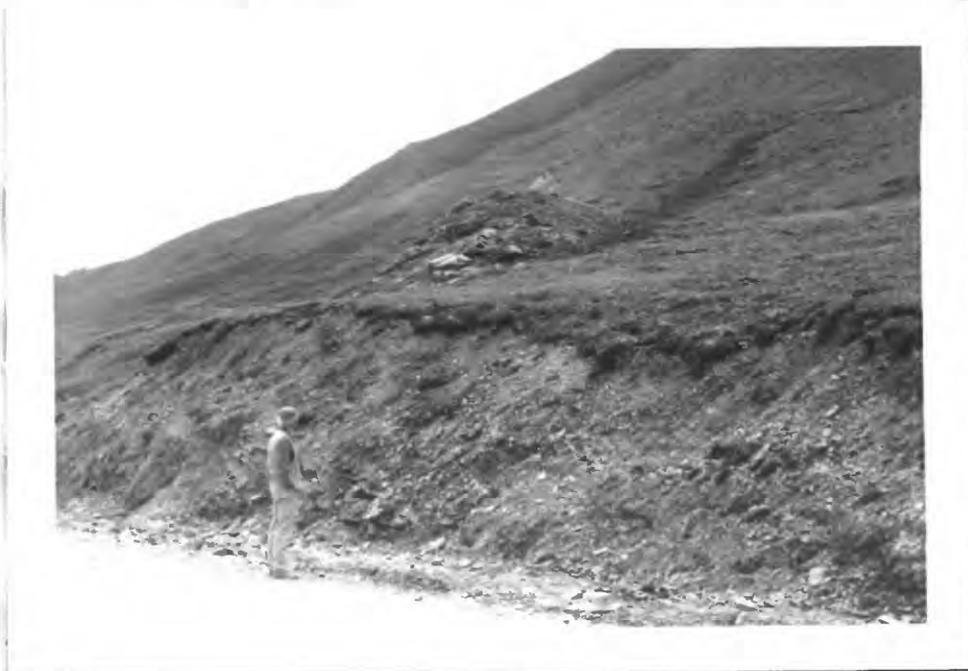
121	193.1	Entrance to Chandalar Camp.
*122	195.3	Kamelike knobs of rock rubble lie above bedrock along both sides of road (Fig. 40). Probable landside deposit, possibly deposited on stagnating glacier.
*123	196.2	Road begins ascent toward Atigun Pass (Fig. 41). Several debris flows below the road appear to have originated from roadbed (Figs. 41 and 42). One of the flows appears generated by concentration of runoff water through a culvert (Fig. 42).
*124	196.6- 198.6	Almost continuous series of road cuts into colluvium flank northwest side of road (Fig. 41). Through Miles 196.6-197.0, the cuts are relatively low (3-5 m) and mainly expose solifluction rubble; farther up the slope they are mainly into talus. Close to the Pass, many of the cuts are as deep as 10-20 m and several expose bedrock at their base. Exposed strata dip directly down-slope toward road in only 1 locality.

Figure 40 (below). Landslide rubble in road cut at Site 122. July 31, 1975.

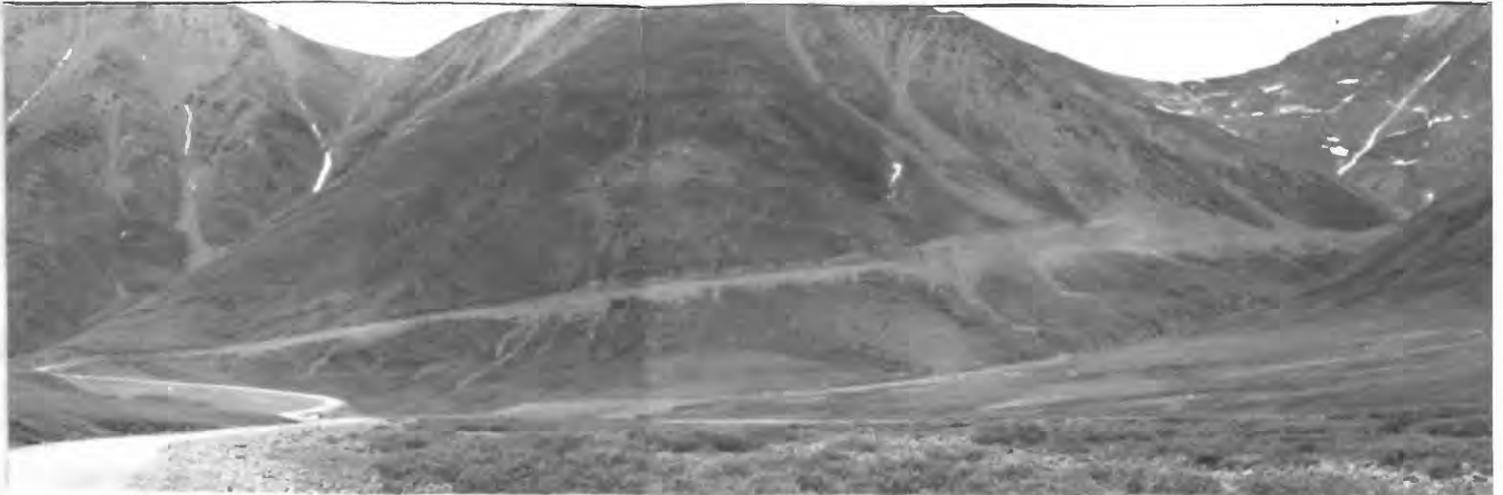
Figure 41. Panoramic view of south flank of Atigun Pass from Site 123. June 25, 1975.

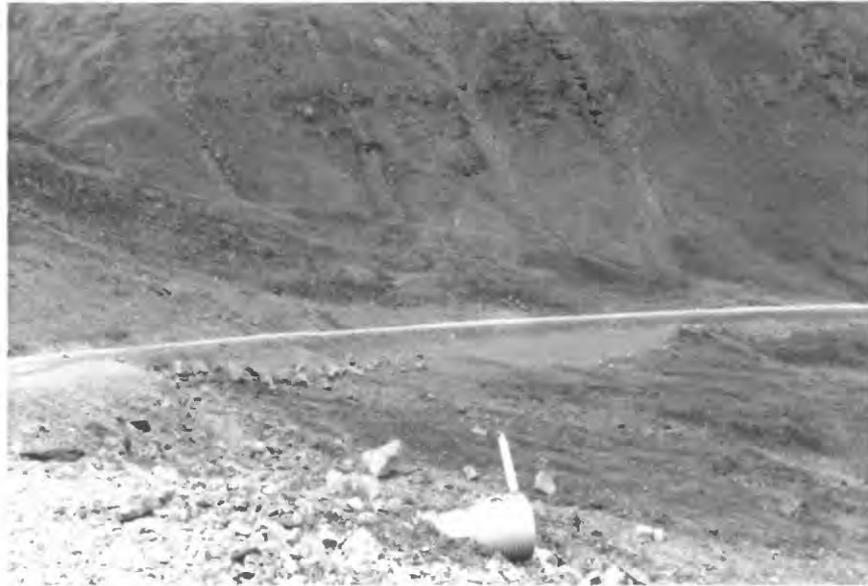
Figure 43. Inactive rock glacier crossed by haul road at north end of Atigun Pass (Site 126). June 25, 1975.

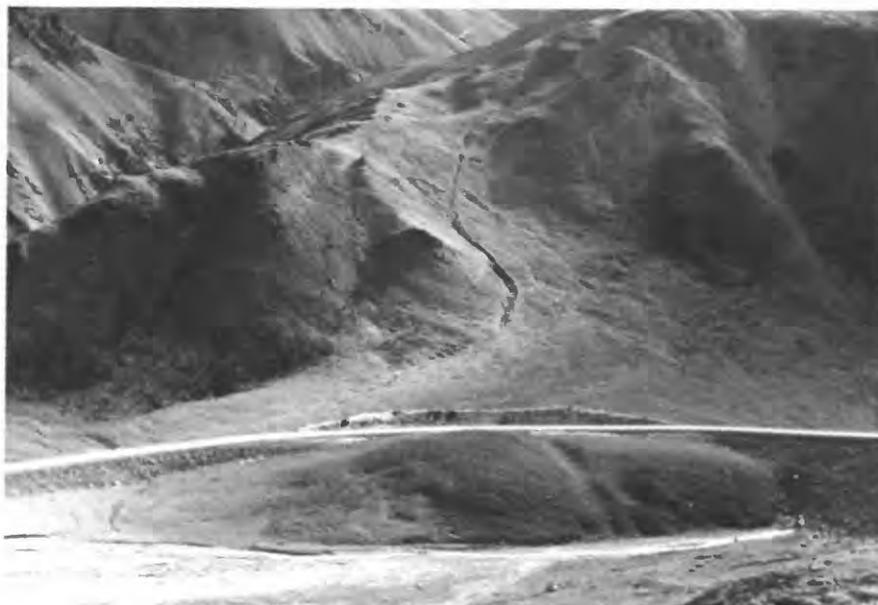
*129	199.7-199.9	Persisting snowbanks along southeast side of road on June 25 (Fig. 46).
*130	200.4	Road crosses very active debris slope (Fig. 47). Cuts 3-5 m deep expose rock rubble in ice-rich silty matrix. Cut west of road was highly unstable on June 25 owing to thaw of ice-rich permafrost. Mudflows, generated along face of cut, were filling roadside ditch (Fig. 48). Bank had been freshly covered with mat of insulating material when seen again on July 8, but by July 31 active flows had disrupted about 10% of the mat along both sides of road (Figs. 49 and 50).
*131	201.1	Road intersects a steep alpine fan which bears fresh-appearing levees and boulder litter indicative of repeated debris flows or slush flows (Fig. 51). Most boulders are weathered, but some lack weathering and lichen cover and may have been deposited recently (Fig. 52).

Figure 47. View east from Atigun Pass to Site 130. July 31, 1975.

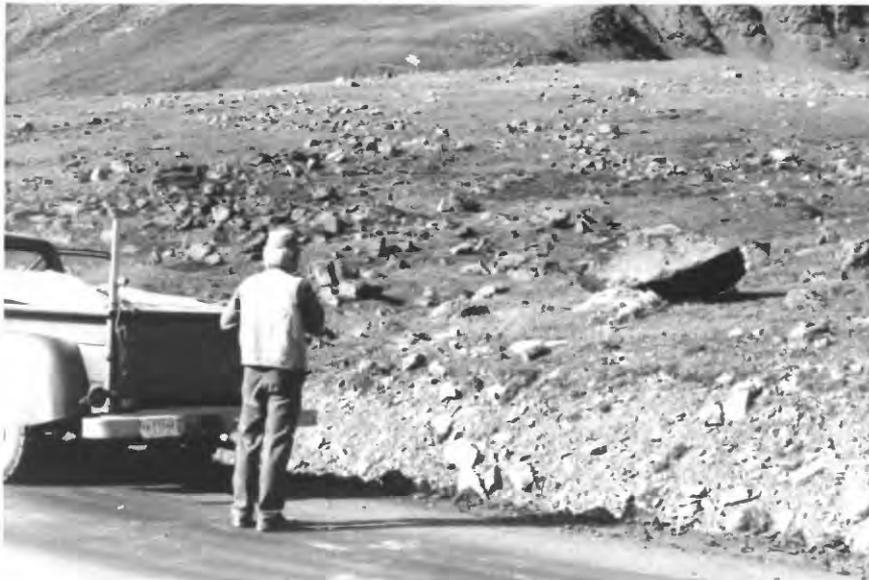
Figure 52 (below). Near view of Site 131. Heavy boulder litter on fan surface. July 31, 1975.

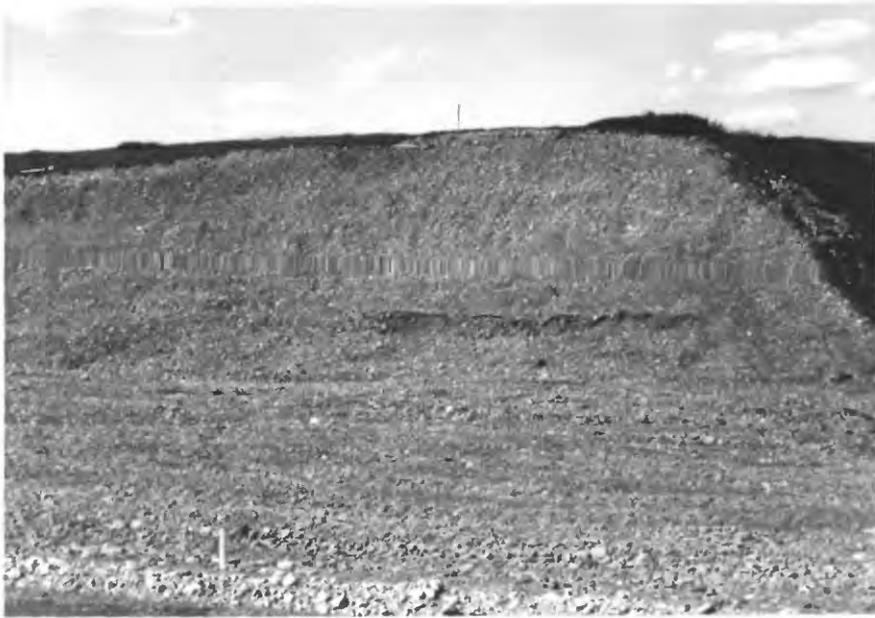
Site No.	Mileage	Description
156	264.7	Begin descent to flood plain of Sagavanirktok River. Cut along west side of road exposes 7 m of grey outwash gravel (rounded stones up to cobble size in a sandy matrix) beneath 40 cm of frost-churned stony silt (Fig. 55).
157	264.7- 269.3	Road follows flood plain of Sagavanirktok River. Excellent gravel subgrade.
*158	269.8	Pond has formed on the upslope (west) side of road where intersected by access road leading to pipeline work pad.
159	269.3- 275.8	Crossing Itkillik-age end moraines. No problems evident on July 7.
*160	276.2- 277.2	Several soft places on road, possibly due either to thaw subsidence or to compaction of poorly graded or improperly emplaced fill. No thermokarst is evident beyond edges of roadway in these places.
*161	277.5	Drainage impounded by road and pipeline work pad has formed 3 shallow ponds.
*162	280.9	Road leaves flood plain of Sagavanirktok River and ascends about 50 m up steep grade to upland surface underlain by bedrock and glacial deposits (Fig. 56). In 1974, road cuts exposed muck and peat with ice wedges and other massive ground ice above a lens of till resting on bedrock (Fig. 57). By July 1975, massive ground ice no longer was visible in road cuts, but continued melting was causing slope retreat by slump and flowage (Fig. 58). Liquefied muck and till were discharging down both roadside ditches into basins behind dikes built at the base of the grade (Fig. 56).

Figure 55. Road cut into gravel of Itkillik Glaciation (Site 156). July 7, 1975.

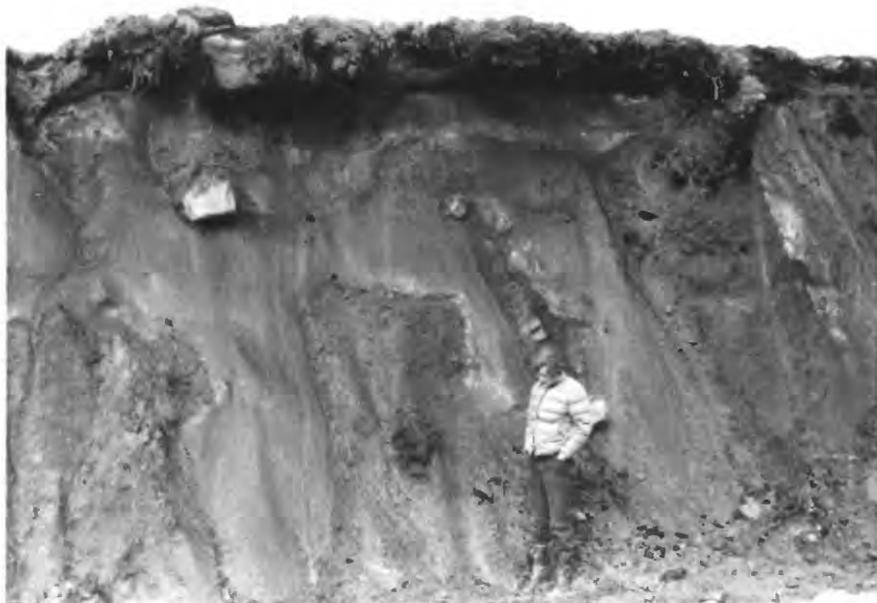
Figure 57. Western road cut at Site 162 shortly after excavation. June 30, 1974.
