**DEPARTMENT OF THE INTERIOR
U.S. GEOLOGICAL SURVEY**

**Preliminary isoseismal map for the Sierra Madre, California,
earthquake of June 28, 1991 UTC**

Open-File Report 91-388

by
Carl W. Stover and B. Glen Reagor

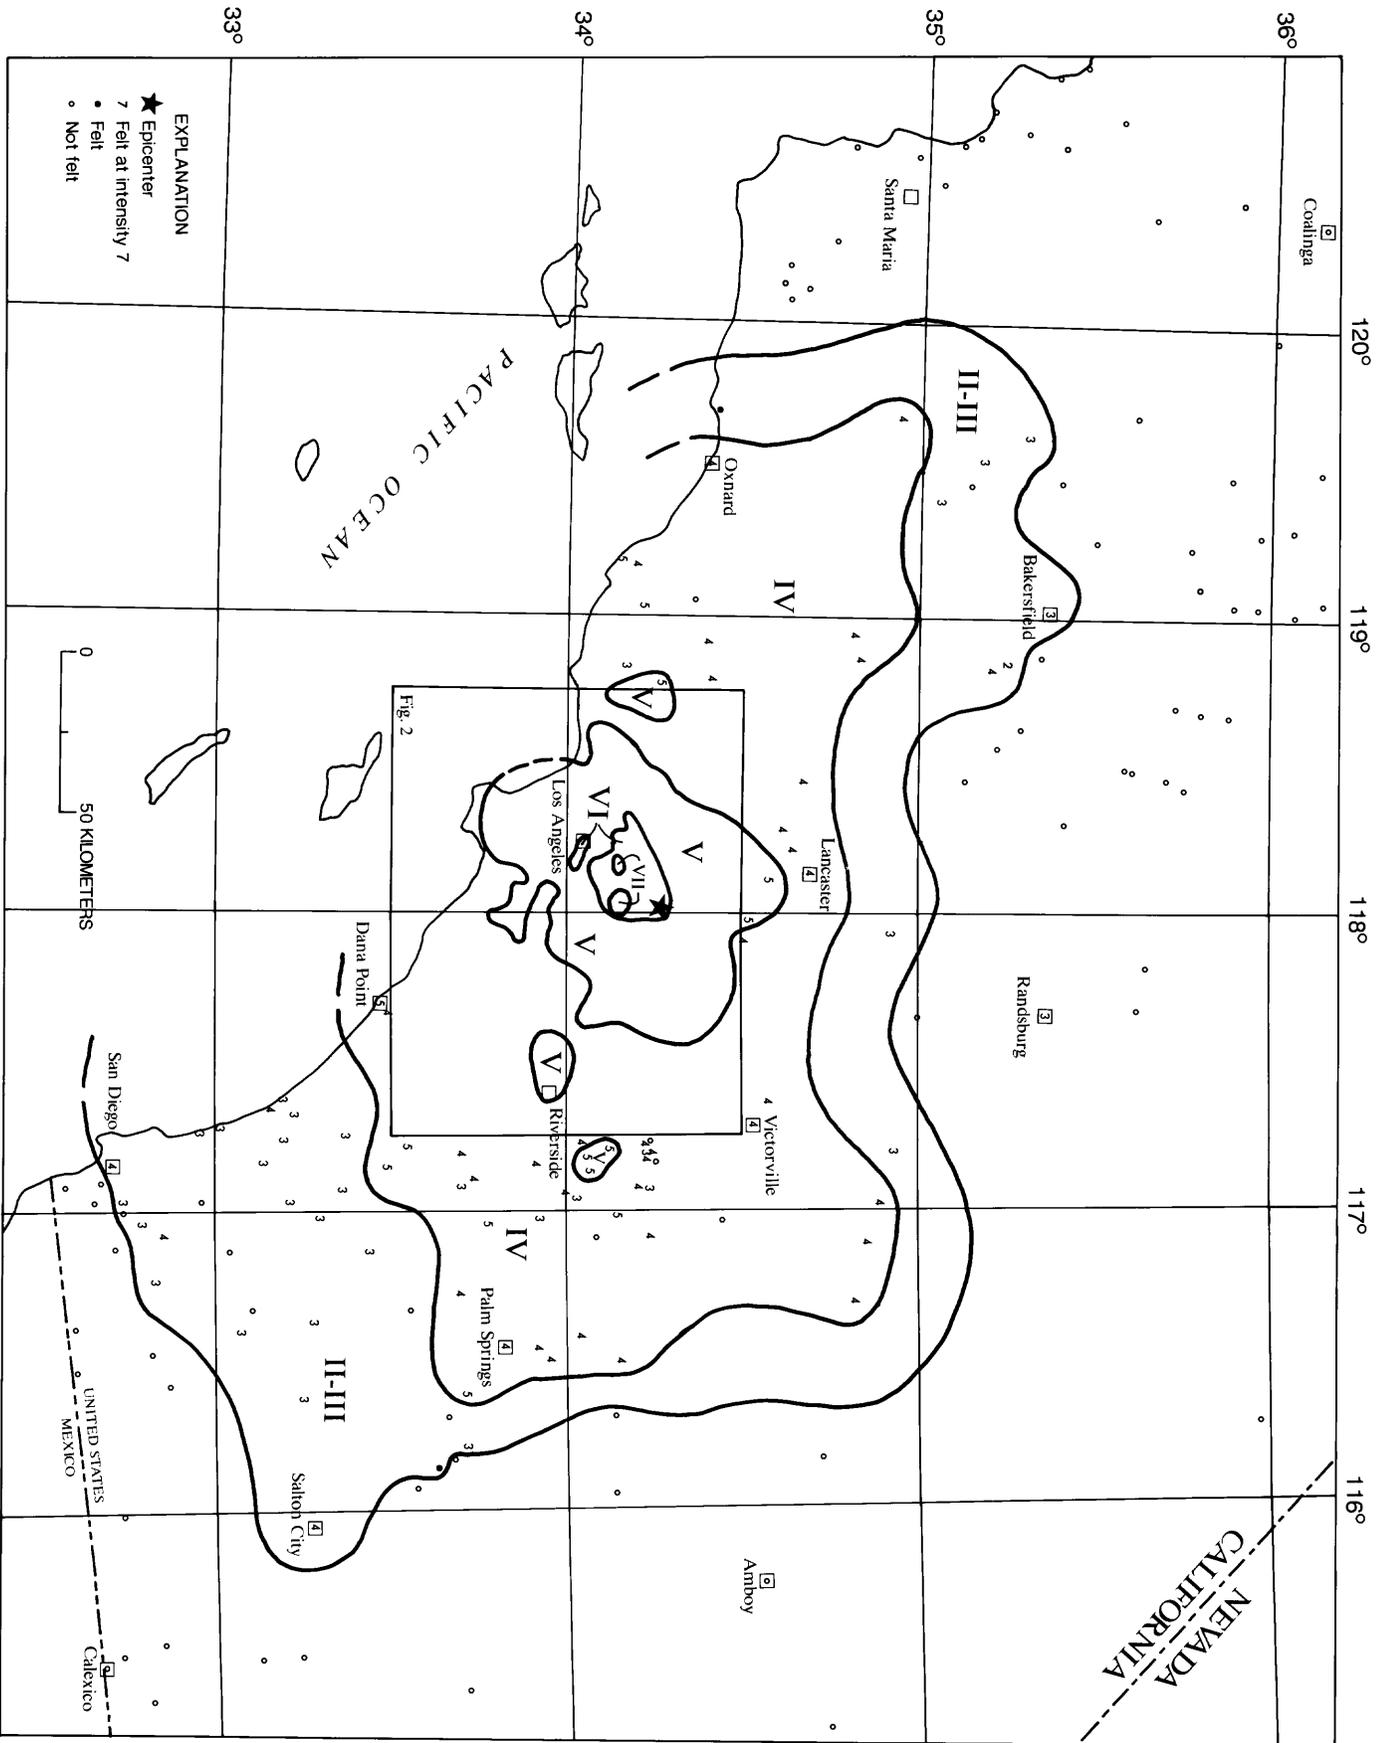
Figure 1. Isoseismal map for the Sierra Madre, California, earthquake of June 28, 1991.

Figure 1 shows the areal distribution of intensities for the 1991 Sierra Madre earthquake. The intensities are based on data from field notes by the authors of this report; mail questionnaires, and newspaper accounts.

The MMI II–III isoseismal in figure 1 defines the limit of perceptibility for the localities that felt the shaking. The contiguous felt area extends from San Diego northward along the coast to Santa Barbara and inland to Bakersfield and beyond Palm Springs. Two communities outside the felt area: Randsburg, Calif. and Las Vegas, Nev., reported feeling this earthquake. The felt area shown in figure 1 is approximately 58,500 km²; considerably less than the 110,00 km² felt area of the October 1, 1987 Whittier, Calif. earthquake of magnitude 5.9 M_L (this event had a magnitude 5.8 M_L).

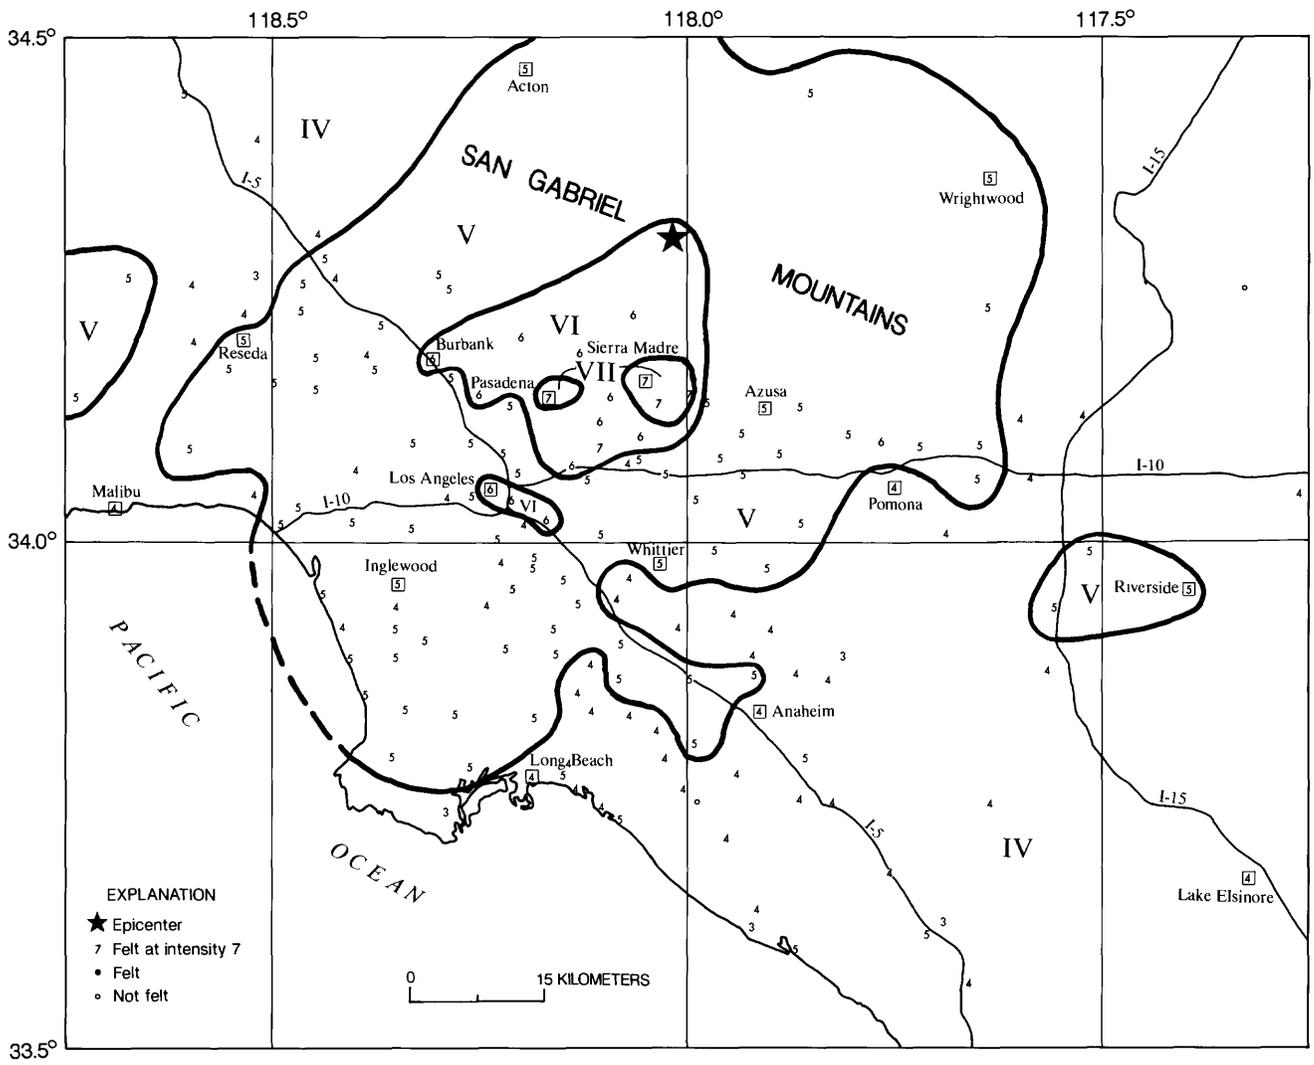
Figure 2. Isoseismal map for the Los Angeles area for the Sierra Madre, California, earthquake of June 28, 1991.

Figure 2 shows the distribution of intensities in Los Angeles and surrounding areas. The maximum intensity as shown on this map is MMI VII in Monrovia and Sierra Madre where the damage was more general and in Arcadia, Pasadena, and San Gabriel where the major damage to several structures was scattered within the city. The epicenter was located in the Angeles National Forest in the San Gabriel Mountains, an area of limited accessibility and human habitation; thus there were no reports of damage in the epicentral area; only reports of strong shaking, landslides, and rockslides.

On figure 2, the MMI VI isoseismal outlines 1,100 km² encompassing the region associated with damage to structures. This damage ranges from minor (broken windows, cracked chimneys, cracked plaster, and masonry walls, etc.) to major (intensity VII– broken and fallen chimneys, houses moved on and off foundations, severely cracked and broken masonry walls with fallen brick, etc.). The dollar damage estimated by the State of California, Governor's Office of Emergency Services as of August 9, 1991 was \$33.5 million (\$26.0 million to private property and \$7.5 million to public property).
