U. S. GEOLOGICAL SURVEY

The Contribution of Marble Characteristics to the Failure of Column Capital  
Volutes at the Jefferson Memorial, Washington, D.C.

Elaine S. McGee

Open-File Report 91-432

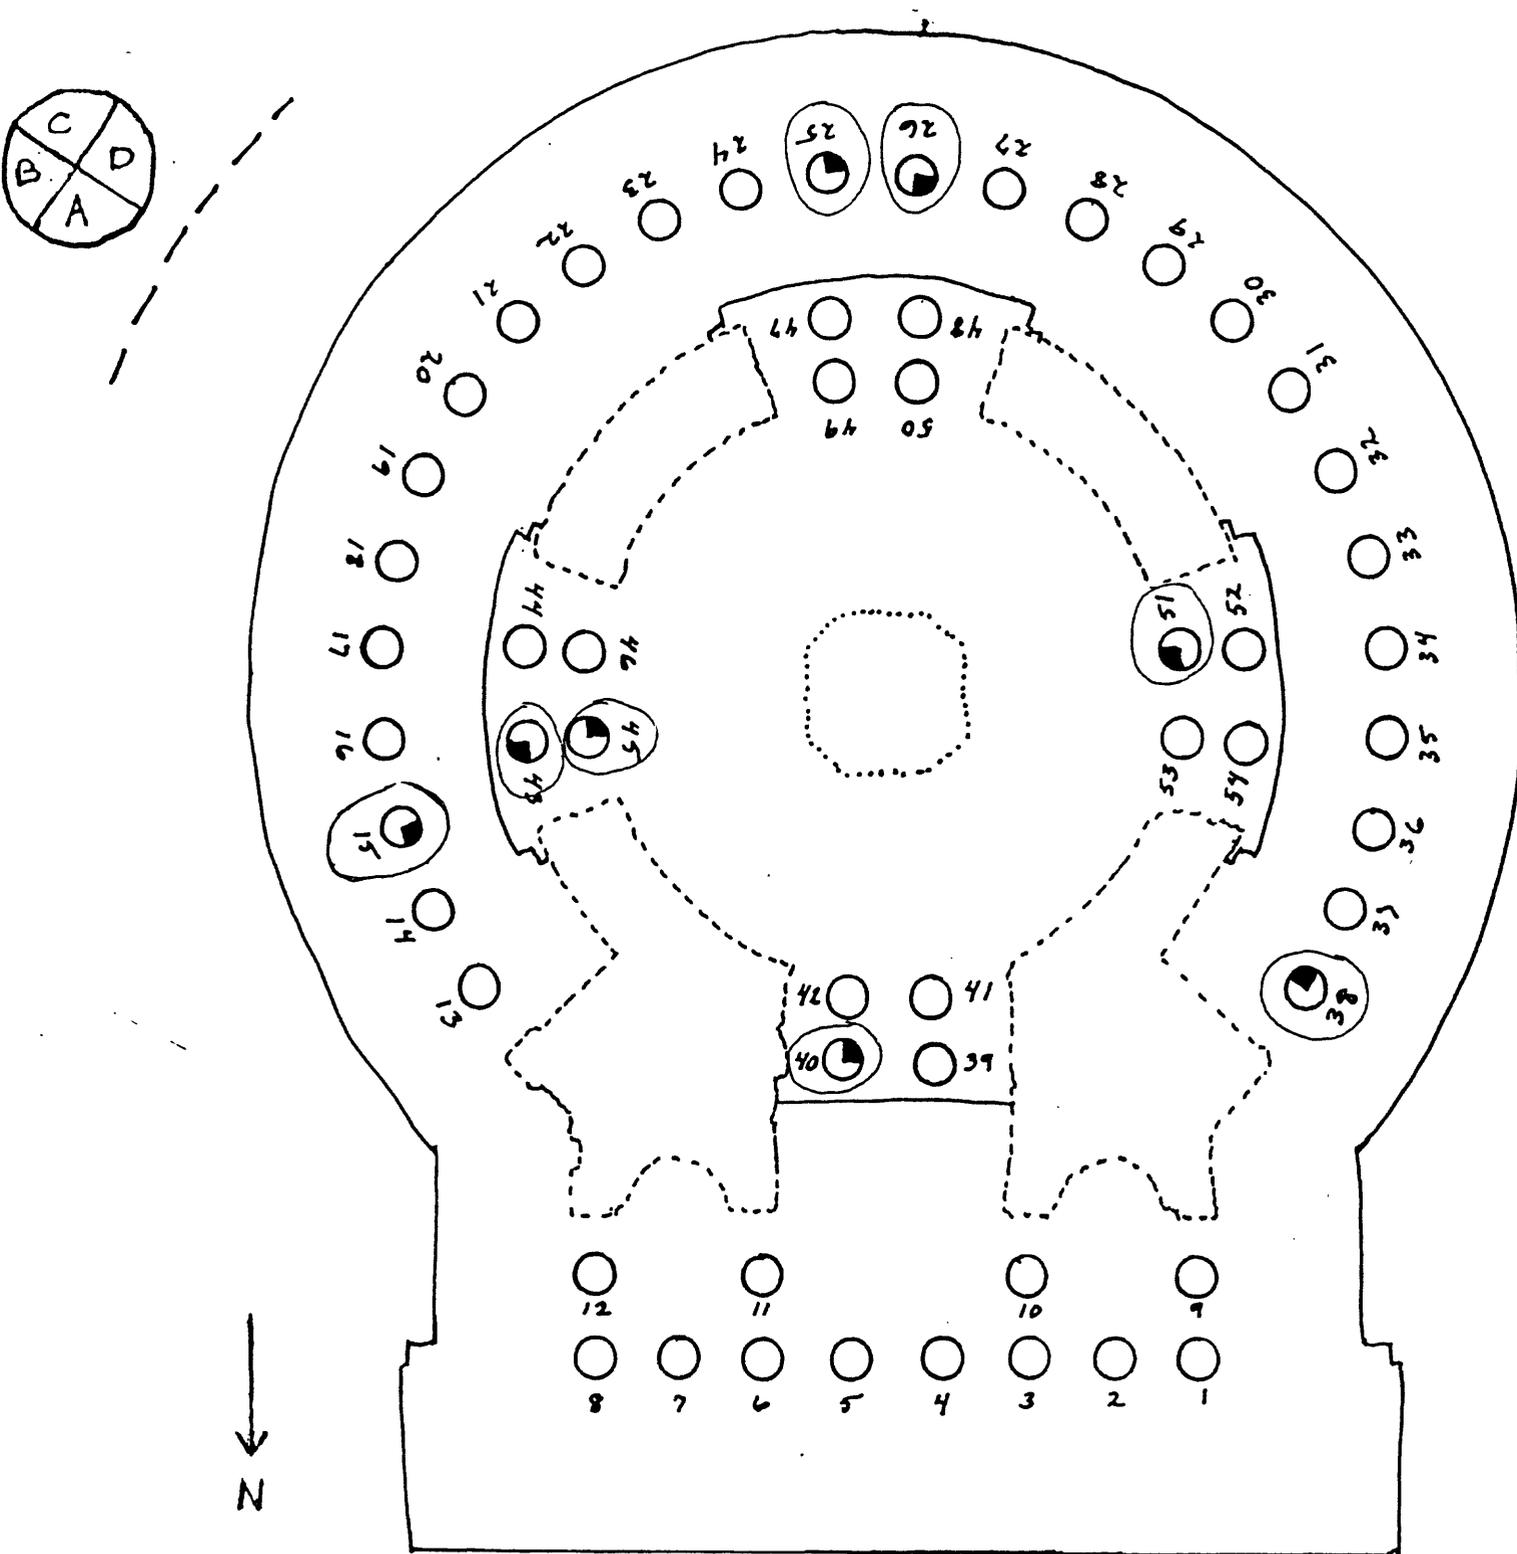
Figure 1. Sketch of Memorial plan, showing column numbers and locations; columns where volutes have been removed are shown with the appropriate quadrant marked in black.

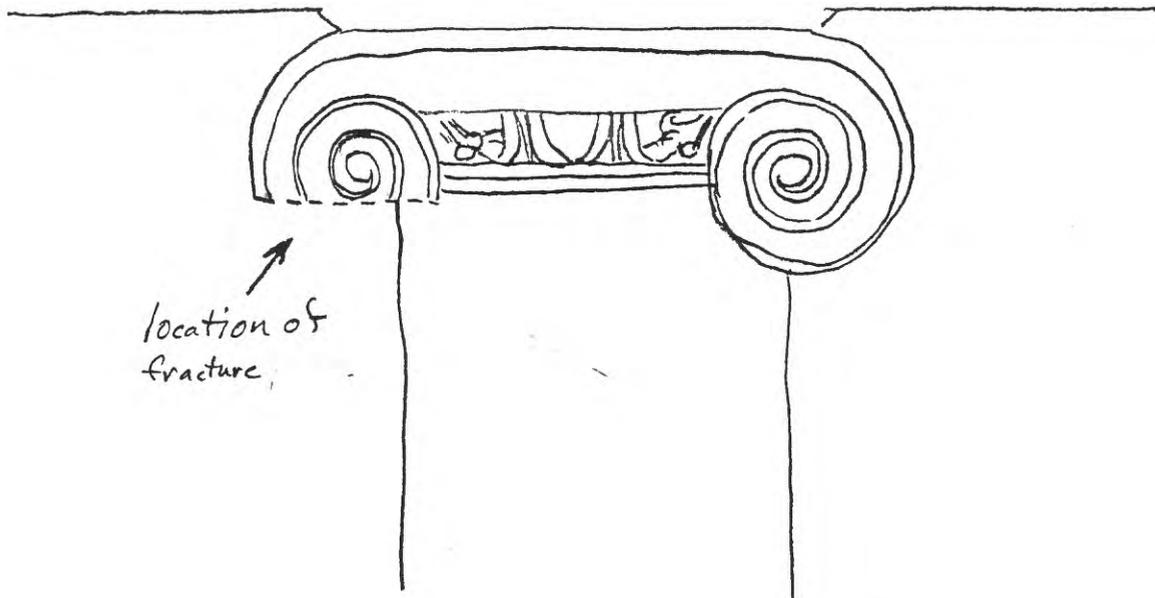
Although each of the samples came from the lower portion of the Ionic volute (Fig. 2), the pieces vary in size. This suggests that although the hanging portion may be susceptible to fracture, something in addition to the design of the capital (perhaps a characteristic of the marble) must also contribute to its failure, because different proportions of the volutes have broken. Each of the pieces was weighed, measured, and photographed (Table 1) to document the range of physical dimensions of the samples. The largest sample (15A) is the one that fell off and was found after it had fallen. The piece is not as complete as the others, as it fragmented when it fell, and those fragments were not considered in determining the dimensions. The smallest sample (25C) is also the only sample that faced outward on the outer colonnade (Fig. 1). On average, the pieces are 18x8x5 inches in size and weigh 21 pounds; sample 45D is closest to the average in size.

Figure 2. Sketch of a column capital, to show the location of a typical missing portion of a volute.

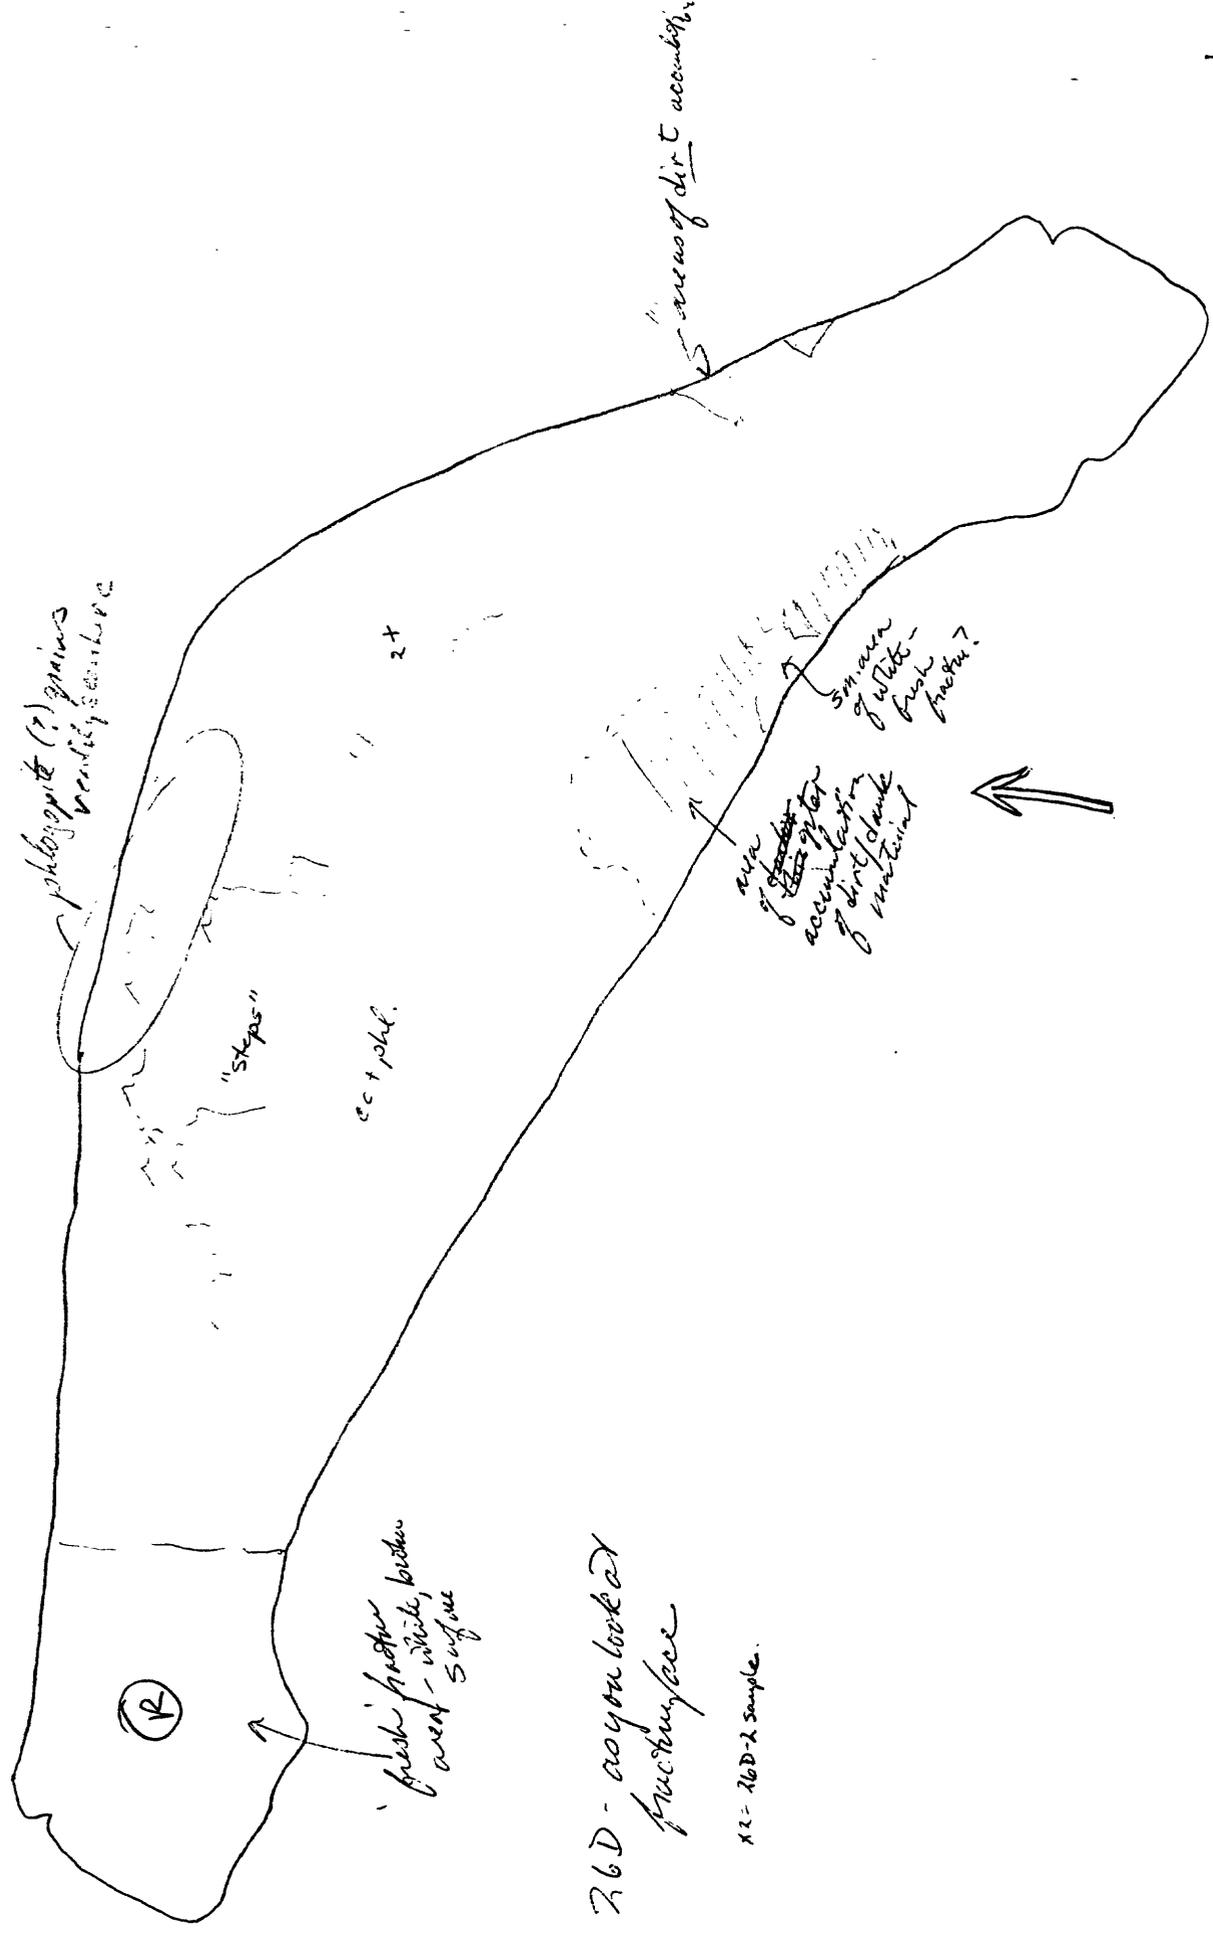
76D - as you look at fracture face

X2 = 76D-2 sample.

fresh fracturing here; perhaps from handling (break-off of thin edge?)

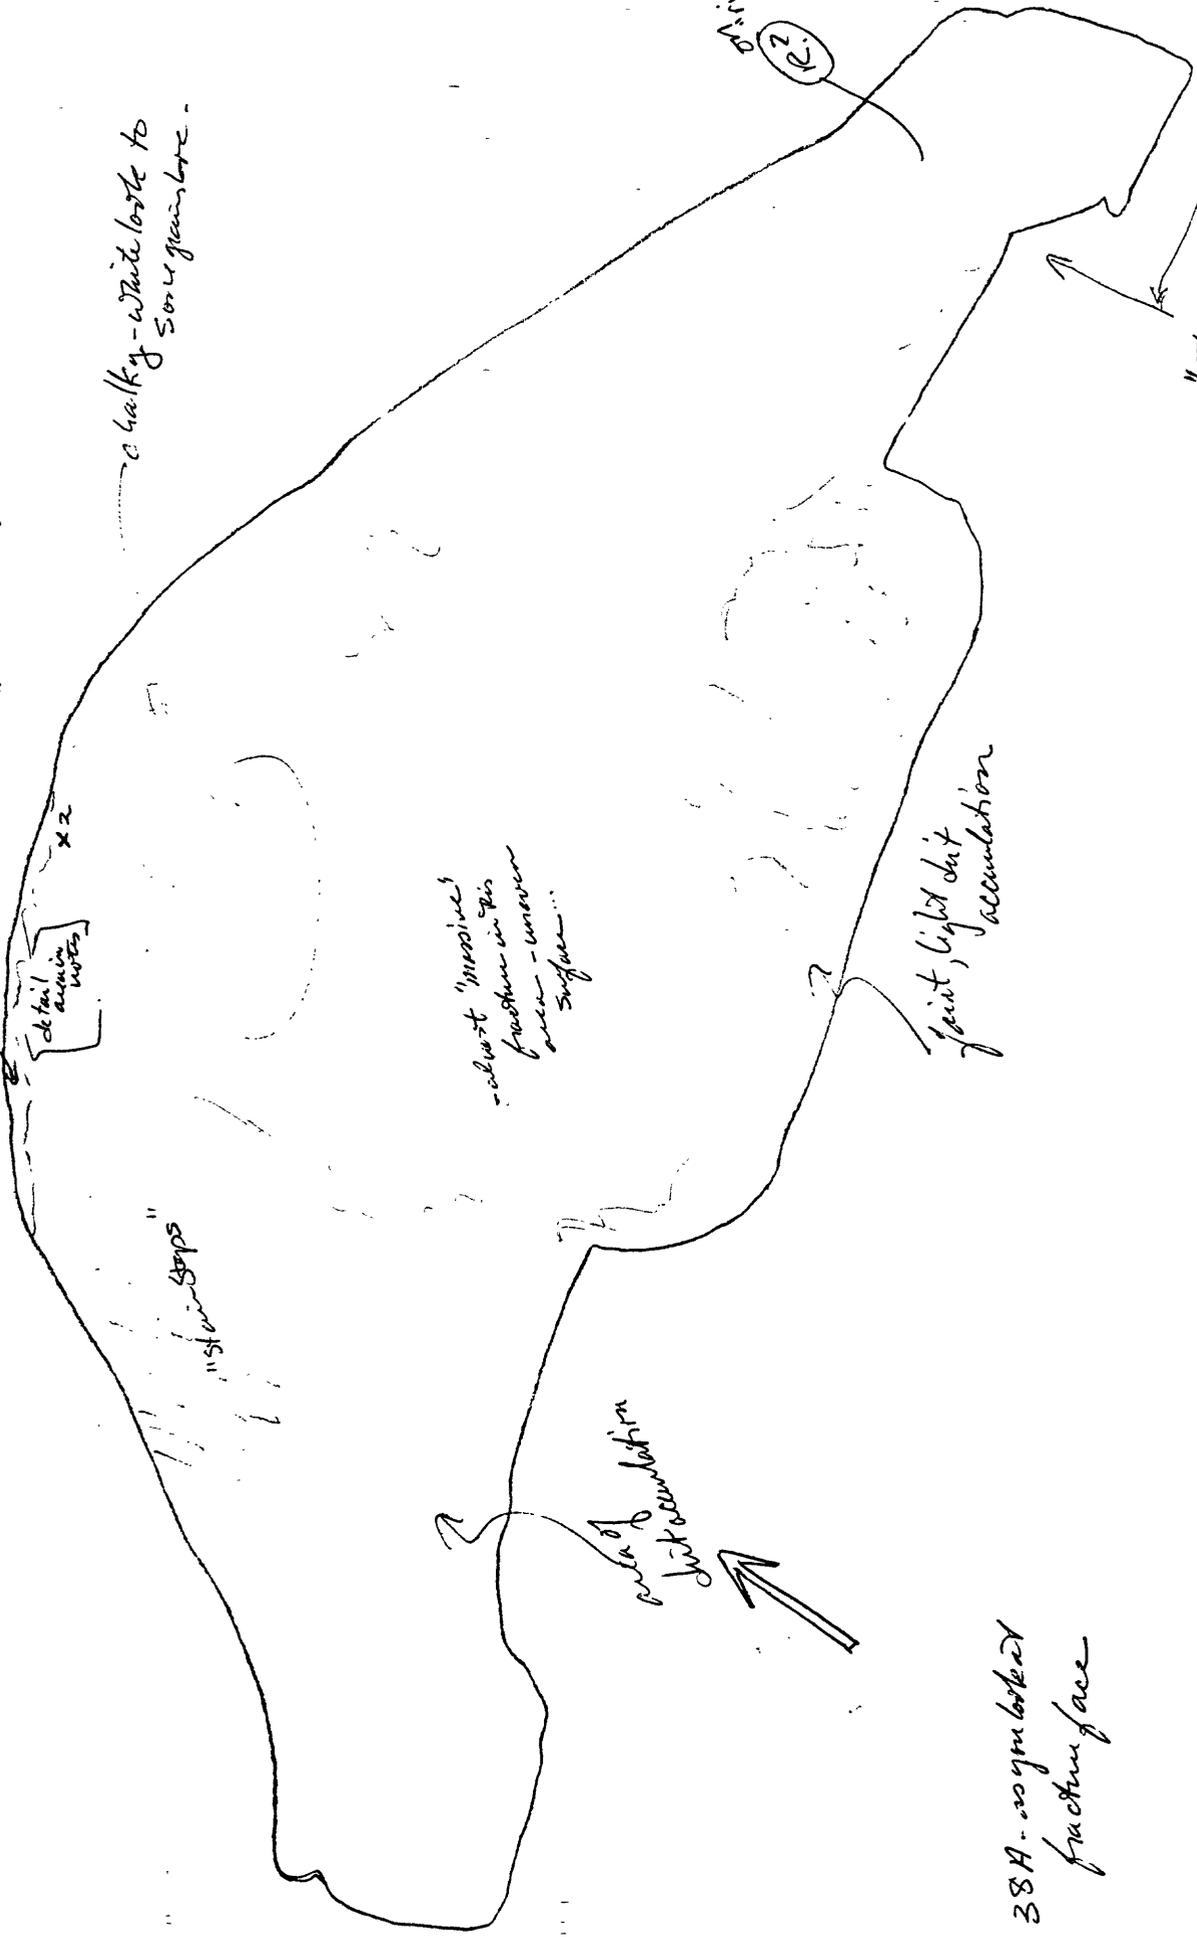
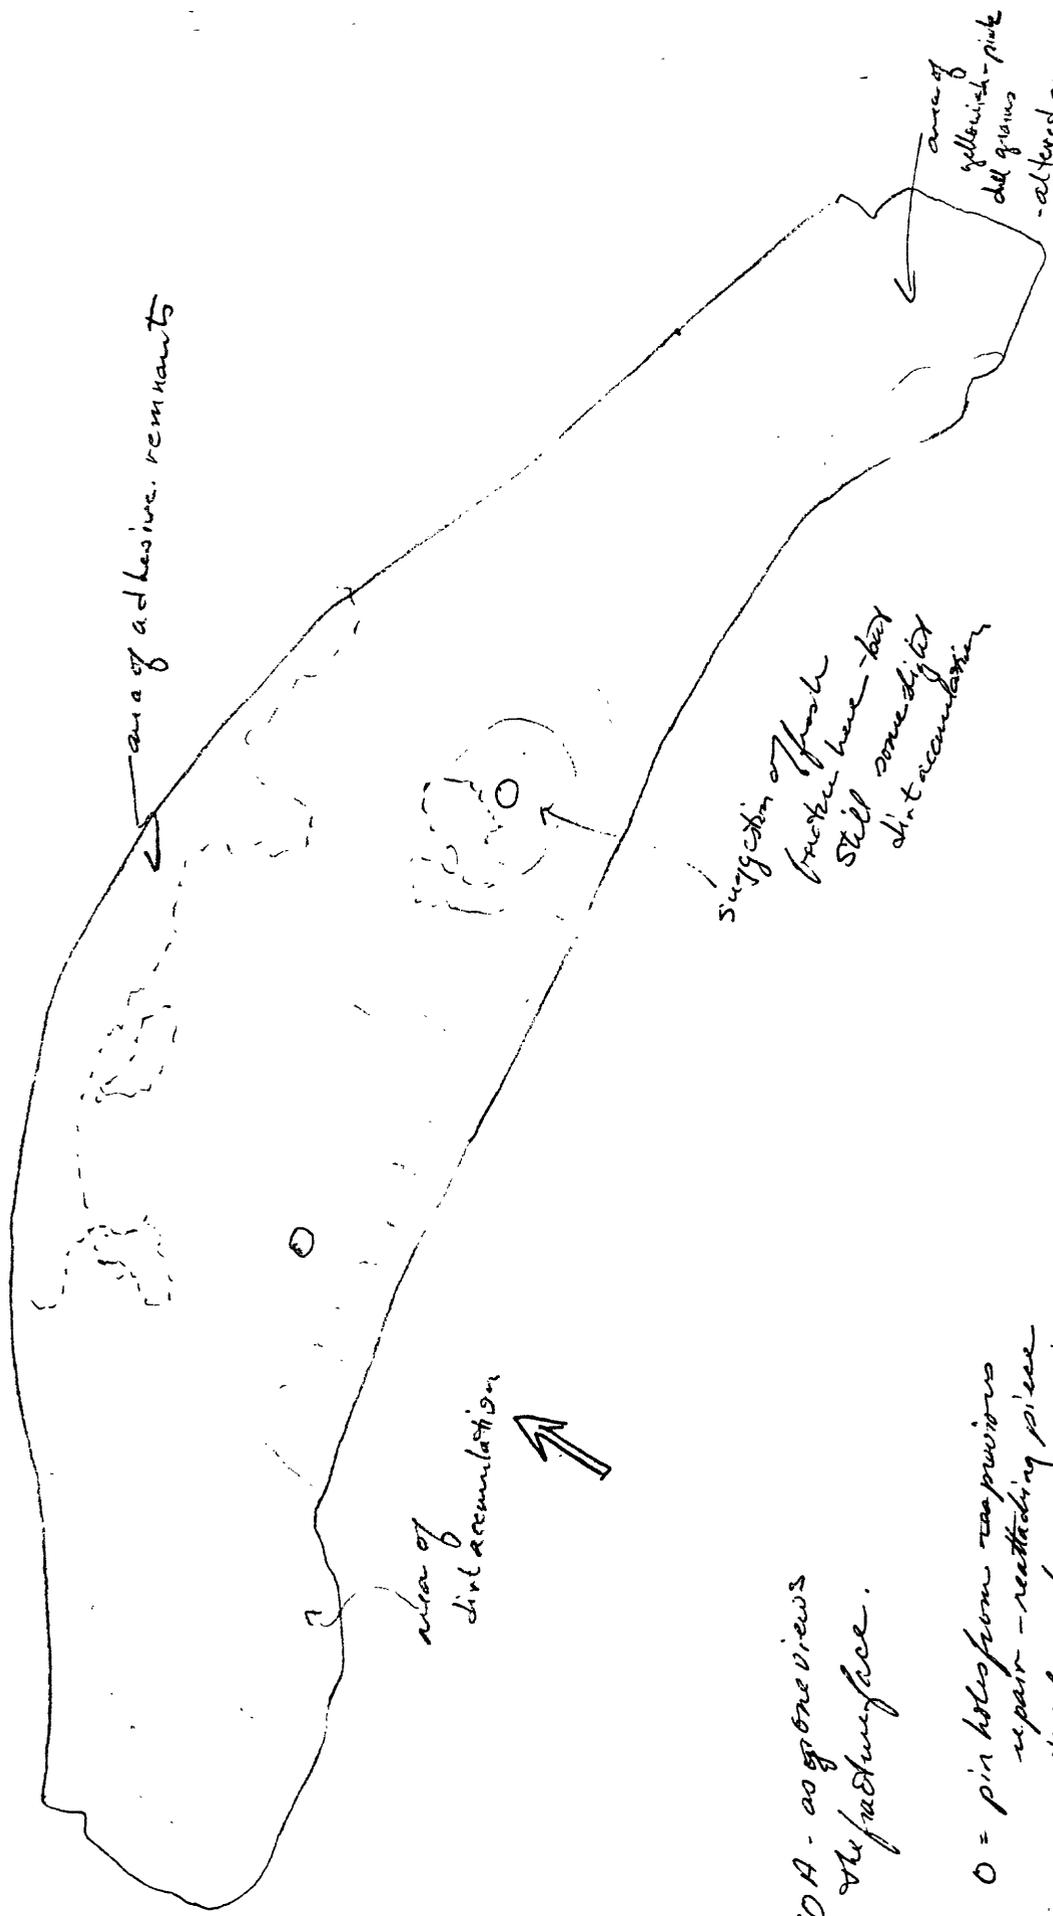
38A - ... fracturing face

area of adhesive remnants

area of yellowish-pink dirt grains  
- altered cc grains or remnants of repair attempt?

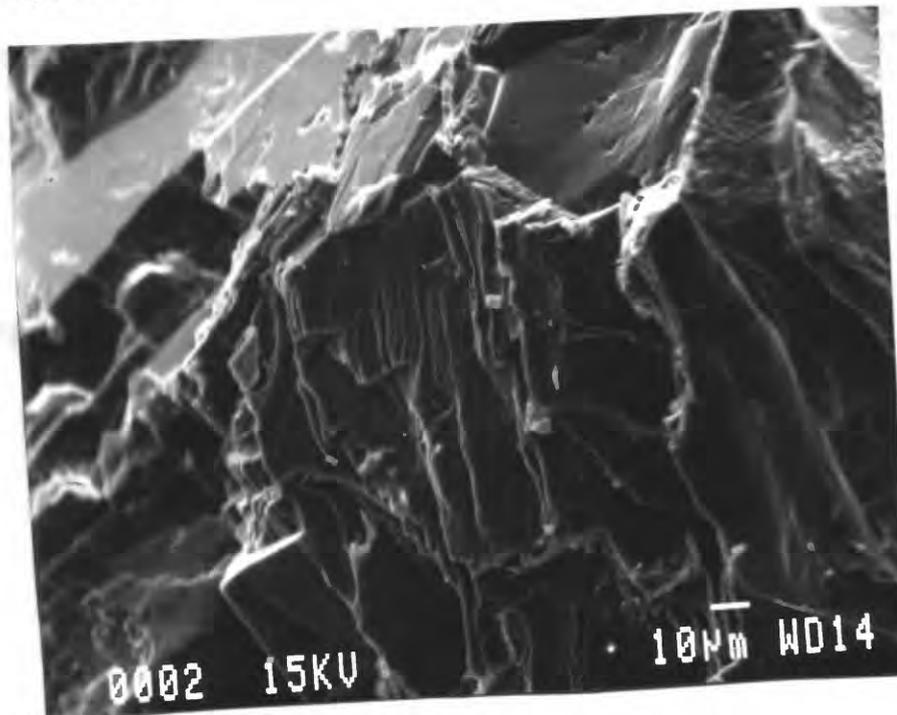
Sample 45D:

0002 - stepped calcite.

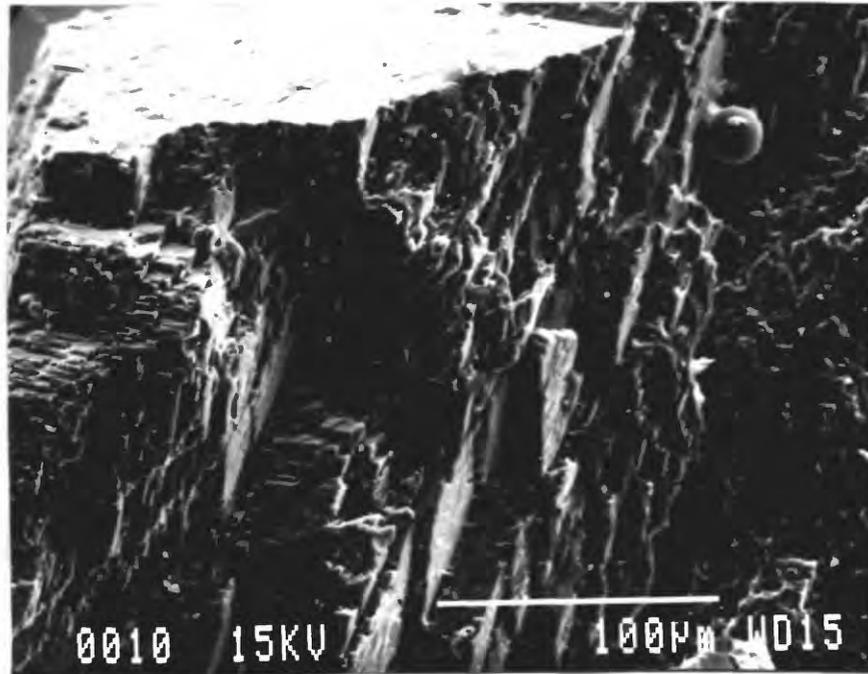
Sample 45D:

0010 - blocky calcite, showing typical cleavage of this mineral.

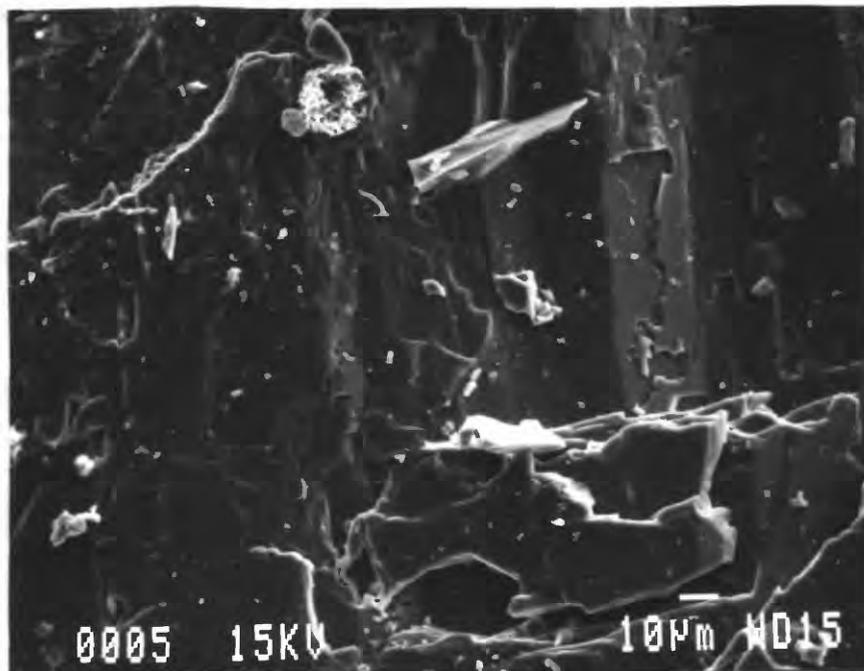
0005 - calcite with an almost rounded planar surface habit.

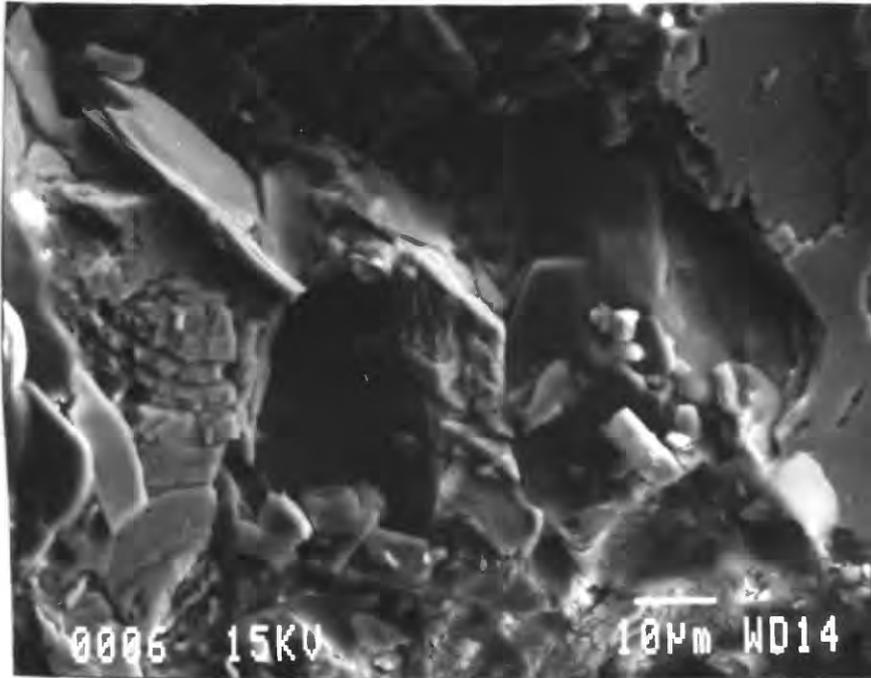
Sample 45D:

0006 - calcite + chlorite; contrast blocky, cracked grains of calcite with smooth, flat surfaces of chlorite grains.

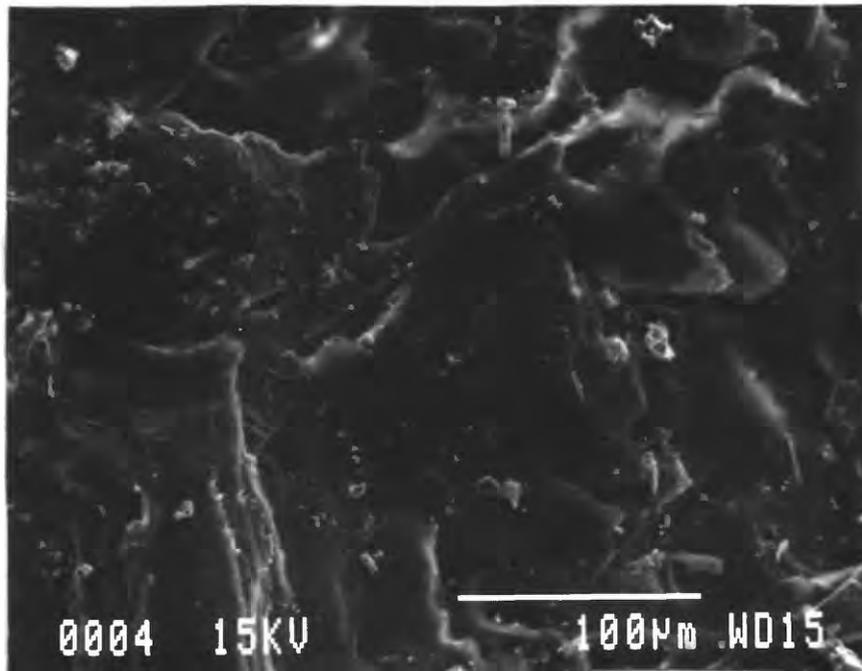
0004 - an area of intergrown mica, chlorite, and calcite, co-planar with each other and with a surface habit similar to some inclusion free areas of the sample (see 0005).

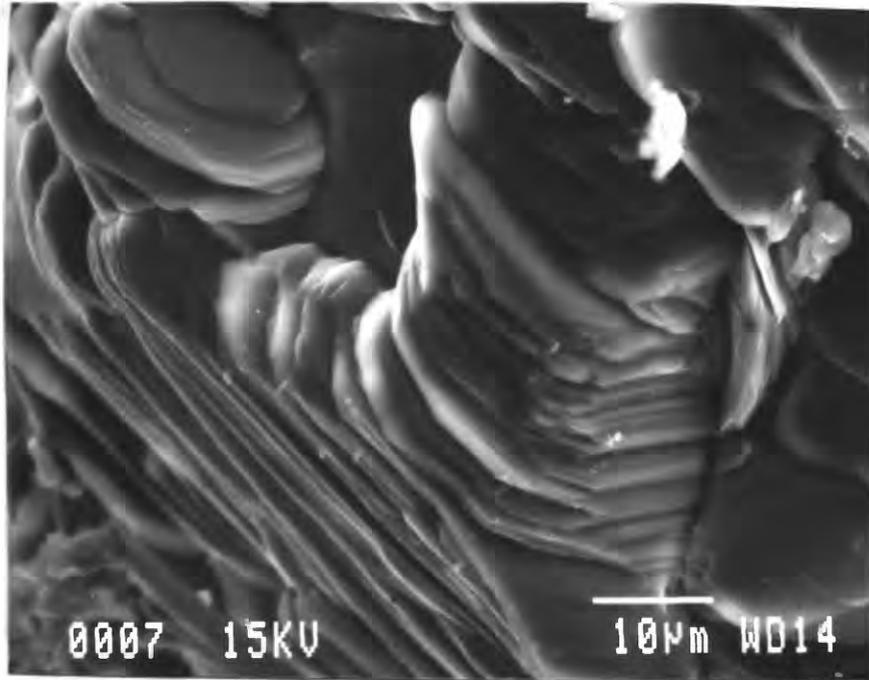
Sample 45D:

0007 - local area of chlorite grains, chlorite forms a cluster of ledges with smooth surfaces and slightly rounded edges that contrast with calcite rich areas.

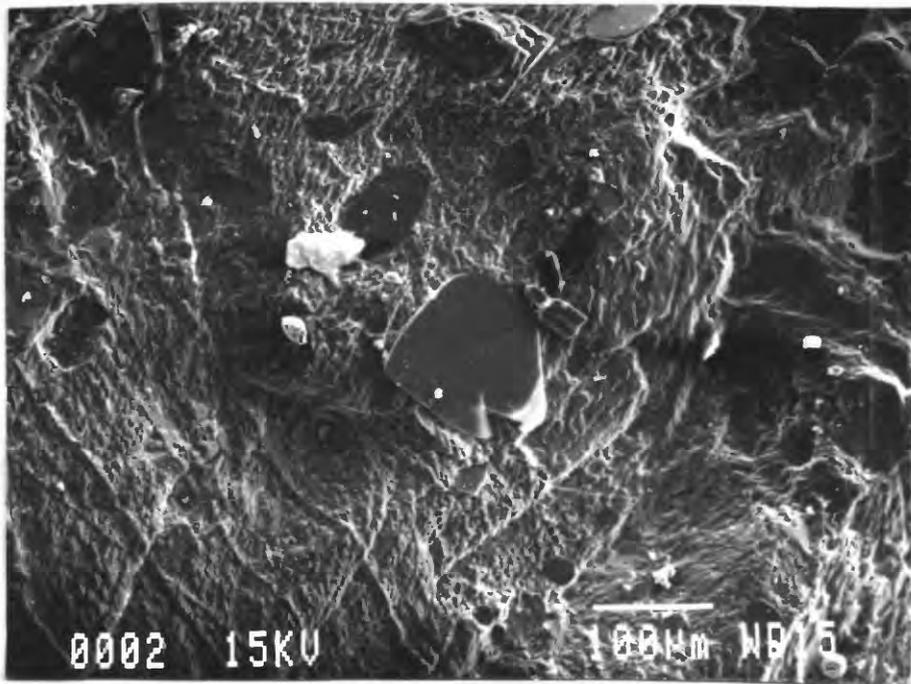
0002 - typical occurrence of stepped calcite with randomly scattered minor muscovite mica inclusions (smooth, slightly rounded grains)

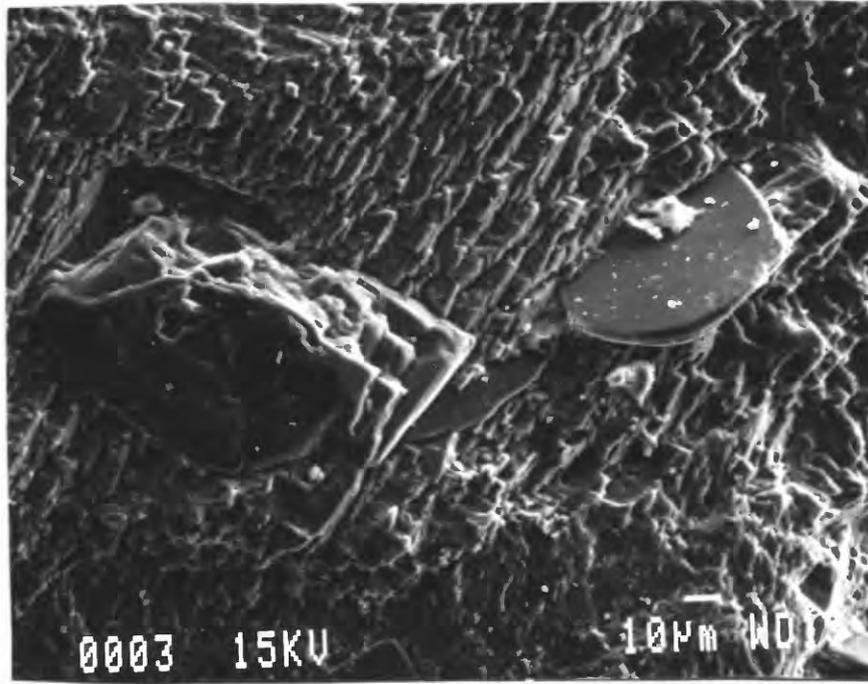
Sample 45D:

0003 - calcite + muscovite mica.

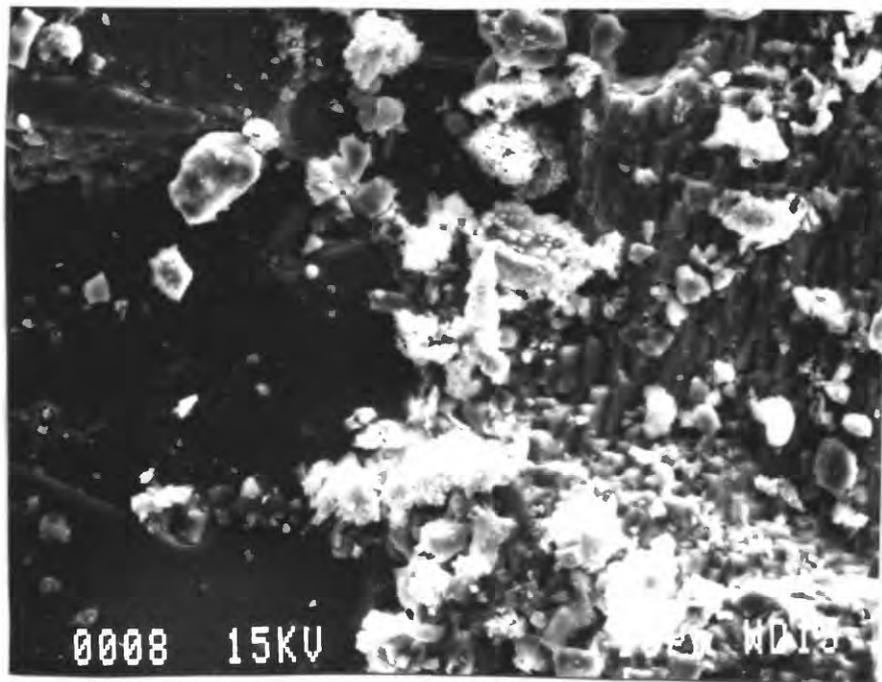
0008 - calcite + muscovite (dark grain on left side), both with surficial dirt .

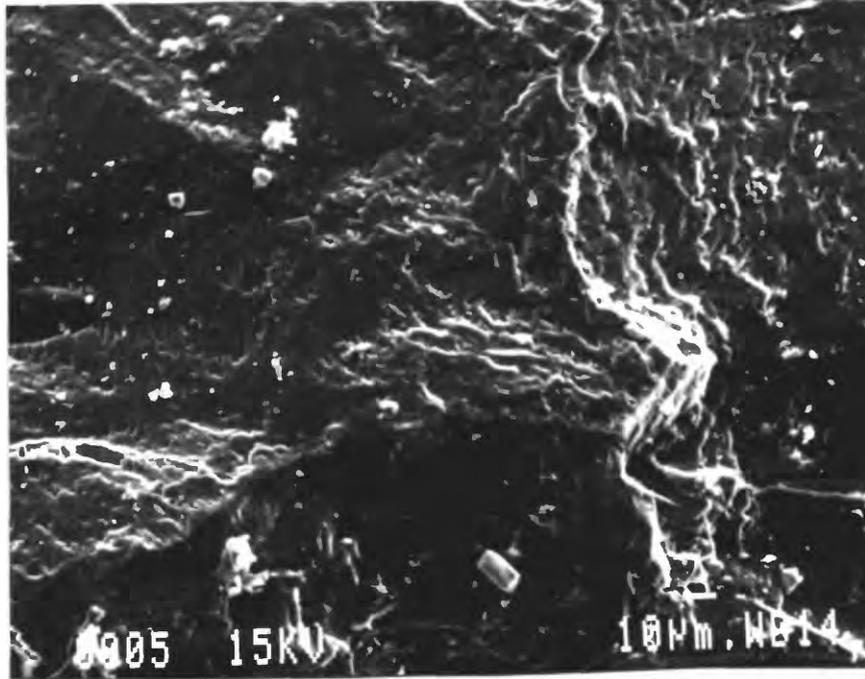
Sample 51D:

0005 - calcite steps.

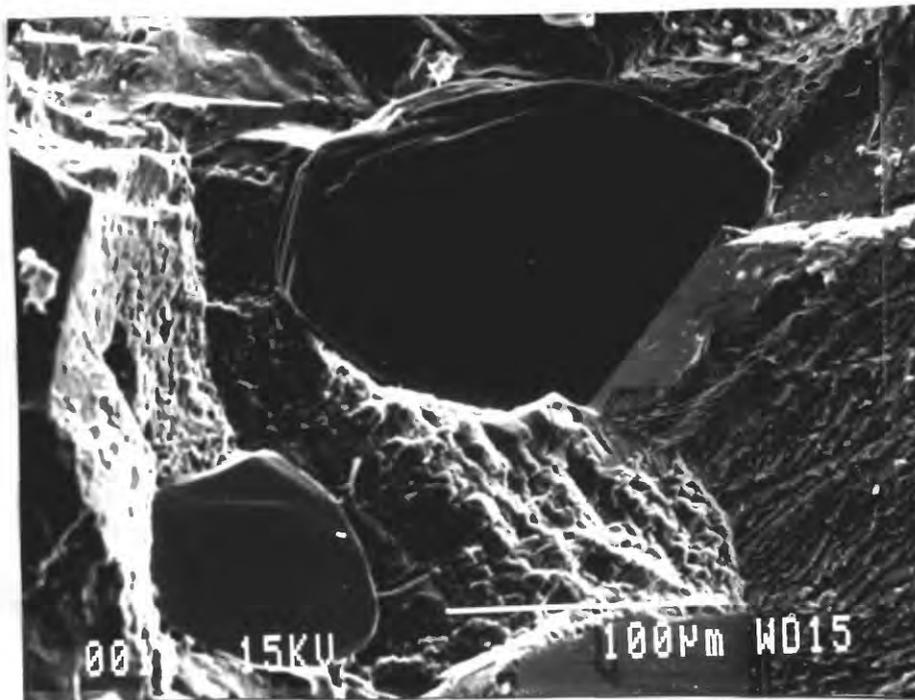
0014 - contrast in surface texture of calcite with muscovite inclusion grains (smooth, darker, slightly rounded).

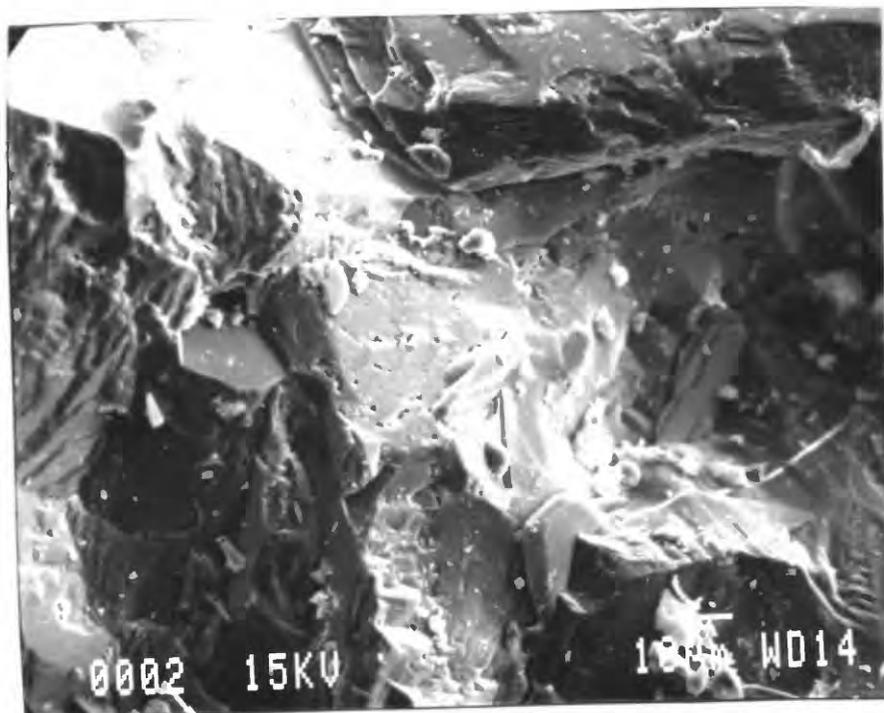
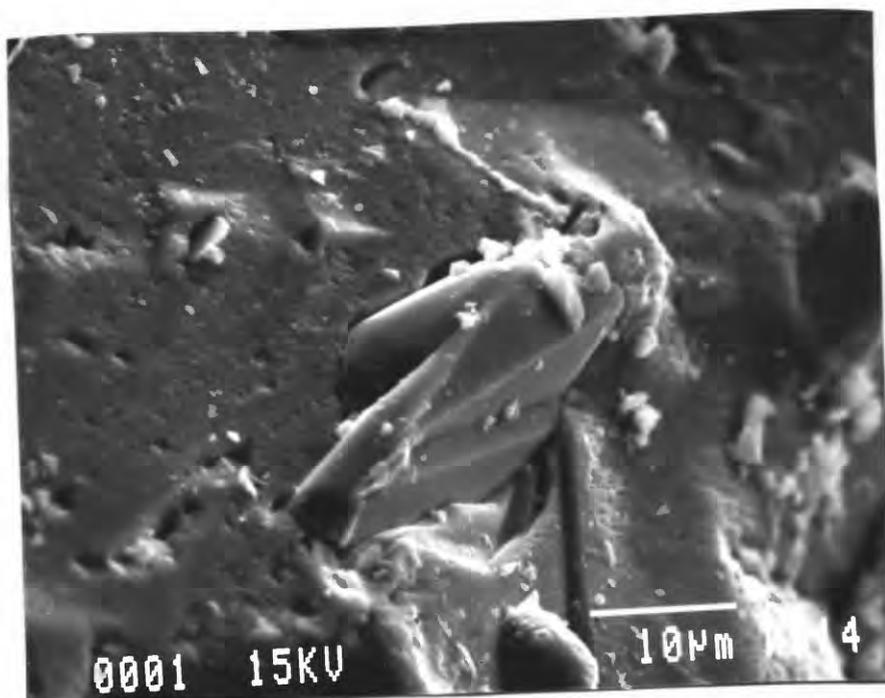
Sample 51D:

- 0002 - randomly oriented muscovite inclusions with calcite.
- 0001 - muscovite inclusion in calcite.
