# The Alaska Earthquake

March 27, 1964

Ground Breakage and  
Associated Effects in the  
Cook Inlet Area, Alaska,  
Resulting from the  
March 27, 1964, Earthquake

GEOLOGICAL SURVEY PROFESSIONAL PAPER 543-F

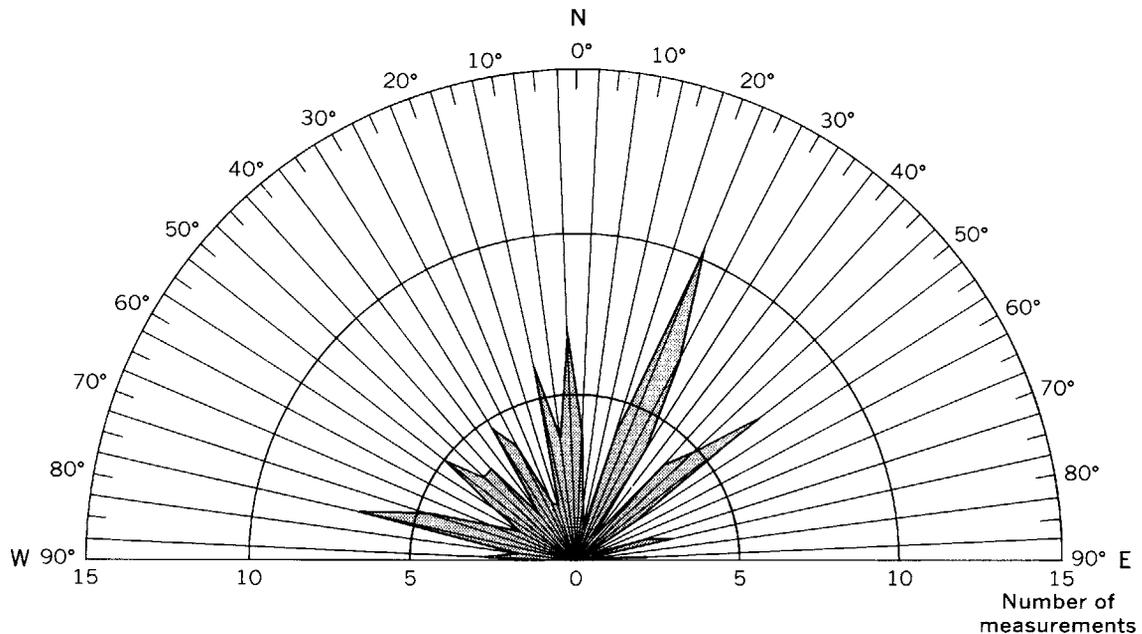
2.—Azimuth-frequency diagram showing dominant trend of ground cracks in the Kenai Lowland resulting from the 1964 Alaska earthquake. Includes measurements of 139 cracks in the central part of the northeast-trending zone of ground breakage in the Kenai Lowland.

and N. 75°–80° W. (fig. 2). Examples of broken ground patterns within the zone are shown in figures 3 and 4. In forested areas, cracking of the ground split numerous trees (fig. 5).

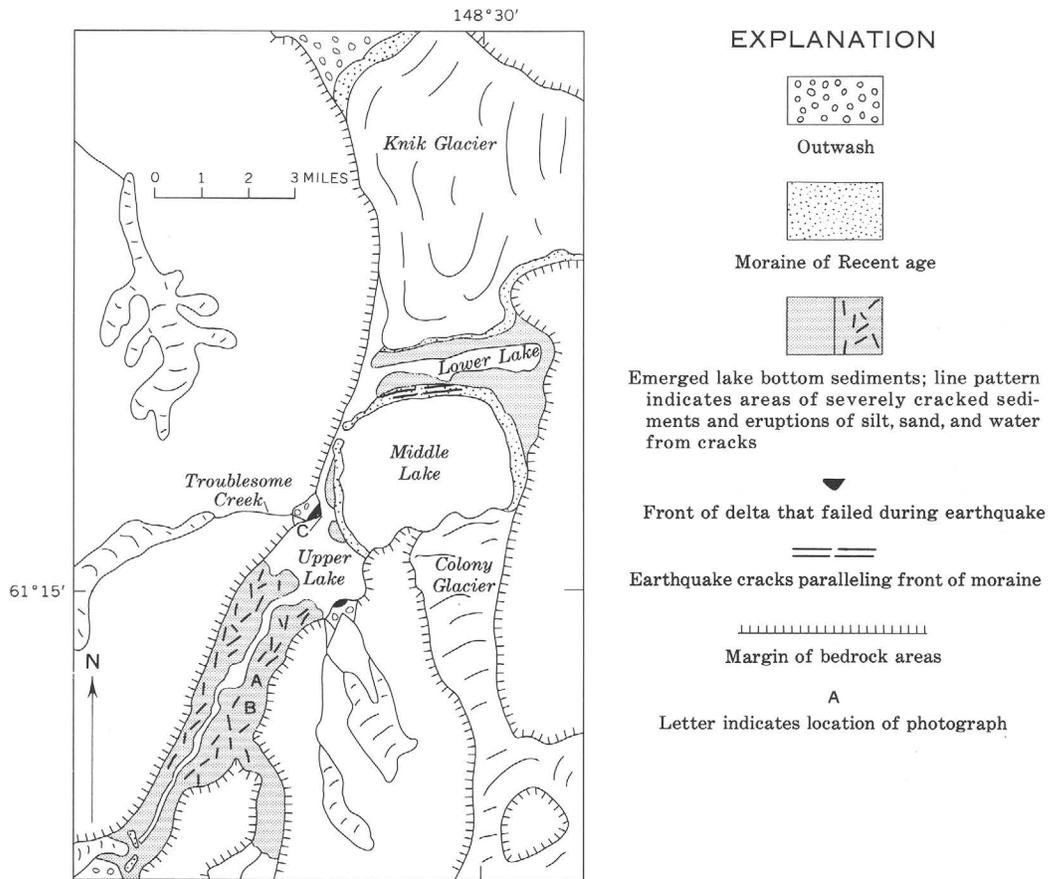
25.—Lake George area showing location of ground breakage.
