A Hydrologic Assessment of the September 14, 1974, Flood in Eldorado Canyon, Nevada

GEOLOGICAL SURVEY PROFESSIONAL PAPER 930

By PATRICK A. GLANCY *and* LYNN HARMSSEN

*A presentation of hydrologic data and interpretations,
eyewitness accounts of destruction,
and documentation of flooding*

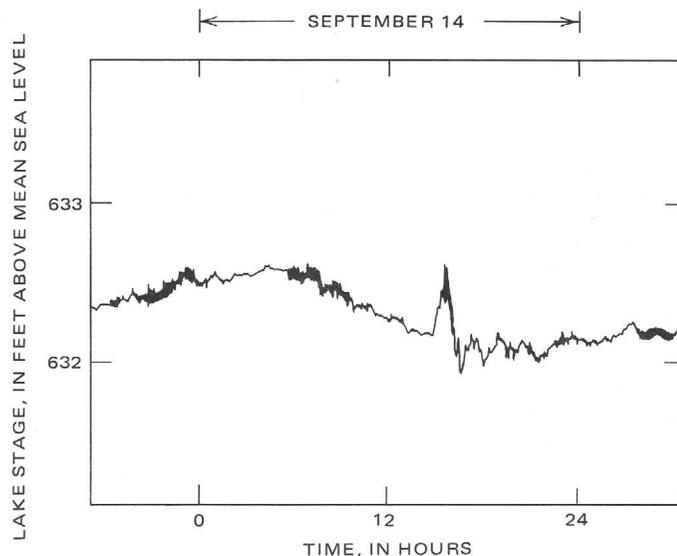
Apparent response of the stage of Lake Mohave at Davis Dam, about 35 mi downstream from Eldorado Canyon (fig. 2), to the flood wave is shown in figure 9. The figure indicates that lake stage rose approximately 0.45 ft shortly after 2:30 p.m. the day of the flood.

FIGURE 9.—Trace of Lake Mohave stage at Davis Dam, showing approximately 0.45-ft rise. Gage is about 35 mi downstream from mouth of Eldorado Canyon. Figure is reproduction of lake stage recorder sheet.

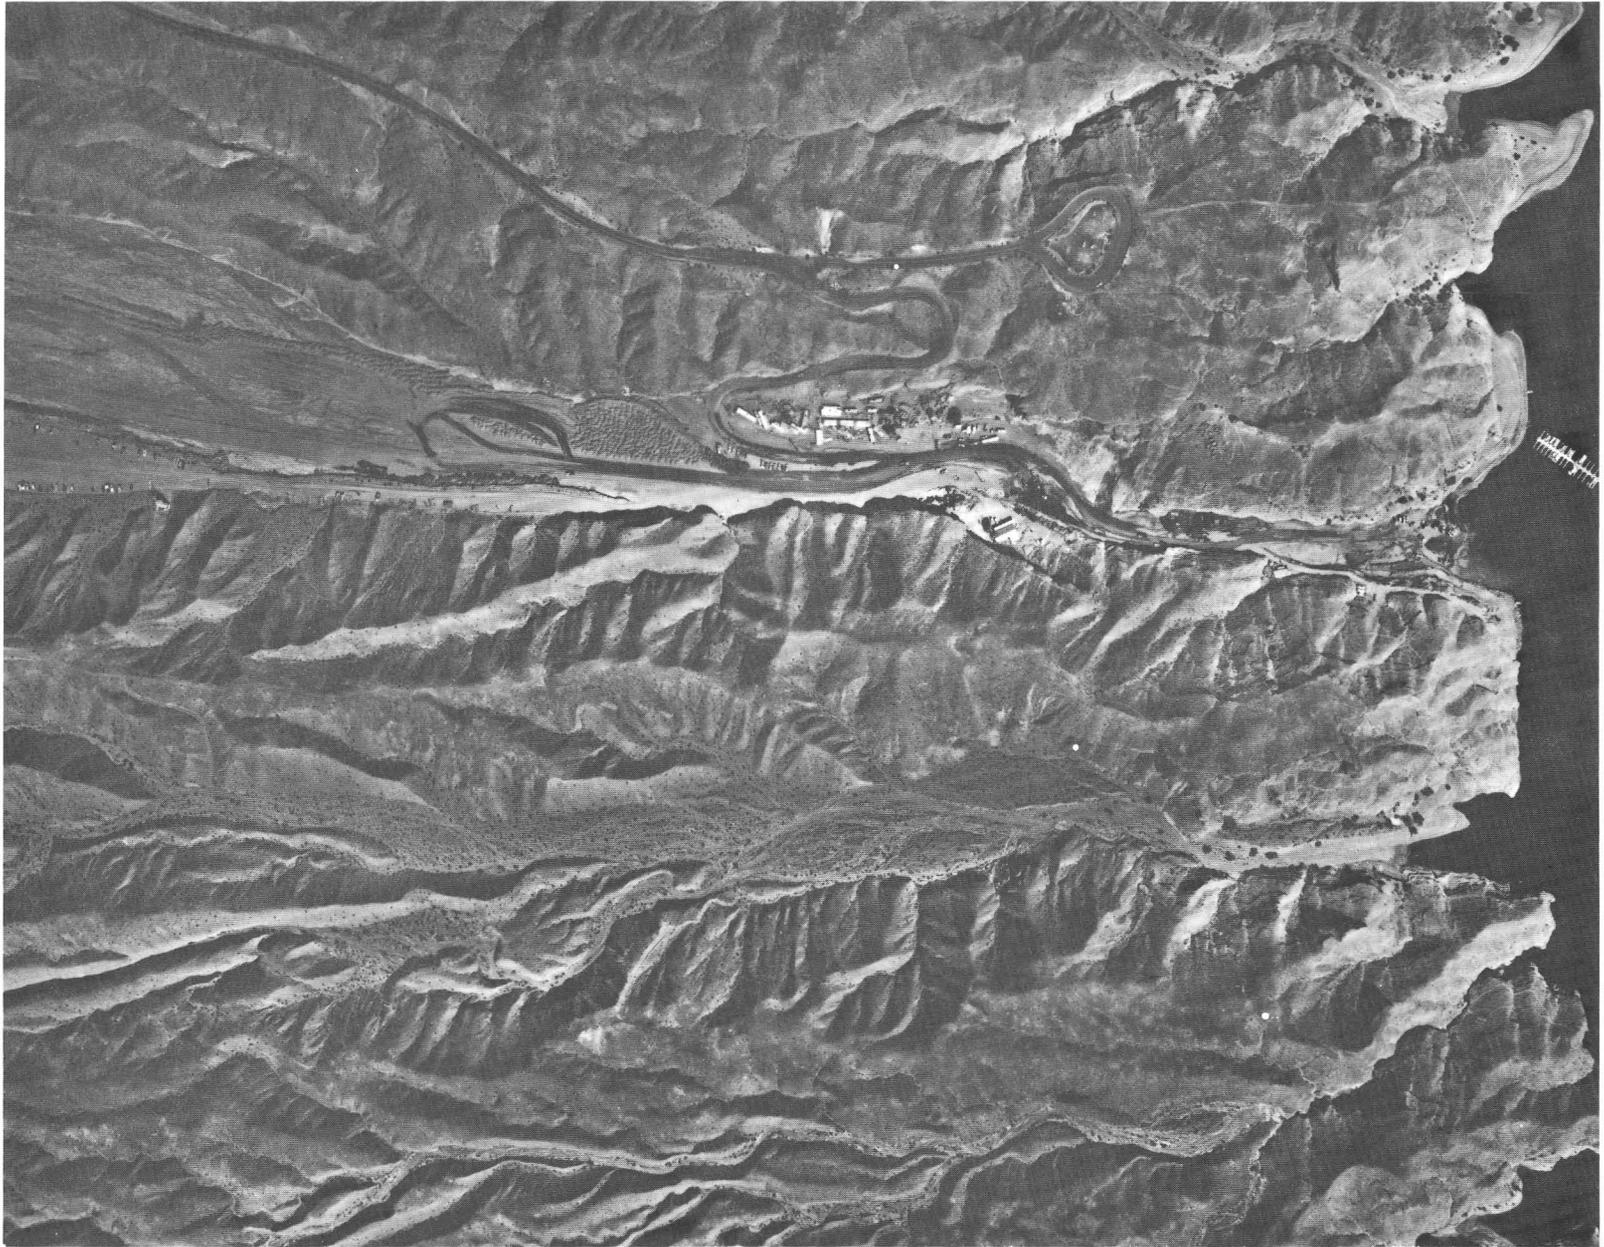
postflood reservoir release trends. Aerial reconnaissance of the general area adjacent to Eldorado Canyon basin affirmed that the major share of inflow to Lake Mohave probably came from Eldorado Canyon. The generally undisturbed character of channel-bottom vegetation shown in figure 10 supports the conclusion that there was no heavy runoff in areas adjacent to Eldorado Canyon. Therefore, the flow to the lake from Eldorado Canyon itself was estimated at about 2,000 acre-ft. Figure 11 shows an estimated hydrograph of runoff to the lake from Eldorado Canyon. This hydrograph was constructed from the following data: (1) known zero flow before and after the flood, (2) an estimated peak flow rate of about 76,000 ft³/s, (3) an estimated total duration of flow as described by eyewitnesses, and (4) the general shape of hydrographs for recorded flash floods in the same general hydrologic area. Runoff volume as determined from the hydrograph is also about 2,000 acre-ft.

FIGURE 10.—Vertical aerial photo of the terminal reach of Eldorado Canyon drainage and adjacent drainages on September 20, 1974. Photograph courtesy of Nevada Division of Highways.

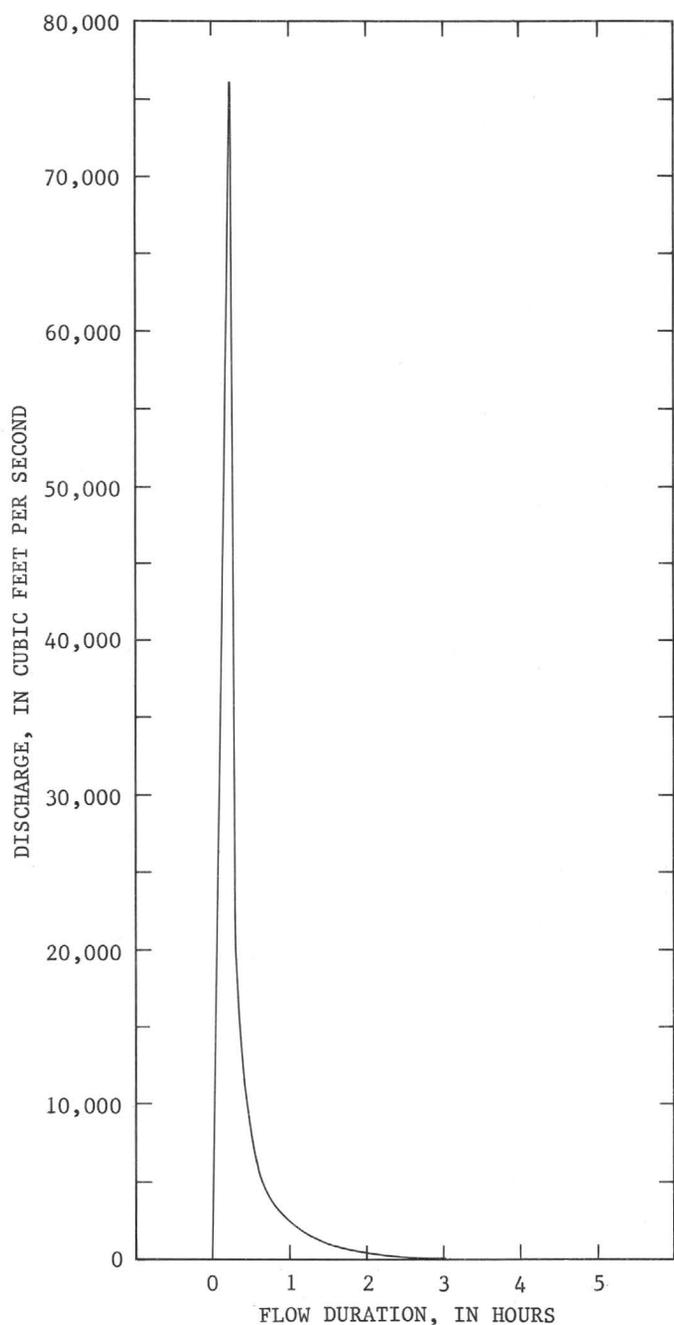
FIGURE 11.—Estimated flood hydrograph for September 14, 1974, near mouth of Eldorado Canyon.

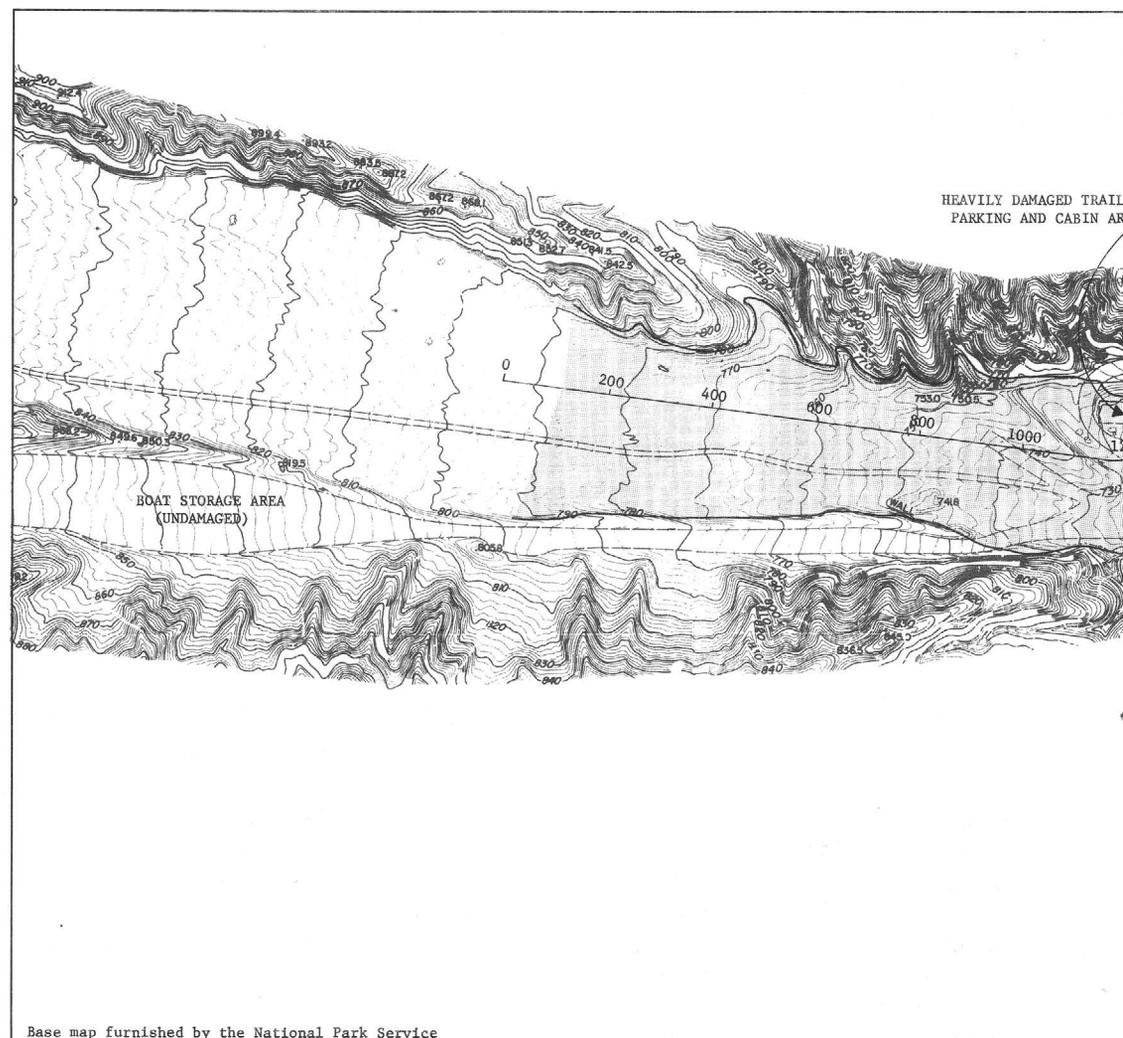
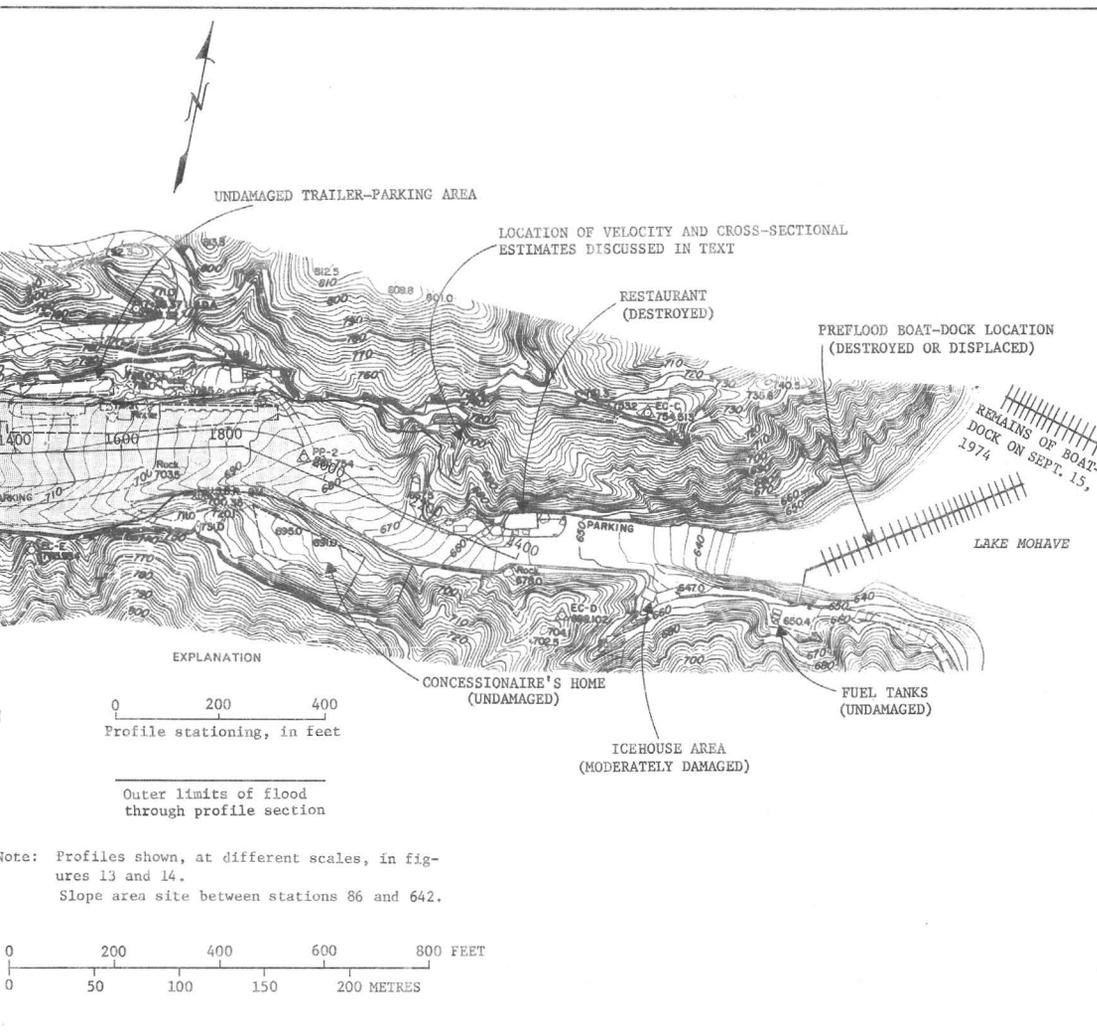
The restaurant was totally destroyed. Five trailer houses were totally destroyed, some have not been found, and a number of others were seriously damaged. Nine cabins near the base of the north canyon wall were destroyed, and 38 vehicles and 19 boat trailers were lost. Twenty-four boat-docking slips were obliterated and 23 boats were lost. Figure 12 shows changes to the boat

docks, the general location of a number of other specific cultural features, and qualitatively describes the nature of the damage sustained. Several photographs of damage to structures and vehicles near the canyon mouth are shown in figure 1. Figure 16 shows an overall view of the heavily damaged trailer park area. When viewing the damage shown in figures 1 and 16, keep in mind that the vehicles and structures receiving the greatest damage are not visible because they were either totally demolished or buried in Lake Mohave. Therefore, the photographs give a somewhat conservative view of the effects of the flood.

Flow velocity can be estimated in the canyon constriction above the site of the destroyed restaurant (fig. 12), if the estimated 76,000- ft^3/s peak flow is assumed to have

Kirby L. Koop watched the approach of the initial flood surge from near the icehouse area (fig. 12). He first saw it at a distance of about 100 yd. He recalled the dull thuds of cars caught up in the surge striking the canyon walls. According to Koop, when the mass of debris and water arrived at the pre-flood shoreline of Lake Mohave, it possessed such momentum that it appeared to "hydroplane" over the lake surface as far as the boat dock gangway (a distance of 100 to 150 ft, scaled from fig. 12). The mass then seemed to fall vertically into the lake.

FIGURE 12.—Flood boundaries, streambed

profile line, and specific cultural features.

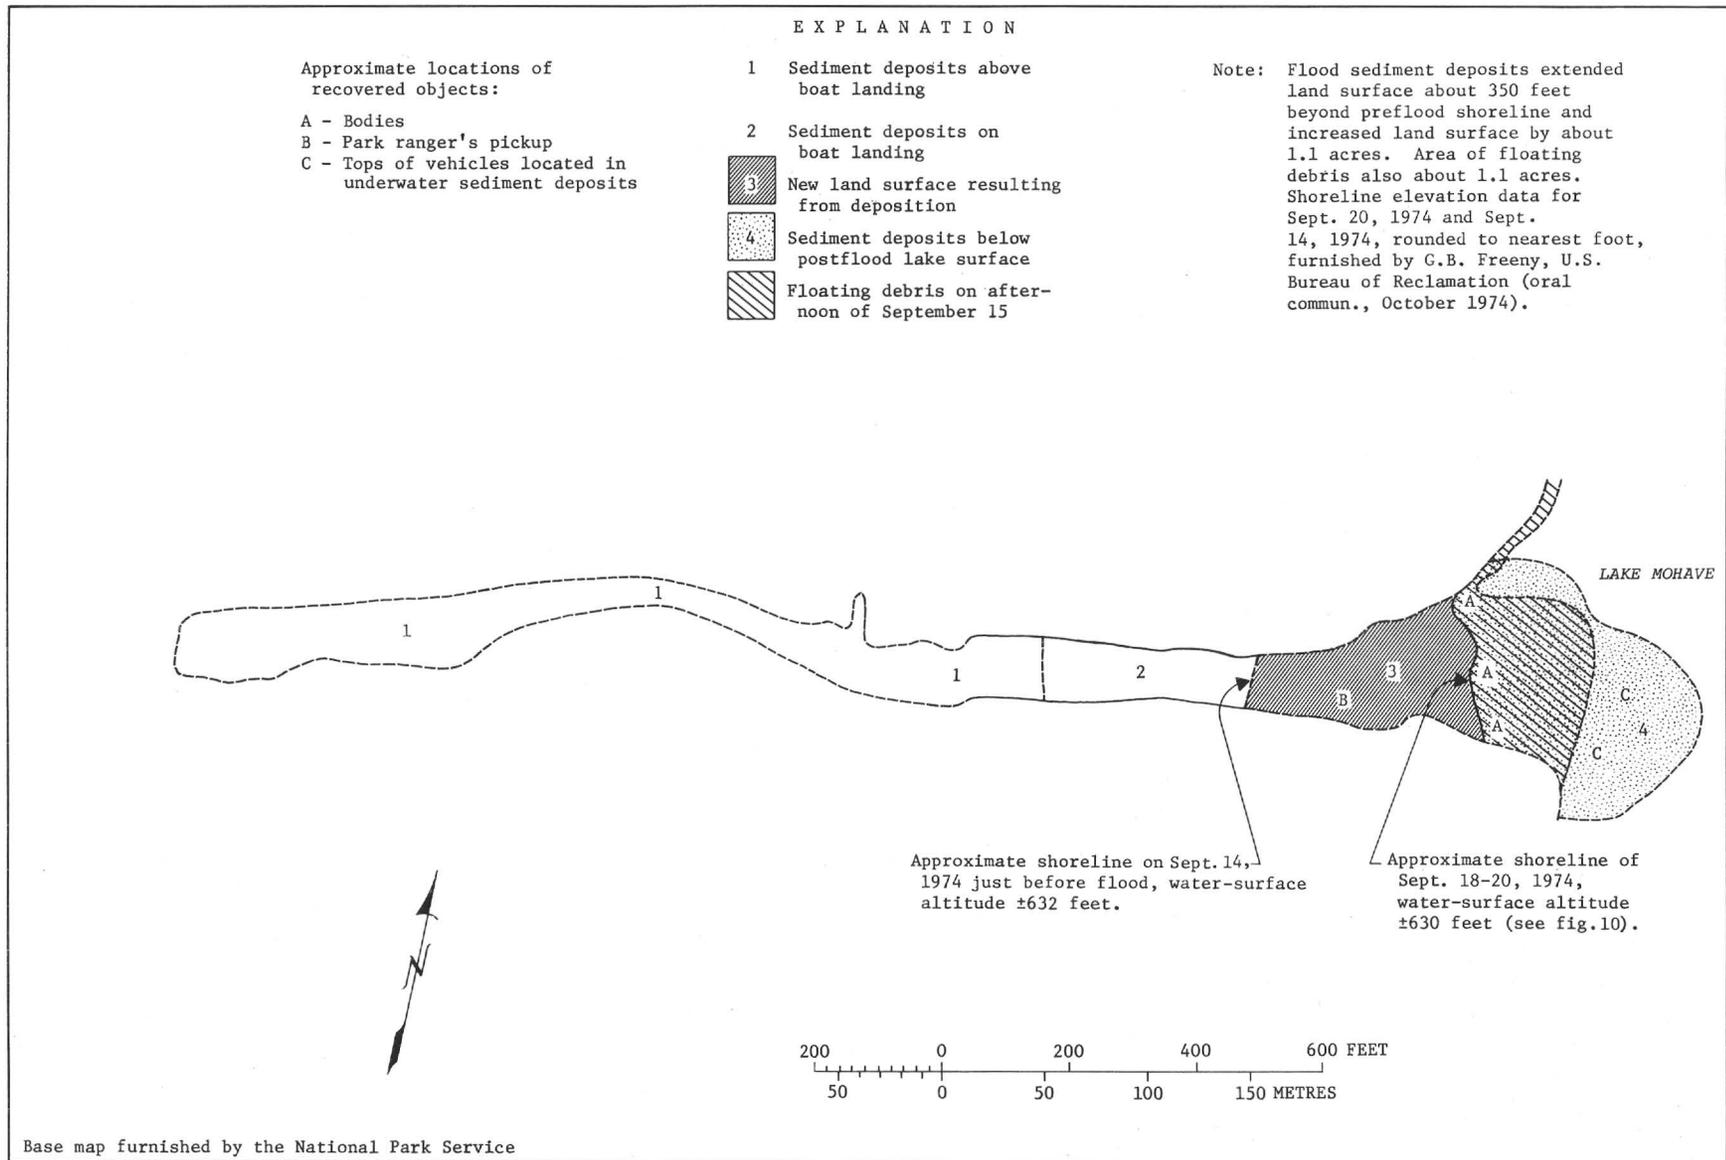
The sediment volume accounted for in known deposits is estimated to be 54,000 yd³. Table 4 describes the location and distribution of the known sediment deposits; location of the depositional units is shown in figure 17. The estimate was made on the basis of post-flood configuration of deposits and on some preflood topographic information. Estimates of deposits upstream from the preflood shoreline of Lake Mohave probably are reasonably accurate because detailed preflood topographic data were available. However, no recent preflood bathymetric data were available for the harbor or adjacent areas. Some general knowledge of preflood water depths is available from observations by the National Park Service staff and others. These sparse data are supplemented with estimates of the quantity of material actually excavated and removed, as well as evidence of depths to apparent preflood lake-bottom clays exposed during excavation.

FIGURE 17.—Sediment deposits and locations of preflood and postflood shorelines.

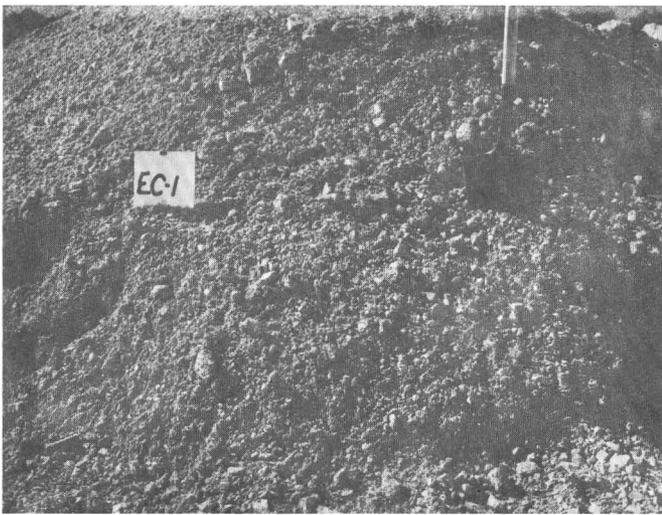
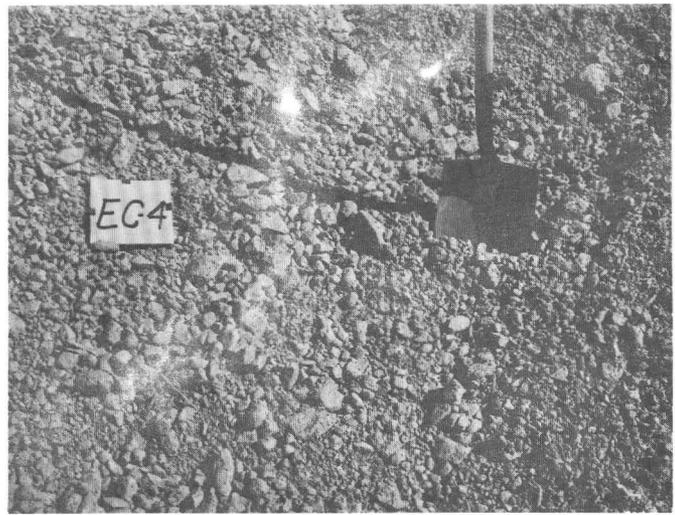
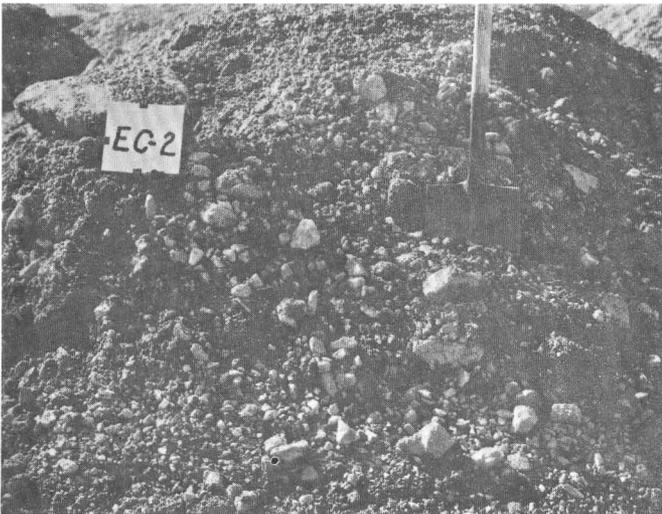
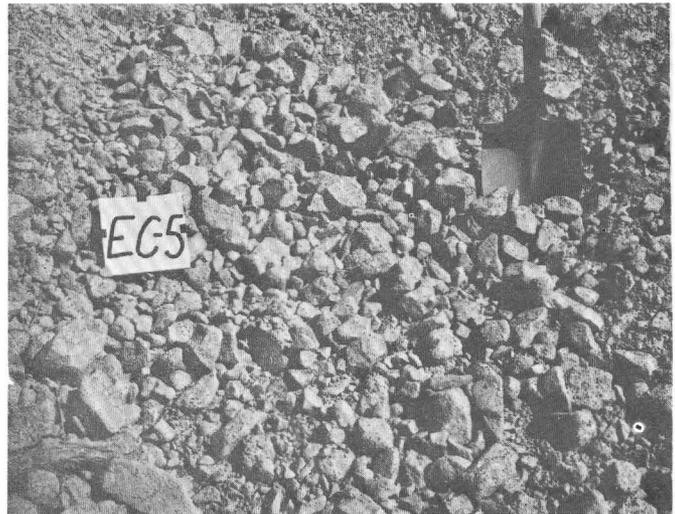
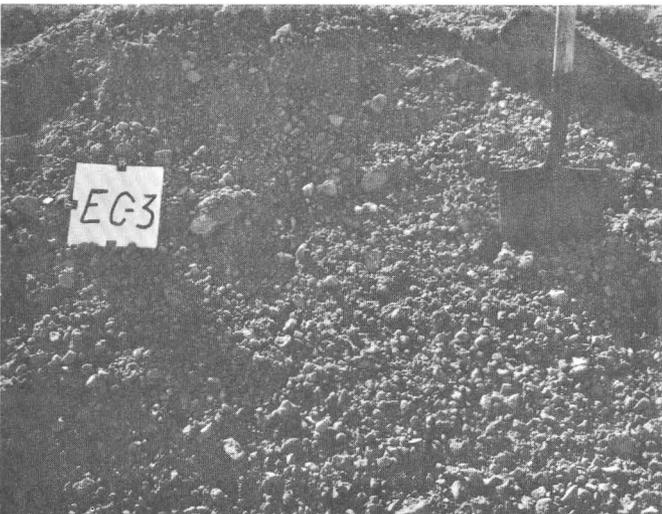
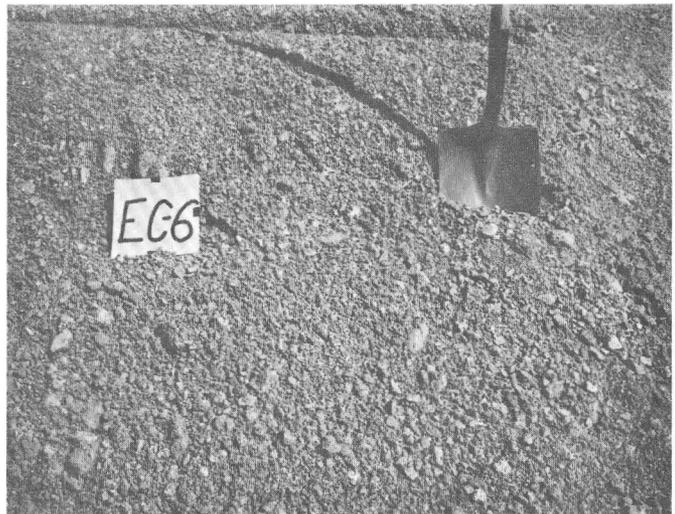
A reconnaissance characterization of the sediment deposit according to particle-size distribution was attempted (extensive sampling and analysis was beyond the scope of the study). Six samples of excavated material were arbitrarily collected on September 30, 1974, when the large mass of available excavated material probably was representative of most of the recoverable sediment. Samples were collected by P. A. Glancy (U.S. Geological Survey), and standard sieve analyses were made by the Materials Testing Laboratory, Nevada State Highway Department, Las Vegas. Results of the sieve analyses are listed in table 5, and figure 18 pictures the material sampled at each site. Samples were collected from piles of excavated sediment dumped upstream from the trailer park area. The piles are clearly visible upstream from the access highway in the aerial photograph of September 20 (fig. 10). Samples were carefully collected to typify the mass of material excavated, and are believed to be generally representative of that mass, within limitations imposed by the small number of samples that could be collected feasibly.

FIGURE 18.—Excavated sediments quantitatively described in table 5.
