# Hydrology, Geomorphology, and Dam-Break Modeling of the July 15, 1982 Lawn Lake Dam and Cascade Lake Dam Failures, Larimer County, Colorado

U.S. GEOLOGICAL SURVEY PROFESSIONAL PAPER 1369

By ROBERT D. JARRETT *and* JOHN E. COSTA

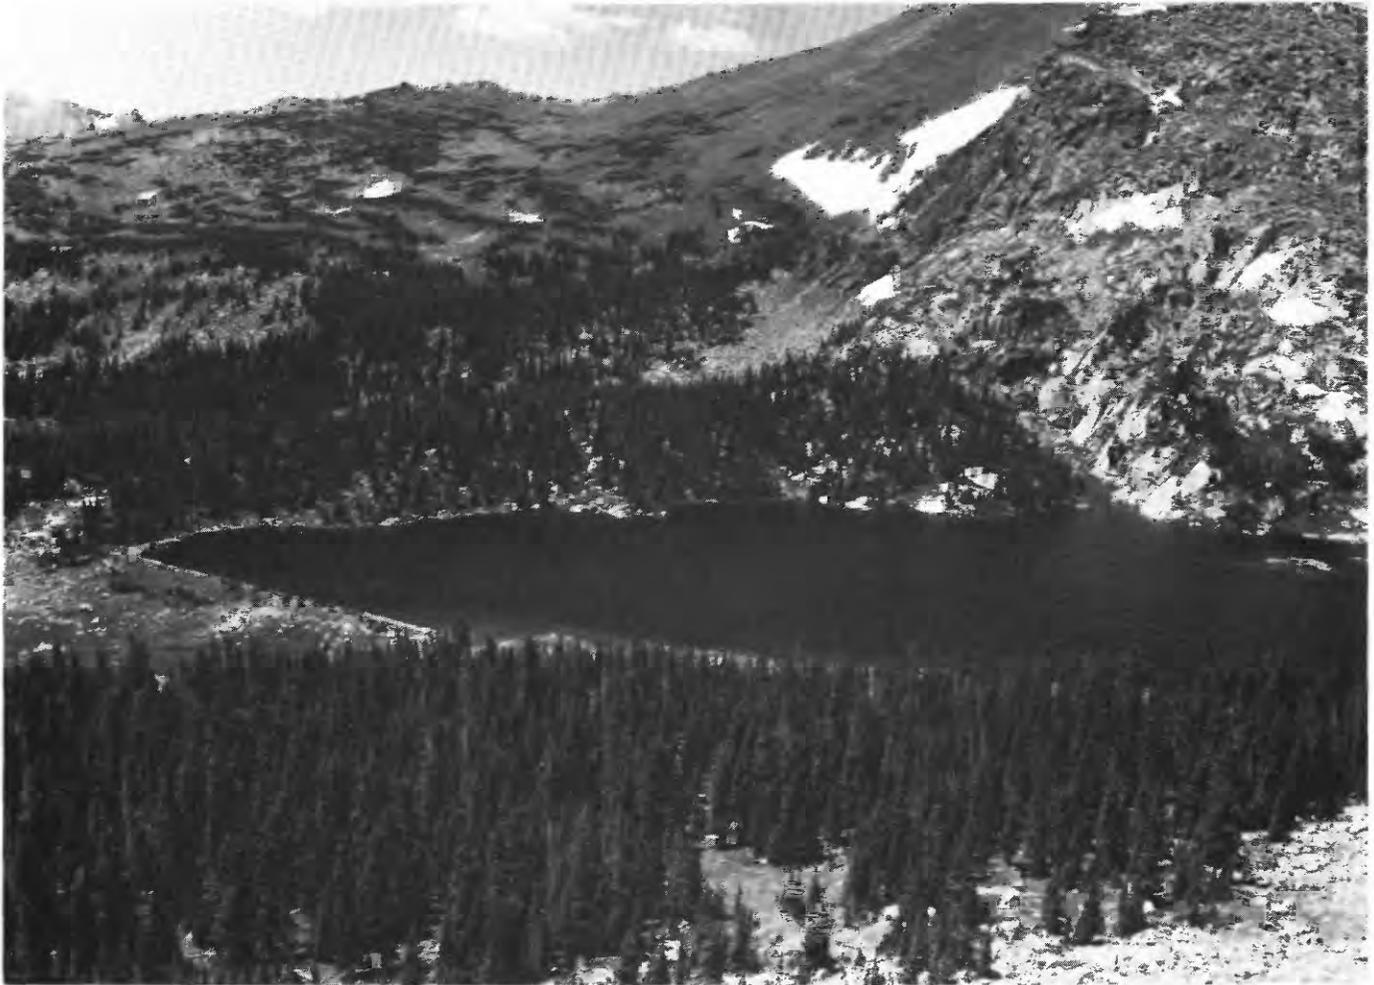
FIGURE 3.—Lawn Lake dam and Reservoir, prior to failure (July 11, 1958) (aerial). Photo courtesy of the National Park Service.

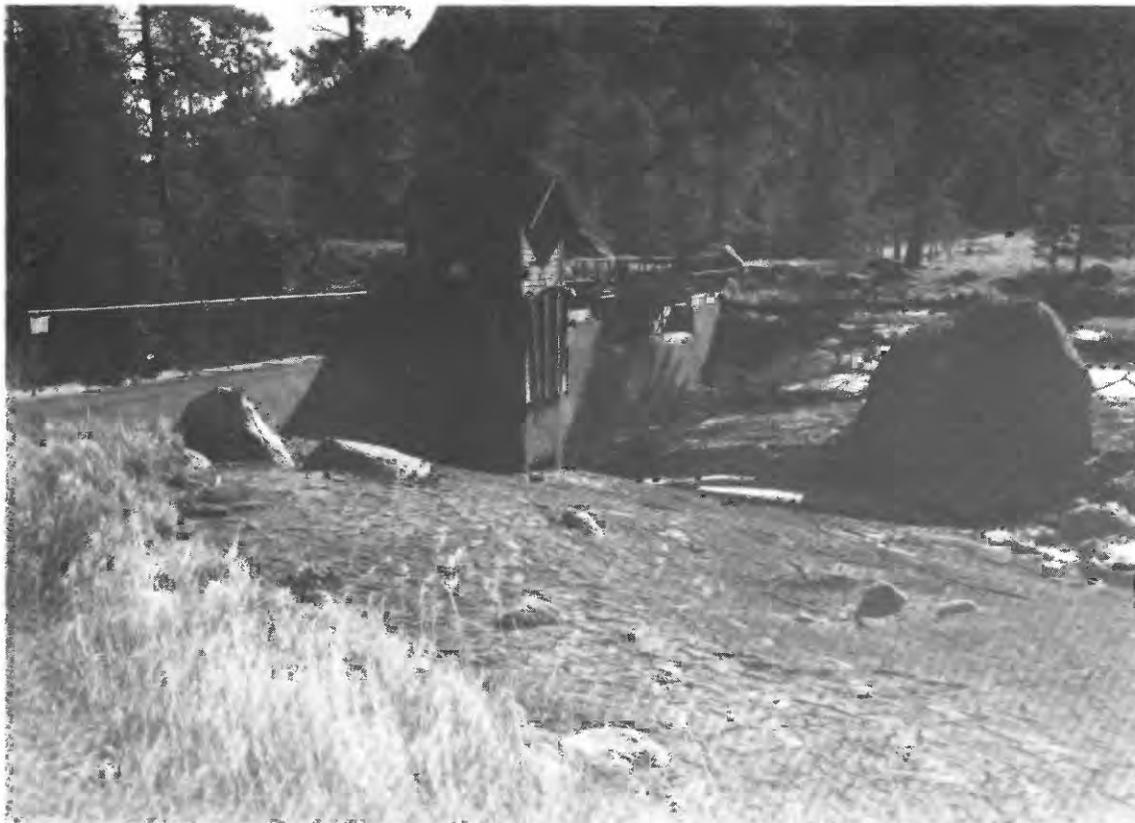
FIGURE 8.—Empty Cascade Lake prior to failure. View is toward upstream face of dam (date unknown). Photo courtesy of the National Park Service.

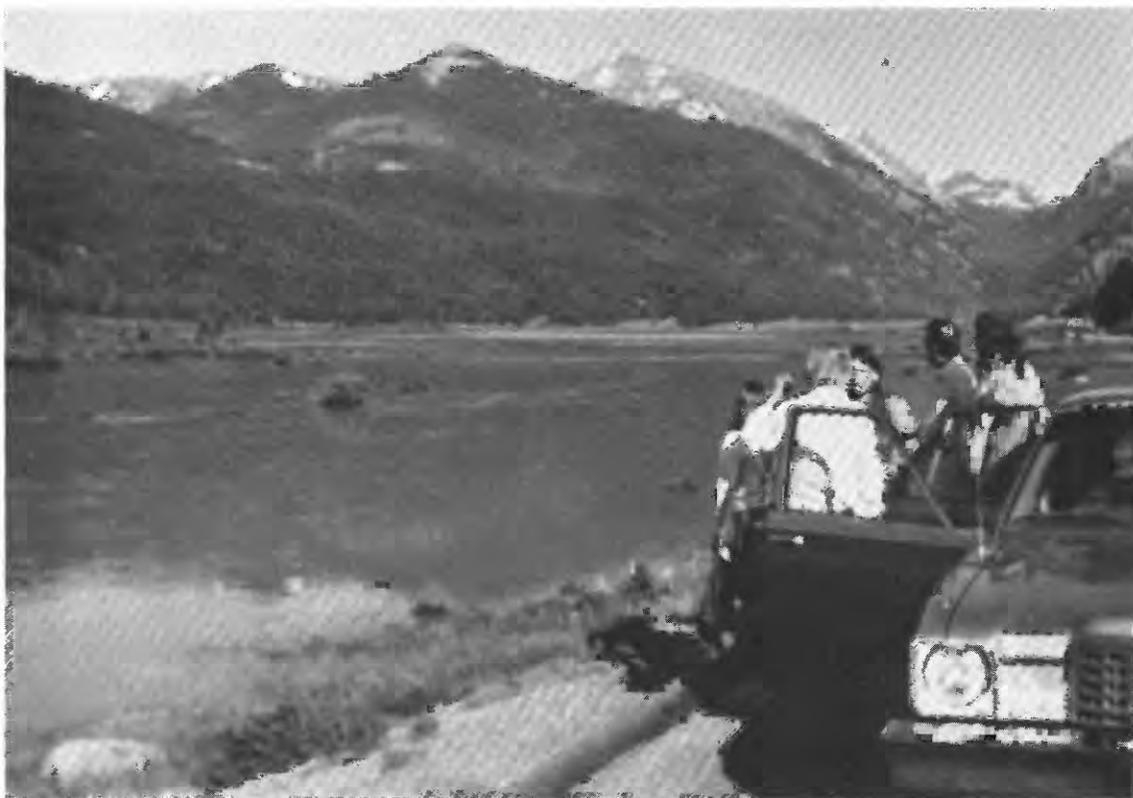
It was fortunate for the numerous people in residences and commercial establishments downstream from Horseshoe Park that the park acted as an efficient flood-retarding basin (fig. 19). By slowing the flood wave, the time available for warning and evacuation was increased. Most other Front Range valleys do not have large mountain meadows (that is, former glacial lakebeds) such as Horseshoe Park; without Horseshoe Park, the flood peak and resulting damages would have been much greater downstream.

FIGURE 19.—The flood peak in the downstream end of Horseshoe Park. Flow peak is approximately 7,200 cubic feet per second. Photo courtesy of Grace Davis George and Jennifer D. George.

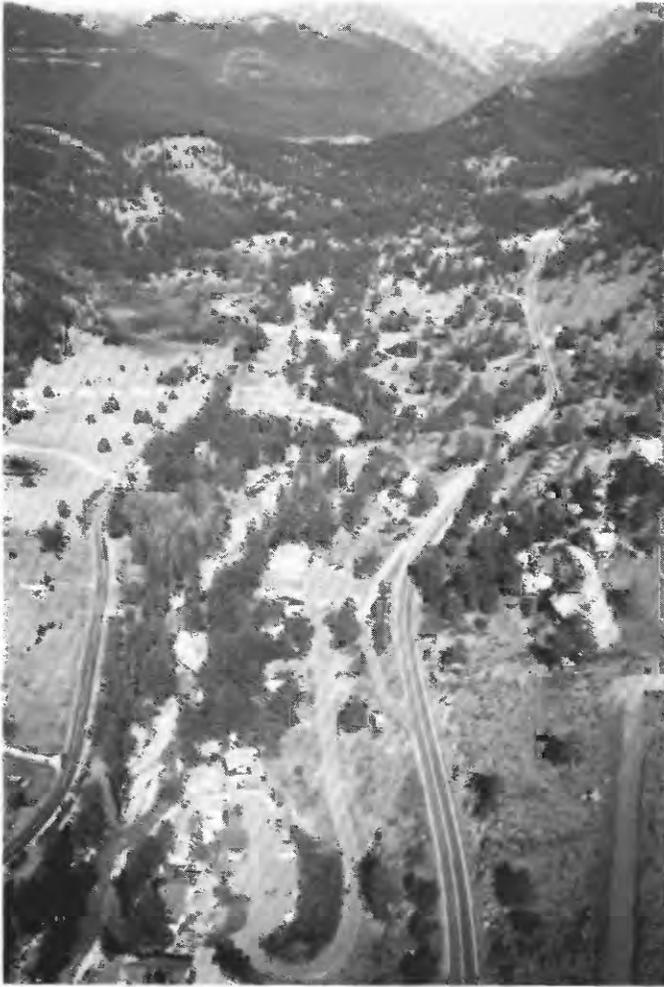
FIGURE 21.—The Fall River valley downstream from Aspenglen Campground (aerial). View is upvalley from about river mile 8.5.

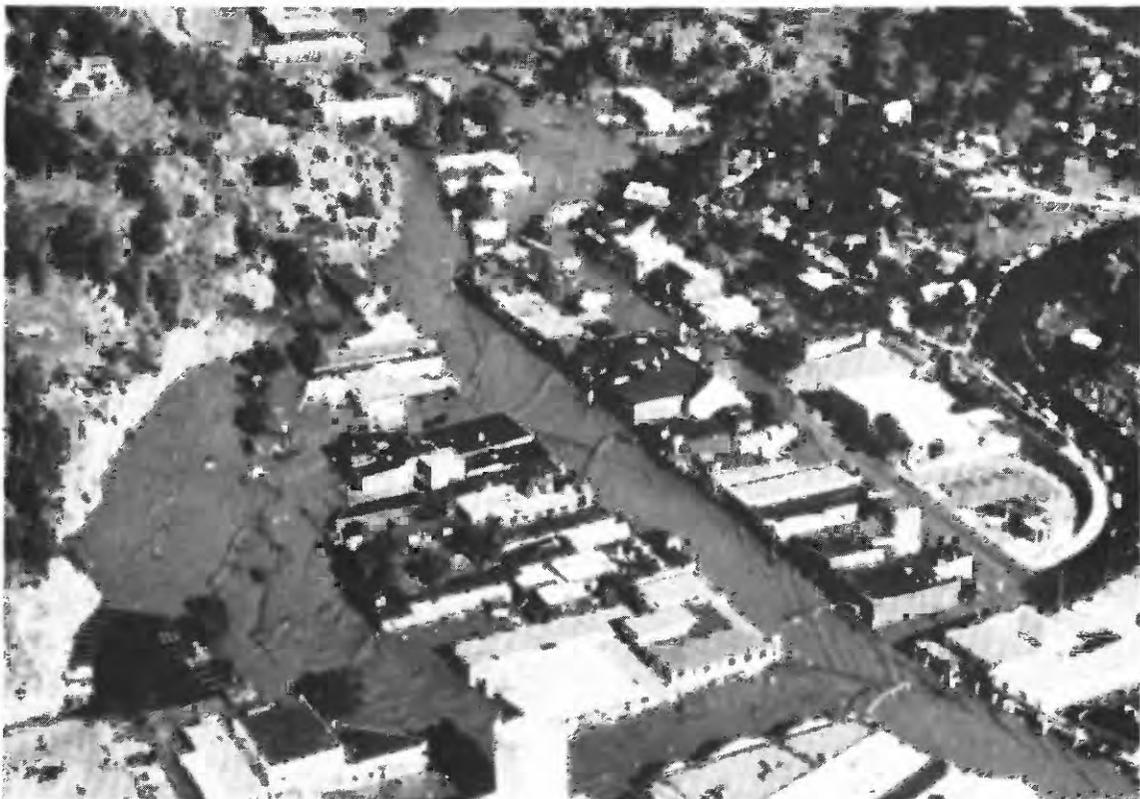
23 and 24 (taken at about the time of peak flow). Note in figures 23 and 24 that flow was very fast only in the main street of Estes Park (as indicated by the cross waves that imply supercritical flow); the majority of flow being impeded by the buildings was subcritical.

FIGURE 23.—The Fall River looking upstream from the western end of Estes Park at river mile 11.9 (aerial). Photo courtesy of Zenas Blevins, U.S. Bureau of Reclamation.

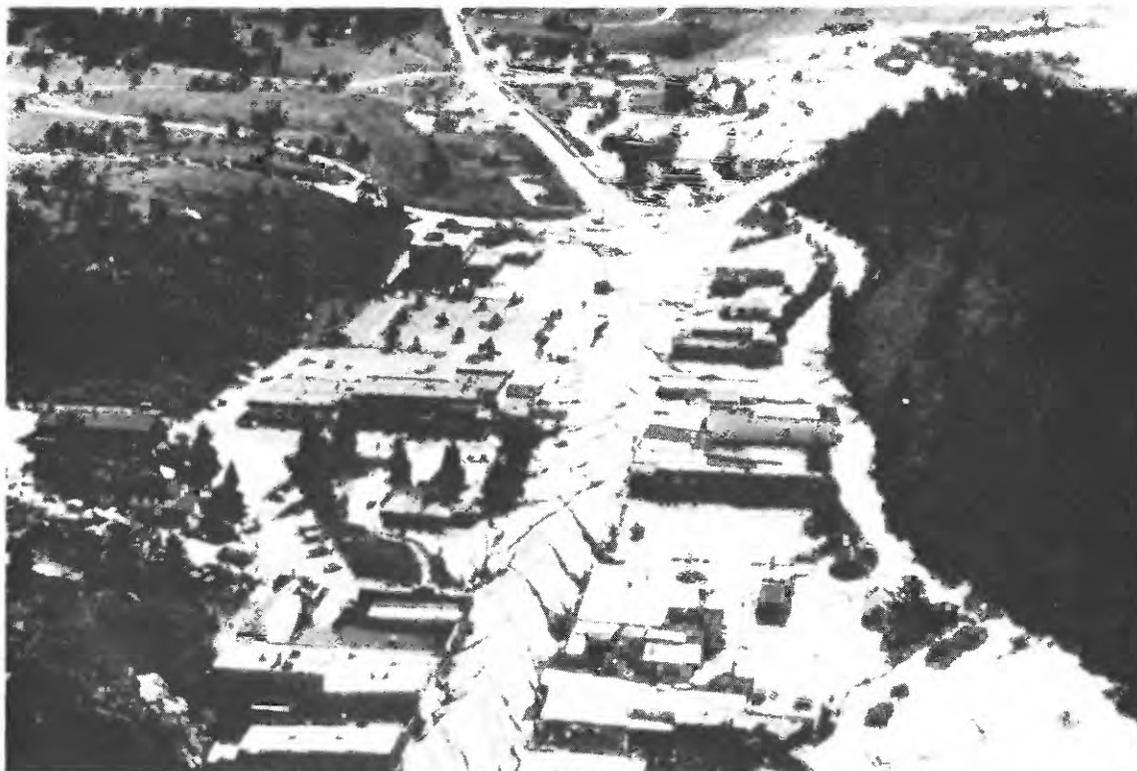
FIGURE 24.—Elkhorn Avenue, Estes Park, looking downstream from river mile 12.0 (aerial). Big Thompson River is along the right side of the photograph; Lake Estes is in the top righthand corner. Photo courtesy of Zenas Blevins, U.S. Bureau of Reclamation.

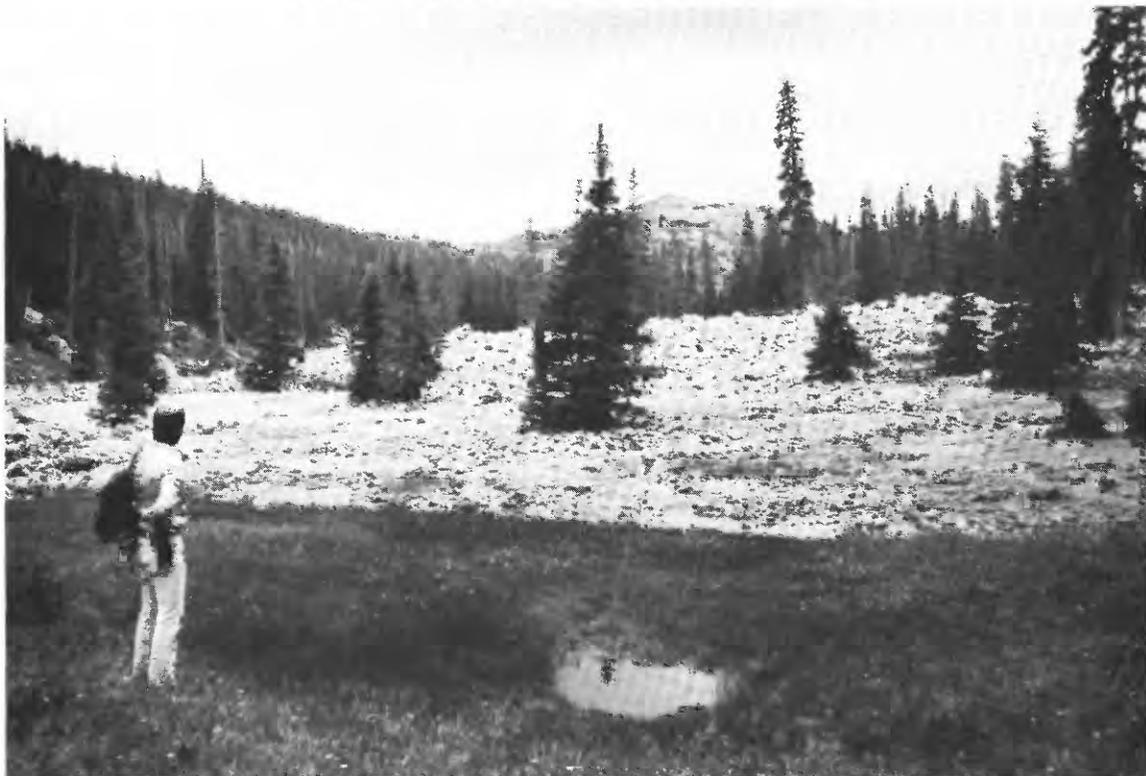
FIGURE 29.—View across a mountain meadow at river mile 0.38, showing the accumulation of a thick boulder deposit in a relatively flat reach in the Roaring River valley.

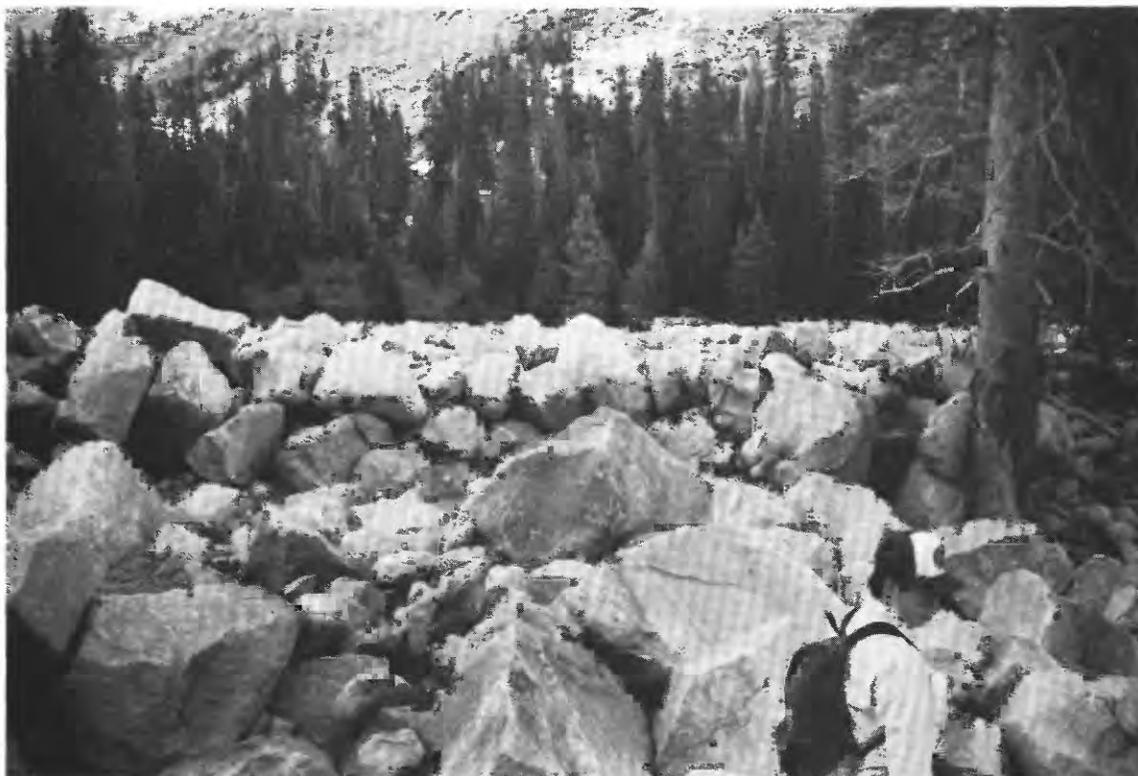
FIGURE 30.—Imbricated structure in boulders deposited in the meadow shown in figure 29. Flow was left to right. Note the near-vertical imbrication of many of the rocks piled behind the tree.

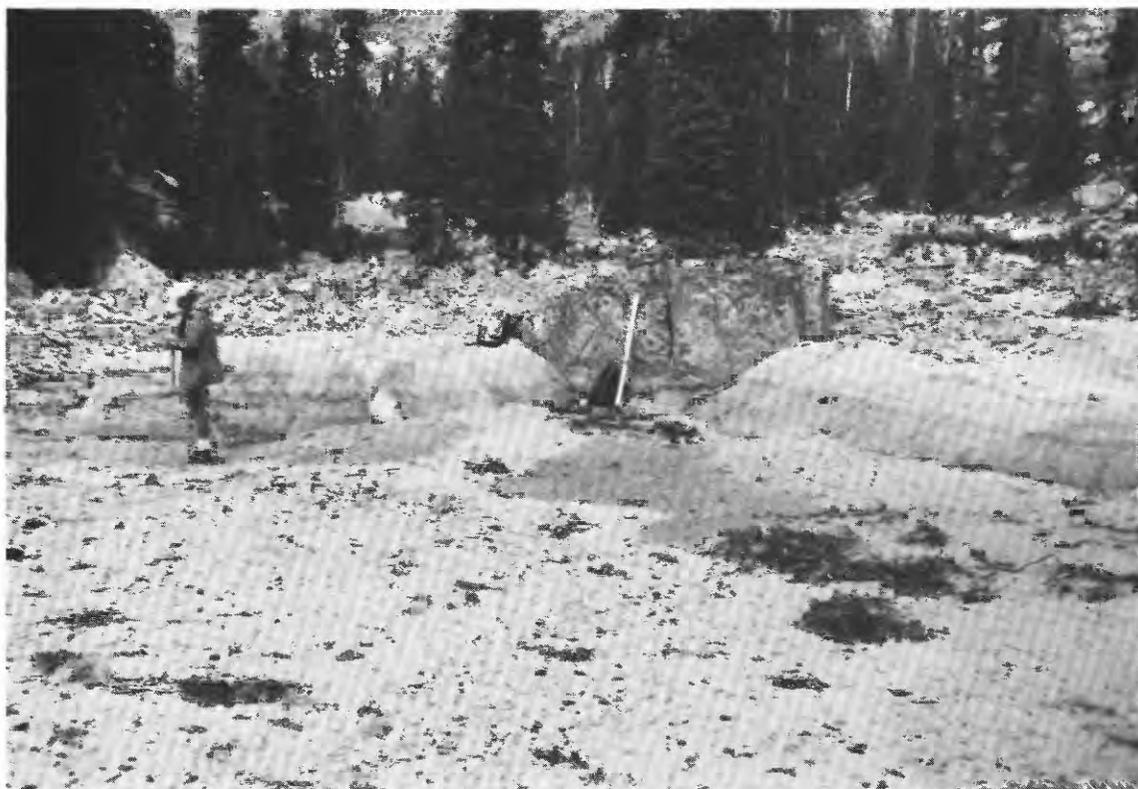
FIGURE 31.—Unusually thick sand waves deposited in the Roaring River valley on the inside of a sharp valley bend at river mile 0.50.

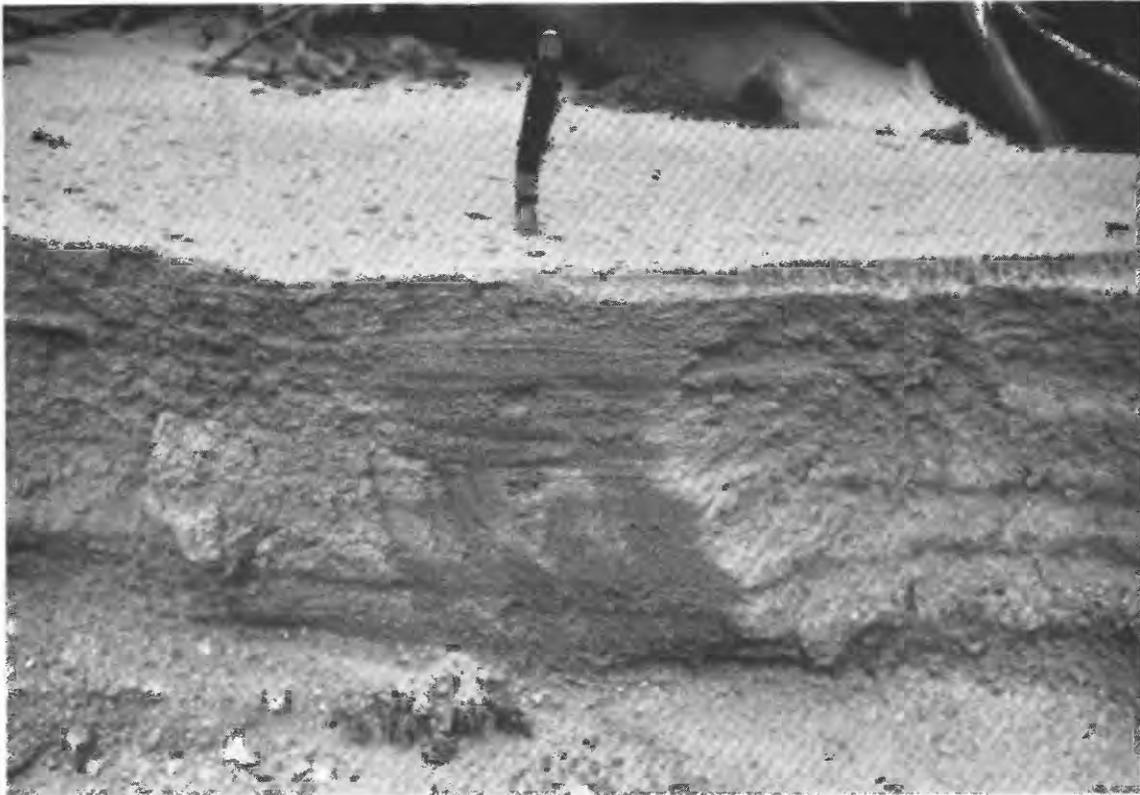
FIGURE 32.—Horizontal laminations in sand deposits at the edge of flow in the Roaring River valley at river mile 3.41.

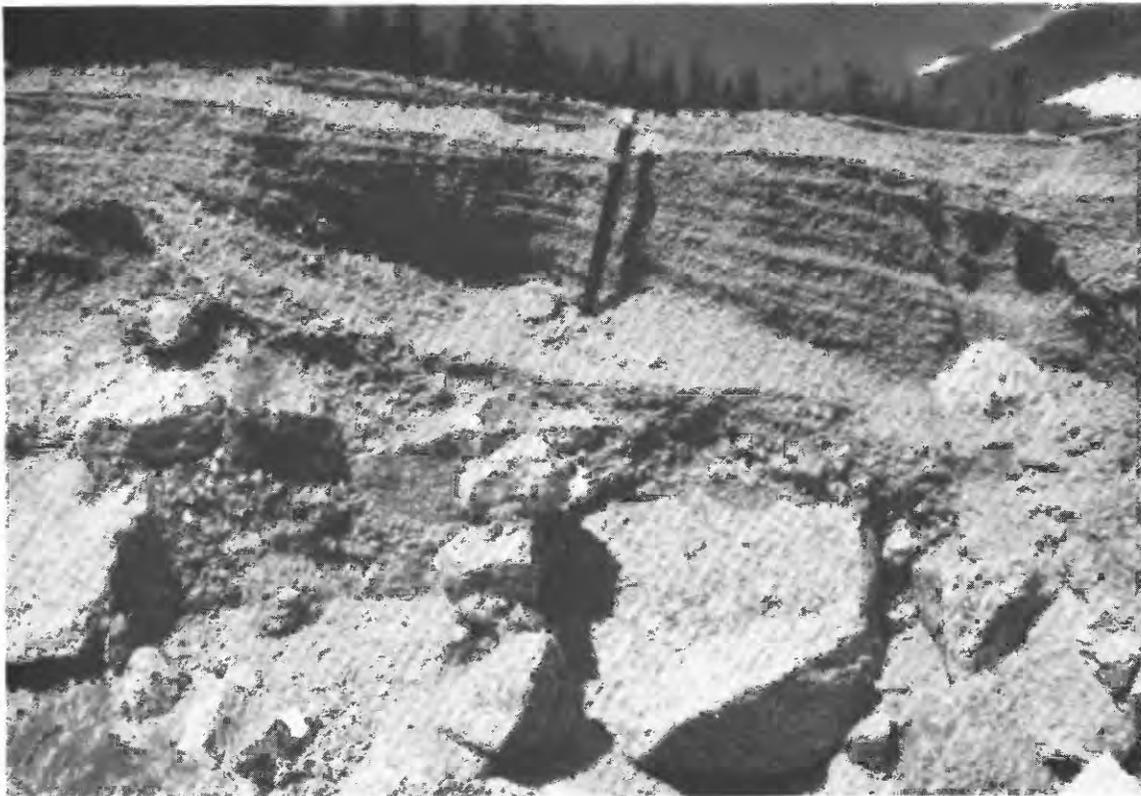
FIGURE 33.—Gently-inclined backset crossbeds interpreted to be antidune structures in a sand splay 0.25 river mile below Lawn Lake dam. Flow was from right to left; pencil is 5.5 in. long.

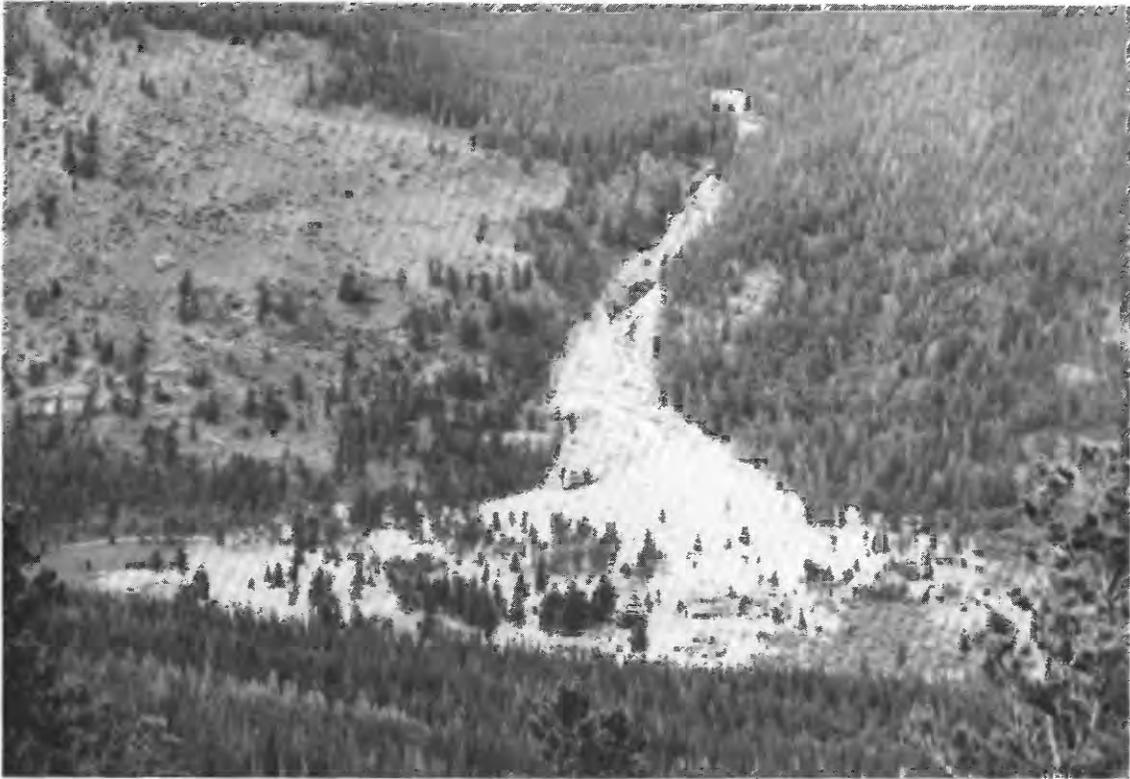
FIGURE 34.—The alluvial fan formed at the mouth of the Roaring River. Note the deep scour into the lateral moraine source materials.

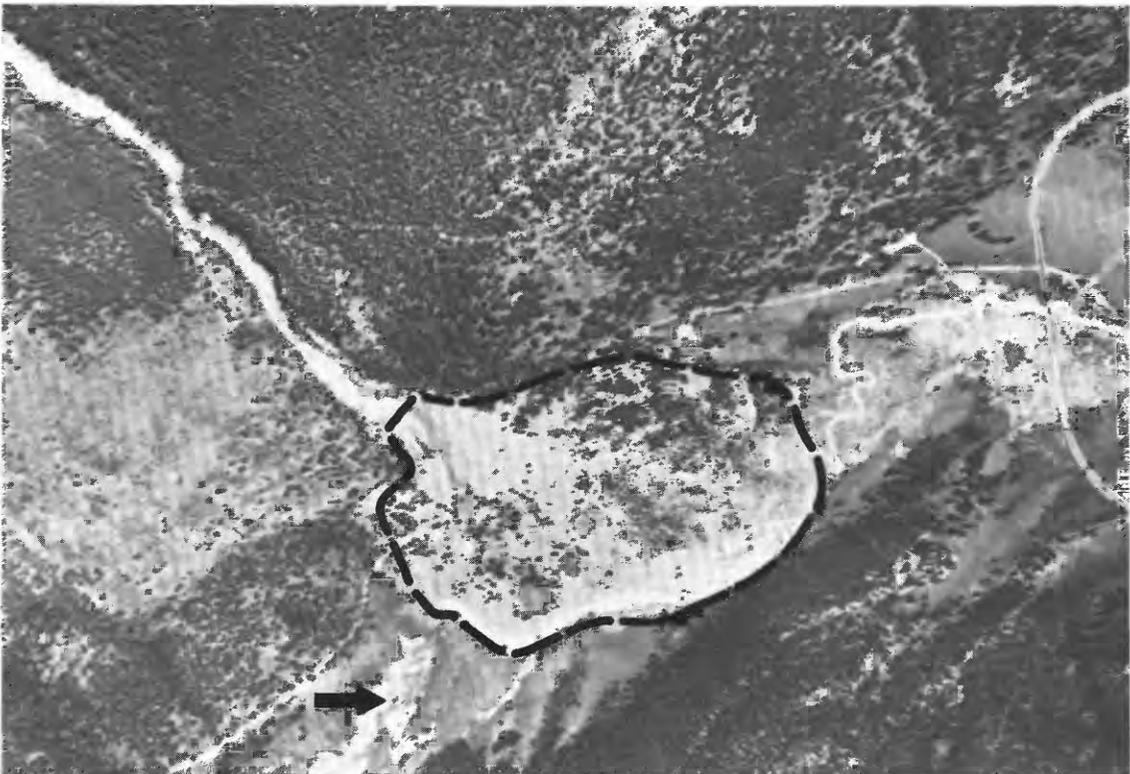
The large volume of sediment deposited in the Roaring River alluvial fan dammed the Fall River in Horseshoe Park upstream from the fan, forming a small lake (fig. 35). By July 1983, the lake had established an equilibrium between inflow of the Fall River upstream and outflow along a marginal channel that formed at

FIGURE 35.—Roaring River alluvial fan taken about 4 hours after the flood (vertical aerial). Incipient lake formed from the damming of the Fall River shown in figure 39 is indicated by arrow; dashed lines indicate the outline of the alluvial fan.

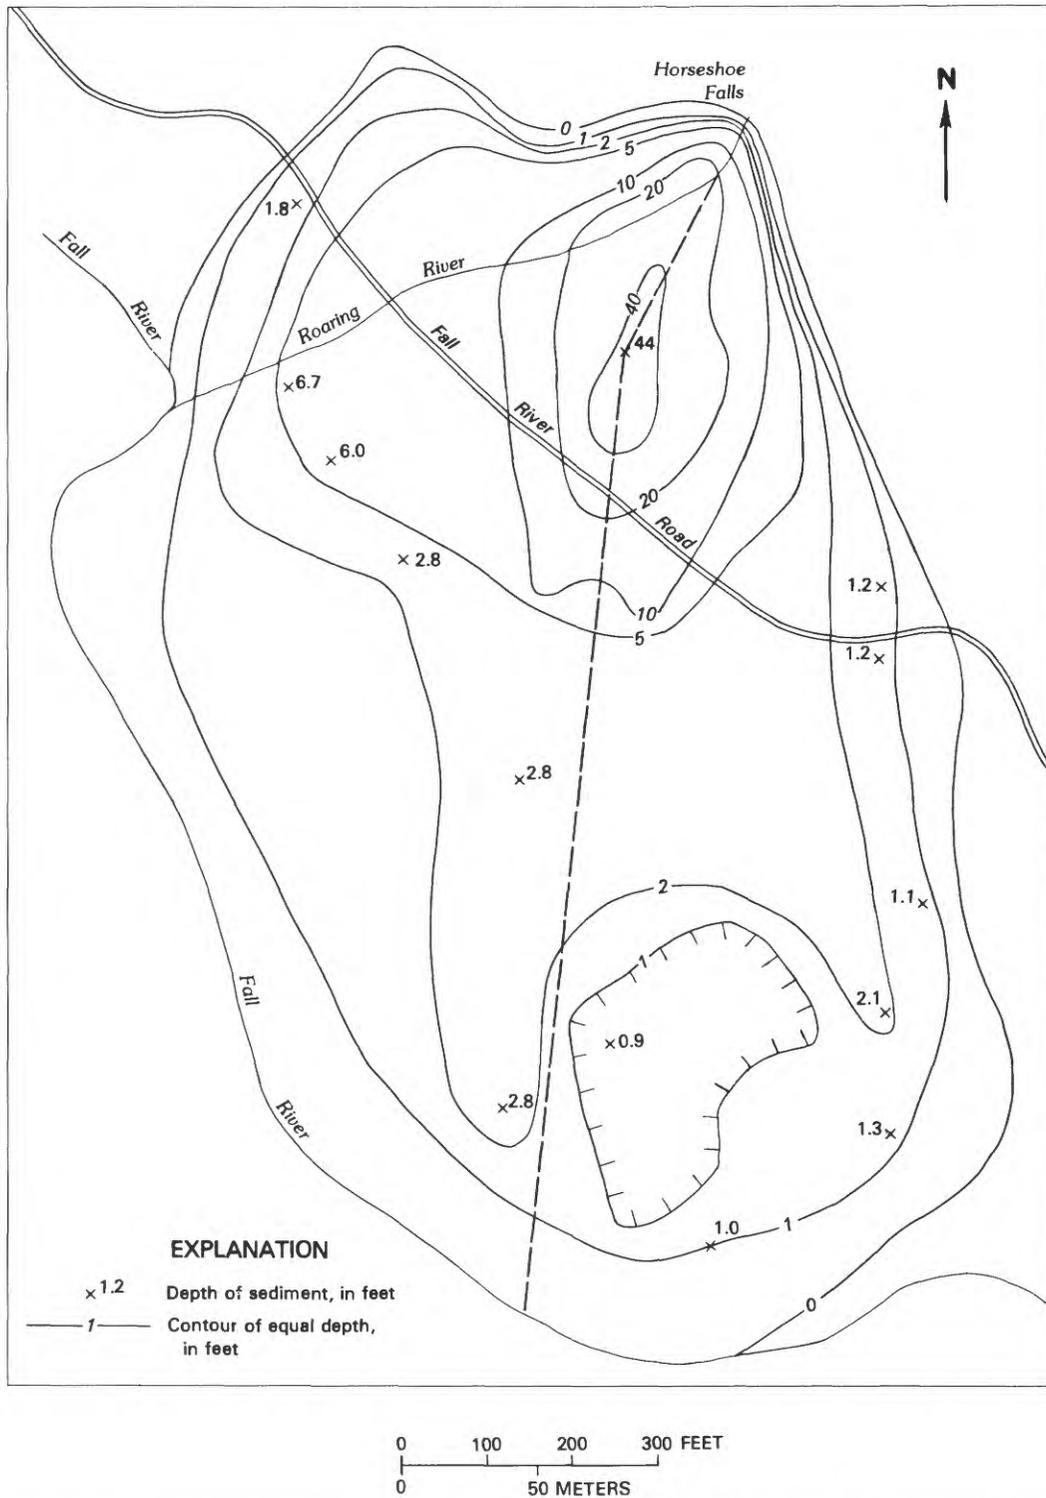
Volume of sediment in the alluvial fan was calculated two ways; both ways produced approximately the same volume. First, the area between the contour lines shown in figure 36 was measured and multiplied by the average thickness of the bounding contours. Second, a Theissen-Polygon method using the 14 data points was used. The calculated sediment volume, assuming 1/3 porosity, is 364,600 yd<sup>3</sup>, which is enough sediment to cover a football field to a height of 205 ft. If a specific gravity of 2.7 is assumed for the granite-gneiss sediments, the unit weight is 168.5 lbs/ft<sup>3</sup>. This produced a sediment weight of 829,000 tons, which is approximately 1½ times the sediment load deposited at the mouth of the Mississippi River in 1 day (Milliman and Meade, 1983).

FIGURE 36.—Contours of sediments in the Roaring River alluvial fan. Axis of main flow direction is shown by dashed line. Dashed line also is the path along which particle sizes shown in figure 37 were measured.

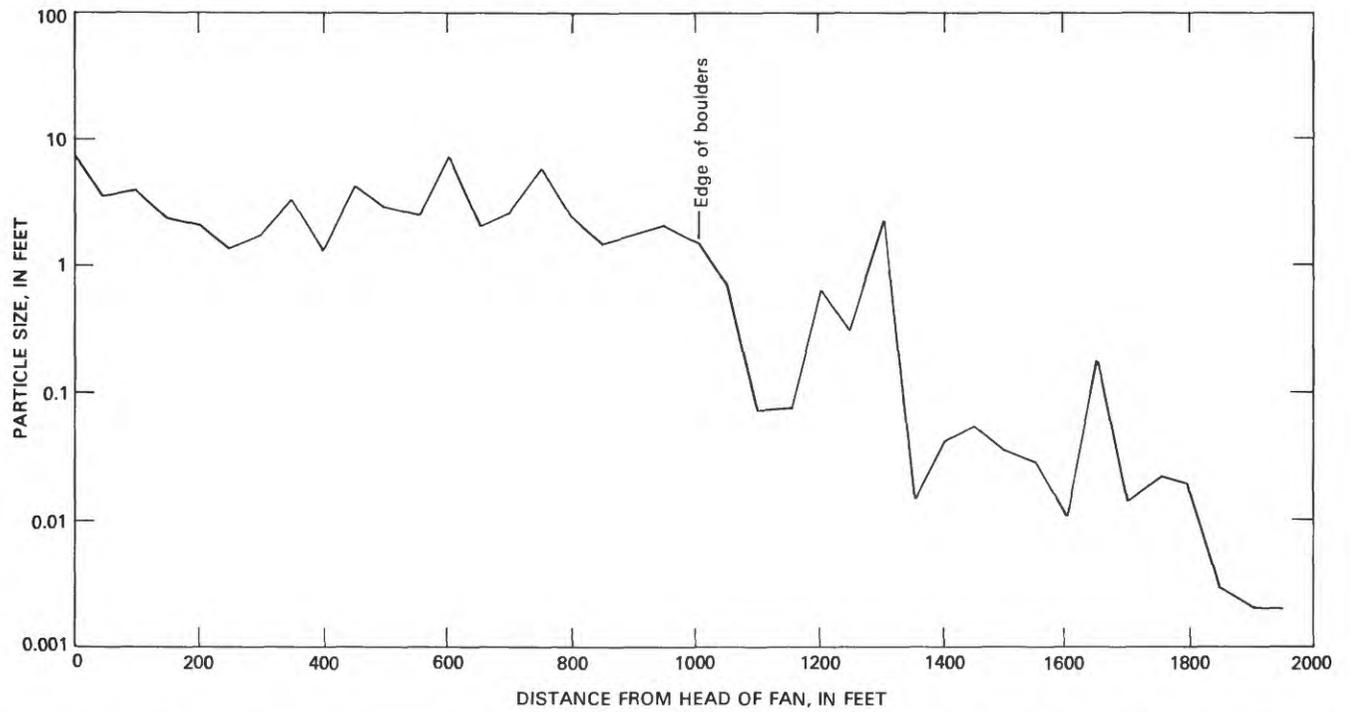
direction. The size of the single largest particle in a 3-ft radius, every 50 ft down the major flow axis of the fan, is plotted in figure 37. The particle size changed from 7.5 ft at the head of the fan to 1 ft midway down the fan, where the largest concentrations of big boulders ended, to 0.002 ft at the toe of the fan, overlapping the flood plain of the Fall River. Winter winds during 1982–83 subsequently eroded some of the flood-plain sand and silt, which collected against U.S. Highway 34 road embankment (fig. 1) as dunes with heights of 2 to 3 ft.

FIGURE 37.—Plot of largest particle measured in 3-foot radius every 50 feet down the major flow axis of the dam-break flood on the Roaring River alluvial fan. Path follows dashed line in figure 36.

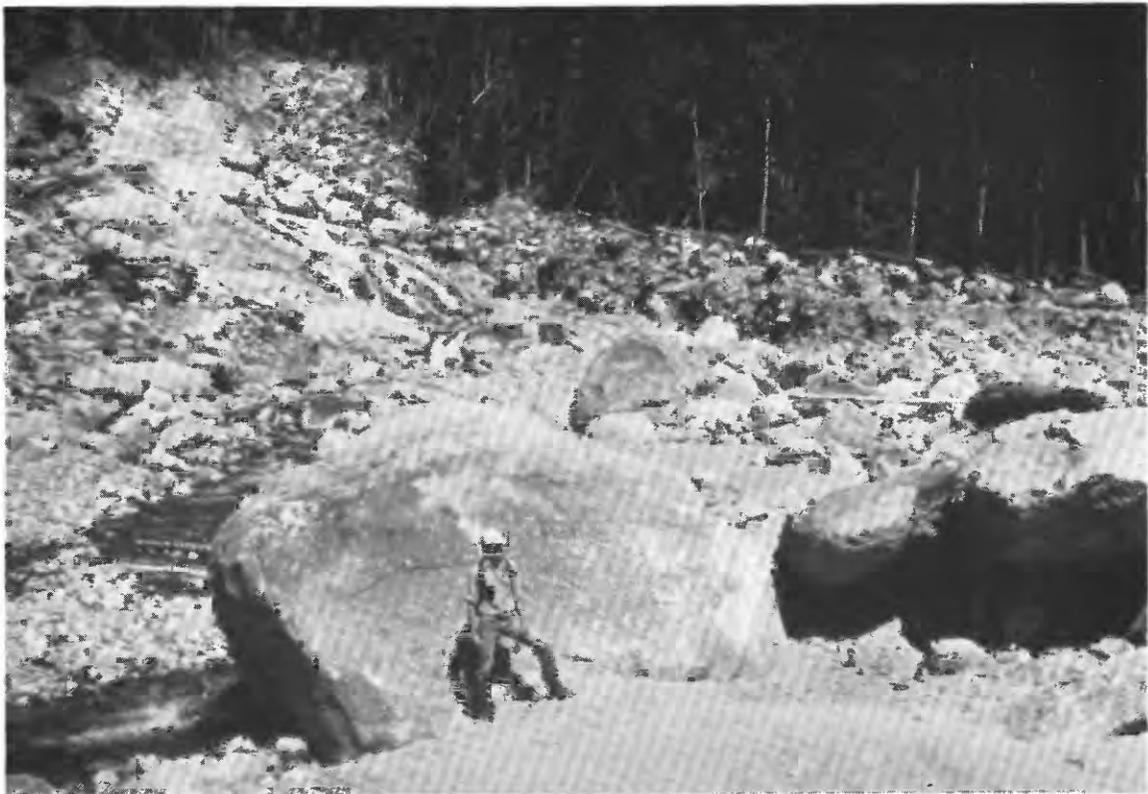
The single largest boulder known to have been transported onto the surface of the Roaring River alluvial fan is 14×17.5×21 ft, and weighs an estimated 452 tons (fig. 38). The force of the boulder-charged flow over Horseshoe Falls battered and destroyed most of the vegetation along the main flow path. Some trees still standing after the flood were struck so hard by transported boulders that their tops were snapped off.

FIGURE 38.—The single largest boulder thought to have been moved by the flood onto the Roaring River alluvial fan. Dimensions of the boulder are 14×17.5×21 ft.

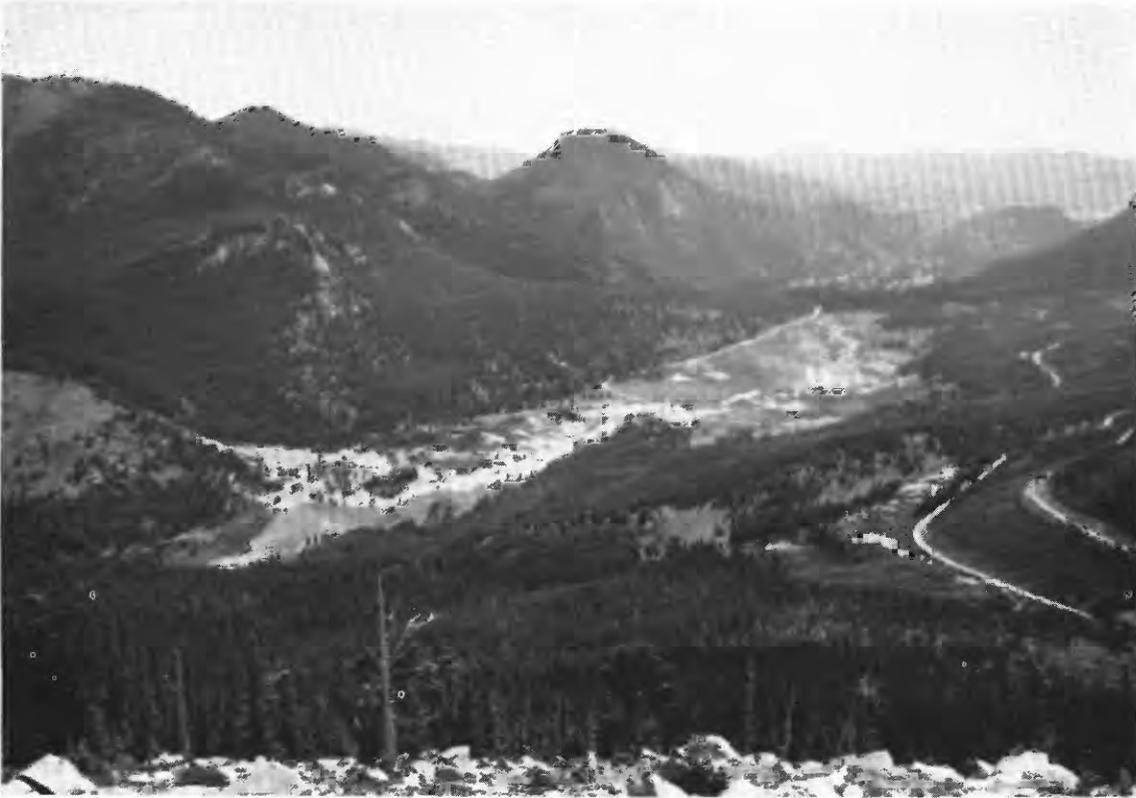
FIGURE 40.—Horseshoe Park and the Fall River valley, looking down-valley. Roaring River alluvial fan is in left-center of photo.

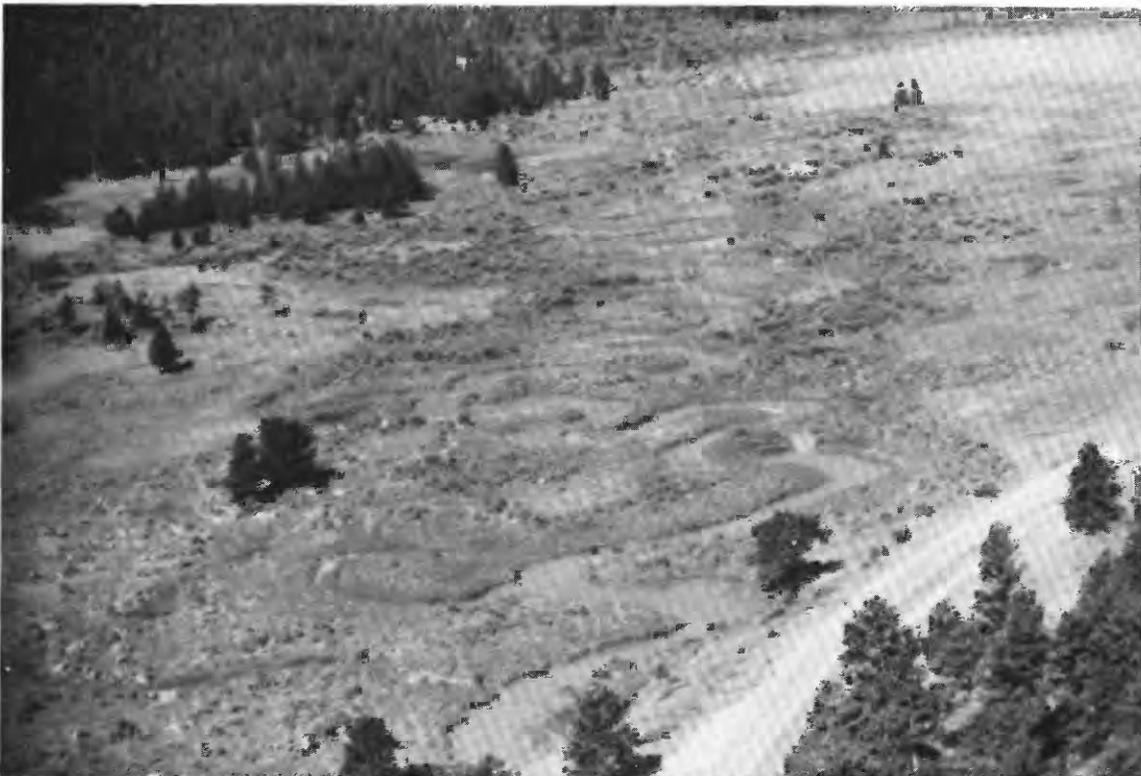
on the Fall River in Horseshoe Park for less than 4 hours, except for local ponded water. The photograph in figure 41 was taken about a week after the flood; it clearly shows that no immediate visible modification occurred to the meandering channel pattern of the Fall River.

FIGURE 41.—Horseshoe Park taken 1 week after the flood, looking upstream from river mile 6.5 (aerial). The tight meanders of the Fall River were unaffected by the floodwaters.

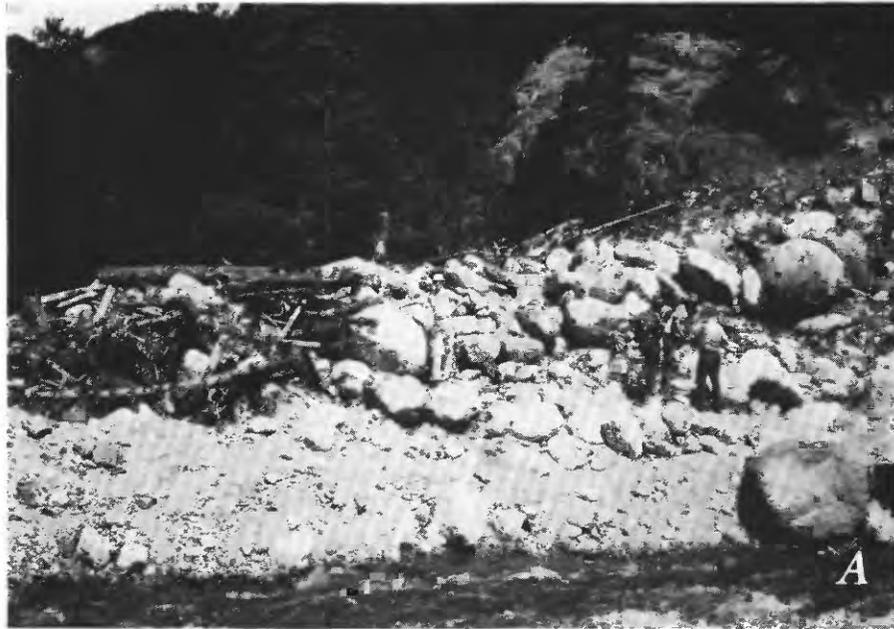
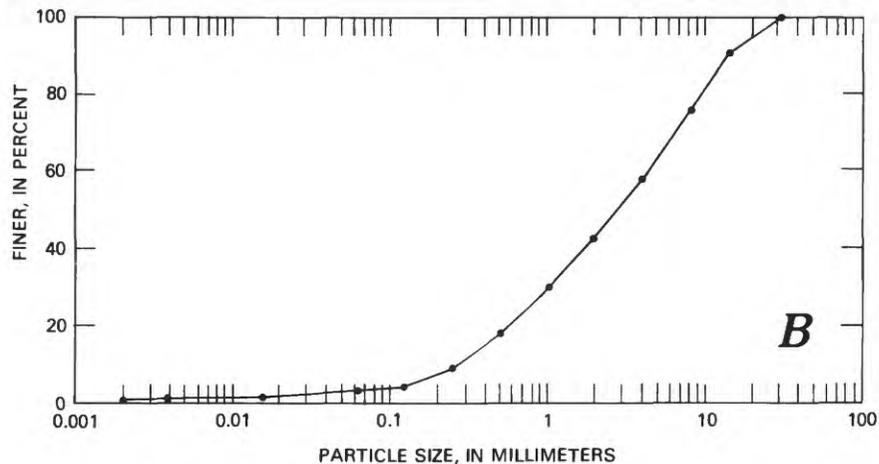
fan, and below Cascade Lake dam above the Aspenglen Campground, boulder berms similar to those described from other catastrophic floods in steep mountain channels (Scott and Gravlee, 1968, p. M13–M14) were well-developed (fig. 43A). These boulder berms are boulder levees deposited by floodwaters in the two locations where sufficient sediment was entrained in the flow to temporarily produce an inertial granular flow (Pierson and Costa, 1986). These conditions existed for only two short reaches where (1) the Roaring River eroded through the high lateral moraine at Horseshoe Falls, and (2) the Fall River deeply eroded Pleistocene terminal moraine sediments below Cascade Lake dam.

Particle-size analysis of a sample of matrix material from the right boulder berm or debris-torrent levee at the Roaring River alluvial fan is shown in figure 43B. The median particle size is 0.118 in., and the matrix contains only 0.5 percent clay. The berm ends with a steep front

FIGURE 43.—A, A well-developed boulder berm along the right bank of the Roaring River on the large alluvial fan at river mile 4.73, showing the concentration of organic material in the front of the berm. View is upslope on the surface of Roaring River alluvial fan. B, Partical-size analysis of matrix from Roaring River alluvial fan boulder berm.

that includes numerous large shattered tree trunks and other organic material as well as large boulders. Upslope, there is no organic material and the berm consists of very coarse boulders and a coarse, noncohesive matrix deposited directly on ground moraine with little or no erosion. The coarse texture of the matrix and the small clay content are characteristic of such flows (Church and Desloges, 1984).

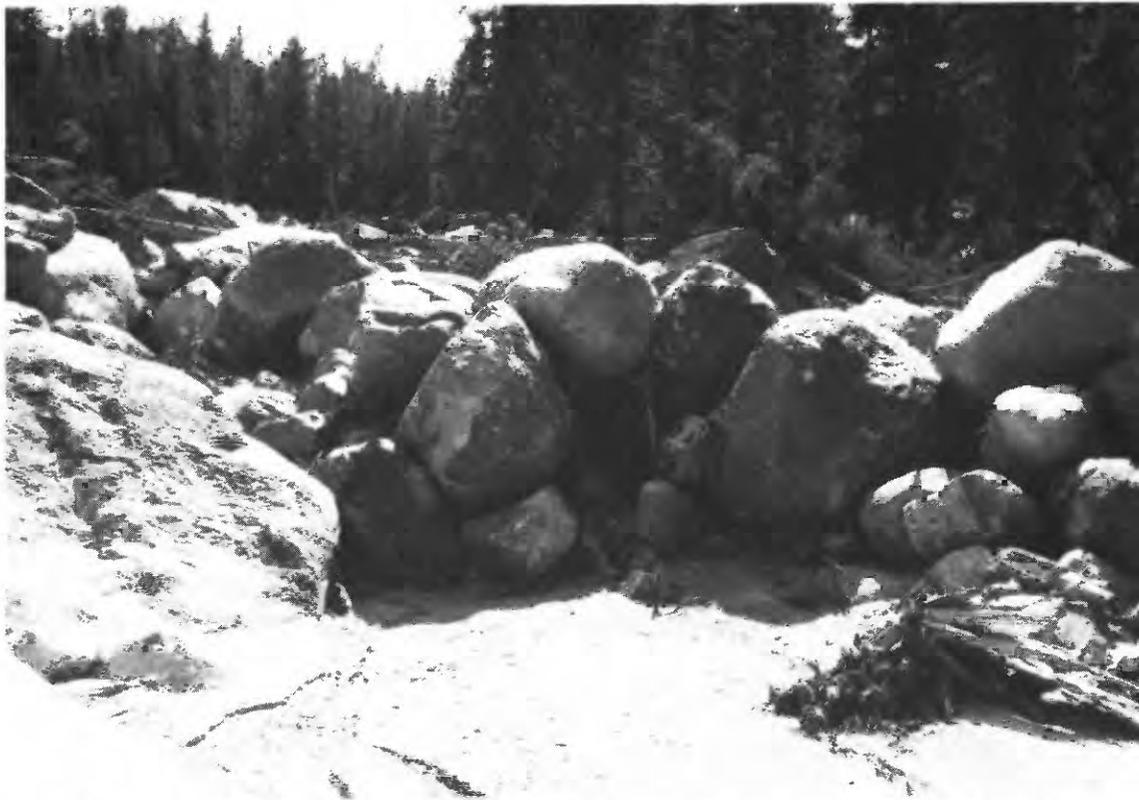
Four well-developed steps ranging in height from 4 to 9 ft were formed within a distance of 110 ft in the Fall River just upstream from Aspenglen Campground. One step-pool bedform in boulder deposits in the Fall River is shown in figure 44. Average sizes of the 10 largest boulders exposed in the front of each of the steps were 3.4 ft, 3.5 ft, 4.0 ft, and 4.4 ft. The steps formed

downstream from Cascade Lake dam probably were analogous to the steppool forms so common in coarse-boulder steep channels, and support the belief that they originate as bedforms under catastrophic flood conditions, probably collecting under hydraulic jumps formed near the peak of the flood.

FIGURE 44.—The front of one step-pool bedform in boulder deposits in the Fall River upstream from Aspenglen Campground at river mile 7.01.

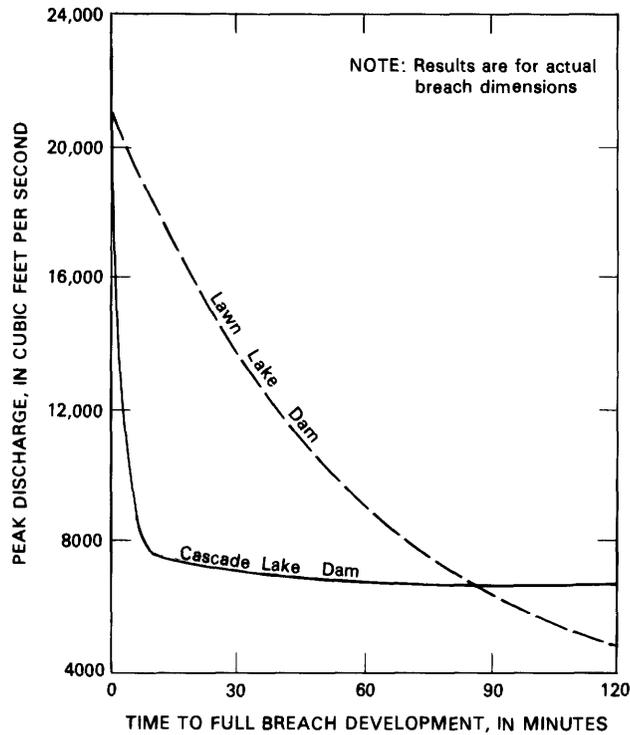
dimensions of the breach at the time of the peak. For the actual breach dimensions, the model was able to evaluate the variation of time of full breach development on the magnitude of outflow discharges from the dams. Outflow discharge for various times to full breach development for both dams is shown in figure 47. This analysis indicates less change of discharge with time occurred for the failure of Lawn Lake dam, and available information indicated a full breach-development time of 10 min, with a probable range of 5 to 20 min. Hence, discharge from Lawn Lake dam probably ranged from

20,000 ft<sup>3</sup>/s to 16,000 ft<sup>3</sup>/s in that time frame. However, for Cascade Lake dam, the rate of change in peak discharge was much greater in the probable time of full breach development of 30 s to 5 min (1 min was assumed). The range of peak discharge from Cascade Lake dam could have been 23,000 ft<sup>3</sup>/s to 9,000 ft<sup>3</sup>/s in that time frame. As the modeling demonstrated, because of the smaller capacity of Cascade Lake, greater attenuation occurred downstream.

FIGURE 47.—Outflow discharge for various times of breach development for Lawn Lake dam and Cascade Lake dam.

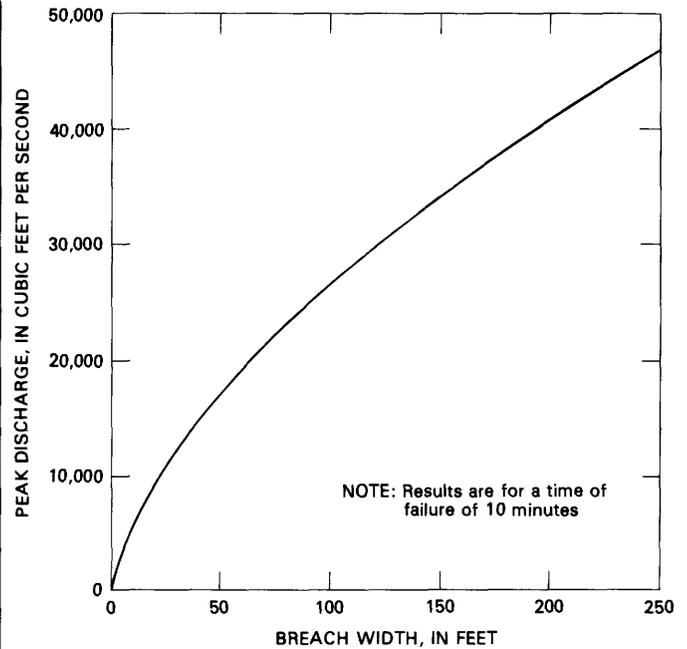
of breach width were made for Lawn Lake dam. Hypothetical breach (bottom) widths of 25 ft and 200 ft were compared with model results of the actual breach width of 55 ft. For consistency, these scenarios were compared to the calibrated model results. This range in breach widths was suggested by McMahon (1981). Outflow discharges for hypothetical breach widths for a time of failure of 10 min for Lawn Lake dam are shown in figure 48. This figure demonstrates how much greater discharge could have been. Results of these model simulations are summarized in table 10 for a breach width of 25 ft, and in table 11 for a breach width of 200 ft.

FIGURE 48.—Outflow discharge for hypothetical breach width for Lawn Lake dam, assuming 10-minute time of failure.
