# Hydrology, Geomorphology, and Dam-Break Modeling of the July 15, 1982 Lawn Lake Dam and Cascade Lake Dam Failures, Larimer County, Colorado

U.S. GEOLOGICAL SURVEY PROFESSIONAL PAPER 1369

By ROBERT D. JARRETT *and* JOHN E. COSTA

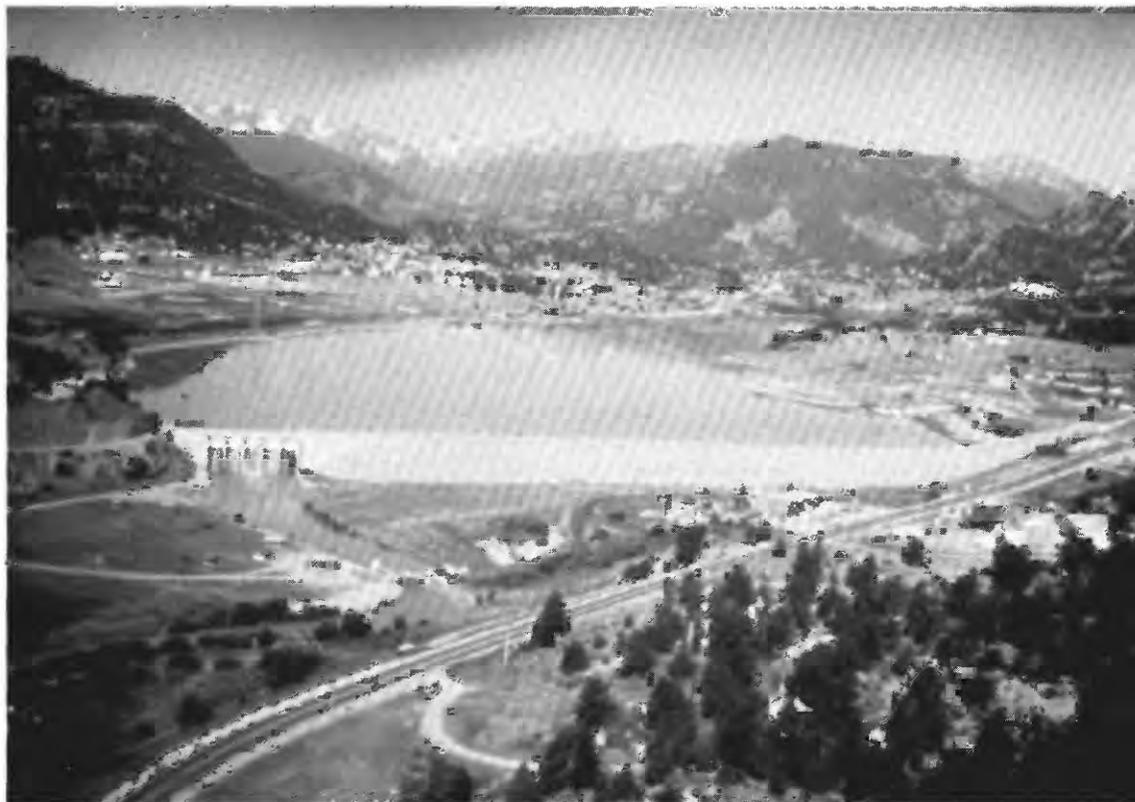
Selected photographs of damages and debris are shown in figures 50, 51, 52, and 53. The Ponderosa Lodge at river mile 9.9 on the Fall River, which was reconstructed above the 500-yr flood level, was totally destroyed (fig. 51A); however, the lodge was rebuilt in the same location as shown in figure 51B. Farther downstream, damages were prevented when the floodwaters were contained in Lake Estes (fig. 54).

FIGURE 54.—View upstream from Olympus dam and Lake Estes, containing the floodwaters (aerial).

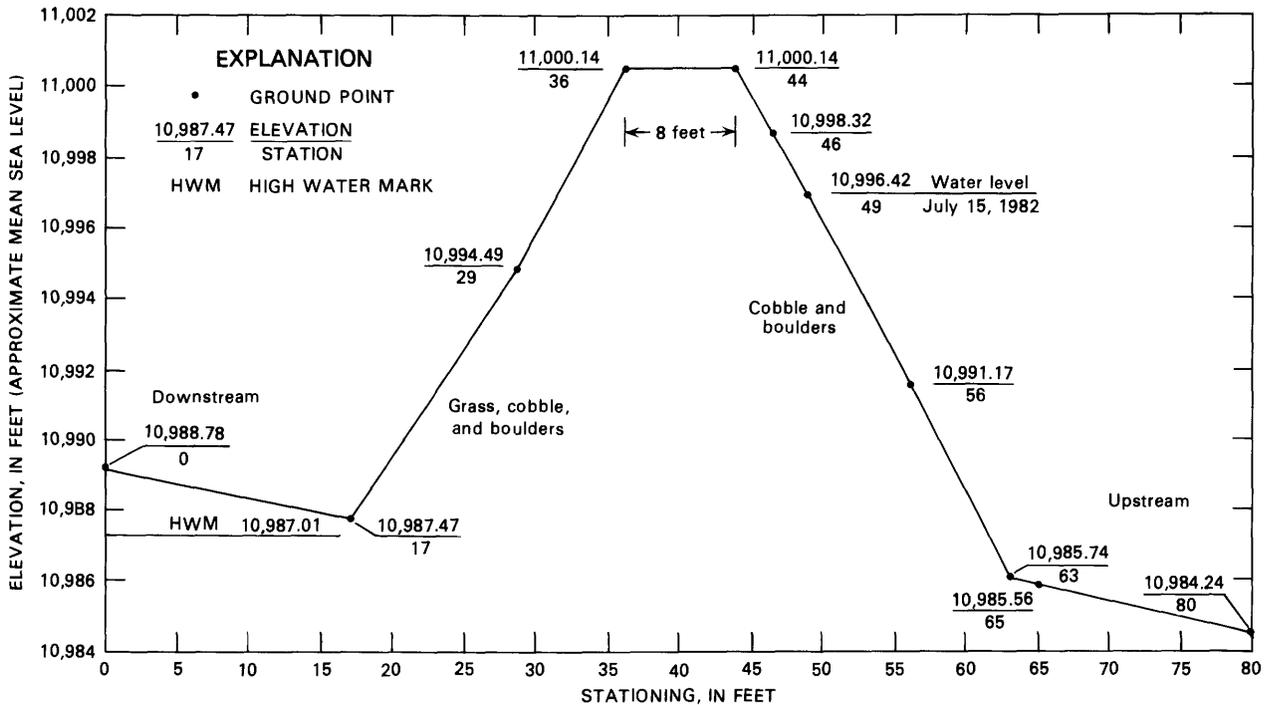
FIGURE 56.—Lawn Lake dam cross section of breach (right side) on the Roaring River at river mile 0.0

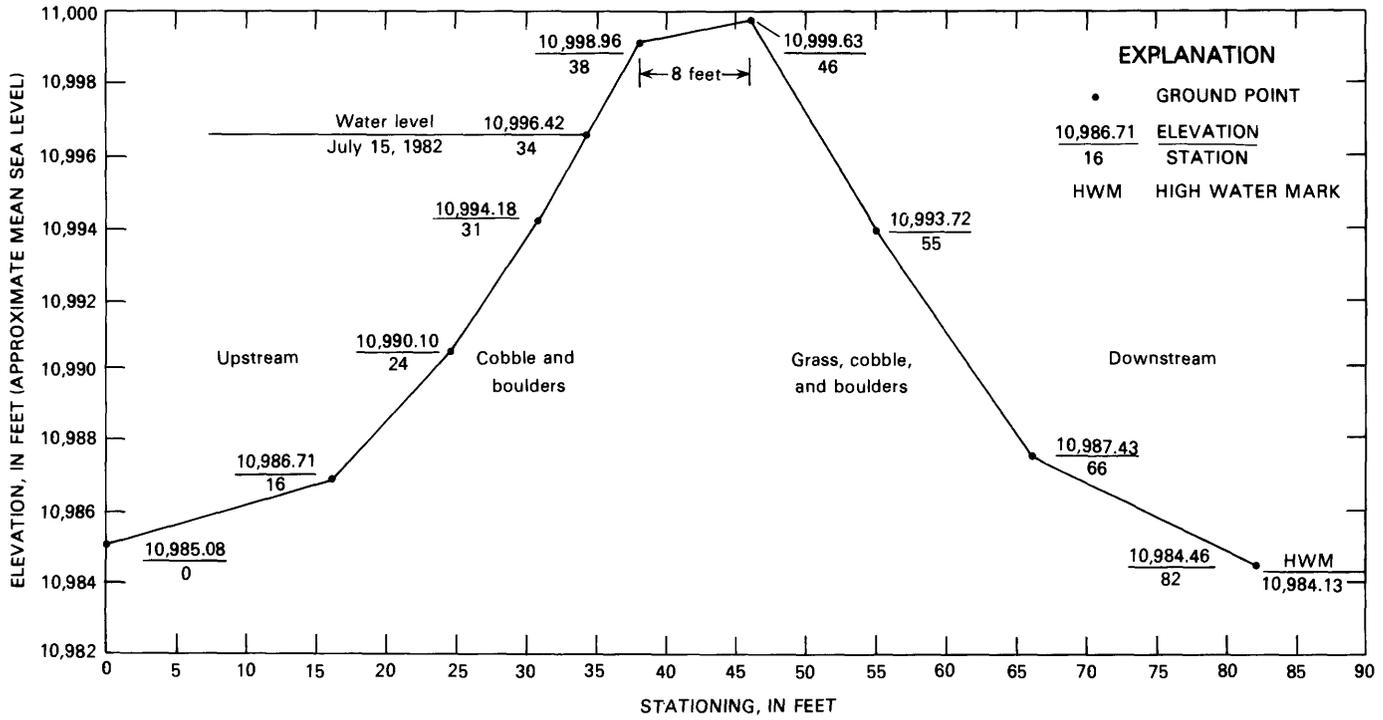
FIGURE 57.—Lawn Lake dam cross section of breach (left side) on the Roaring River at river mile 0.0.
