# The Loma Prieta, California, Earthquake of October 17, 1989— Liquefaction

THOMAS L. HOLZER, *Editor*

STRONG GROUND MOTION AND GROUND FAILURE

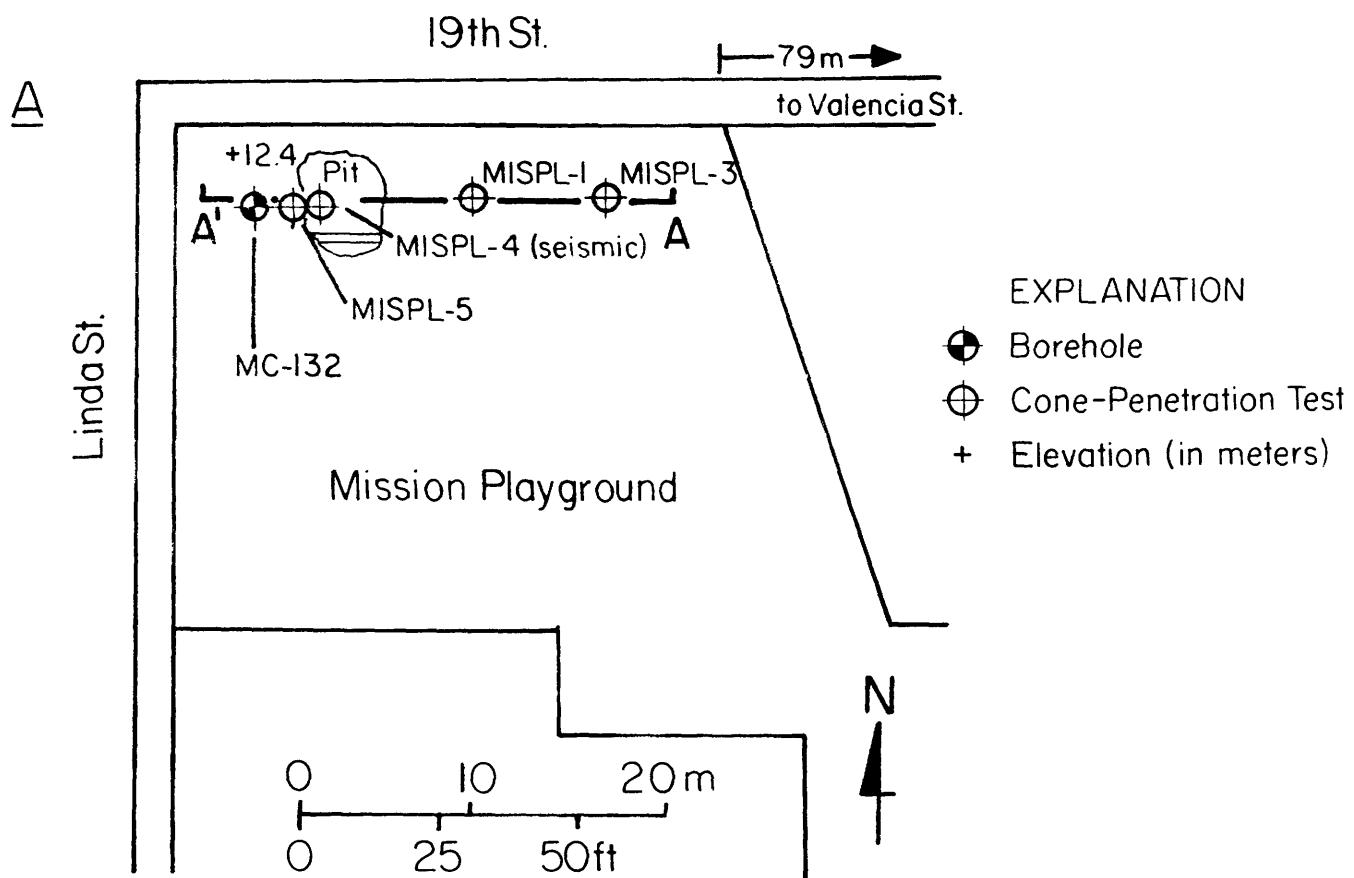
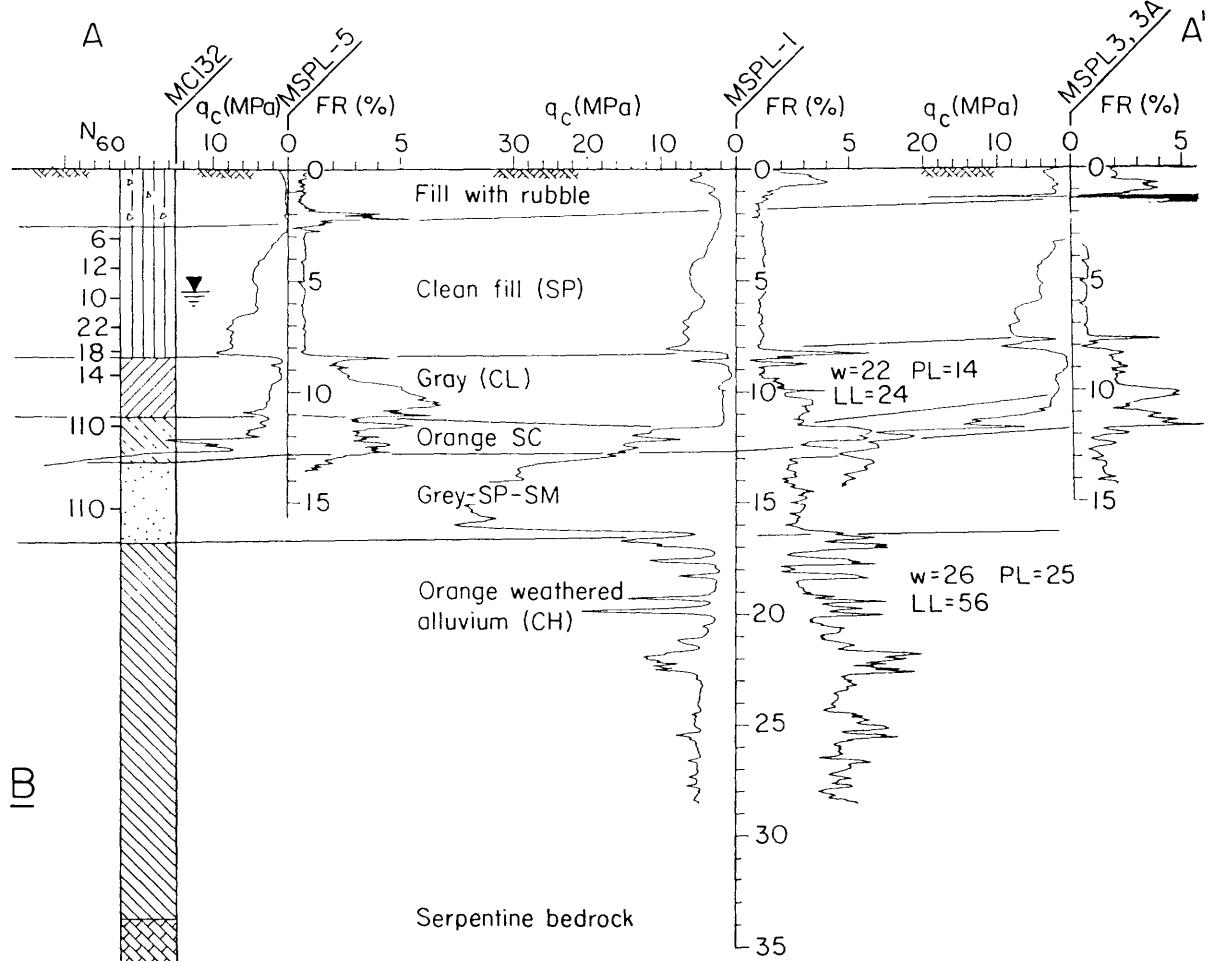
Figure 3.—Schematic map (A) and cross section (B) of Mission Playground site (fig. 1), showing locations of boreholes, cone-penetration tests (CPT's), and soil profile. Soil profile is 19 m long. Depths on cross section are in meters. CPT measurements:  $q_c$ , tip resistance (in megapascals); FR, friction ratio (in percent). Soils are identified by sym-

bols in Unified Soil Classification (American Society for Testing and Materials, 1991b): CH, high-plasticity clay; CL, low-plasticity clay; SC, clayey sand; SM, silty sand; SP, poorly graded sand. LL, liquid limit; PL, plastic limit; w, natural-water content (in percent).

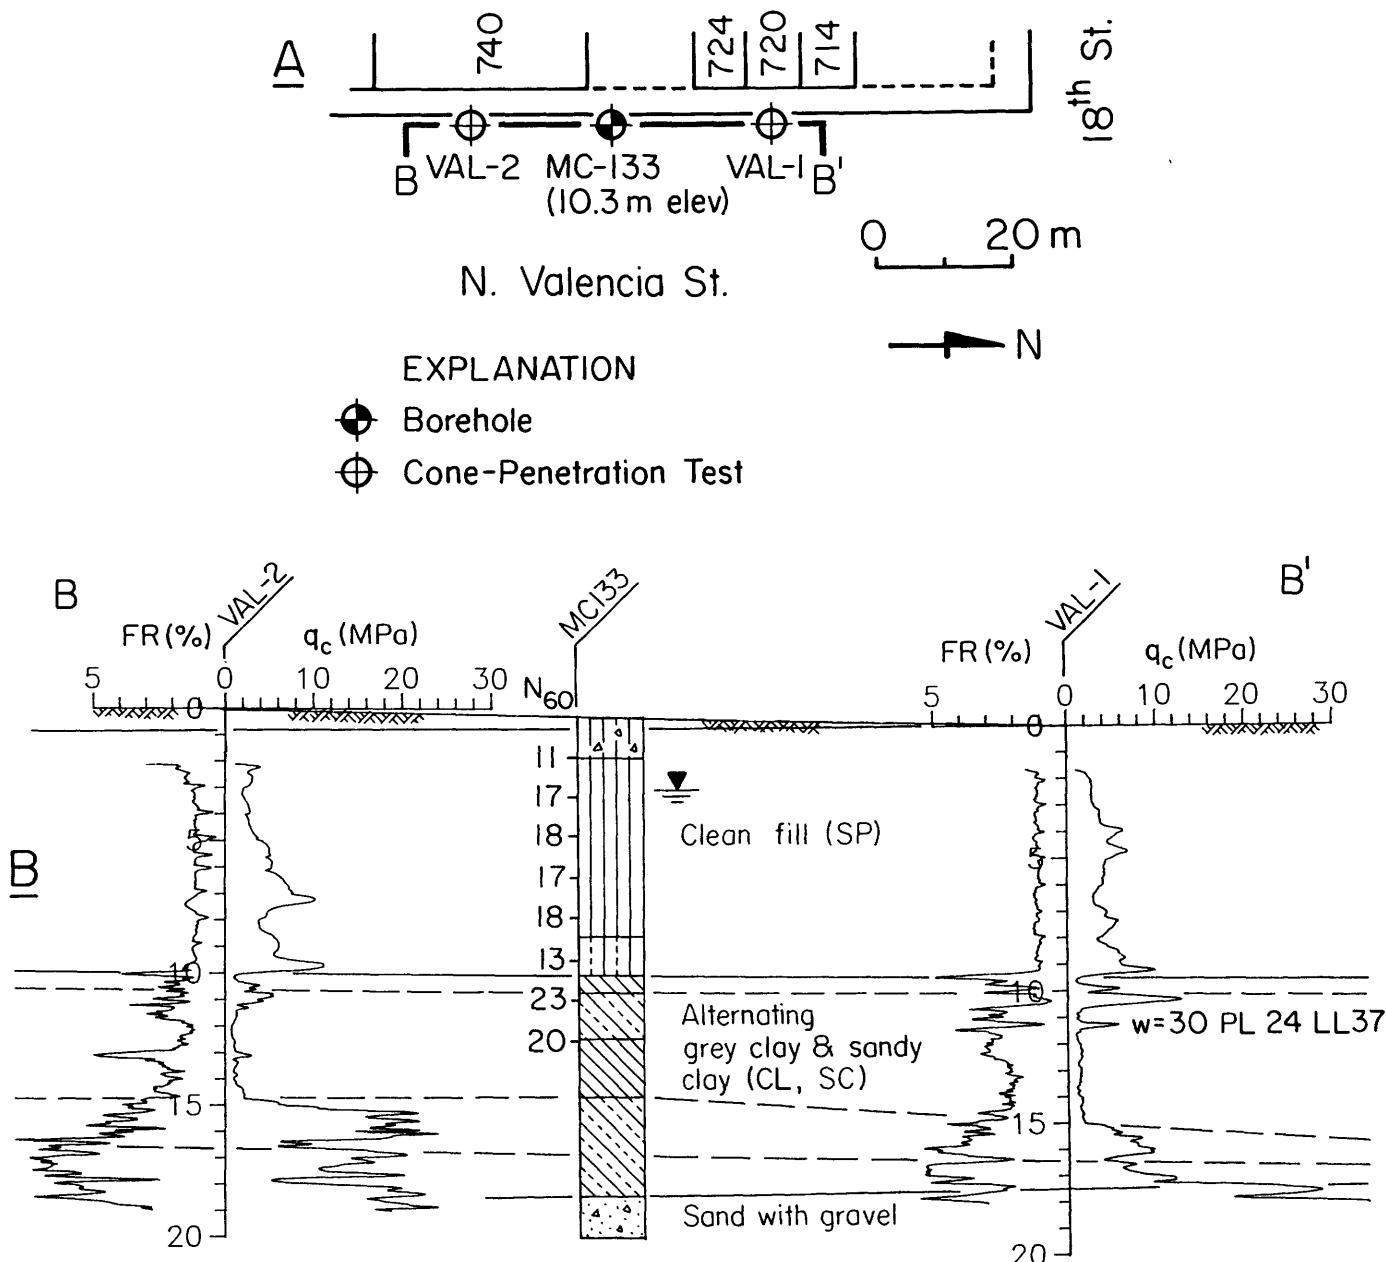
Figure 4.—Schematic map (A) and cross section (B) of Valencia Street site (fig. 1), showing locations of boreholes, cone-penetration tests (CPT's), and soil profile. Soil profile is approximately 55 m long. Depths on cross section are in meters. CPT measurements:  $q_c$ , tip resistance (in megapascals); FR, friction ratio (in percent);  $N_{60}$ , standard-penetration-test blowcount (in blows per foot). Soils are identified by symbols in Unified Soil Classification (American Society for Testing and Materials, 1991b): CL, low-plasticity clay; SC, clayey sand; SP, poorly graded sand. LL, liquid limit; PL, plastic limit; w, natural-water content (in percent).

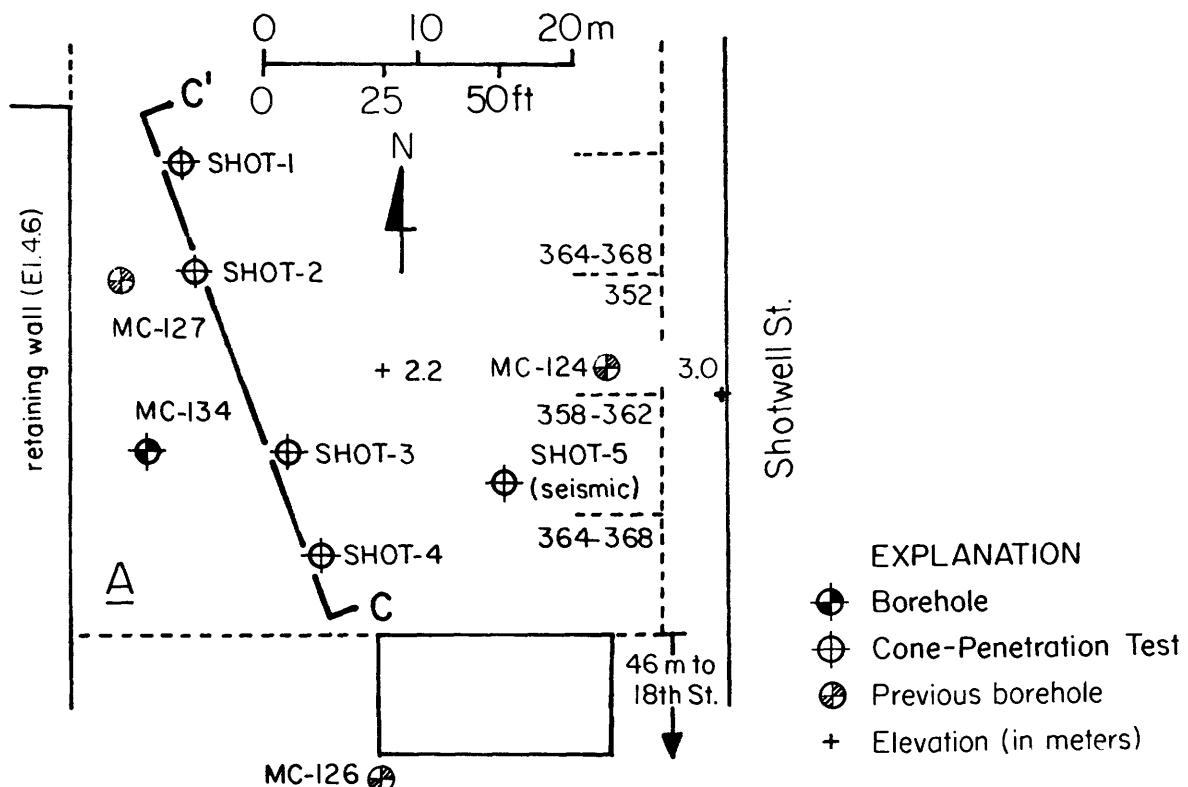
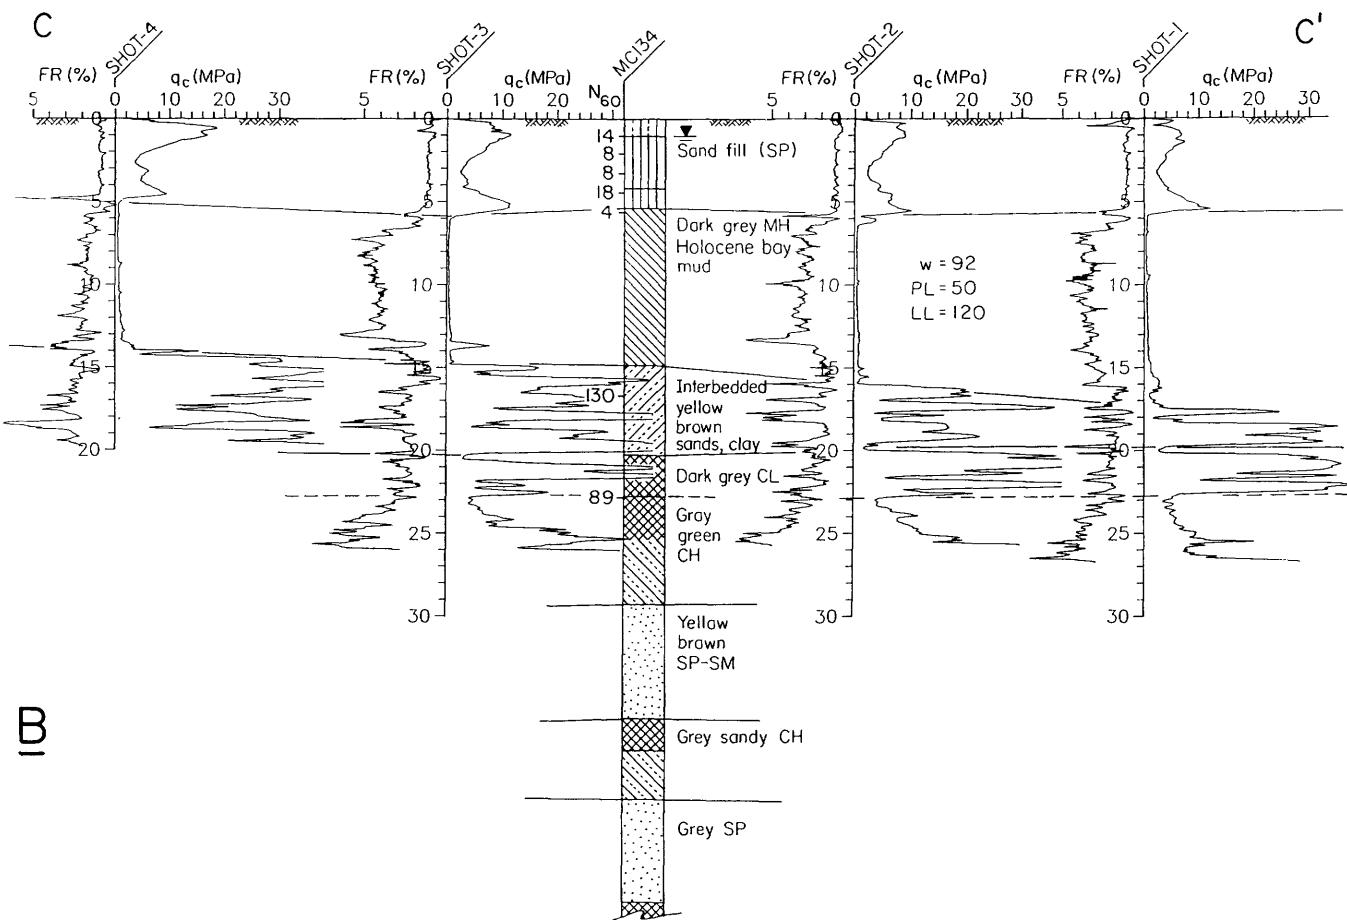
We investigated a site in the Mission District in vacant lots on the west side of Shotwell Street between 17th and 18th Streets. Two- to three-story wood-frame houses had existed at these sites before 1989, but they were damaged by liquefaction during the 1906 earthquake and subsequently removed. Earthquake damage at this site is discussed in more detail in the following subsections. The locations of boreholes and CPT soundings and a soil profile are shown in figures 5A and 5B, respectively.

The existing grade of the lots at the time of our investigation was at about 2.0-m elevation. The upper 0.9 m of sandy fill had been removed, replaced, and compacted with a vibratory roller in 1990. The soil profile (fig. 5B) shows a considerable increase in tip resistance above 2- to 3-m depth, probably owing to surface compaction. The fill averages 5.5 m in depth across the site, slightly decreasing in thickness toward the south. As at the other sites, the fill is clean, poorly graded, fine sand containing less than 2 percent fines. The bottom of the fill is at -2.4-m elevation, slightly above mean sea level and within the

Figure 5.—Schematic map (A) and cross section (B) of Shotwell Street site (fig. 1), showing locations of boreholes, cone penetration tests (CPT's), and soil profile. Soil profile is approximately 30 m long. Depths on cross section are in meters. CPT measurements: qc, tip resistance (in megapascals); FR, friction ratio (in percent);  $N_{60}$ , standard-penetration-test blowcount (in blows per foot). Soils are identified by symbols in Unified Soil Classification (American Society for Testing and Materials, 1991b): CH, high-plasticity clay; CL, low-plasticity clay; SM, silty sand; SP, poorly graded sand. LL, liquid limit; PL, plastic limit; w, natural-water content (in percent).

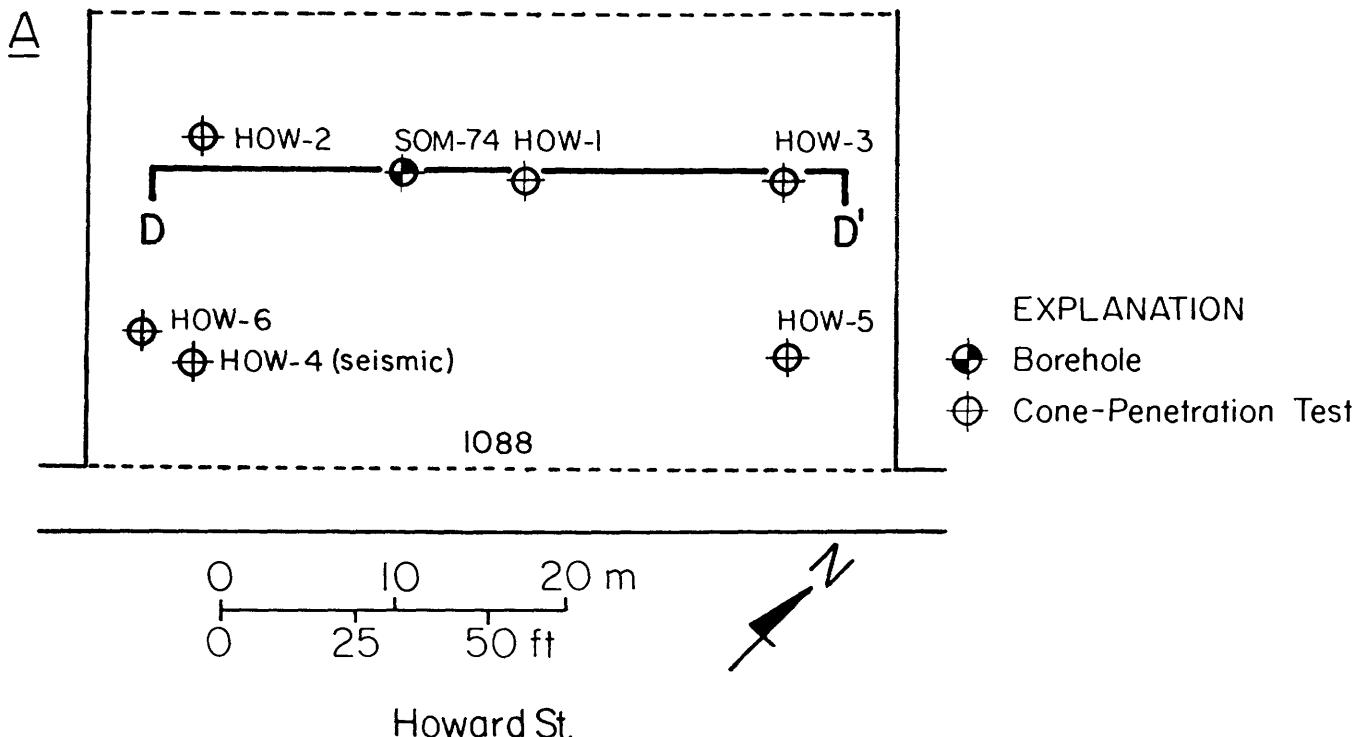
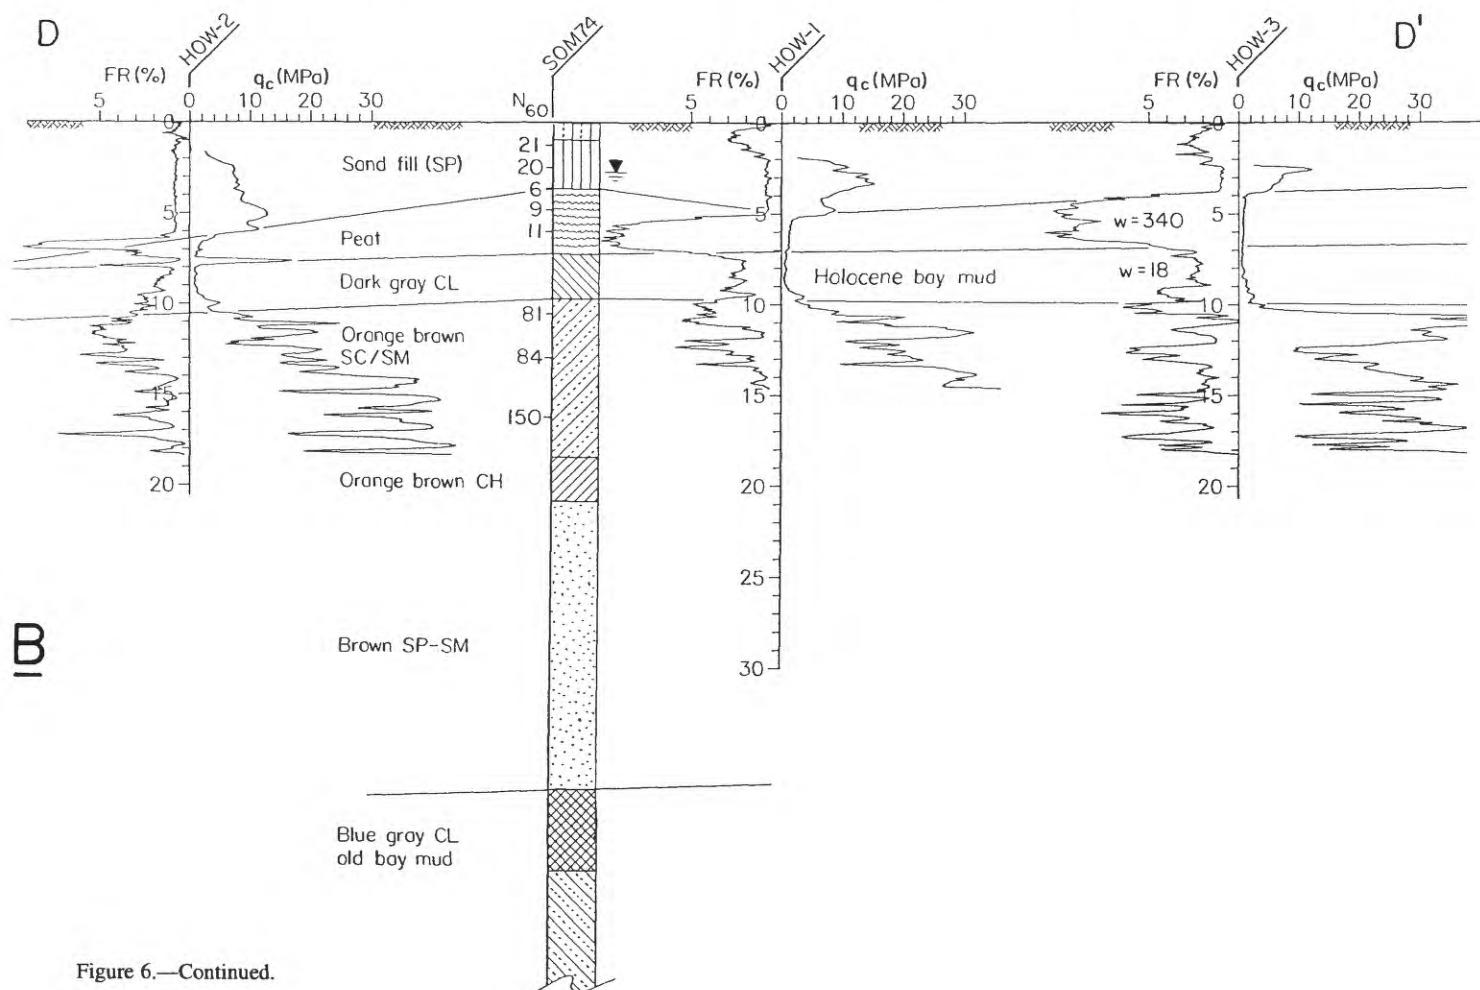
tween 6th and 7th Streets, near the north boundary of a former marsh (fig. 2B). Extensive wavelike deformations of the ground were observed near this site after the 1906 San Francisco earthquake. The locations of boreholes and CPT soundings and a soil profile are shown in figures 6A and 6B, respectively.

sists of easily penetrable sand, gravel, and rubble. The fill below the surface layer is poorly graded sand containing less than 2 percent fines. The fill at this site appears to be somewhat denser than those at the Mission District sites, on the basis of blowcounts and CPT logs. The water table is at 2.7-m depth. There is a liquefiable layer 1 to 3 m thick at this location.

Figure 6.—Schematic map (A) and cross section (B) of Howard Street site (fig. 1), showing locations of boreholes, cone-penetration tests (CPT's), and soil profile. Soil profile is approximately 34 m long. Depths on cross section are in meters. CPT measurements:  $q_c$ , tip resistance (in megapascals); FR, friction ratio (in percent);  $N_{60}$ , standard-penetration-test blowcount (in blows per foot). Soils are identified by symbols in Unified Soil Classification (American Society for Testing and Materials, 1991b): CH, high-plasticity clay; CL, low-plasticity clay; SM, silty sand; SP, poorly graded sand. LL, liquid limit; PL, plastic limit; w, natural-water content (in percent).

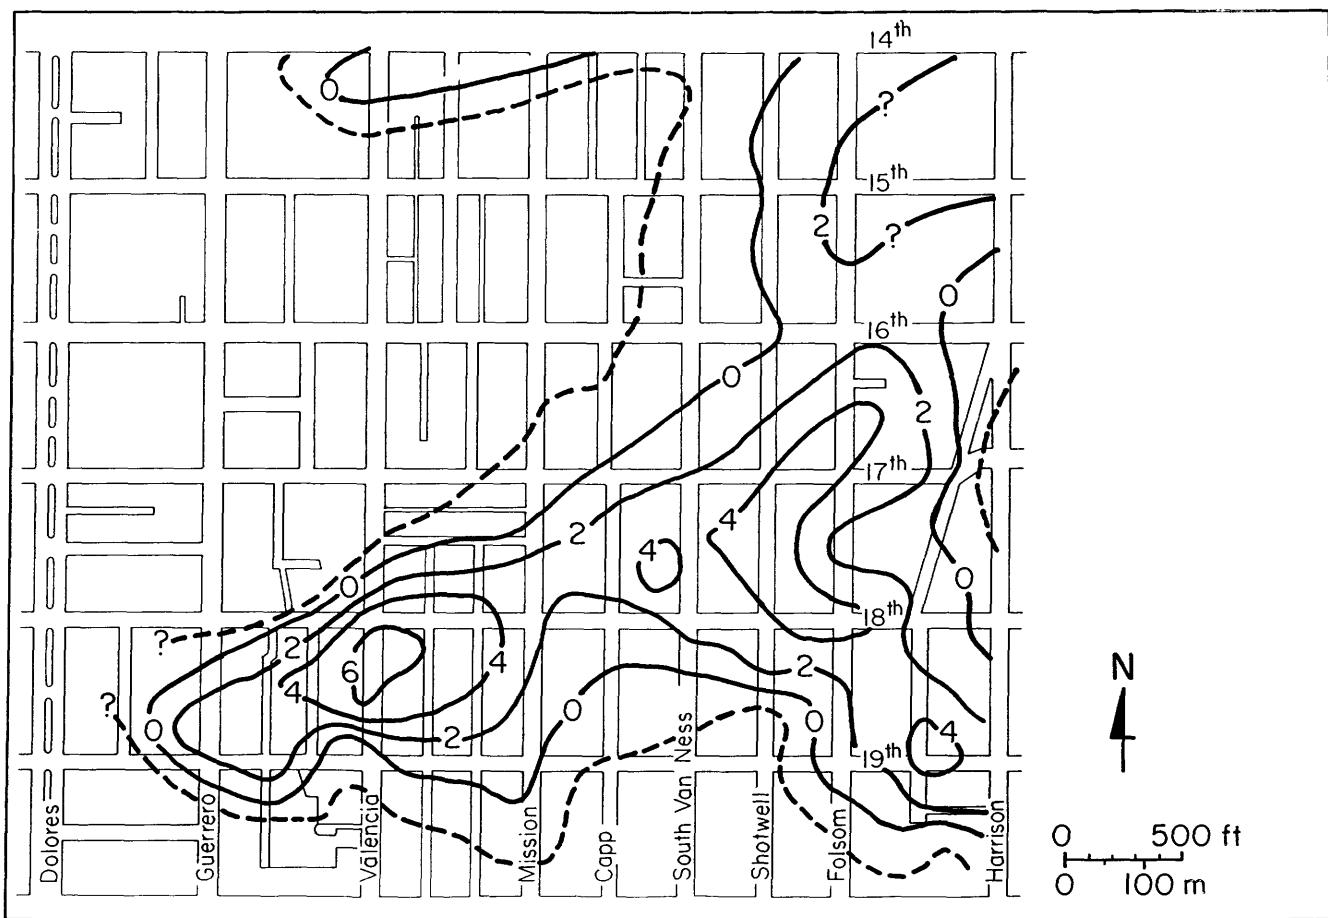
Liquefaction is likely to be most severe in thick layers of submerged fill. In figure 8, 4 to 8 m of submerged fill was observed at both Valencia and Shotwell Streets in former Upper Mission Creek, only 2 to 3 m under Mission Street near 18th Street, and as much as 4 m in former

Figure 8.—Mission District study area, showing thickness of submerged fill (solid contours; interval, 2 m). 0-m contour, which indicates where elevation of water table is at base of fill, represents a theoretical boundary between regions where liquefaction can and cannot occur. Upper-bound

contour (dashed), which delimits area where ground-water level is within 2 m of base of fill, is proposed as a reasonable limit on maximum extent of potential hazard in case of nonuniform changes in fill thickness or unpredictable variations in ground-water level.

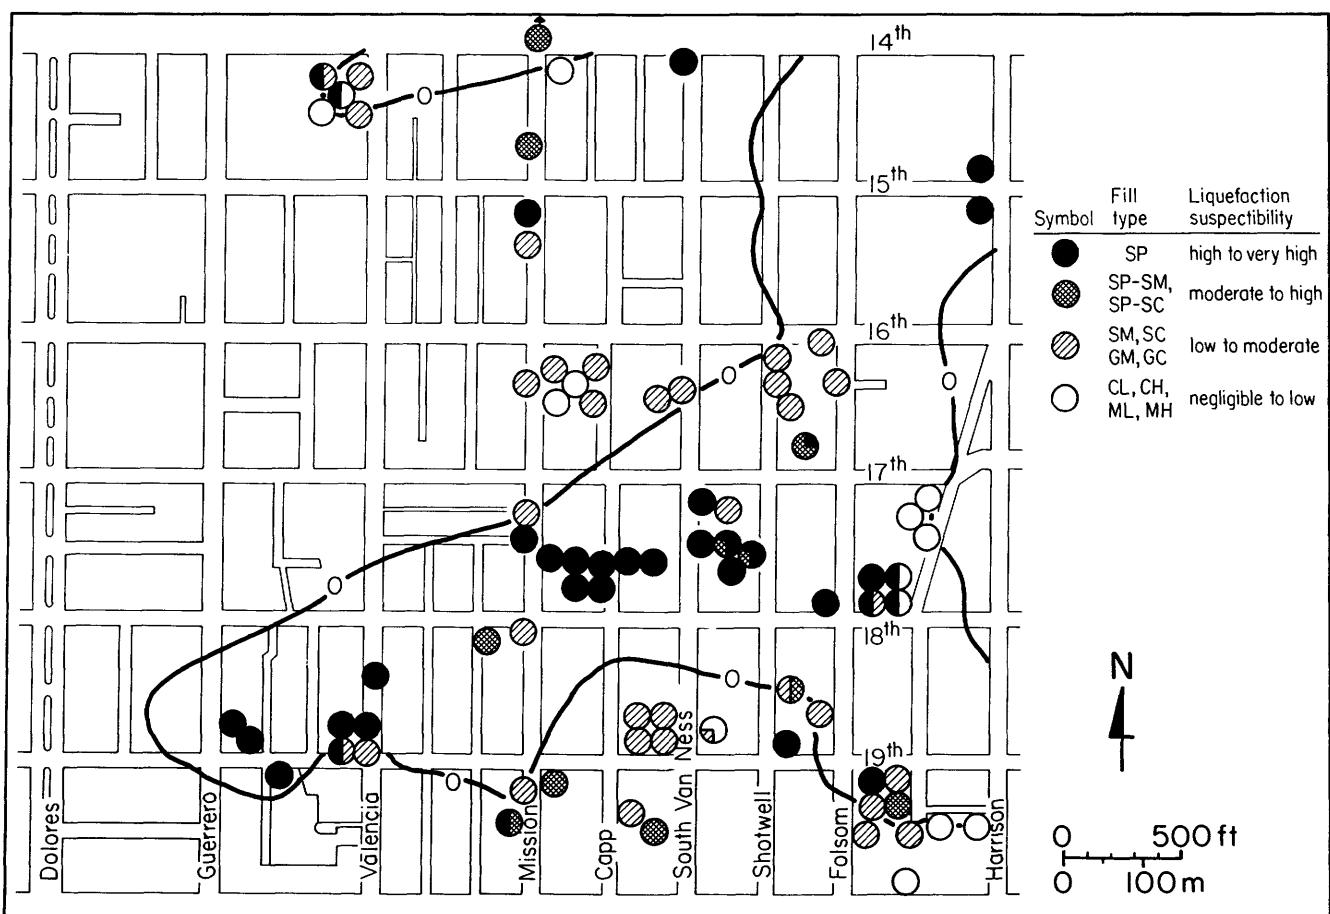
Soil types in the Mission District are classified with respect to liquefaction susceptibility in figure 9. Highly liquefiable soils are present along the axis of Upper Mis-

Figure 9.—Mission District study area, showing soil characteristics and liquefaction susceptibility of submerged fill. 0-m contour marks boundary between areas of submerged fill and unsaturated fill, as shown in figure 8. Shaded circles indicate classification of fills based on data from boreholes or cone-penetration-test soundings at each location. Where submerged fill occurs (within bounded area), shading indicates only soil types below water table; where there is no submerged fill below water table or borehole terminated above water table, shading indicates only soil type closest to base of fill. Soils are identified by symbols in Unified Soil Classification (American Society for Testing and Materials, 1991b): CH, high-plasticity clay; CL, low-plasticity clay; GC, clayey gravel; GM, silty gravel; MH, high-plasticity silt; ML, low-plasticity silt; SC, clayey sand; SM, silty sand; SP, poorly graded sand. Clays and silts consist of materials of

which more than 50 weight percent passes a No. 200 sieve. Proportion of circle with a particular shading reflects approximate proportion of corresponding soil type below water table at that location. In general, liquefaction susceptibility of soils containing 20 to 50 weight percent fines is considered to be low, and that of fairly clean soils containing less than 20 weight percent fines to be moderate. This classification is considered valid for San Francisco soils on the basis of observations that the fines in these soils (particles smaller than 0.075 mm) are typically clay minerals and that relatively few soil samples contain much low-plasticity or cohesionless silt. Although soils containing more than 20 weight percent fines have been observed to liquefy during earthquakes, such occurrences have been confined to regions where low-plasticity silts are a common constituent of fines (Cao and Law, 1991).

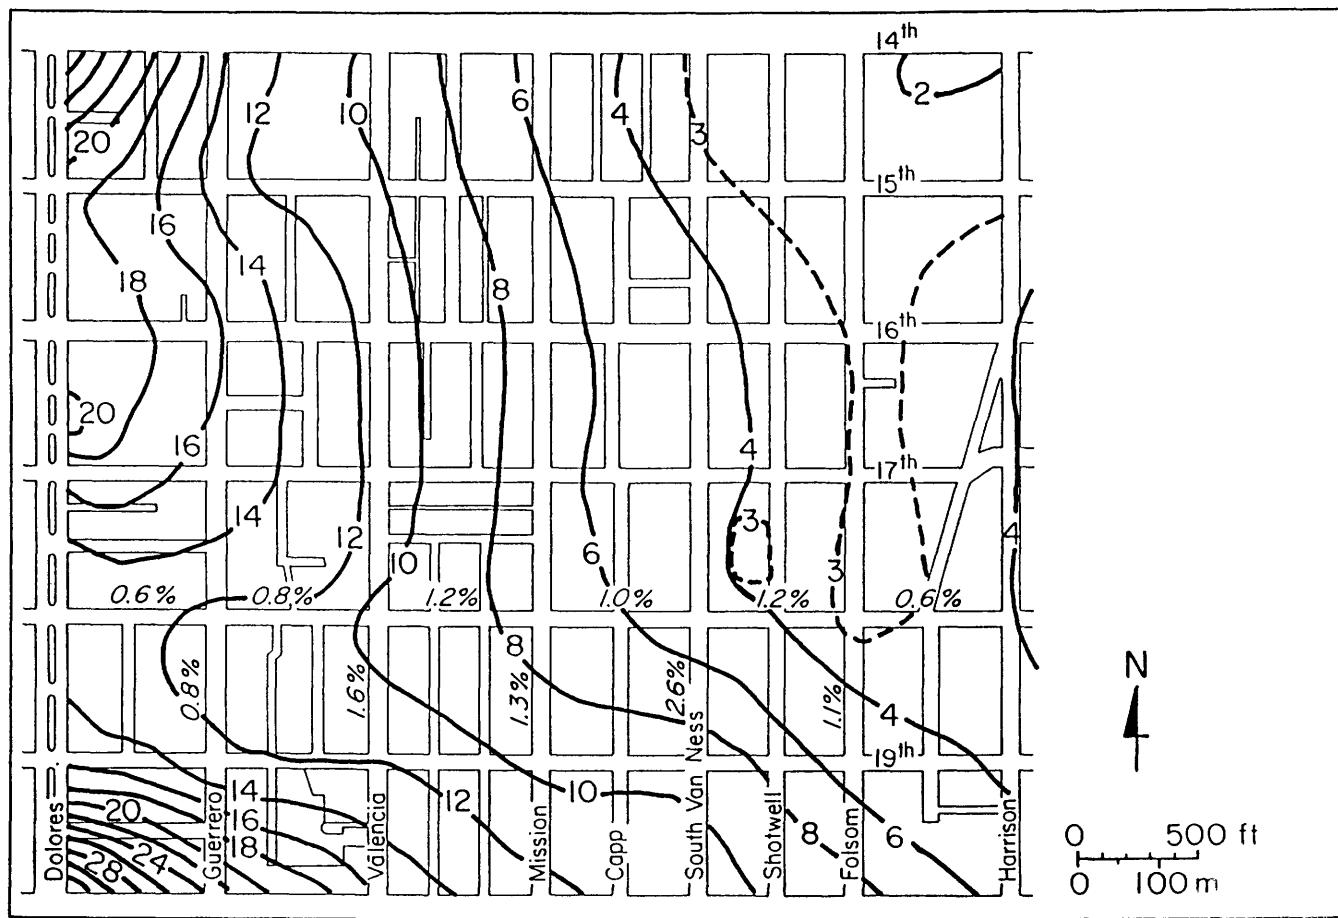
Current surface contours in the Mission District are mapped in figure 10. The ground surface in the study area has gradients toward the east of 2.5 percent or less; steeper slopes occur along bedrock spurs at 20th and Dolores Streets and at 14th and Dolores Streets. Between 17th and 19th Streets, the former Upper Mission Creek ravine is shown by the looping of contours between Dolores and Valencia Streets; below Valencia Street, this ravine is not apparent. Along 18th Street from Valencia Street to South Van Ness Avenue, the typical gradient of the filled ravine is 1.1 percent. Uphill, from Valencia to Guerrero Streets, the gradient of 18th Street decreases to 0.6 percent. The area of Lower Mission Creek in the vicinity of Folsom Street between 14th and 18th Streets is nearly flat.

Figure 10.—Mission District study area, showing surface elevation (solid contours; interval, 2 m) and intermediate contour (dashed) relative to San Francisco City Datum. Contours are based on survey data from major

street intersections at approximately 190-m spacing collected by San Francisco Department of Public Works in 1973 and 1991. Italic numbers, average street gradient (in percent).

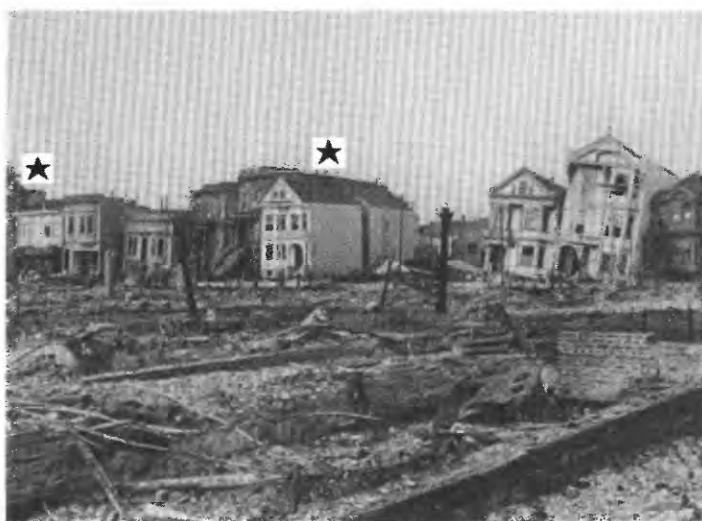
Figure 13.—Buildings on east side of South Van Ness Avenue between 17th and 18th Streets after 1906 San Francisco earthquake and fire. Stars denote structures still standing in 1993. Two buildings to left of center sustained cripplewall failure and were shifted to left (northward) off their foundations. As a result of these failures, they are tilted to right and away from street. Rubble from another building that collapsed into an adjacent vacant lot is visible in center. View from Capp and 18th Streets (see fig. 9 for location).

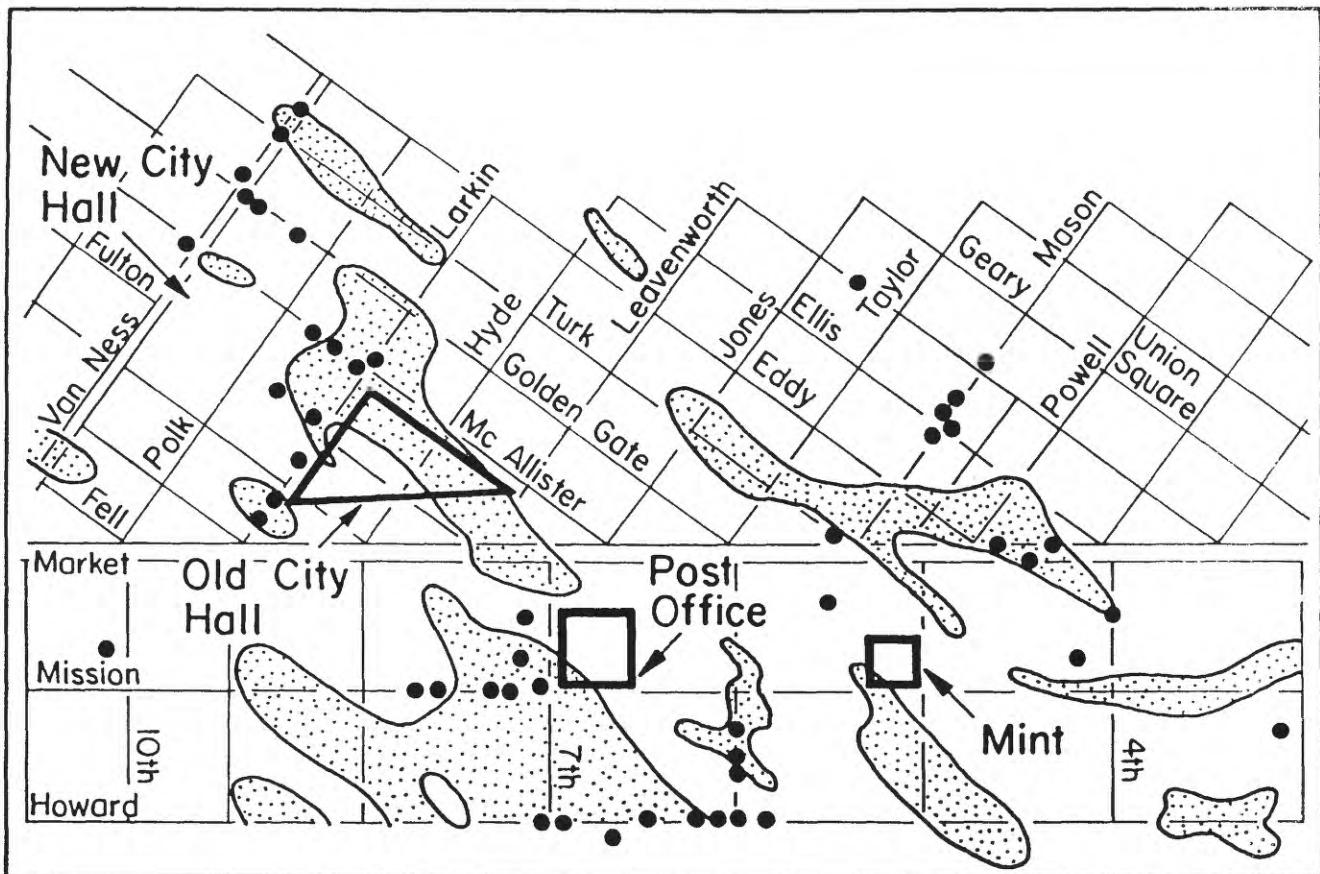
In the South of Market area, figure 23 agrees substantially with figure 17 on the locations of zones of submerged fill in former Sullivan Marsh but also indicates other small, deep fill areas. North of Market Street, the broadest depressions were observed under the Civic Center between Fulton, Golden Gate, Polk, and Market Streets and between Turk, Ellis, Jones, and Market Streets. Ex-

Of the 32 pipeline breaks near Market Street that were located outside former Sullivan Marsh, 16, or 50 percent, occurred in or adjacent to the zones of deep fill (shaded areas, fig. 23). Deep, loose fills may pose a seismic hazard due to consolidation and settlement in response to prolonged shaking. Moreover, subsurface evidence suggests that submerged fills were present at sites near Market Street, and so liquefaction could also have affected ground movement in these areas. These submerged fills are probably no more than 2 m thick and are overlain by 4 to 10 m of unsaturated fill that would have substantially damped and restricted any movement of the liquefiable layer.

Figure 23.—Vicinity of Market Street between Third and 11th Streets, showing locations of zones of probable submerged fill (stippled areas), based on interpretation of historical topography (U.S. Coast Survey, 1853, 1857), and broken water mains (dots). South half of map overlaps with area of figures 17 through 21, 24, and 27.

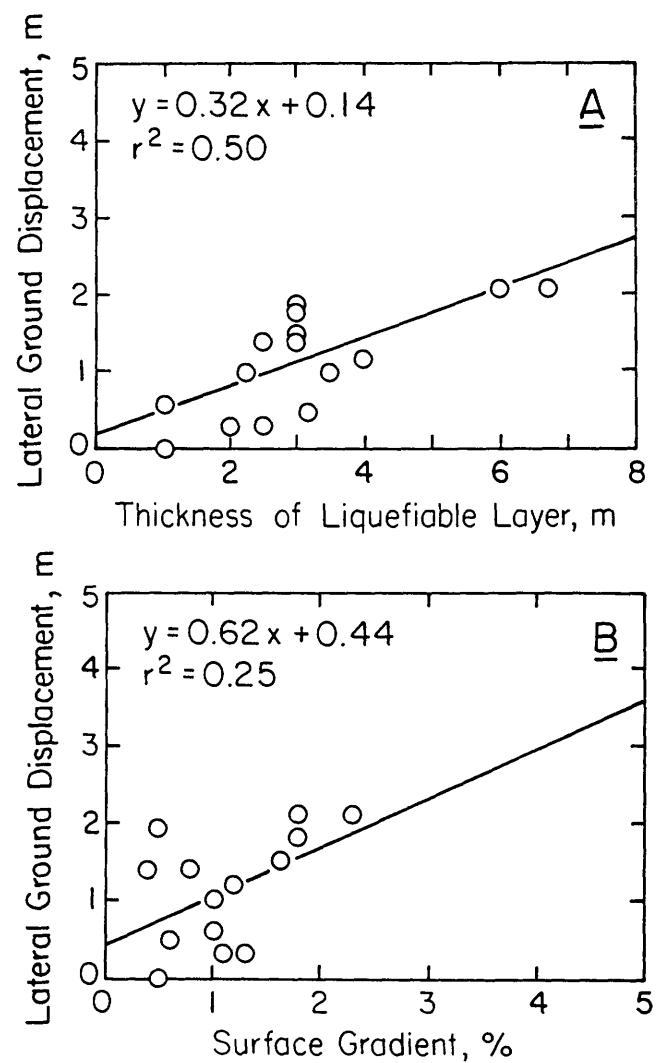
As shown in figure 25A, a reasonable fit exists for the plot of lateral ground displacement versus submerged-fill thickness. About half the variation in displacement data is explainable by the thickness of liquefiable soils ( $r^2=0.50$ ). Lateral displacement is about 30 percent of the thickness of submerged fill, and most data are bounded by ratios corresponding to 15 to 45 percent of submerged-fill thickness.

Surface gradient as a function of lateral ground displacement is plotted in figure 25B. Consistent with observations by the U.S. National Research Council (1985), surface slopes of lateral-spread zones range from 0.5 to 2.5 percent. The best linear fit of the data has  $r^2=0.25$ , which represents a poor correlation for explaining the variation in observations. Single-variable and multiple linear regressions involving surface-layer thickness did not improve the coefficient of determination achieved by regression with only the thickness of liquefiable fill.

The data of Hamada (1992a, b) indicate that lateral spreads in Japan average 125 percent of liquefied thickness, about 4 times greater than the displacement at San Francisco sites plotted in figure 25A. The models of Bartlett and Youd (1992), who included data from the Mission District and South of Market area in their study, significantly overpredict lateral displacement in 1906 by a factor of 5 to 10.

Figure 25.—Linear regressions of thickness of liquefiable layer (A) and surface gradient (B) versus lateral ground displacement in 1906 San Francisco earthquake.

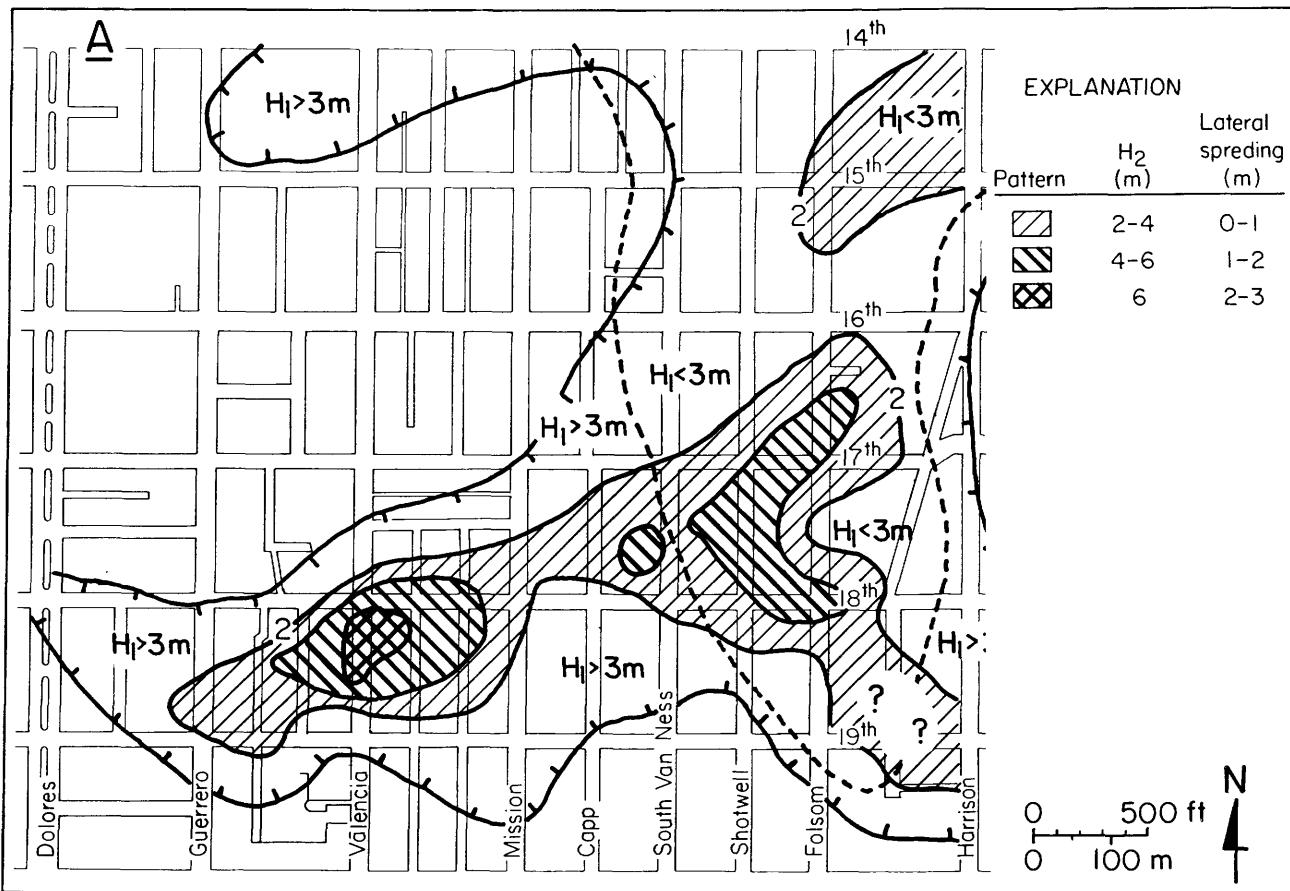
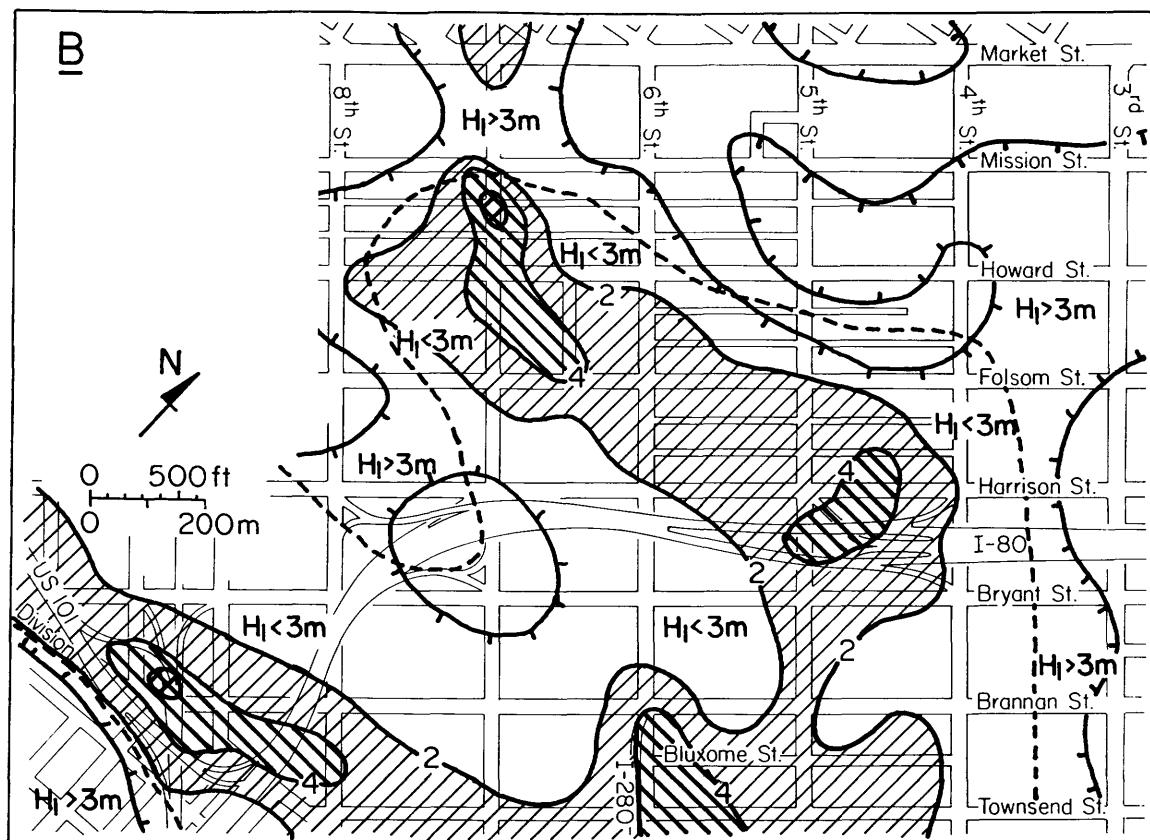
A remarkably consistent spatial correlation exists between the zones of thickest liquefiable fill and the areas of most severe damage in the 1906 and 1989 earthquakes. Recognizing the close correlation between the thickness of liquefiable fill and the potential severity of such damage, we present liquefaction-susceptibility maps of the Mission District and South of Market area in figures 26A and 26B, respectively. In each of these figures, the thick-

The limits of the liquefaction zone in the Mission District shown in figure 26A approximately coincide with the delineations of liquefaction zones in previous studies (for example, Youd and Hoose, 1978; O'Rourke and others, 1992a). In contrast, the upper bound of the liquefaction zone in the South of Market area shown in figure 26B includes dune depression fills that were not recognized in previous studies and that may increase the extent of the potential hazard.

In the course of our study, we identified other factors that reduce the liquefaction susceptibility in areas of submerged fill. Specifically, any hazard assessment must include consideration of the fines content and plasticity of fill materials. In particular, figure 26 shows that severe liquefaction is unlikely in the vicinity of 19th Street between Folsom and Harrison Streets, despite the presence of submerged fill more than 2 to 4 m thick. Boreholes in this area indicate that the fill has a relatively high fines content, which substantially reduces its liquefaction susceptibility. Similarly, the hazard in other areas may be low because of fill characteristics. Figures 9 and 18 can be used to make preliminary estimates of soil types and their influence on liquefaction susceptibility. We advise caution, however, because liquefiable-sand pockets and seams may occur in the predominantly fine grained fill. Figure 26, supplemented by figures 9 and 18, would best be used to delineate hazards in a general way for planning purposes, whereas site-specific investigations would be needed to provide detailed information for engineering and design decisions.

Figure 26.—Liquefaction-susceptibility maps of the Mission District (A) and South of Market area (B), showing areas of highest potential for damage from lateral spreading, based on submerged-fill thickness.  $H_1$ , thickness of nonliquefiable surface layer;  $H_2$ , thickness of liquefiable deposit. Upper-bound contour (dashed), which delimits area where ground-water level is within 2 m of base of fill, is proposed as a reasonable limit on maximum extent of potential hazard in case of nonuniform changes in fill thickness or unpredictable variations in ground-water level. Patterned

areas, where  $H_2 > 2$  m, are associated with estimates of expected lateral spreading for an event similar in magnitude to 1906 San Francisco earthquake. Dashed line, contour of  $H_1 = 3$  m; in areas where  $H_1 < 3$  m, liquefaction-induced damage is more likely to be observed during smaller events, such as 1989 Loma Prieta earthquake. In figure 26A, fill in area of 19th Street between Folsom and Harrison Streets contains much clay, which reduces its liquefaction susceptibility.

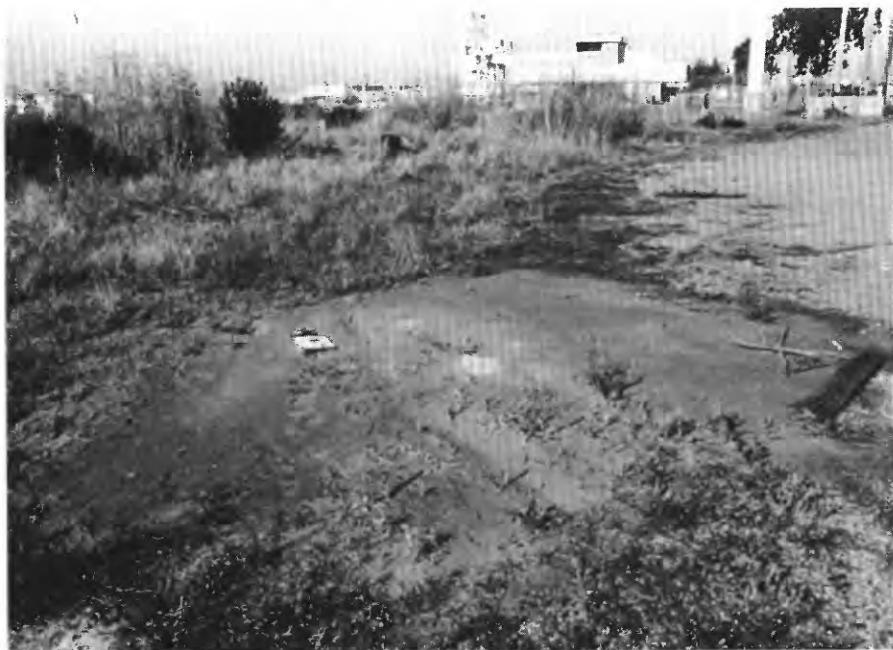
Figure 3.—Sand boils on undeveloped land at end of Harbor Way Road in the Port of Richmond.
