# The Loma Prieta, California, Earthquake of October 17, 1989— Liquefaction

THOMAS L. HOLZER, *Editor*

STRONG GROUND MOTION AND GROUND FAILURE

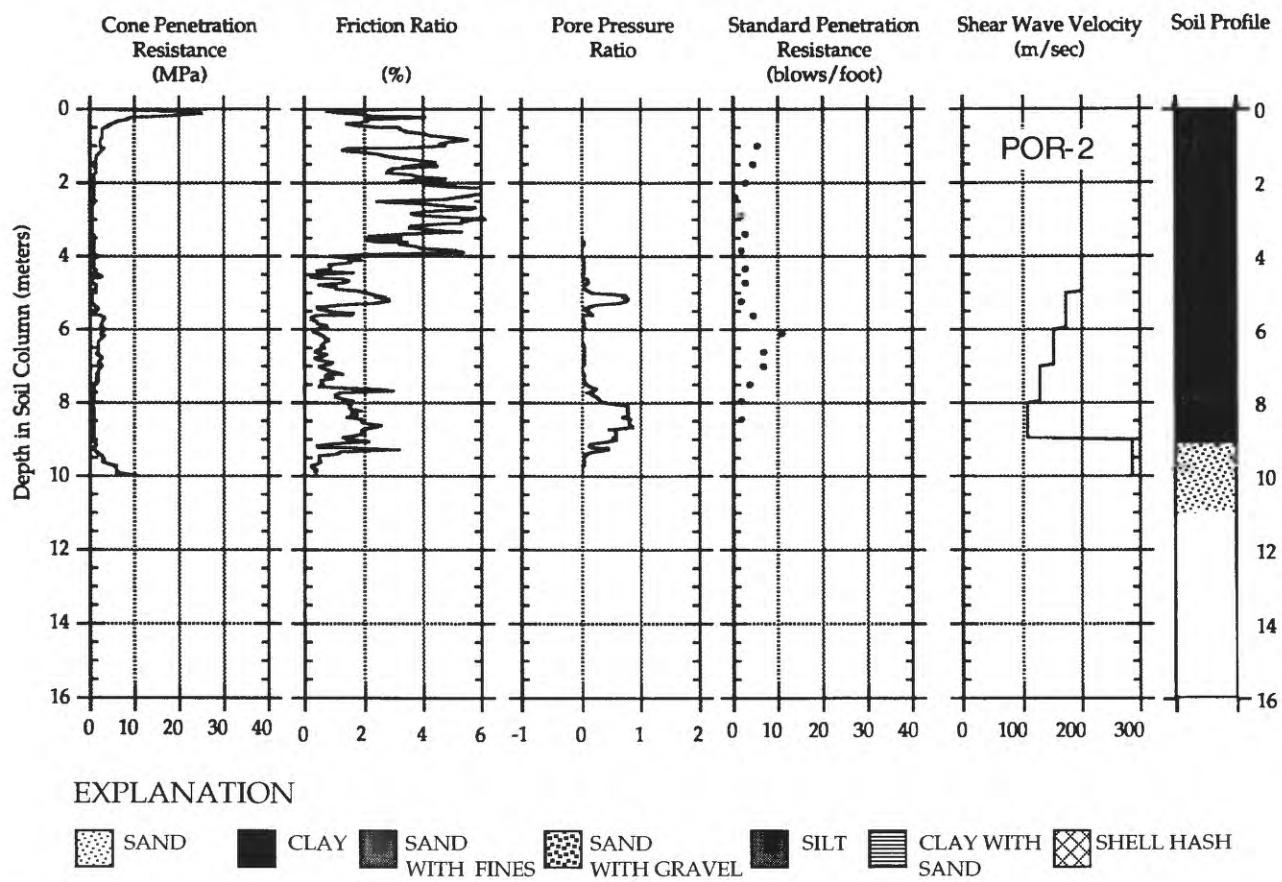
silty sand to 0.8-m depth; oxidized tan-brown silty sand to 1.8-m depth; and oxidized, tan-brown sandy clay to reduced sandy clay to 4.1-m depth (fig. 4). The water table was approximately at a depth of 2.5-m during sampling. This section has low  $q_c$  values (approx 1–3 MPa), FR values greater than 3 percent, minor pore-pressure generation, and  $N$  values ranging from 1 to 6 blows/ft.

Below this section, at 4.1- to 7.8-m depth, is a hydraulic-fill layer of olive-gray fine-silty sand containing shell fragments. This layer almost certainly was responsible for

the observed liquefaction at the surface, and surface sand-boil material is identical to SPT samples of this layer. This layer has extremely low  $q_c$  values (1-3 MPa), aver-

age FR values of 0.3 to 1.0 percent, and minor pore-pressure generation during cone penetration, and  $N$  values of 2 to 11 blows/ft but typically 2 to 5 blows/ft when

Figure 4.—Log of borehole POR-2 in fill deposits at Port of Richmond study site (see fig. 2 for locations).

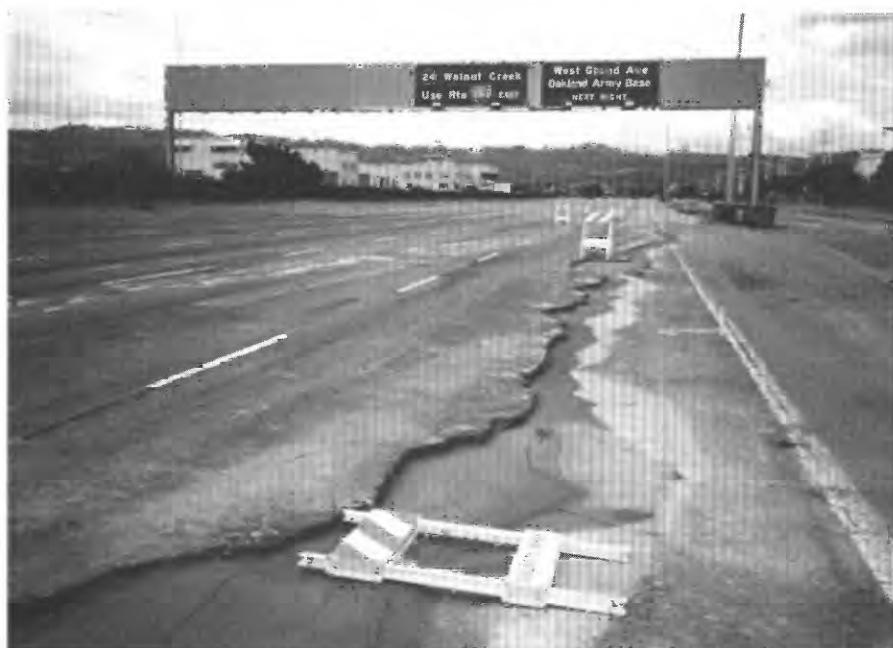
Settlements of the mole and the elevated structures of Interstate Highway 580 and West Grand Avenue were severe, resulting, at each site, in pavement collapse and open fissures, as much as 0.3 m wide, at the soil-structure interface. The approach mole also settled below the bridge- and ramp-structure road level by as much a 0.5 m. The fissures and uneven pavement surface interrupted ground transportation in the interchange areas after the earthquake. Soil liquefaction was also observed adjacent to the piers of elevated-highway distribution structures (fig. 8)

Figure 6.—Fissure in pavement caused by settlement in rightmost eastbound lane of Interstate Highway 80 west of San Francisco-Oakland Bay Bridge Toll Plaza administration building (visible in distance).

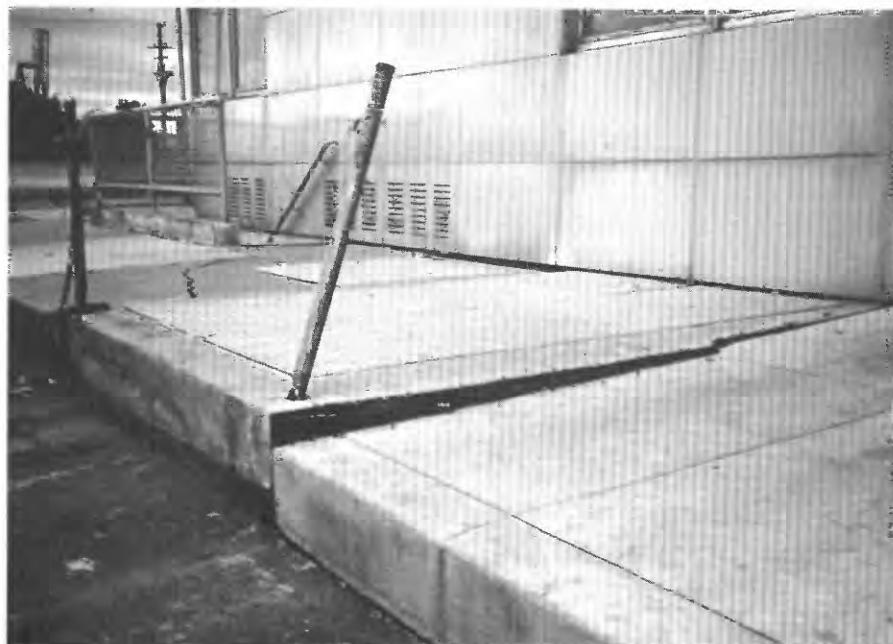
Figure 7.—Settlement at the east side of the San Francisco-Oakland Bay Bridge Toll Plaza administration building.

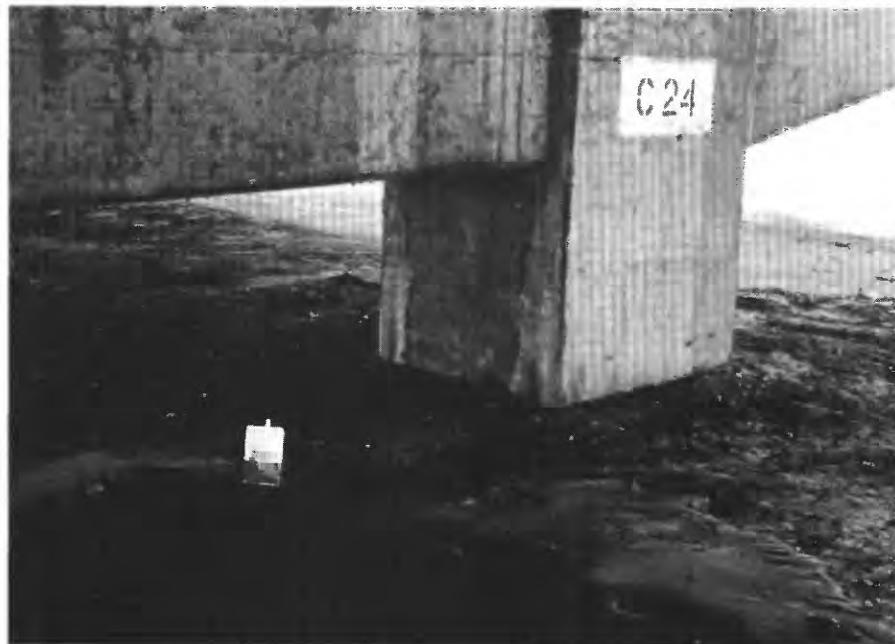
Figure 8.—Sand boils beneath elevated West Grand Avenue distribution structure adjacent to Interstate Highway 80 east of San Francisco Oakland Bay Bridge Toll Plaza.

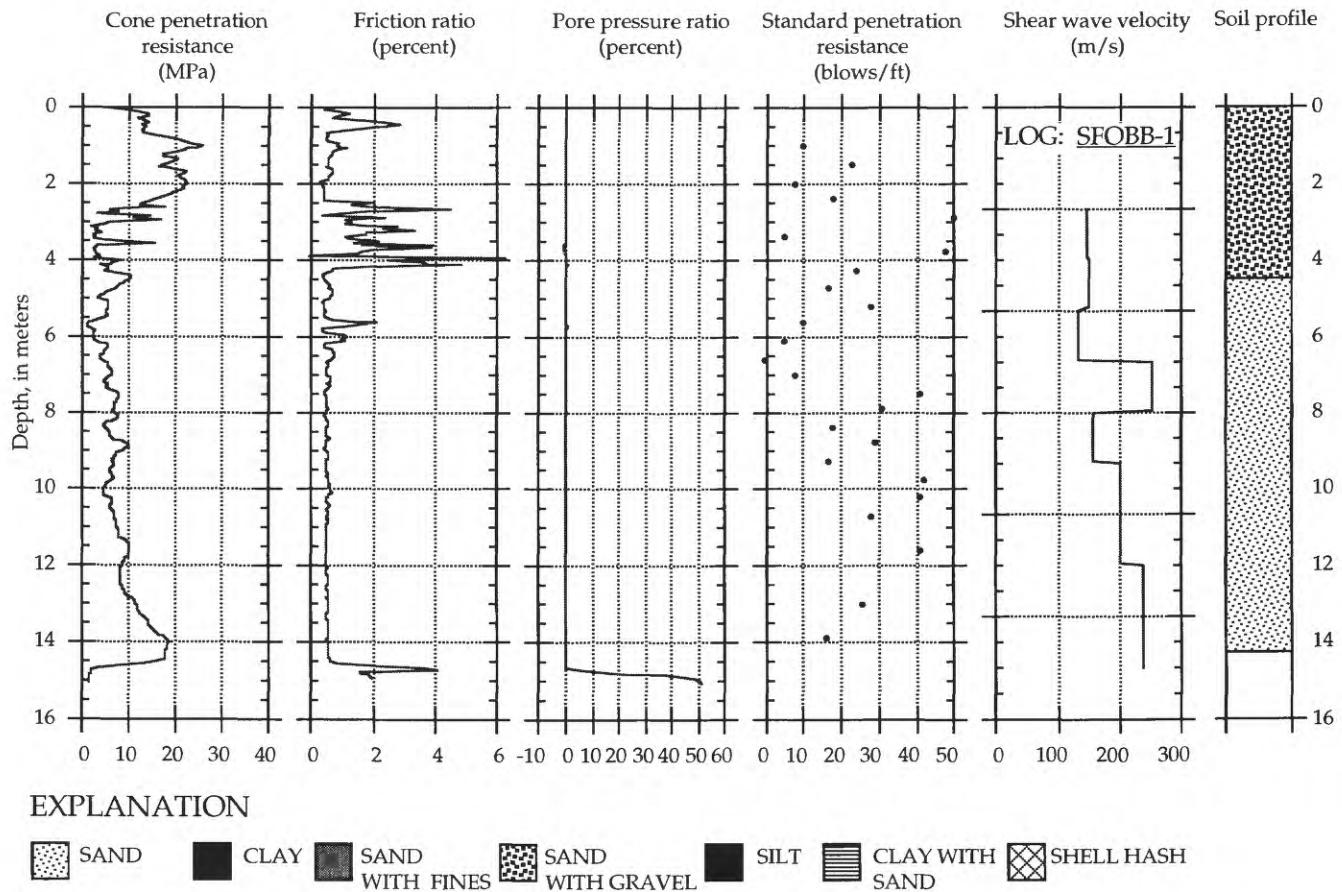
The log of borehole SFOBB-1 (fig. 9) was taken at the easternmost end of the Toll Plaza parking lot. This log

indicates essentially no piezocone pore-pressure generation during cone penetration until bay mud was reached at 15-m depth. The log is marked by a moderately dense surface crust between 0- and 2.8-m depth, followed by an apparently interbedded sequence of cohesionless silty sand and cohesive clay to 4.5-m depth, as noted by the local variations in FR and  $q_c$  values. The water table during sampling was in the upper part of the section at approximately 2-m depth. Between 4.5- and 7.5-m lies cohesionless material with low  $q_c$  values averaging 5 MPa and  $N$  values of typically 5 to 17 blows/ft, with a maximum  $N$  value of 28 blows/ft at 5.2-m and a minimum  $N$  value of 0

Figure 9.—Log of borehole SFOBB-1 on east shoreline of San Francisco-Oakland Bay Bridge mole (see fig. 5 for location).

blows/ft (drill rod and hammer sank under their own weight) at 6.6-m depth. This layer appears to have been responsible for the observed liquefaction, on the basis of both in-place testing and correlation with surface sand-boil material.

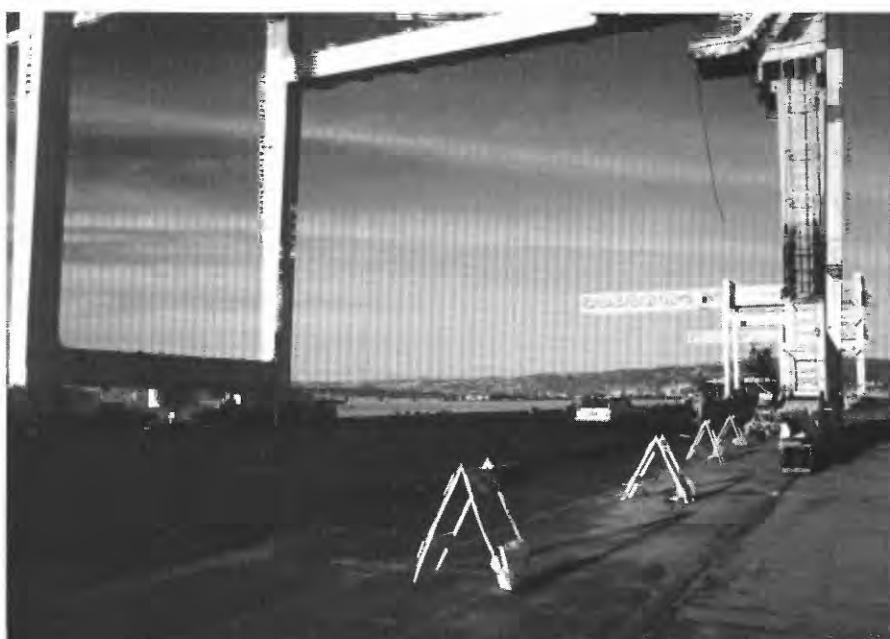
Figure 11.—Wharf of Port of Oakland's Marine Container Terminal at Seventh Street (viewed from Berth 37), showing shipping-container cranes, damaged pavement, and extruded sand.

36 and 37. We note that evidence of liquefaction of the subbase material appears to have extended across much of the entire western part of the Marine Container Terminal, as evidenced by settlement, sand boils, and tension cracking of the asphalt. The study sites were selected for ease of access, not because of the severity of liquefaction damage, except at borehole POO7-3, where liquefaction was not observed. These sites typically have a resistant surface layer in the upper 3 to 4 m, with  $q_c$  values typically 25 to 35 MPa and  $N$  values of 25 to 36 blows/ft. The water table within this layer averages approximately 2- to 2.3-m depth and fluctuates with tidal action. Below this surface layer, the fill consists of looser deposits of fine marine sand with  $q_c$  values of 5 to 15 MPa and  $N$  values of 10 to 25 blows/ft. Liquefaction appears to have occurred in the materials between 4- and 8-m depth in borehole POO7-2, on the basis of correlations of SPT samples with surface sand-boil material recovered. Borehole POO7-3 is characterized by  $q_c$  values greater than 10 MPa and  $N$  values greater than 21 for the entire submerged soil profile, except for a muddy-sand unit between 5- and 7-m depth.

As a result of widespread damage to the battered piles, they have been replaced by the Port of Oakland with vertical piles that are designed to provide lateral flexibility during earthquake loading. The pile-supported wharf deck has also been extended inboard, with additional vertical piles to provide improved support for the inboard crane rails. Stone columns were installed through the sand dike fill to limit deformations of the dike during future earthquakes.

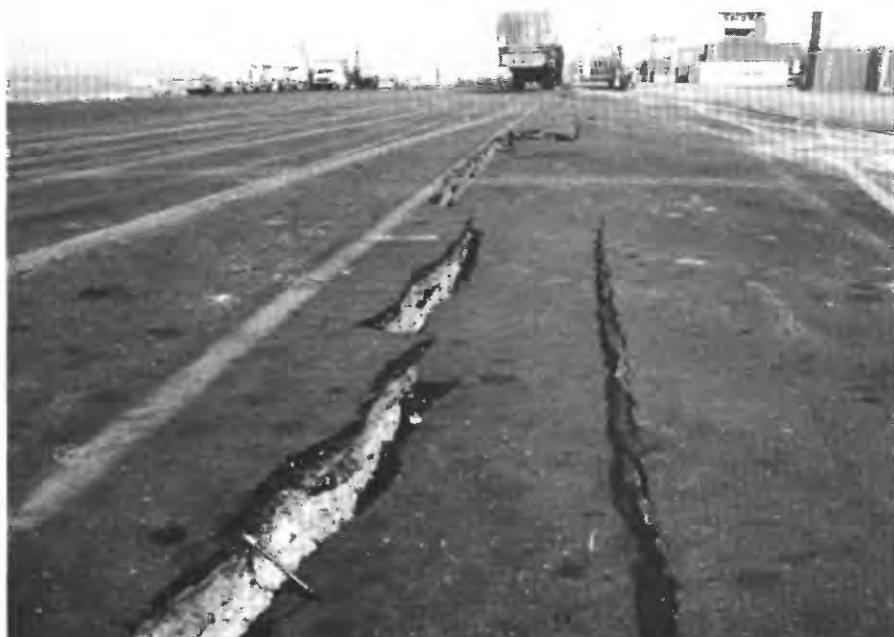
Figure 12.—Closeup of damaged pavement near boreholes POO7-5 and POO7-6 at Port of Oakland Berths 36 and 37 (see fig. 5 for locations), showing differential settlement, open fissures, and lateral spreading.

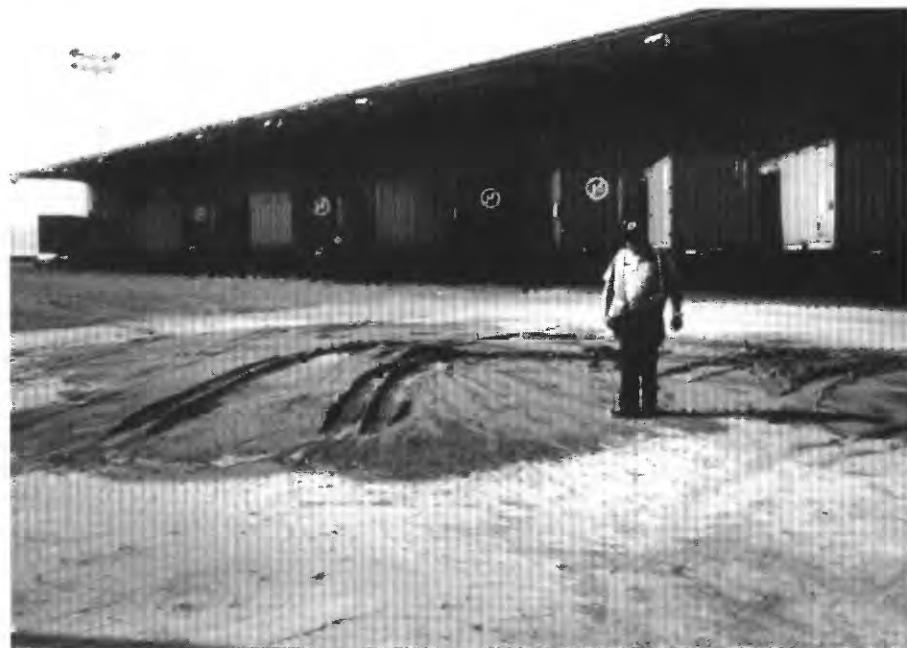
Figure 13.—Sand boil near borehole POO7-1 at Port of Oakland Berth 38 and Port View Park (see fig. 5 for locations).

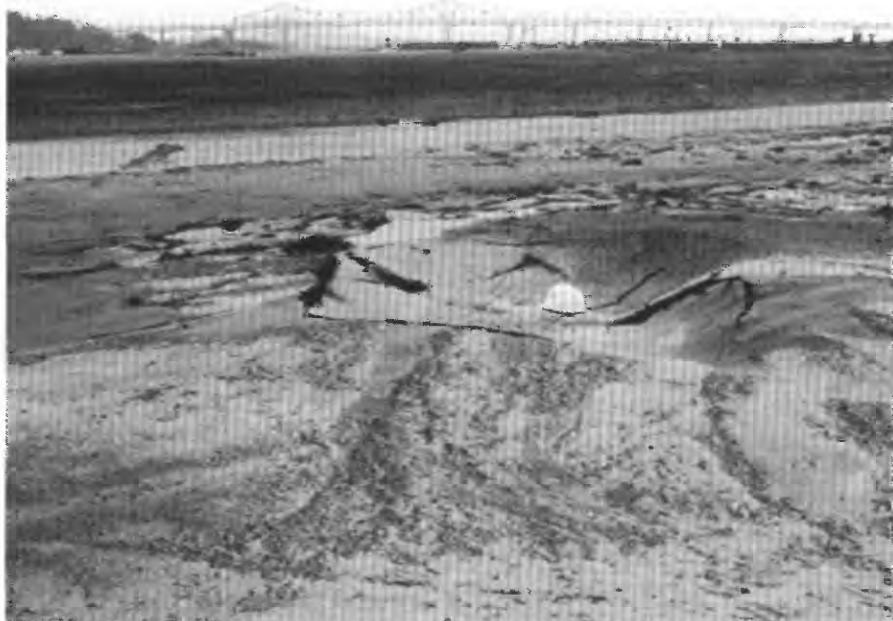
two runways and two taxiways were significantly damaged and inoperable after the earthquake. A large sand boil and vent on the taxiway of the two runways at ANAS is shown in figure 16. Pavement damage consisted of heaving, settlement, and minor lateral spreading, resulting in separation at joints. Maximum crack and joint openings were about 10 cm, and maximum vertical offsets were approximately 5 cm.

Figure 16.—Liquefaction-induced damage to taxiway pavement at Alameda Naval Air Station.

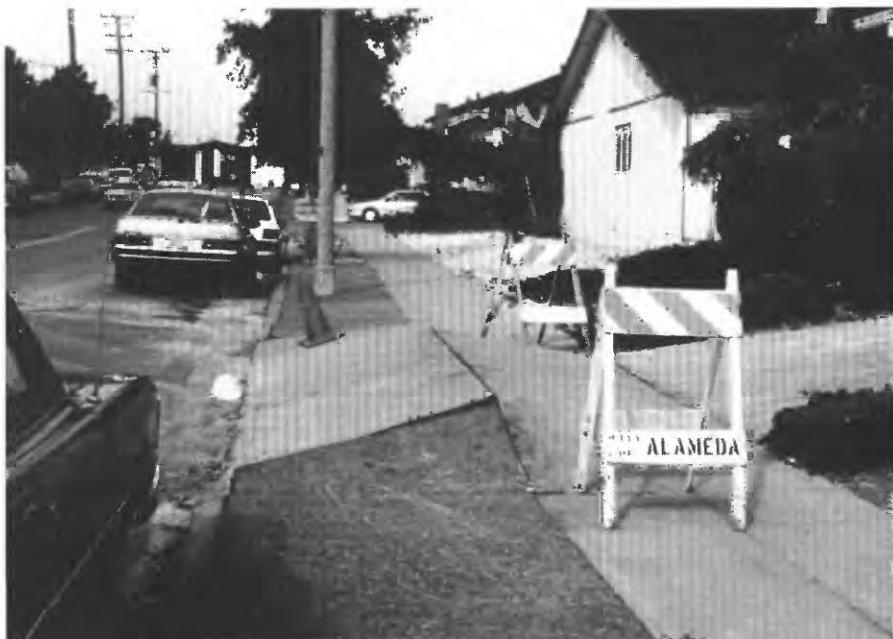
Scattered evidence of liquefaction, as evidenced by sand boils, minor settlements, and minor lateral spreading, occurred in several places along the west coast of the Alameda outside ANAS. These ground deformations caused minor cracking of pavements and ruptured many pipelines but caused no serious damage to structures. A typical example of the minor ground deformations in this area is shown in figure 17. No in-place testing was performed either at ANAS or on the Alameda as part of our studies.

Figure 17.—Minor settlement and buckling of pavement at southwest edge of the Alameda (fig. 1).

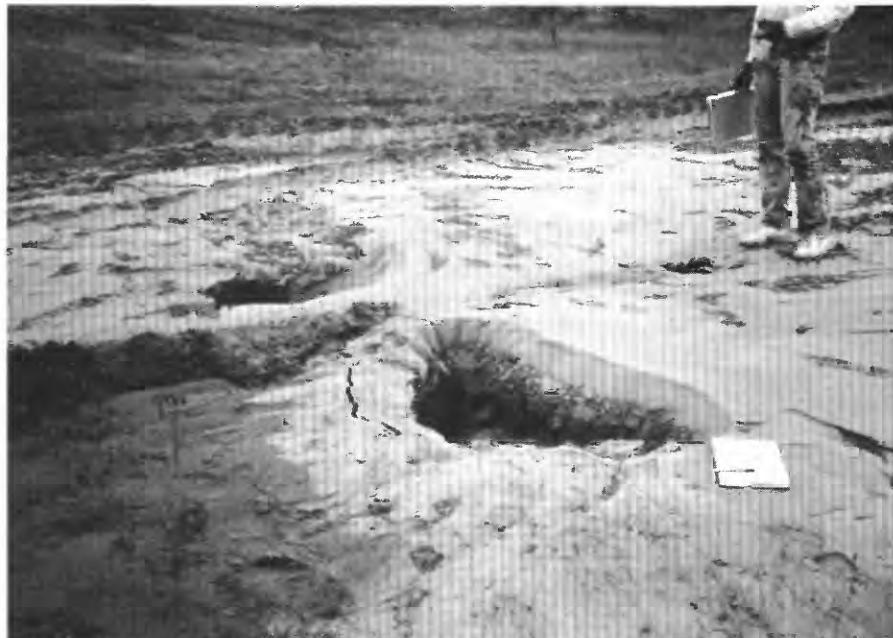
At Bay Farm Island, immediately north of Oakland International Airport (figure 1, 18), considerable liquefaction occurred at the northwest corner and at points along the west edge of the fill (fig. 19).

Figure 19.—Sand boils west of Aughinbaugh Way near borehole HBI-CPT1 on Bay Farm Island (see fig. 18 for locations).

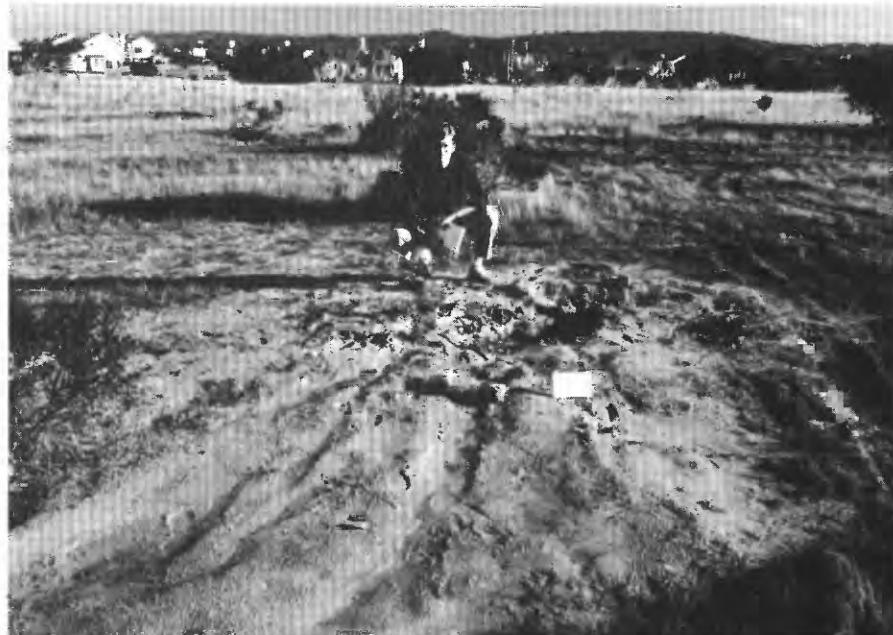
Fill in the perimeter dike was densified by dynamic compaction. Densification appears to have successfully prevented soil liquefaction of the western-perimeter dike during the earthquake. In contrast, in an area of unimproved fill, damage to roadway and parking-lot pavements occurred at the Harbor Bay Plaza business park (fig. 18). Numerous sand boils, many relatively large (more than 3 m in diameter), erupted in this area (fig. 20).

Figure 20.—Sand boil near Harbor Bay Plaza on west side of Bay Farm Island.

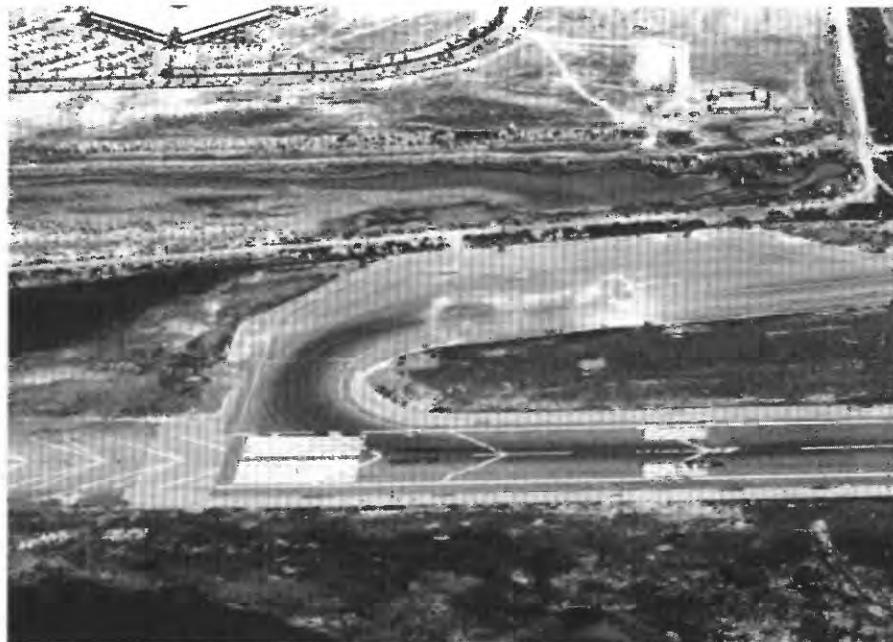
Extensive soil liquefaction occurred in the western section of the airport fill, damaging the northwestern 900 m of the 3,000-m-long main runway. In addition, the adjacent taxiway pavement also was heavily damaged (fig. 22). At the northwest end of the main runway (left side, fig. 22), sand boils and cracks appeared in the pavement (figs. 23, 24). These cracks were as much as 30 cm wide, with vertical offsets of as much as 15 cm. Most of the runway damage was repaired within 4 weeks, and as a result, the airport was able to resume essentially full operations with a shortened operational runway 2,700 m long on November 20, 1989.

Figure 22.—Northwest end of main runway (bottom) and adjacent taxiway (top) at Oakland International Airport (fig. 1). Photograph taken October 18, 1989.

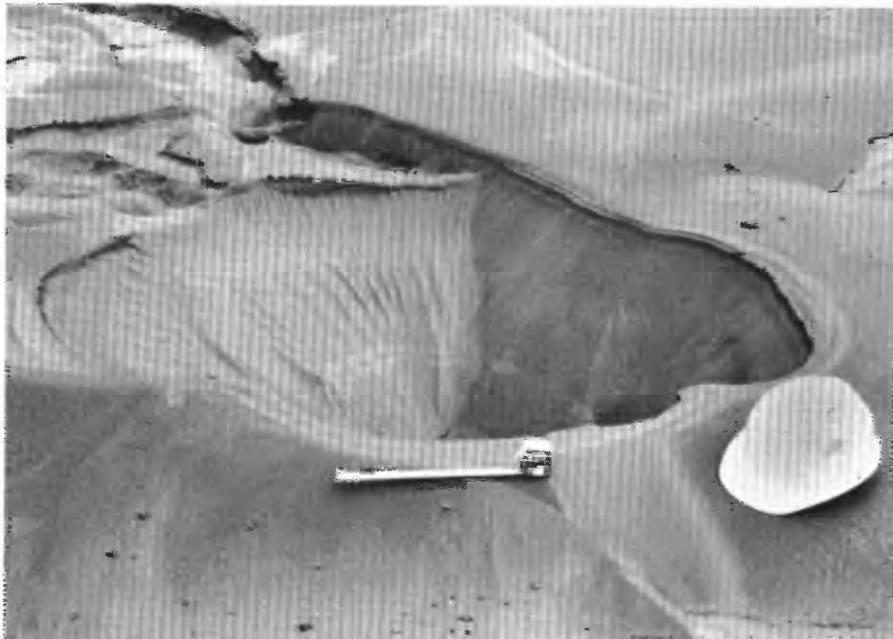
Figure 23.—Large sand boil near north end of main runway at Oakland International Airport (fig. 1).

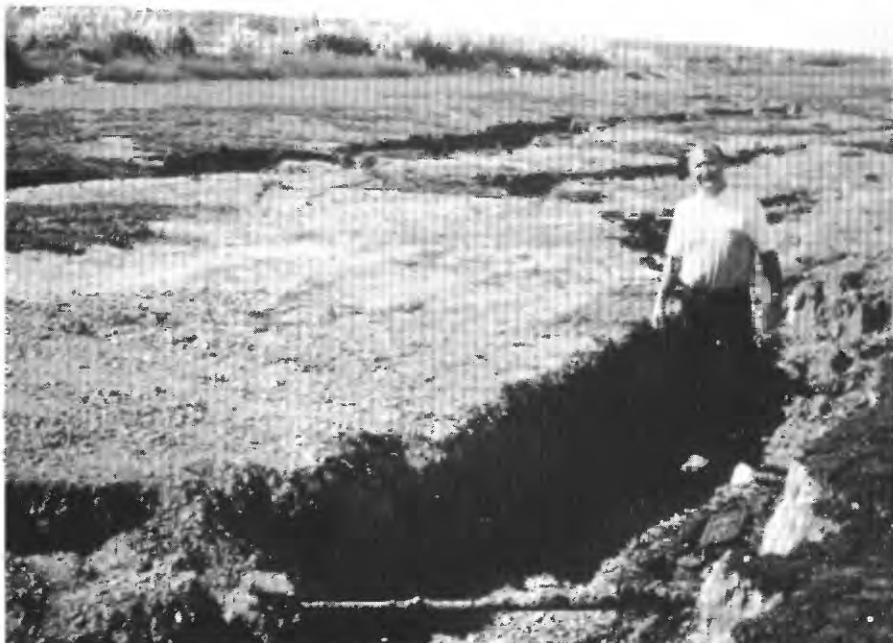
Figure 24.—Fissures, sand boils, and grabens associated with lateral spreading near northwest end of main runway at Oakland International Airport. Photograph courtesy of B.A. Vallerga.

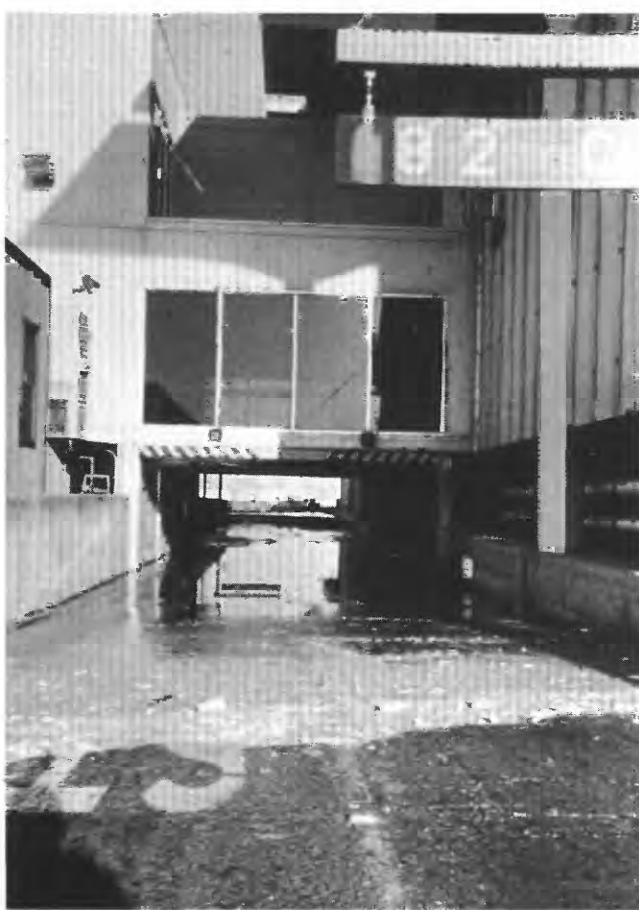
Figure 25.—Below-grade tramway, filled with as much as 1.8 m of extruded sand, at Oakland International Airport Terminal Building. Photograph courtesy of B.A. Vallerga.

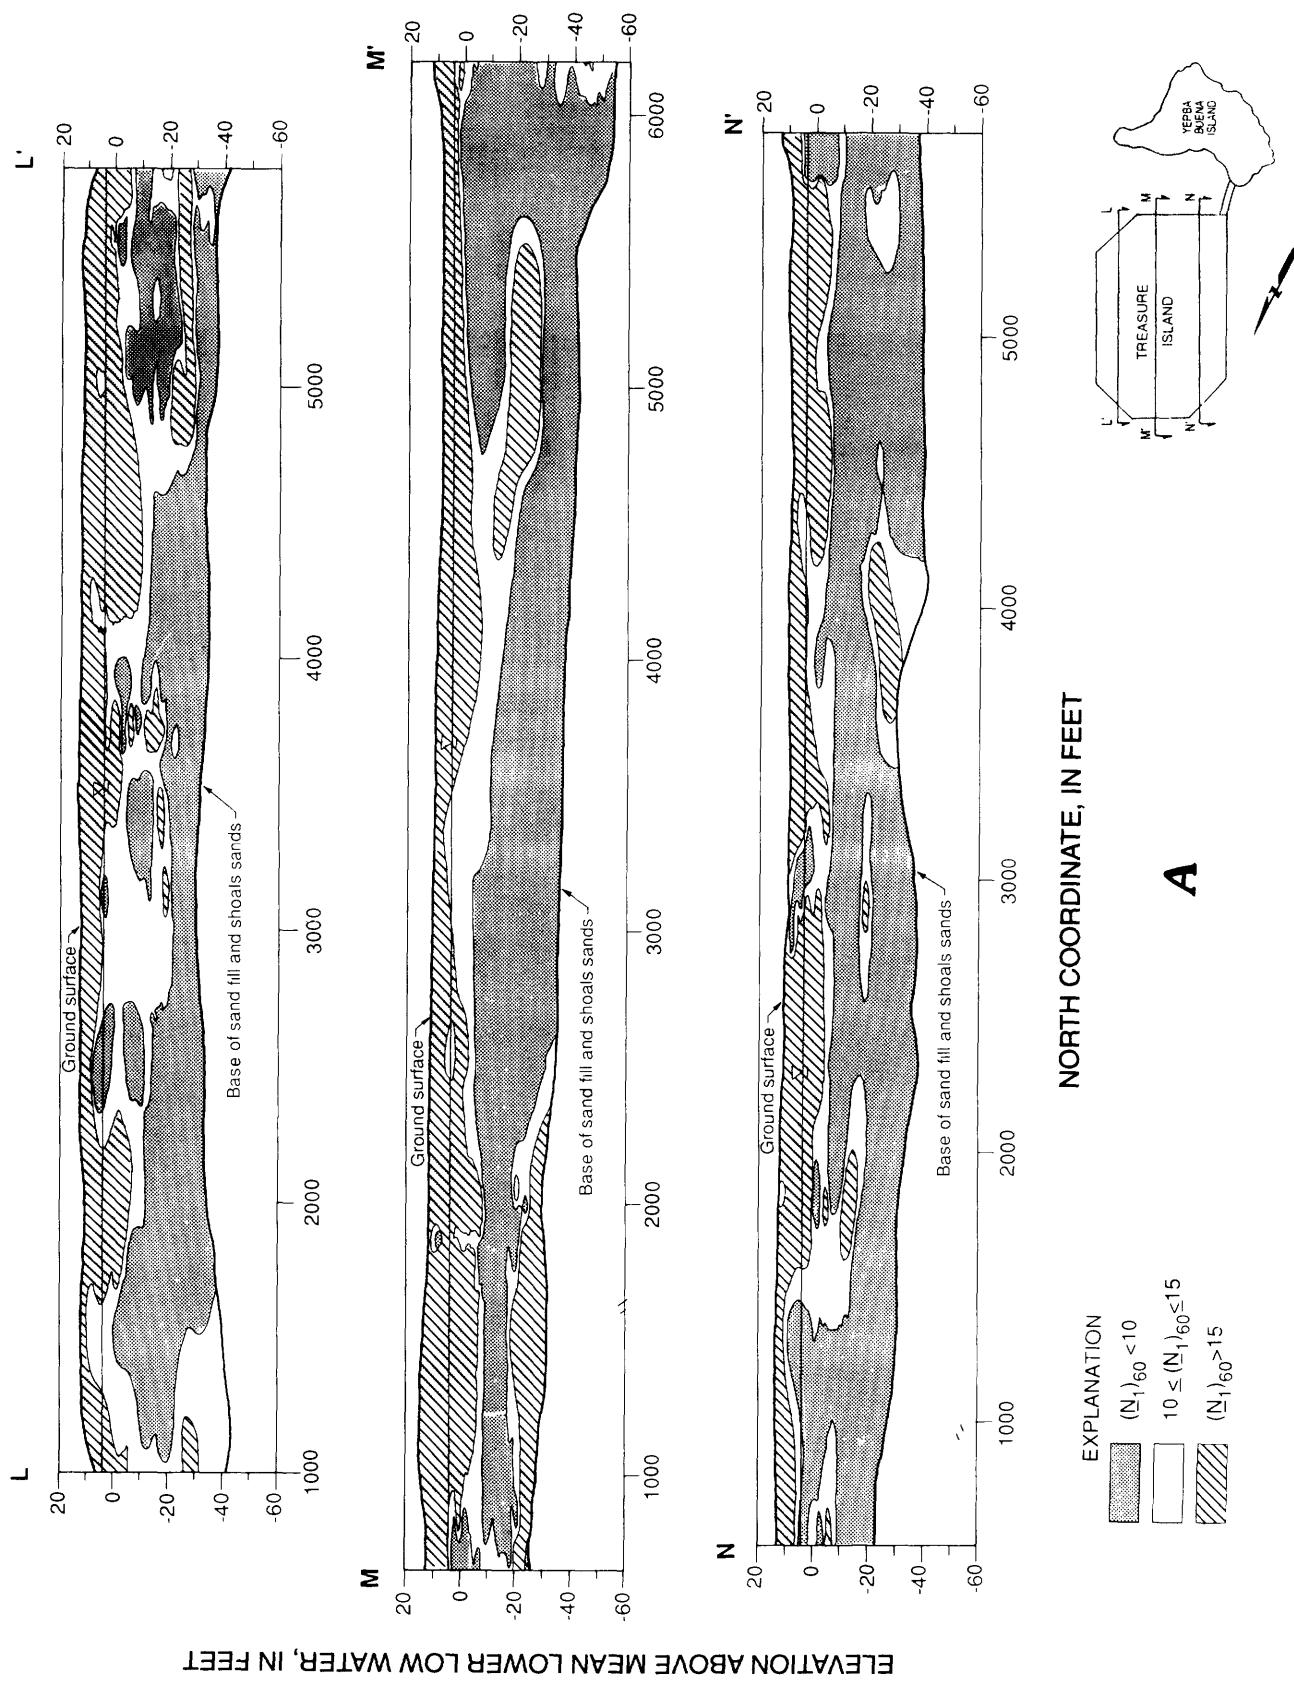
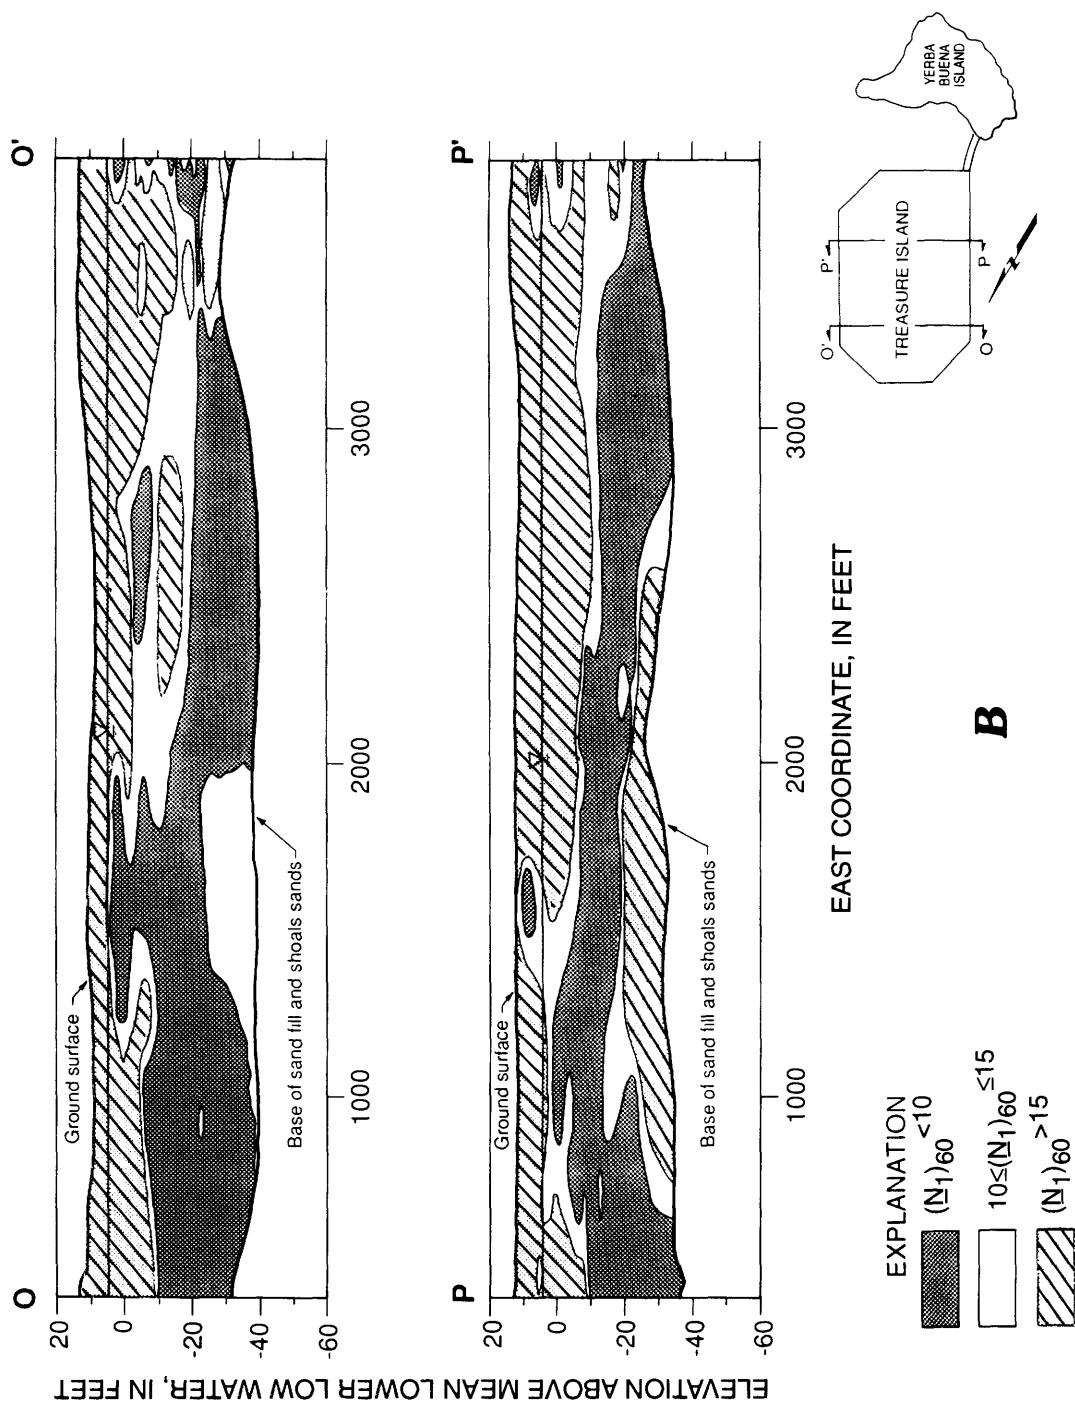
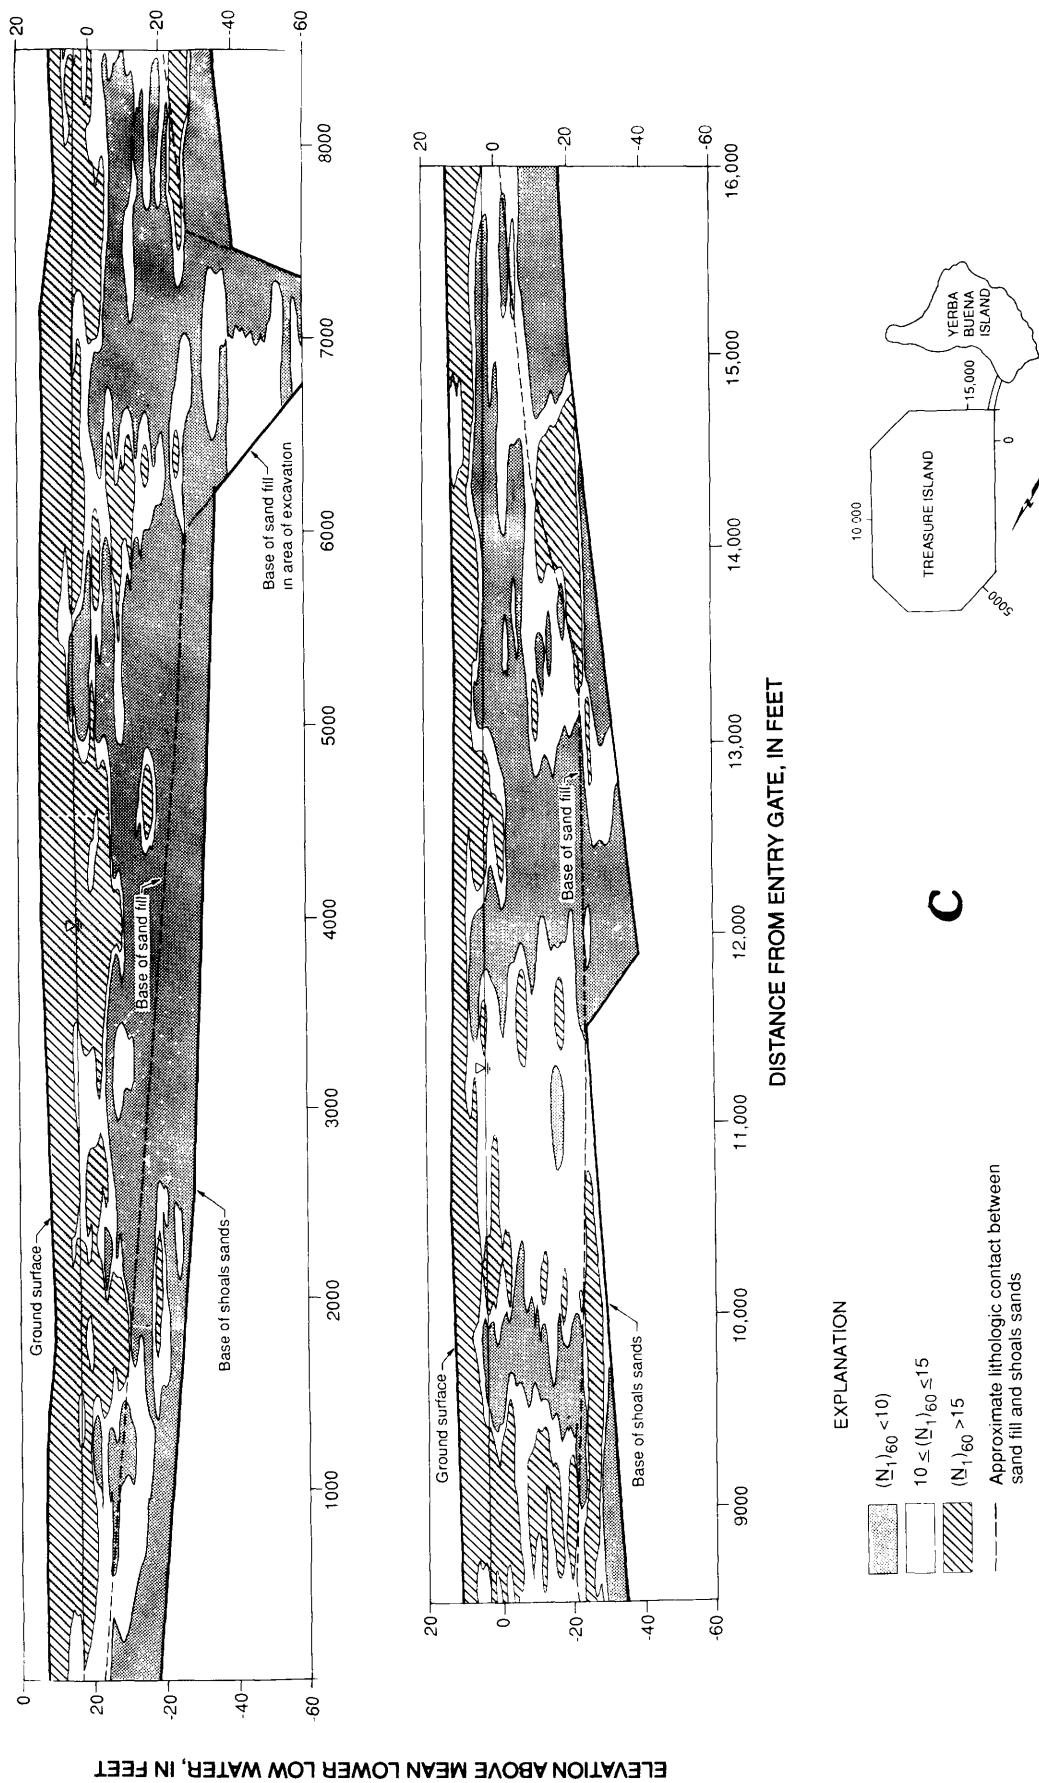
The ( $N_1$ )<sub>60</sub> values contoured in figure 10 indicate that the sand fill and shoal sand generally are relatively loose and susceptible to liquefaction under seismic loading. Liquefaction susceptibility is discussed in the next section. Near-surface materials are generally denser than the deeper materials. This layer of denser surficial material appears to vary in thickness across the island in no consistent pattern.

Figure 10.—Stratigraphic cross sections in longitudinal (north-south) (A), transverse (east-west) (B), and circumferential (C) directions on Treasure Island (see fig. 5 for locations), showing distribution of normalized standard penetration resistance,  $(N_1)_{60}$ , in sand fill and shoal sand. Cross sections extend horizontally to top of perimeter slope at island edge; contours of  $(N_1)_{60}$  value (in blows per foot) only indicate trends and do not represent actual  $(N_1)_{60}$  values at any point.

The spatial distribution of expected occurrence and nonoccurrence of liquefaction can be illustrated by examining the contours of  $(N_1)_{60}$  data for typical island cross sections, such as those in figure 10. As shown in figure 18, the critical  $(N_1)_{60}$  value was estimated at 10 to 15 blows/ft. Figure 10 indicates that substantial proportions of the island's subsurface materials have an  $(N_1)_{60}$  value less than 10 and so could reasonably be expected to have liquefied during the 1989 Loma Prieta earthquake. For the zones of material in figure 10 with an  $(N_1)_{60}$  value of 10 to 15 blows/ft, the occurrence of liquefaction was only marginal, and materials with an  $(N_1)_{60}$  value greater than

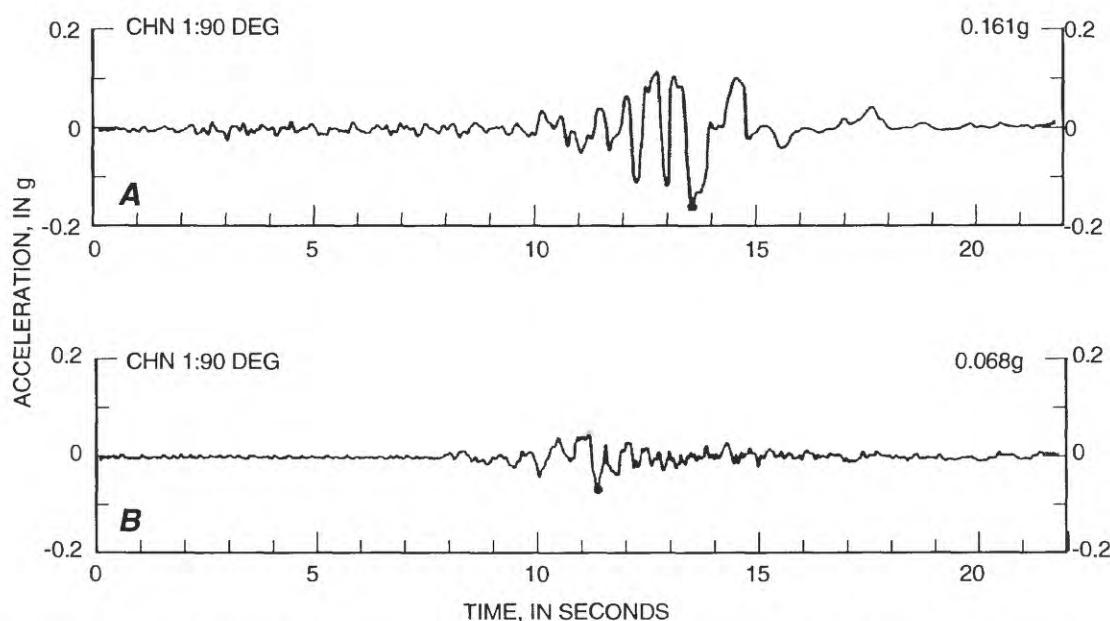
Treasure Island is approximately 50 mi (80 km) north of the closest part of the Loma Prieta rupture zone (fig. 1). Ground motion was recorded at the fire station (fig. 5) on Treasure Island, and a recording on bedrock was obtained on Yerba Buena Island. The recorded east-west components of ground motion on Yerba Buena Island and the corresponding ground motion on Treasure Island are plotted in figure 11. As shown, the peak acceleration of 0.06 g on Yerba Buena Island was amplified to 0.16 g on Treasure Island.

Figure 11.—Accelerograms of east-west ground motion recorded on Treasure Island (A) and Yerba Buena Island (B). After California Strong Motion Instrumentation Program (1989)

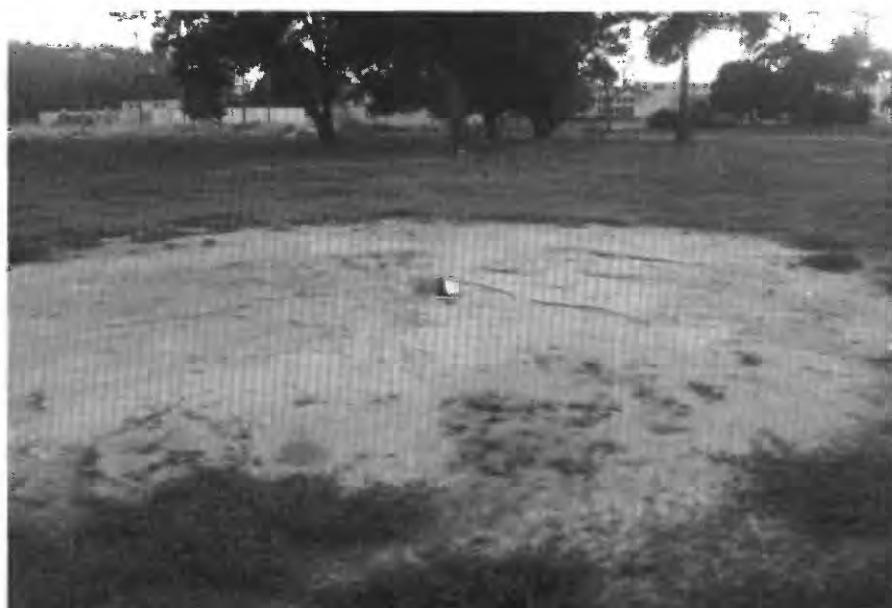
dence of liquefaction was observed on Treasure Island in the form of sand boils. In mapping conducted by the U.S. Geological Survey in November 1989, sand boils were documented at 18 locations on the island, as shown on plate 1. A large sand boil is shown in figure 12. At several other locations on the island, the U.S. Geological Survey (in November 1989) or Geomatrix Consultants (in January and February 1990) noted sinkholes that may have indicated the locations of earlier sand boils where the sand had been removed (see pl. 1).

Figure 12.—Sand boil on Treasure Island. Photograph courtesy of Michael J. Bennett, U.S. Geological Survey.

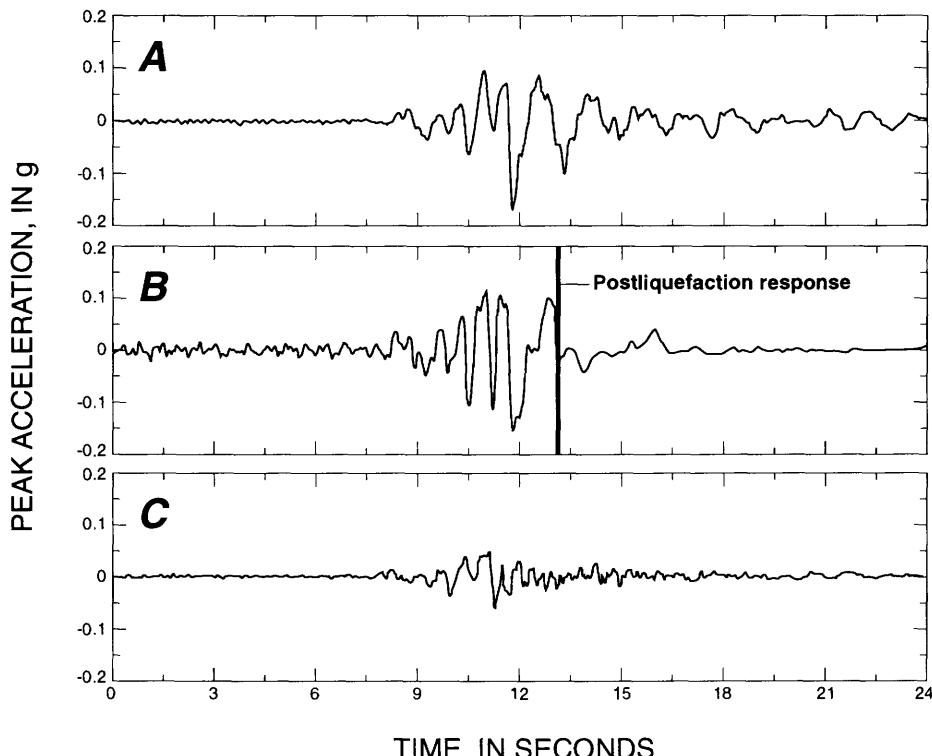
Figure 15.—Computed (A) and recorded (B) peak acceleration at ground surface on Treasure Island and recorded peak acceleration on bedrock on Yerba Buena Island (C).

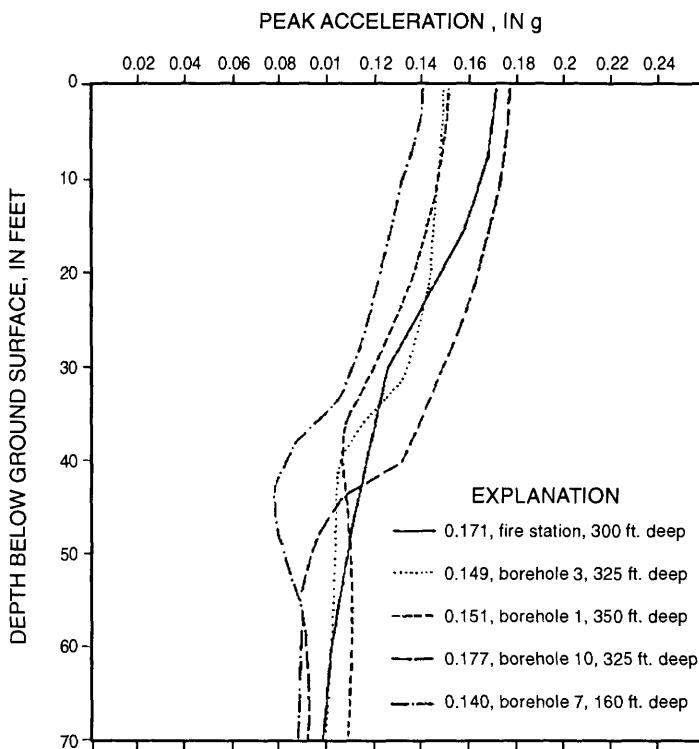
Figure 16.—Peak acceleration versus depth at sites on Treasure Island (see pl. 1 and fig. 5 for locations), calculated from analyses of soil profiles above bedrock using computer program *SHAKE* (Schnabel and others, 1972). Description of curves lists peak acceleration at ground surface at each site.
