# The Loma Prieta, California, Earthquake of October 17, 1989— Liquefaction

THOMAS L. HOLZER, *Editor*

STRONG GROUND MOTION AND GROUND FAILURE

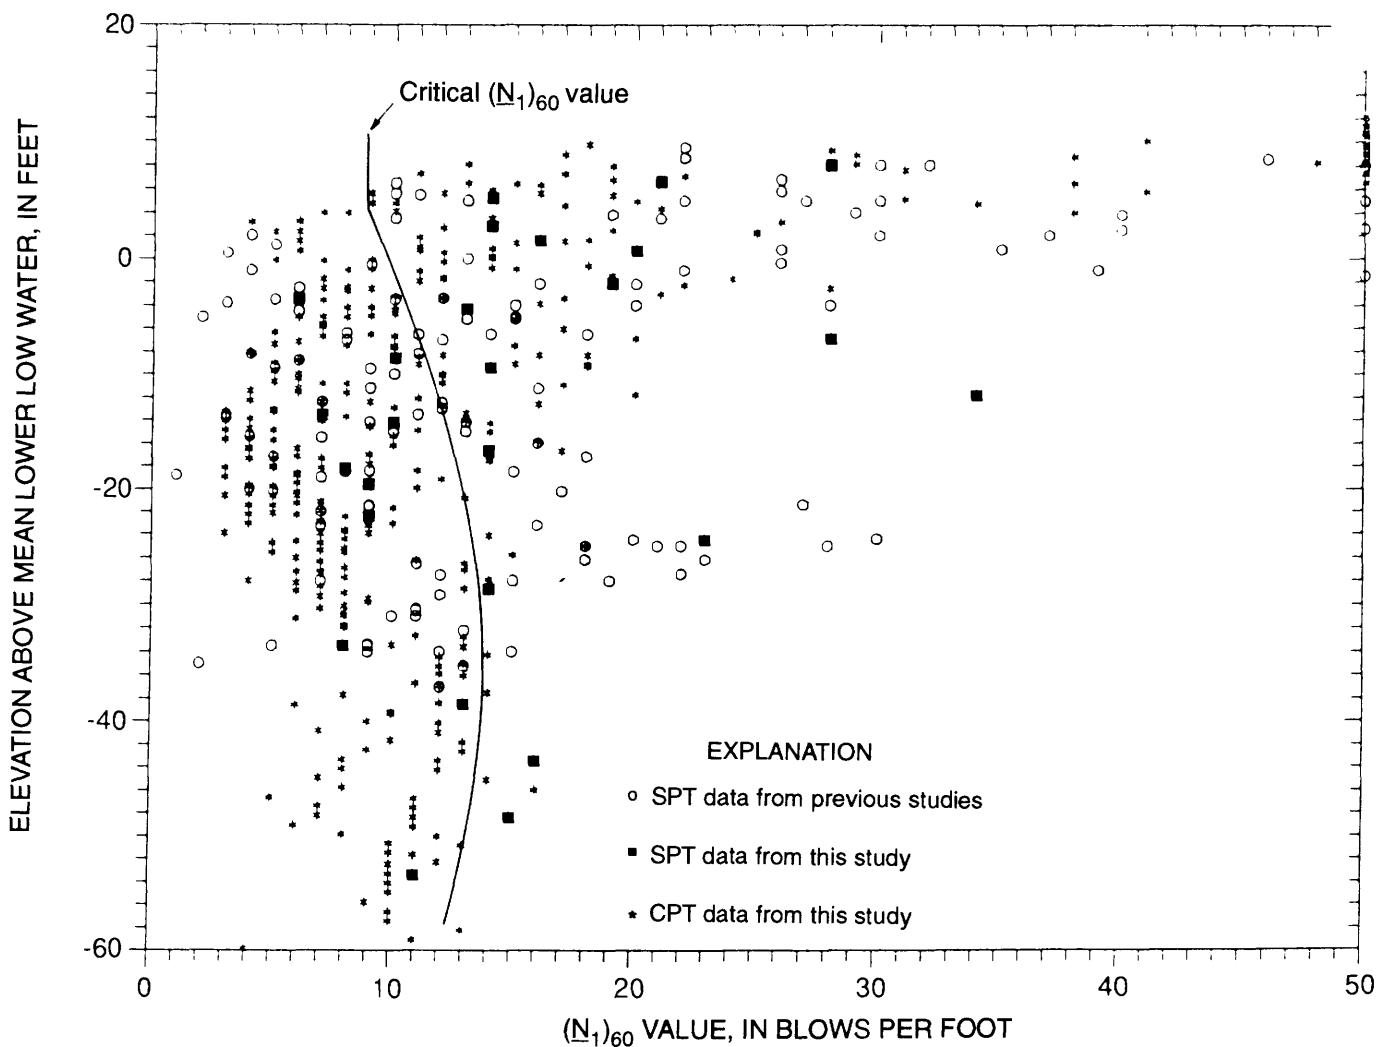
The spatial distribution of expected occurrence and nonoccurrence of liquefaction can be illustrated by examining the contours of  $(N_1)_{60}$  data for typical island cross sections, such as those in figure 10. As shown in figure 18, the critical  $(N_1)_{60}$  value was estimated at 10 to 15 blows/ft. Figure 10 indicates that substantial proportions of the island's subsurface materials have an  $(N_1)_{60}$  value less than 10 and so could reasonably be expected to have liquefied during the 1989 Loma Prieta earthquake. For the zones of material in figure 10 with an  $(N_1)_{60}$  value of 10 to 15 blows/ft, the occurrence of liquefaction was only marginal, and materials with an  $(N_1)_{60}$  value greater than

Figure 18.— $(N_1)_{60}$  value versus elevation, based on SPT and CPT data. Curve shows critical  $(N_1)_{60}$  value at various elevations.

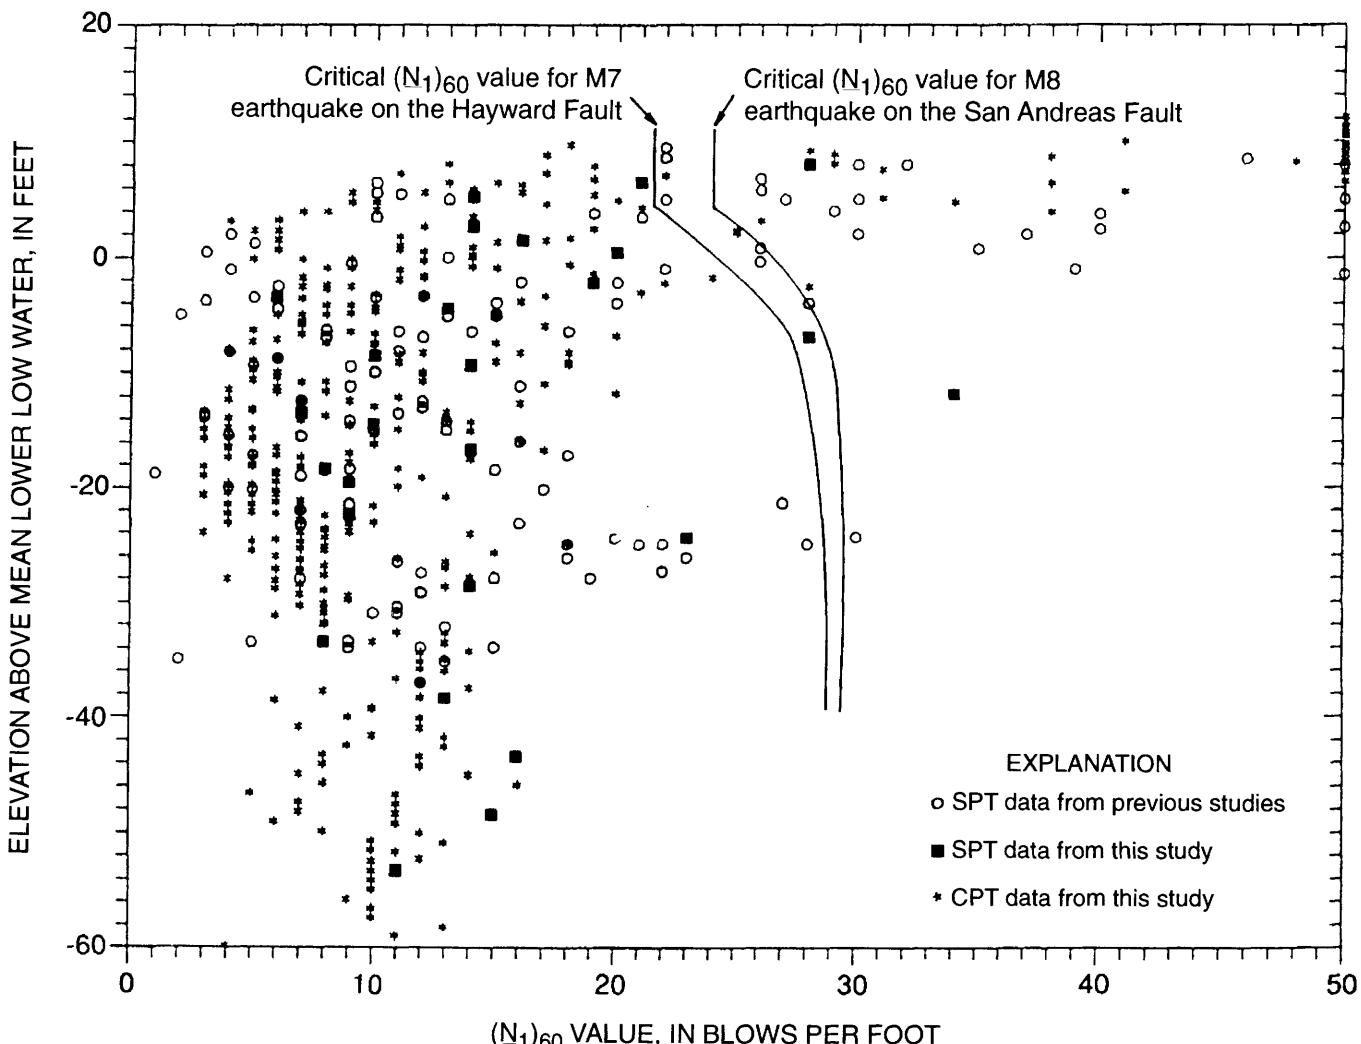
for liquefaction for potential future earthquakes of  $M=7$  on the Hayward fault and  $M=8$  on the San Andreas fault. A typical comparison of the critical ( $N_1$ )<sub>60</sub> values for these earthquakes with that for the sand deposits on Treasure Island is shown in figure 21, which illustrates that essentially complete liquefaction of the sand would be expected during these earthquakes.

Figure 21.— $(N_1)_{60}$  value versus elevation, based on SPT and CPT data. Curves show critical  $(N_1)_{60}$  values for hypothetical  $M=7$  earthquake on the Hayward fault and  $M=8$  earthquake on the San Andreas fault.

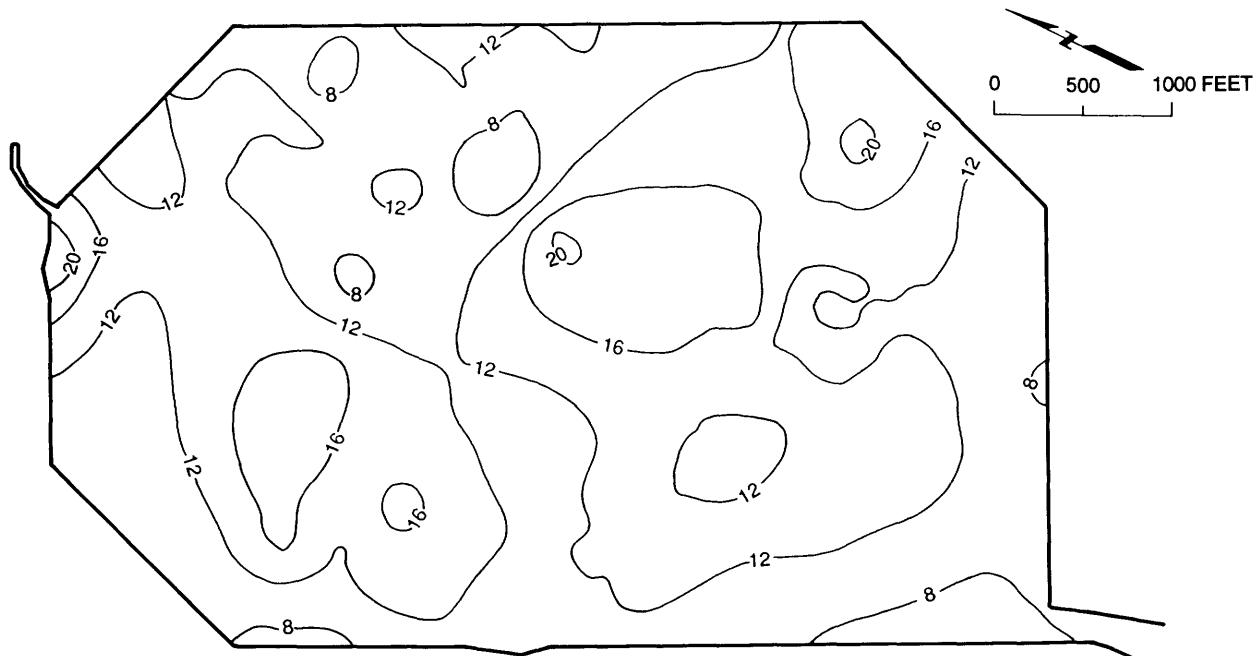
Figure 22.—Sketch map of Treasure Island, showing contours of estimated ground-surface settlement (in inches) caused by compaction for hypothetical  $M=7$  earthquake on the Hayward fault and  $M=8$  earthquake on the San Andreas fault.

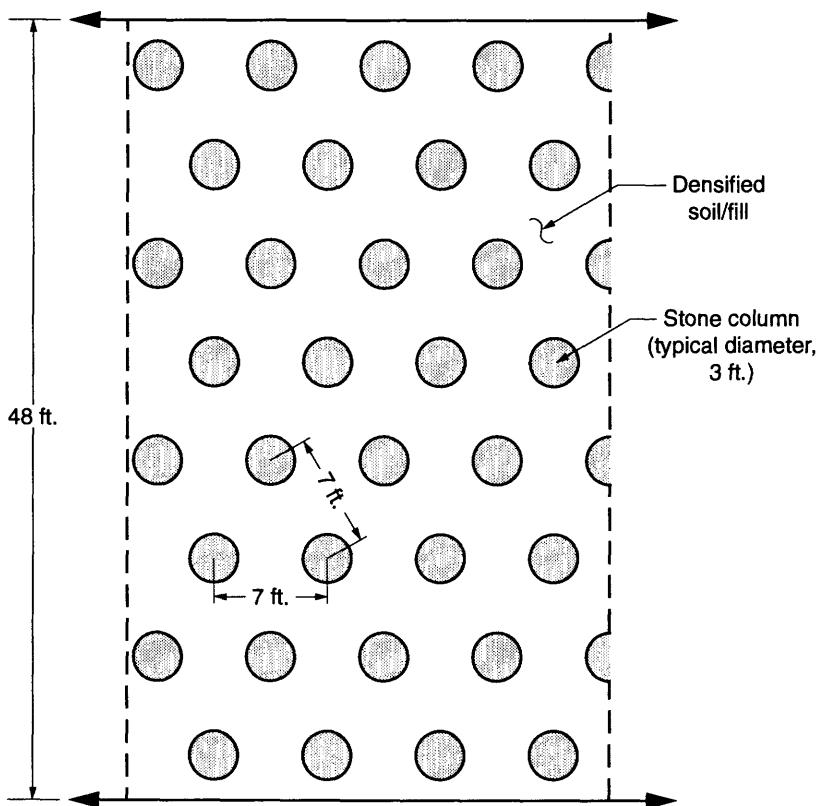
Figure 23.—Plan view of stone-column configuration for remedial scheme to mitigate liquefaction-induced lateral spreading.

earthquakes. Creation of a buttressing, stabilized area of sand adjacent to the perimeter slope by the vibro-replacement method was found to be the most cost effective means of mitigating the hazard. By this method, the sand would be densified by vibroflotation at approximately 7 ft on center, and stone columns approximately 3 ft in diameter would be constructed at the vibroflotation locations. Analysis indicated that a stabilized buttressing zone approximately 50 ft wide extending back from the top of the perimeter slope would be enough to effectively retain any liquefied sand behind (landward of) this zone and thus reduce lateral-spreading displacements through the sand to less than approximately 1 ft. A plan view of the stone-column configuration is shown in figure 23, and a cross section of the stabilized zone is shown in figure 24.

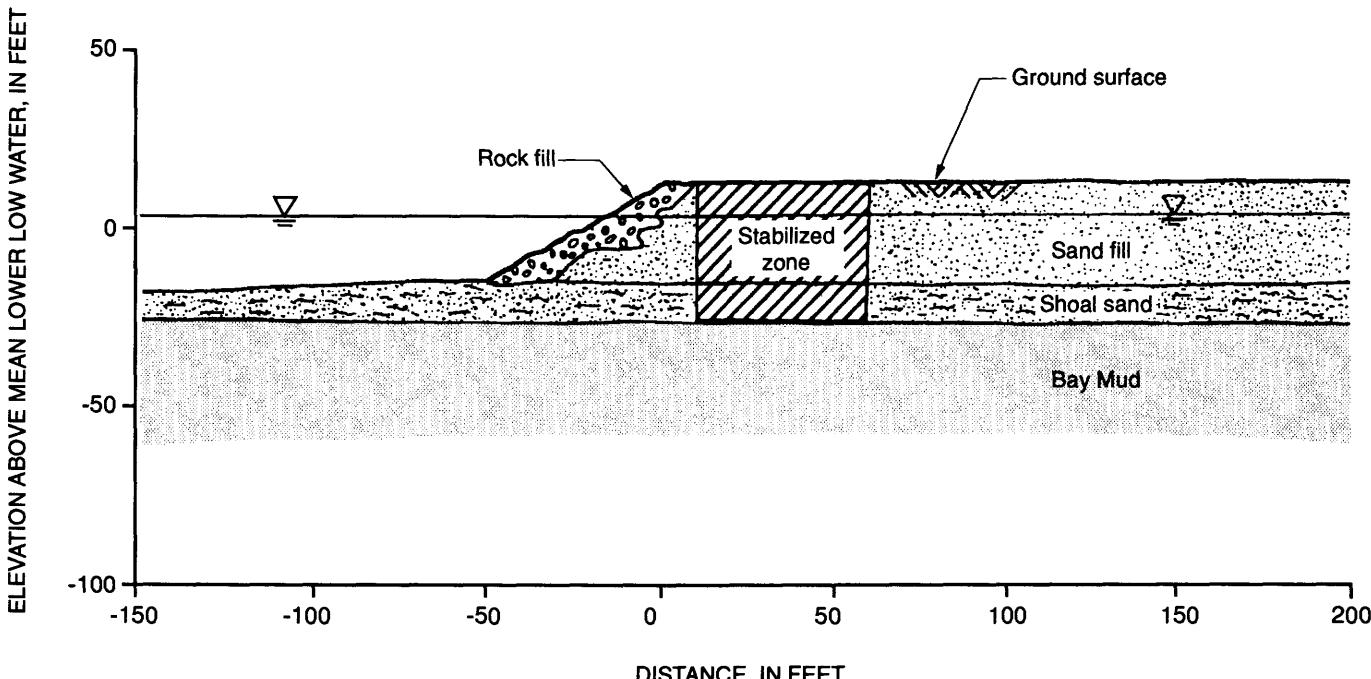
relatively soft material that could be further reduced in strength and deform during strong earthquake shaking. With the sand-stabilization measures in place, the area susceptible to lateral-spreading movements then shifts below the stabilized zone into the bay mud (fig. 24). Larger movements might occur on sliding surfaces that pass through the bay mud below the stabilized zone than on sliding surfaces passing through this zone. Within the scope of our studies, we could not assess in detail the potential for such movements through the bay mud around the perimeter of Treasure Island. Preliminary analyses using the method of Newmark (1965) indicate that movements of several feet might occur and that therefore more detailed consideration of this potential hazard would be desirable.

Figure 24.—Cross section of remedial scheme to mitigate liquefaction-induced lateral spreading.

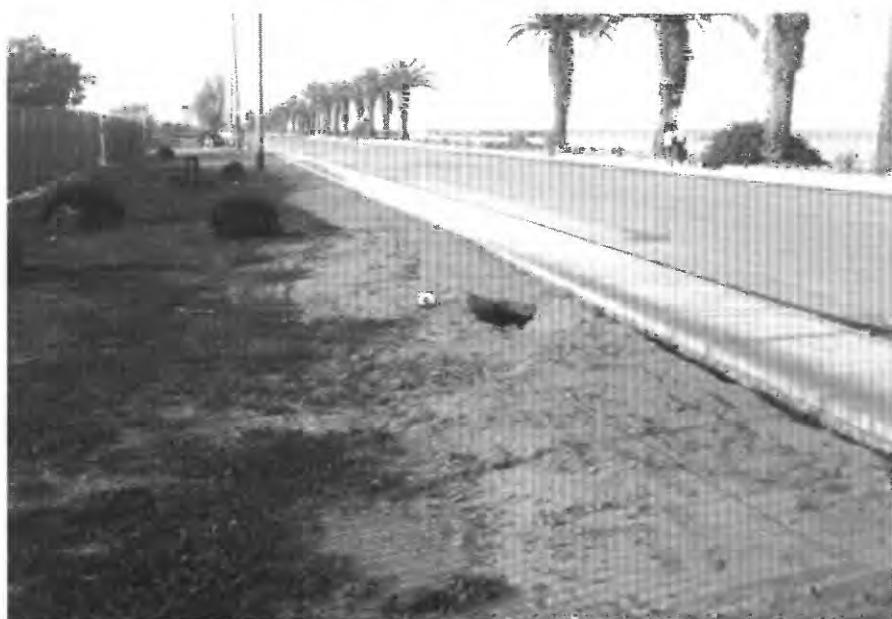
Figure 5.—Sand boil on east side of Treasure Island at locality 5 (fig. 4).

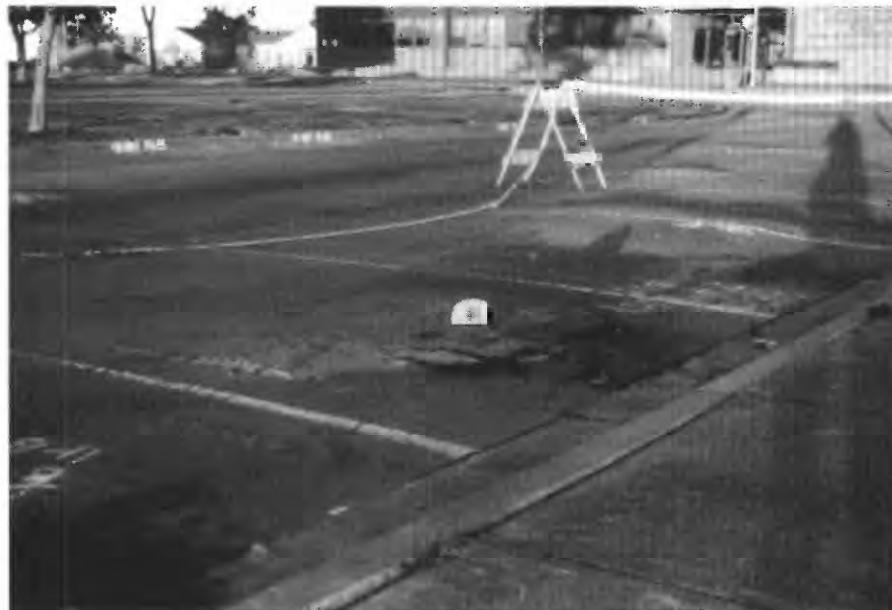
Figure 6.—Differential settlement (approx 90 mm) on Treasure Island where piles erupted through pavement in parking lot near Building 450 (loc. 28, fig. 4).

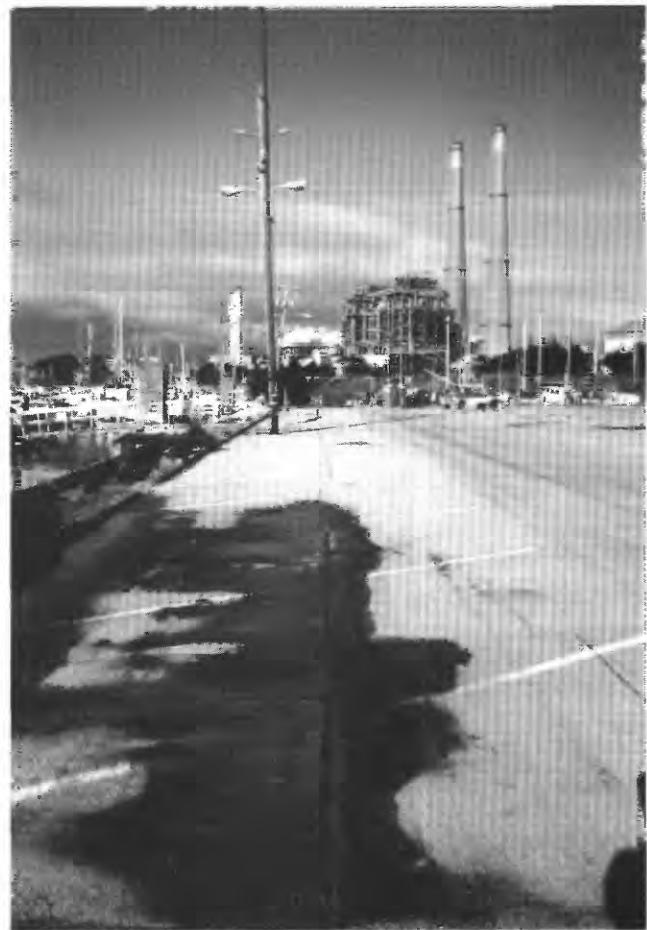
Figure 4.—Sand boils in Moss Landing Harbor District parking lot. Smokestacks for Units 6 and 7 of Pacific Gas & Electric powerplant are visible in background.

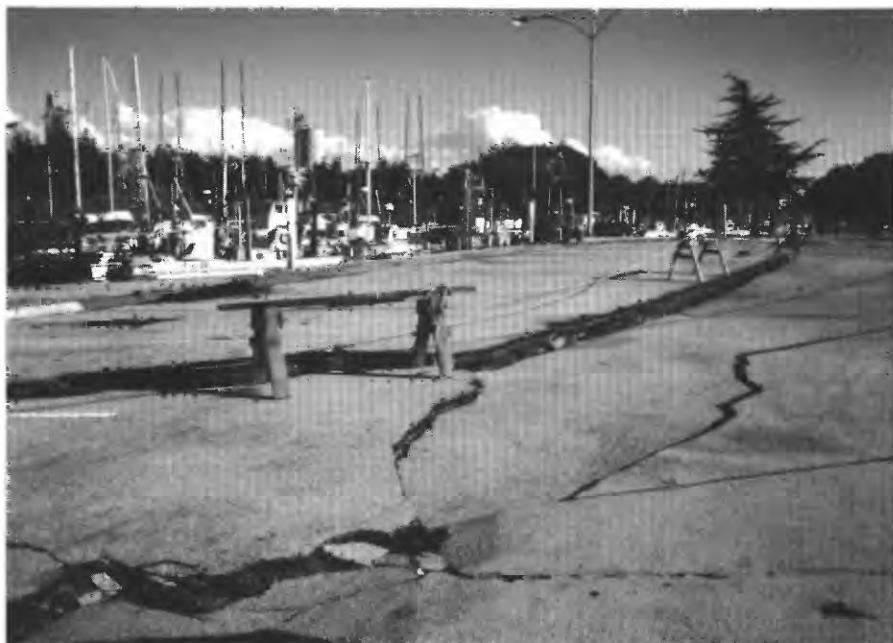
Figure 5.—Ground cracks at north end of Moss Landing Harbor District parking lot.

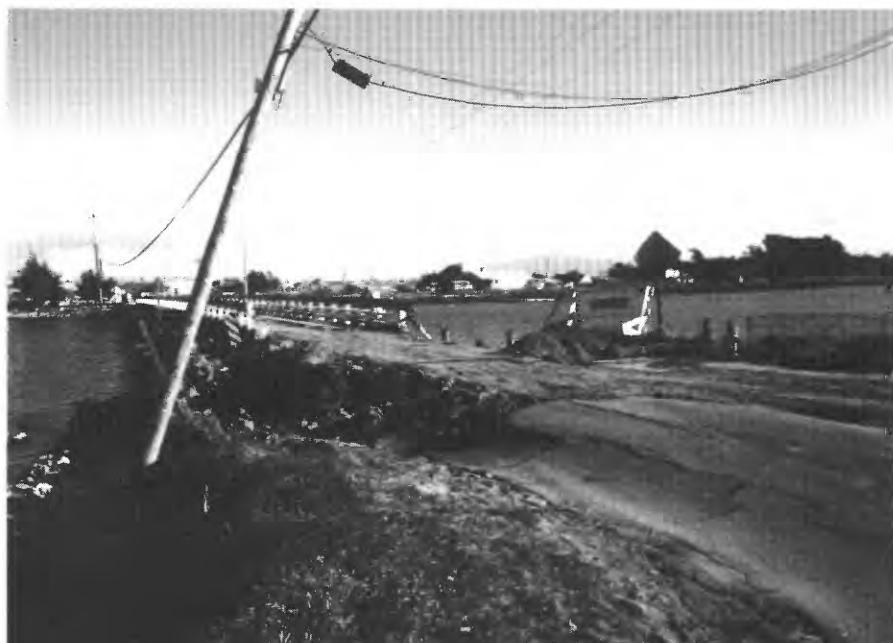
Figure 6.—West approach to single-lane timber bridge across the Old Salinas River (see fig. 2 for locations).

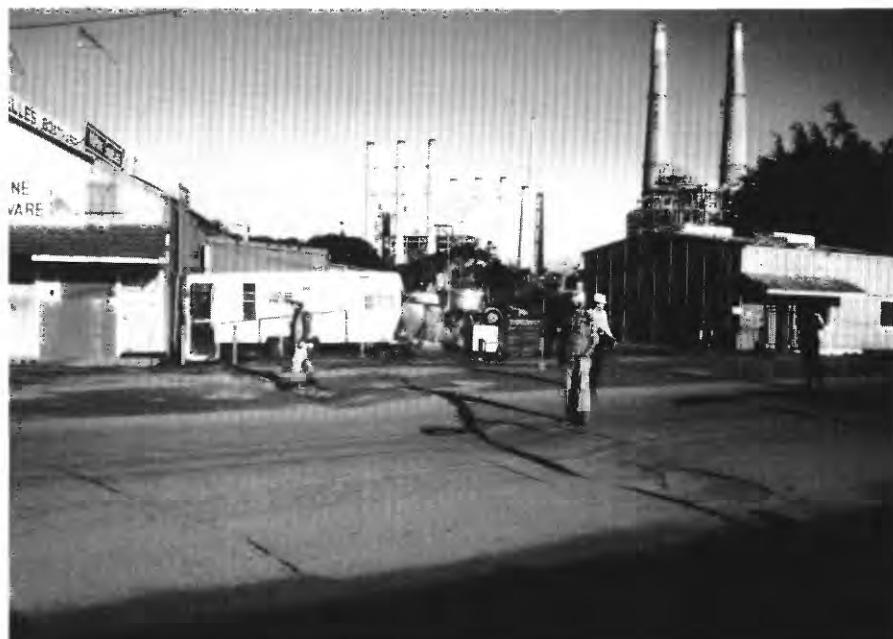
Figure 7.—Settlement across Sandholdt Road near north end of Moss Landing spit (see fig. 2 for locations).

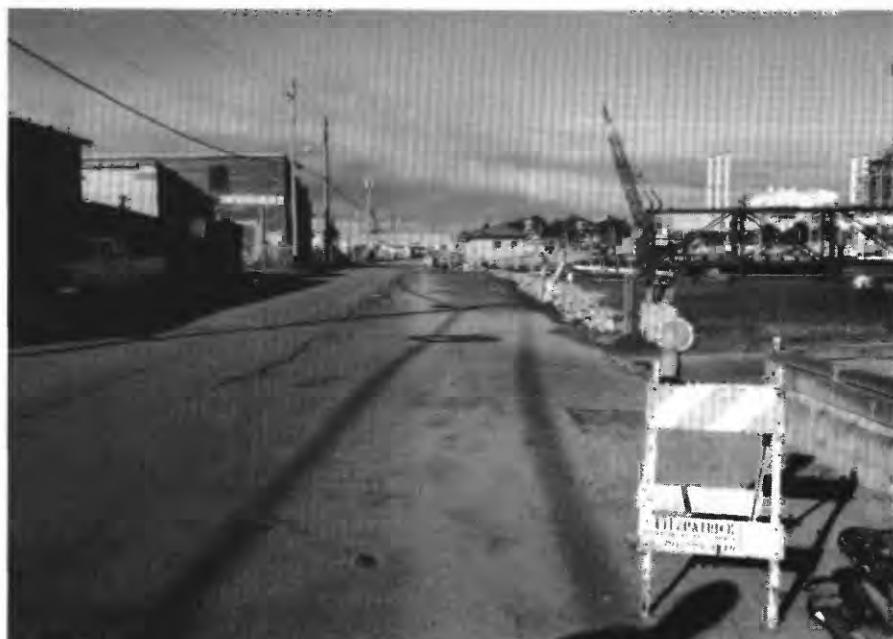
Figure 8.—Sandholdt Road halfway between timber bridge and Monterey Bay Aquarium Research Institute facilities (see fig. 2 for locations). Photograph taken 3 days after earthquake. View northward.

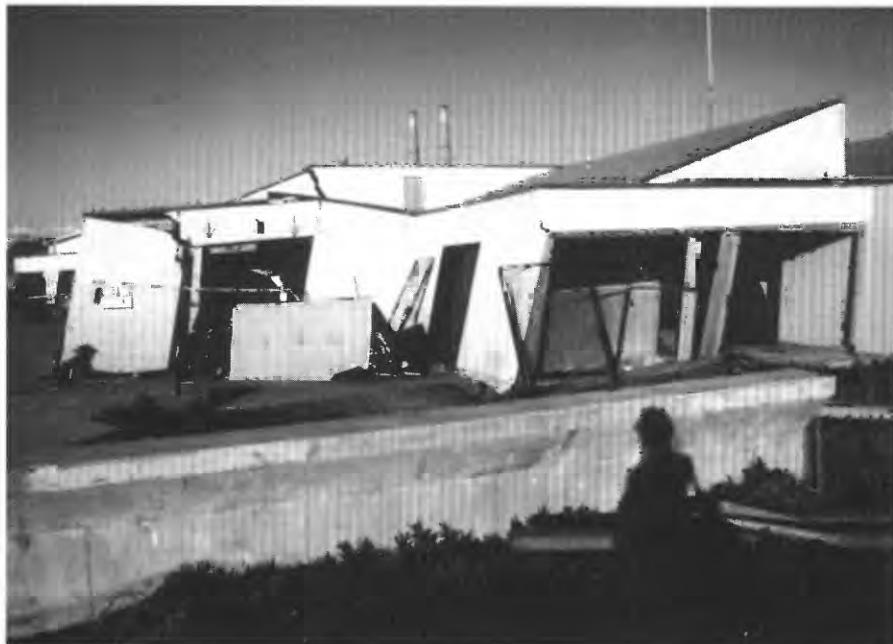
Figure 12.—Racking of director's office at southwest corner of Moss Landing Marine Laboratory (fig. 11).

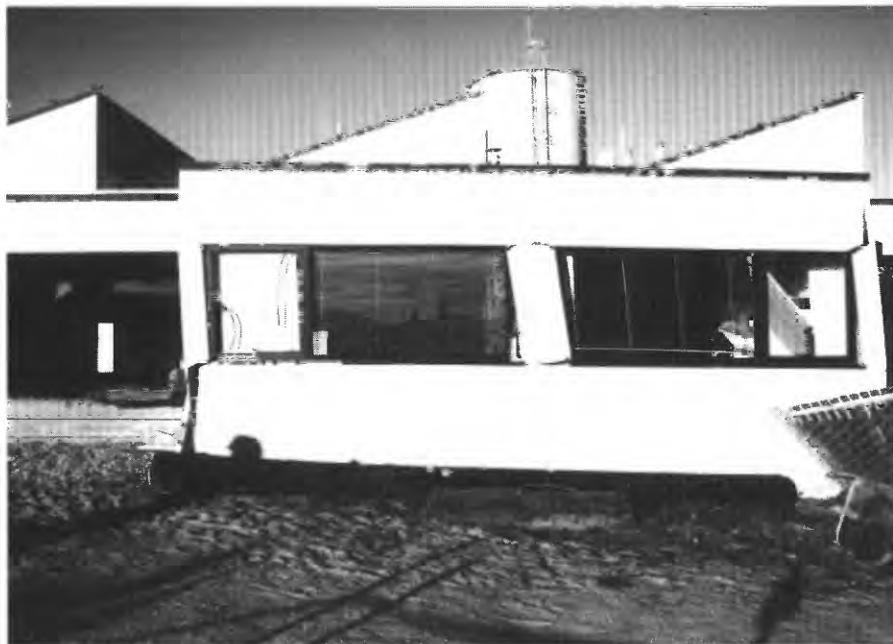
Racking of the southeast corner of the MLML is shown in figure 13; this corner of the facility moved laterally

toward the river about 1.5 ft and settled about 1 foot. Similar displacements were observed at the northeast corner. Measured lateral displacements on the east side of Sandholdt Road were 2.5 to 4.5 ft toward the river (fig. 11). Thus, the total extension of the spit due to lateral spreading at the site appears to have ranged from about 4.5 ft on the north side of the MLML to 7 ft on the south side. This difference in displacement appears to be related mainly to slight differences in topography between the north and south sides of the site and to slight differences in soil conditions.

Figure 13.—Racking of southern building at southeast corner of Moss Landing Marine Laboratory (fig. 11).

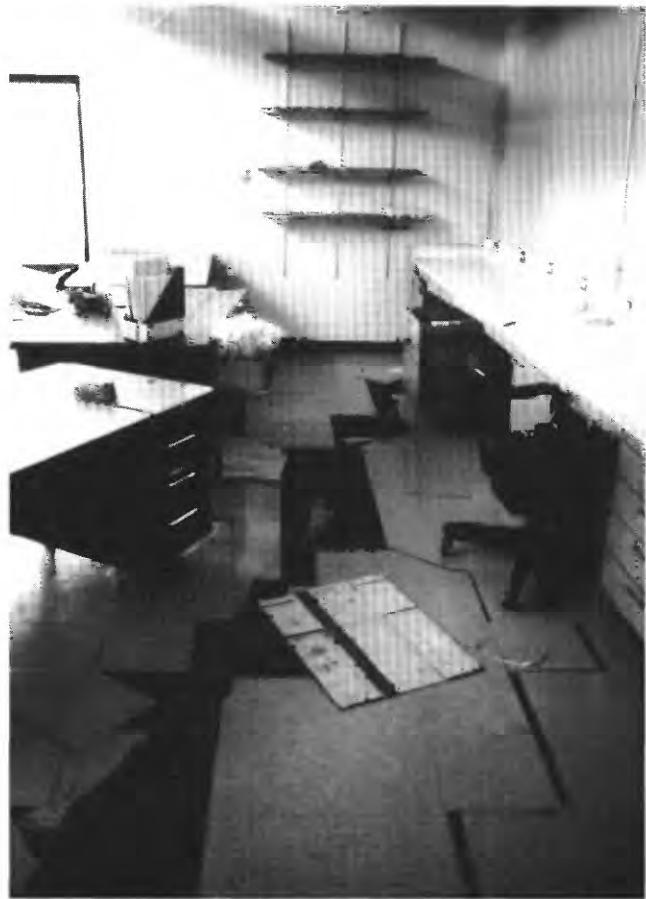
As shown in figure 11, lateral spreading resulted in extensive cracking throughout the site and formation of an approximately 15-ft-wide, 1-ft-deep graben south of the MLML. The southern building sustained severe cracking in the foundation and slab floor; cracks as much as 6 in. wide formed in the slab, and separations of as much as 10 in. occurred between building floors and walls. Cracking of the concrete floor in the southern building, just north of the graben, is shown in figure 14. The northern

building also sustained severe cracking at the roof and foundation levels, and separations of more than 18 in. in some places.

Figure 14.—Cracks in concrete floor in southern building of Moss Landing Marine Laboratory (fig. 11).

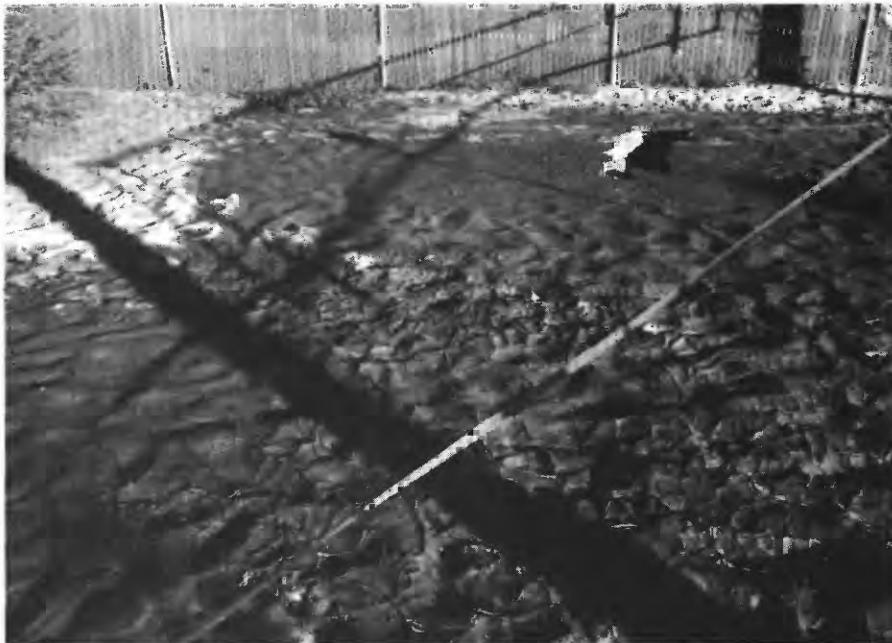
Soil boils, which geysered as much as 3 ft high, flowed for 30 to 45 minutes after the earthquake at the volleyball court south of the MLML (Greene and others, 1991). As shown in figure 15, the soil-boil ejecta consisted of predominantly fine clayey silt, although medium sand also flowed to the surface at this site. Sand boils of

The soil-boil ejecta at the volleyball court indicates that the clayey silt underlying the dune sand in this area also appears to have developed high excess pore pressures (fig. 15). Several liquefaction vents through the dune sand were carefully examined in an 8-ft-deep test pit at this site. The appearance of the clayey silt in these vents suggests that the silt flowed to the surface in a liquefied state. An LL value of 38 percent, a PI value of 17 percent, a fines content of 78 percent, and a minus-5- $\mu\text{m}$  fraction of 24 percent were measured in a sample of the soil ejecta at the surface.

Figure 15.—Sand-boil ejecta in volleyball court of Moss Landing Marine Laboratory (fig. 11).

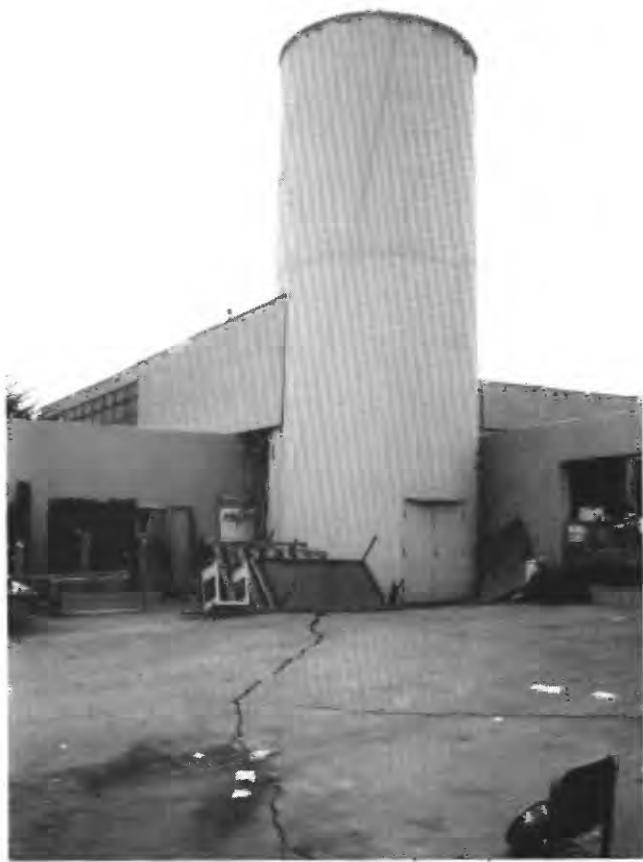
curred through cracks in the corporation-yard pavement shown in figure 16. The pavement heaved upward about 2 ft and resettled as muddy water erupted through the cracks,

Figure 16.—Cracks in corporation-yard pavement of Moss Landing Marine Laboratory (fig. 11). Seawater-storage tank in background settled differentially 2 to 3 in.

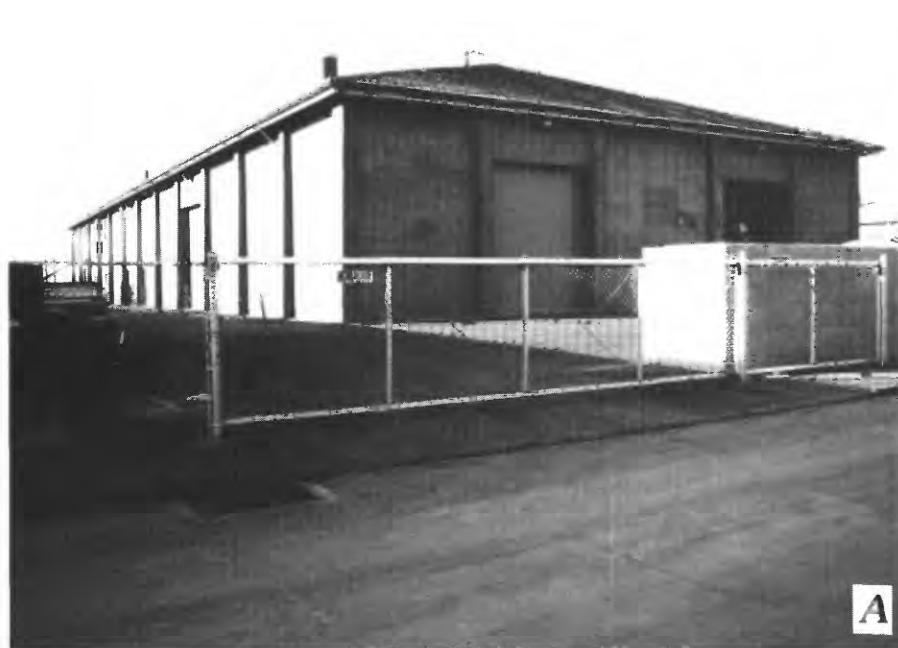
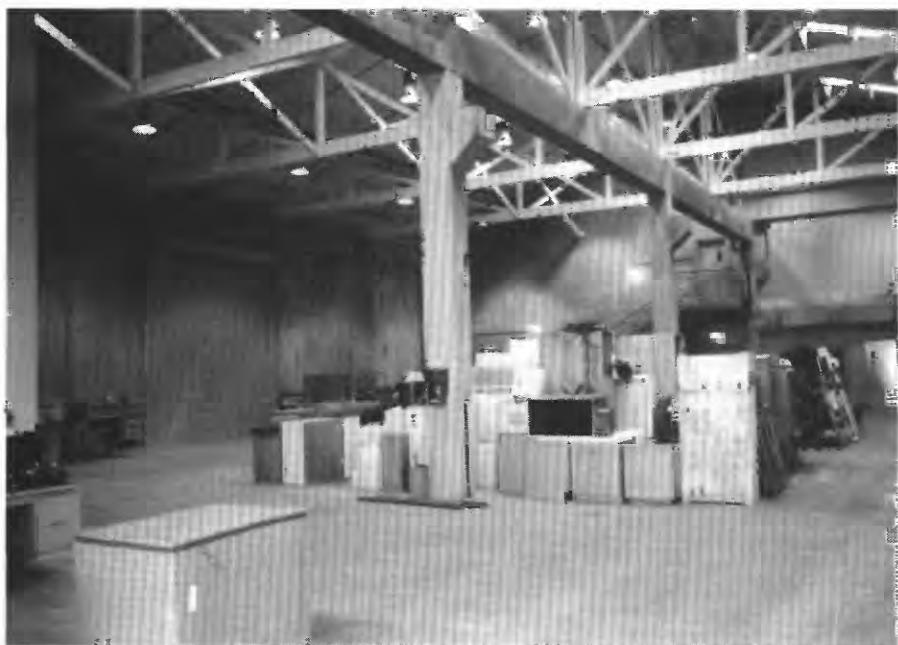
In contrast to the MLML, the MBARI facilities performed very well during the earthquake. The exterior and interior of the technology building 3 days after the earthquake are shown in figures 20A and 20B, respectively. The structure was undamaged by the shaking, and no evidence of damage to the foundation or concrete floor was observed. Permanent ground deformations at the site were small, and the building appears to have settled uniformly. A few cracks, less than about  $1/2$  in. wide, were observed in the paved area in front and around the sides of the building. No evidence of sand boils was observed in the immediate area of the building, although sand boils erupted on Sandholdt Road in front, north, and south of the pier.

Figure 20.—Appearance of Monterey Bay Aquarium Research Institute technology building 3 days after earthquake. A, Building exterior. B, Building interior.

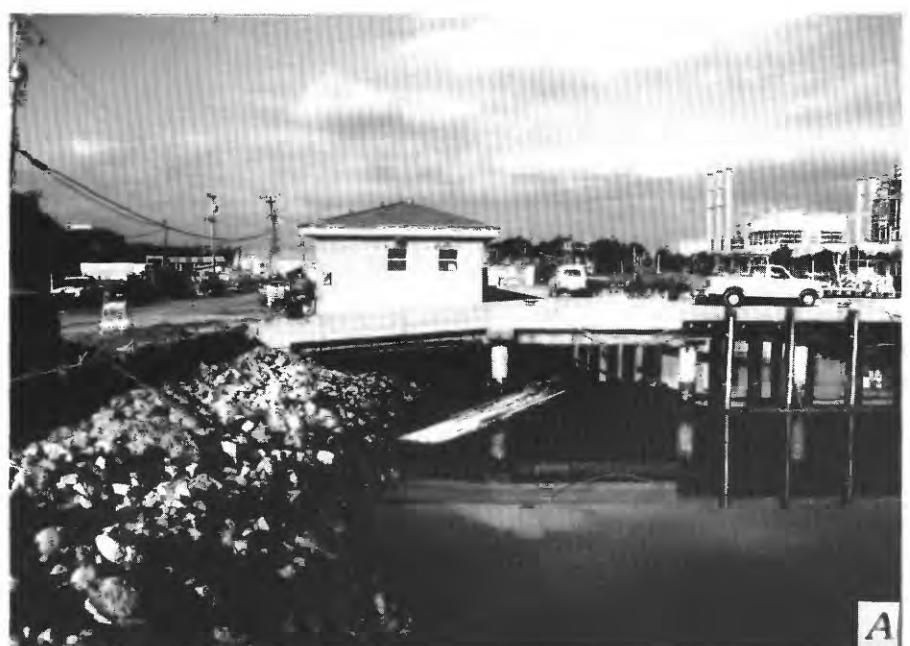
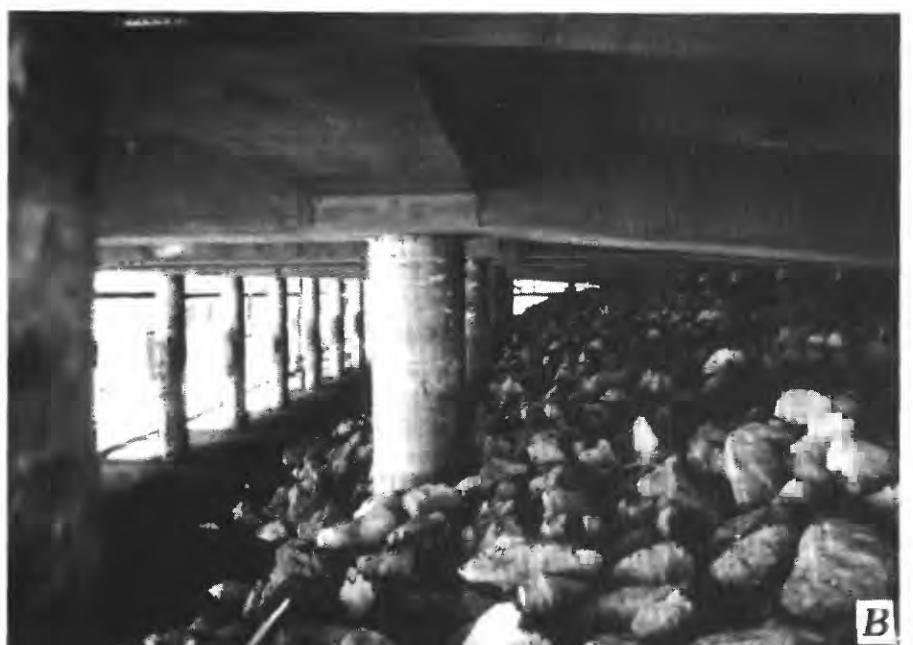
of the concrete deck on the north side of the pier are shown in figures 21A and 21B, respectively. Evidence of small movements in the form of minor concrete spalling was observed at the joints between some of the piles and the deck. Lateral displacements of the edge of the road toward the harbor were about 10 in. and 3 in. just north and south of the pier, respectively; however, the pier appears to have been displaced laterally toward the harbor less than about 1 in.

Figure 21.—Appearance of Monterey Bay Aquarium Research Institute pier 3 days after earthquake. A, South side of pier. B, Under-side of concrete deck.

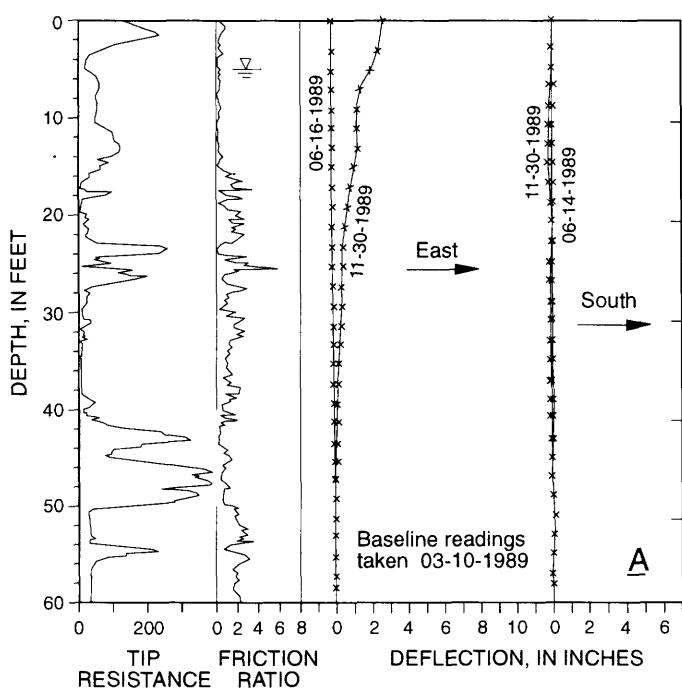
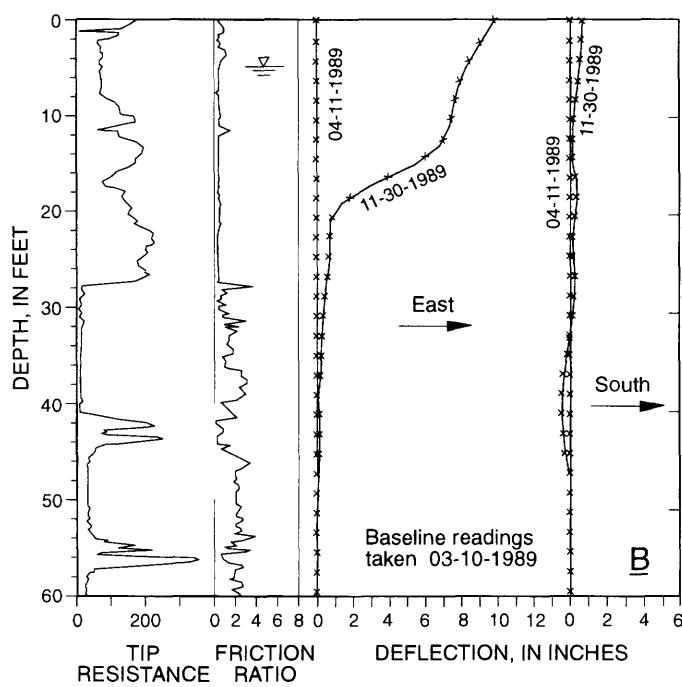
The horizontal deflections measured after the earthquake with a slope inclinometer (SI-5, fig. 19) located on the east edge of Sandholdt Road, about 20 ft north of the MBARI pier, are plotted in figure 24A, along with the log of a CPT sounding by Rutherford and Chekene (1988) located within about 10 ft of the inclinometer. The deflections measured with another slope inclinometer (SI-4, fig. 19) located about 20 ft south of the pier, within about 5 ft of another Rutherford and Chekene CPT sounding, are plotted in figure 24B. The edge of the road north of the pier moved about 10 in. towards the harbor, and south of the pier about 3 in. Movements parallel to the road were small.

The movements north of the MBARI pier appear to have resulted primarily from liquefaction of a medium-dense lens of sand at 13- to 19-ft depth. The observed deformations correspond to an approximately uniform shear strain of about 8 percent over a depth interval of 6 ft. Interestingly, the slope-inclinometer deflections suggest that deformation also occurred in the clayey silt and silty sand at about 28- to 36-ft depth. South of the pier, liquefaction appears to have occurred in the loose to medium-dense sand immediately below the water table at 5 to 7-ft depth, and in the clayey silt and silty sand at about 15- to 22-ft and 28- to 40-ft depth. No deformations occurred in the soils below 40-ft depth.

Figure 24.—Cone-penetration resistance (in tons per square foot), friction ratio (in percent), and deflection measured in slope inclinometers SI-4 (A) and SI-5 (B) (see fig. 19 for locations) versus depth at east edge of Sandholdt Road north (B) and south (A) of Monterey Bay Aquarium Research Institute pier.

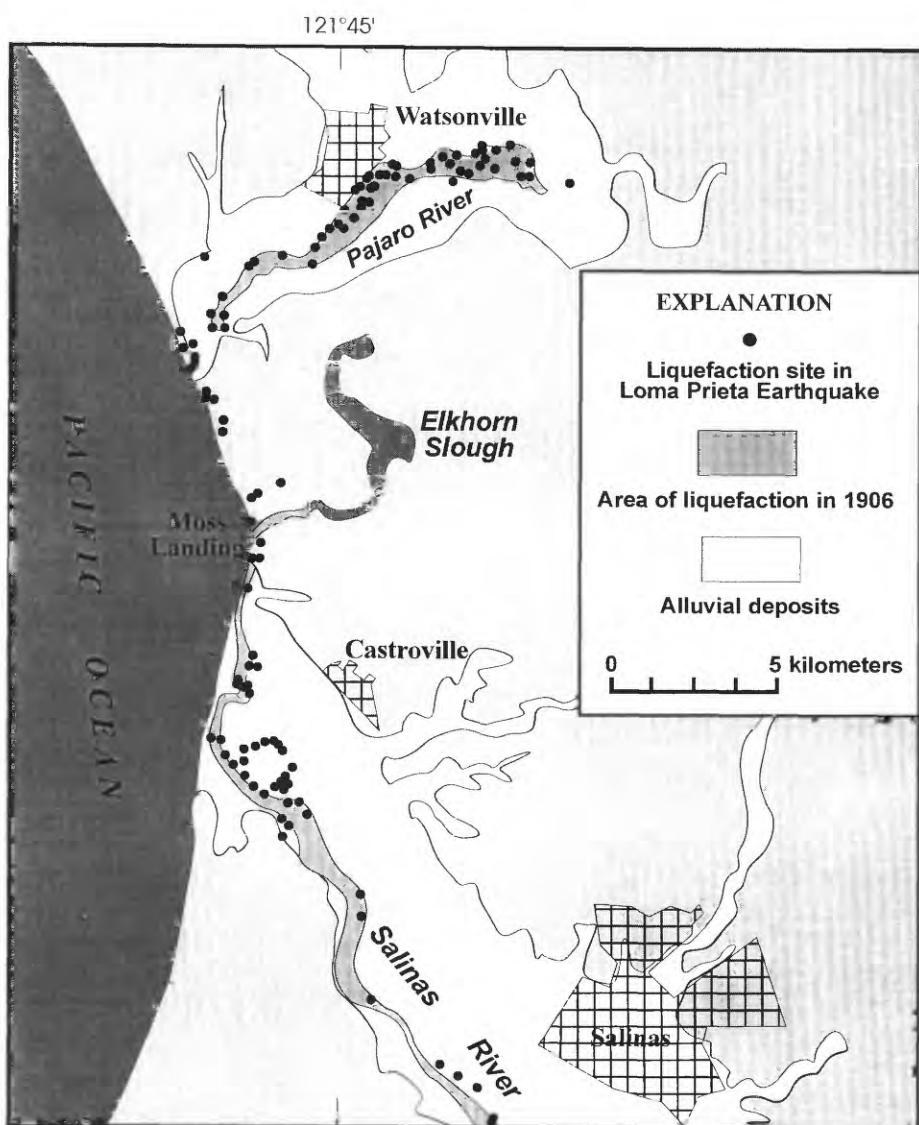
Figure 2.—Area of Salinas and Pajaro Rivers, showing regional distribution of earthquake-induced liquefaction in 1906 San Francisco and 1989 Loma Prieta earthquakes.

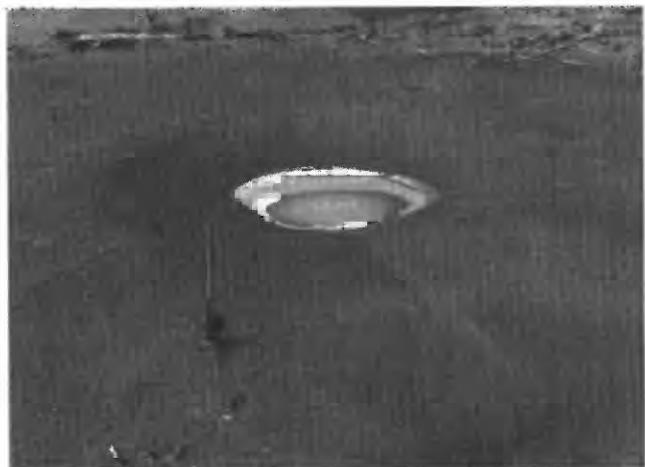
Figure 4.—Sandblow reactivated by March 23, 1991,  $M=4.6$  aftershock. Surface is smooth in comparison with eroded and vegetated cones shown in figures 5 and 7. Diameter of vent between arrows is approximately 30 cm. Photograph taken March 26, 1991.

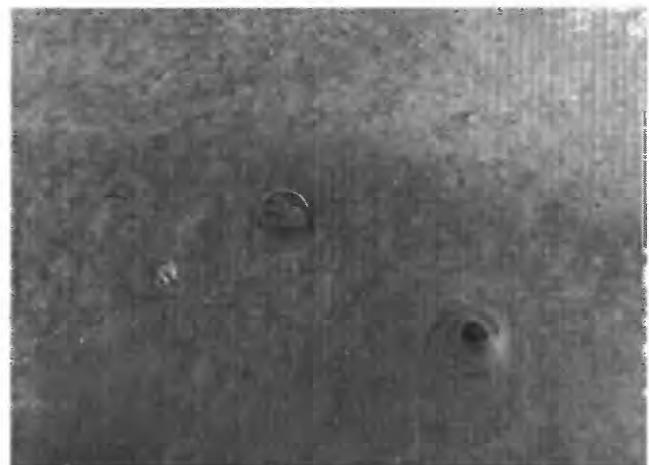
Figure 6.—Microvent on flank of cone reactivated in March 23, 1991, aftershock. Diameter of microvent is approximately 1 cm. Photograph taken March 26, 1991.

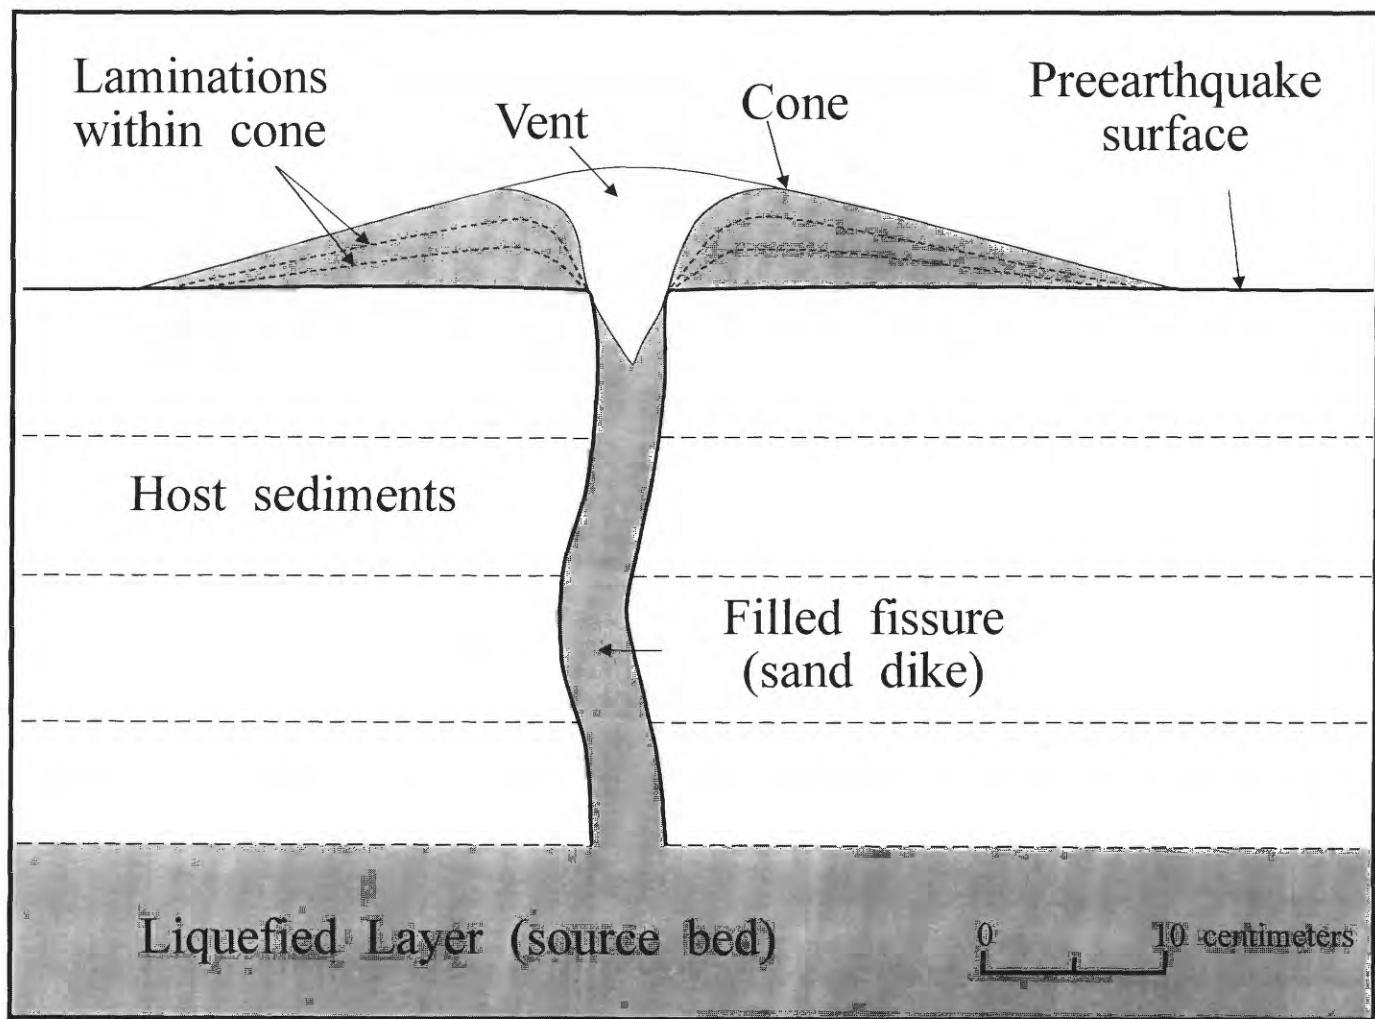
Figure 8.—Schematic cross section of a sandblow, showing typical stratigraphic and structural relations and terminology used in this paper.
