# The Loma Prieta, California, Earthquake of October 17, 1989— Liquefaction

THOMAS L. HOLZER, *Editor*

STRONG GROUND MOTION AND GROUND FAILURE

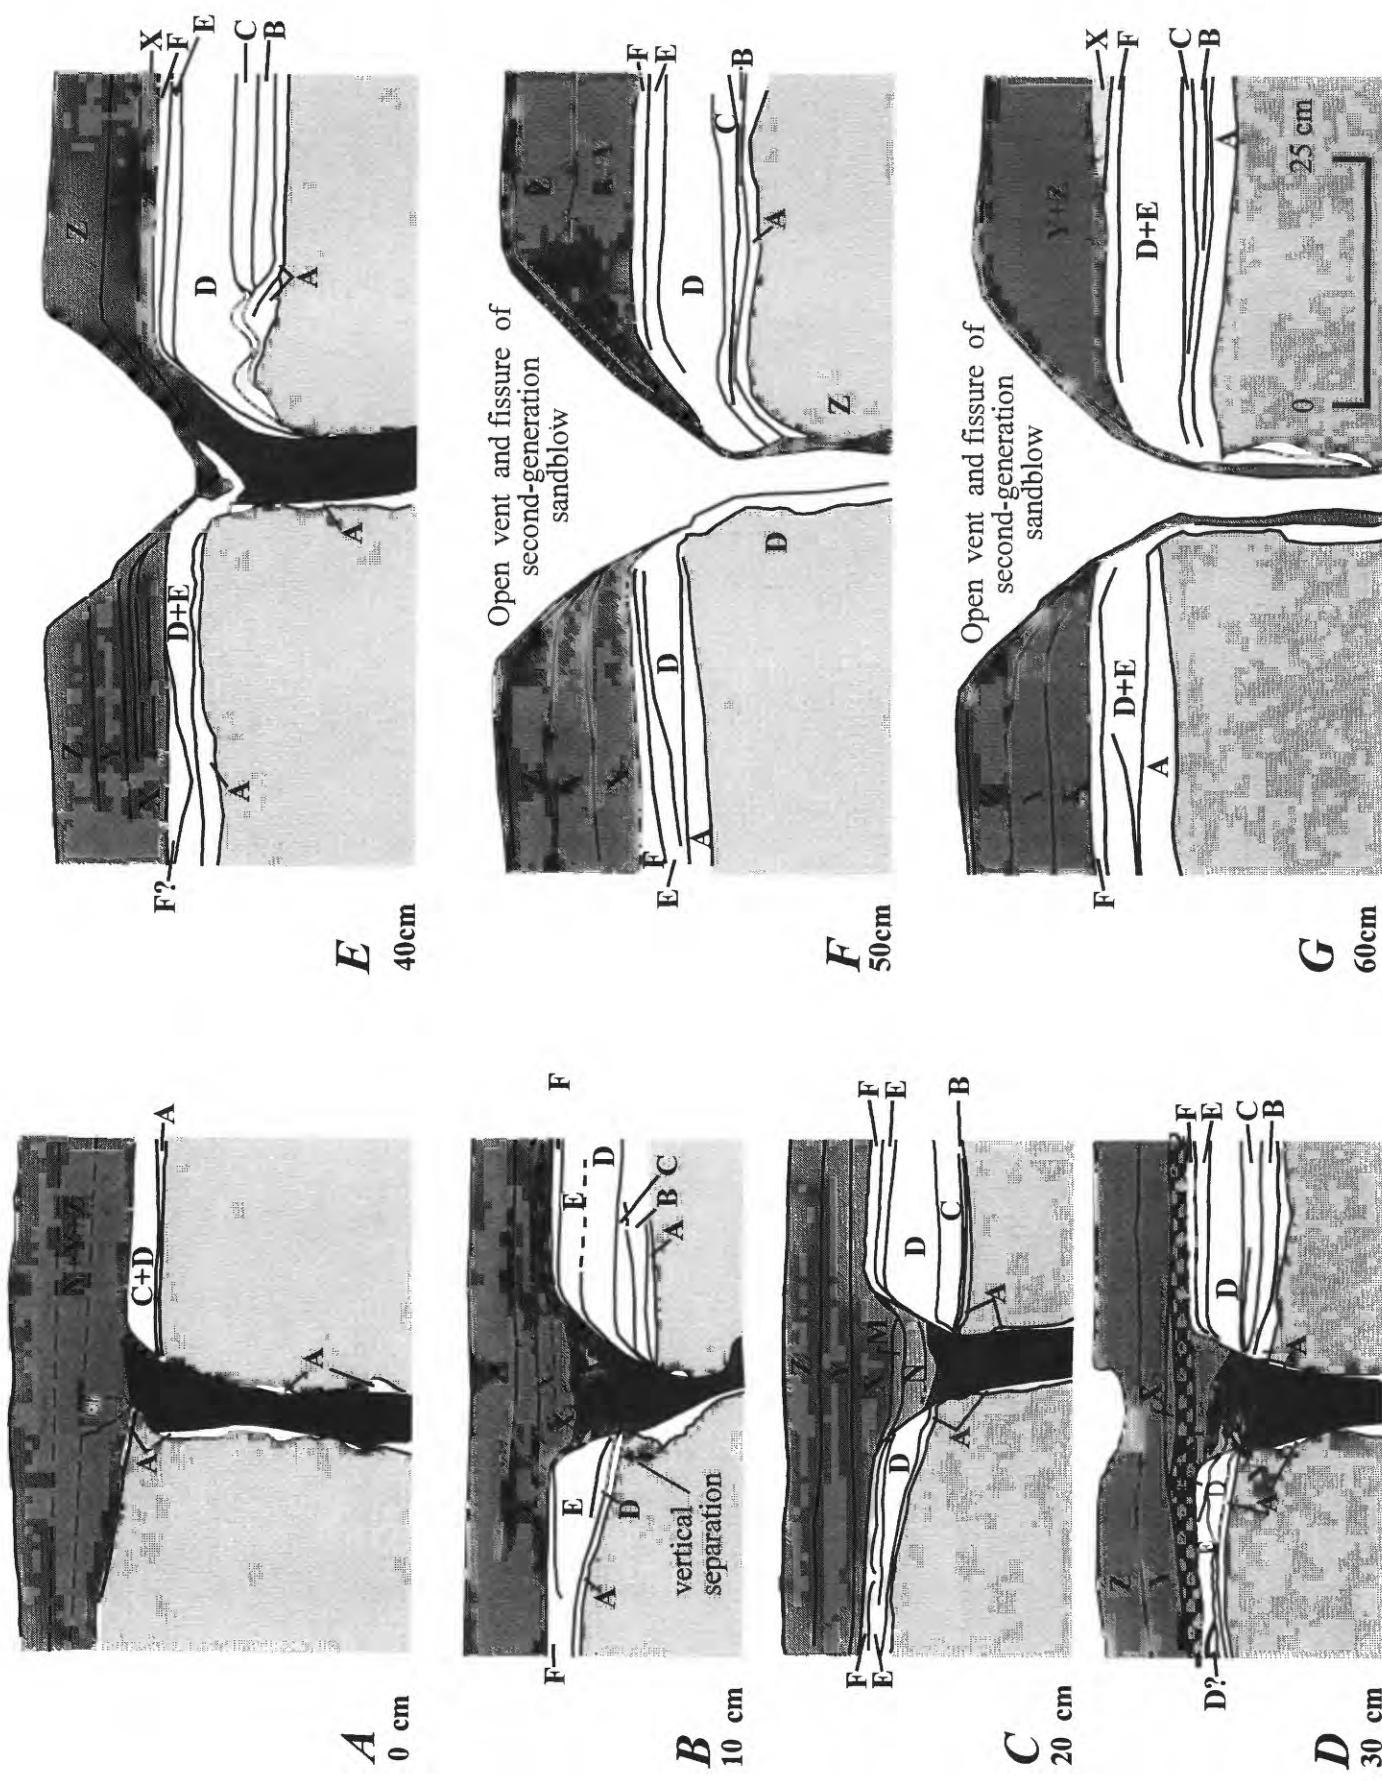
Unit I, consisting of subunits A through F (fig. 9), is composed of laminated fine sand and silt that overlies a basal subunit of coarse sand. The upper surface of unit I consists of an irregular silt lamina, about 3 to 5 mm thick, with desiccation cracks and raindrop impressions (fig. 9B).

At least six subunits, A through F, are present on the downthrown side of the fissure (fig. 9). Subunit A, the basal subunit of the cone, is composed of wavy-laminated, laterally discontinuous coarse sand that rests directly on the lake bed surface. Subunit B consists of parallel-laminated, fining-upward, medium to fine sand that is laterally more extensive than subunit A. The upper boundary of subunit B is a zone of discontinuous dark mineral laminations composed of silt-size grains. Subunit C consists of wavy-laminated, fining-upward, fine to medium sand. The upper contact of subunit C is marked by a diffuse, thick, dark lamina (fig. 9B). Subunit C is overlain by subunits D through F, a sequence of three layers of fining-upward, fine to medium sand with faint dark, discontinuous laminations (figs. 9B, 9C).

Cone deposits on the upthrown side of the fissure are less complex and less extensive (fig. 9). The basal subunit is a thin, coarse sand identical to subunit A on the downthrown side. In cross sections at intervals 40, 50, and 60 cm, subunit A is overlain by dark deposits similar to, but thinner than, subunits B and C. This subunit is overlain by a sequence of three subunits identical to subunits D through F on the downthrown side of the fissure.

Figure 9.—Schematic drawing based on photographs of serial sections through sediment in trench 2 in Soda Lake (see fig. 3 for location), showing host sediment, feeder dikes, and cone deposits that formed after October 17, 1989, Loma Prieta earthquake and April 18, 1990, aftershock. Feeder sand dikes cut well-bedded, laminated host sediment that is vertically offset as much as 3 cm across fissure. Downdropped side of fissure is to right toward center of lake. Finely laminated surface cone deposit is composed of two groups of subunits: A through F are deposits from October 17, 1989, Loma Prieta earthquake, and X through Z are from April 18, 1990, aftershock. October 17, 1989, deposits are subdivided into two depositional stages represented by subunits A through C and D through F. Serial sections at intervals 40, 50, and 60 cm progressively expose open vent and fissure that resulted from the April 18, 1990, episode of sandblast deposition. This vent probably remained open after October 17, 1989, earthquake and was reactivated during April 18, 1990, aftershock. Subunits N and M in serial sections at intervals 10, 20, and 30 cm are deposits of windborne and waterborne sediment that filled vent depression after first phase of sandblast formation.

Deposition of the lowest subunits of unit I was strongly controlled by vertical separation along the fissure (fig. 9). Cone building on the lower side of the fissure was favored until the vertical offset on the lakebed surface was eliminated. Deposition of multiple subunits built the cone during a second stage of formation. These two stages of cone building are also apparent in the dike of this sandblow. The final stage of formation of the sandblow was during the waning stages of flow, when waterflow had decreased to the point that sedimentation occurred in part of the vent. Deposition in standing water resulted in an irregularly laminated sequence in the vent depression. These late-stage deposits overlie, in part, the feeder-dike deposits (fig. 9B-9D).

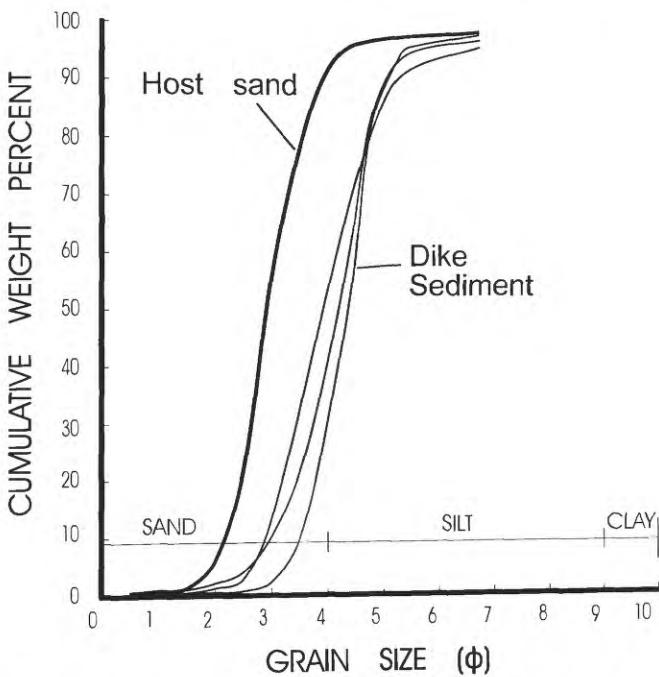
Sand dikes are subsurface deposits of dewatered liquefied sediment that fill fissures. The dikes are composed of well-sorted, fine to medium sand (fig. 10). Some of the sand-dike deposits contain laminations subparallel to parallel to the fissure wall (fig. 11). In cross section, the walls of sand dikes are undulatory, and most of the con-

Figure 10.—Grain size versus cumulative weight percent of sand-dike material and sandy host sediment.

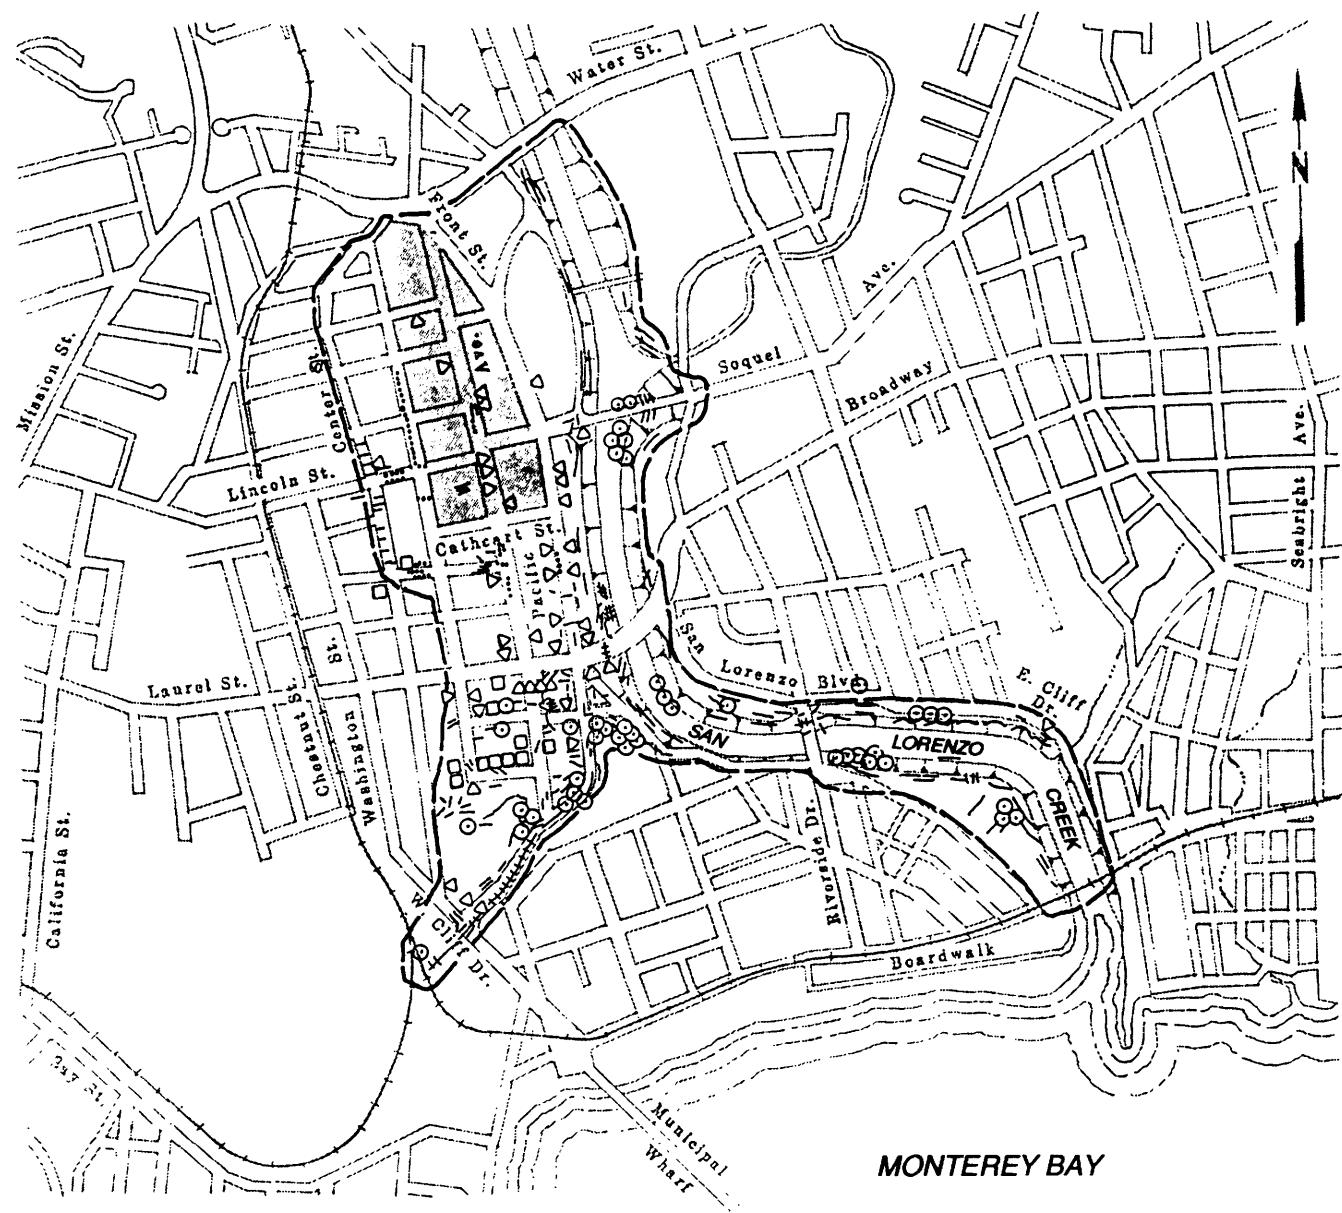
Kropp and Thomas (1991) performed detailed mapping of ground-failure features in downtown Santa Cruz on October 18, 19, and 20, 1989. By October 21 and 22, heavy rains had obscured much of the ground failure evidence. The locations of ground-failure features, mostly along San Lorenzo Creek are shown in figure 2. Note that the investigation and mapping were conducted after at least one tidal fluctuation in the San Lorenzo River. Therefore, more sand boils and lateral spreads probably formed in the immediate river channel than are shown in figure 2.

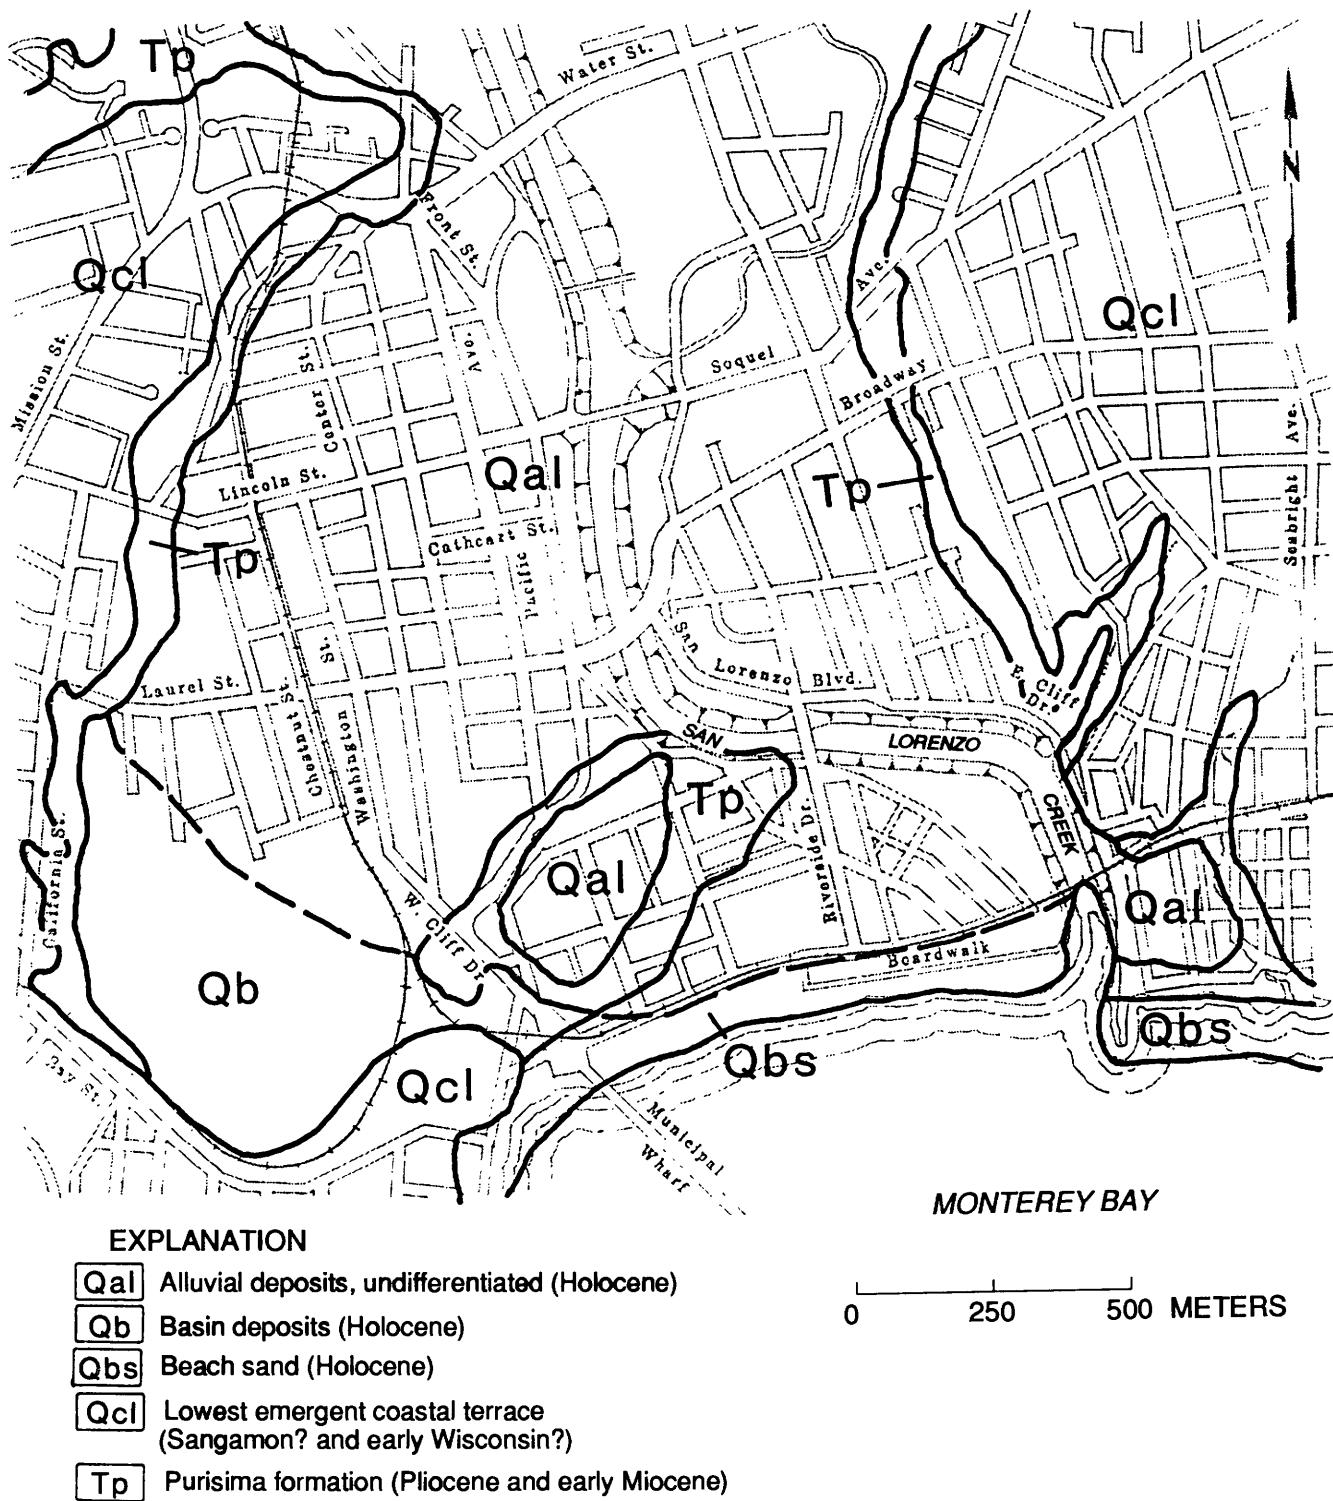
Liquefaction from the earthquake occurred primarily within an area of undifferentiated Holocene alluvial deposits previously mapped by Dupré (1975) and Brabb (1986) (fig. 3). The city of Santa Cruz had previously classified these deposits as having a high liquefaction susceptibility (fig. 4). Kropp and Thomas (1991) compared the observed damage features after the earthquake with Dupré's mapping and found that the area in which liquefaction had actually occurred in 1989 was included within Dupré's area of predicted high liquefaction susceptibility.

Figure 3.—Geologic map of downtown Santa Cruz. After Dupré (1975) and Brabb (1986).

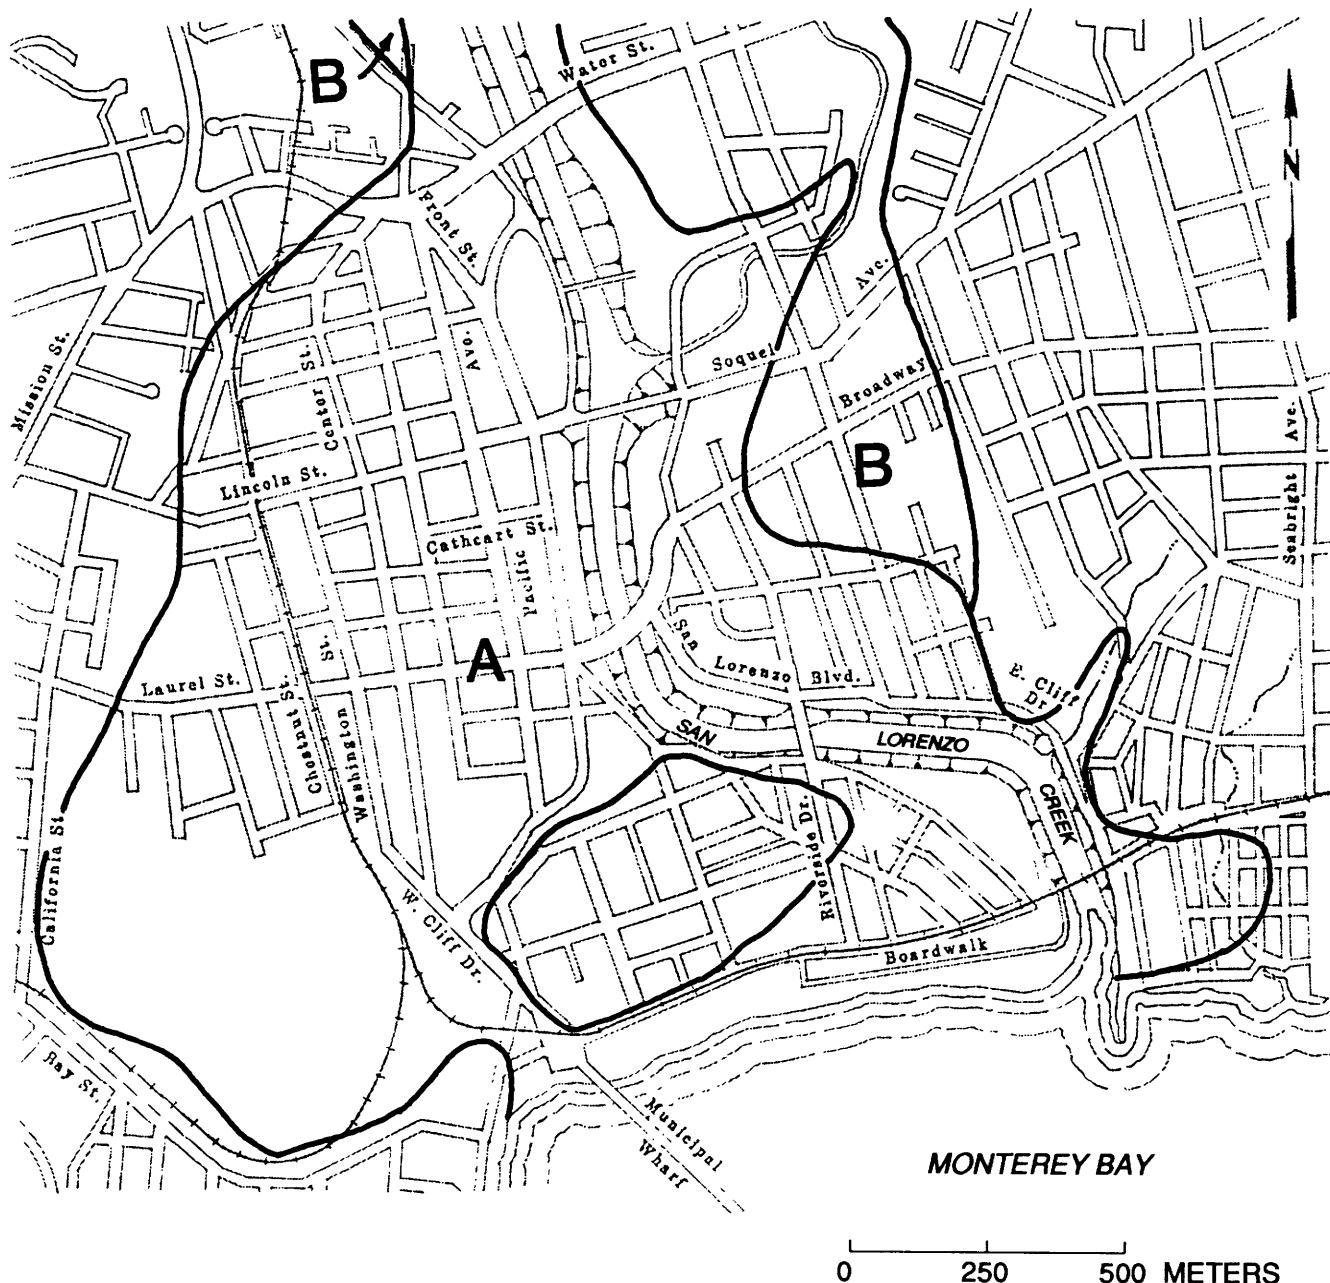
Nonetheless, liquefaction features were absent in a significant part of zone A in figure 4. Therefore, in our investigation, we conducted tests both at sites where liquefaction was observed and at sites where no evidence of liquefaction was observed (fig. 5). Liquefaction was confirmed at sites SC03 and SC14 by sand boils. At site SC02, lateral spreading had been reported. At the other three test sites (SC04, SC05, SC13), no clear evidence of liquefaction was observed. DMT's and SCPT's were performed at each site approximately 2 m apart.

Figure 4.—Downtown Santa Cruz, showing zones of high (A) and moderately high (B) liquefaction susceptibility. From City of Santa Cruz (1976).

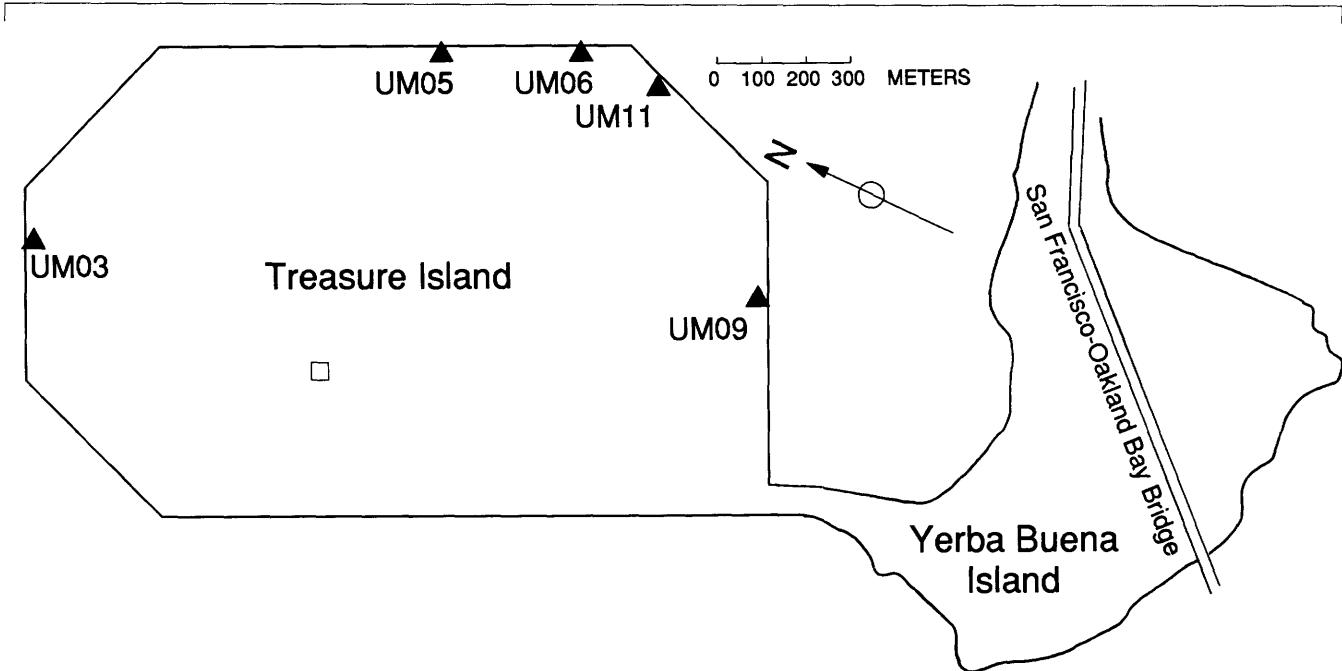
The best performance of the retaining systems was on the west and north sides of the island. No damage was evident at site UM03 (fig. 7), although some liquefaction did occur in adjacent inland areas and a large slump of the retaining system occurred northeast of site UM03. As much as 9 cm of vertical settlement was observed adjacent to a building approximately 60 m inland from site UM09. At site UM05, some 9 cm of horizontal dis-

placement of the soil was observed. In addition, 5 cm of vertical settlement was observed 30 m away. At site UM06, sand boils and 12 to 15 cm of horizontal movement of the levee were observed. Liquefaction was observed at site

UM11; however, soils in an area immediately south of site UM11 has been improved by vibroflotation and were undamaged. We were unable to perform any tests in this area.

Figure 7.—Sketch map of Yerba Buena Island and Treasure Island, showing locations of test sites.

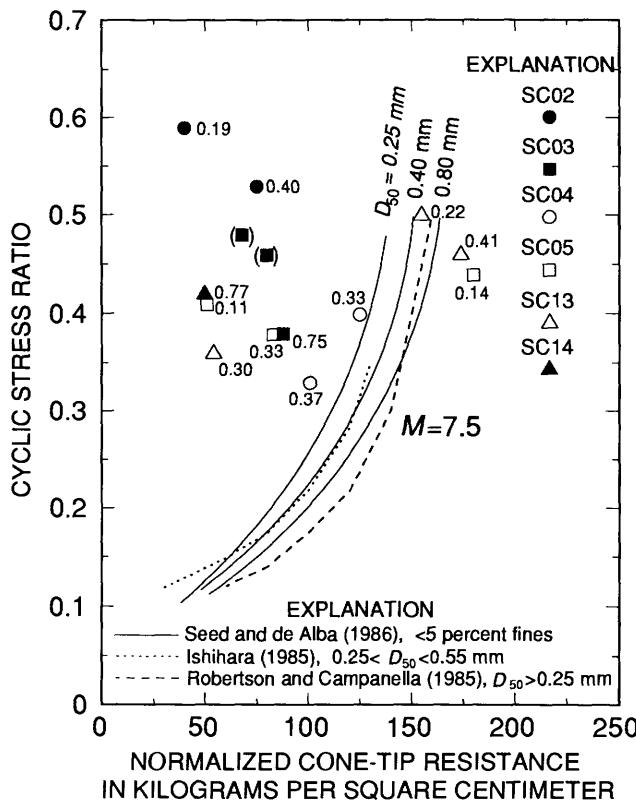
For Santa Cruz, correlation of our results with field performance is more difficult, owing to soil stratification. On the basis of CPT results, it appears that when the ratio of layer thickness to center depth ( $t/z$ ) was less than approximately 0.4, ground damage and the formation of surface liquefaction features did not occur, despite possible subsurface liquefaction. We also note that the material index averages 4.3 (suggesting clean sand) at test sites with surface evidence of liquefaction but only 3.0 (suggesting silty sand) at test sites with no surface evidence of liquefaction.

Figure 8.—Cone-penetration-test results at sites in Santa Cruz (see fig. 5 for locations). Solid data points denote sites with surface evidence of liquefaction. Values near data points indicate ratio of thickness of liquefiable layer to its center depth ( $t/z$ ); data points in parentheses denote sites where  $t/z < 0.1$ .

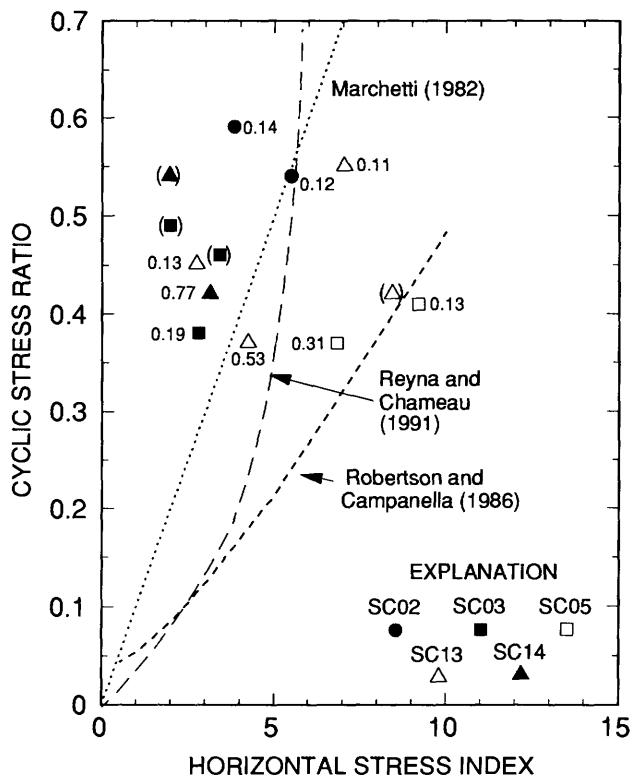
Figure 9.—Flat-plate-dilatometer-test results at sites in Santa Cruz (see fig. 5 for locations). Solid data points denote sites with surface evidence of liquefaction. Values near data points indicate ratio of thickness of liquefiable layer to its center depth ( $t/z$ ); data points in parentheses denote sites where  $t/z < 0.1$ .

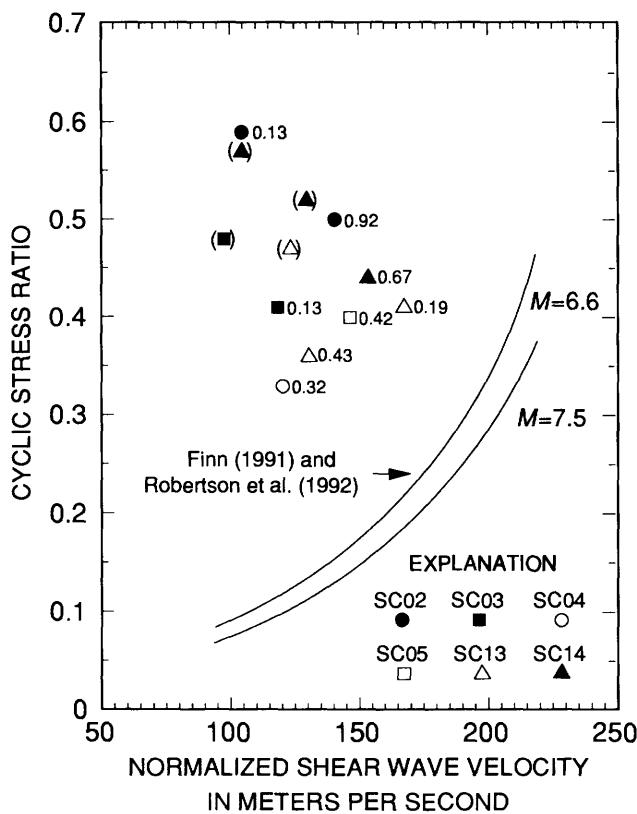
Figure 10.—Shear-wave-velocity results at sites in Santa Cruz (see fig. 5 for locations). Solid data points denote sites with surface evidence of liquefaction. Values near data points indicate ratio of thickness of liquefiable layer to its center depth ( $t/z$ ); data points in parentheses denote sites where  $t/z < 0.1$ .

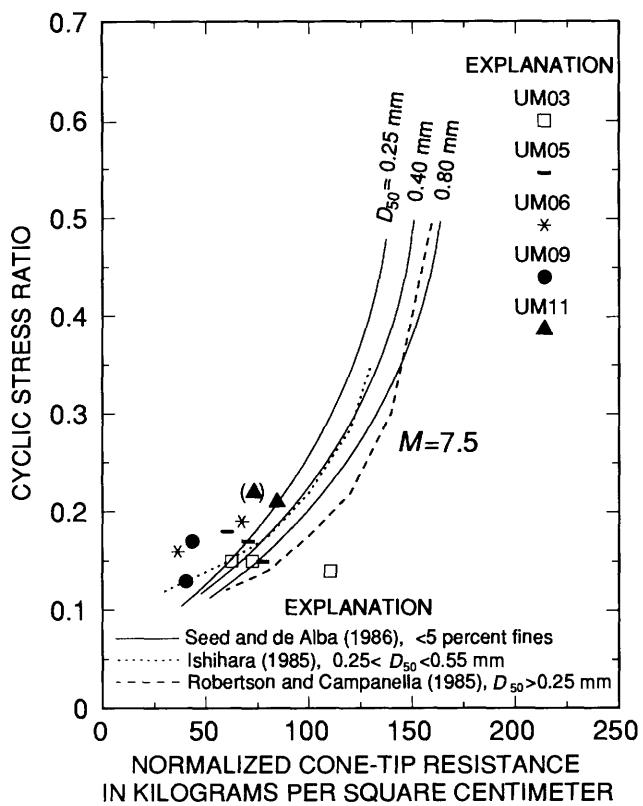
Figure 11.—Cone-penetration-test results at sites on Treasure Island (see fig. 7 for locations). Solid data points denote sites with surface evidence of liquefaction. Data point in parentheses denotes site where  $t/z < 0.1$ .

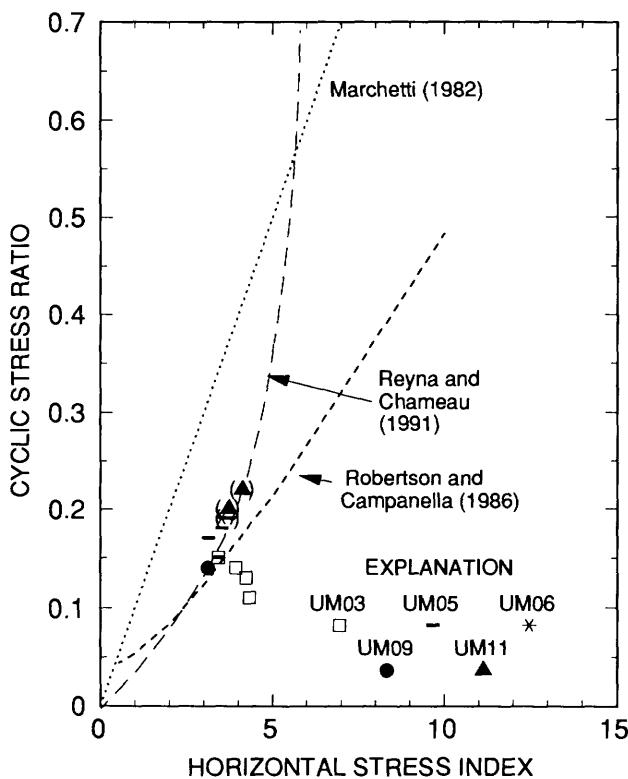
Figure 12.—Flat-plate-dilatometer-test results at sites on Treasure Island (see fig. 7 for locations). Solid data points denote sites with surface evidence of liquefaction. Data points in parentheses denote sites where  $t/z < 0.1$ .

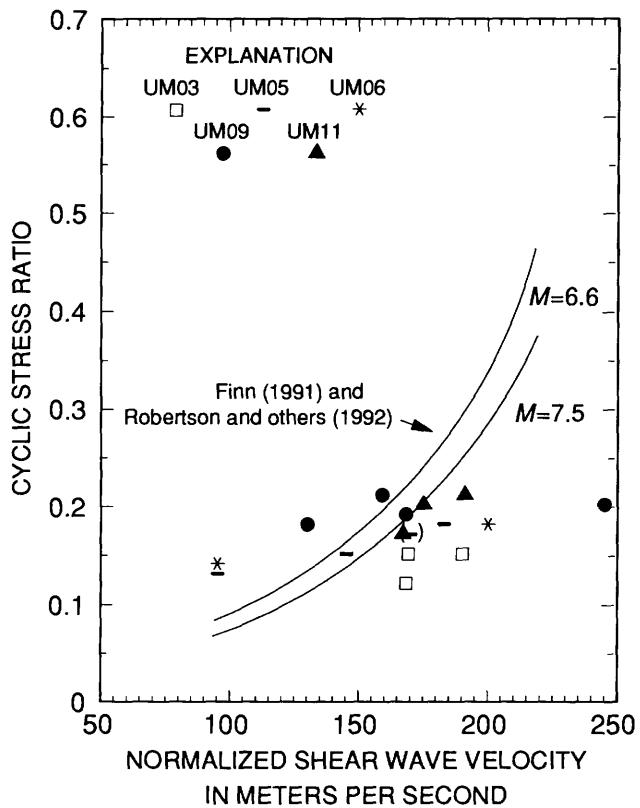
Figure 13.—Shear-wave-velocity results at sites on Treasure Island (see fig. 7 for locations). Solid data points denote sites with surface evidence of liquefaction. Data point in parentheses denotes site where  $t/z < 0.1$ .

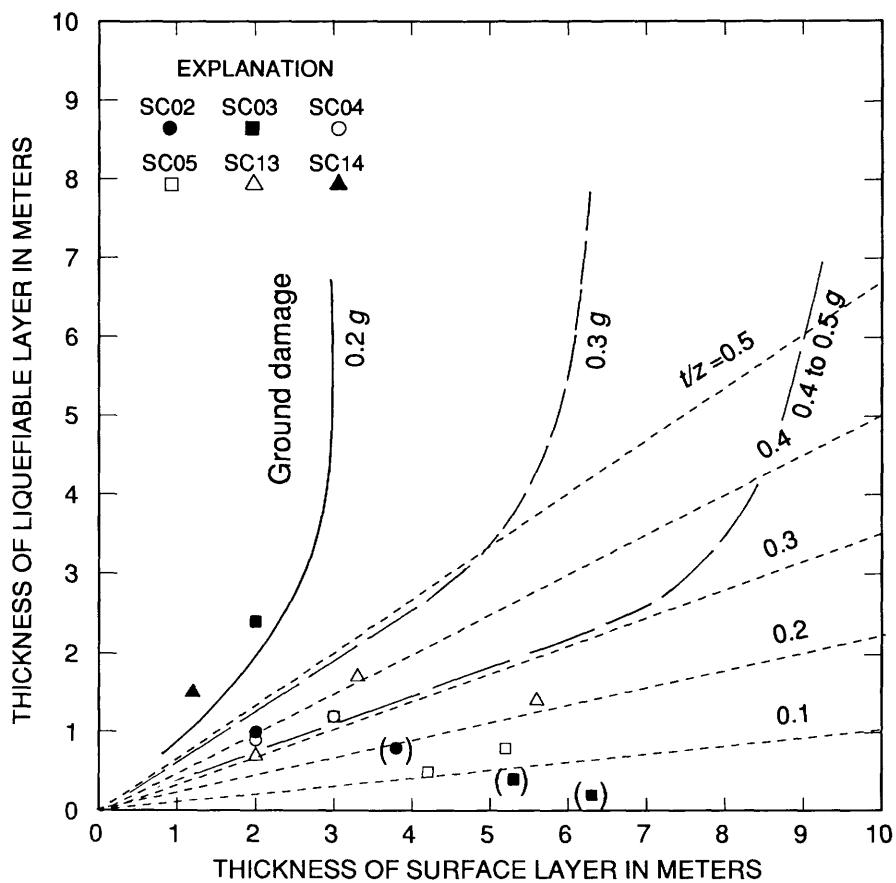
Ishihara (1985) studied the effects of nonliquefiable surface layers. He suggested that the ground damage at sites with nonliquefiable surface layers is also related to the peak accelerations. Ishihara compared the thickness of the liquefiable layer with that of the surface layer, as shown in figure 14, rather than using a  $t/z$  ratio. Nevertheless, the  $t/z$  ratio is easily convertible to Ishihara's approach, as shown in figure 14. The test data for Santa Cruz are also plotted in figure 14. We note that the observed  $t/z=0.4$  threshold for ground damage corresponds to a suggested peak acceleration slightly smaller than that believed to have occurred in Santa Cruz. Therefore, an upward shift of the lower part of Ishihara's 0.4- to 0.5-g line may be warranted.

Figure 14.—Comparison of criterion of Ishihara (1985) for ground damage with observed  $t/z$  ratios at sites in Santa Cruz (fig. 5). Solid data points denote sites where ground damage occurred; data points in parentheses denote sites where ground damage was probably not attributable to secondary liquefiable layers. Three sloping curves illustrate approximate peak accelerations suggested by Ishihara.

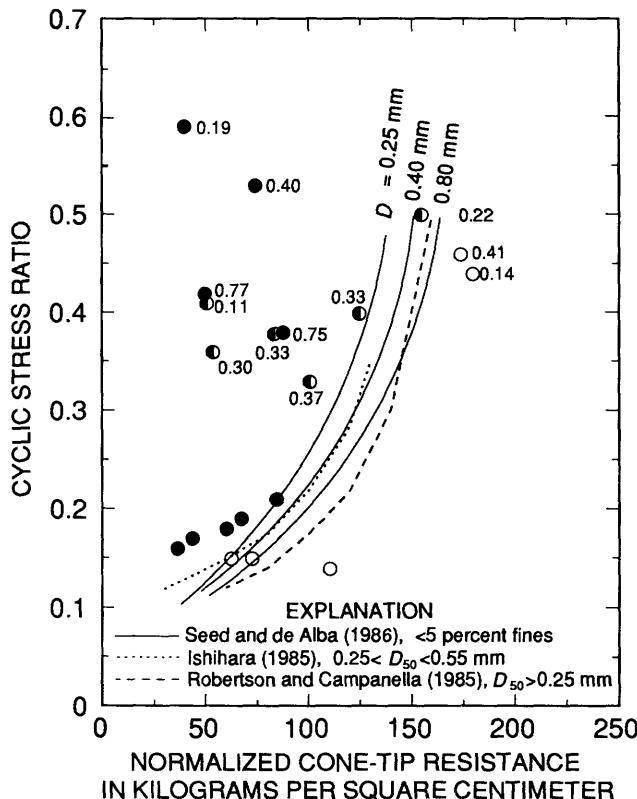
◀ Figure 15.—Combined cone-penetration-test results (for critical layers only) at sites in Santa Cruz (fig. 5) and on Treasure Island (fig. 7). Values near data points indicate ratio of thickness of liquefiable layer to its center depth ( $t/z$ ). Dots, sites with surface evidence of liquefaction; circles, sites with no surface evidence of liquefaction where  $t/z > 0.4$ ; half-solid circles, sites with no surface evidence of liquefaction where  $t/z < 0.4$ . Data for sites in Santa Cruz where  $t/z < 0.1$  are omitted.

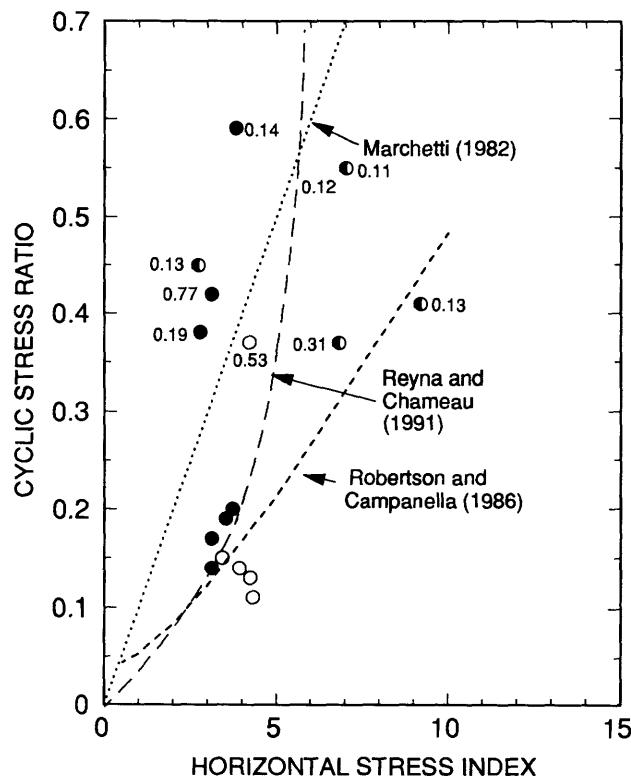
◀ Figure 16.—Combined flat-plate-dilatometer-test results (for critical layers only) at sites in Santa Cruz (fig. 5) and on Treasure Island (fig. 7). Values near data points indicate ratio of thickness of liquefiable layer to its center depth ( $t/z$ ). Dots, sites with surface evidence of liquefaction; circles, sites with no surface evidence of liquefaction where  $t/z > 0.4$ ; half-solid circles, sites with no surface evidence of liquefaction where  $t/z < 0.4$ . Data for sites in Santa Cruz where  $t/z < 0.1$  are omitted.

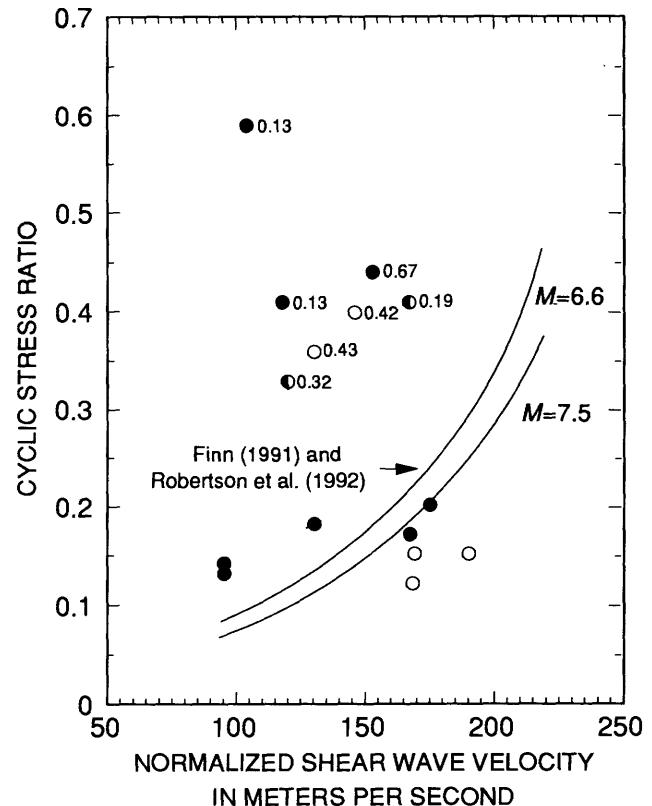
Figure 17.—Combined shear-wave-velocity results (for critical layers only) at sites in Santa Cruz (fig. 5) and on Treasure Island (fig. 7). Values near data points indicate ratio of thickness of liquefiable layer to its center depth ( $t/z$ ). Dots, sites with surface evidence of liquefaction; circles, sites with no surface evidence of liquefaction where  $t/z > 0.4$ ; half-solid circles, sites with no surface evidence of liquefaction where  $t/z < 0.4$ . Data for sites in Santa Cruz where  $t/z < 0.1$  are omitted.

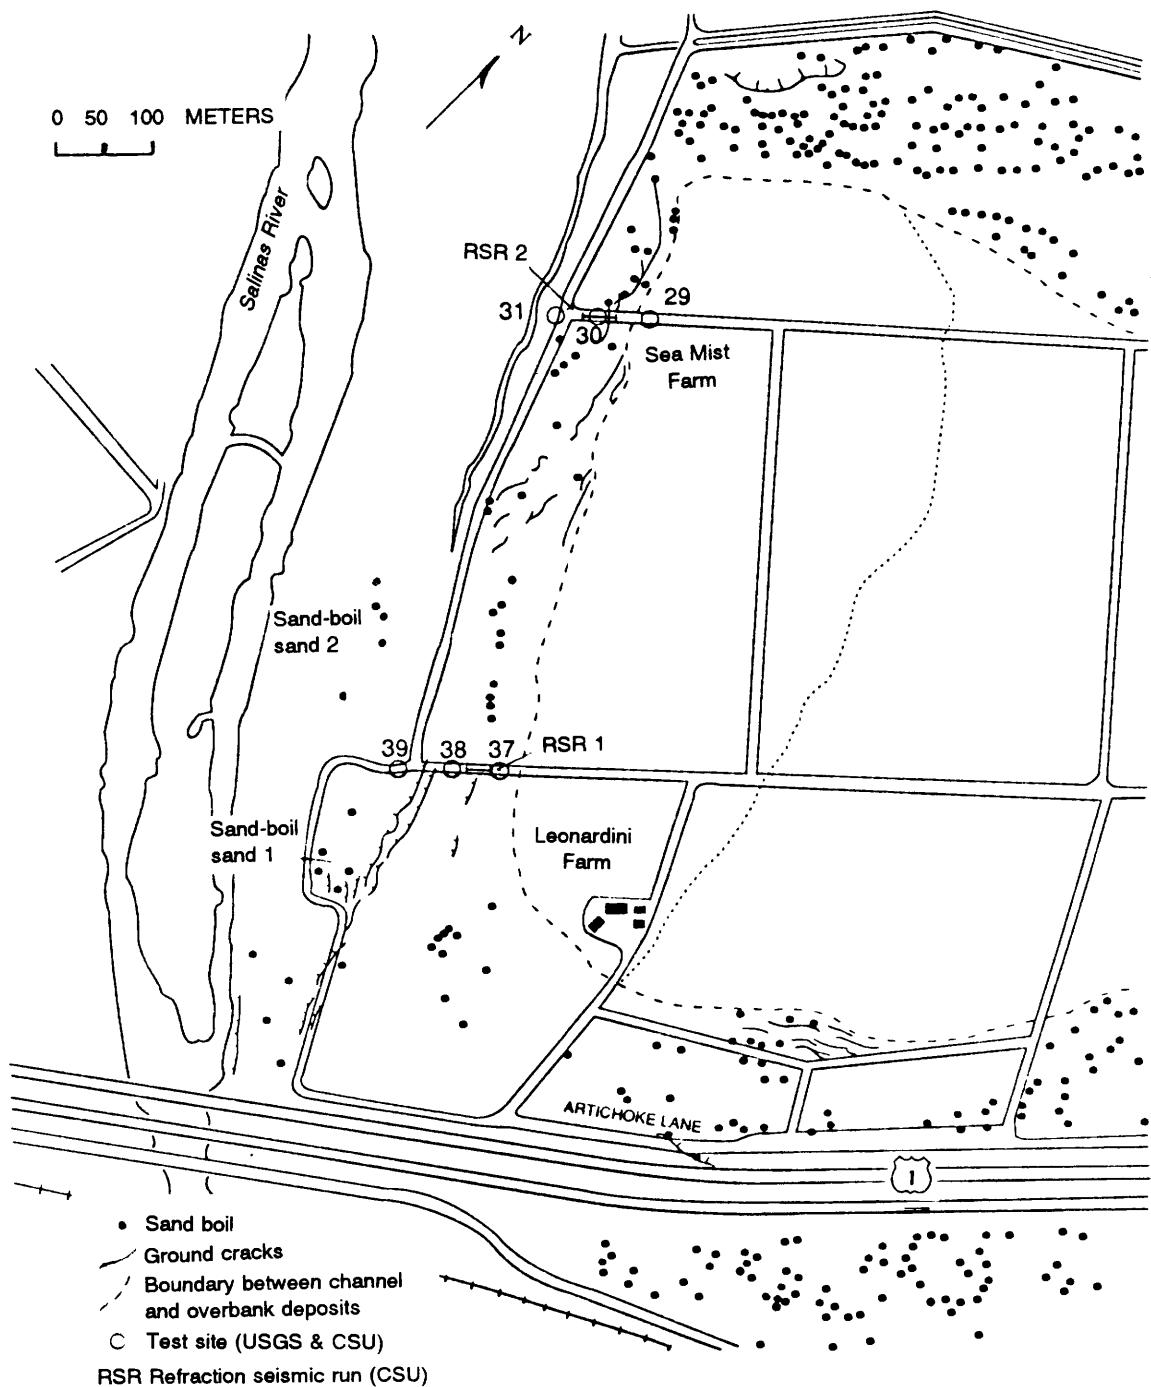
Figure 8.—Sea Mist-Leonardini Farms study site (fig. 7), showing locations of liquefaction features and tests by Colorado State University (CSU) and U.S. Geological Survey (USGS).

three study sites, indicating the presence of liquefiable soils. At the Sea Mist-Leonardini Farms study site (figs. 8, 13), extensive lateral spreads, ground cracks, and sand boils were confined to sedimentary deposits within a paleochannel meander bend. Sand boils, ground cracking, and lateral spreading at the Miller Farm (figs. 13, 14) decreased away from the Pajaro River where fine-grained sedimentary deposits are present. Sand layers that appear susceptible to liquefaction are interpreted as fluvial or estuarine in origin. Overbank deposits consist of silt and clay that did not liquefy. The channel sand layers shown

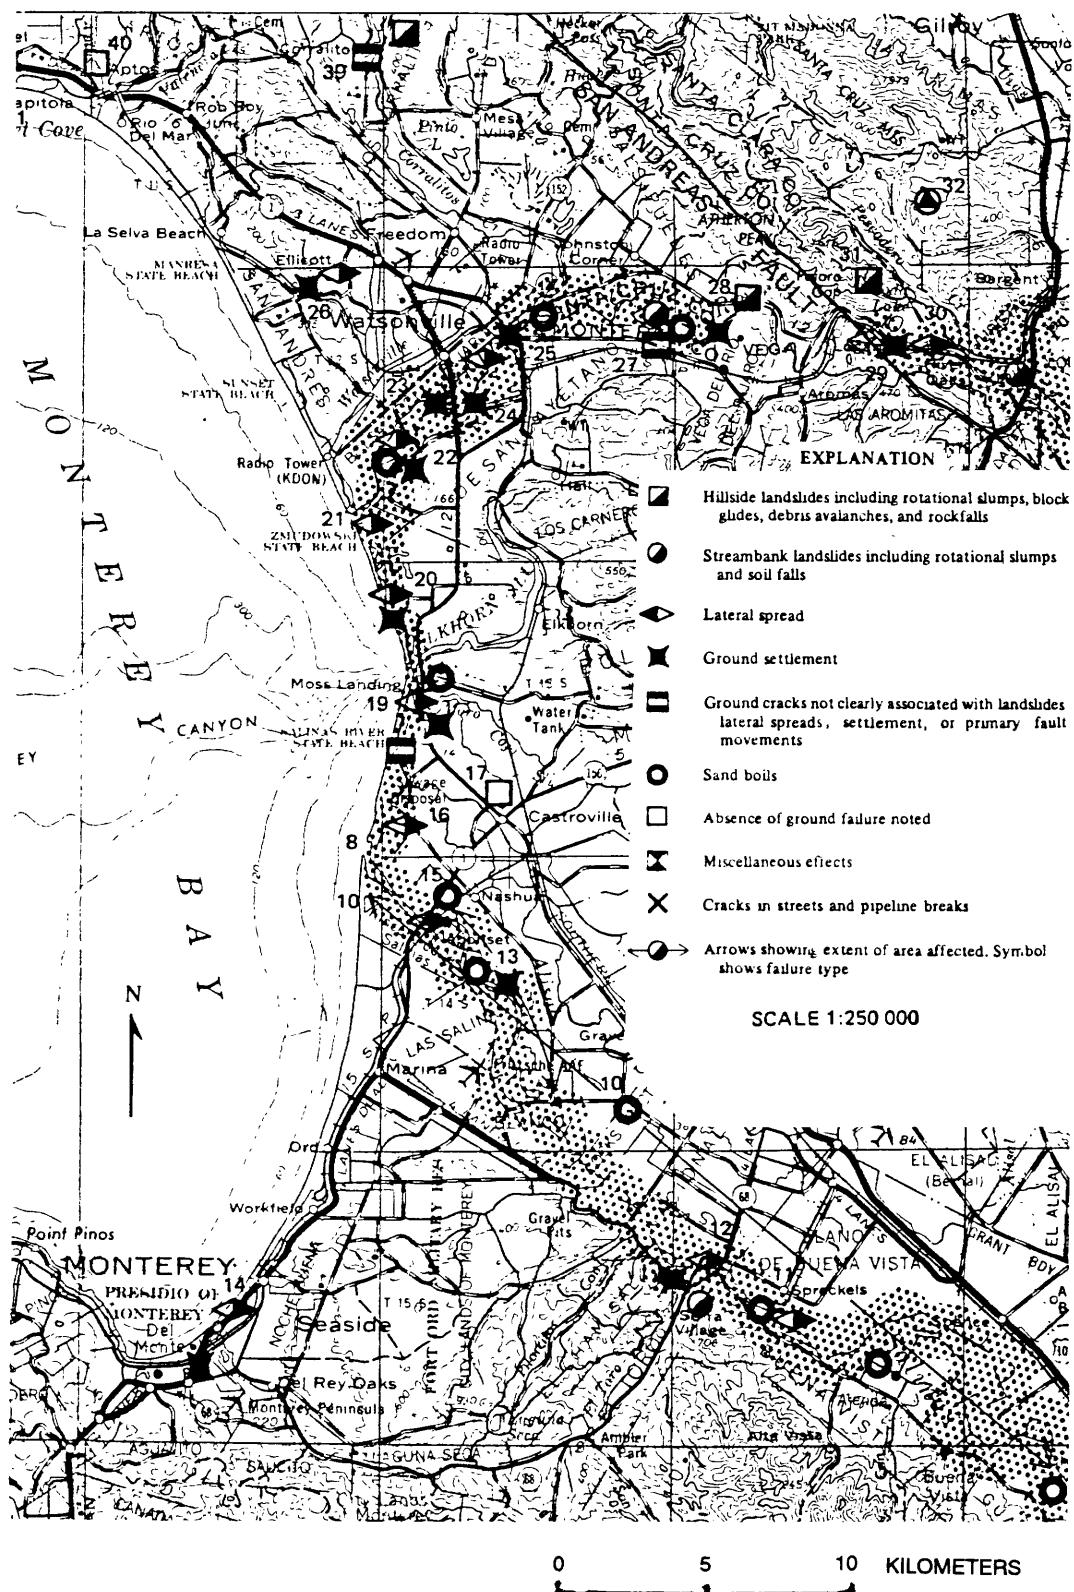
are shown in figure 16; the location of the borehole at test site CSU 48 is shown in figure 17. Extensive lateral spreading during the earthquake caused ground cracking and disrupted bridge pile supports that later required repairs. Ground cracking and extensive lateral spreading also occurred in the area during the 1906 San Francisco earth-

Figure 13.—Monterey Bay area, Calif., showing locations of ground failures induced by 1906 San Francisco earthquake. From Youd and Hoose (1978).

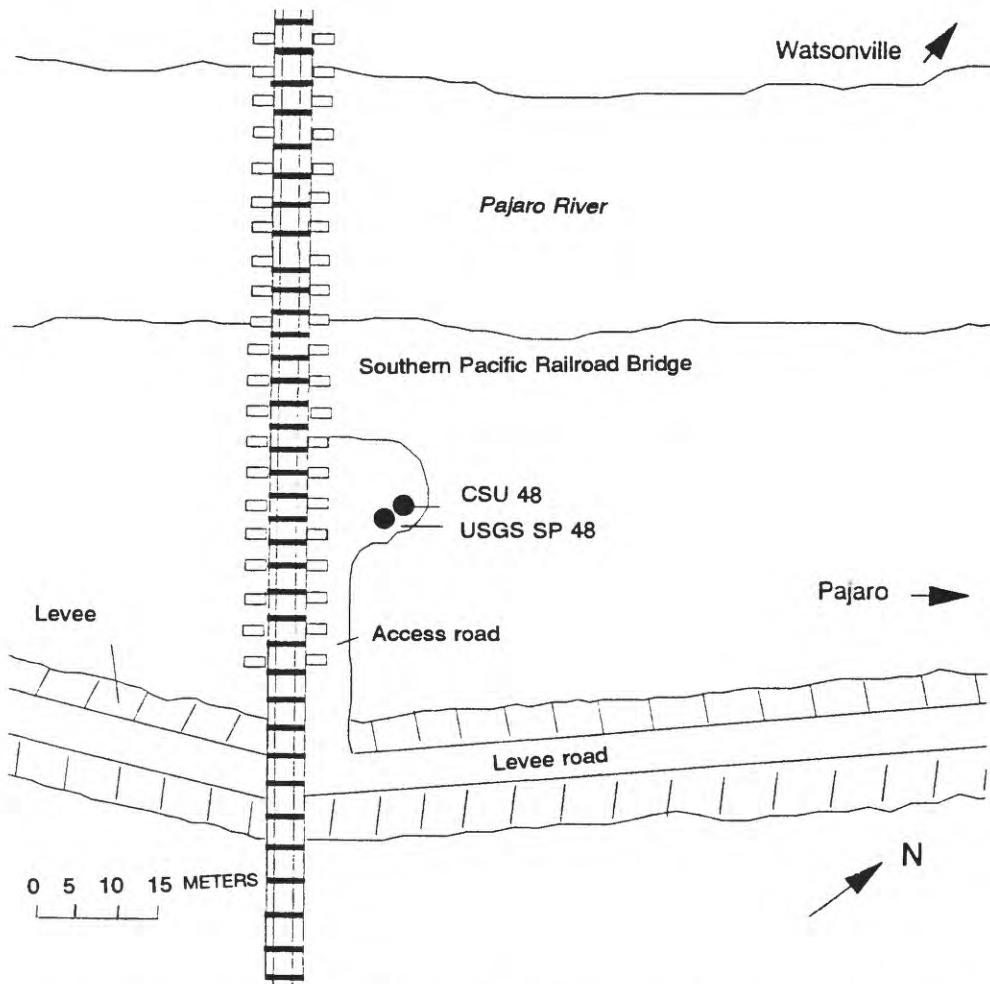
We conducted one Piezovane test (CSU 48, fig. 16) at the study site 10 m west of the damaged piles in soils in

Figure 16.—Southern Pacific Railroad Bridge study site (fig. 7), showing locations of tests by Colorado State University (CSU) and U.S. Geological Survey (USGS).
