# The Loma Prieta, California, Earthquake of October 17, 1989— Liquefaction

THOMAS L. HOLZER, *Editor*

STRONG GROUND MOTION AND GROUND FAILURE

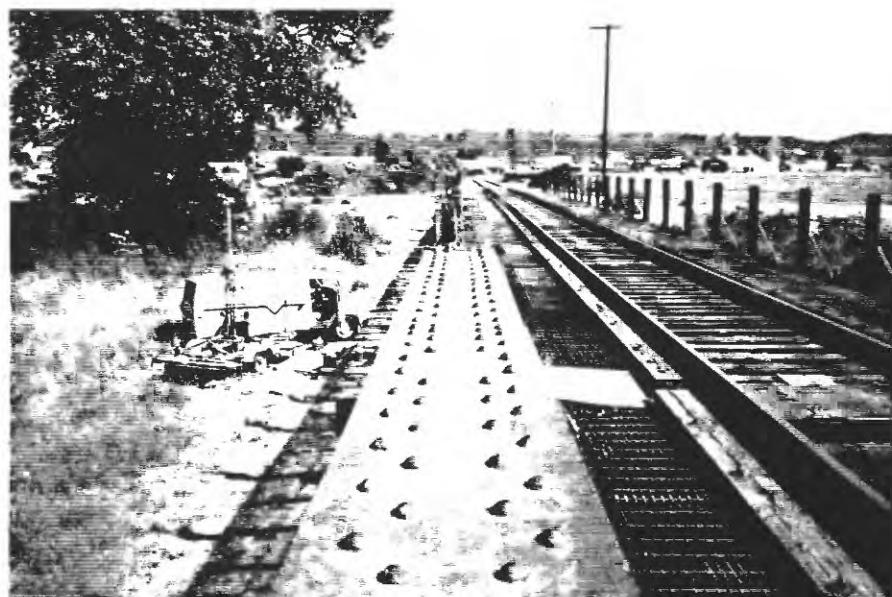
Figure 17.—Test site CSU 48 (fig. 16) at Southern Pacific Railroad Bridge study site (fig. 7).

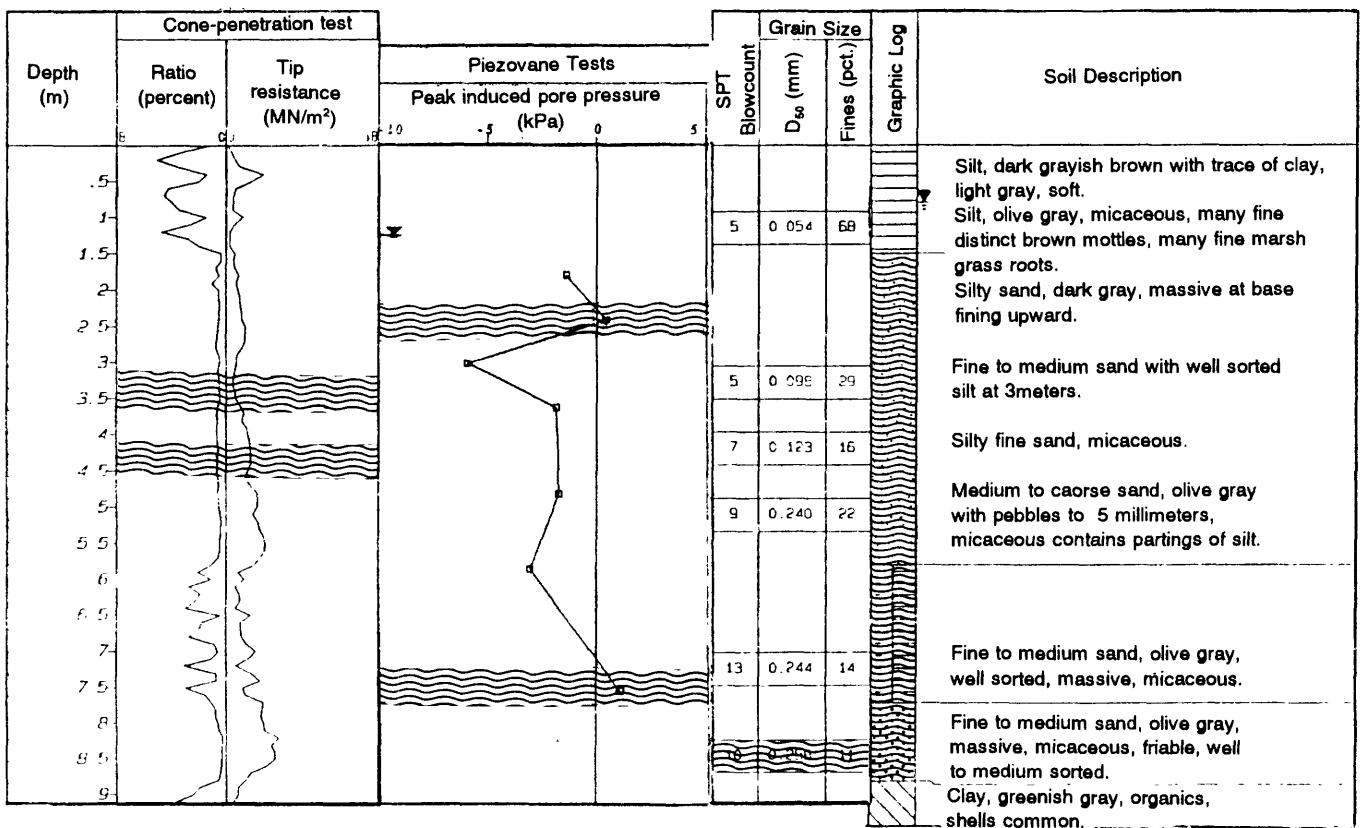
The Piezovane recorded positive pore-pressure changes at specific depths at 8 of the 12 test sites. Significant lateral spreading occurred at all eight of these sites during the earthquake. At the four sites where no lateral spreading occurred, three tests (CSU 1, 10, 29) were conducted in clays and are omitted from this analysis. One test (CSU 37, fig. 8), performed in stable sand, yielded all negative pore-pressure changes, except for two points where no pore-pressure change was detected.

of safety against liquefaction was calculated from the site SPT blowcounts, using estimates of soil conditions and earthquake ground motion. We used estimated peak accelerations of 0.14  $g$  for the Sea Mist-Leonardini Farms study site and 0.39  $g$  for the Miller Farm and Southern Pacific Railroad Bridge study sites. The data, assumptions, and methods used for factor-of-safety calculations are summarized below in the section entitled "Supplementary Information," and details were given by Brislaw (1992). Zones with SPT factors of safety against liquefaction of less than 1 are shown in figure 18.

Figure 18.—Pore-pressure logs of U.S. Geological Survey cone-penetration tests (CPT's) (left), Colorado State University Piezovane tests (middle), and U.S. Geological Survey standard penetration tests (SPT's) (right) (A) on the Sea Mist Farm (site CSU 31, fig. 8), (B) on the Miller Farm (site CSU 3, fig. 14), and (C) on the Southern Pacific Railroad Bridge (site

CSU 48, fig. 16). Shading denotes zones with liquefaction potential based on factors of safety; inverted solid triangle, depth to water table. CPT and SPT data from Tinsley and others (this chapter); soil descriptions from U.S. Geological Survey.

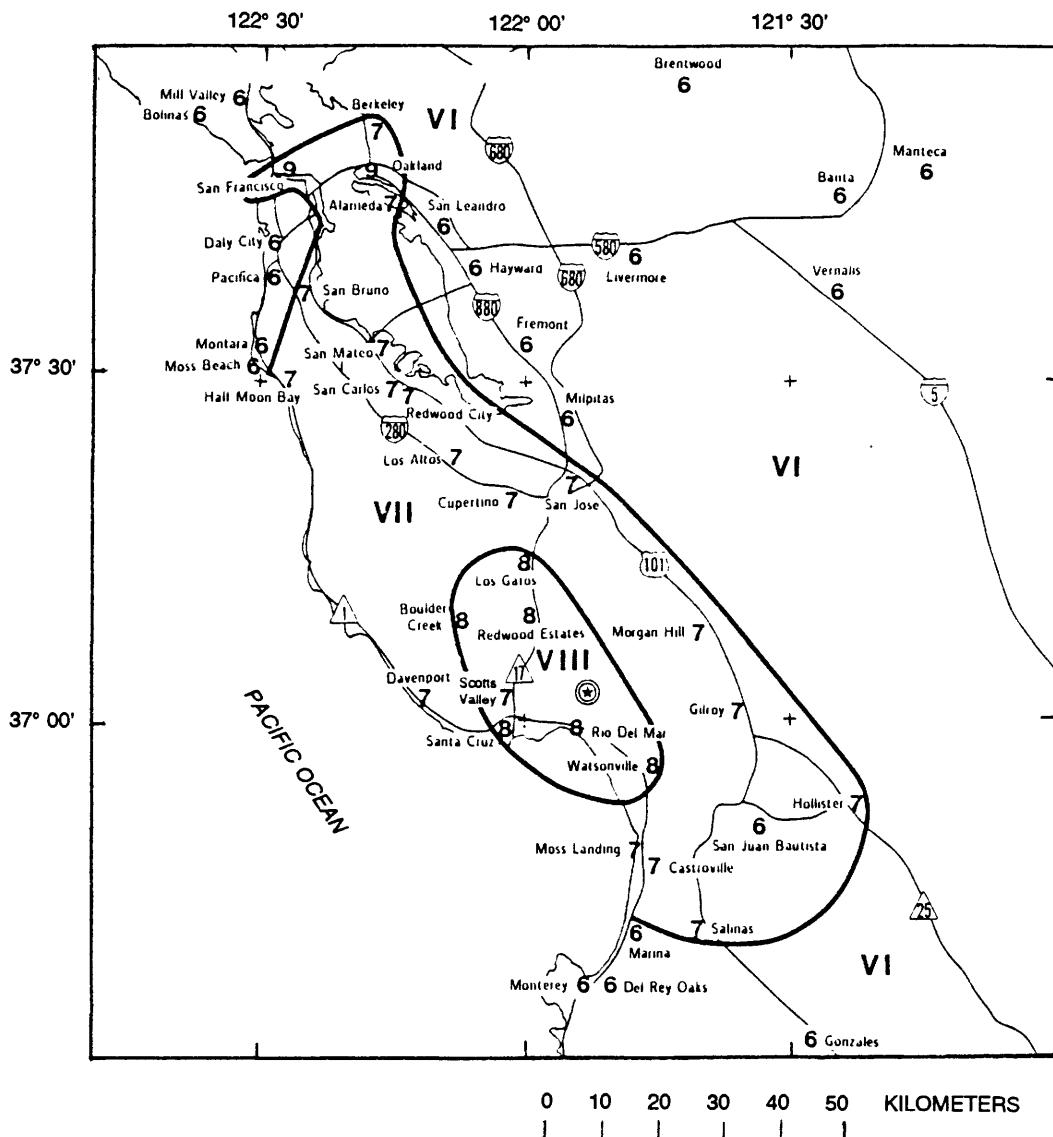
The ground motion measured closest to the Sea Mist-Leonardini Farms study site was a peak acceleration of 0.12 g at a station located 14.6 km away in the town of Salinas. Modified Mercalli intensities (fig. 21; Plafker and Galloway, 1989) and soil/rock attenuation relations reported by the U.S. Department of the Navy (1983, p. 22–34) were used to independently estimate peak accelerations at the three study sites. Modified Mercalli intensities of VIII and IX for the Miller Farm and Southern Pacific Railroad Bridge study sites correspond to a peak acceleration of 0.21 to 0.39 g, which agrees with the 0.39 g recorded in Watsonville. The modified Mercalli intensity at the Sea Mist-Leonardini Farms study site is almost VII, which corresponds to a peak acceleration of 0.07 to 0.13 g. We used distance and soil/rock attenuation relations to estimate a peak acceleration of 0.16 g for the Sea Mist-Leonardini Farms study site. We used peak accelerations of 0.39 g for the Miller Farm and Southern Pacific Railroad Bridge study sites and 0.14 g for the Sea Mist-Leonardini Farms study site for this study, on the basis of the information described above.

Figure 21.—San Francisco-Monterey Bay region, showing distribution of modified Mercalli intensities (Roman and Arabic numerals) from 1989 Loma Prieta earthquake. After Plafker and Galloway (1989).

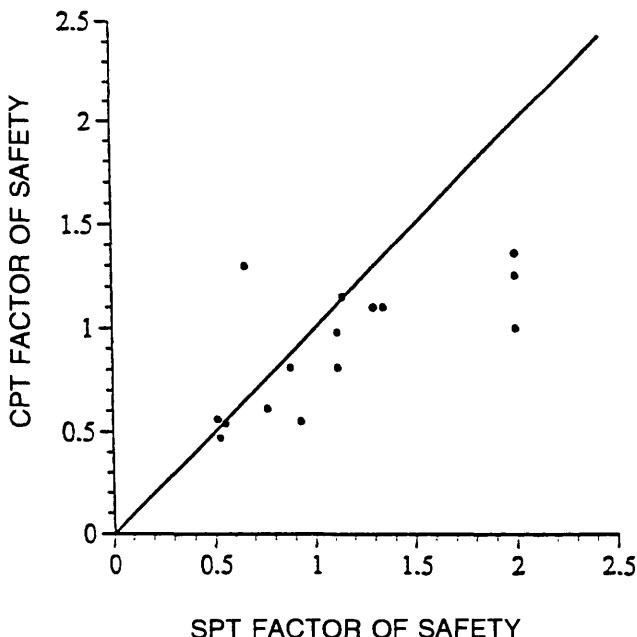
Figure 22.—Cone-penetration-test (CPT) versus standard-penetration-test (SPT) factors of safety against liquefaction, calculated from data of this study.

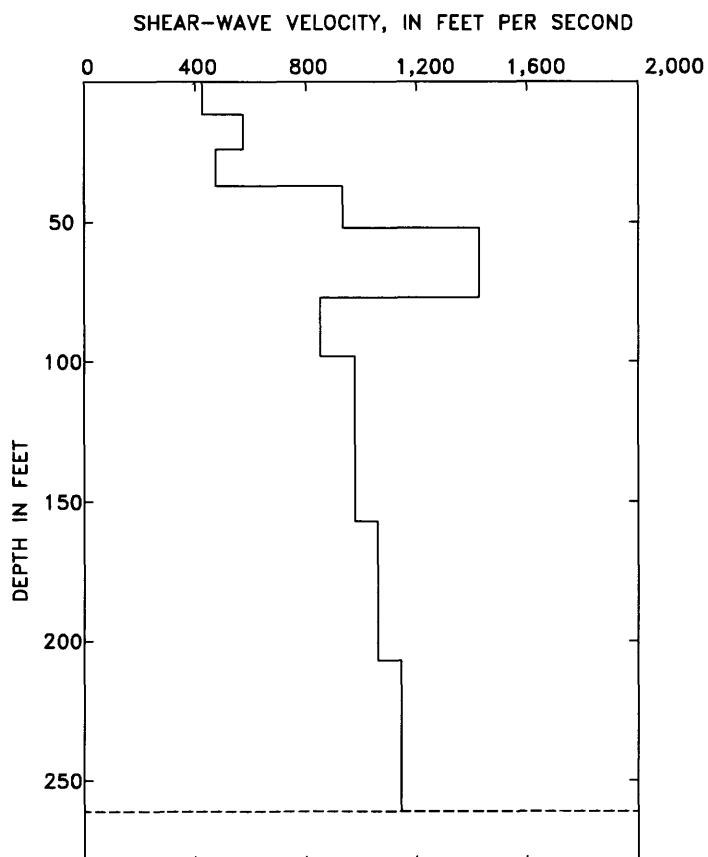
Earthquake damage in the Marina District resulted from both ground shaking and liquefaction, phenomena both influenced by local ground-response. Deep soil profiles, loose granular fills, and thick clay layers are all factors known to amplify earthquake shaking. All of these conditions are present in the Marina District. The soil profile at Winfield Scott School, which is 261 ft deep, shows loose fills and significant clay layers (fig. 1).

Figure 1.—Soil profile and variation in shear-wave velocity ( $V_s$ ) with depth at Winfield Scott School in the Marina District of San Francisco.

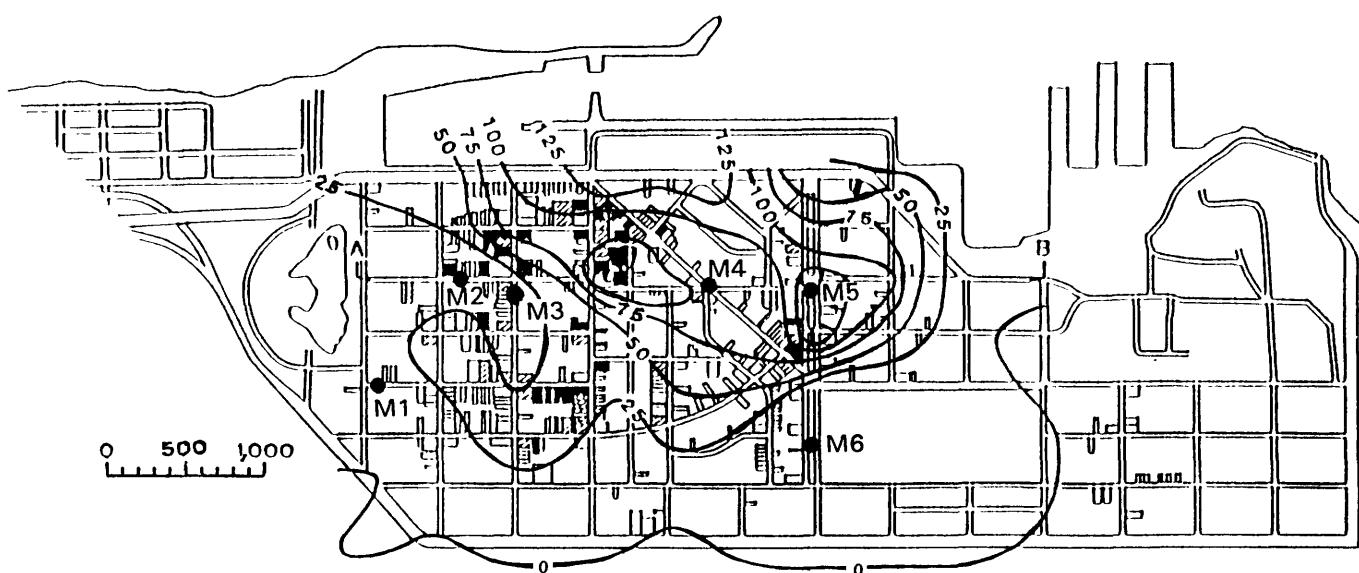
in the Marina District. These data allow calculation of settlement contours from measurements between 1974 and November 1989 (fig. 13). Most of this settlement resulted from liquefaction during the earthquake, although a small fraction may be due to other sources. The settlement ranges

Figure 13.—Marina District of San Francisco, showing contours of settlement (in millimeters) and locations of boreholes drilled by the U.S. Geological Survey (Bennett, 1990).

from less than 25 mm at the margins of the hydraulic fill to more than 125 mm in certain places within the fill. After the earthquake, the U.S. Geological Survey drilled six test borings to depths of approximately 40 ft at locations shown in figure 13, and SPT's were conducted at each site. The soil profiles and SPT results for each borehole are shown in figure 14.

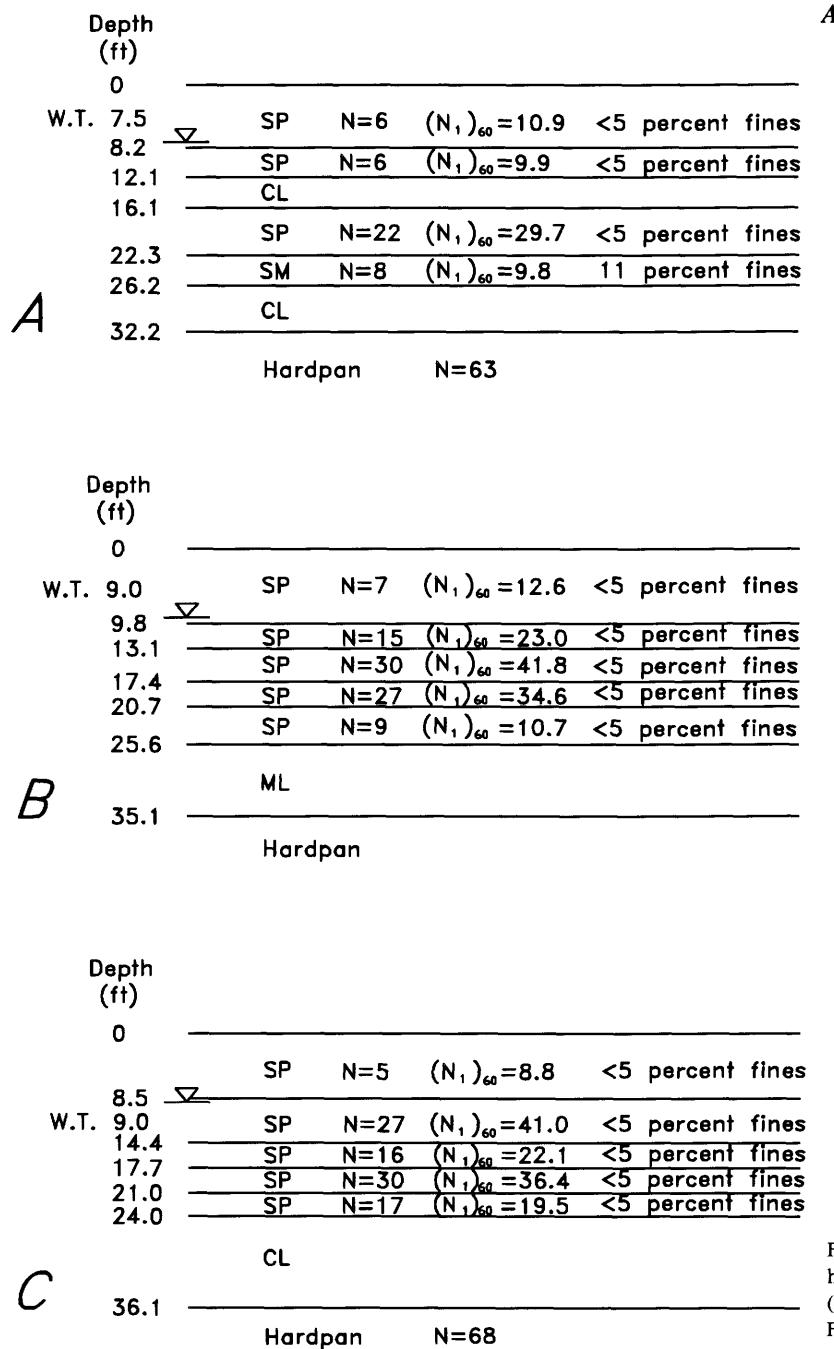
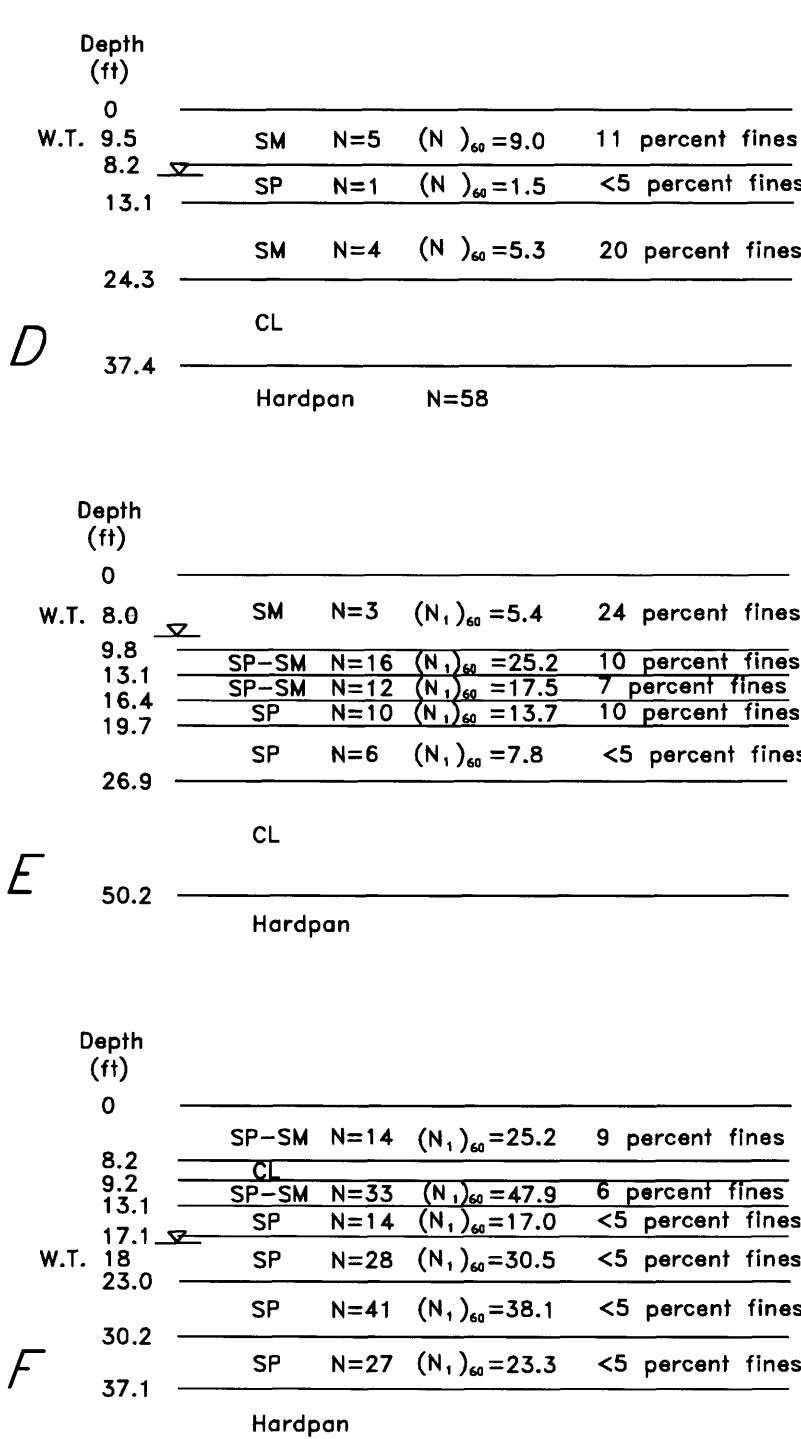
Figure 14.—Soil profiles in U.S. Geological Survey boreholes M1 (A), M2 (B), M3 (C), M4 (D), M5 (E), and M6 (F) in the Marina District (see fig. 13 for locations). From Bennett (1990).

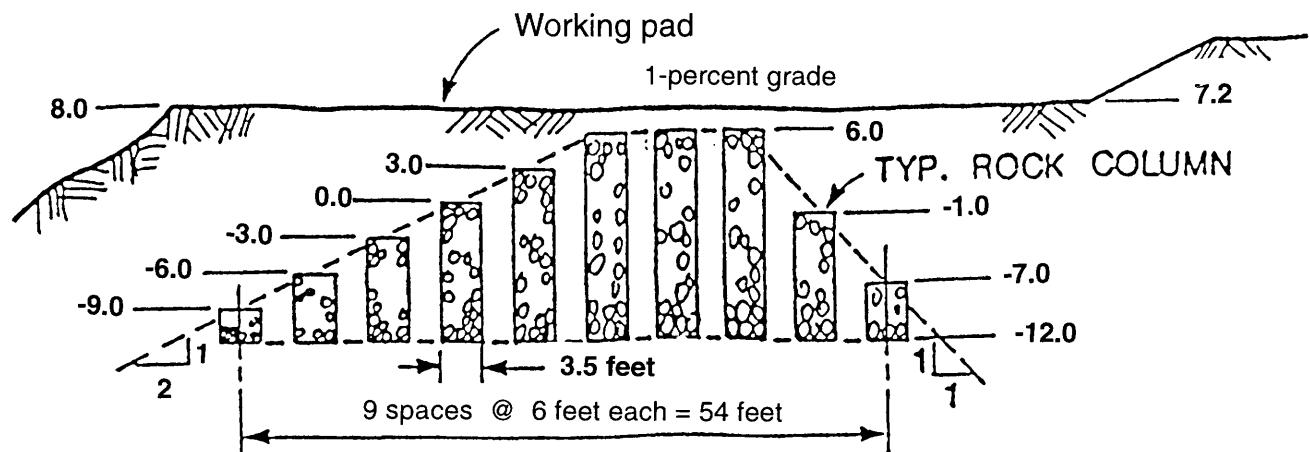
For the first several days of construction, the cranes were working from a pad excavated to an elevation of 8 ft and frequently became stuck in the soft subgrade soils. Therefore, the cranes were moved to the paved area just east of the buttress alignment. Minor slope failures and settlement occurred in the asphalt-paved area north of the Penterra office building (fig. 12), owing to construction-induced vibrations. In addition, tension cracks appeared in several areas behind the vertical slope parallel to the centerline of the buttress. Because of a concern that construction-induced vibrations might damage the Yacht Club at the north end of the buttress, the northernmost row of columns was eliminated. In addition, the vibrators were unable to penetrate the ground surface at five locations

Figure 13.—Typical cross section of buttress on Marina Bay Esplanade, Richmond (study site 6, fig. 1). Numbers are elevations in feet above National Geodetic Vertical Datum. From Harding Lawson Associates (1987).

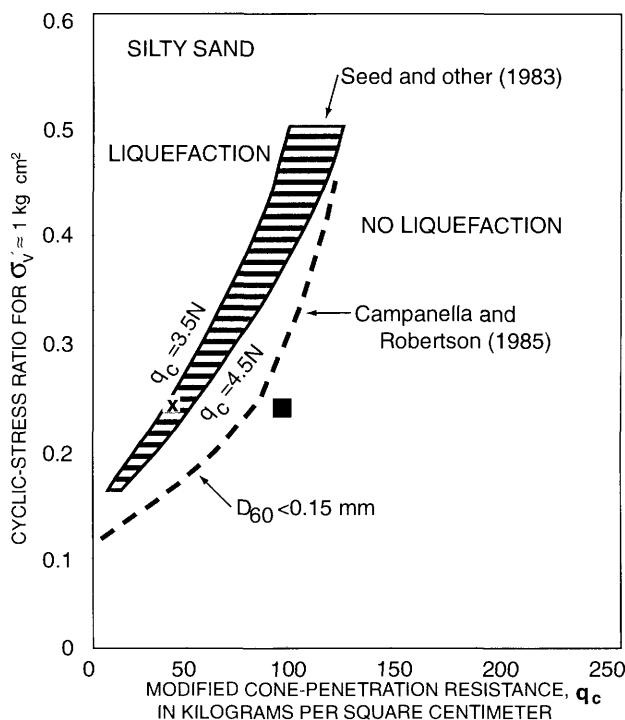
Figure 14.—Comparison of preconstruction (x) and postconstruction (square) cone-penetration-test data for an  $M=6.5$  earthquake at Marina Bay Esplanade, Richmond (study site 6, fig. 1). From Rinne and others (1988).

Average preconstruction and postconstruction  $q_{c1}$  values are plotted in figure 14. The liquefaction potential of the deposits before densification was moderate to high, using the correlation of Seed and others (1983), and high, using the correlation of Robertson and Campanella (1985). The average  $q_{c1}$  value increased by approximately 45 kg/cm<sup>2</sup> after column installation. It was concluded, on the basis of CPT correlations, that the postconstruction liquefaction potential of the hydraulic fill between the stone columns was low for the design earthquake. Increases in cone-tip resistance were greatest in zones with lower silt contents.

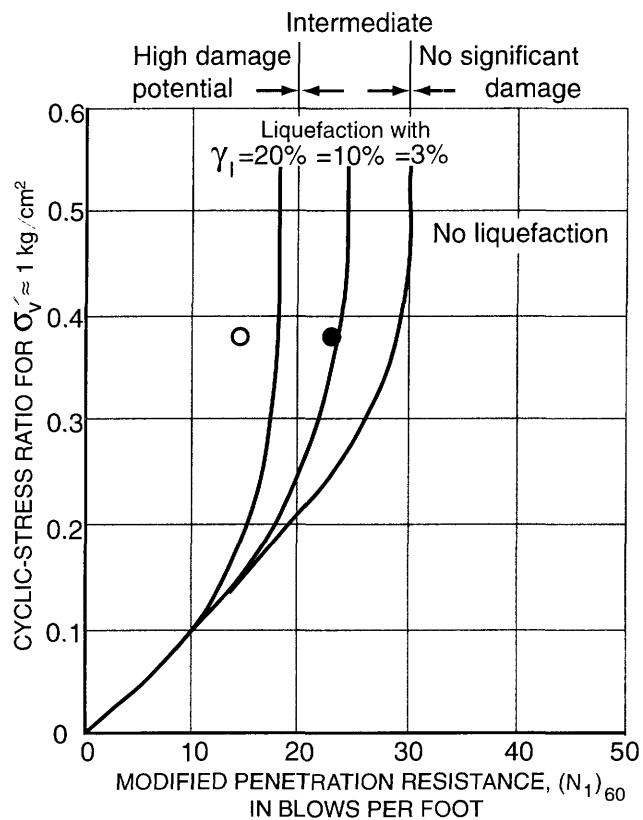
Average preconstruction and postconstruction  $(N_1)_{60}$  values are plotted in figure 15, which shows the correlation between liquefaction resistance and  $(N_1)_{60}$  values for the maximum credible earthquake ( $M=7.5$ ). As shown, the average  $(N_1)_{60}$  value increased by 7 blows/ft. Despite this increase, some liquefaction potential exists for the soil between the stone columns during a maximum credible earthquake. The estimated shear-strain potential of the liquefiable deposits, however, decreased from more than 20 percent to approximately 10 percent as a result of ground improvement. Overall, the combination of stone-

Figure 15.—Comparison of preconstruction (circle) and postconstruction (dot) standard-penetration-test data for an  $M=7.5$  earthquake at Marina Bay Esplanade, Richmond (study site 6, fig. 1). From Rinne and others (1988).

column reinforcement and the increase in liquefaction resistance of the soil between the columns was judged to be sufficient to prevent lateral spreading into the bay in the event of liquefaction of the unimproved ground on the inland side of the buttress.

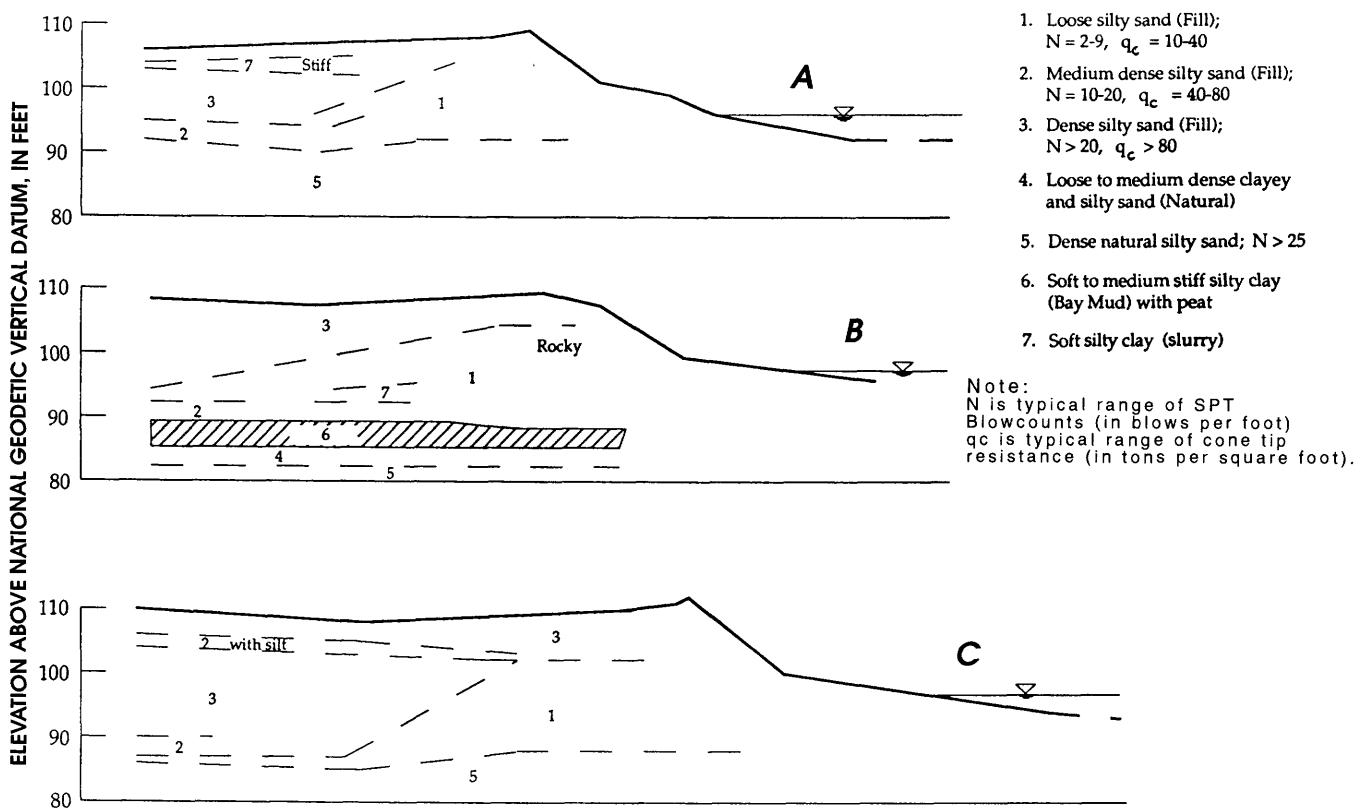
On the basis of the results of extensive geotechnical studies, the 4,000 ft of dikes can be divided into three different sections, as shown in figure 16; an idealized subsurface profile of each section is shown in figure 17. Section I consists of a 5- to 7-ft-thick upper layer of medium-dense to dense sand, with SPT blowcounts ranging from 15 to 35 blows/ft. This sand layer is underlain by a layer of loose to medium-dense silty sand, approximately 12 ft thick, with SPT blowcounts ranging from 3 to 10 blows/ft. Both the surface medium-dense to dense sand and the underlying loose sand consist of hydraulically placed fill. Medium-dense to dense silty and clayey sand, with SPT blowcounts of more than 25 blows/ft, was penetrated at 17-ft depth.

Section II similarly consists of 5 to 12 ft of medium-dense sand crust over a layer of loose sand fill; the medium-dense sand has SPT blowcounts ranging from 10 to 20 blows/ft. The loose sand layer is approximately

6 to 13 ft thick and is interspersed with thin clay lenses; this sand layer has SPT blowcounts ranging from 3 to 8 blows/ft. The loose sand is underlain by a layer of soft bay mud, approximately 3 ft thick. The bay mud, in turn, is underlain by a layer of natural loose to medium-dense sand extending to a maximum depth of 26 ft below the ground surface; this sand layer has SPT blowcounts ranging from 8 to 15 blows/ft. Below 26-ft depth, the sand is denser, with SPT blowcounts of more than 30 blows/ft.

Section III consists of a surface fill layer of 10 to 16 ft of dense sand, with SPT blowcounts ranging from 30 to 40 blows/ft. The dense sand is underlain by a layer of loose to medium dense sand, 6 to 12 ft thick, with SPT blowcounts ranging from 5 to 10 blows/ft. The lower 5 ft of the loose sand layer consists of natural sand. Below 22-ft depth, the natural sand is denser, with SPT blowcounts of more than 30 blows/ft. The hydraulic sand fill is everywhere generally fine grained and contains an average of less than 11 percent of material finer than a No. 200 sieve. The natural sand also is generally fine grained, with an average fines content of about 22 percent. The ground-water level at the study site was at approximately the same elevation as mean sea level at the time of drilling.

Figure 17.—Subsurface profiles of sections I (A), II (B), and III (C) (see fig. 16 for locations) of perimeter sand dikes at Harbor Bay Isle Development, Alameda (study site 8, fig. 1).

The liquefaction potential of the loose hydraulic sand fill was evaluated by using an analytical-empirical procedure based on SPT  $N$  values corrected for fines content (Seed, 1987). An  $M=8.25$  earthquake occurring on the San Andreas fault was used as the design earthquake. The results of this analysis showed that the liquefaction potential of the loose and medium-dense sand fill in the dikes was high, and it was concluded that the dikes could undergo excessive yielding or slope failure during a major earthquake. Such yielding or failure would reduce confinement of the interior soils and might allow lateral spreading in the interior of the Harbor Bay Isle development. On the basis of these conclusions, it was recommended that the loose sand fill in the dikes be densified to minimize its liquefaction potential.

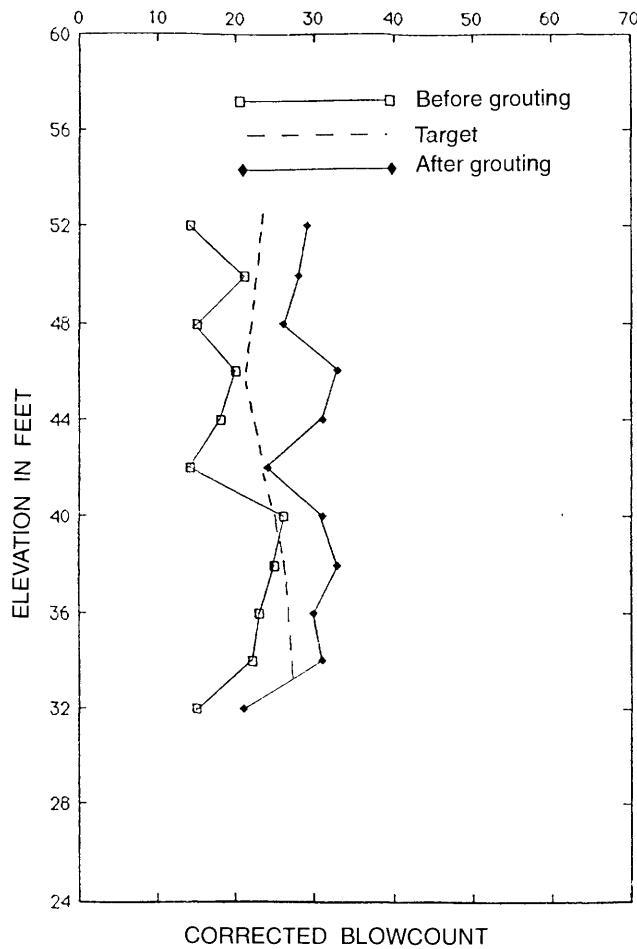
Figure 18.—Mean corrected blowcounts in test section before and after compaction grouting at Kaiser-Permanente Medical Center addition, South San Francisco (study site 10, fig. 1). From Donovan (1978).

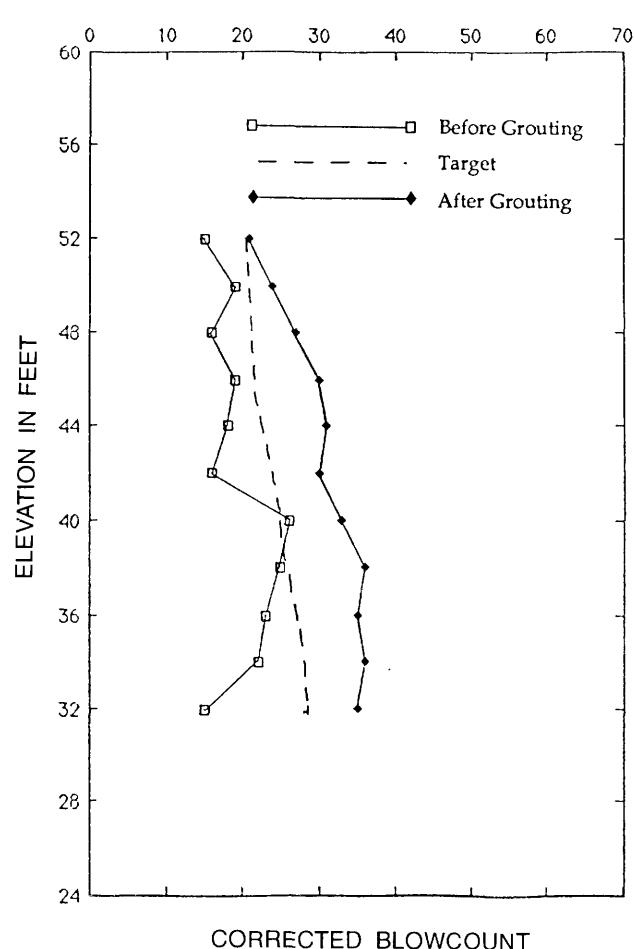
Figure 19.—Mean corrected blowcounts at end of compaction grouting at Kaiser-Permanente Medical Center addition, South San Francisco (study site 10, fig. 1). From Donovan (1978).

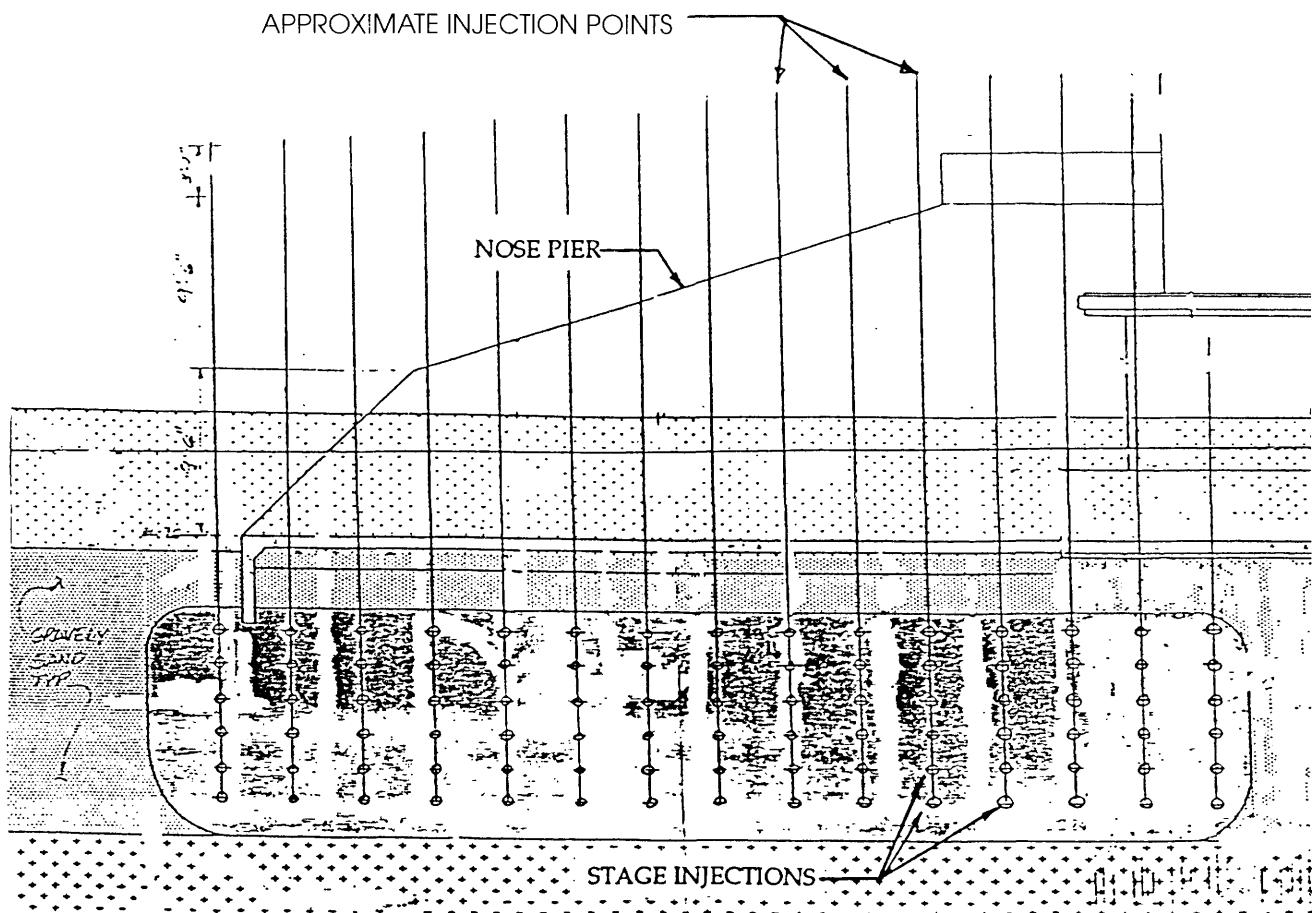
The granular bearing soils underneath the south nose pier were being eroded by the river, thereby undermining the pier. The resulting settlement of the pier was damaging the bridge decking above. Over time, the erosion and resulting settlement appeared to be increasing, and so it

Figure 20.—Cross section of Riverside Avenue Bridge, Santa Cruz (study site 11, fig. 1), showing typical grouting pattern. From Georesource Consultants (1986).

was decided that some method of improving the granular soils to prevent further erosion must be implemented.

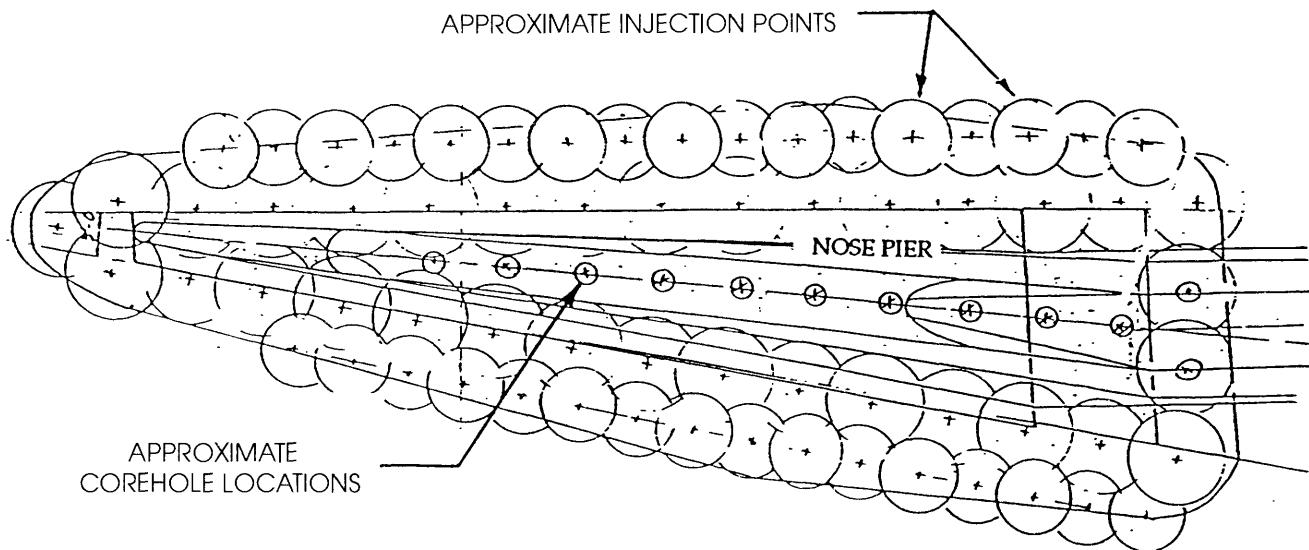
Figure 21.—Plan view of Riverside Avenue Bridge, Santa Cruz (study site 11, fig. 1), showing typical grouting pattern. From Georesource Consultants (1986).

eted duration of 15 s during the earthquake. According to the Santa Cruz city engineer, no settlement of the bridge pier or other detrimental ground movements were observed.

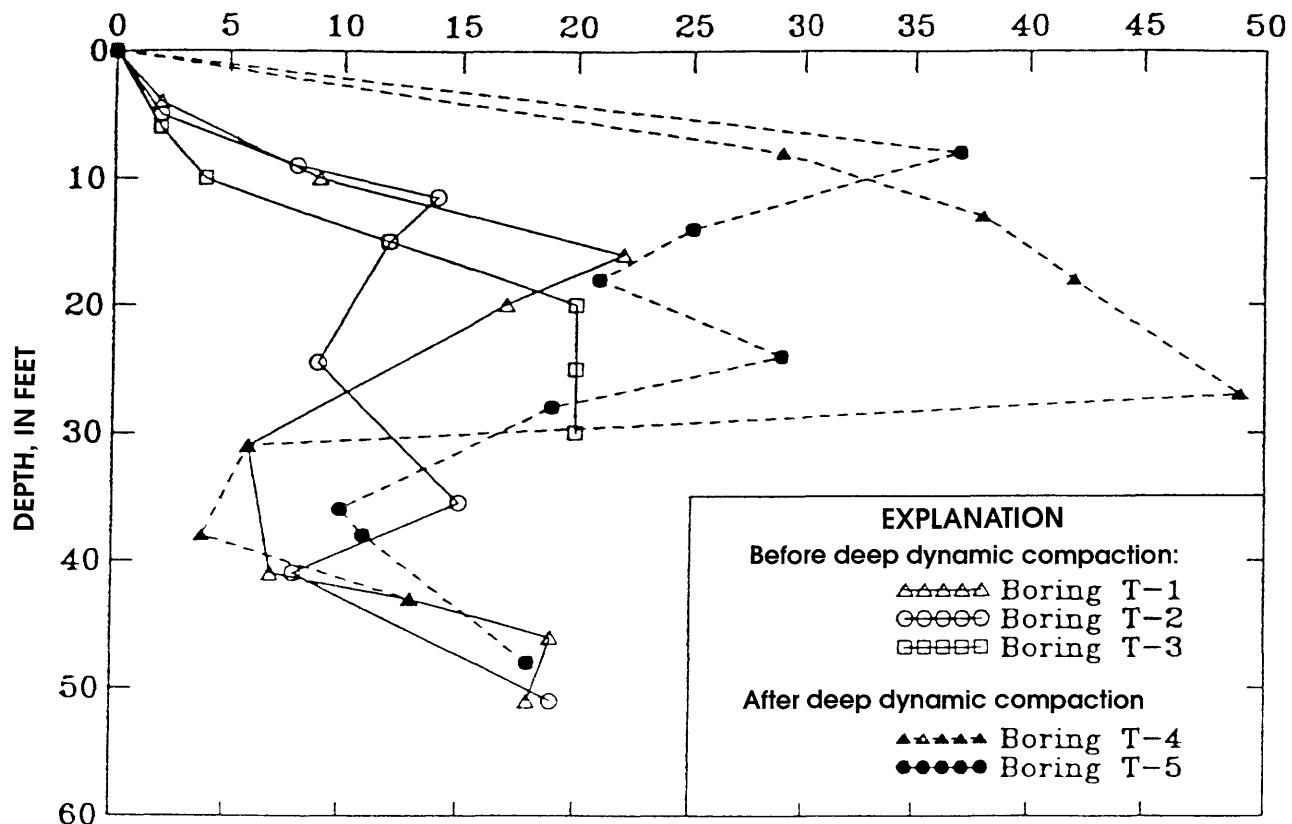
A comparison of the subsurface profile in the test area before and after improvement, indicating that a substantial amount of densification was achieved in the layers above about 25- to 30-ft depth, is shown in figure 23. A significant increase in SPT blowcounts was achieved in the silty-sand layer above about 30-ft depth (fig. 24). Overall, it was concluded that the liquefiable layer in the test area had been adequately densified.

Figure 24.—Comparison of standard-penetration-test blowcount before and after dynamic deep compaction at Santa Cruz County Detention Facility, Santa Cruz (study site 12, fig. 1). See figure 22 for locations of boreholes T-1 through T-5. From Peter Kaldveer and Associates (1977).

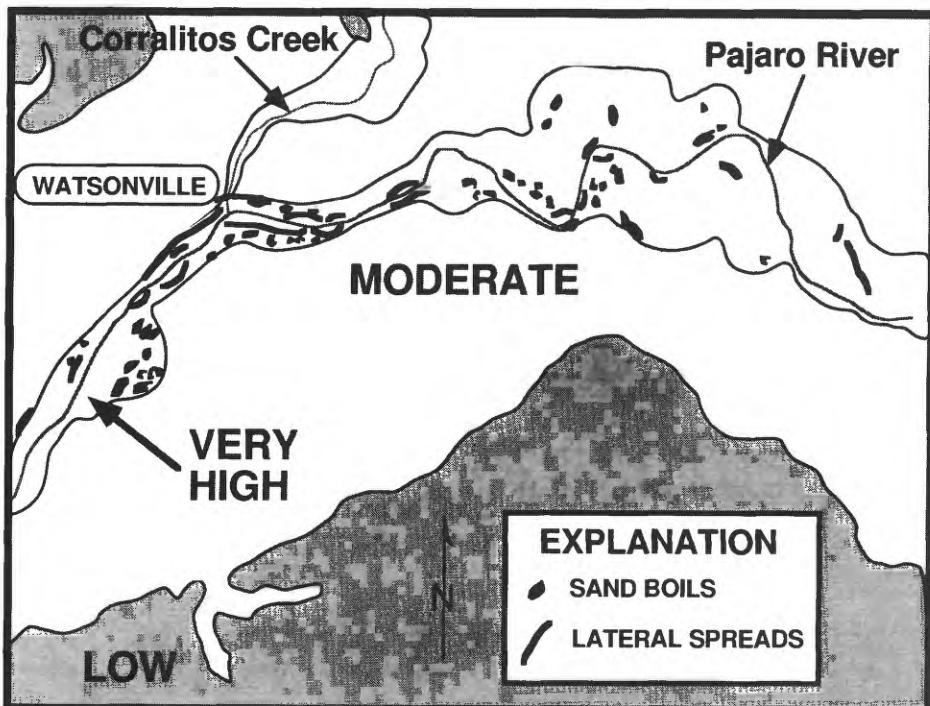
Figure 3.—Watsonville, Calif., area (see fig. 1 for location), showing distribution of liquefaction effects from 1989 Loma Prieta earthquake in relation to zones of predicted susceptibility as determined by Dupré and Tinsley (1980).

were not zoned by Dupré and Tinsley (1980) as having a high or very high liquefaction susceptibility. Minor sand boils occurred at two of these localities zoned as moderate (sites 100, 101) in basin deposits, along the lower part of the Pajaro Valley.

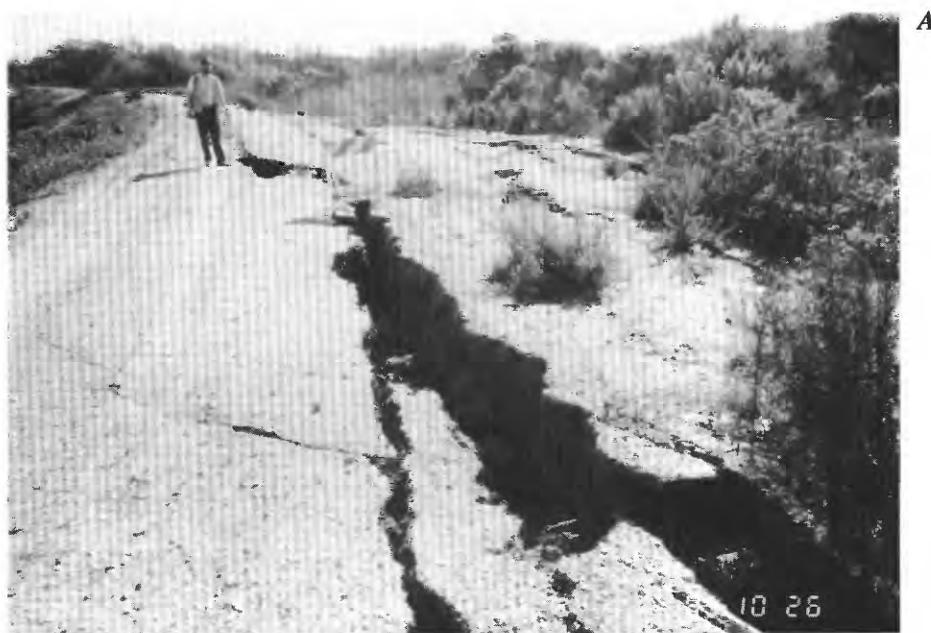
The lateral-spread failures (figs. 4A–4D) typically occurred within 150 m of channel margins characterized by a free face or gently sloping point bar 3 to 5 m high. Some failures, however, occurred along the margins of abandoned channels filled with organic-rich sediment, where the free face was less than 1 m high but where the compressible material filling the channel readily accommodated the laterally displaced mass. Lateral displacements ranged from a few millimeters to as much as 2 m, measured cumulatively across a failure from its head to its toe; vertical displacements were similar but generally less than 0.3 m. Failure commonly occurred on both sides of the modern channel, and zones of failure were mappable for distances of as much as 2 km along the channel margins.

Figure 4.—Liquefaction features from 1989 Loma Prieta earthquake in Monterey Bay region. A, Lateral spread in channel and point-bar deposits beneath flood-control levee near mouth of the Pajaro River (fig. 1; site 103 of Tinsley and others, this chapter). Extension was from left to right, toward free face formed by river channel. B, Lateral spread along margin of lower course of the Pajaro River (fig. 1; site 99 of Tinsley and others, this chapter). Partial view emphasizes nearly 2 m of differential settlement of narrow strip of land adjacent to channel. Extension was right to left by nearly 1 m. C, Lateral spread in estuarine and overlying artificial fill deposits at the entrance to Moss Beach (MB, fig. 1; site 116 of Tinsley and others, this chapter). Extension was from right to left, toward tidal inlet north of Elkhorn Slough. D, Lateral spread in estuarine deposits and overlying dunes at Moss Beach (MB, fig. 1; site 116 of Tinsley and others, this chapter). Extension was from right to left, including differential settlement of about 0.4 m. E, Sand boils along paleochannel within younger fluvial deposits in the Pajaro Valley (PV, fig. 1; site 91 of Tinsley and others, this chapter).

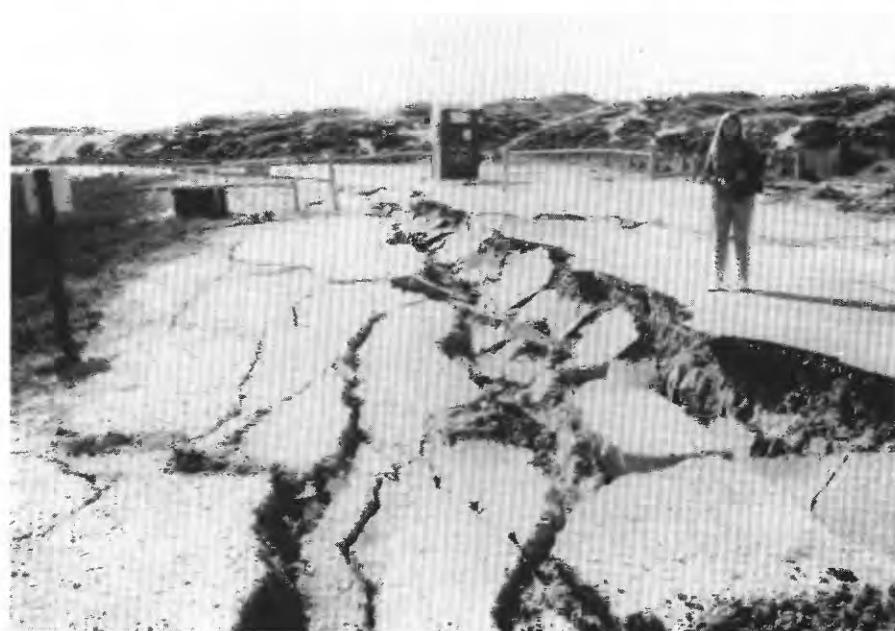
**C**

In addition, **dune deposits** (unit Qd of Dupré and Tinsley, 1980), exhibited ground failure only where underlain by young estuarine or tidal-channel deposits; failure actually occurred within the underlying deposits (figs. 4C, 4D). The discontinuous patterns of failure in the Moss Landing area (ML, fig. 1; Tuttle and others, 1990; Greene and others, 1991), and at the mouth of the Pajaro River

Figure 4.—Continued.

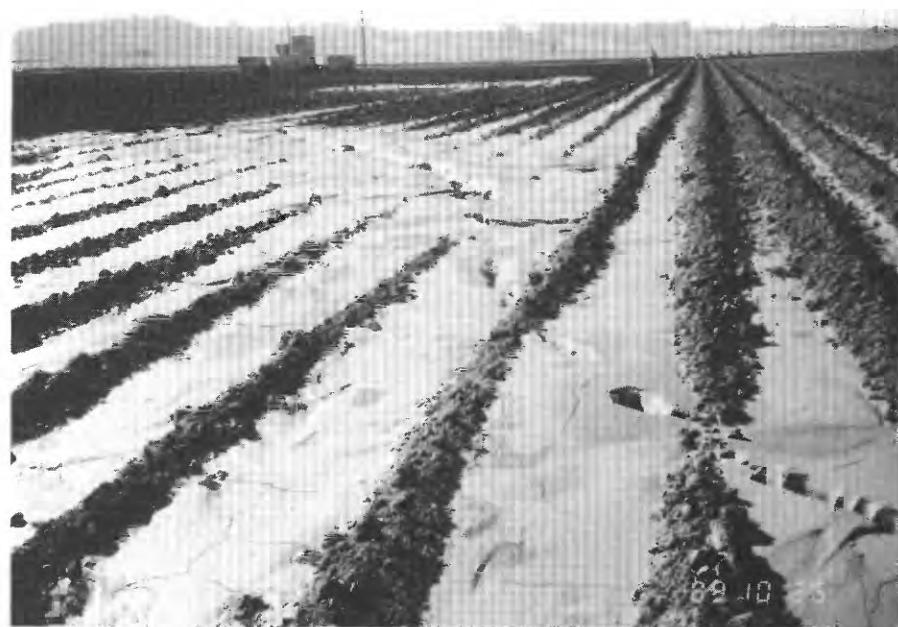
**E**

Differential settlement, fracturing, and sand boils were especially common over abandoned channels within the late Holocene flood plain (fig. 4E). For example, as part of a larger lateral failure in the town of Pajaro, just south of Watsonville (W, fig. 1), extensive fracturing and as much as 0.5 m of subsidence occurred over a filled chan-

Figure 4.—Continued.

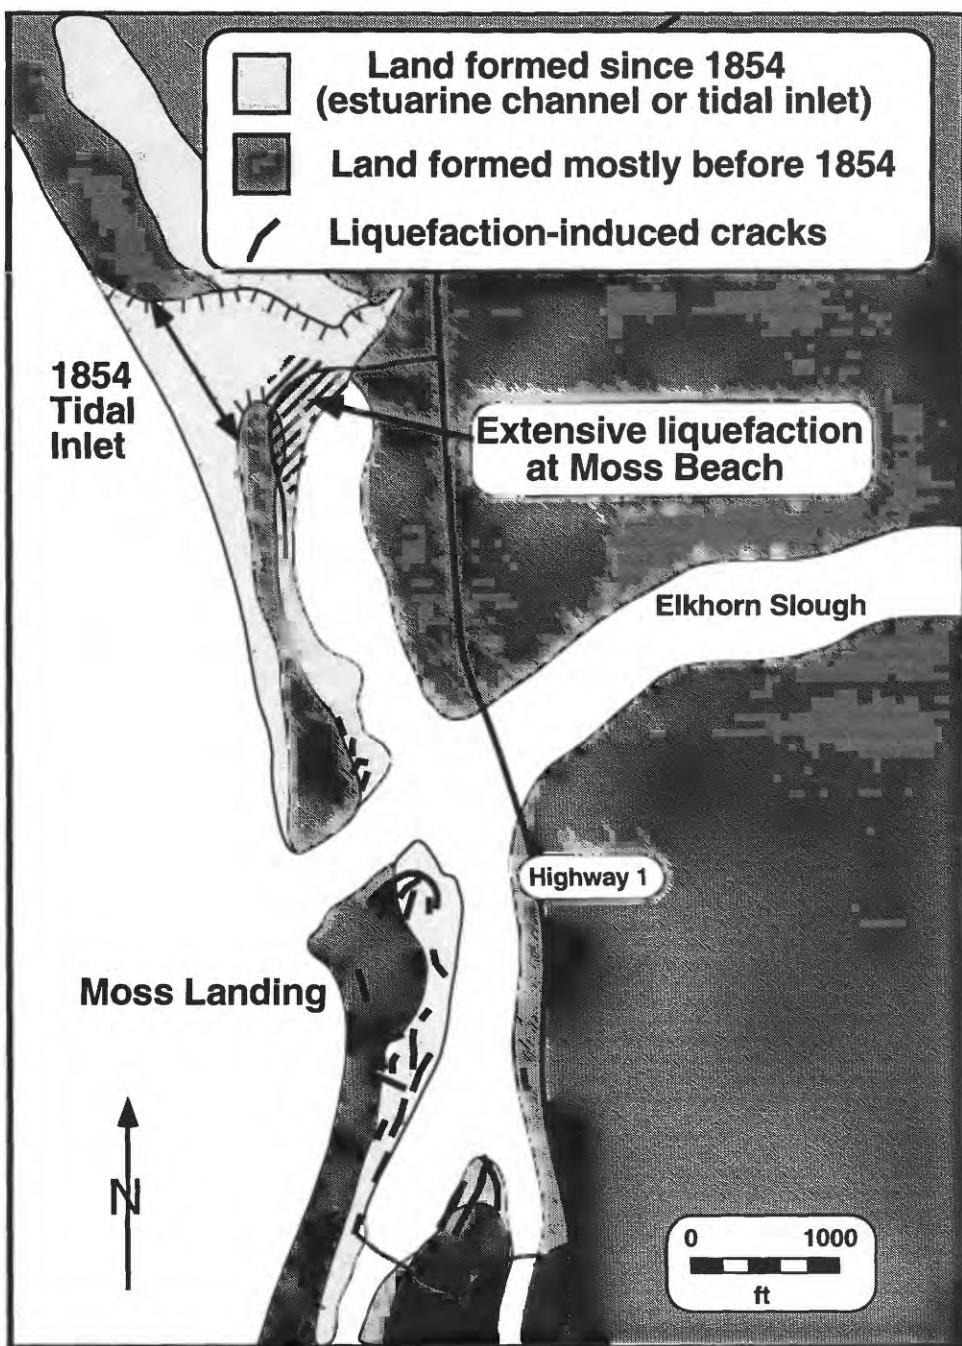
Most failures along the coast occurred in areas underlain by estuarine and tidal-channel deposits subsequently buried by channel migration, washover deposits, and landward-migrating dune deposits, as was particularly evident between the mouth of the Pajaro River and Moss Landing (fig. 5).

(sites 109 and 108 of Tinsley and others, this chapter) coincide largely with areas that were originally tidal inlets or estuaries which had been filled within the last 150 years (fig. 5). The geologic units as mapped at the surface, such as dunes and washover deposits, do not reflect these differences in subsurface stratigraphy. These differences become readily apparent, however, when historical maps of the shoreline are superimposed on the modern map (fig. 5).

Figure 5.—Moss Landing area, Calif. (see fig. 1 for location), showing distribution of liquefaction-induced deformation (modified from Greene and others, 1991). Areas of young deposits (post-1854 estuarine-channel or tidal-inlet fill), are mapped on basis of comparisons with historical shoreline changes (modified from Hans Nielsen, unpub. data, 1991).

Future mapping should attempt to differentiate sand-poor and sand-rich facies within basin and fluvial deposits so as to more accurately delineate zones of liquefaction susceptibility. In addition, relatively young estuarine deposits should be differentiated from other types of basin deposits, because estuarine deposits are particularly prone to failure.
