The Loma Prieta, California, Earthquake of October 17, 1989—Lifelines

PERFORMANCE OF THE BUILT ENVIRONMENT
Thomas L. Holzer, *Coordinator*

U.S. GEOLOGICAL SURVEY PROFESSIONAL PAPER 1552-A

LIFELINES

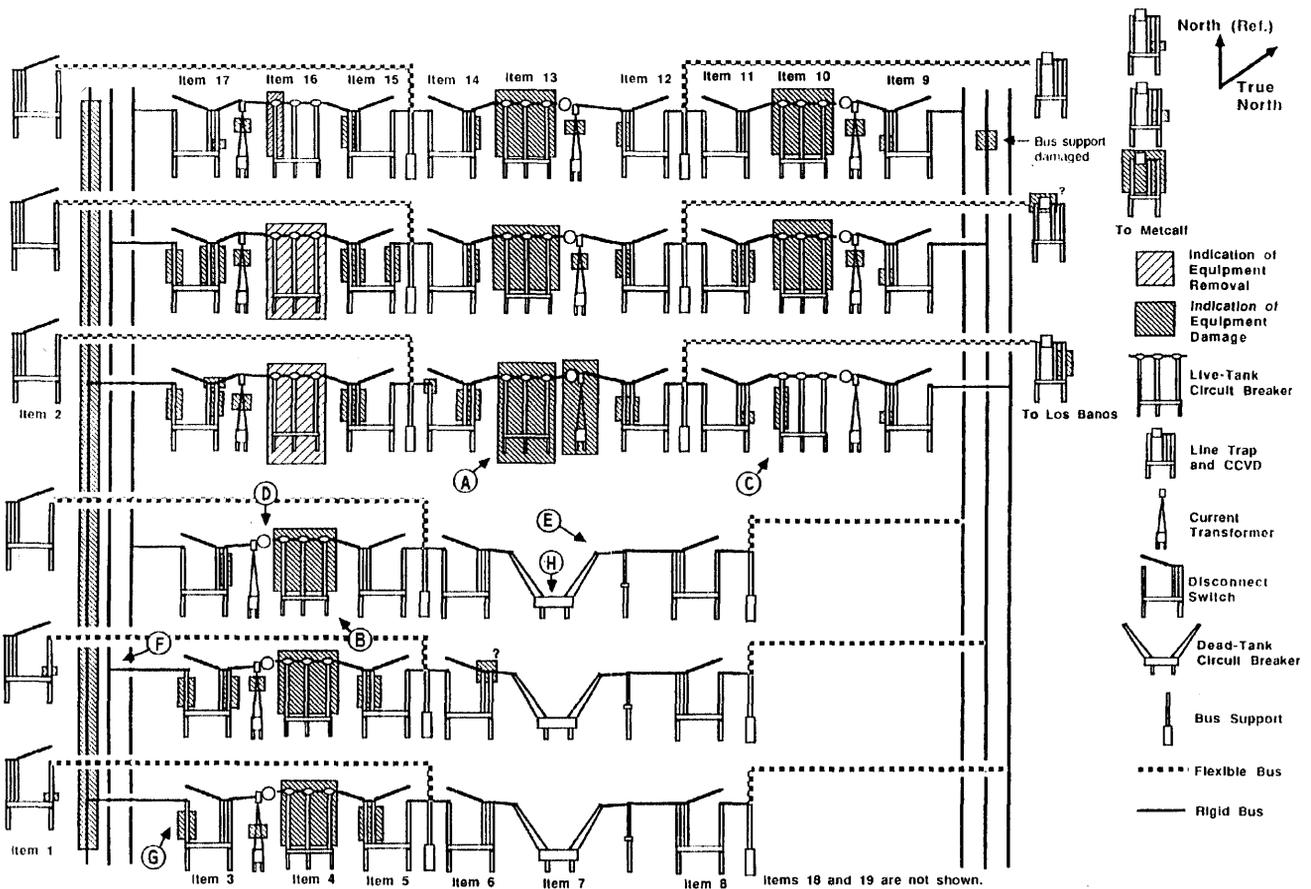
All of the 12 phases of the live-tank circuit breakers in the 500-kV switchyard were damaged, 2 phases of item 16 (fig. 3) were removed, and the details of their damage is unknown. All the friction-clip anchors had bent or stretched bolts, allowing the circuit breakers to move. Three types of circuit-breaker failures were noted. In the first type of failure (fig. 6), one phase slid off its support pad, and the entire circuit breaker, including its support structure, tipped over (for example, item 13, fig. 3). In the second type of failure (fig. 7),

The anchorage of the current transformers did not fail, except for one phase on item 13 in figure 3. Only 2 of the 12 current transformers at the Moss Landing Substation were

Figure 3.—Schematic diagram of 500-kV switchyard at the Moss Landing Substation (fig. 1), showing locations of damaged and removed equipment and numbered items referred to in text. Equipment shown as undamaged may have required repair that was not obvious from cursory inspection. A, 500-kV circuit breaker (fig. 6); B, interrupter heads on 500-kV live-tank circuit breaker (fig. 7); C, interrupter-head-support columns on 500-kV circuit breaker (fig. 8); D, 500-kV current transformer (fig. 9); E, support of 500-kV current transformer (fig. 10); F, disconnect switch with rigid bus (fig. 11); G, disconnect switch with flexible bus (fig. 12); H, disconnect switch of channel design (fig. 13). CCVT, capacitatively coupled voltage transformer.

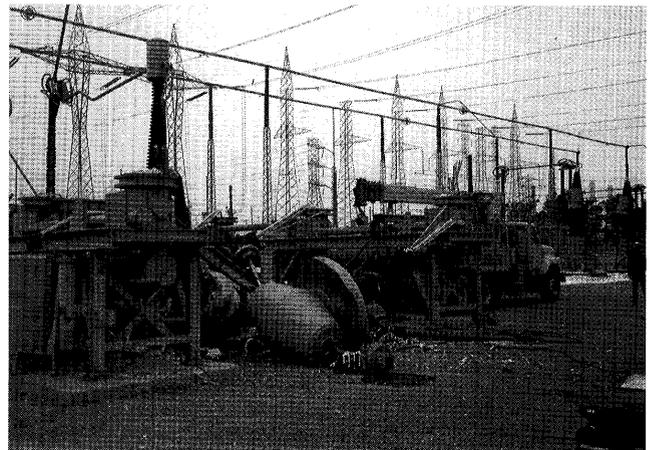
Figure 7.—Fallen interrupter heads on 500-kV live-tank circuit breaker at the Moss Landing Substation (fig. 1).

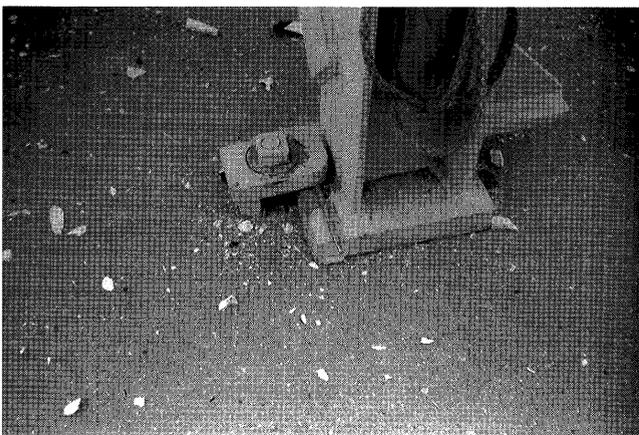
Figure 5.—Friction-clip anchorage of 500-kV circuit breaker at the Moss Landing Substation (fig. 1).

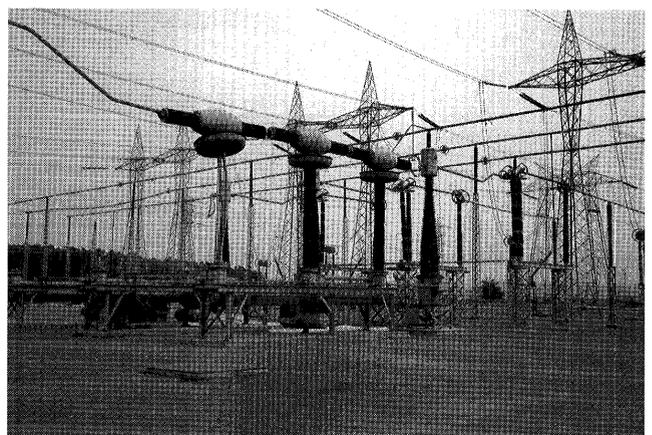
the interrupter-head-support column collapsed, and the interrupter fell to the ground (for example, item 4, fig. 3). In the third type of failure (fig. 8) the support column shattered, but the interrupter head did not fall over (for example, item 10, fig. 3). In other circuit breakers, the support column was cracked but did not shatter. Support columns of this design contain SF₆ gas for insulation, and so a crack in the porcelain will generally put the circuit breaker out of service.

Figure 8.—Shattered interrupter-head-support columns on 500-kV circuit breaker at the Moss Landing Substation (fig. 1).

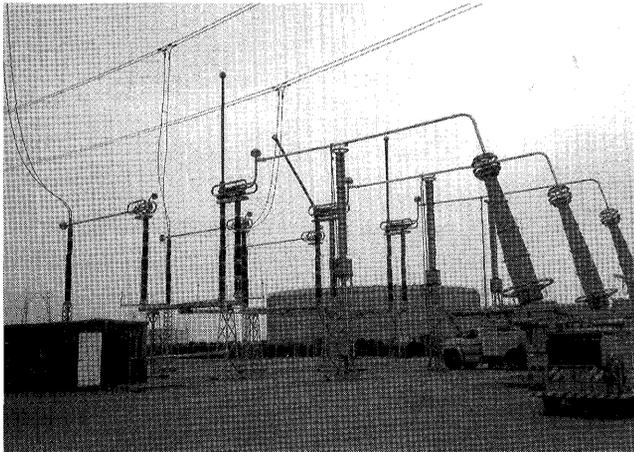
Figure 11.—Disconnect switch with rigid bus at the Moss Landing Substation (fig. 1).

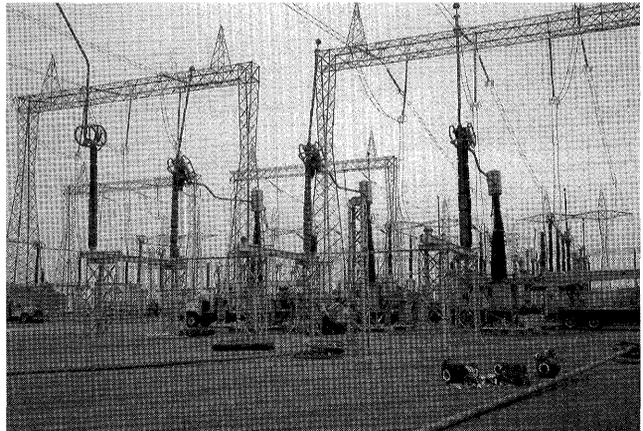
cast-in-place bolt through a plate at the bottom of each of four legs. Items 1, 2, 18, and 19 in figure 3 were connected with long drops of flexible bus from overhead flexible bus runs, as shown in figure 12. Three disconnect switches of the channel type are shown in figure 13 (item 3, fig. 3). Of the 12 phases of the tube-type construction, 3 failed; none of these failures is attributable to the failure of adjacent equipment. Of the 24 channel-type disconnect switches, 22 were damaged, but most were adjacent to equipment that had failed and collapsed.

Figure 13.—Disconnect switch of channel design at the Moss Landing Substation (fig. 1).

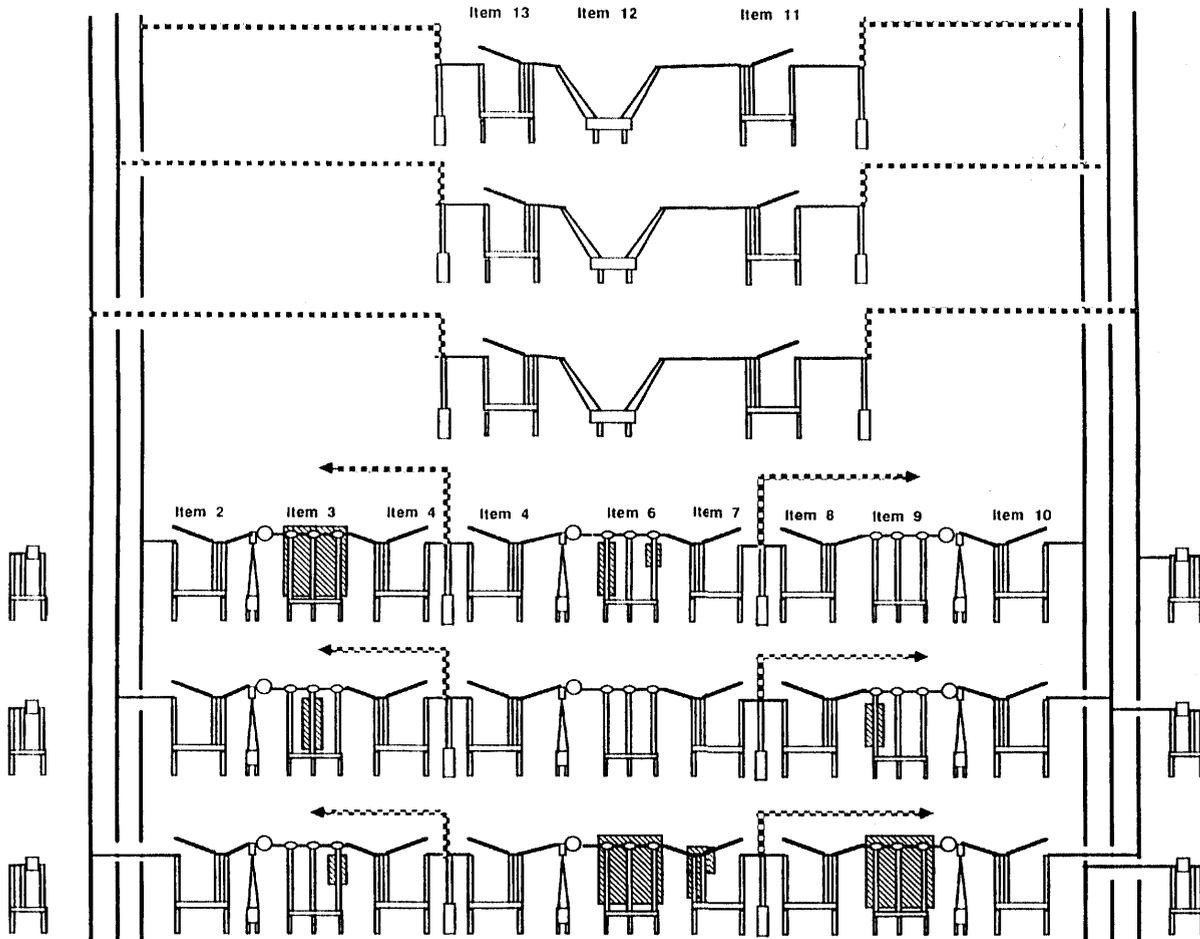
In addition, four line traps, five CCVT's, and 23 air disconnect switches were undamaged. An HVB dead-tank circuit breaker was also undamaged and showed no signs of distress. Bus-support structures and rigid buses were undamaged. A schematic diagram of the 500-kV switchyard is shown in figure 17. This diagram shows all major equipment items for each phase and corresponds to the layout in figure 16. The discussion of the damage to the live-tank circuit breakers at the Moss Landing Substation also applies here. In general, the damage at the Metcalf Substation was less severe. Although friction-clip anchors also failed, the equipment moved only from 2 to 8 in. A smaller fraction of interrupter-head-support columns failed than at the Moss Landing Substation. One disconnect-switch phase failed when it was pulled down by a damaged circuit breaker to which it was connected.

Figure 17.—Schematic diagram of 500-kV switchyard at the Metcalf Substation (fig. 1), showing locations of damaged and removed equipment and numbered items referred to in text. Equipment shown as undamaged may have required repair that was not obvious from cursory inspection. Same symbols as in figure 3.

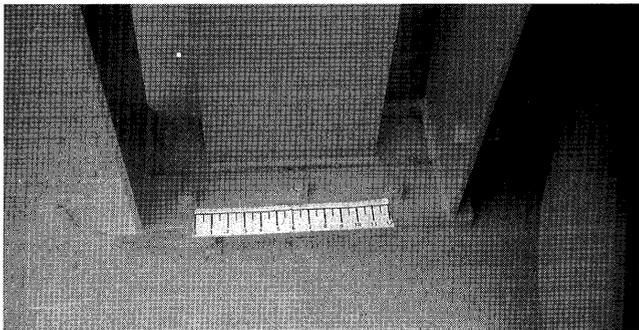
The HVB dead-tank circuit breaker was undamaged and showed no signs of distress. It had been installed on a pad remaining from a live-tank circuit breaker that was damaged in the 1987 Morgan Hill, Calif., earthquake. The three bolts used on each of the four legs are shown in figure 18; the equipment is nearly identical to that shown in figure 12.

Figure 18.—Detail of bolted anchorage on 500-kV dead-tank circuit breaker at the Metcalf Substation (fig. 1).

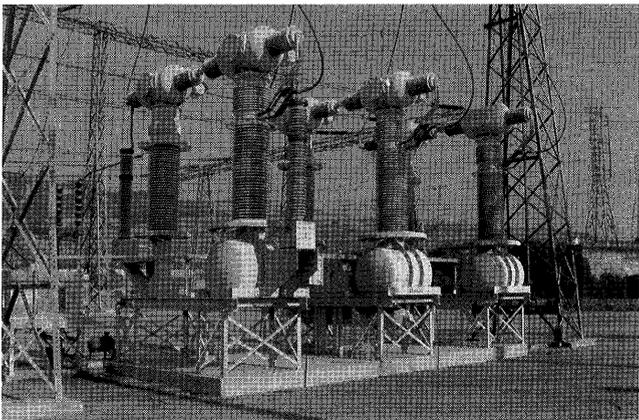
The 230-kV switchyard was undamaged, but some disconnect switches became misaligned, so that they would not reclose once they were opened. The switchyard's two General Electric model ATB6 live-tank circuit breakers were undamaged (fig. 19). In past earthquakes, these circuit breakers were vulnerable to earthquake damage. All other circuit breakers of the oil type or dead-tank type were undamaged.

Figure 19.—Undamaged General Electric model ATB6 live-tank circuit breaker in 230-kV switchyard at the Metcalf Substation (fig. 1).

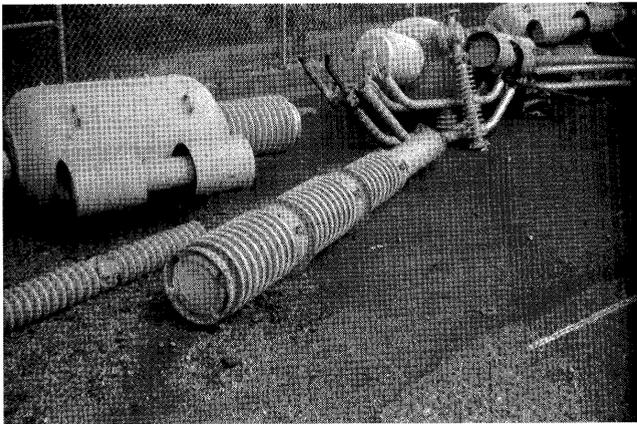
Figure 21.—Interrupter-head-support columns on 230-kV circuit breaker at the San Mateo Substation (fig. 1).

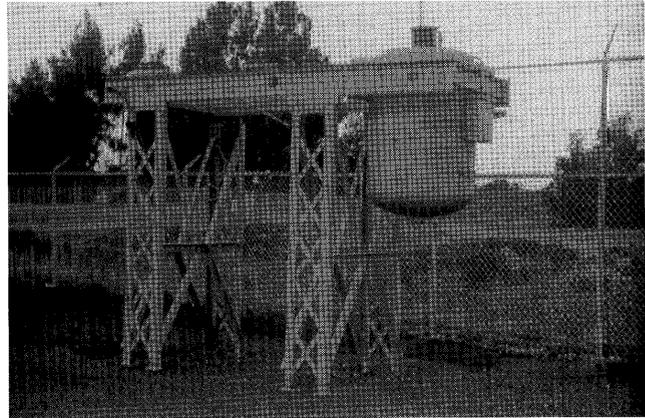
Figure 22.—Support structure of 230-kV live-tank circuit breaker at the San Mateo Substation (fig. 1).

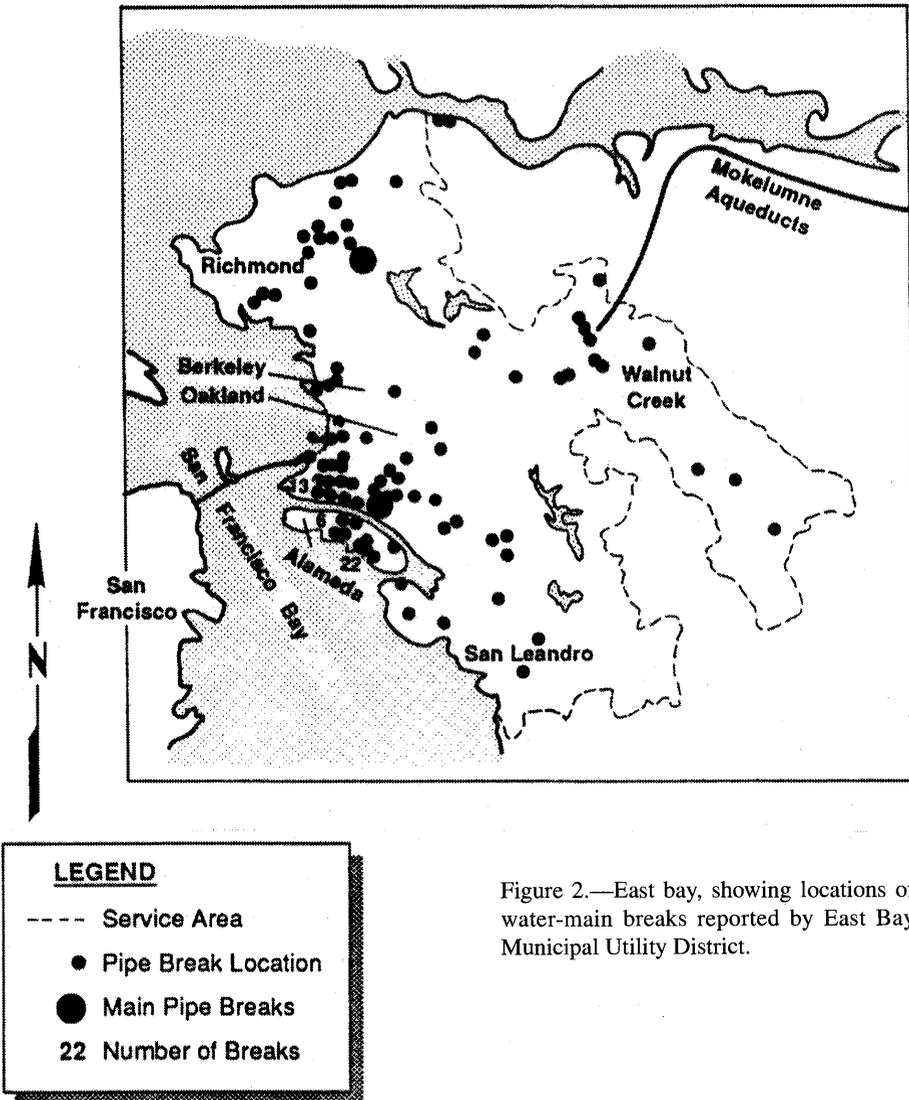
unstable areas the along the bayshore in Oakland, Berkeley, and Alameda (fig. 2), and in San Francisco in the infirm (unstable) areas of the Marina District and South of Market area and along the bayfront. The longitudinal and circumferential breaks occurred mainly in 4-, 6-, and 8-in.-diameter cast-iron pipe (sand cast) with fixed (cement or lead caulked) bell-and-spigot joints. The breaks were due to tension, compression, or bending associated with differential settlement, especially in areas of liquefaction. Corrosion of the pipe and fittings also played a part in some of these breaks. The mains in the Marina District, which were installed in the 1930's and earlier, were unlined (fig. 3). More than 100 repairs were reported in the Marina District out of a total of about 150 in the entire city. San Francisco is replacing the damaged pipe in the Marina District with 9,000 ft of ductile-iron pipe with rubber-gasket joints. Leaks in 20- and 30-in. water mains were fixed with repair couplings. Most of the water-main breaks in Alameda occurred in 6- and 8-in.-diameter welded-steel pipe because of joint corrosion.

Figure 2.—East bay, showing locations of water-main breaks reported by East Bay Municipal Utility District.

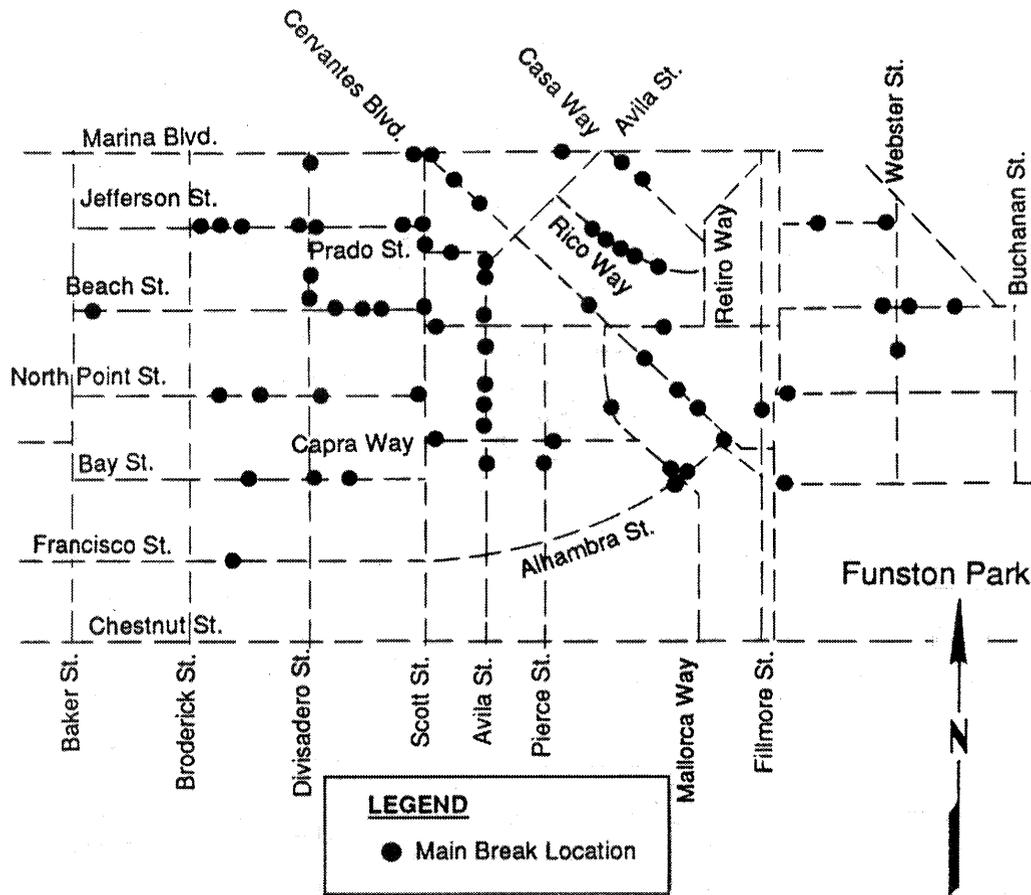
Figure 3.—Marina District of San Francisco (fig. 1), showing locations of water-main breaks reported by San Francisco Water Department.

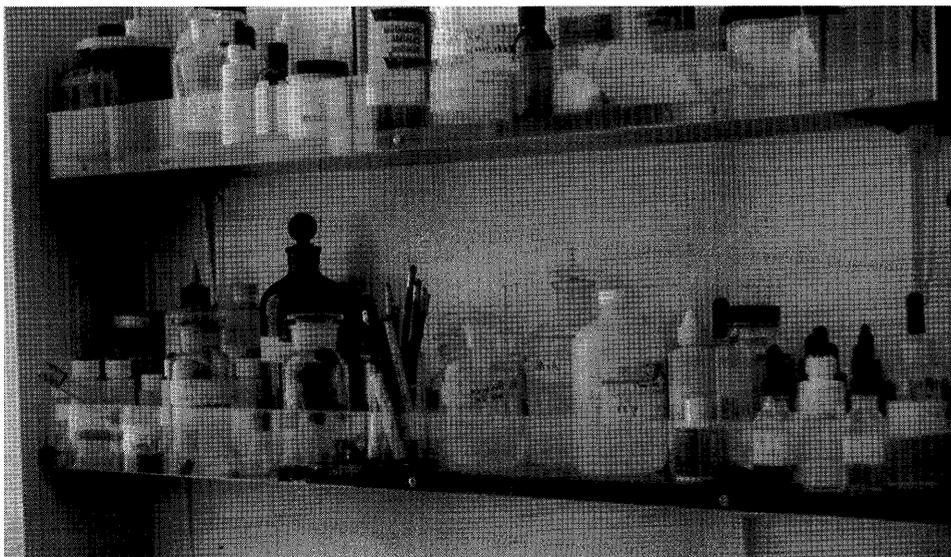
rotating sludge scraper (fig. 6). A fourth clarifier, which was empty at the time of the earthquake, was undamaged and was placed into service within 24 hours. One of the damaged clarifiers was put back into operation as a static chemical mixer for direct filtration, without removing the damaged equipment. The plant operated at 50-percent capacity, adequate for the winter demand, while a contractor repaired the other clarifiers. The water-quality laboratory performed well, even though some unanchored equipment moved. Restraining devices kept bottles containing chemicals on their open shelves (fig. 7).

Figure 7.—Chemical shelves in water-quality laboratory at the Rinconada Water Treatment Plant, showing restraining devices.

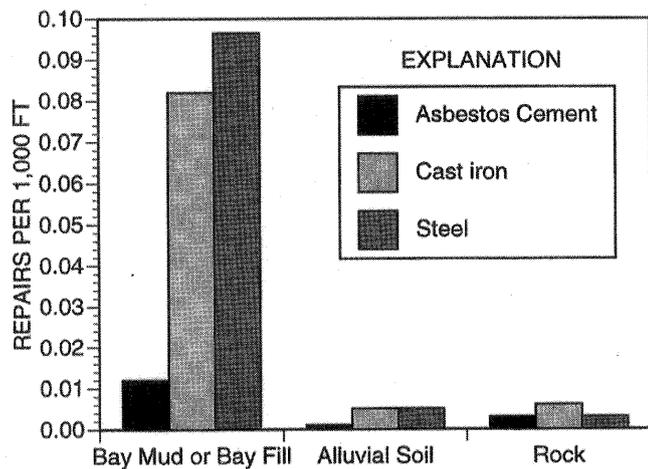
The repair rates for cast-iron, asbestos-cement, and steel pipe according to soil unit are plotted in figure 4. (PVC pipe

Figure 4.—Pipe-repair rate versus soil type.

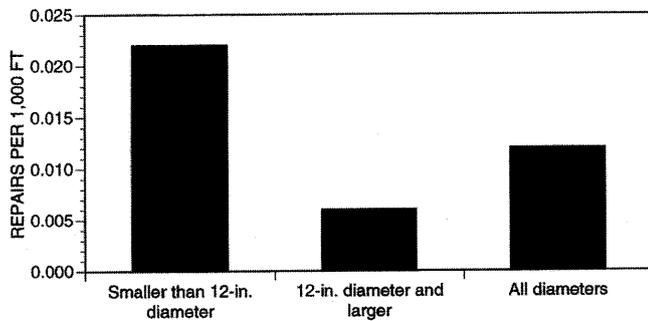
The repair rates for steel within two different diameter ranges are plotted in figure 5. Note that smaller-diameter steel pipes had a higher repair rate, probably owing to two contributing factors. (1) Smaller diameter pipes tend to have a large number of bends, branches, and service laterals that produce virtual anchorpoints. These anchorpoints, in turn, contribute to damage under seismic motions. (2) Smaller-diameter pipes are thinner walled, making them more susceptible to corrosion.

Figure 5.—Pipe-repair rate for steel pipe, by diameter.

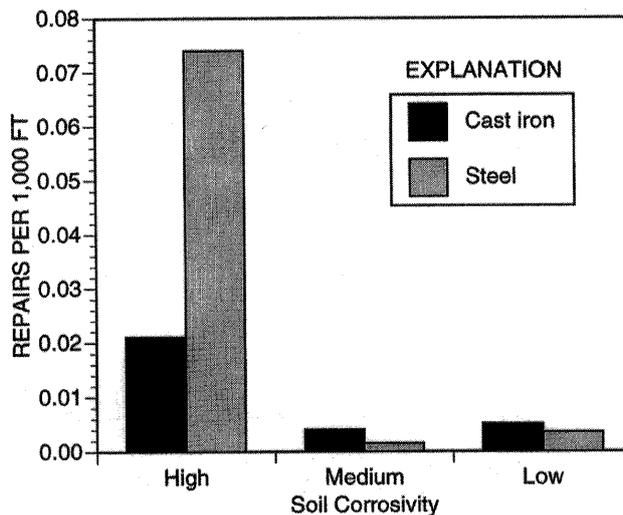
The repair rates for cast-iron and steel pipe according to relative soil corrosivity are plotted in figure 6. In areas where corrosion is not too important (noncorrosive and medium-corrosivity soils), segmented cast-iron pipe fared worse than welded steel pipe, as expected, whereas in areas where corrosion is important (high-corrosivity soils), welded steel pipe fared worse than segmented cast-iron pipe. Note that both PGV's and PGD's in high-corrosivity soils vary considerably. Downtown Oakland, which has mostly cast-iron pipe and is in a high-corrosivity-soil area, had only about one-third the level of PGV relative to the dominantly steel pipe inventory

located on Alameda Island in high-corrosivity soils. Although these factors tend to mask one another, the trend is that steel pipe is more susceptible than cast-iron pipe to corrosive-soil environments, all other factors being equal.

Figure 6.—Pipe-repair rate for cast-iron and steel pipe versus corrosive-soil type.

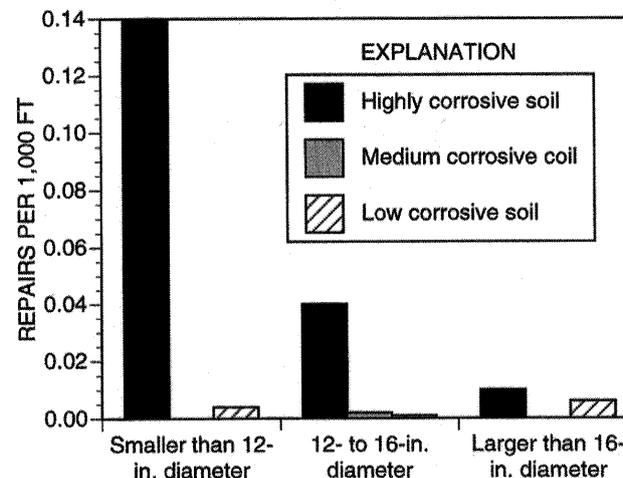
The repair rate for steel pipe versus diameter for the different corrosive soils is plotted in figure 7. Steel pipe shows the influence of diameter in high-corrosivity soils, with larger repair rates for smaller-diameter pipe than for large-diameter pipe. In figure 7, both PGV's and PGD's are relatively constant within each category, indicating that diameter dependency is important for steel pipe in high-corrosivity soils.

Figure 7.—Pipe-repair rate for steel pipe, by diameter and corrosive-soil type.

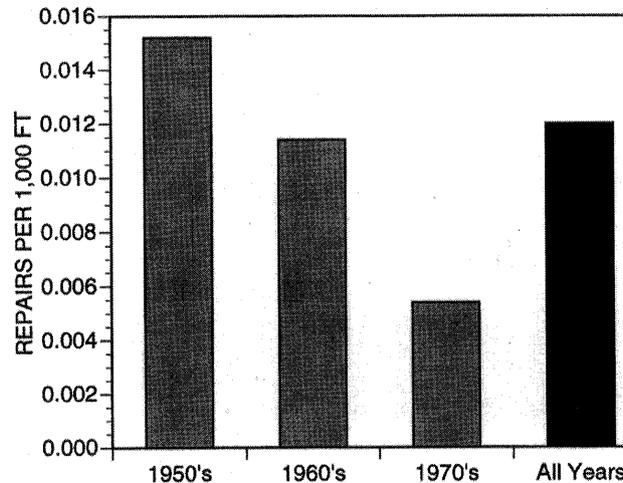
The data plotted in figures 6 and 7 indicate that corrosion effects are important for steel pipe and, to a lesser extent, for cast-iron pipe. (Note that most of the cast-iron and steel pipe inventory is in either medium- or low-corrosivity soils). Because corrosion is a continuing process, its effects should increase over the time since initial installation. The resulting repair rate according to the decade when the steel pipe was installed is plotted in figure 8, showing that corrosion does have a time dependency and that older steel pipe has a higher repair rate.

Figure 8.—Pipe-repair rate for steel pipe, by decade installed.

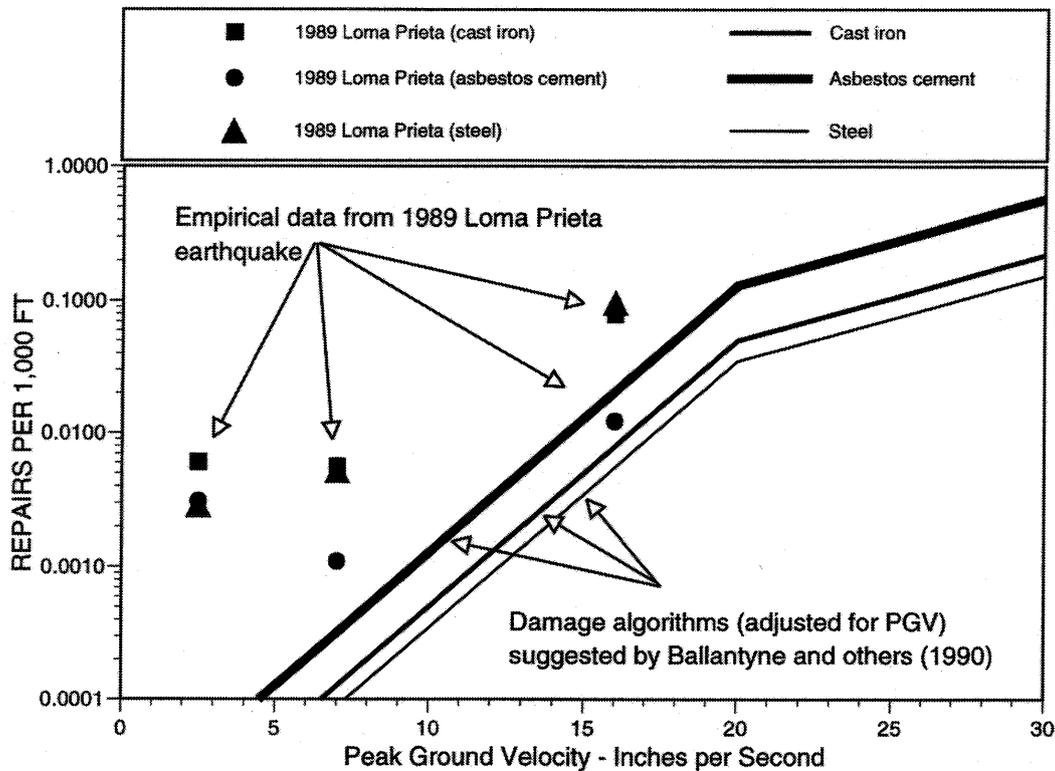
The pipe repair rates for the actual Loma Prieta earthquake data (digitized points) versus the pipeline-fragility curves of Ballantyne and others (1990) are plotted in figure 9. Note that the work by Ballantyne and others related pipe-repair rates to modified Mercalli intensity (MMI), whereas the current work relates pipe-repair rate to PGV. Accordingly, an MMI of VIII was equated to a PGV of 20 in/s, which reasonably matches the empirical building damage versus instrumental readings. Similarly, an MMI of IX was equated to a PGV of 25 in/s, and so on.

Although the Loma Prieta empirical repair rate at low PGV's (less than 10 in/s) exceed those in Ballantyne and others (1990) by a large amount (factor of 10 or more), the low absolute values of these repair rates are not extremely important for overall system-analysis purposes. For example, by using the pipeline-fragility curves of Ballantyne and oth-

Figure 9.—Empirical pipe repair rate (symbols) compared to damage algorithms of Ballantyne and others (1990).

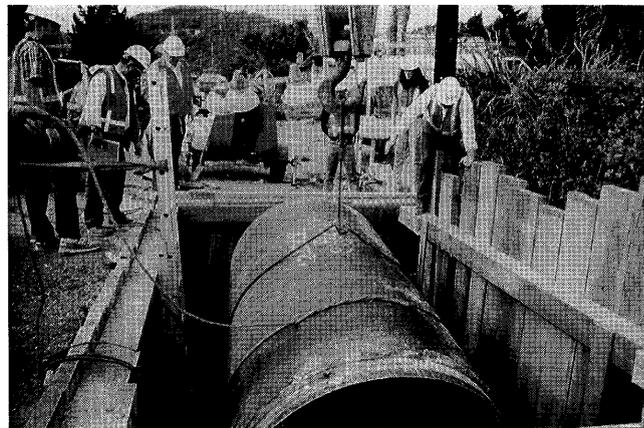
Figure 2.—Repair crew replacing section of split 60-in.-diameter raw-water line shown in figure 1.

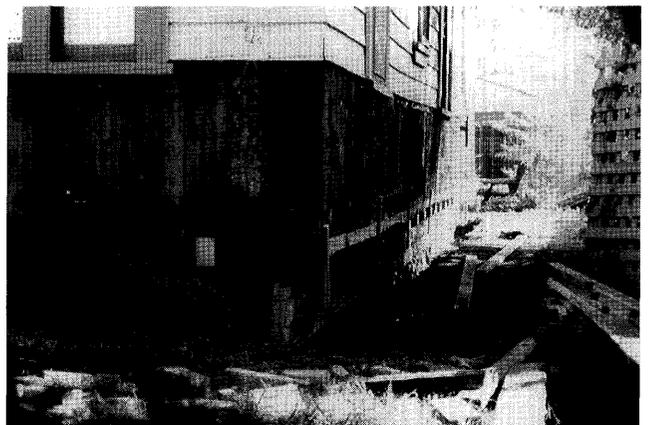
Figure 6.—Repair of cripplewall in a private residence in Hollister.

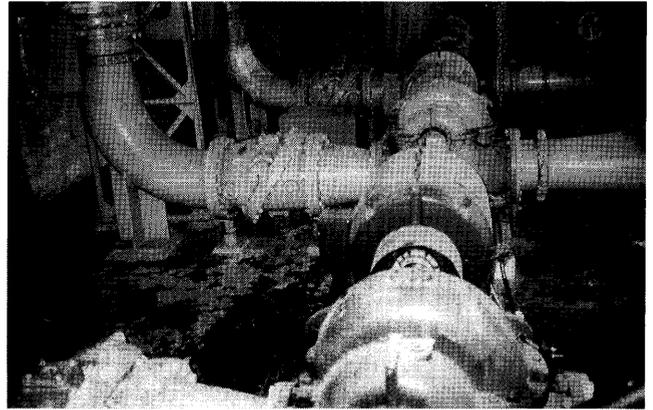
year, causing the pipe shown in figure 11 to become inclined from its originally vertical position. In a pumphouse located about one block from this pipe, creep has caused gradual movement of the supports for the suction and discharge piping of several pumps (figs. 12, 13).

Figure 12.—Interior of water-pumping plant located near the Hayward fault in Oakland. Note pipe supports.

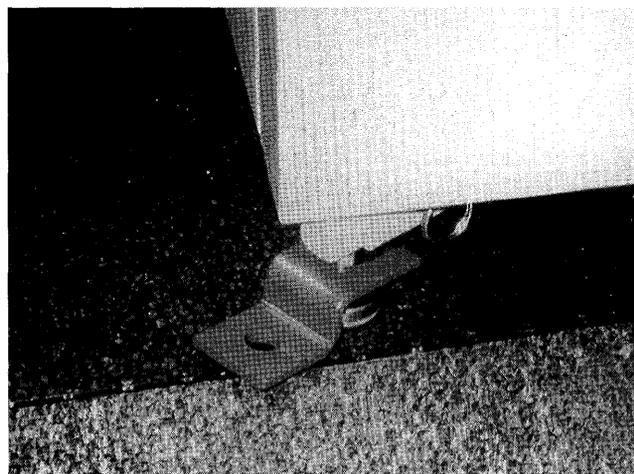
Figure 14.—Typical anchor clip for an electronics cabinet, use to prevent it from overturning.

Utilities should ensure that all equipment is positively anchored. Note that the anchor clip for the electronics cabinet shown in figure 14 provides a more secure restraint than

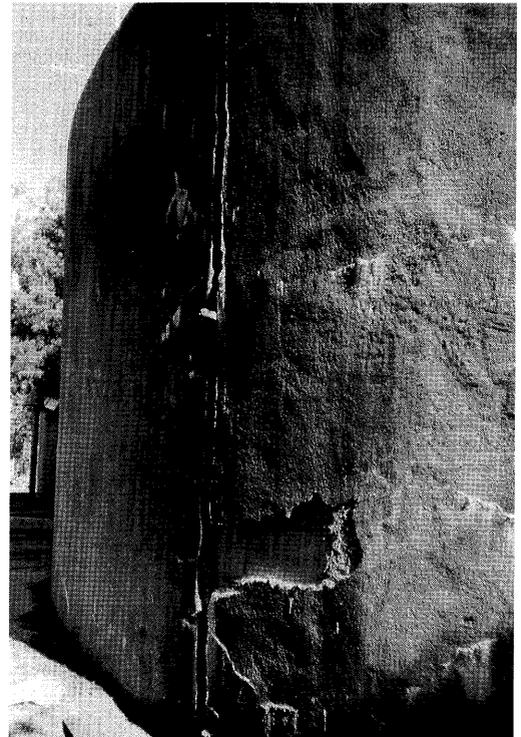
For example, earthquake-induced ground and water motion significantly damaged a concrete tank in the Purisima Hills Water District (figs. 17, 18). This wire-wound posttensioned-concrete tank was constructed in 1964 by alternate pours of the vertical panels. The earthquake caused the collapse of the col-

Figure 17.—Wire-wound posttensioned-concrete tank in the Purissima Hills Water District. Tank was constructed in 1964 by alternating pours of vertical panels.

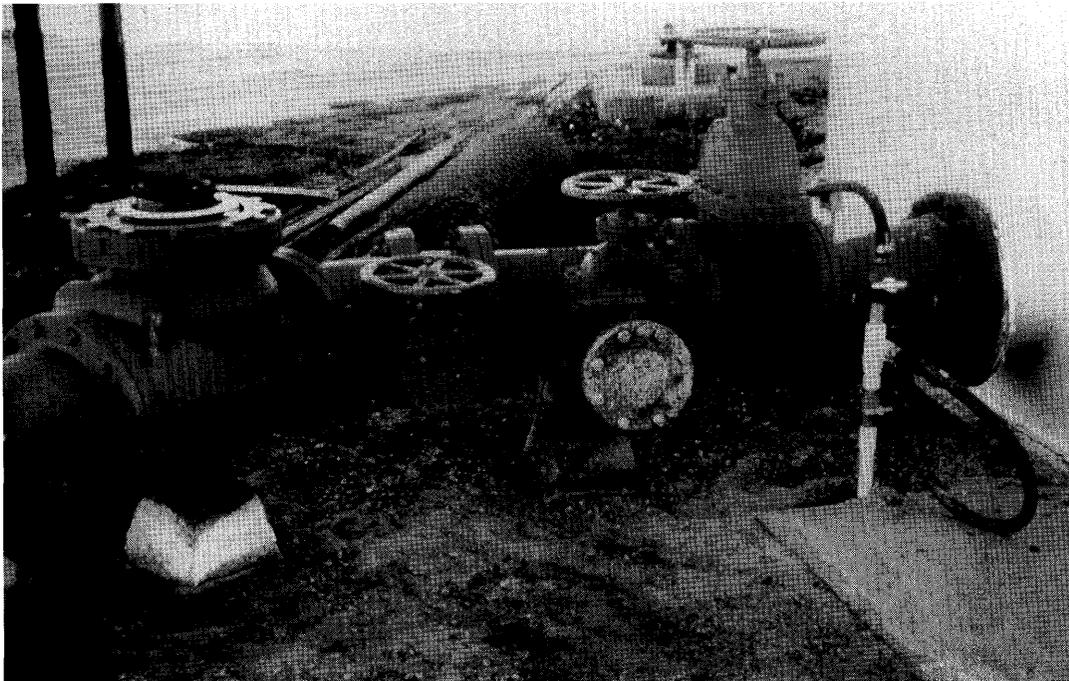
Figure 19.—Pipe connections to water tanks should be flexible enough to allow at least 6 in. of differential movement (both horizontal and vertical) between tank and piping.

Because tanks are susceptible to significant motion of their contents and support pad, the flexibility of the waterline connections to the tank is vitally important. Flexible connections should be provided that will allow relative motions of at least 6 in. (vertically and in both horizontal directions) between the tank and the waterlines (fig. 19).

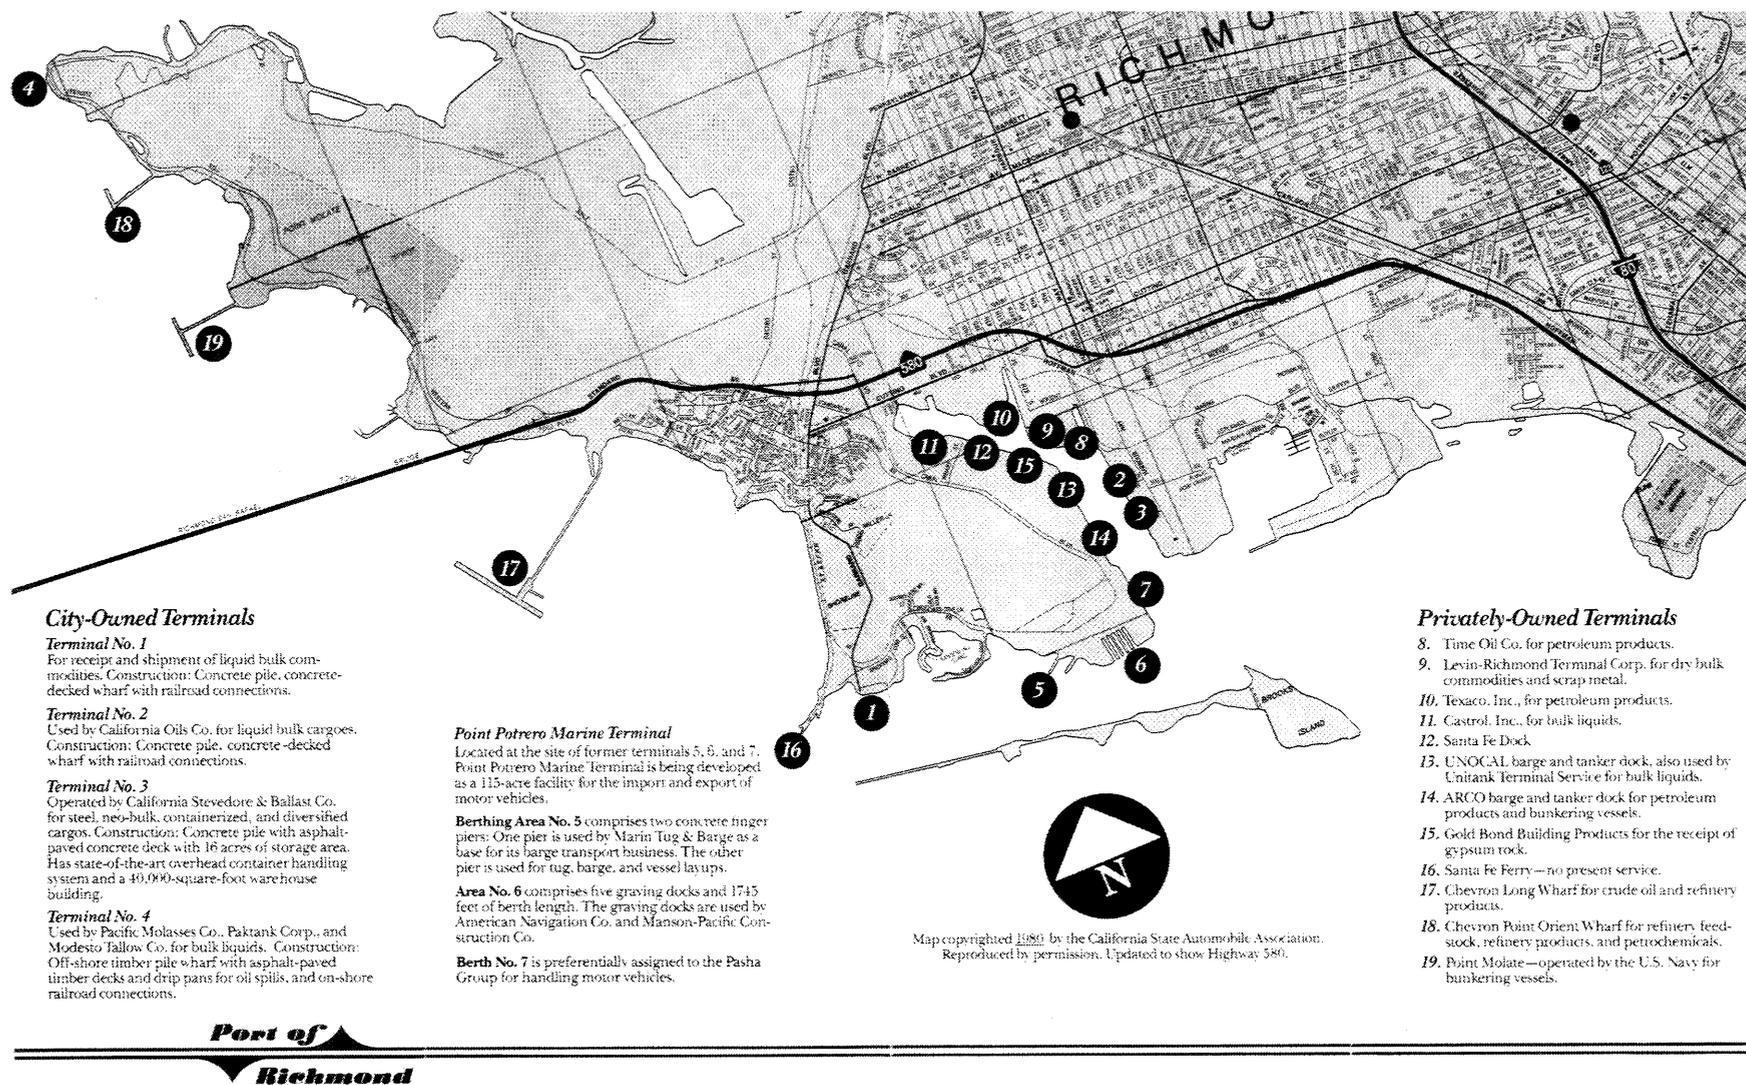
Figure 3.—Layout of the Seaport of Richmond.

The primary earthquake damage sustained by the Seaport of Richmond was a ruptured gasoline-storage tank at the Unocal terminal (Terminal 13, fig. 3). Fuel from this tank was contained by the surrounding berm. Some liquefaction occurred at the undeveloped areas on fill south of Terminal 3. Sand boils erupted at Terminal 3, and waterlines were broken at the Ford Motor Co. plant located on fill east of Terminal 3.

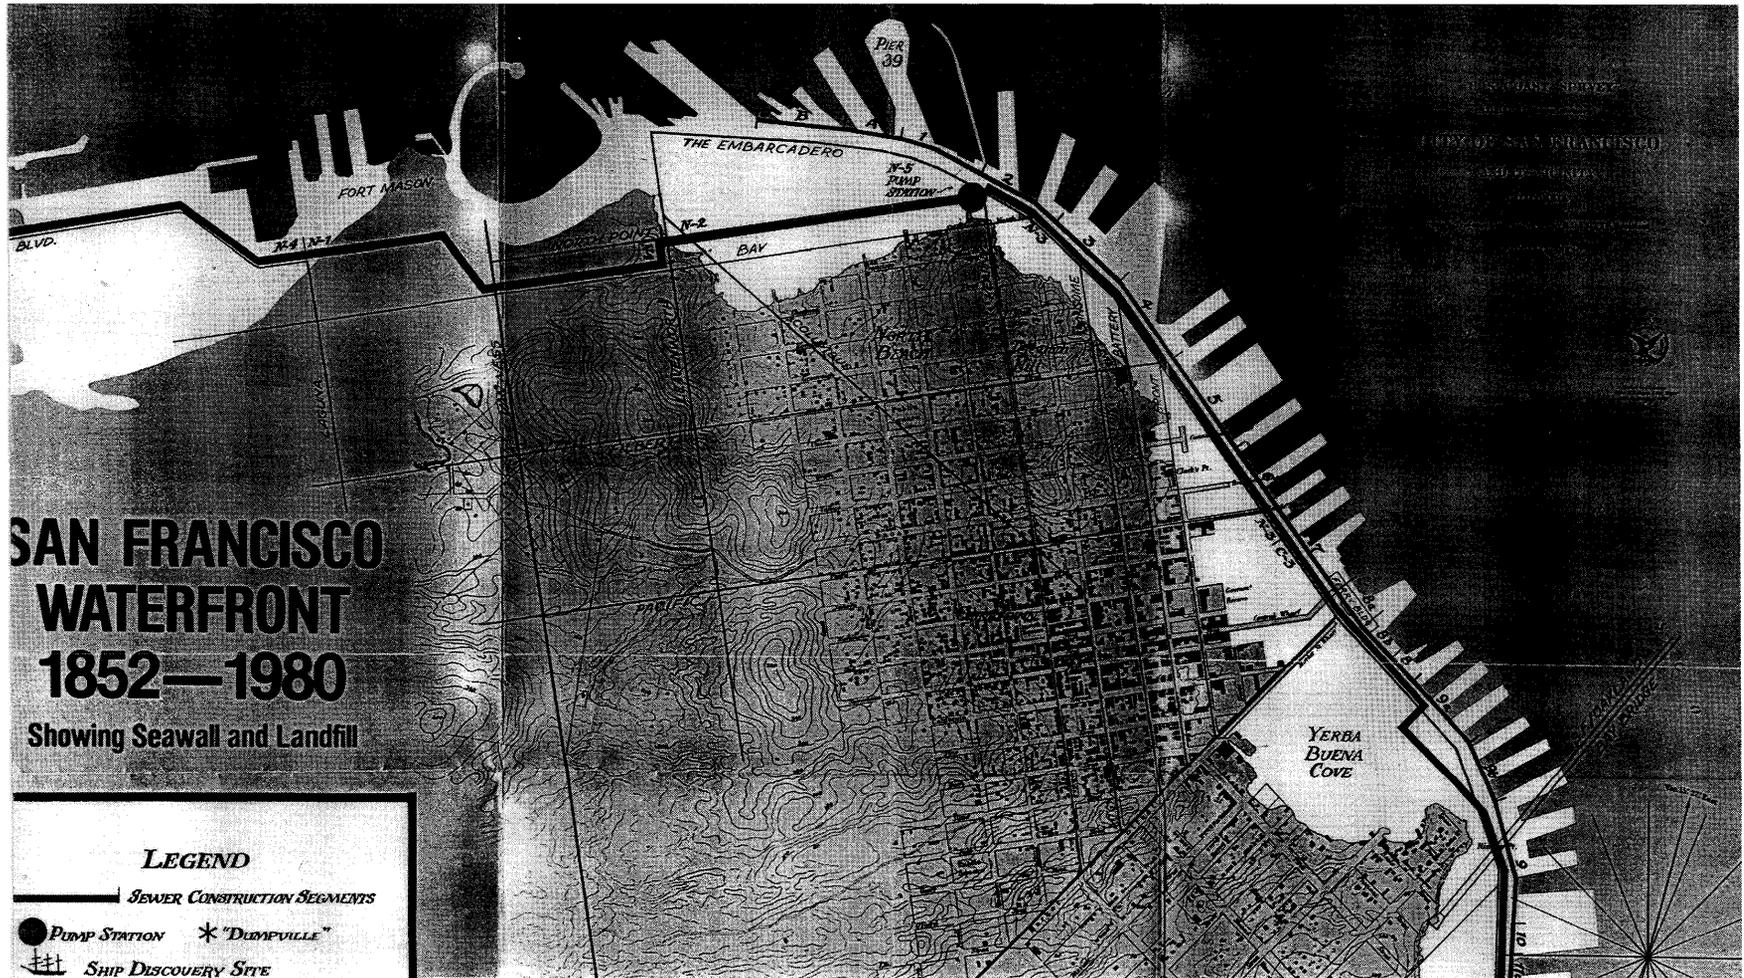
Figure 4.—Seaport of San Francisco and landfill areas.

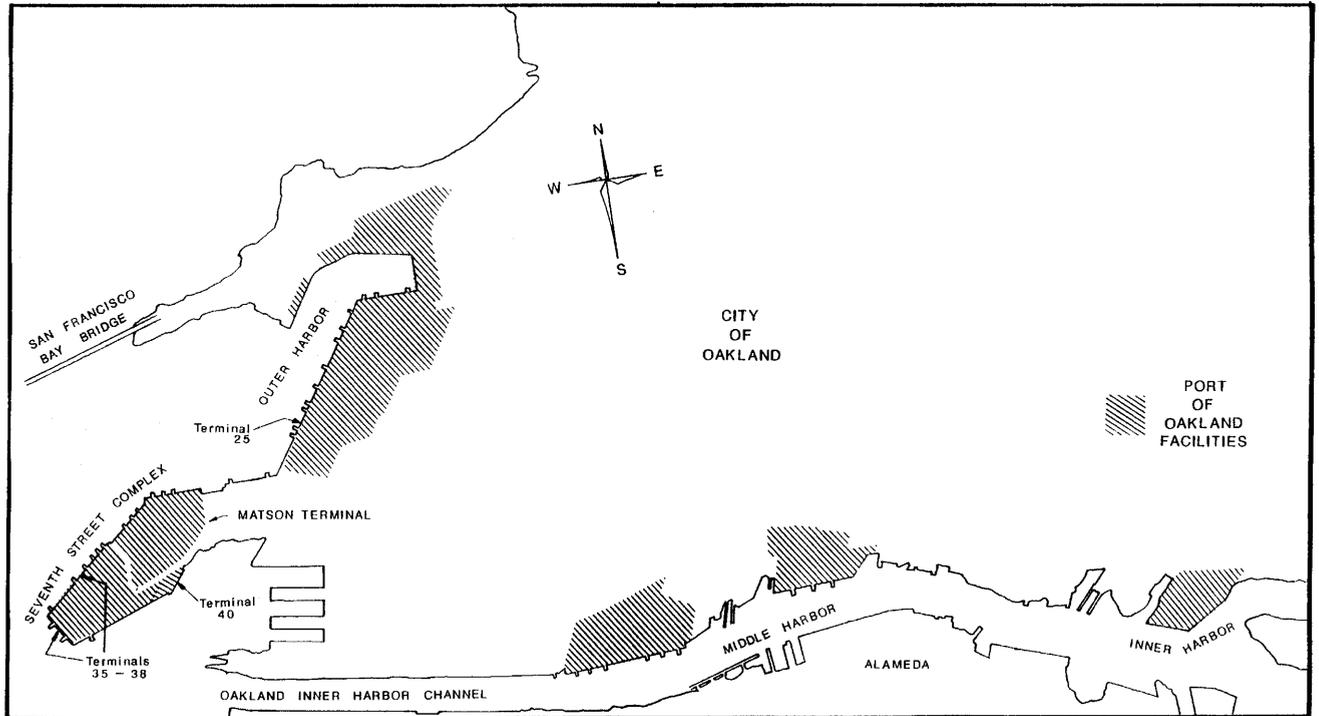
Initially, earthquake damage at the Seaport of Oakland was estimated at \$75 million. Damage occurred primarily at the Seventh Street Complex and the Middle Harbor; the Inner and Outer Harbors were relatively undamaged. As at the Seaport of San Francisco, the primary cause of damage was liquefaction of the fill and the resulting settlement and spreading of areas on fill relative to areas supported by piles. The many broken waterlines and fire lines washed the fine material from the soil, causing both settlement and uplift of the asphalt pavement at numerous places throughout the seaport. Concrete batter piles were broken at the Seventh Street Complex terminals and at the Matson Terminal; a cross section of these terminals is shown in figure 6. The piles support a concrete deck covered by 3 ft of sand through which utility lines run; 3 in. of asphalt pavement covers the sand. The damage to piles at this terminal resulted from the inertial forces generated by the large mass supported on top of these piles. A horizontal ground acceleration of 0.29 *g* and a vertical ground acceleration of 0.07 *g* were measured at Terminal 25 of the Outer Harbor; a horizontal acceleration of 0.45 *g* was measured on the wharf at Terminal 25. Wood piles with concrete

to the crane rail on piles, making the container cranes inoperable. The rail spur serving Terminal 40 was out of service because of horizontal and vertical displacement of the rails on fill relative to the part of the spur supported by piles. Significant settlement and separation of the truck-access road to Terminals 35 through 38 at the Seventh Street Complex occurred as a result of liquefaction.

Figure 5.—Seaport of Oakland and facilities.

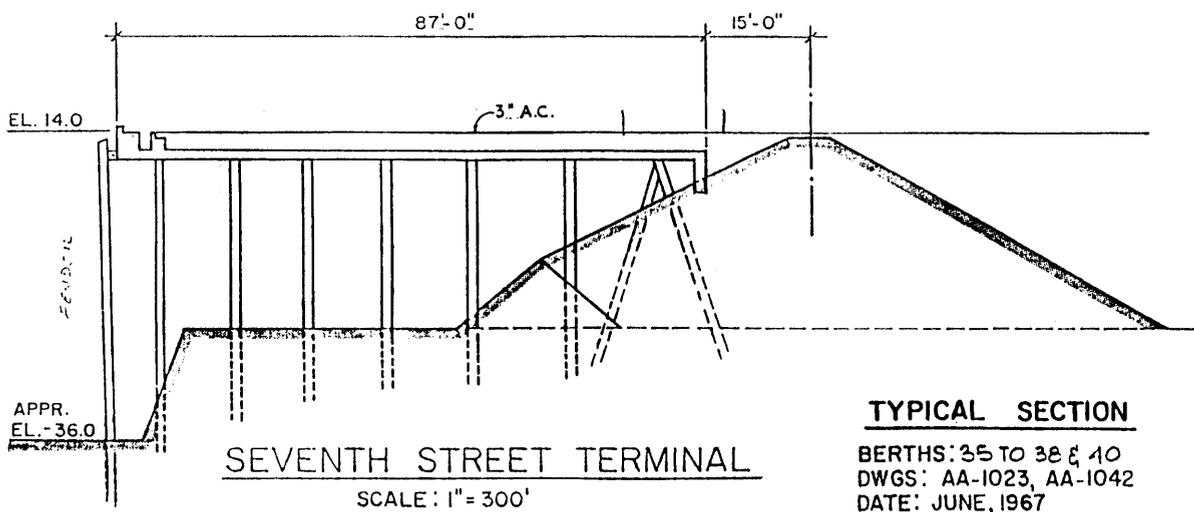
Figure 6.—Typical cross section of the Seventh Street Terminal at the Seaport of Oakland.

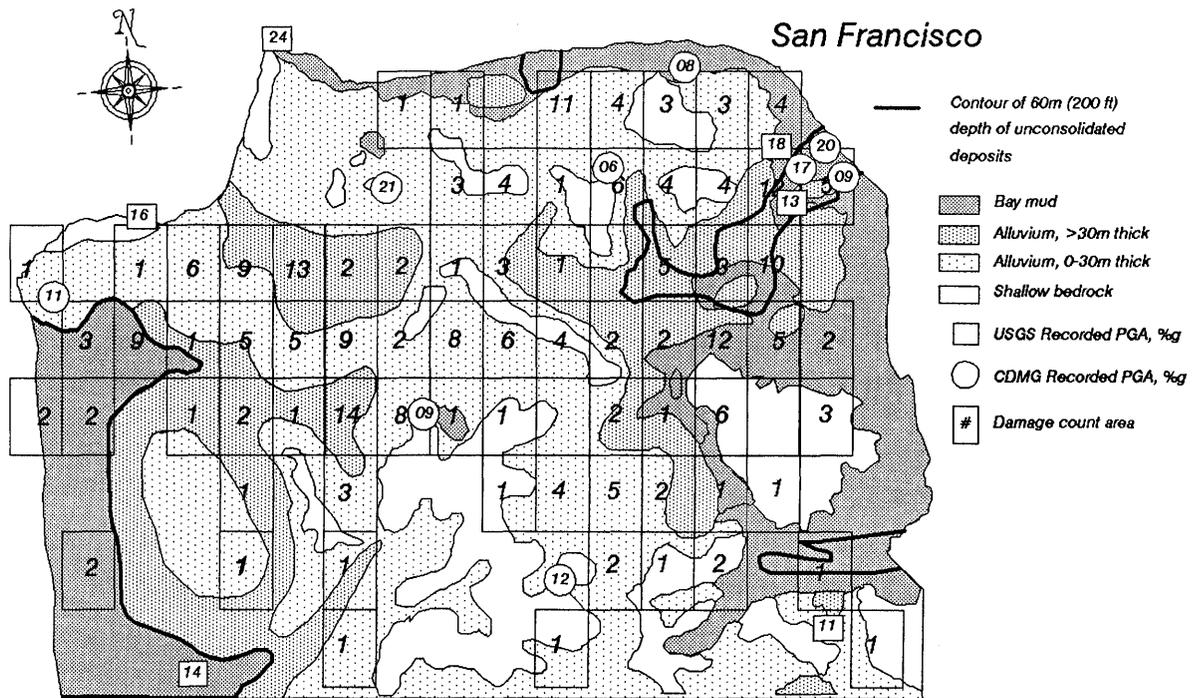
Figure 1.—Northern part of San Francisco, showing correlation of grade I leak repairs with surficial deposits and recorded ground motions. CDMG, California Division of Mines and Geology; PGA, peak ground acceleration; USGS, U.S. Geological Survey.

A comparison of the locations of grade I leak repairs with surficial soil deposits and peak ground acceleration is shown in figure 1. Some correlation is evident between higher numbers of repairs and the sites of deep alluvial deposits. When the exact addresses of repairs are examined, a qualitative trend is evident for higher incidences of repairs near the boundaries between different soil deposits. However, this trend is not evident in figure 1 because of grouping of the data according to plat-map boundaries.

As expected, no correlation is evident between the pattern of leak repairs and peak ground acceleration, possibly partly as a result of different concentrations of gaslines in the vicinity of seismic recording stations and the sparsity of seis-
