The Loma Prieta, California, Earthquake of October 17, 1989—Lifelines

PERFORMANCE OF THE BUILT ENVIRONMENT
Thomas L. Holzer, *Coordinator*

U.S. GEOLOGICAL SURVEY PROFESSIONAL PAPER 1552-A

LIFELINES

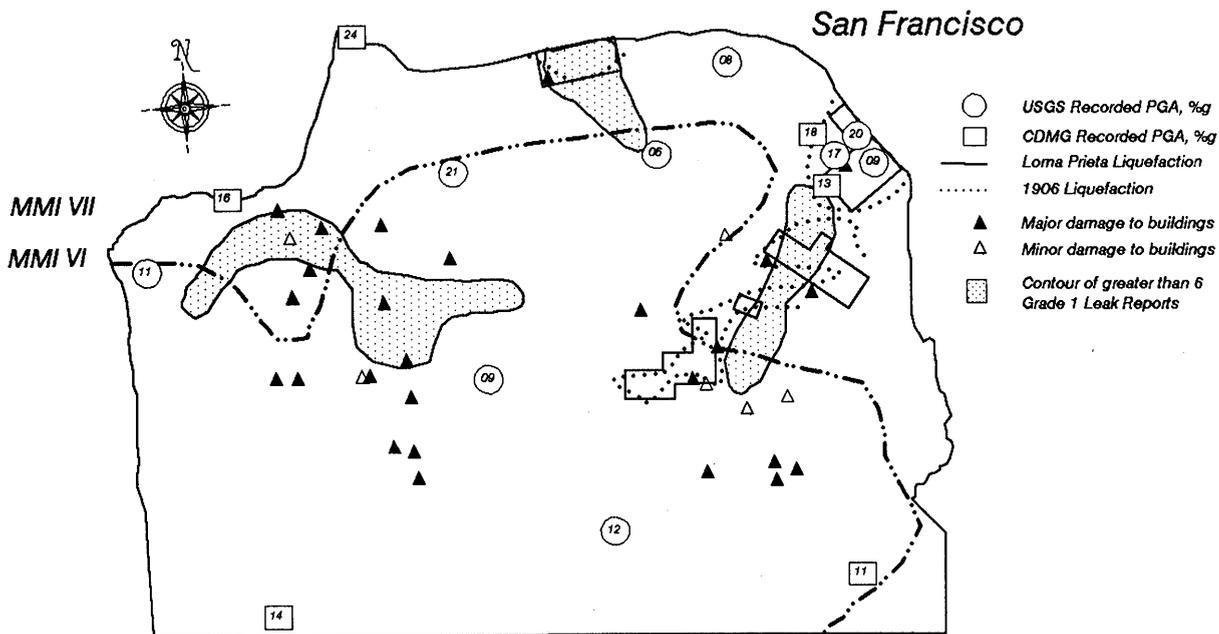
Figure 2.—Northern part of San Francisco, showing correlation of grade I leak repairs with areas of observed liquefaction and building damage. CDMG, California Division of Mines and Geology; MMI, modified Mercalli intensity; PGA, peak ground acceleration; USGS, U.S. Geological Survey.

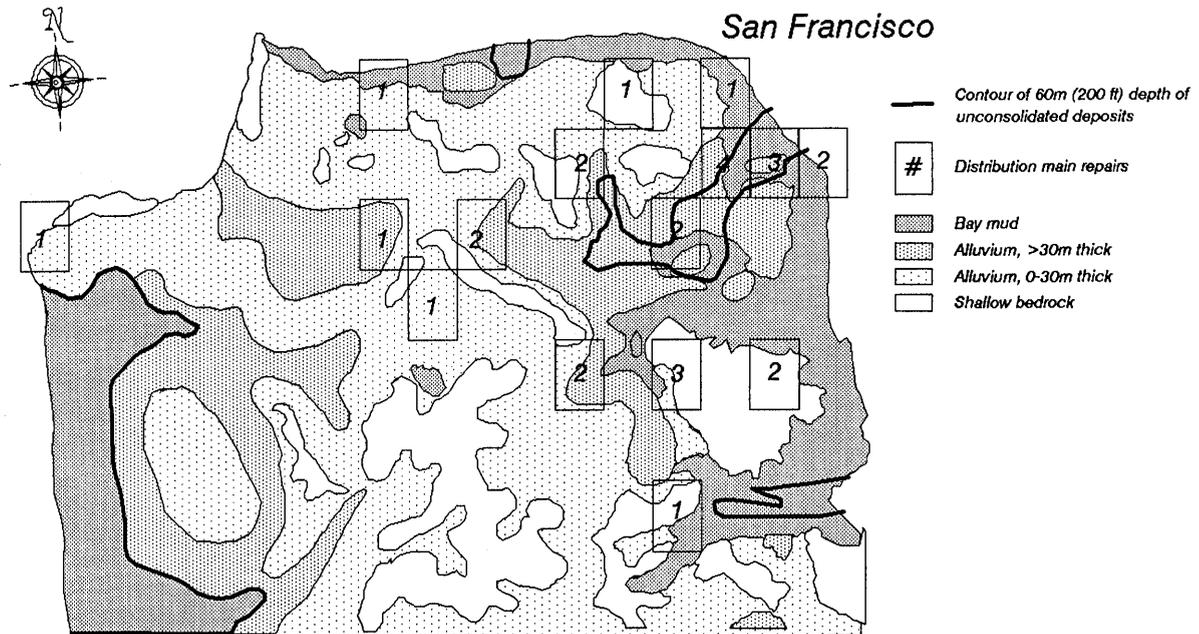
As mentioned above, most of the repairs addressed service lines. Because of the few repairs to gas-distribution mains, the correlations made are only tentative. The distribution-main repairs by PG&E are mapped in figure 3. The concentration of distribution-main repairs generally follows that for the total data base, with more repairs in the northeast quadrant of the city near Market Street. Nearly 50 percent of the distribution-main repairs are located north of Market Street and east of Leavenworth Street. Areas with distribution main repairs are mapped along with building damage, liquefaction, and MMI in figure 4. Distribution-main repairs correlate reasonably well with the sites of liquefaction during the 1906 San Francisco and 1989 Loma Prieta earthquakes. Except for this trend, the concentration of distribution-main repairs does not closely match that observed for service lines.

Figure 3.—Northern part of San Francisco, showing correlation of grade I distribution-main repairs with areas of surface deposits.

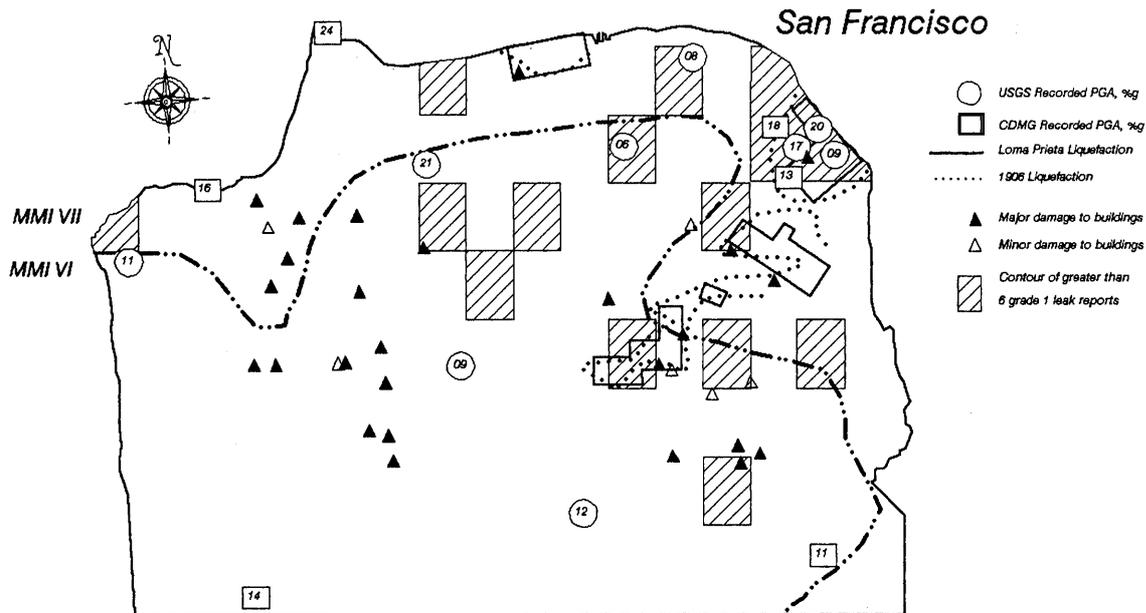
Figure 4.—Northern part of San Francisco, showing correlation of grade I distribution-main repairs with areas of observed liquefaction and building damage. CDMG, California Division of Mines and Geology; MMI, modified Mercalli intensity; PGA, peak ground acceleration; USGS, U.S. Geological Survey.
