Water-Supply Paper 866-C

**GEOLOGY OF DAM SITES ON THE
UPPER TRIBUTARIES OF THE COLUMBIA RIVER
IN IDAHO AND MONTANA**

**Part 3. MISCELLANEOUS DAM SITES ON THE
FLATHEAD RIVER UPSTREAM FROM
COLUMBIA FALLS, MONTANA**

By
C. E. ERDMANN

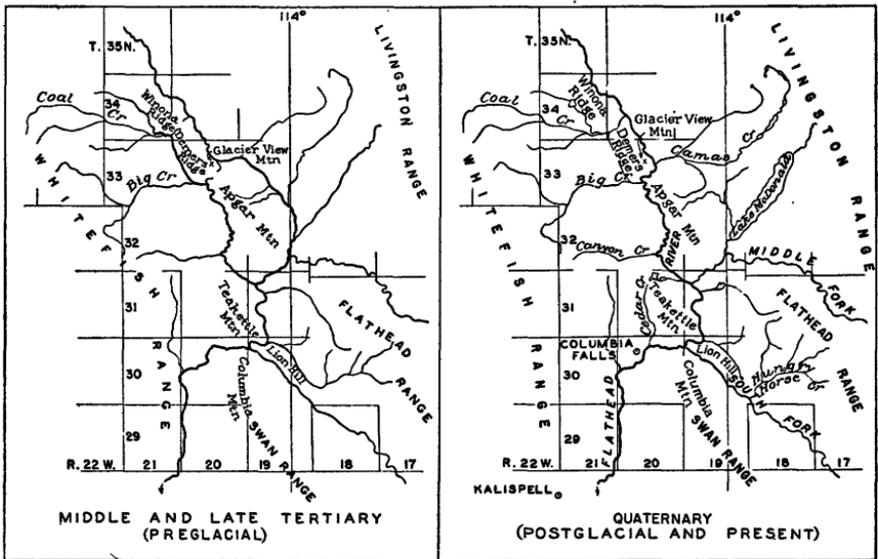
FIGURE 9.—Map showing probable major drainage changes of the upper Flathead River, Flathead County, Mont.

principal tributaries was the south-flowing consequent stream west of Apgar Mountain, here named Apgar River but now constituting the Flathead (North Fork) between Middle Fork and Big Creek. This relationship is strongly asserted by the topography and drainage pattern in the neighborhood of Glacier View Mountain. The generalized drainage pattern at the close of the first epoch of river superimposition is shown in figure 9 (Tertiary).

After the second epoch of basin filling, superimposition occurred again. The present course of the Flathead (North Fork) through Glacier View Canyon was established over the divide connecting Apgar Mountain and Demers Ridge. This change resulted in the abandonment of the old subsequent valley east of Apgar Mountain, and the capture of its headwaters by Apgar River. (See fig. 9, Quaternary.) These events well illustrate the complex character of this branch of Flathead River. Its upper reaches are in a subsequent valley of structural origin; the lower part flows through a consequent valley; and the short connecting stretch is superimposed and is younger than the parts it joins. Below Middle Fork, it again enters a superimposed valley, probably later made antecedent by successive minor movements on the Swan fault. Another change that took place at this time was the loss of part of the headwaters of Apgar River to Coal Creek, which had succeeded in cutting through the Winona-Demers Ridge. These changes, with the later blocking of the subsequent valley by glacial debris, were responsible for the creation of the Glacier View reservoir, the largest storage basin in the upper Flathead drainage basin.
